Former Coolidge Bus Terminal
 Existing Parcel

FORMER COOLIDGE BUS TERMINAL
 ASBESTOS SURVEY

TITLE COOLIDGE SITE:
BUS GARAGE

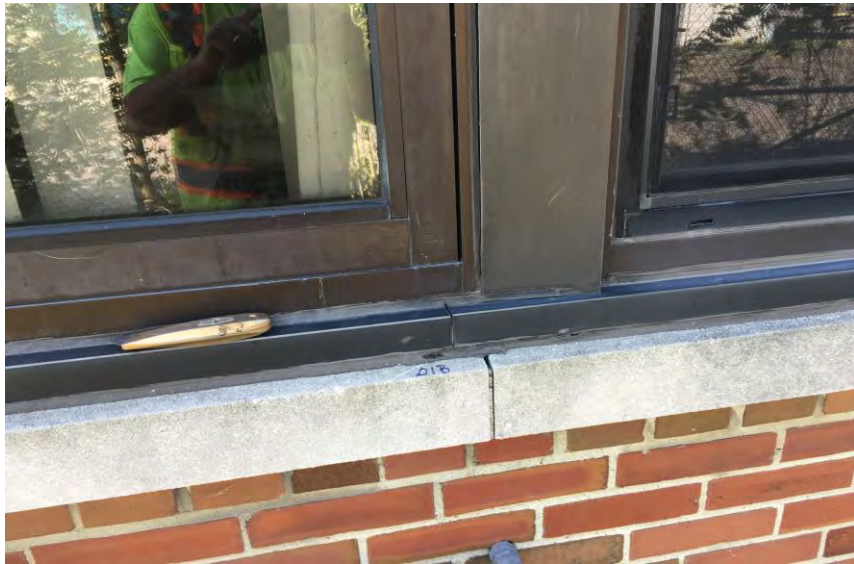
Sample #1 a Brown Caulk of Terminal Building

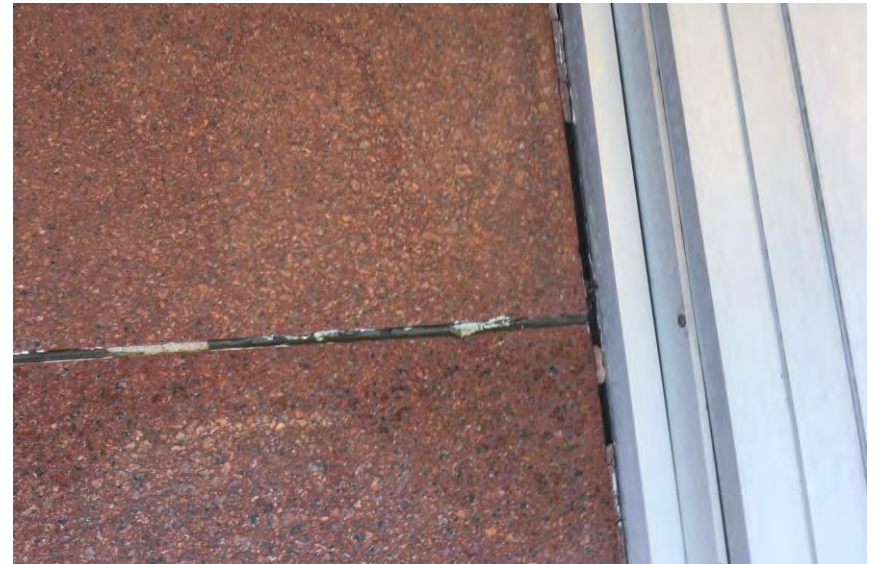
Sample #5 Red Caulk on the South side of Terminal Building

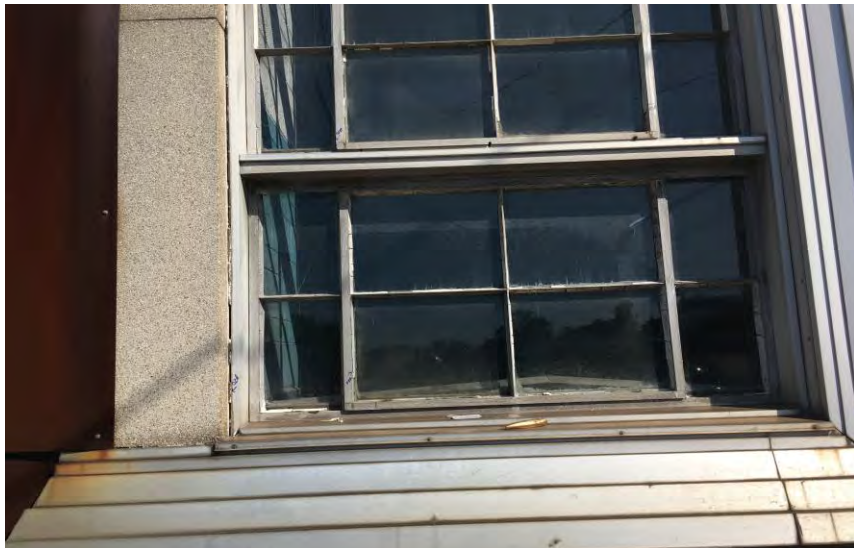
Sample # 2, 3 and 4 Caulk, Gray and White Window Glazing on Terminal Building

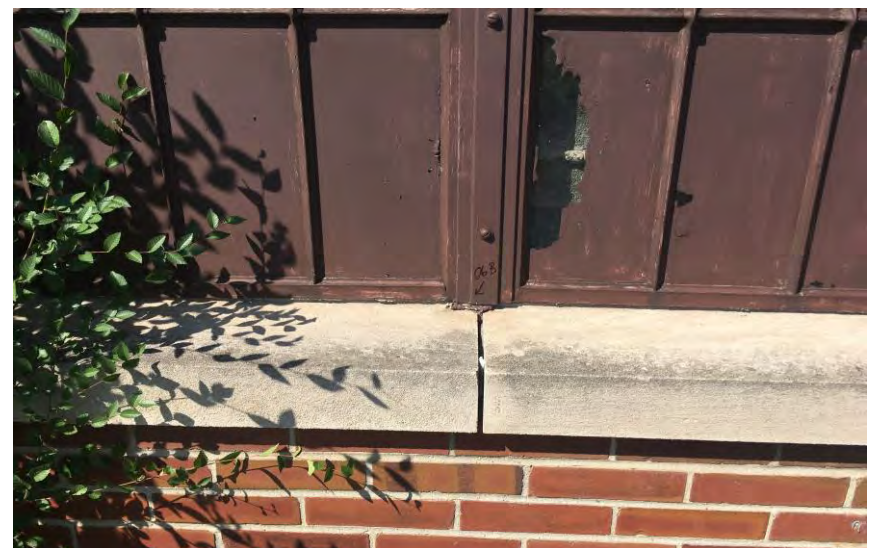
Sample #6 Painted Caulk East side of Terminal Building

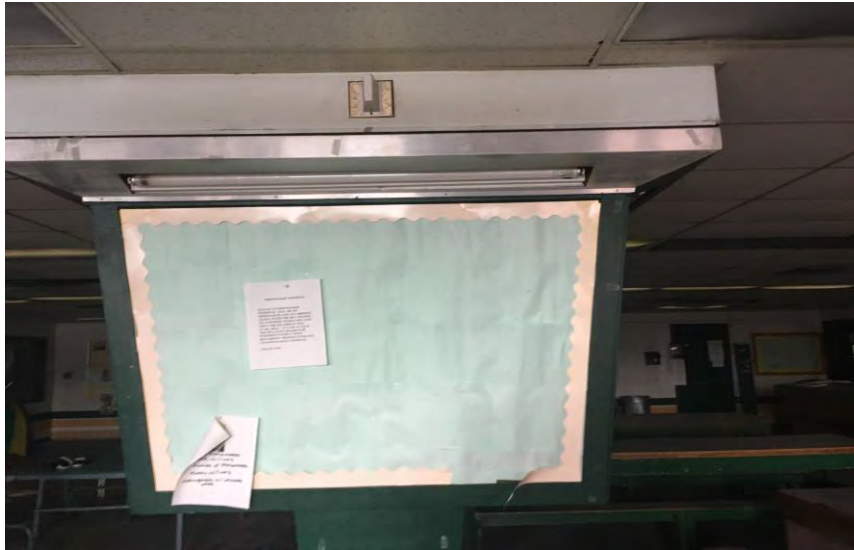
Message Boards in the Terminal Building

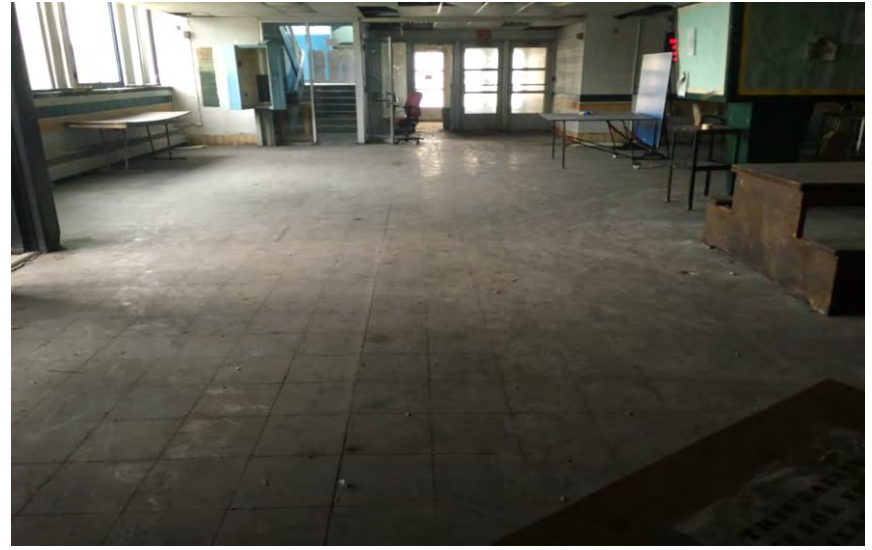
Sample #23 9"x 9" VFT under the 12" Tiles in Terminal Building

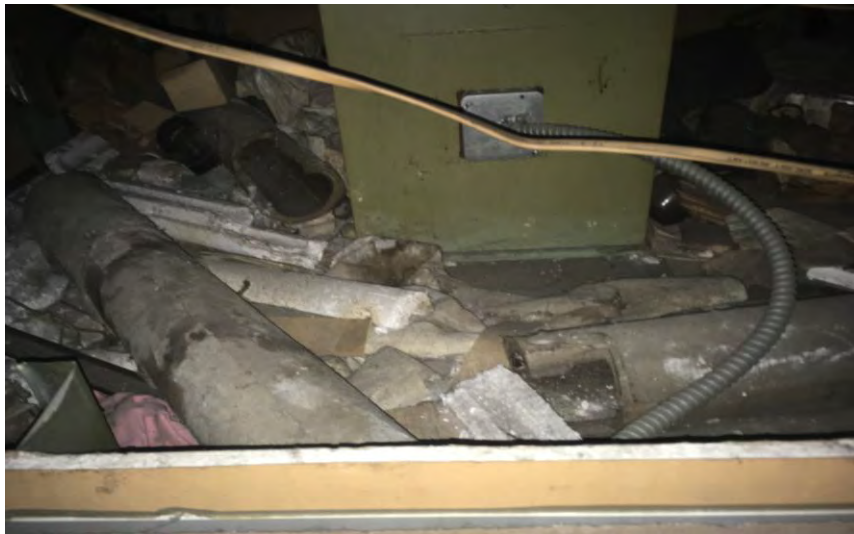
Pipe Insulation that is above the Message Boards in the Terminal Building

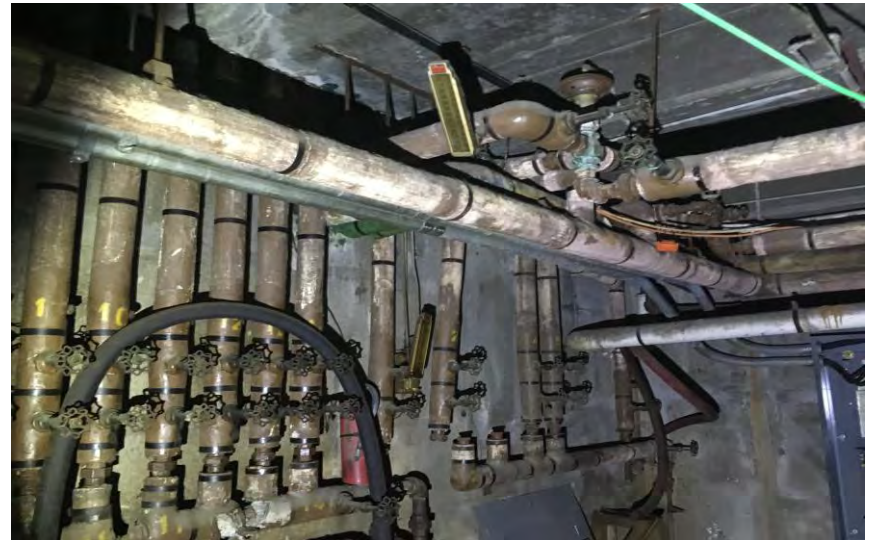
Aircell Insulation and Mercury Thermometers in the Basement to the Tunnel in the Terminal Building

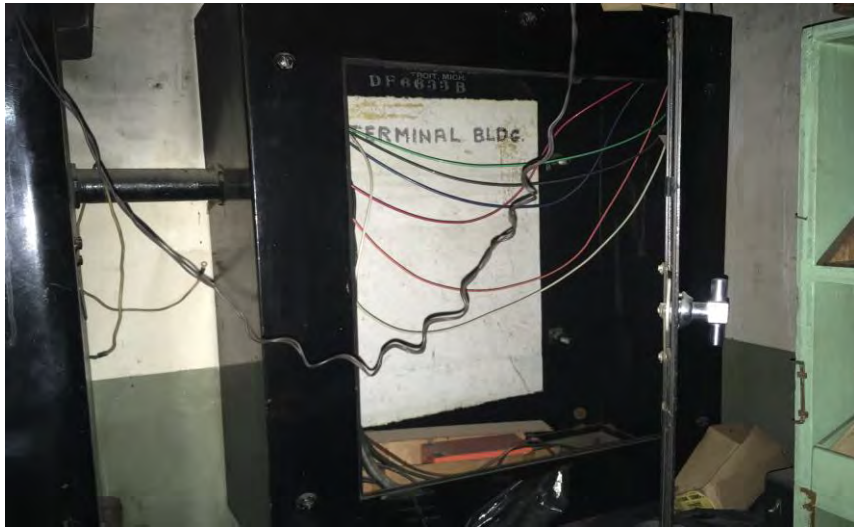
Asbestos Paper in the Electrical Room in Basement to the Tunnel in Terminal Building

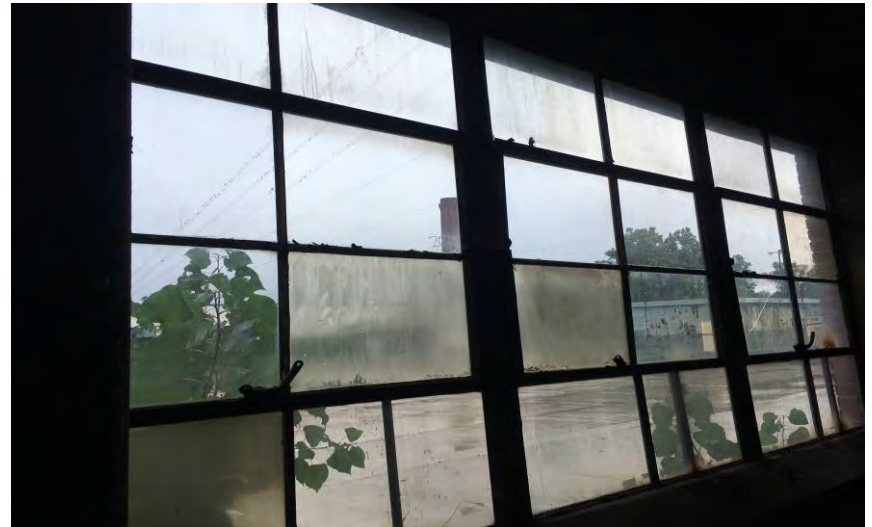
Window Glazing in the Boiler Building Samples #2 & #3

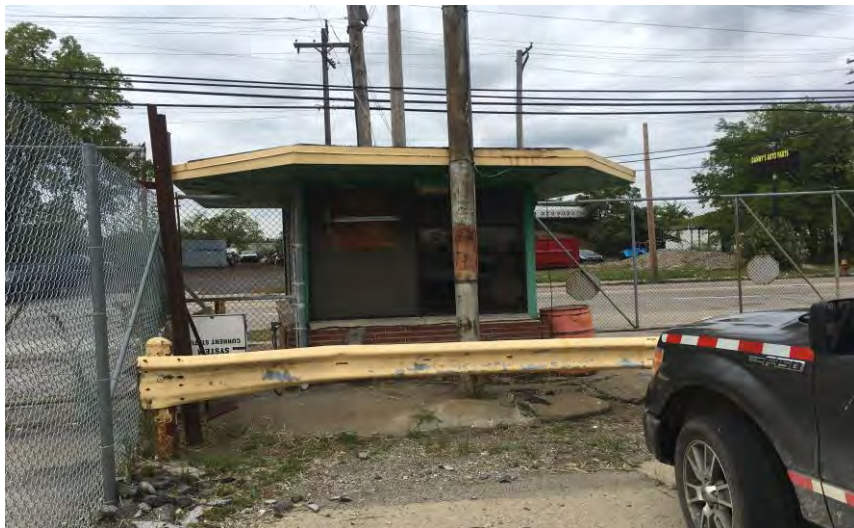
Caulk Around Windows in the Guard Shack Sample 4a

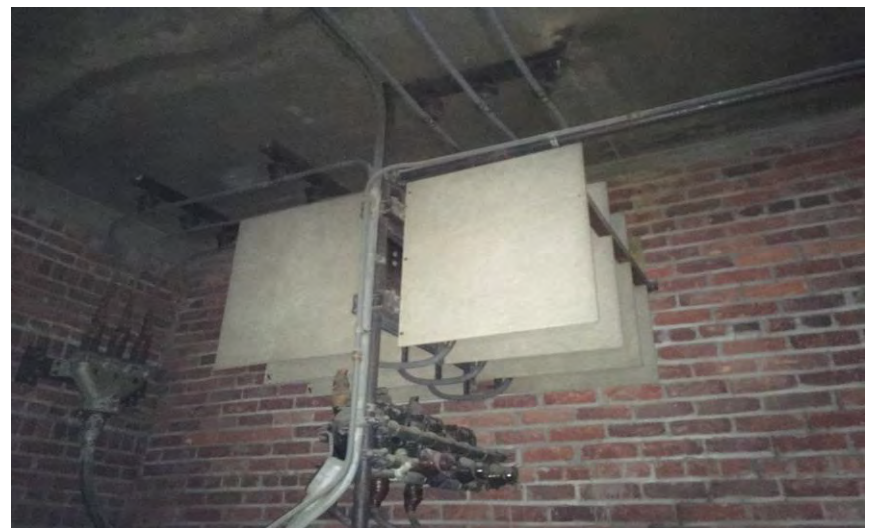
Transite Panels in the Boiler Building Electrical Room

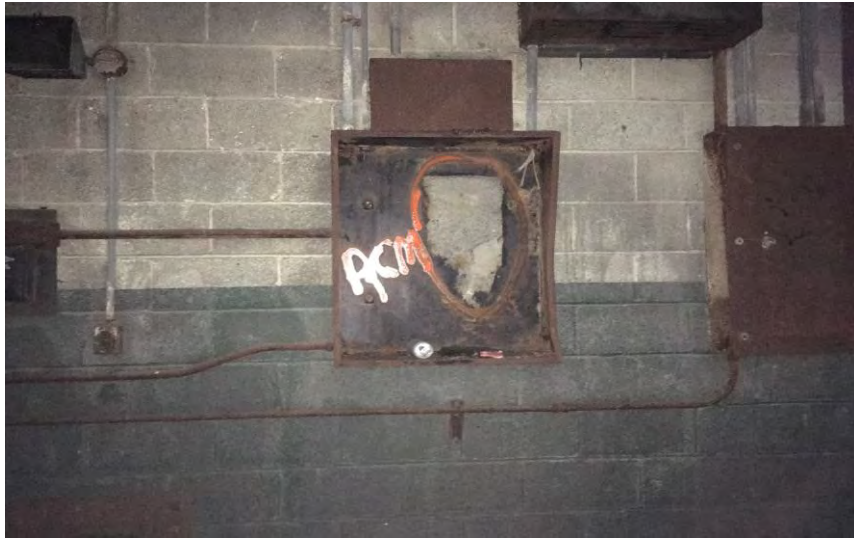
Asbestos Paper in Electrical Boxes in the Bus Garage, 1 of 9, Sample #7 and Sample #21

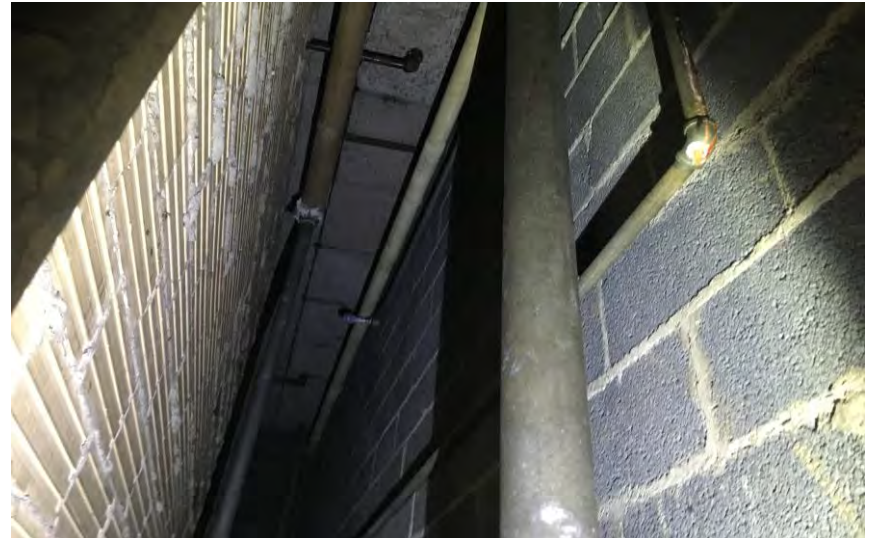
Asbestos Block Pipe Insulation Sample #11 in the Bathroom Plumbing Closets in the Bus Garage

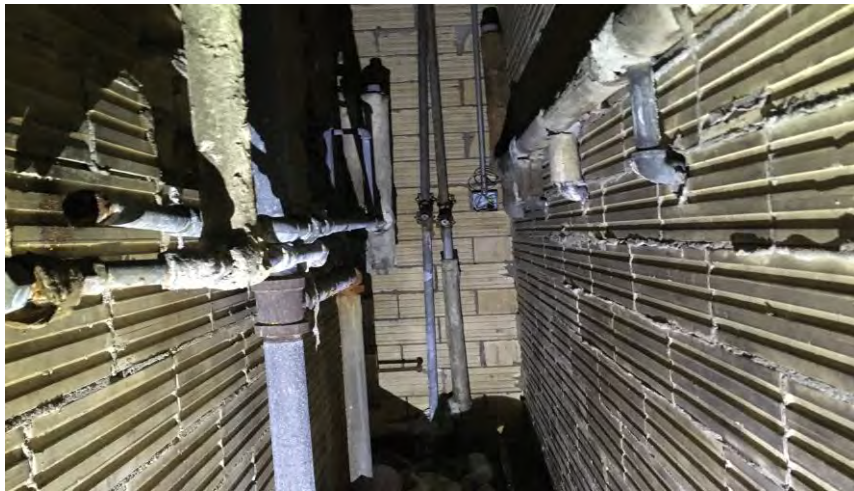
Mud Joints on the Non-asbestos Paper Insulation in the Men's Bathroom Plumbing Closets in the Bus Garage Sample #10

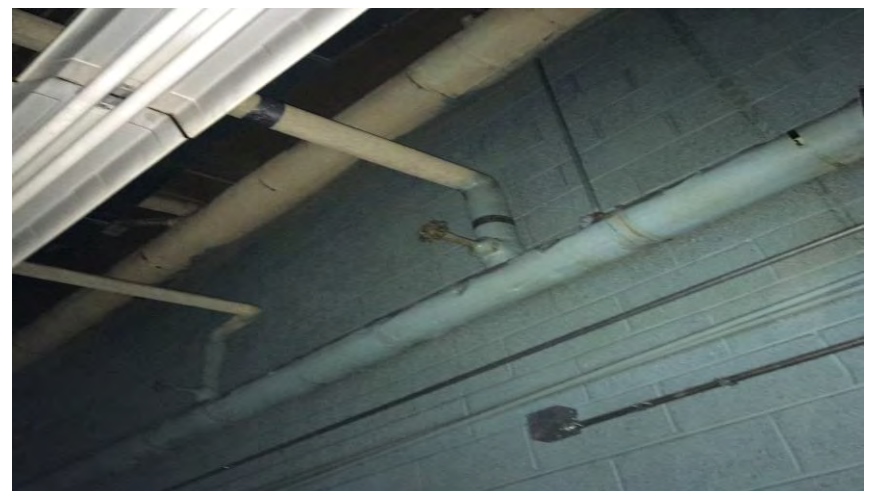
Block Insulation Pipes in Room BB1112 Sample #15, Also Aircell Pipe Insulation Assumed in Bus Garage.

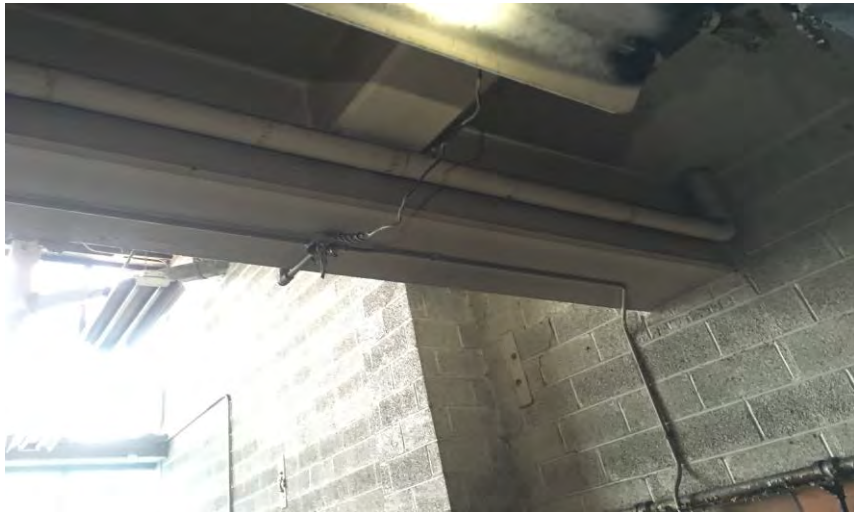
Assumed Aircell pipe insulation in Room BB1121 in Bus Garage.

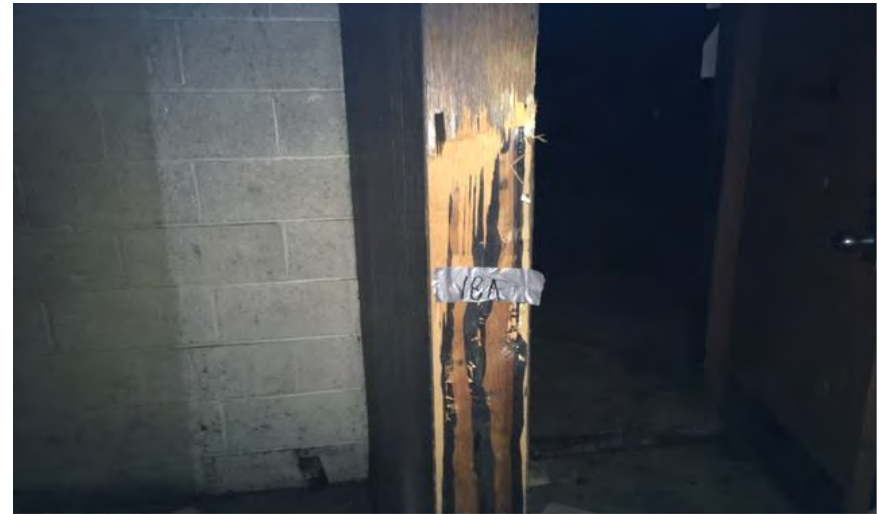
Paneling Mastic in the Bus Garage Building Sample # 18 Room BB1114

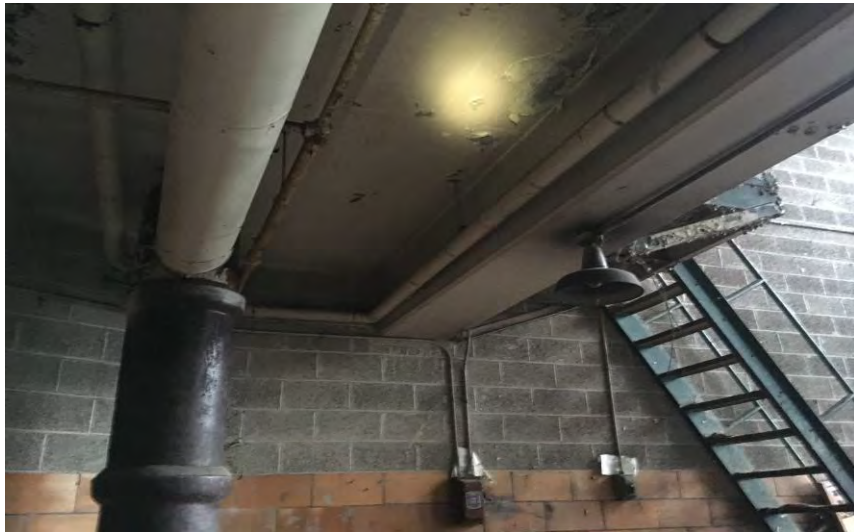
More Assumed Aircell pipe insulation in Room BB1121 in Bus Garage.

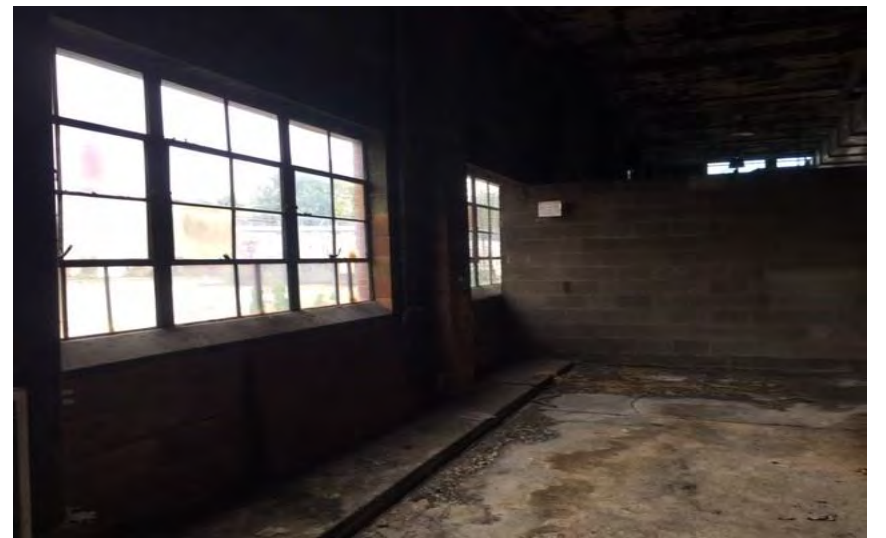
Window Glazing in the Bus Garage Sample #20 Room BB1118

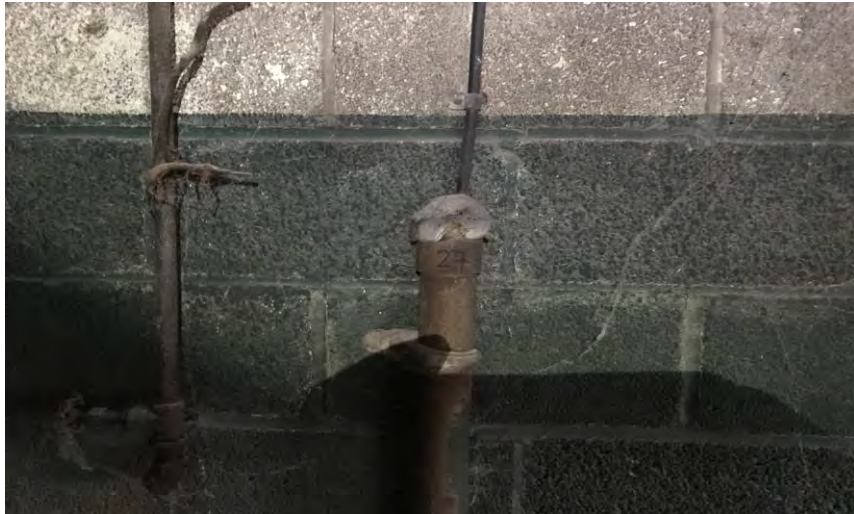
Sealant on top of Conduit Sample #27 Carriage Storage Bay #4

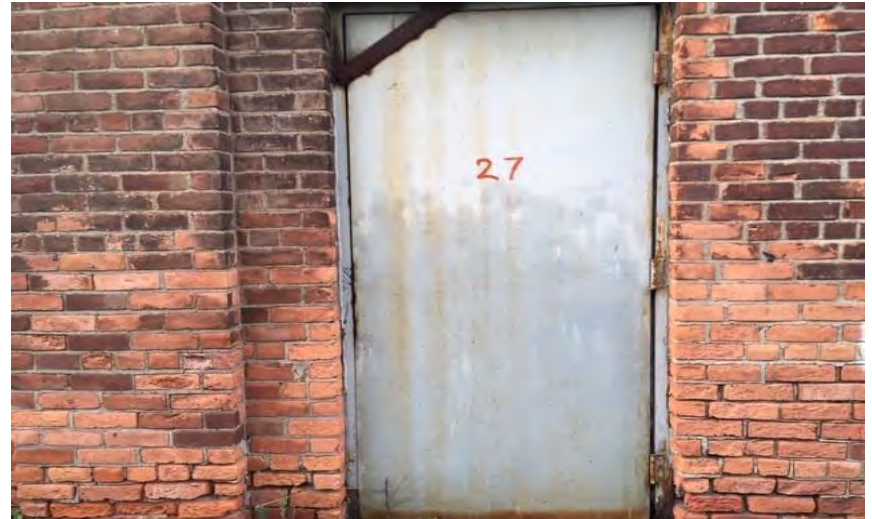
Exterior Door and Window Caulk on Carriage Storage Building Sample # 34

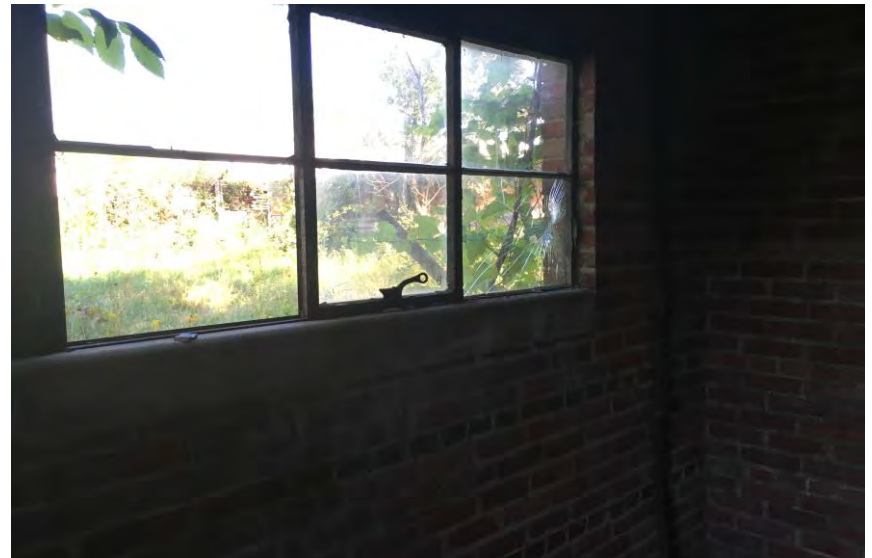
Window Glazing in the 1 Story Brick Building Sample # 38

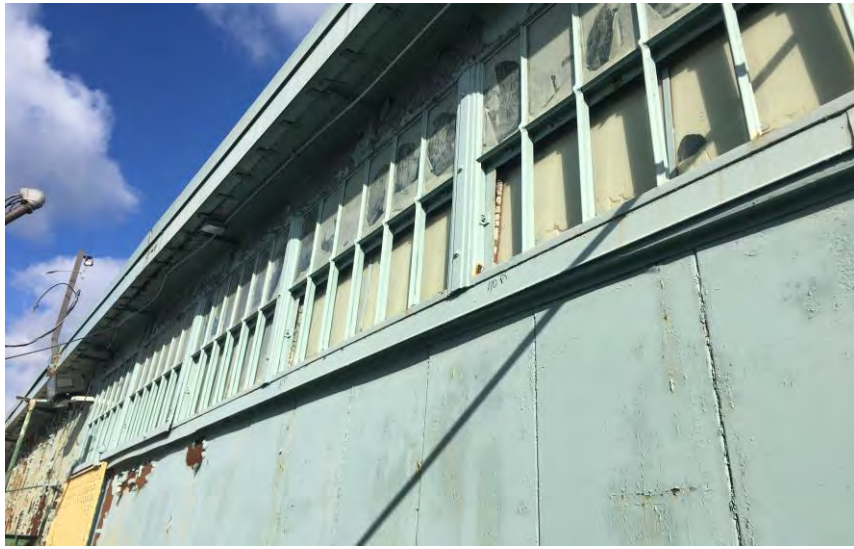
Window Glazing on the Fare Box Building Sample # 40

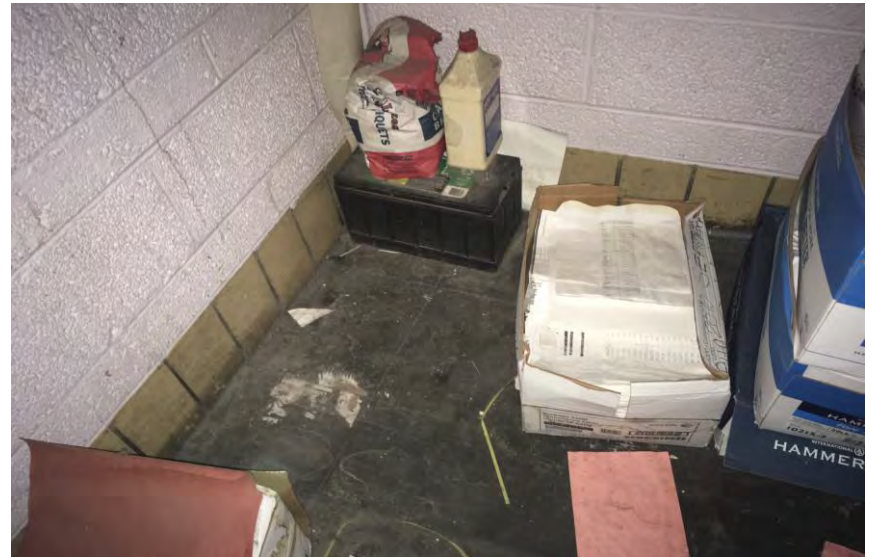
Battery and Lighter Fluid in Adjacent to the Vault in the Terminal Building

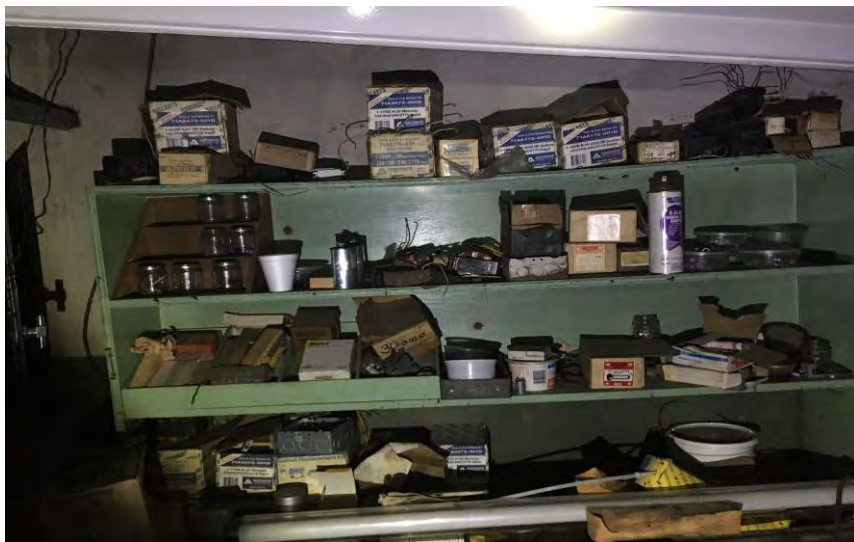
Florescent Bulbs and Ballasts in the Basement Electrical Room in the Terminal Building

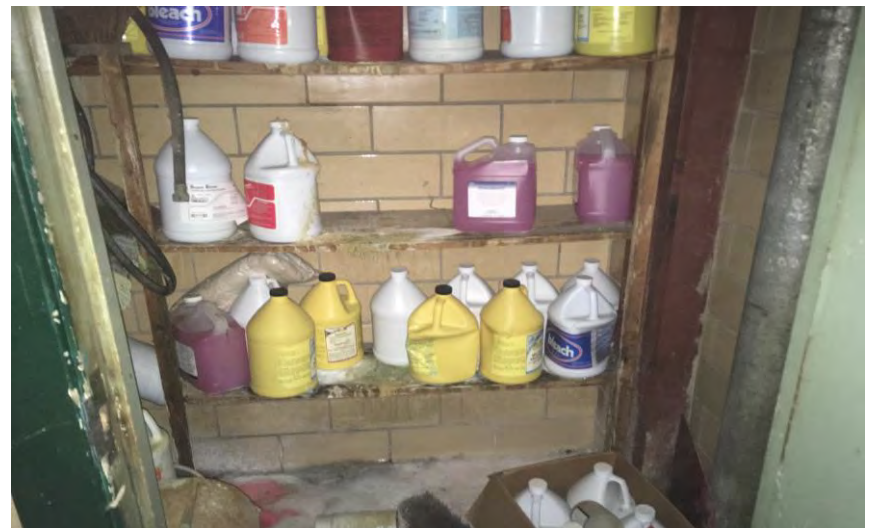
Cleaning Chemicals in the 1st Floor Janitors Closet in the Terminal Building

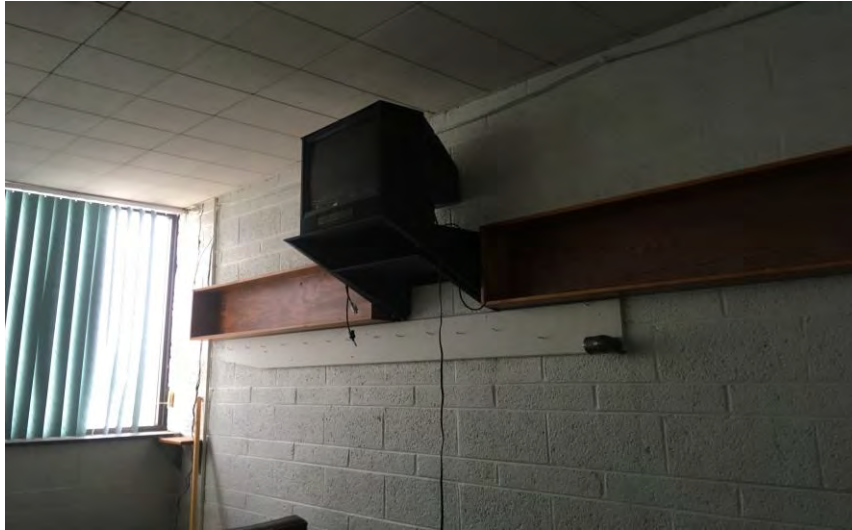
TV on the 2nd floor of the Terminal building

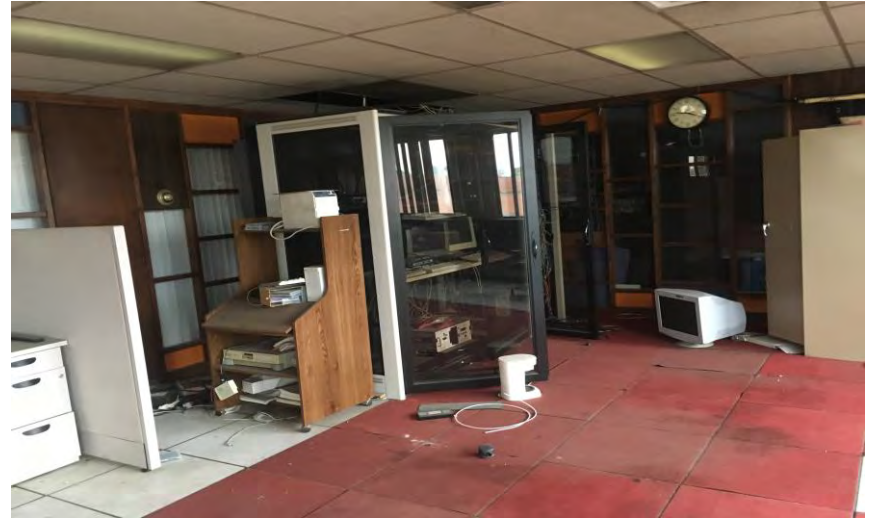
Monitors, UPS, Mercury Switch Thermostat and Computers on the 2nd Floor of the Terminal Building

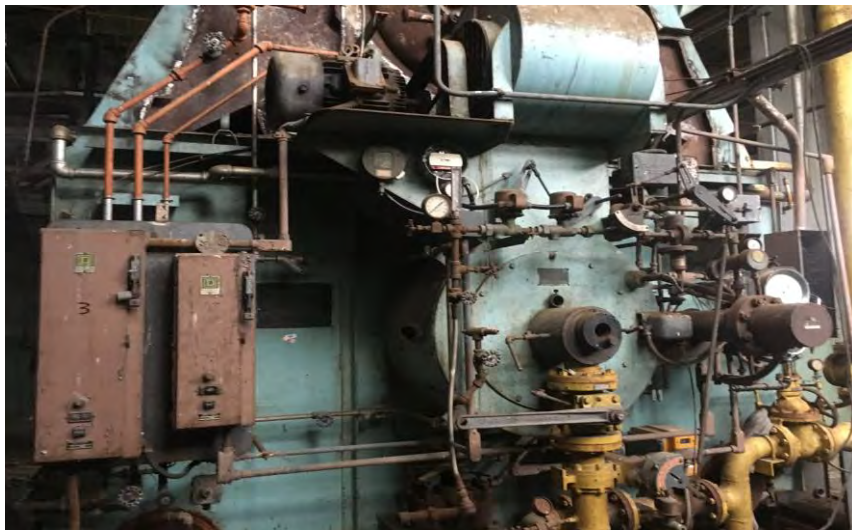
Mercury Containing Switches on the Boiler in the Boiler Building

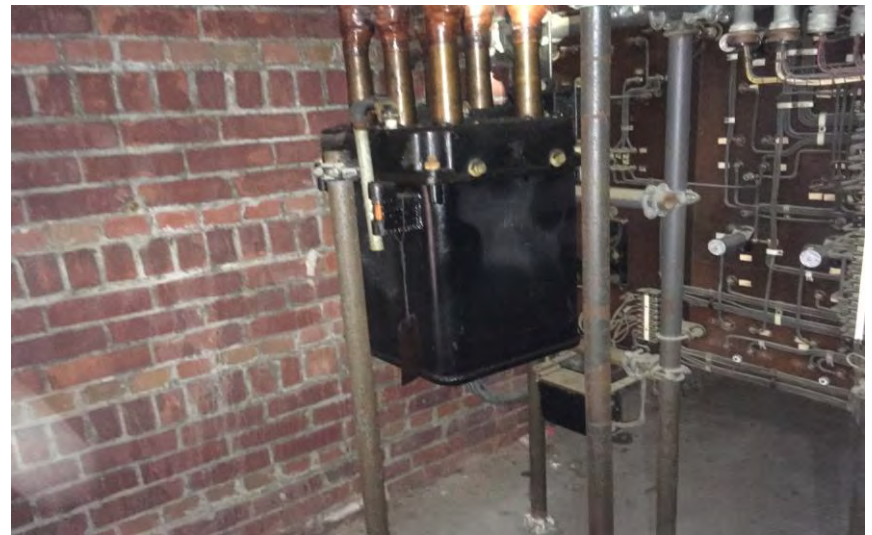
Oil Filled Transformers possible PCB Oil and Stained Concrete in the Electrical Room in the Boiler Building

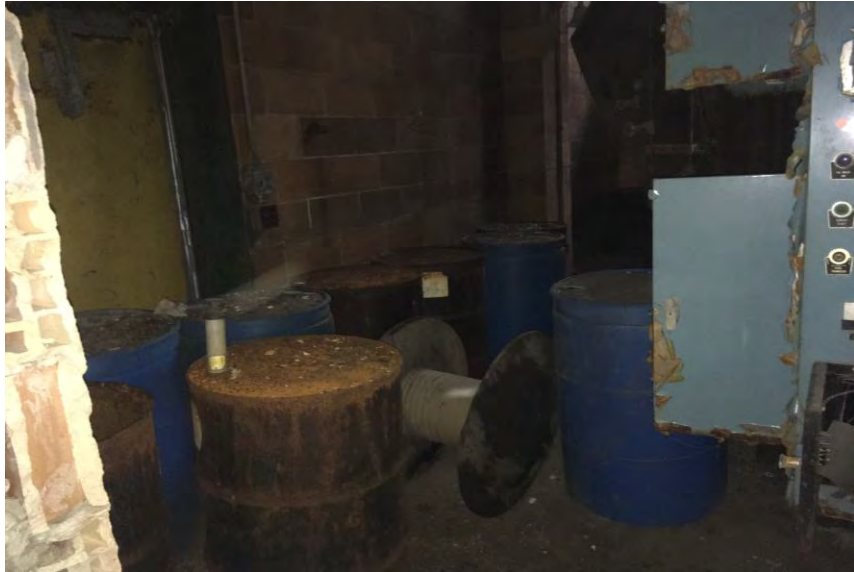
Drums in the Boiler Building

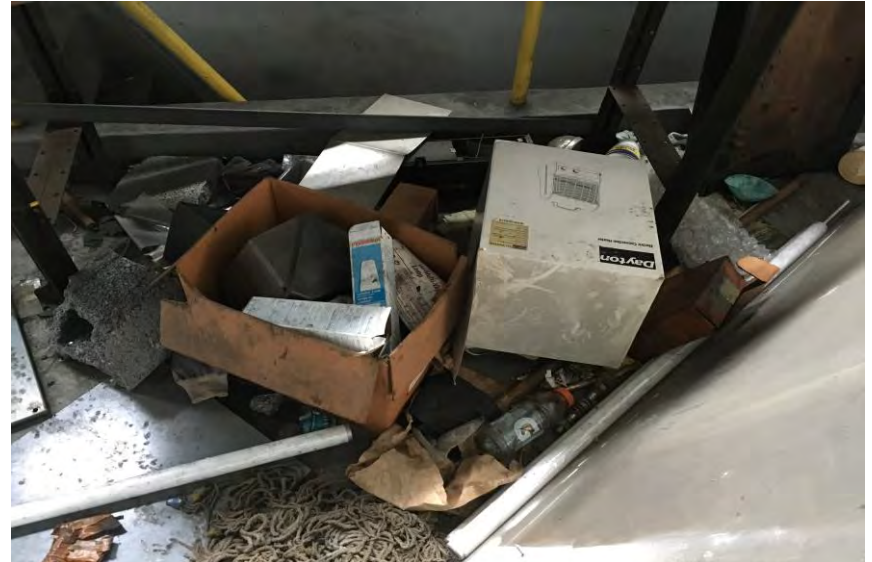
Mercury Vapor Bulbs and Ballasts in the Electrical Room above Room BB1108 in the Bus Garage

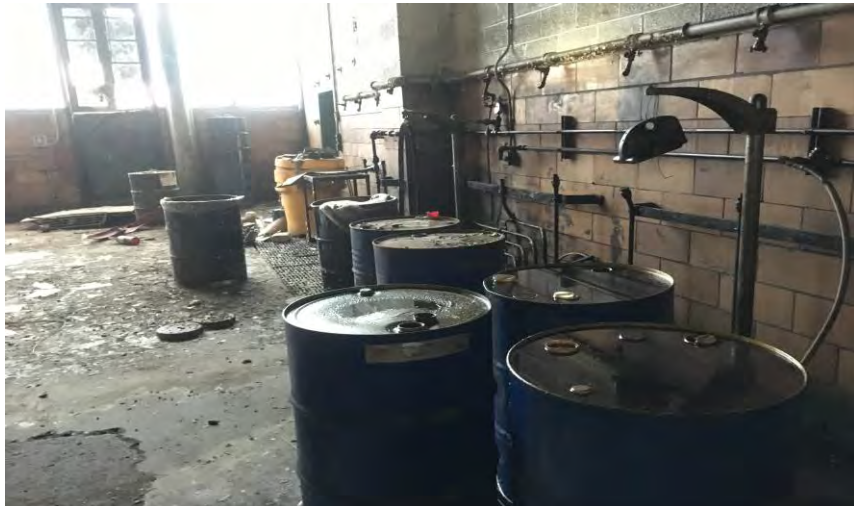
Drums in the Bus Maintenance Building Room BB1121

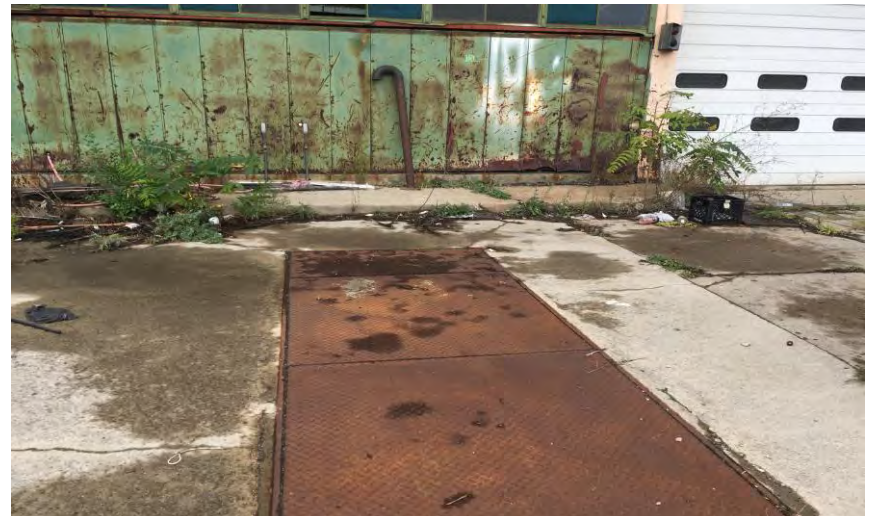
Unable to remove and determine what is under the plates. Located on the East Side of the Bus Garage
