7 Parkman

Address: 15000 Mackenzie
 Parcel: 22044630
 District: 7
 SNF Area: n/a
 Owner: City of Detroit
 Site Area: 3.75 ac
 Gross Floor Area: 40,800 sf
 Floors: 2
 Plan Type: U
 School Type: Elementary
 Year Built: 1940, 1947, 1953
 Zoned: R1
 Base Rehab Cost (est): \$1.3M
 Total Rehab Cost (est): \$9.9M

Building Overview

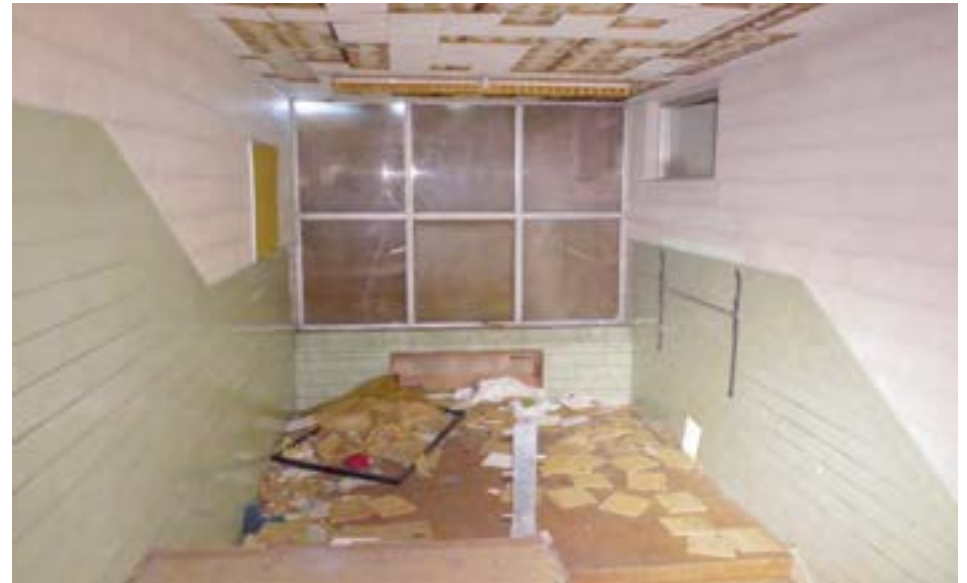
The building has been extensively scrapped, but finishes and structure remain in relatively good condition. The school's corridors feature glazed block finishes with a unique shade of jade green.

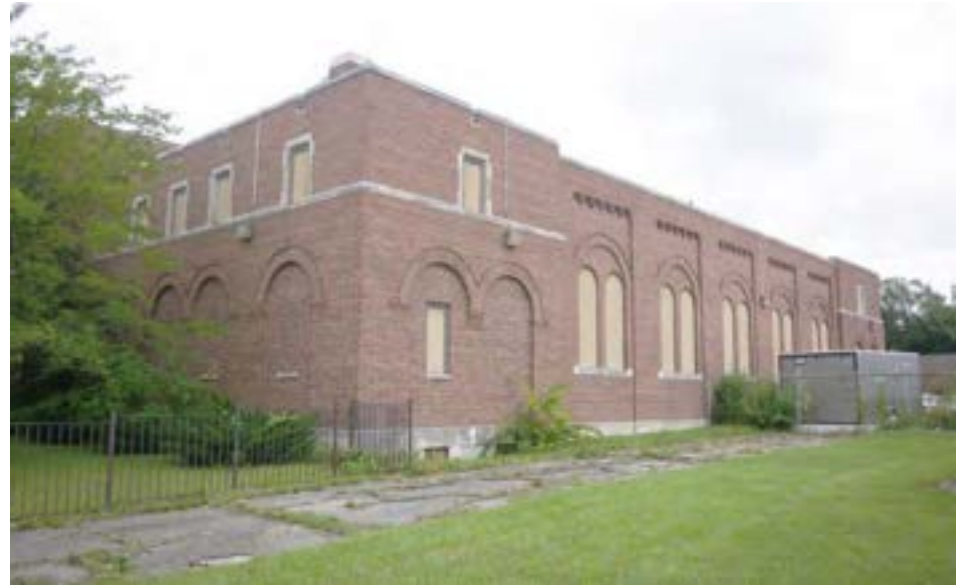
The large gymnasium wing viewed from southwest. The original arched window openings have been covered up with the same stucco panels as the classroom windows.

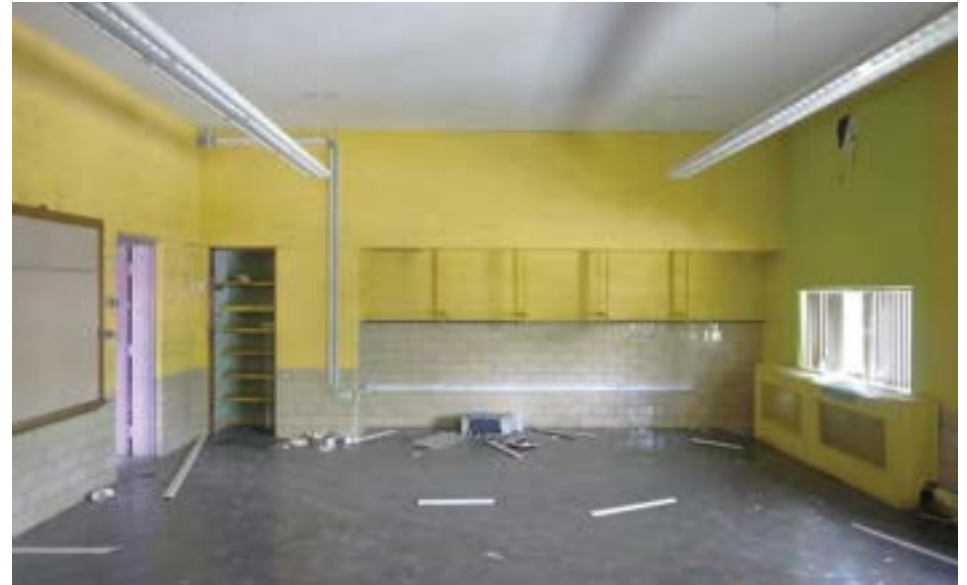
Typical classroom, view of back wall with coat/storage alcove. Note drastically reduced-size window to the right. Green painted area shows the size of the original window opening.

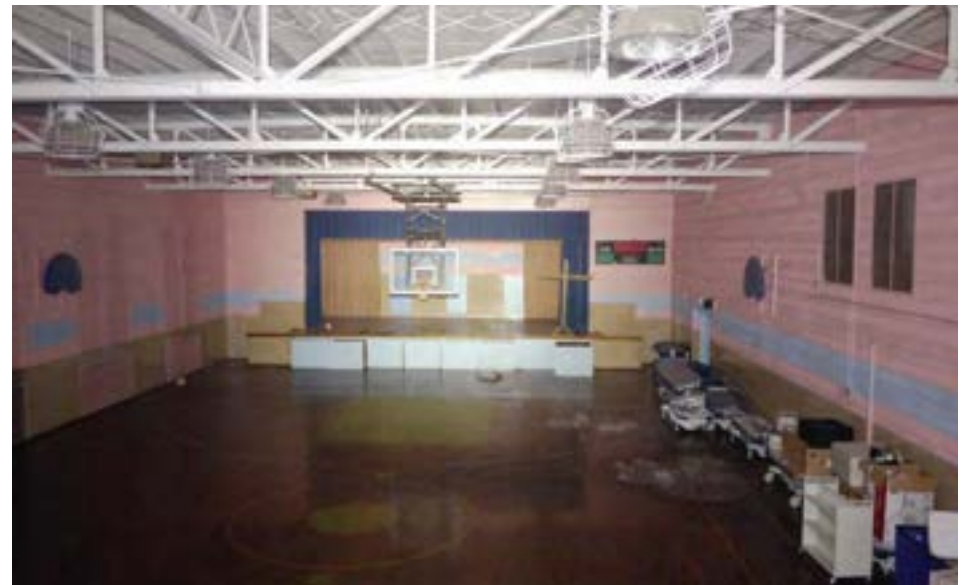
Gym and stage viewed from balcony seating. The gym's exterior wall was originally lined with pairs of tall arched windows, which were later filled in with CMU. These windows could be restored to flood this currently dark space with natural light.

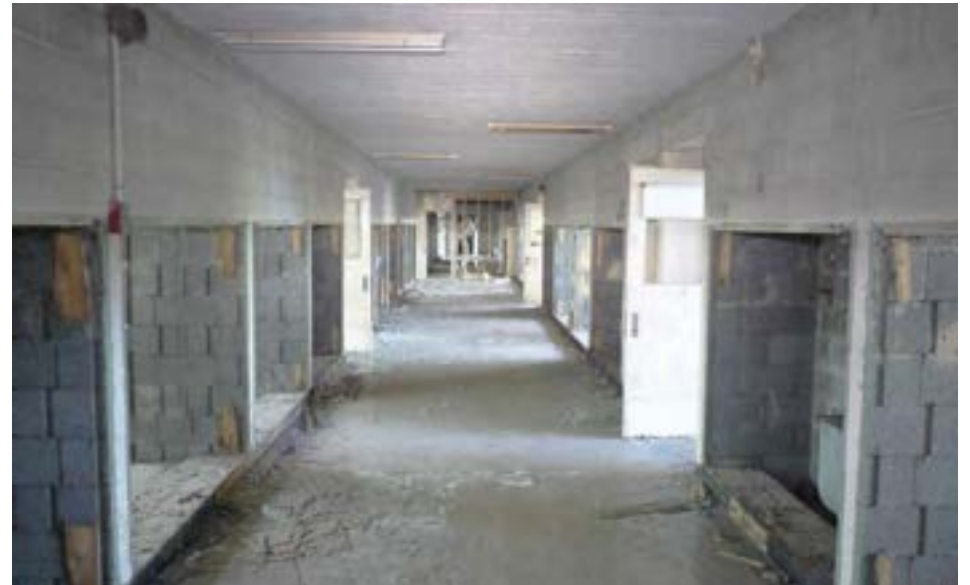
Corridor in the east classroom wing with concrete block structure visible where locker banks have been removed.

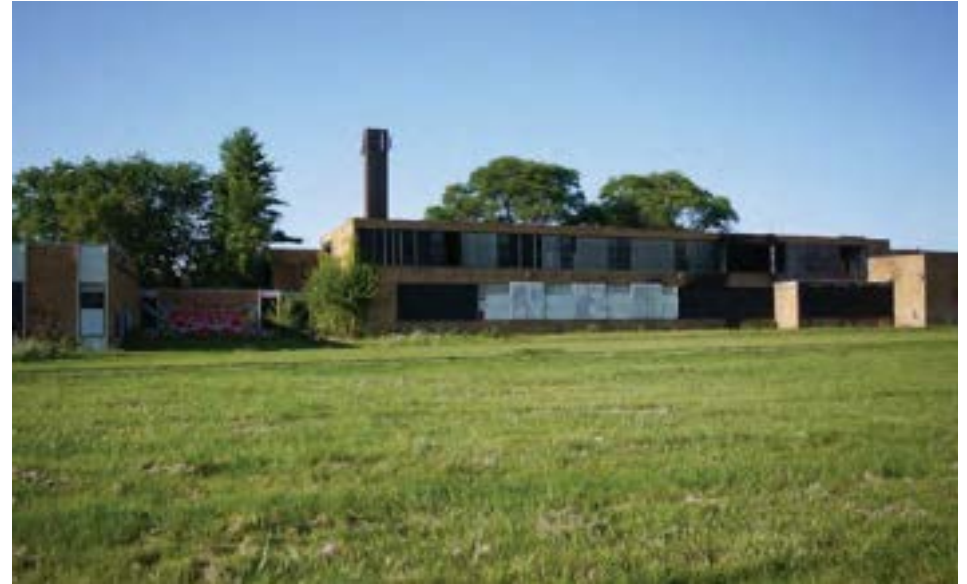
North elevation of the 1955 unit, viewed from Simanek Playfield. Strong horizontal lines typical of 1950s-era International Style school architecture. Smoke damage from first floor fire is visible at right.

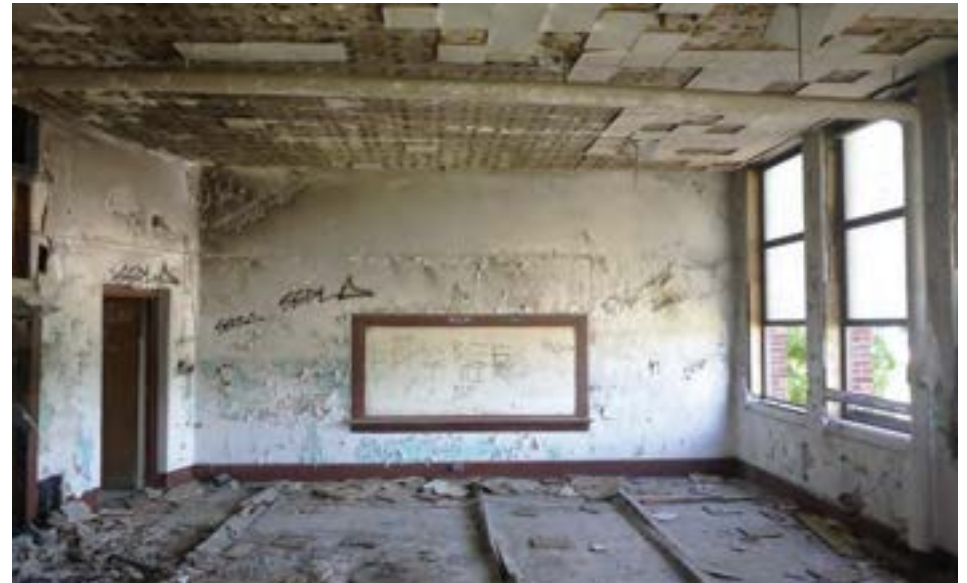
Typical classroom in 1924 unit, with plaster walls and wood floors. Aluminum replacement windows are partly intact.

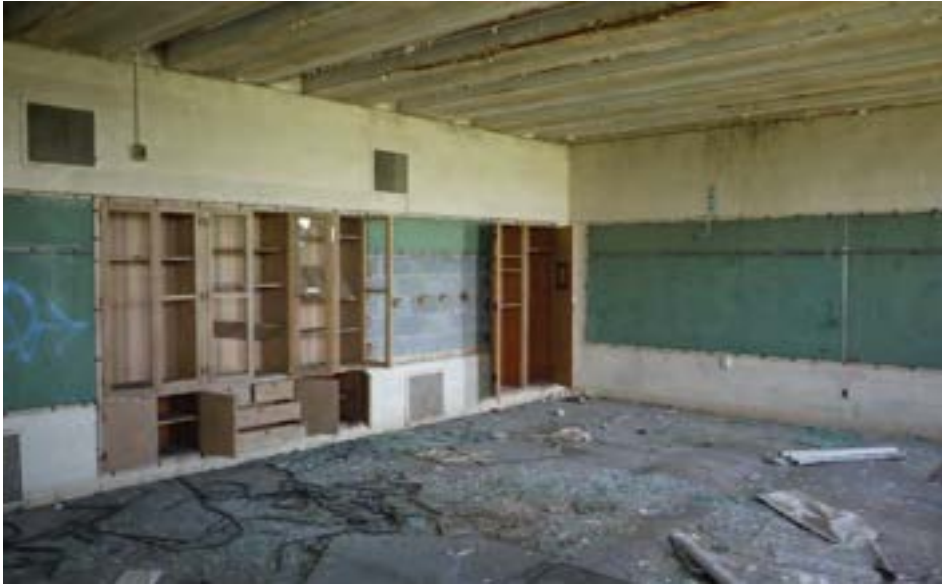
Typical 1955 classroom with concrete block walls, wood floors, and wood built-in cabinets. Note corrosion on steel ceiling system.

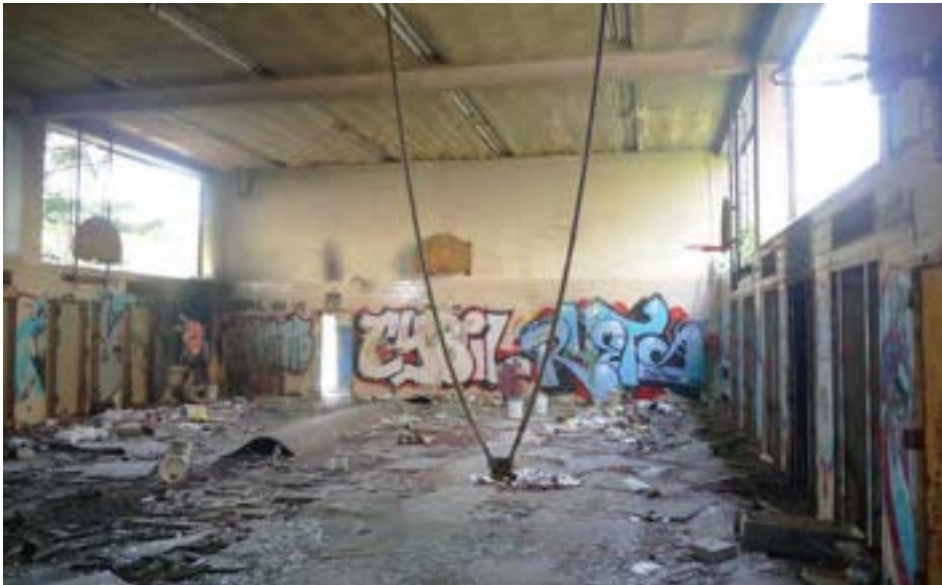
1955 gymnasium features large clerestory windows facing east and west; windows are missing but were likely glass block.
