Comprehensive Conditions Assessment

part of the East Riverfront Asset Study

EAST RIVERFRONT ASSET STUDY

CONDITION ASSESSMENT & SEAWALL SHORELINE INVESTIGATION

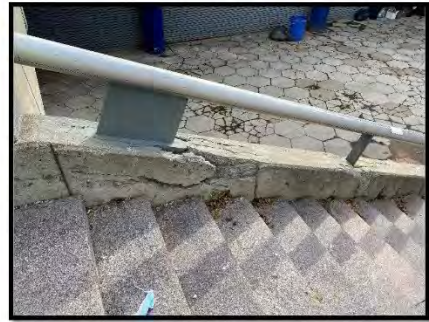
Reinforced Concrete Column	LL9	Vertical crack in 24"x24" concrete column- 6 LF	Structural
Reinforced Concrete Wall and Columns	LL11, LL12	Significant deterioration of concrete wall and columns exposing rebar in multiple locations- 60 SF	Structural
Reinforced Concrete Wall and Columns	LL13, LL14	Horizontal cracking in lower section of concrete columns and walls- 30 LF	Structural
Masonry and Concrete Surfaces	LL15	Fire and Smoke residue on all concrete structural surfaces due to fire in recessed area.	Structural
Reinforced Concrete Wall	LL19	Significant crack at concrete beam and wall tie in location at stairwell	Structural
Reinforced Concrete Wall	LL20	Loss of concrete surface at corner of poured wall exposing rebar- 20 SF	Structural
Masonry Wall	LL23	Vertical crack in CMU wall- 12 LF	Structural
Concrete Footing	LL24	6' section of concrete masonry footing with loss of material and exposed rebar approximately 6" in depth	Structural

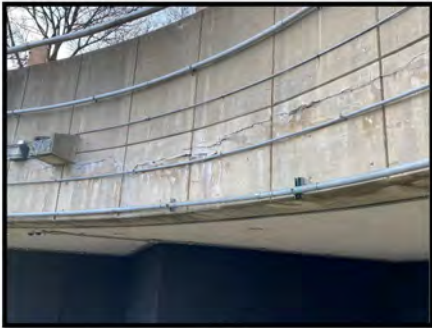
Reinforced Concrete Beam and Wall	LL16	Severe horizontal cracking causing delamination of concrete surface exposing reinforcement. Significant moisture present potentially caused by insufficient drainage. Approximately 60' LF of 12"x12' wall/beam section	Structural
Reinforced Concrete Wall	LL21, LL22	Severe spalled concrete section at guard rail insert locations. 7 locations along top of wall approximately 4'x2' sections at each.	Structural
Concrete Structure	LL26	Loss of concrete and noted cracking along top of concrete screen structure	Structural
Precast Concrete Barrier Wall Sections	AT1, AT3	Guard Rail and precast concrete temporary barrier wall section damaged	Structural
Slab/tile steps	UL57, UL57A	Walk way steps need replacement due to being undermined by water run-off, trench drain needs to be replaced	Civil
Concrete ramp	UL64, UL65	Concrete barrier free ramp deteriorating, needs replacement	Civil

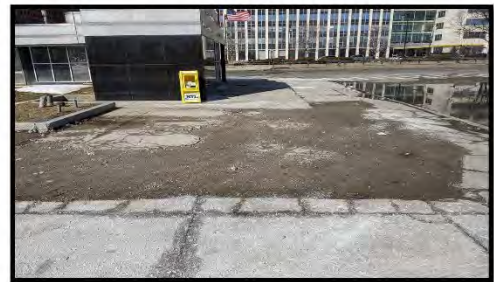
UL-32

- d. The walkway leading to the Gateway to Freedom sculpture is in good condition and appears to be very recently constructed.
- e. The section of pavement adjacent to the [former] drive to Ford Auditorium is in very poor condition (refer to photo UL-32A).

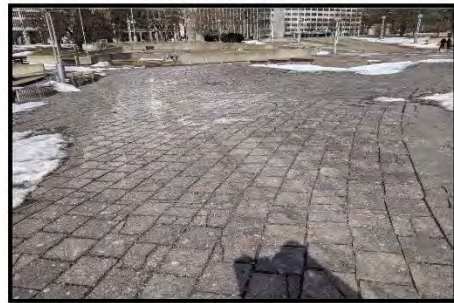
UL-58

- Nearly all stairs need rehabilitation (refer to photos UI-40, UL-40A, UL-57, UL-57A, UL-58, UL-60, UL-61 and UL 61A).
- Approximately 50% of the stone curbing is in need of repair; primarily in the main entrance area and the walkway section between the main entrance from Jefferson and the abandoned drive to the [former] Ford Auditorium.
- Trench drains located in the plaza need to be removed and replaced. They are too small and get plugged quickly, causing standing water and runoff to areas not designed to have excessive runoff. This condition results in accelerated deterioration to steps and walkways.
- Drainage by the Gateway to Freedom sculpture needs to be fixed, as there is standing water for extended time periods following precipitation events.

Slab/tile steps	UL58	Steps need replacement due to being undermined by water run-off, trench drain needs to be replaced	Civil
