Hazardous/Regulated Materials Survey and Inspection Report

100 Lenox Street
Detroit, MI 48215

ASBESTOS-CONTAINING MATERIAL SURVEY
VACANT COMMERCIAL PROPERTY

On the date indicated above, a licensed State of Michigan Asbestos Inspector from Atlas Technical Consultants (Atlas) conducted a pre-demolition asbestos and other regulated materials survey of the unoccupied commercial subject property.

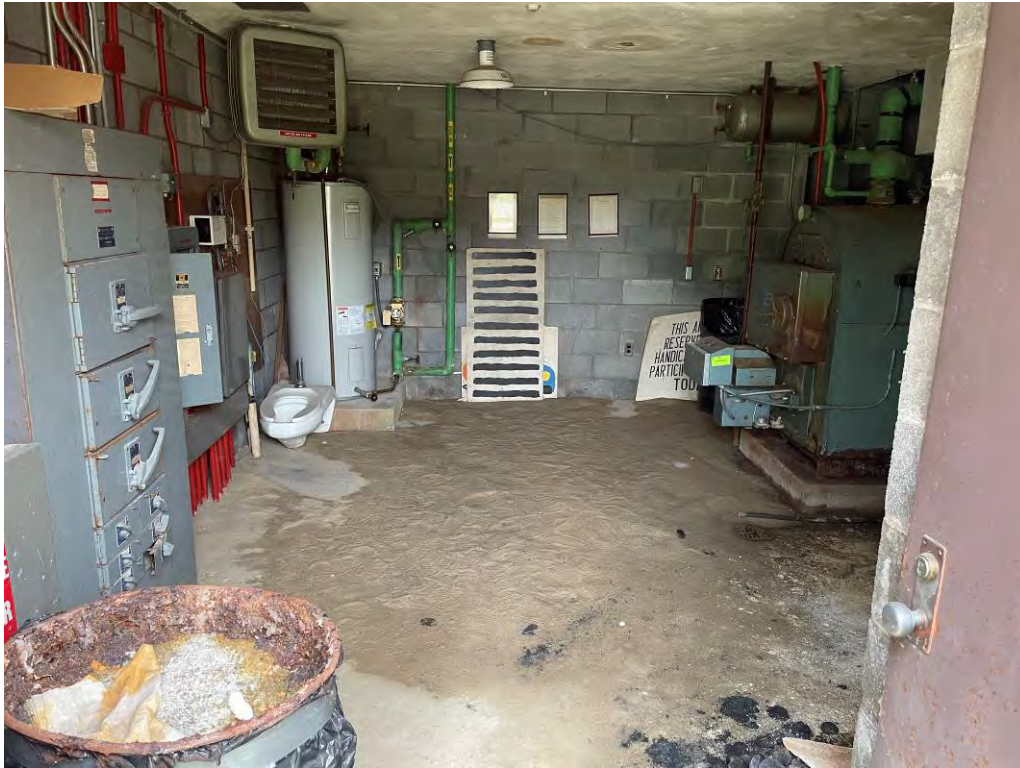
Boiler Room

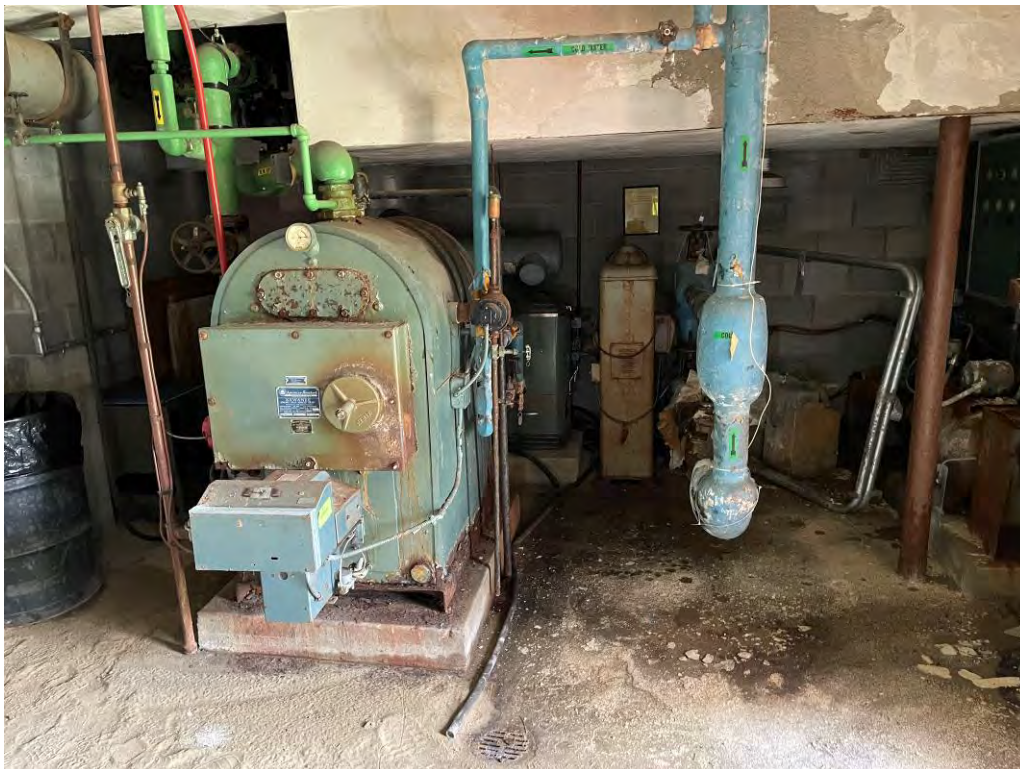
Boiler

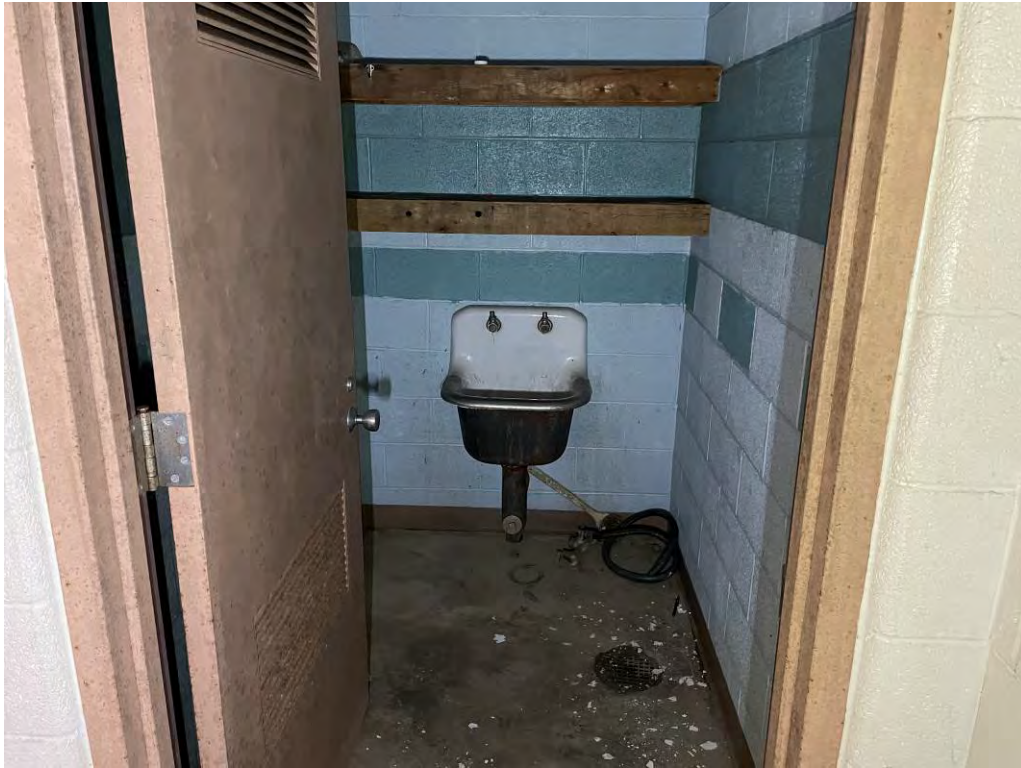
Janitor Closet

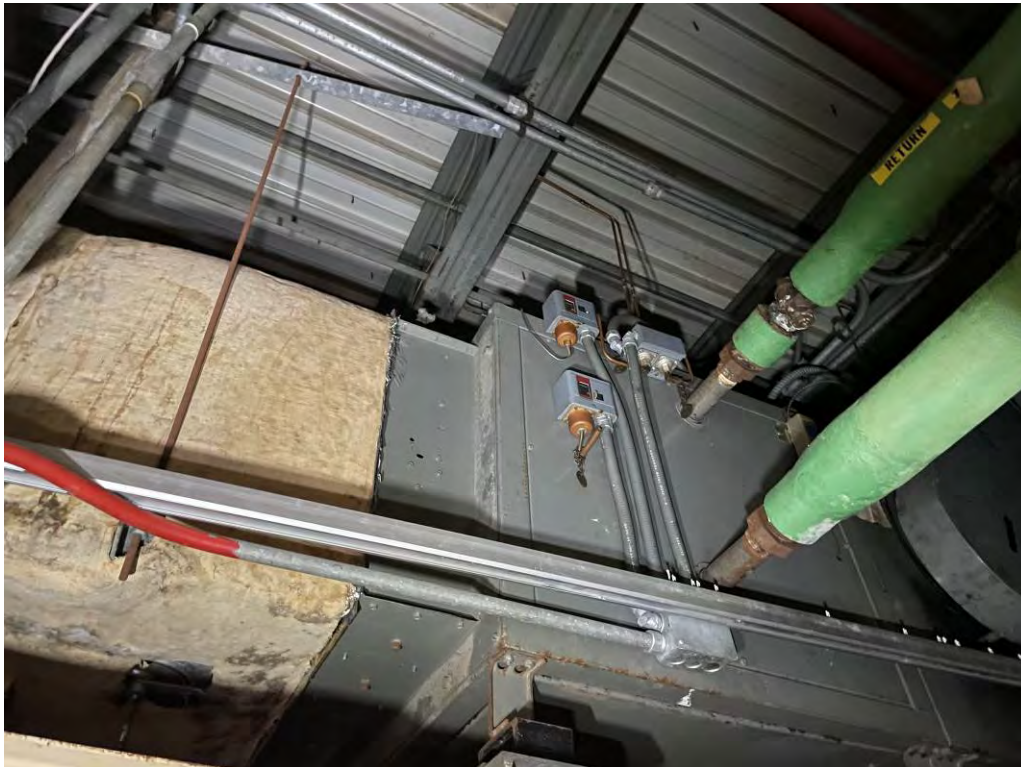
Old HVAC unit

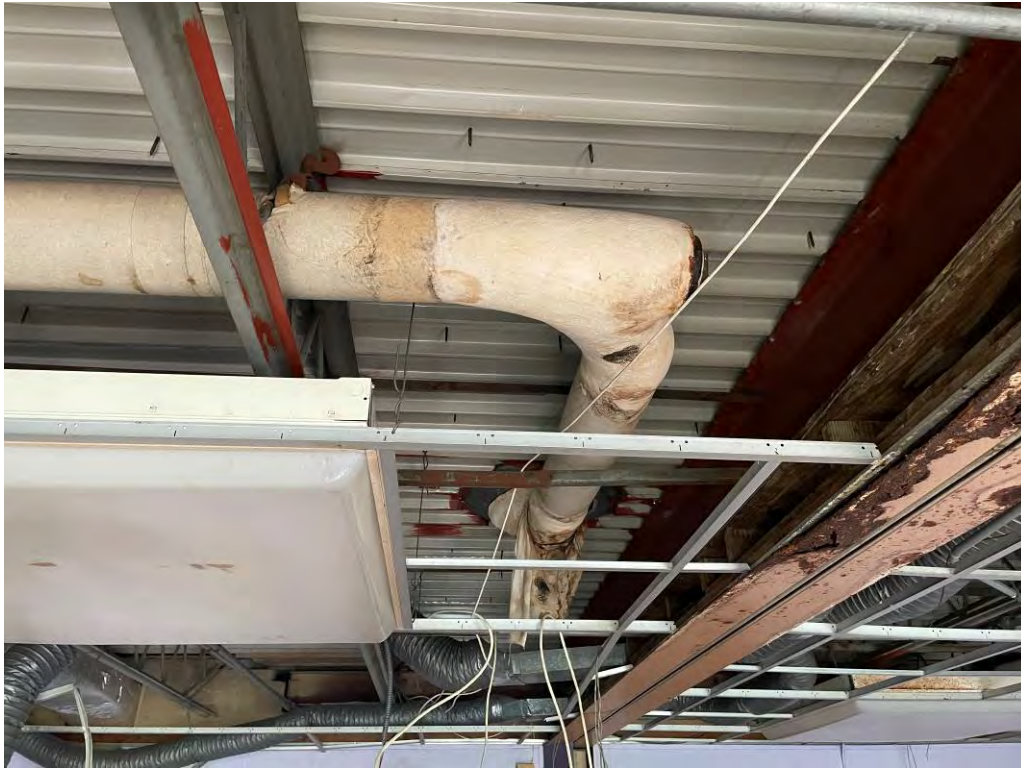
Roof drain pipe

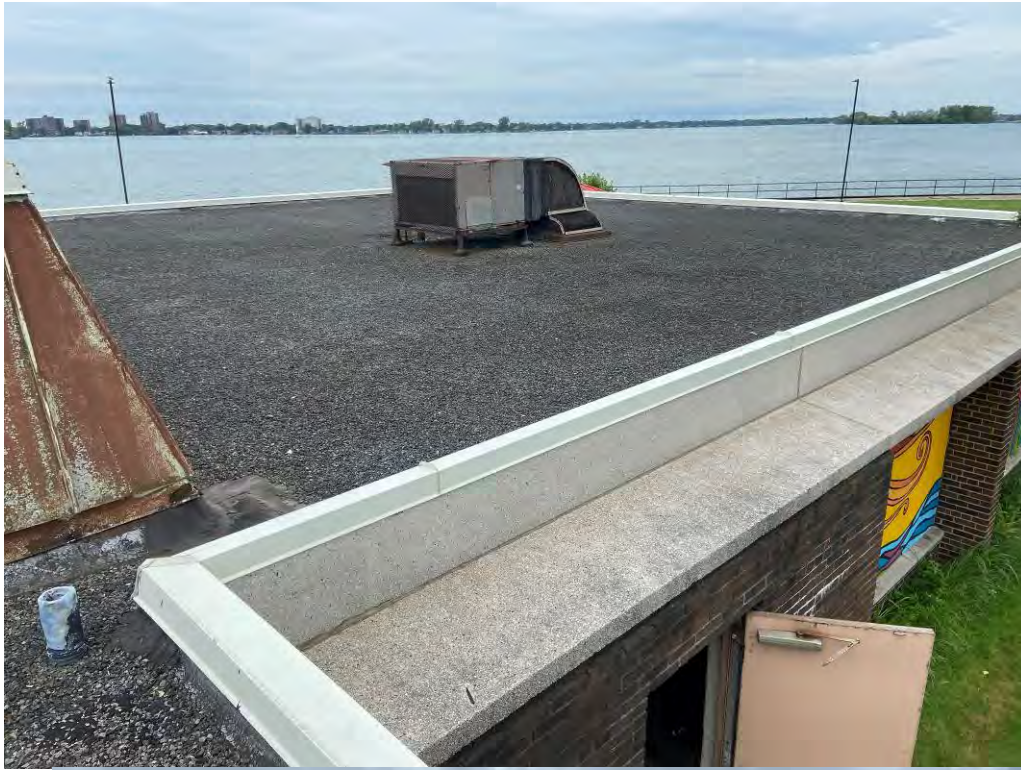
Roof

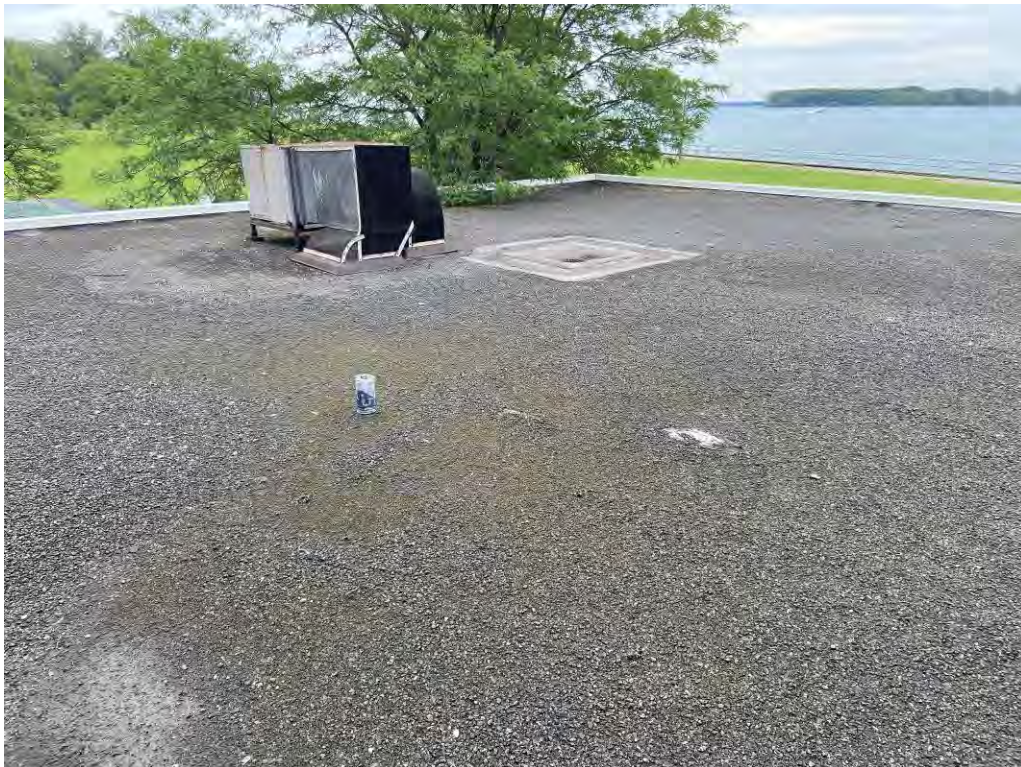
Roof
