STAFF REPORT 7-10-2019 MEETING
APPLICATION NUMBER 19-6314
ADDRESS: 1778 SEYBURN
HISTORIC DISTRICT: WEST VILLAGE
APPLICANT: GEORGE DANAYAN / GERALD GRUBEY
DATE OF STAFF VISIT: 7-3-2019

ADDITIONS, ALTERATIONS, & REPAIRS TO BACK OF 1778 SEYBURN STREET, DETRIOT, MI

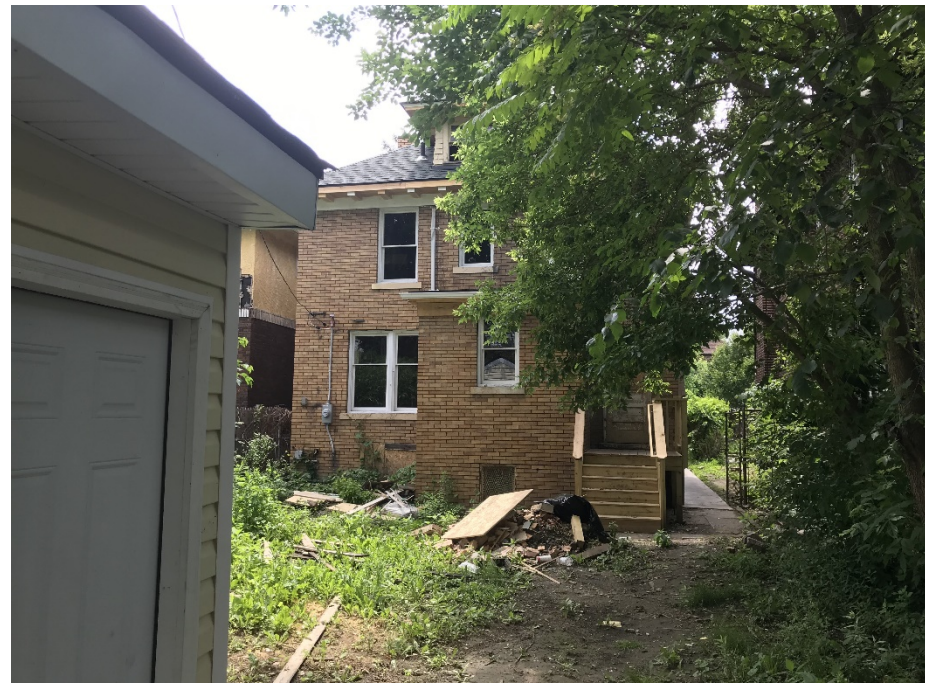
TOP: 1778 Seyburn, Rear Façade, *Staff Photo*

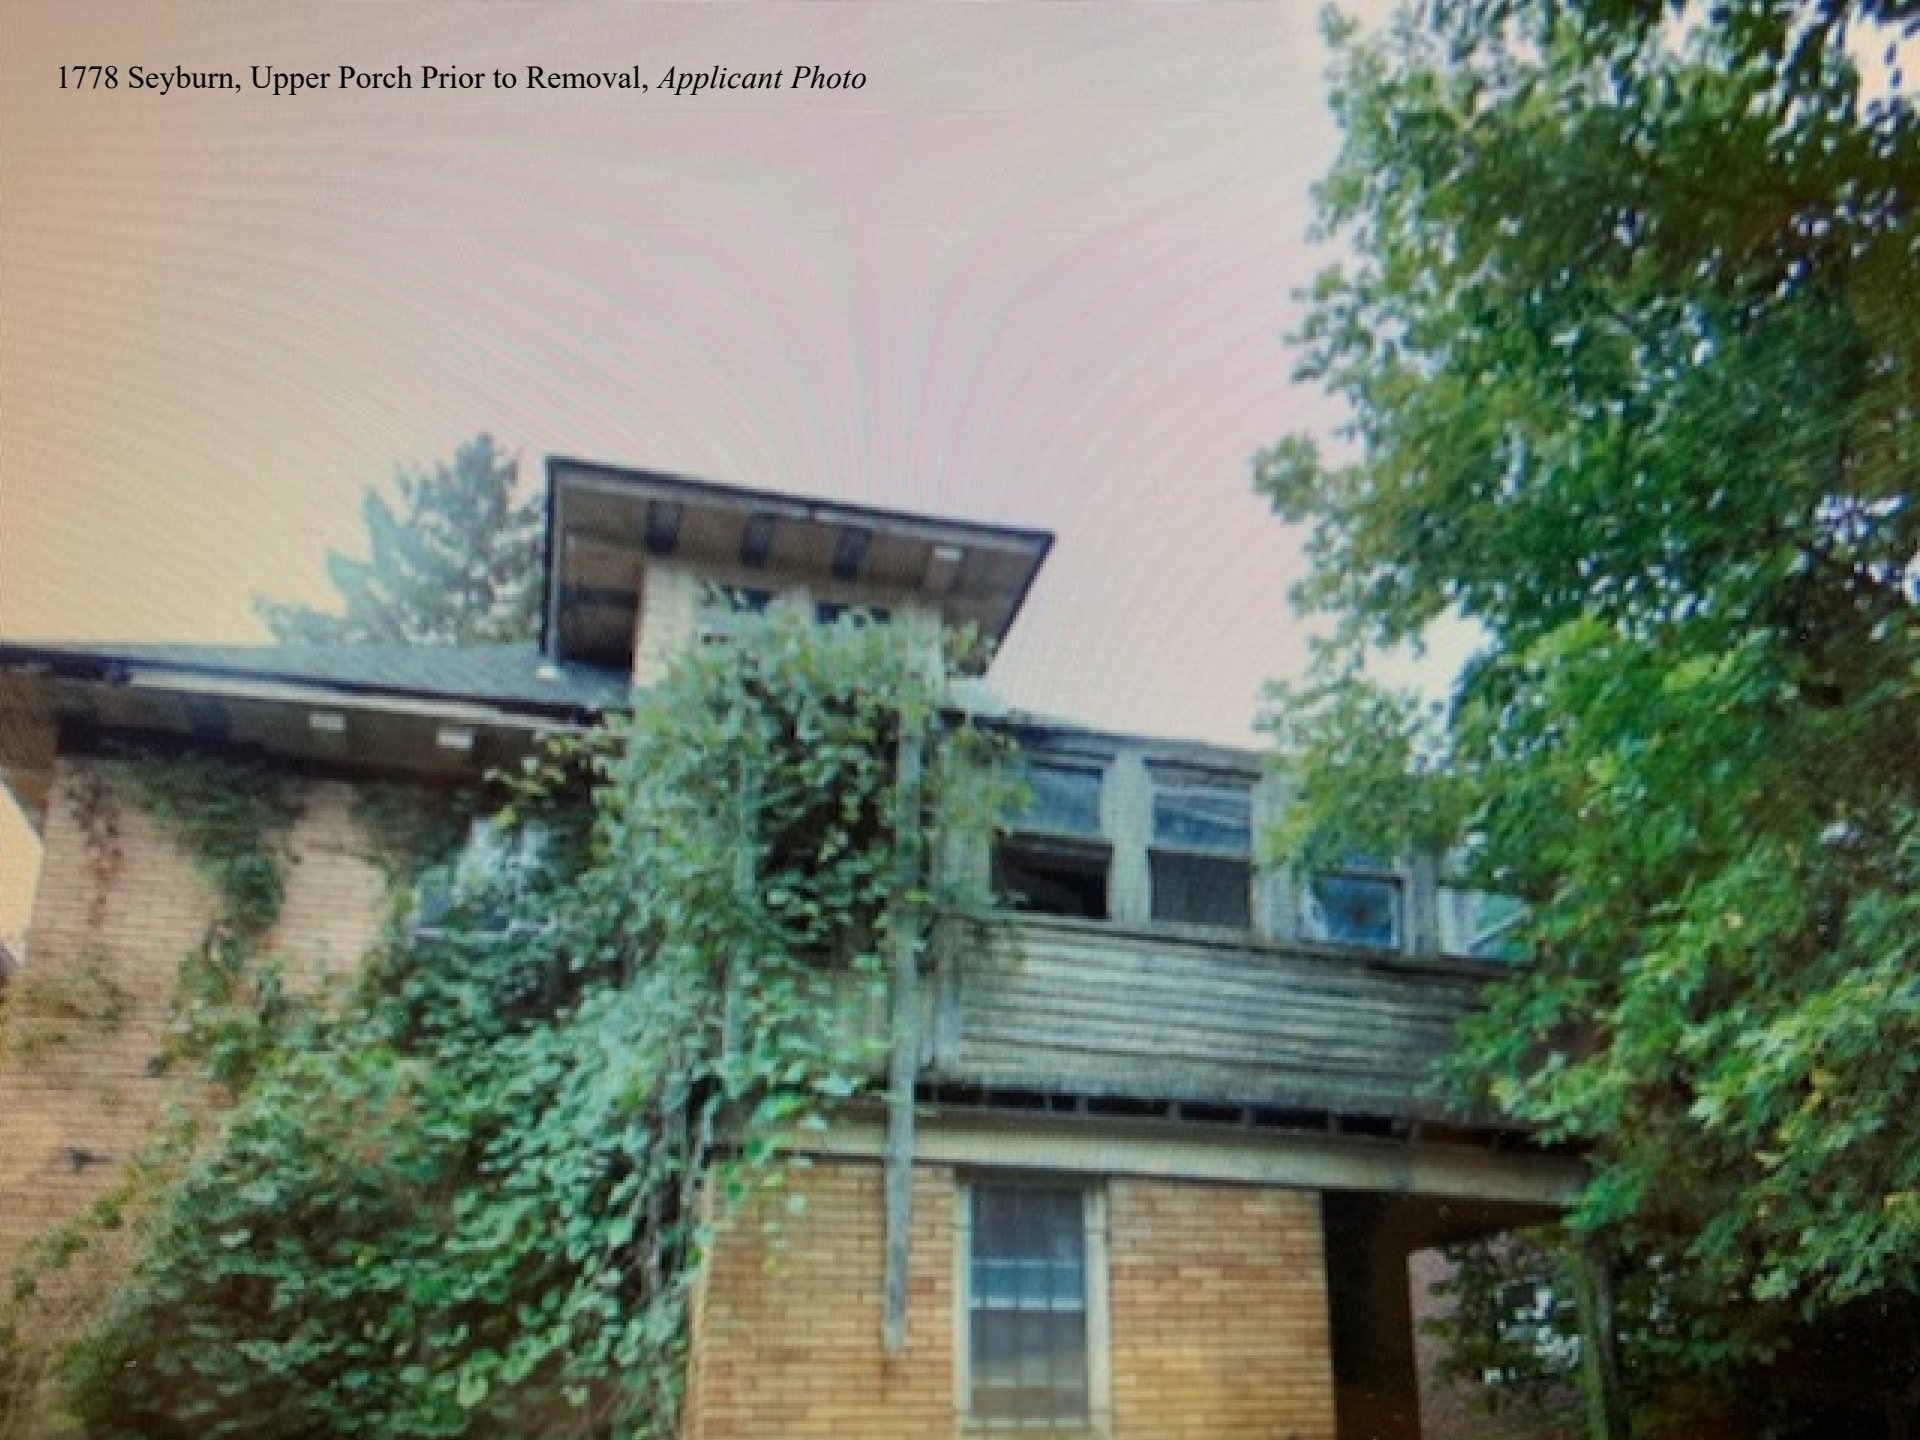
1778 Seyburn,
Upper Porch Prior to
Removal,
Applicant Photo

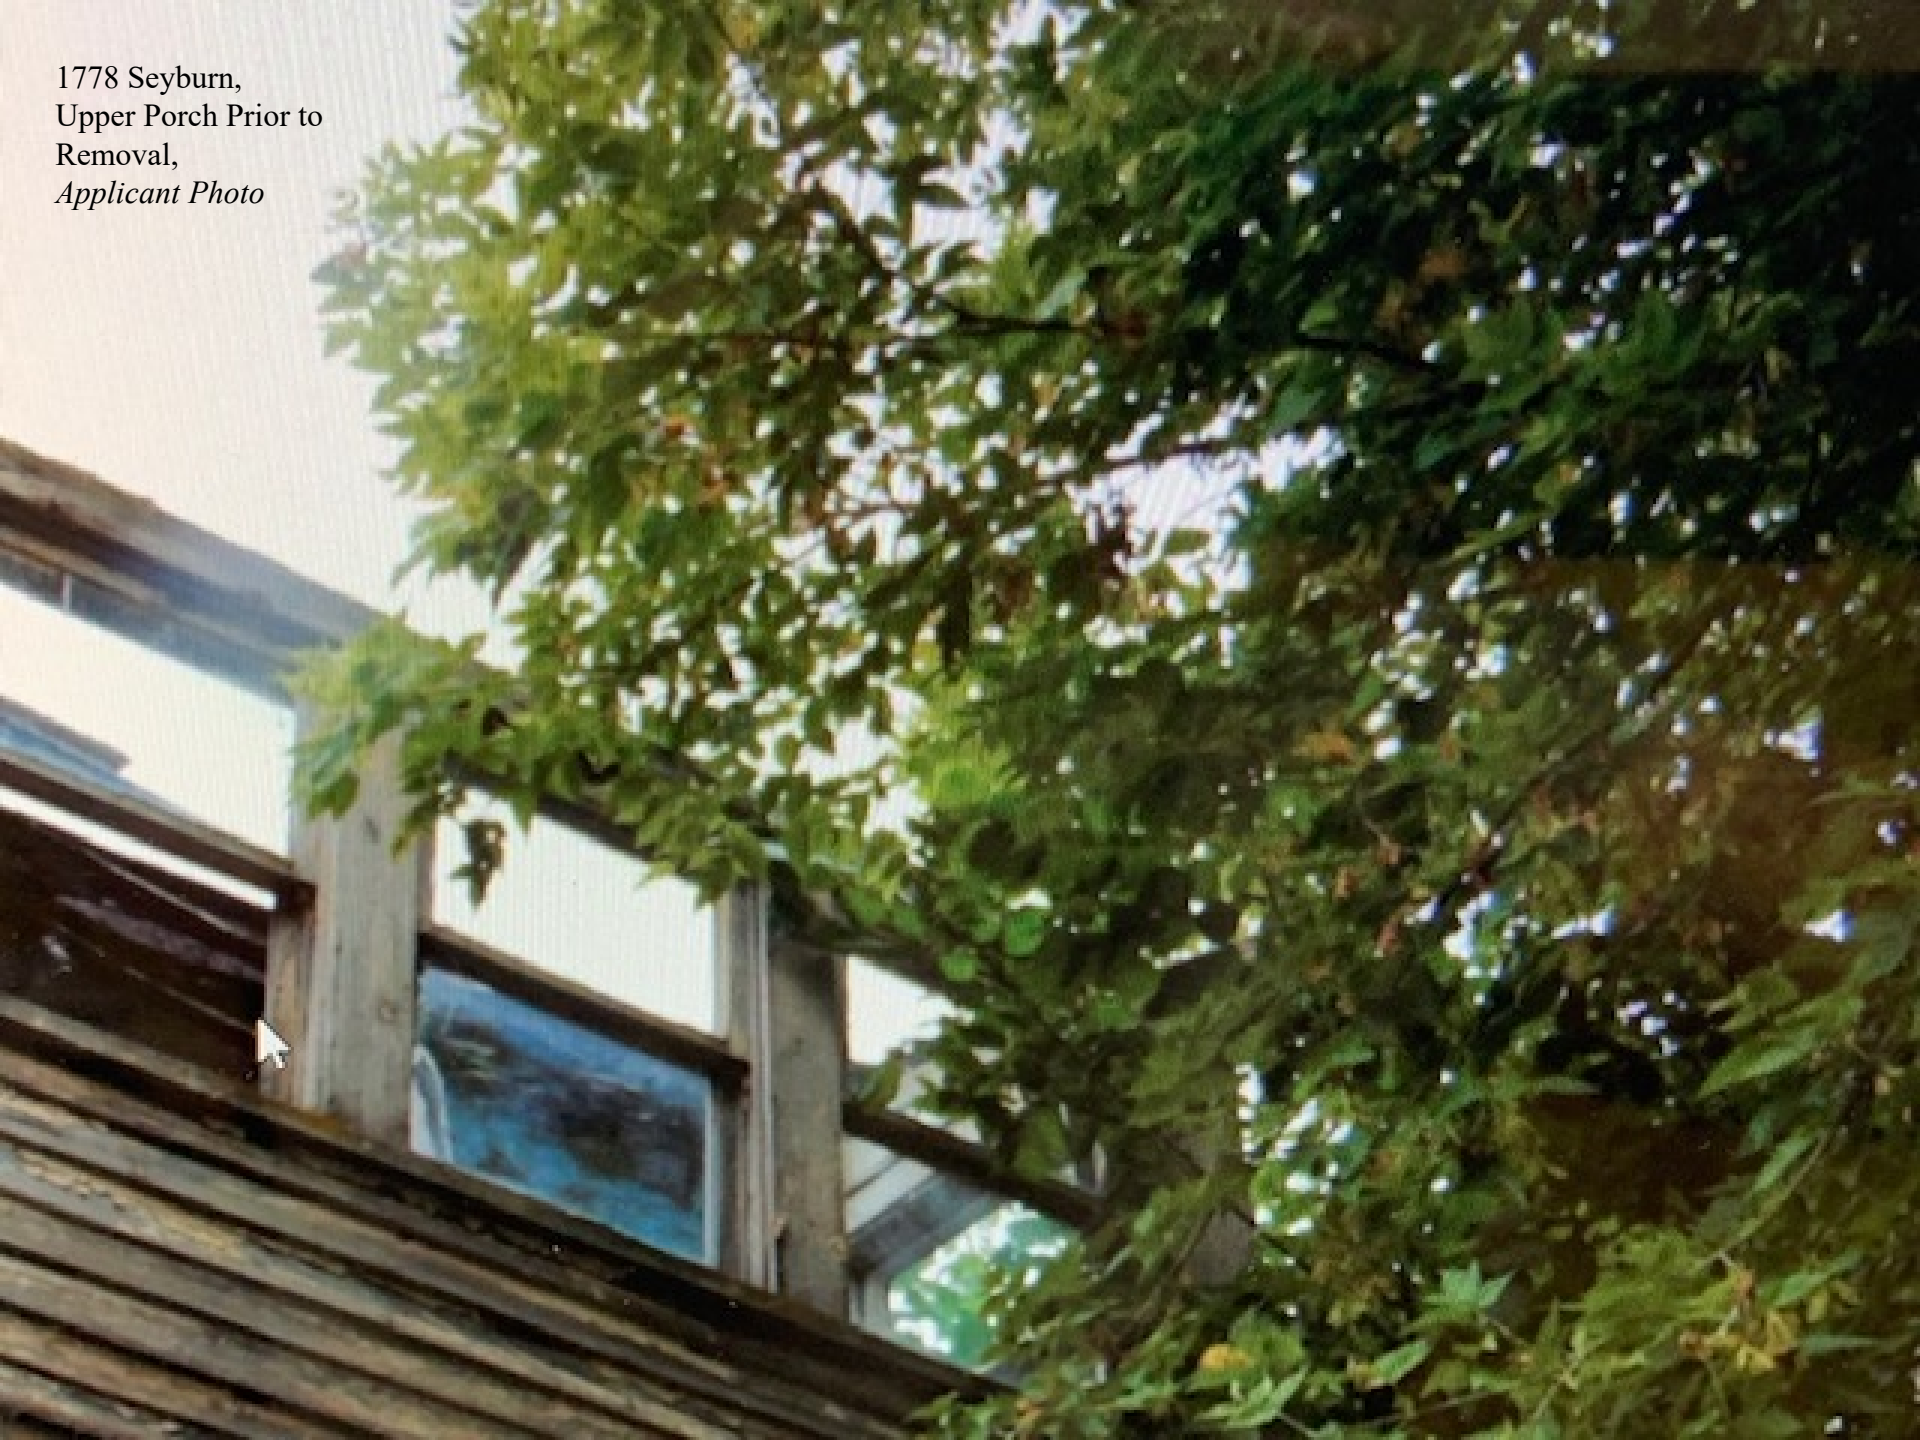
1778 Seyburn,
Upper Porch Detail,
Applicant Photo

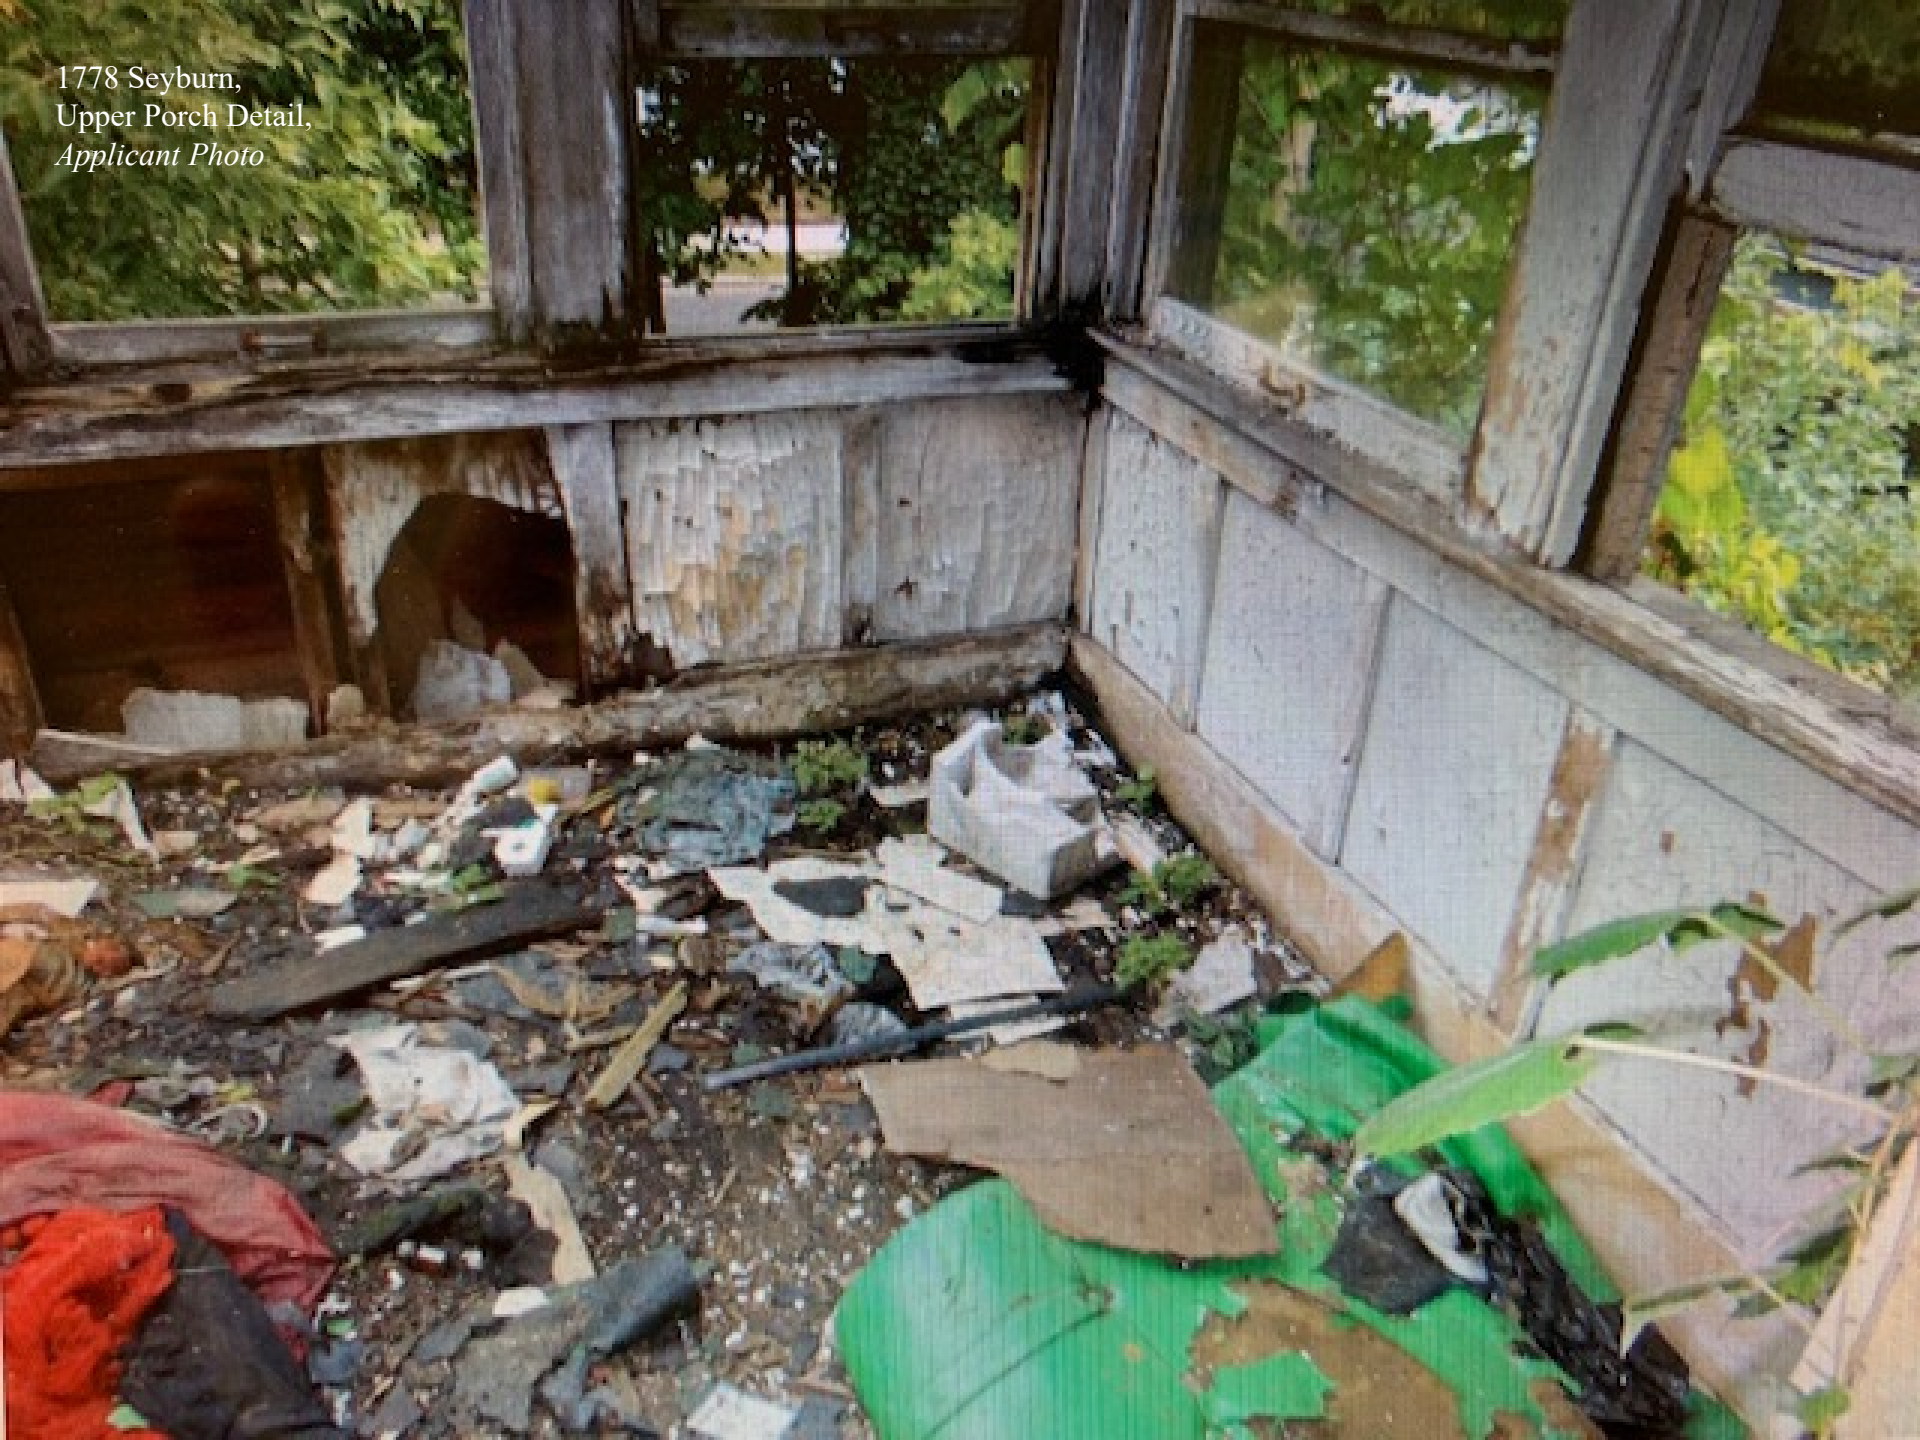
1778 Seyburn,
Upper Porch Detail,
Applicant Photo

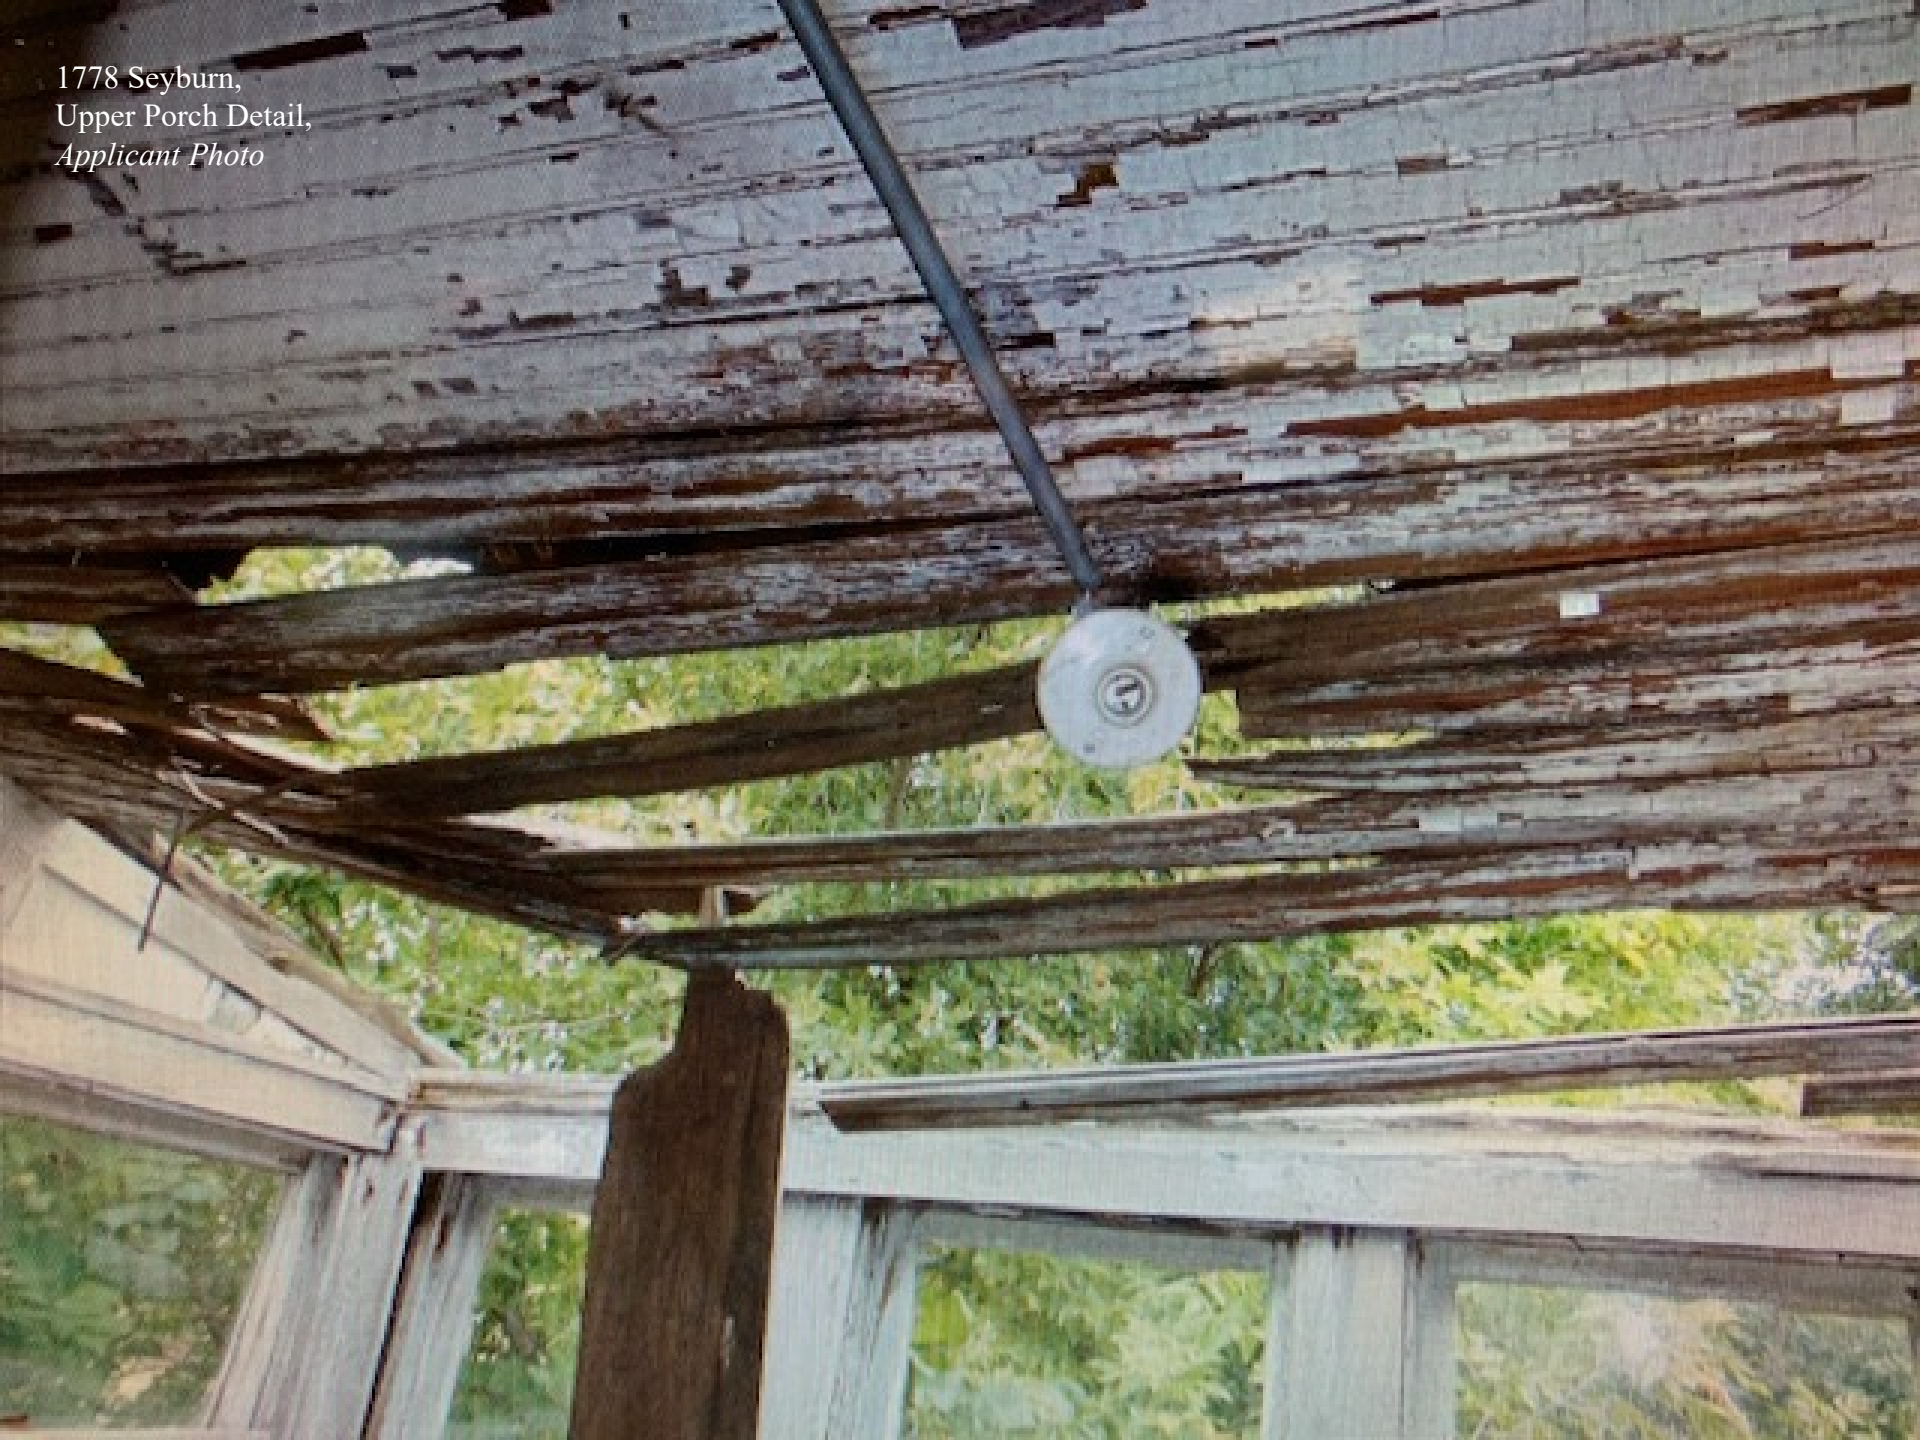
1778 Seyburn,
Upper Porch Detail,
Applicant Photo

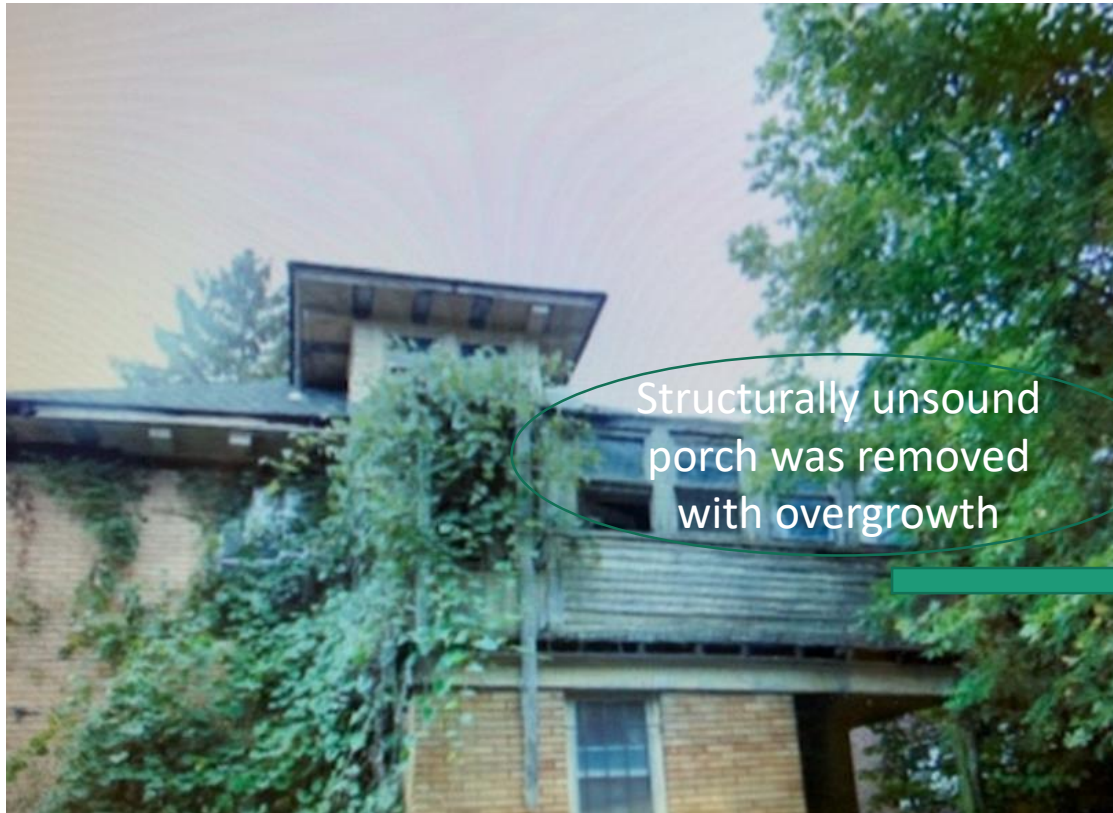
Current: closed-in upper deck porch has been removed

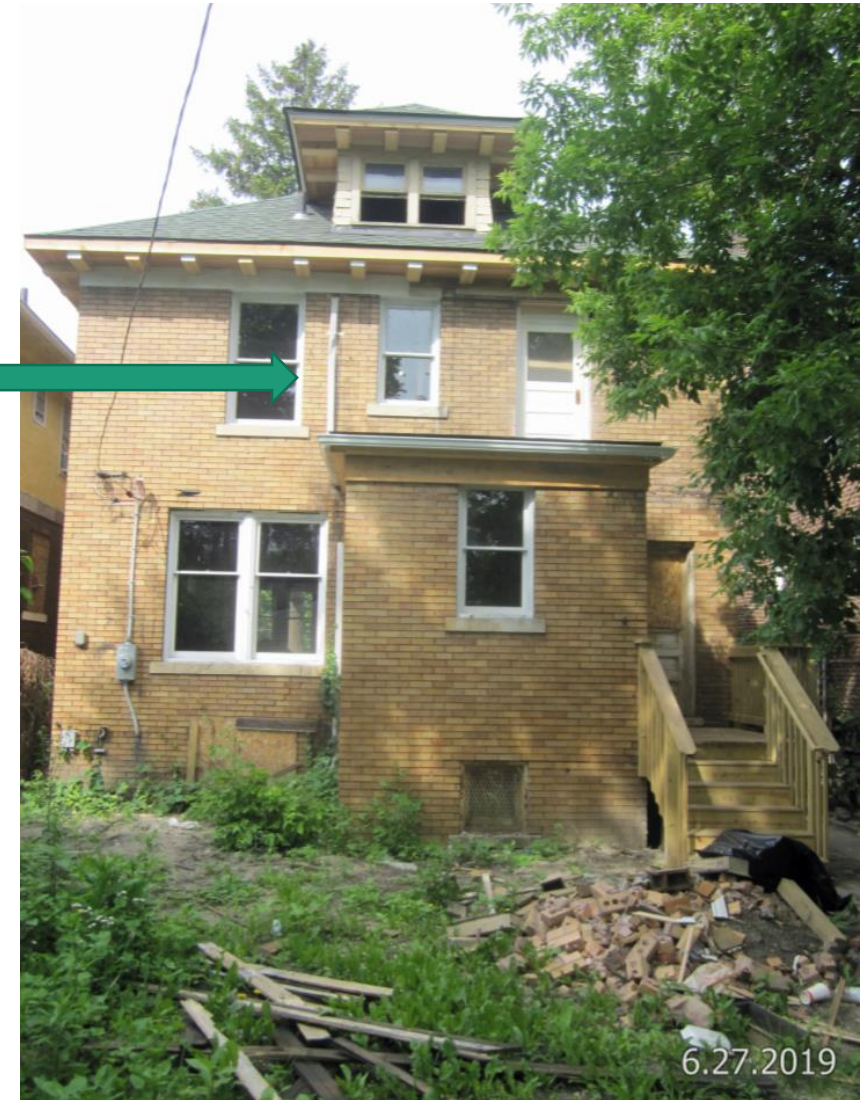
Before: Rear porch, structurally unsound.

Plan: Add railings to upper deck to match lower porch railings

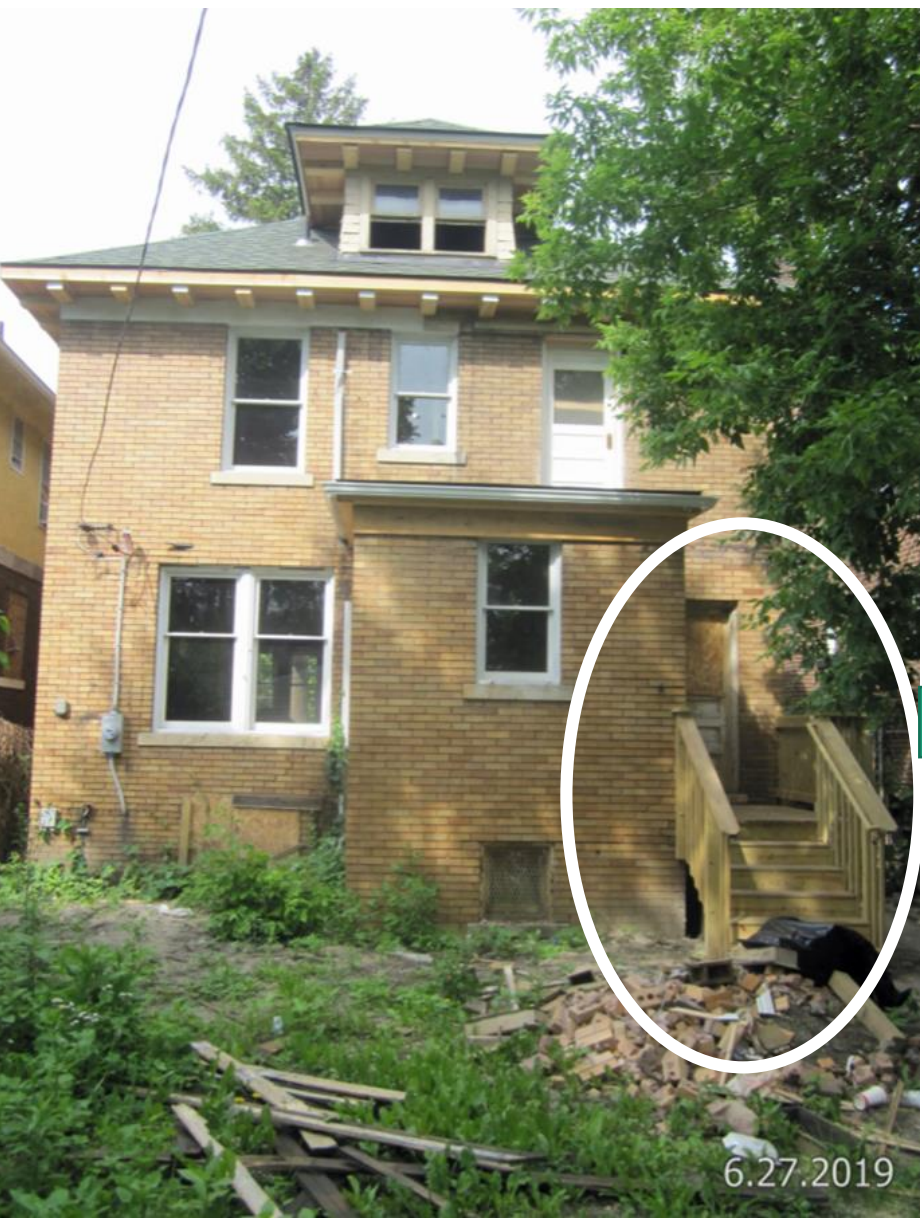
Current: Rear entrance railing details

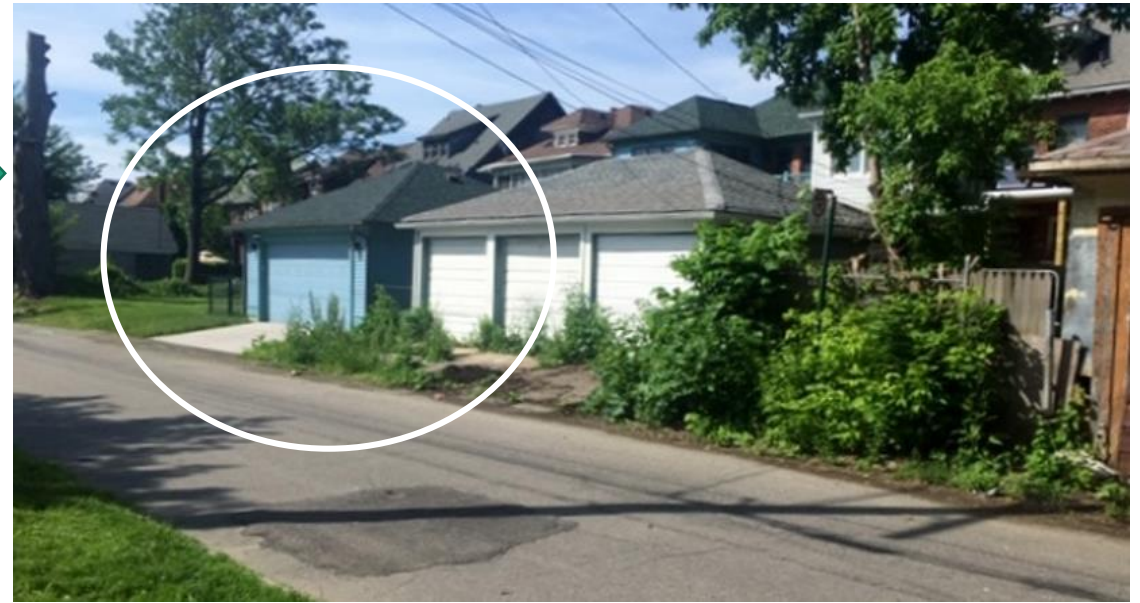
Current: Two car garage built
on slab

Plan: Replace siding with
appropriate color (per
samples) with similar details
to blue neighboring garage
circled above.
