CERTIFICATE OF APPROPRIATENESS

RE: Application Number 20-6968; 691 W. Alexandrine Street, Willis – Selden Historic District

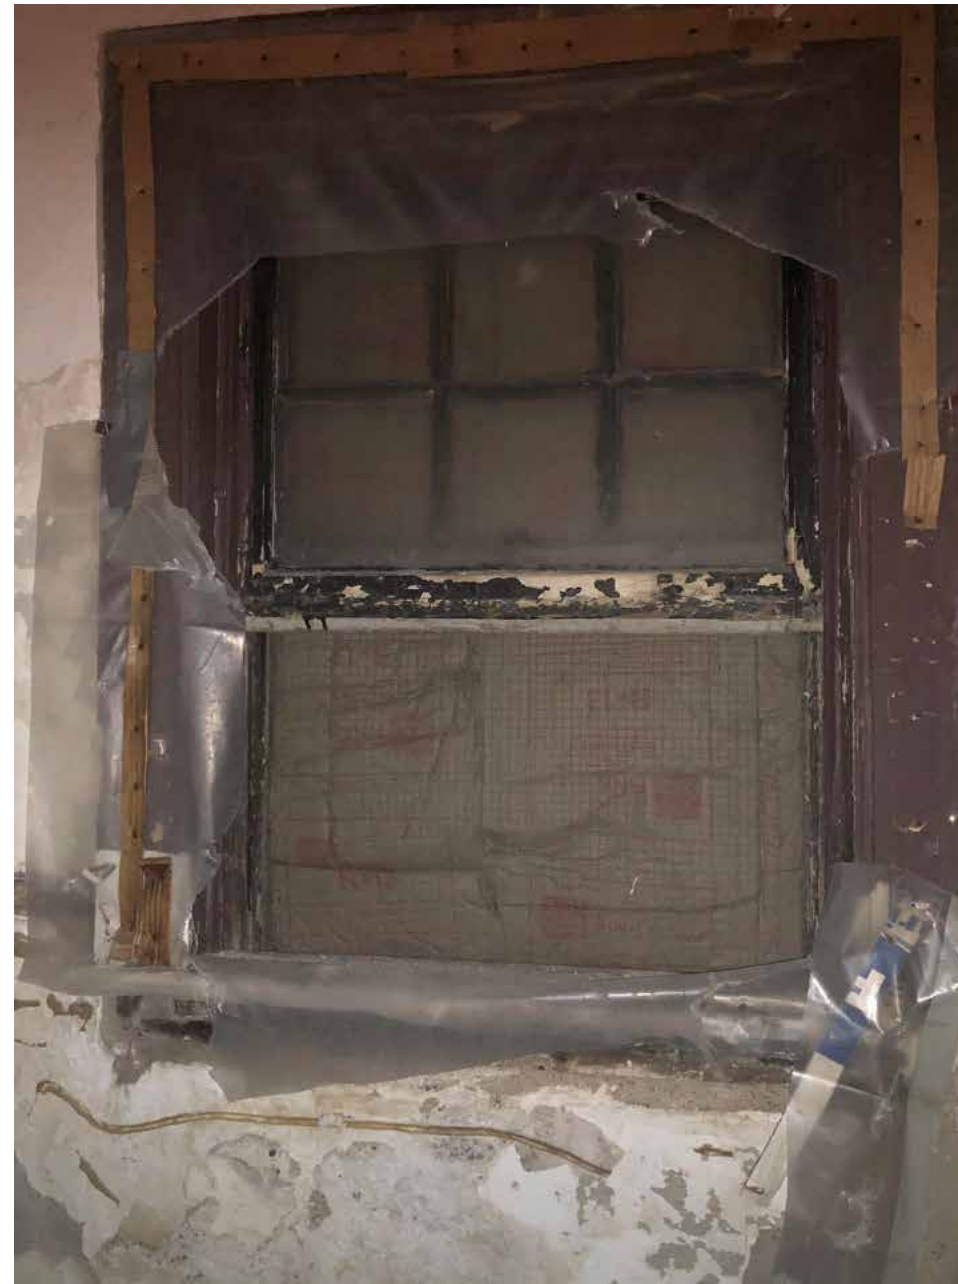
- INTERNAL SILL IS MISSING
- WINDOW WAS BOARDED UP ON THE OUTSIDE
- BOTTOM SASH MISSING
- STOPS ARE BROKEN ON BOTH SIDES
- SEVER ROT ON JAMBS

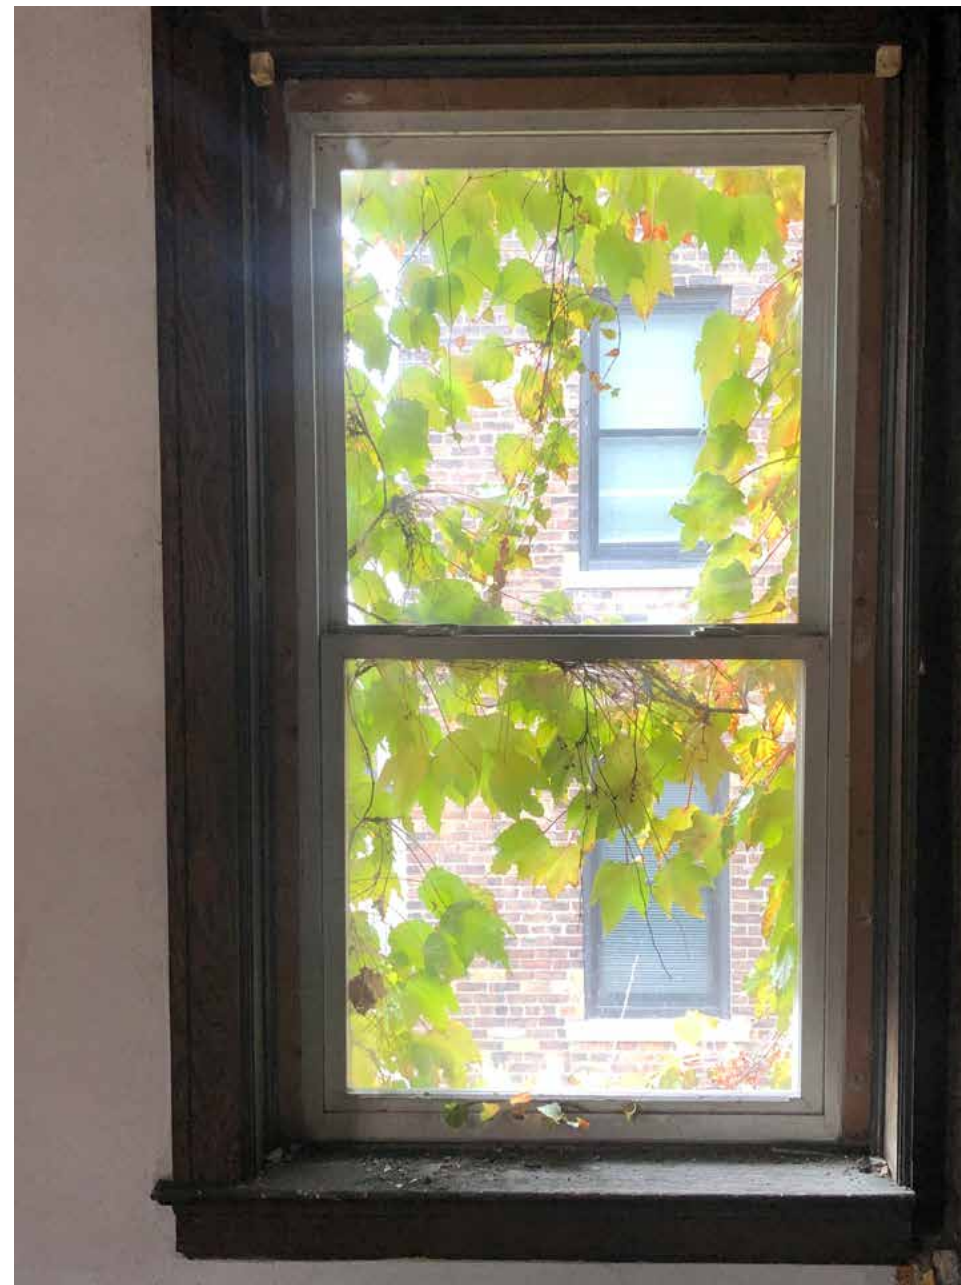
- WINDOW HAS BEEN REPLACED WITH A VINYL REPLACEMENT THAT DOES NOT FIT IN OPENING
- WOOD WAS USED TO INFILL THE GAPES
- STOPS ARE MISSING
- SASHES ARE MISSING
- LEAD WEIGHTS ARE MISSING
- EXTERIOR SILL IS ROTTEN

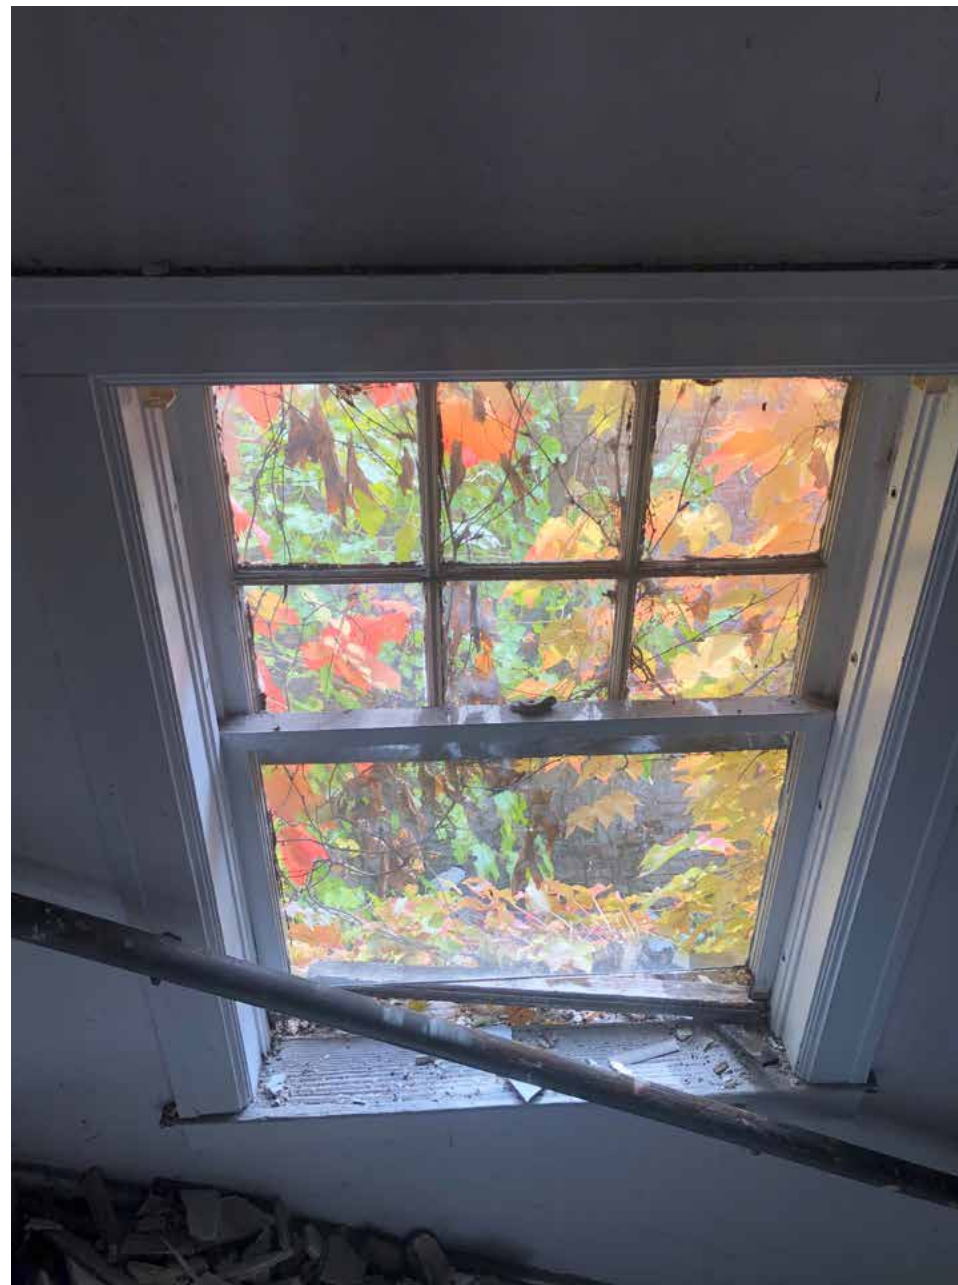
- WINDOW WILL NOT OPEN
- LEAD WEIGHTS ARE IN PLACE, BUT CORDS NEED REPLACING
- EXTERIOR SILL HAS MASSIVE ROT
- INTERIOR SILL IS ROTTEN AND LOOSE
- WEATHER STRIPPING MISSING
- WINDOW NEEDS TO BE RE PUTTED
- BOTTOM SASH HAS EXTENSIVE ROT

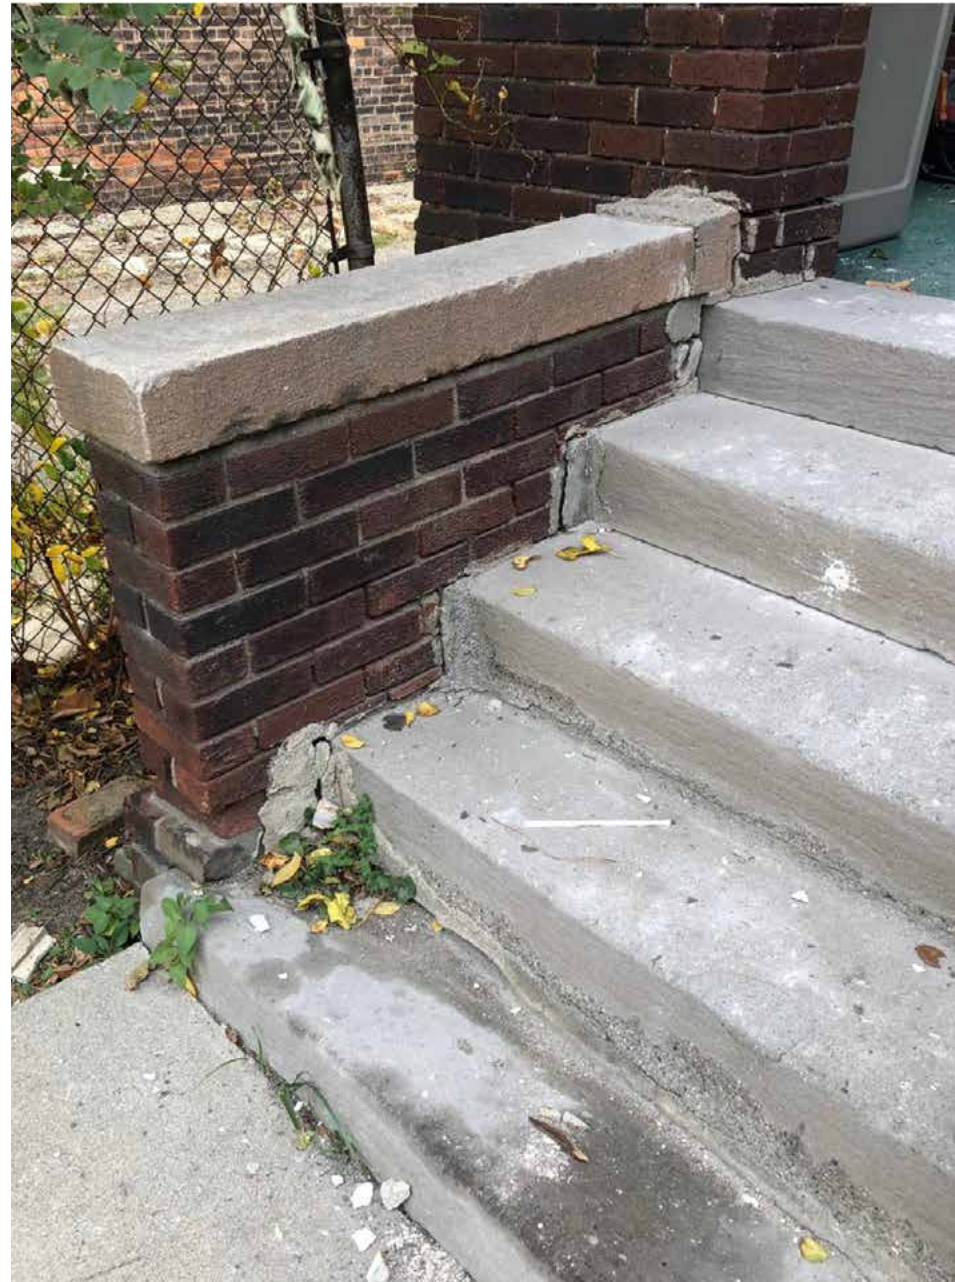
- STEPS HAVE PULLED AWAY FROM THE PORCH AND WAS IMPROPERLY FILLED
- WALL HAS PULLED AWAY FROM THE PORCH AND WAS IMPROPERLY FILLED
- STEPS ARE NOT TO CODE OR ADA COMPLIANCE.
- THERE ARE GAPS BETWEEN THE STEPS AND HAVE BEEN FILLED

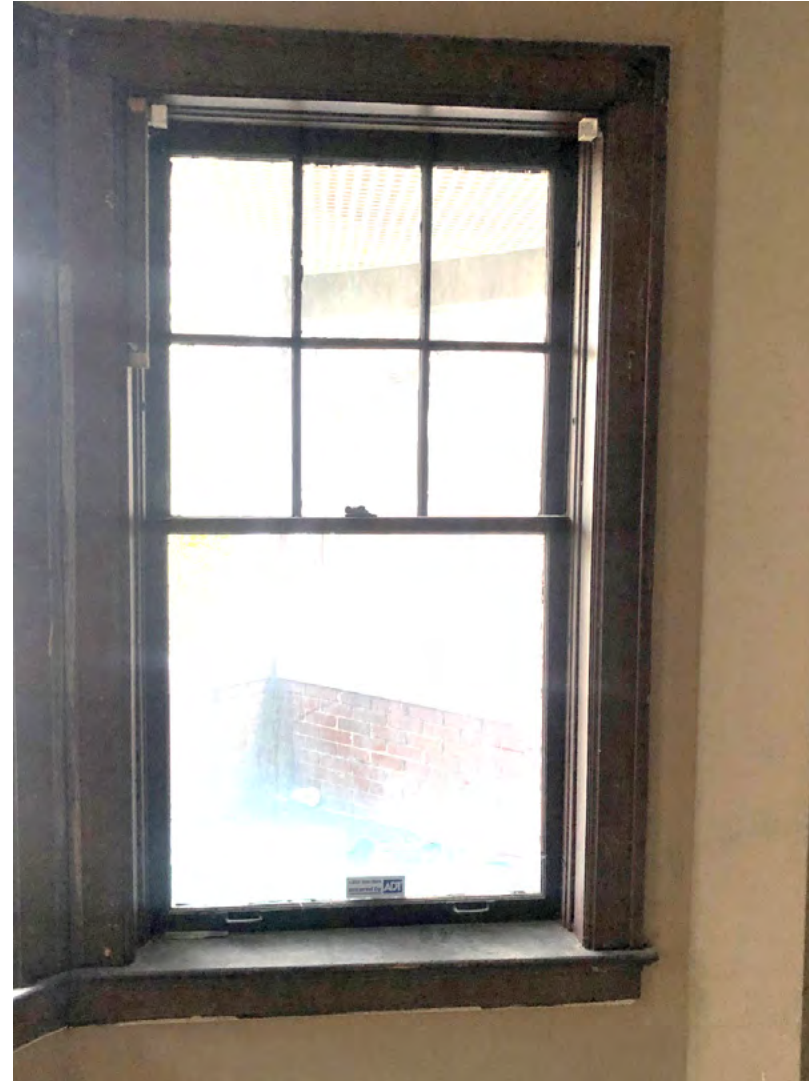
- Window is sealed shut
- Exterior windowsill has some rot
- One of the lead weights is missing
- Window is cocked in opening
- Window will not lock
- Window needs to be re-putted
- Weather stripping missing

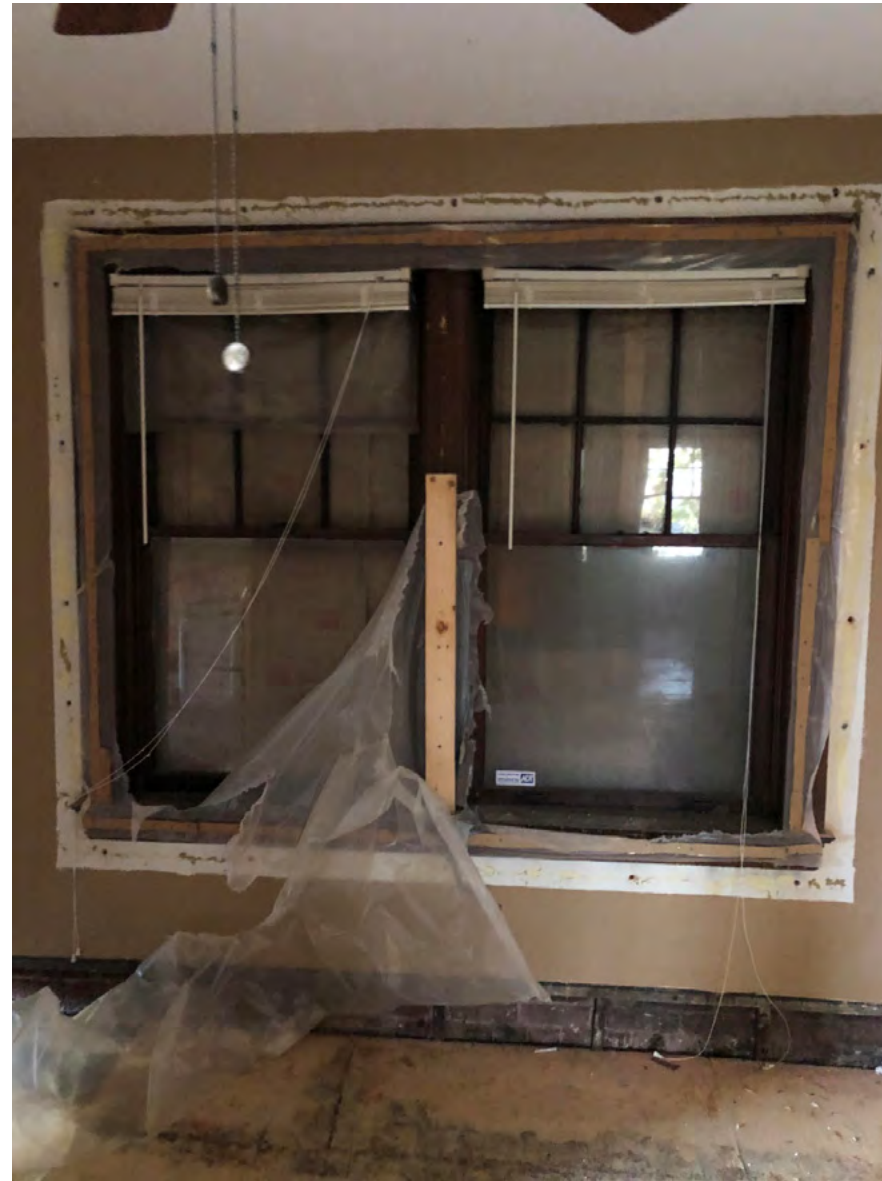
- The window is boarded up on the outside.
- Exterior sill has extensive rot
- Both sashes' have severe rot
- Windows need to be re-putted
- Weather stripping missing
- Lead weights are missing in both windows

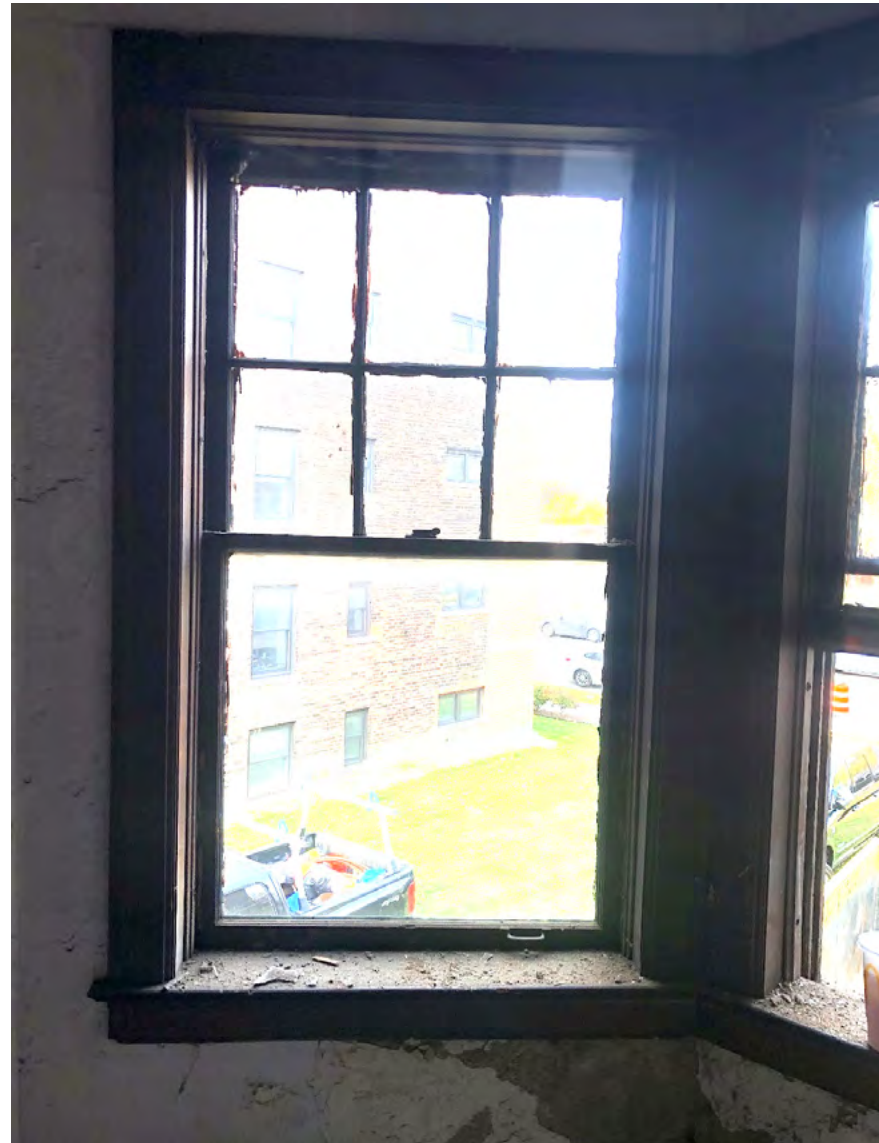
- Right lead weight is missing
- Exterior Sill is broken
- Brick molding on left side has severe rot
- Window will only open halfway
- Missing one handle
- Weather stripping missing
- Bottom sash has rot at bottom

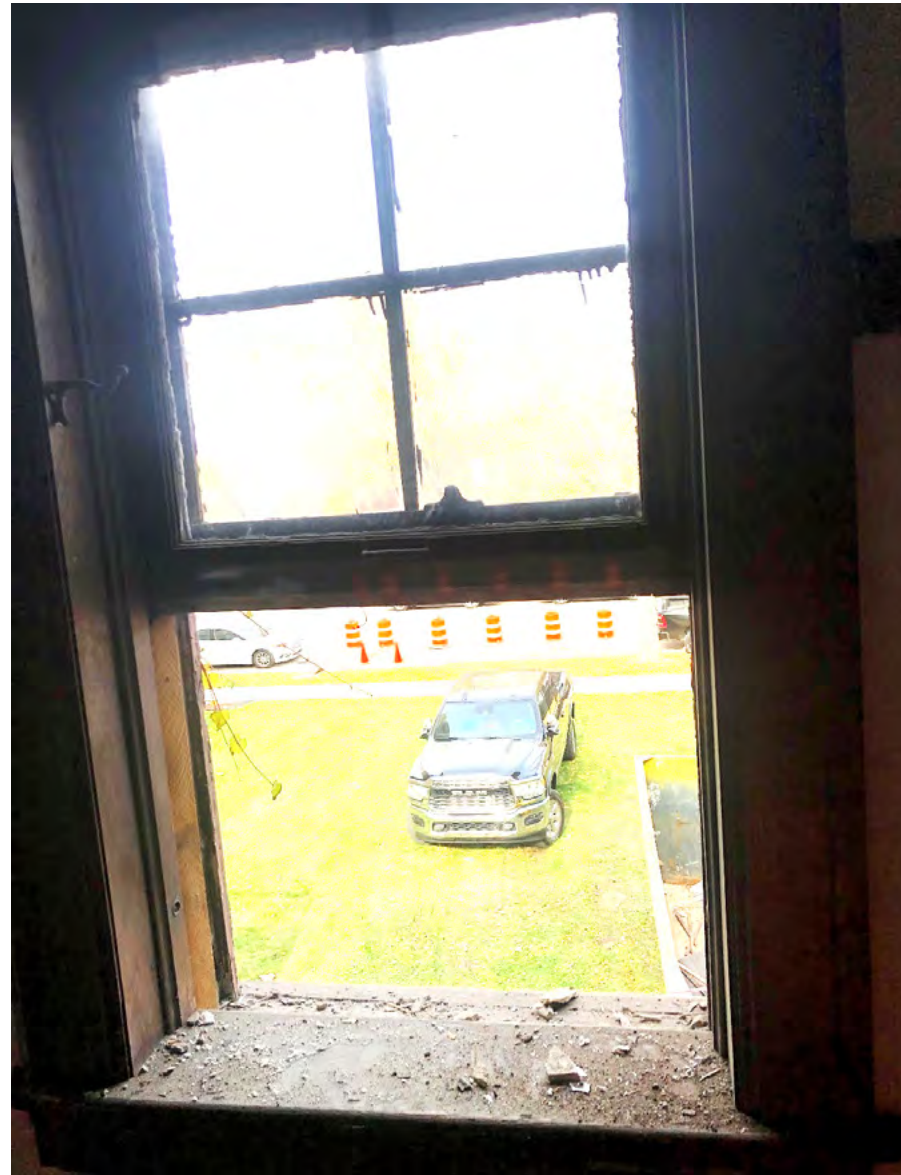
- Window will open
- Lead weights are missing in both sides
- Exterior sill is broken and has rot
- Interior Jamb has water damage
- Window needs to be re-putted
- Weather stripping missing

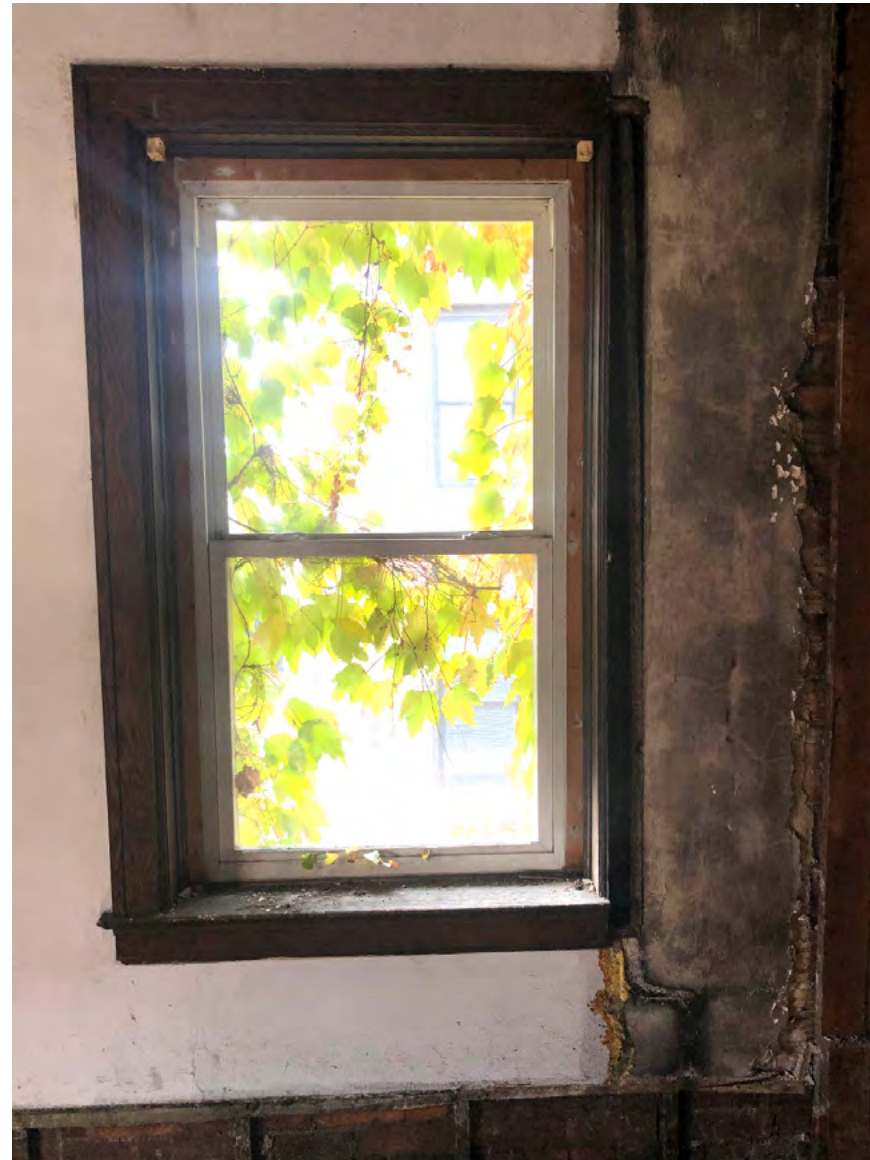
- Window has been replaced with a vinyl replacement that does not fit in opening
- Wood was used to infill the gapes
- Stops are missing
- Sashes are missing
- Lead weights are missing
- Exterior sill is rotten

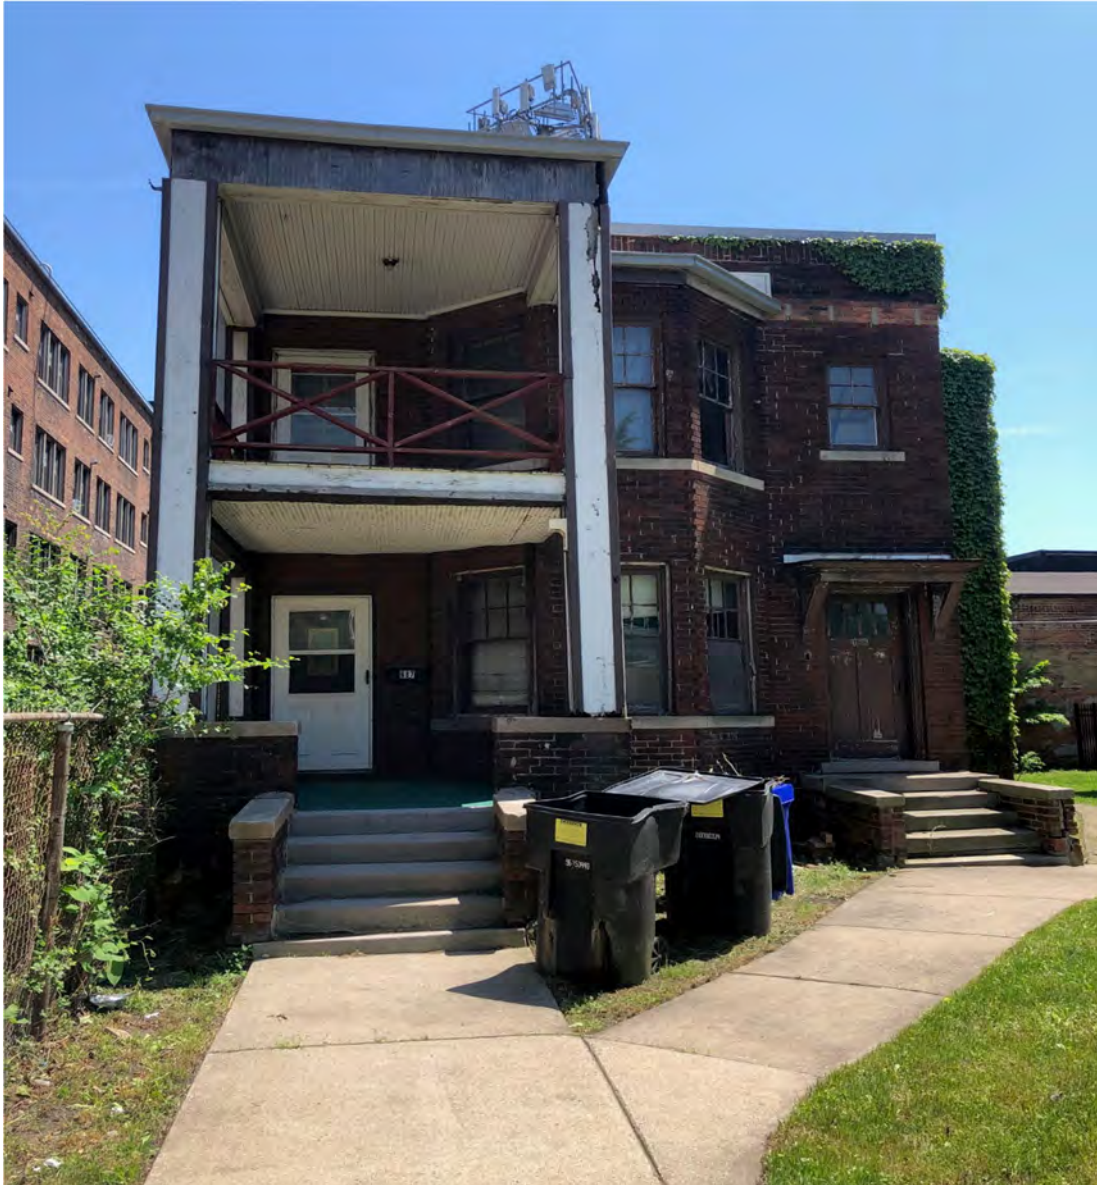
STEP and STEP WALLS

- Steps have pulled away from the porch and was improperly filled
- Wall has pulled away from the porch and was improperly filled
- Steps are not to code or ADA compliance.
- There are gaps between the steps and have been filled
