NOTICE OF DENIAL

RE: Application Number 23-8396; 2405 Burns St.; Indian Village Historic District

CERTIFICATE OF APPROPRIATENESS

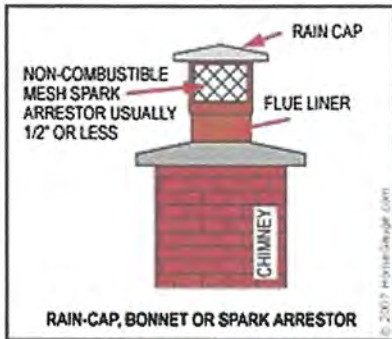
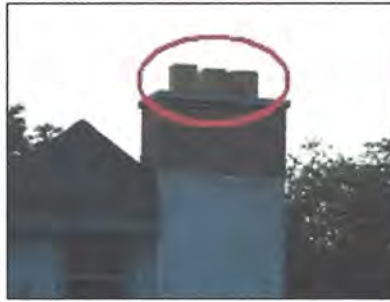
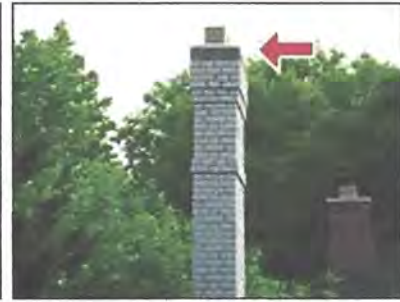
6.1 (1) We suggest installing a spark arrester and rain cap on the chimneys. This helps prevent water and pest intrusion.

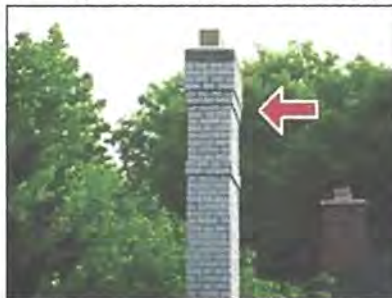
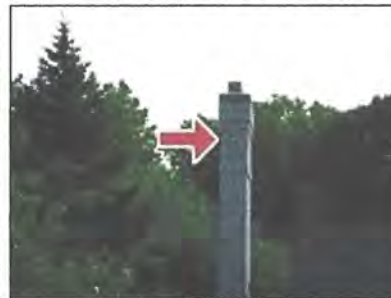
(2) The chimney at the rear left of the house has a slight lean to it, but it could have been this condition for an extended period of time. We did not see any issues at the time of inspection and recommend to monitor the area as needed.

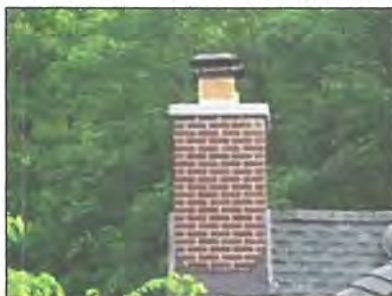
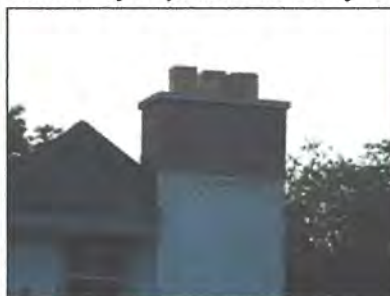
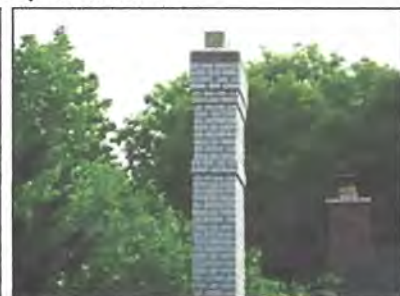
(3) Due to the height of the chimney, slope of the property or steep roof, we could not observe the condition of the masonry or metal chimney cap. The cap performs the important function of keeping water out of the masonry or wood chimney structure, and must be kept maintained. - SUGGESTION: If there is any concern about the condition of the cap, the client is advised to have the condition evaluated by a qualified chimney sweep contractor.

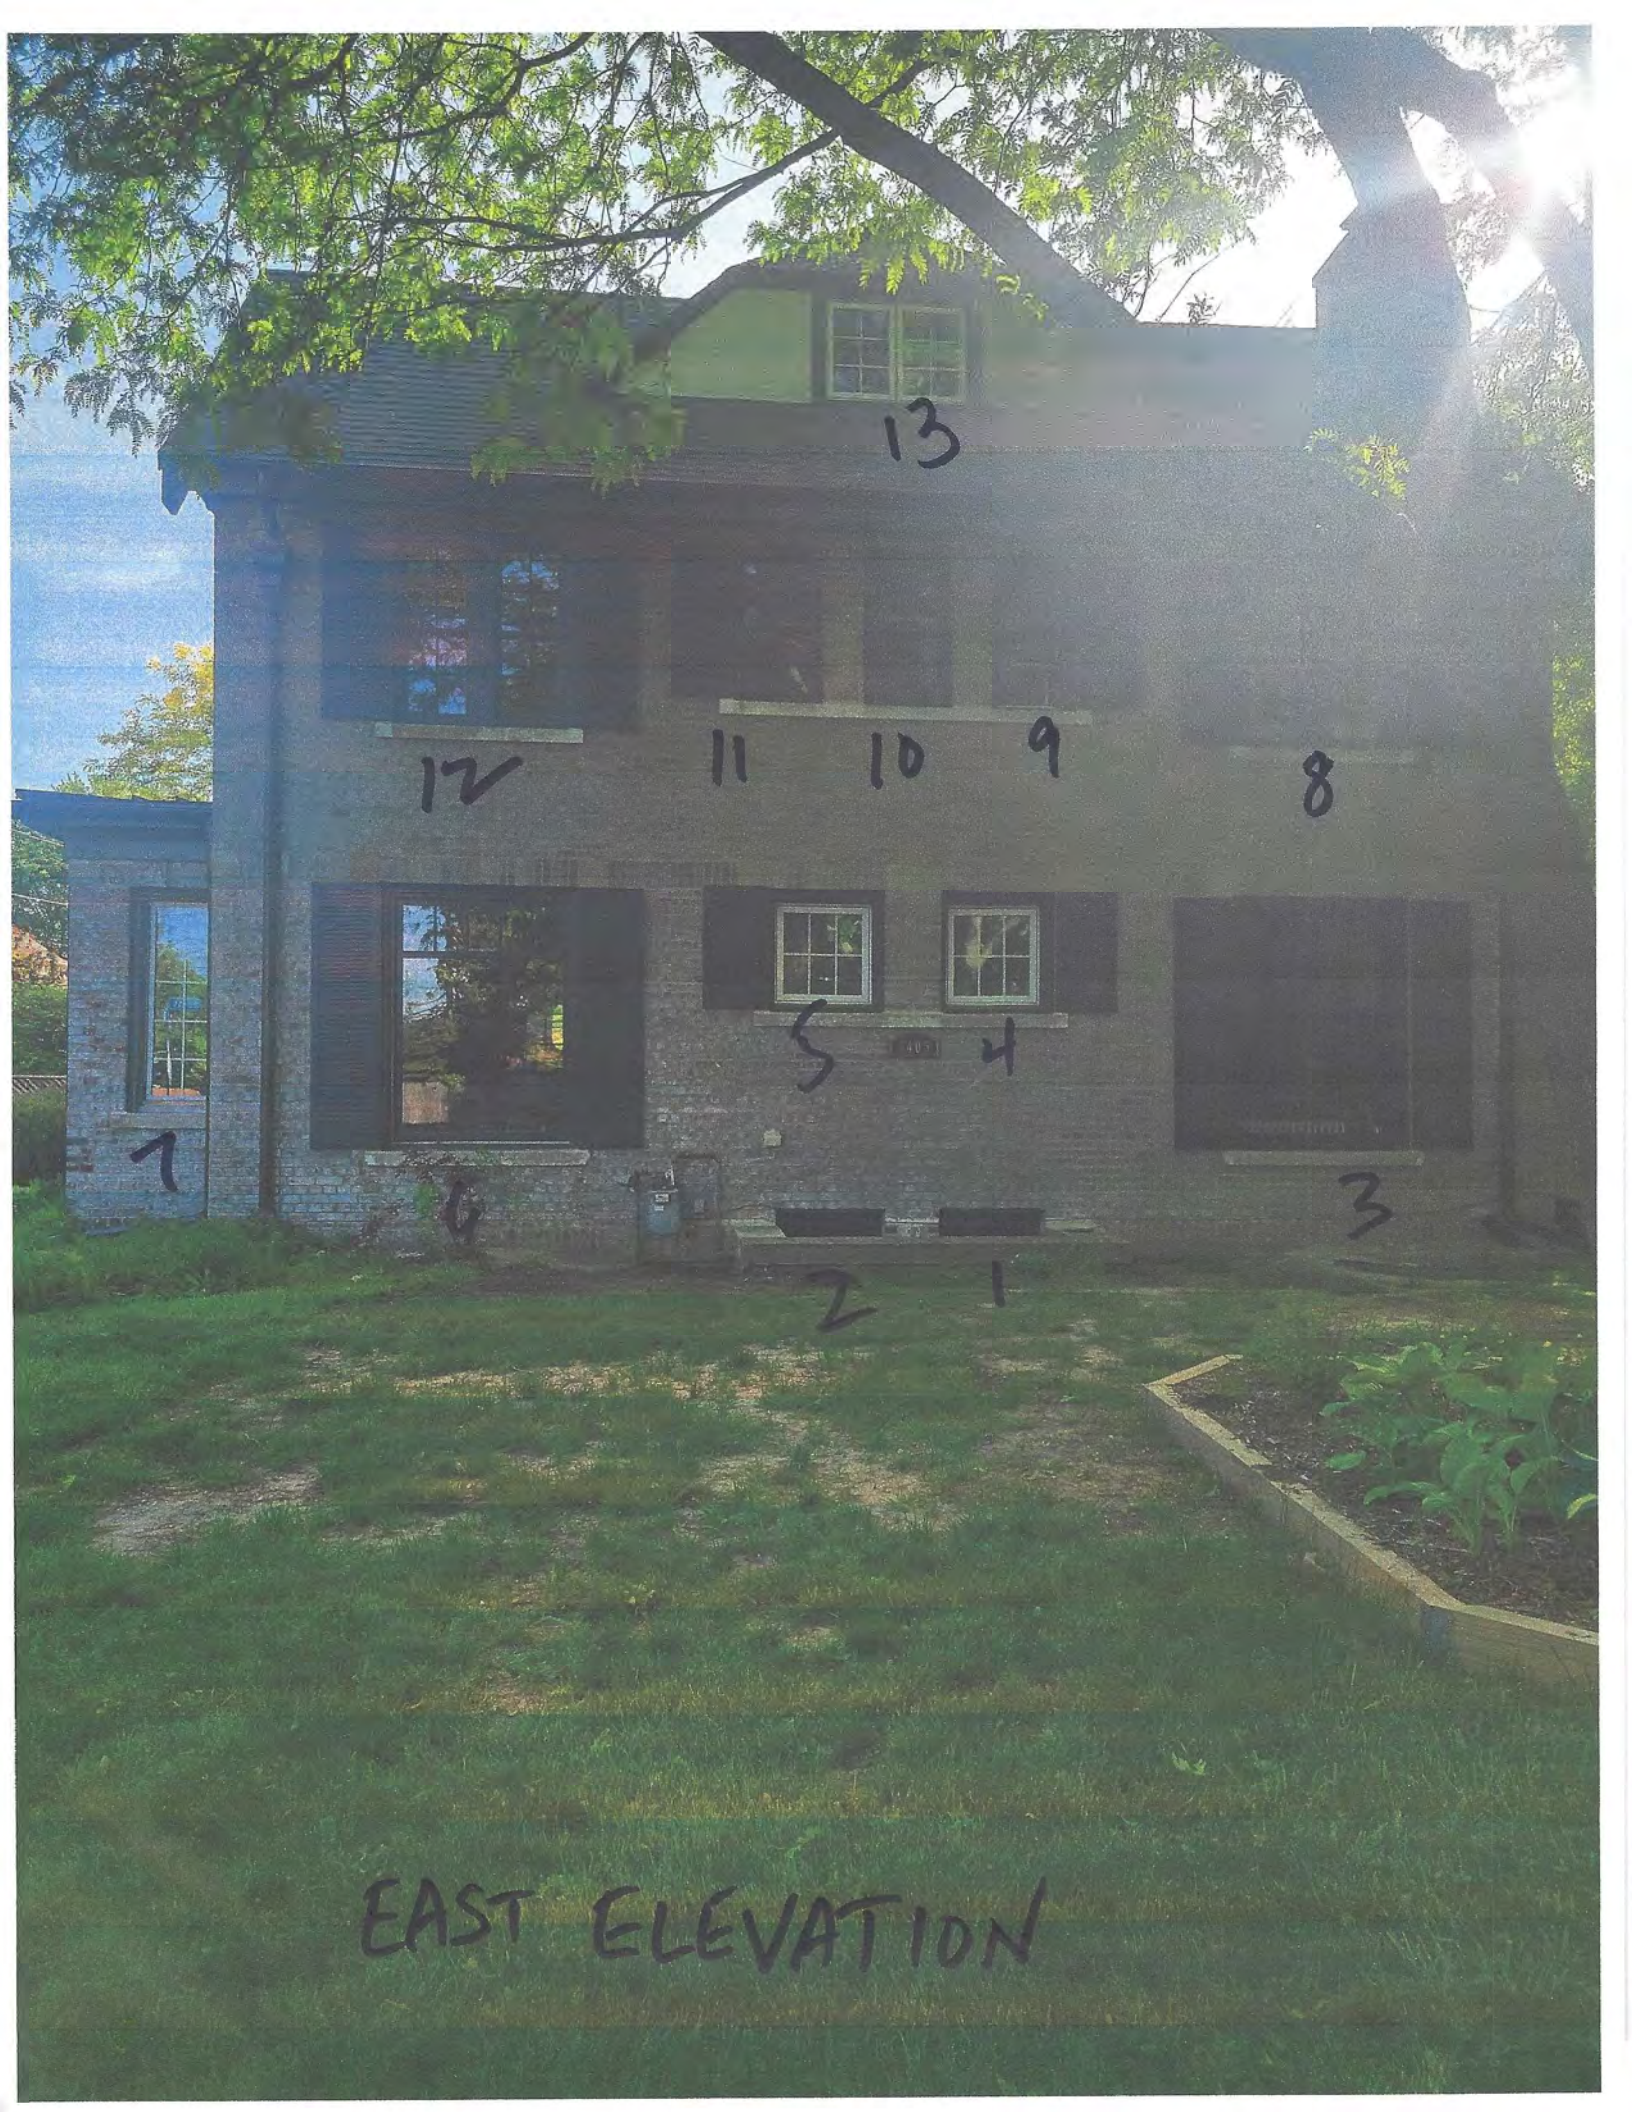
EAST ELEVATION

1,2 – basement, full size sash window pair. Found buried and intact. Removed, stripped, repaired and placed back into original openings.

3,6 – found in garage, stripped, repaired, reglazed. Replaced vinyl windows that was broken. Old replacement removed along with all breakmetal surrounding. Trim on outside cleaned and painted, inside frame from original installation still intact. Replaced brass insulating strips with identical new. Reglazed and stripped old window left in attic and rebuilt and reinstalled.

4,5 – replaced Vinyl window with windows from attic. **Windows are wood framed and 6 individual pains of glass. These were original windows from the attic.** Same process as previously explained. **Windows are operable.**

8-12 – **All are double hung, sash windows.** All are original windows that were removed from their frames, stripped and reglazed. All working hardware was reconditioned. Only new materials used in any of the rebuilds is the rope for the counterweights. All tracks were restored. No new glass was used.

13 – attic window will not be replaced

7 – Original window is currently being disassembled and reconditioned. **No work is being done now.**

*******Note******* In removing the vinyl replacement windows, and break metal surrounding the windows, it was remarkably discovered that the frames are in perfect condition as built originally. All the original windows are in near perfect condition once paint and glazing is removed.

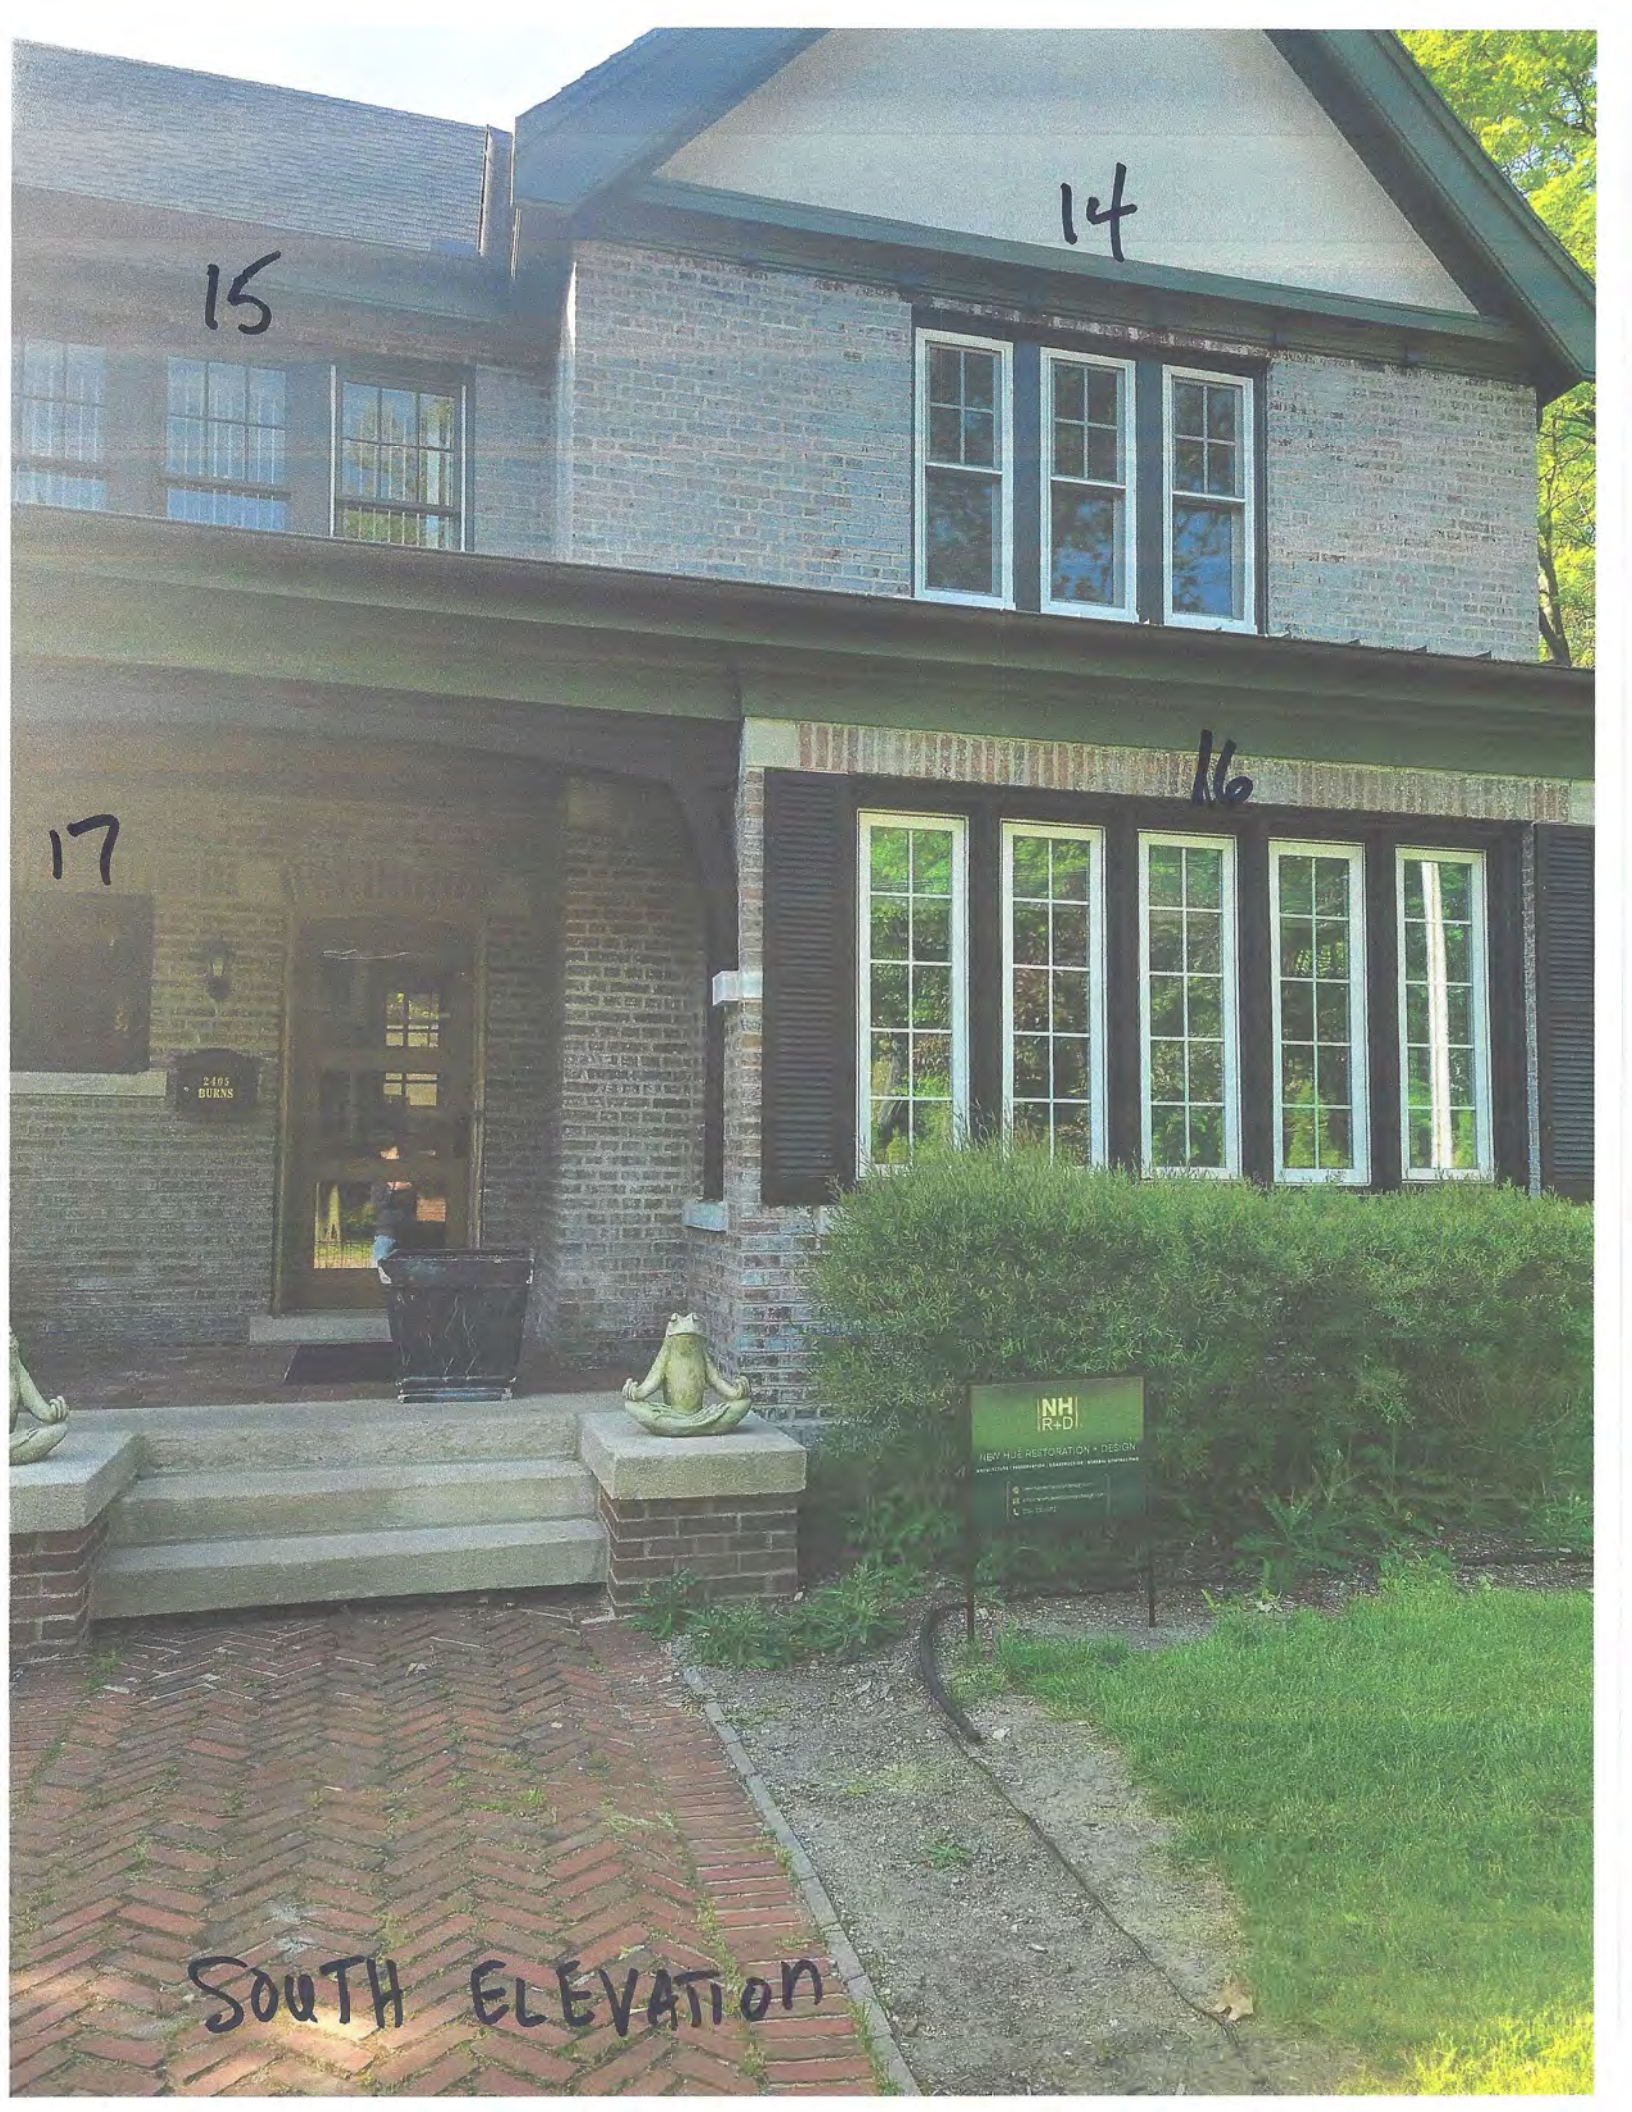
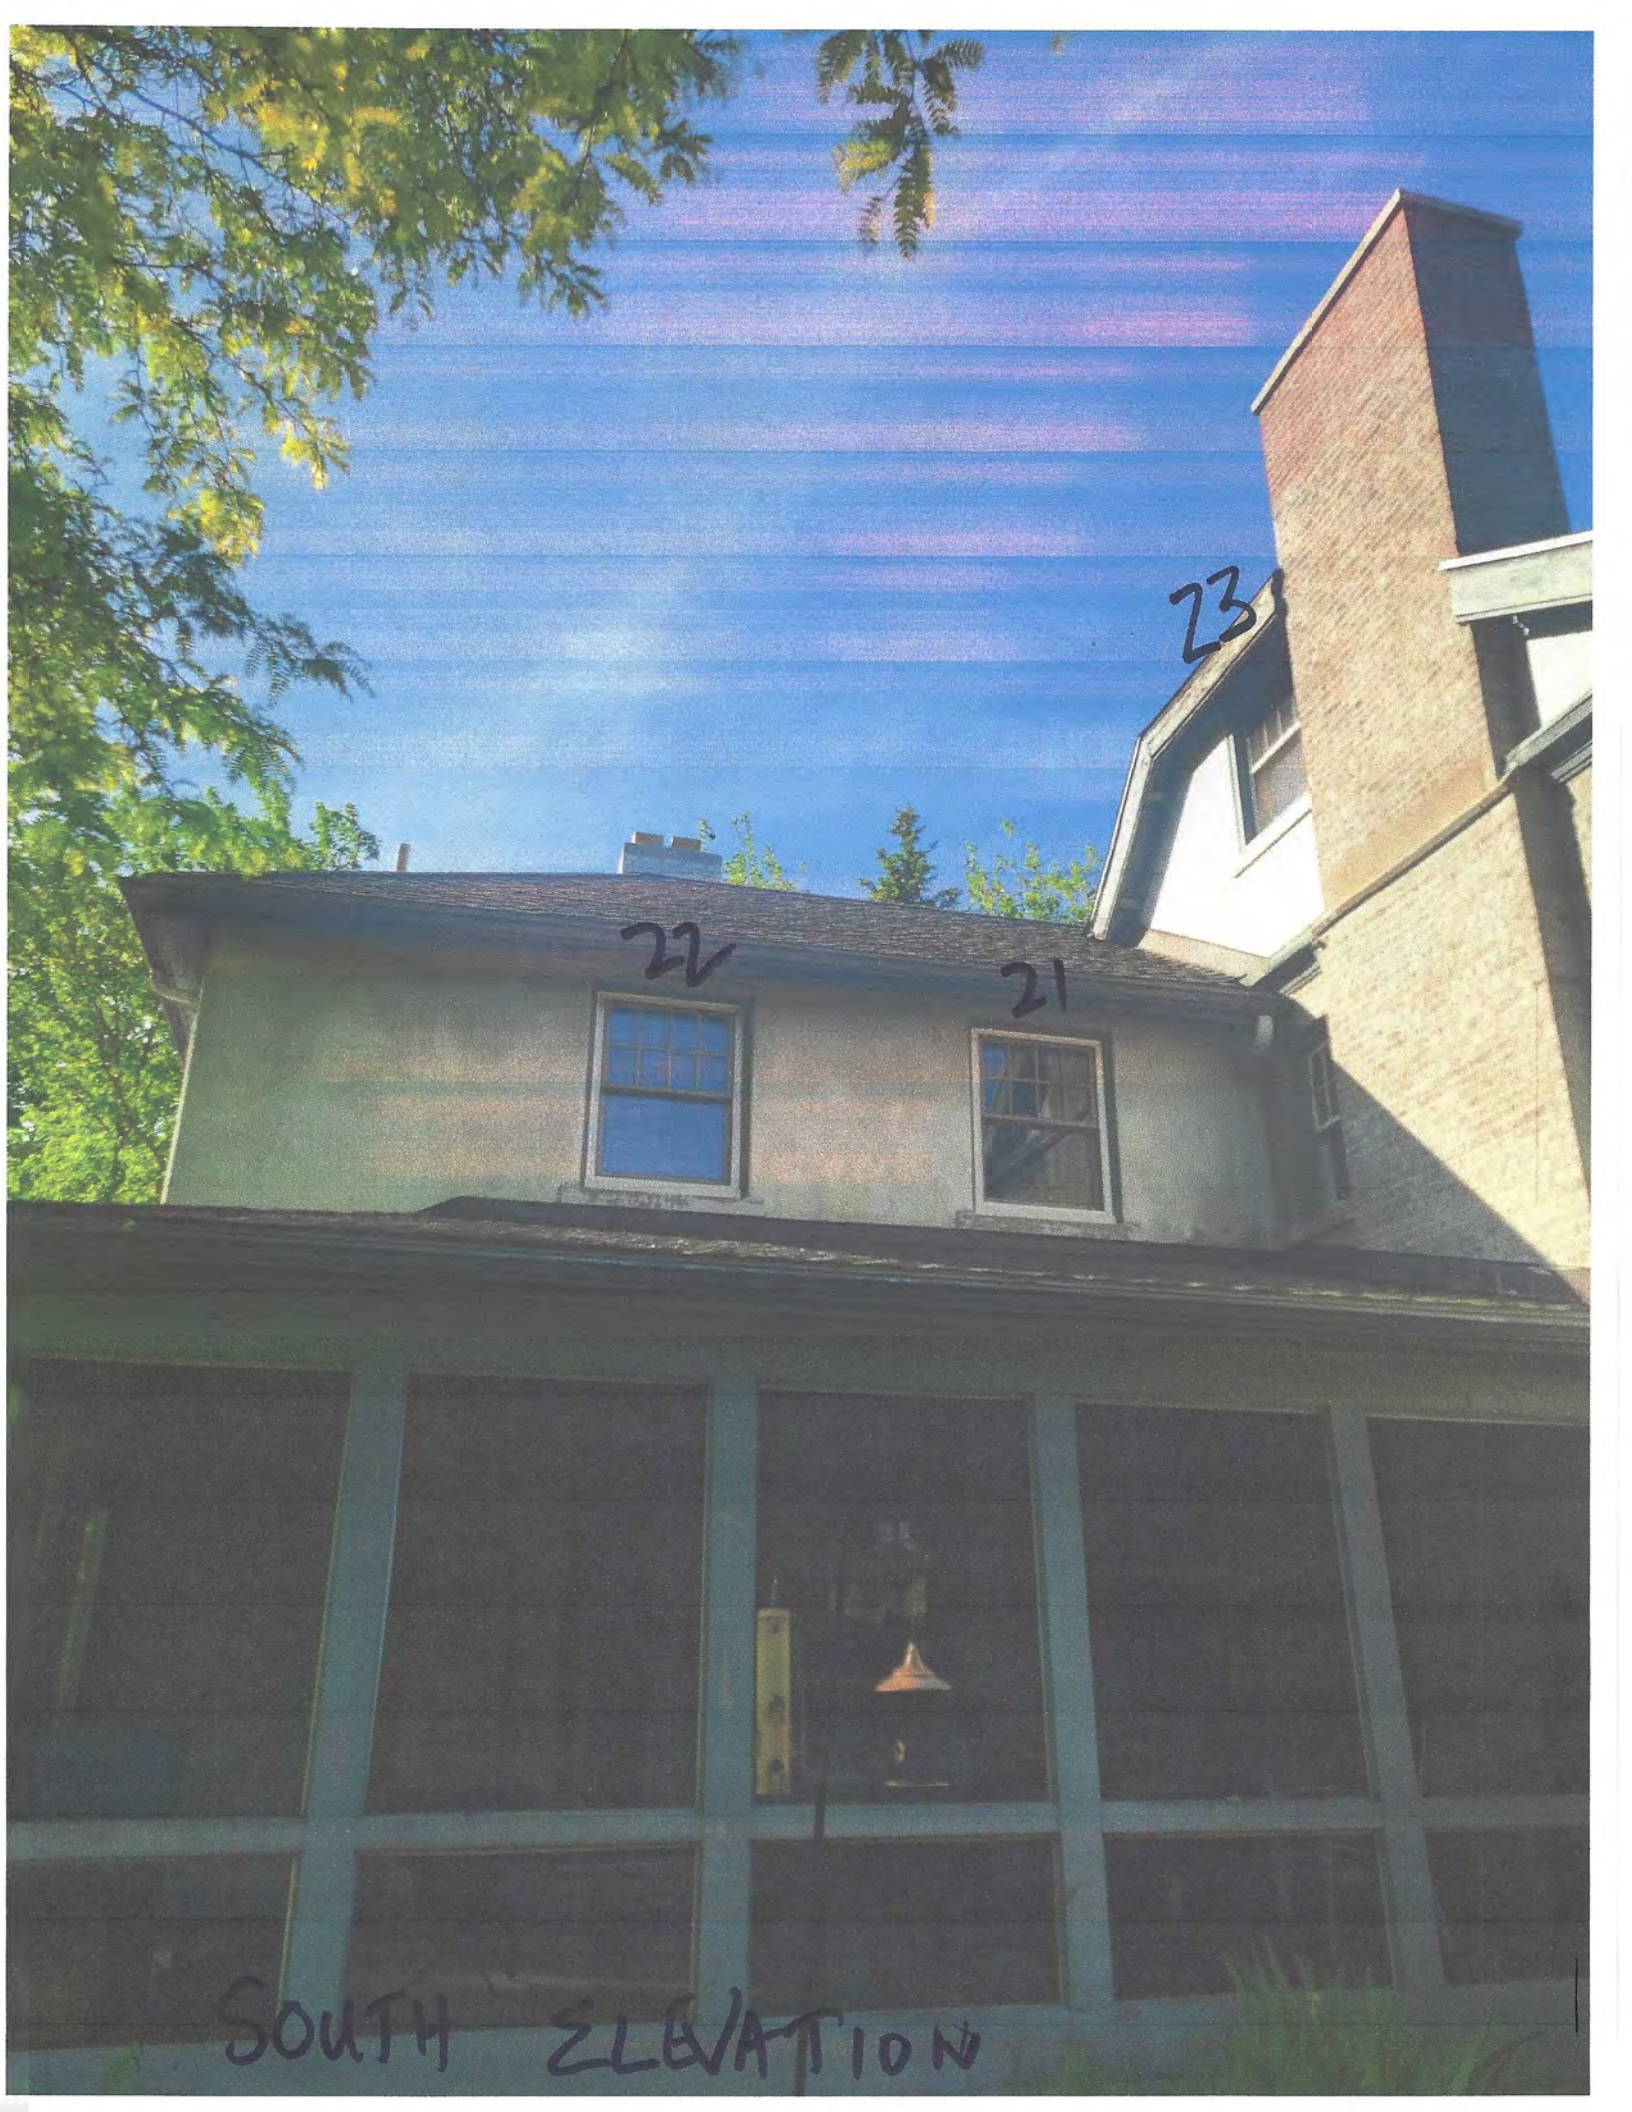
SOUTH ELEVATION

14 – Vinyl windows to be replaced with found windows from attic **which are wood framed and the exact configuration as vinyl. The windows are double hung sash windows that are being reinstalled. The condition of the old windows is excellent.** Same window configuration as show in the vinyl window. Same process of stripping and repairing.

15 – Original windows that were still installed in opening. Windows were removed and cleaned, repaired and reglazed.

16 – windows found in attic and are being restored as previously described. **These windows are a combination of operable (one swings from left and one from right on brass hinges). Left to right are fixed, operable, fixed, operable, fixed. Hinge locations still on frames indicating the original configuration.**

17- original window restored.

18 – 22 – currently showing the vinyl windows. Original windows to be installed after restoration.

23 – attic window vinyl, **not found in pile of old windows. I would like to have this window custom made to match the original windows in the house.**

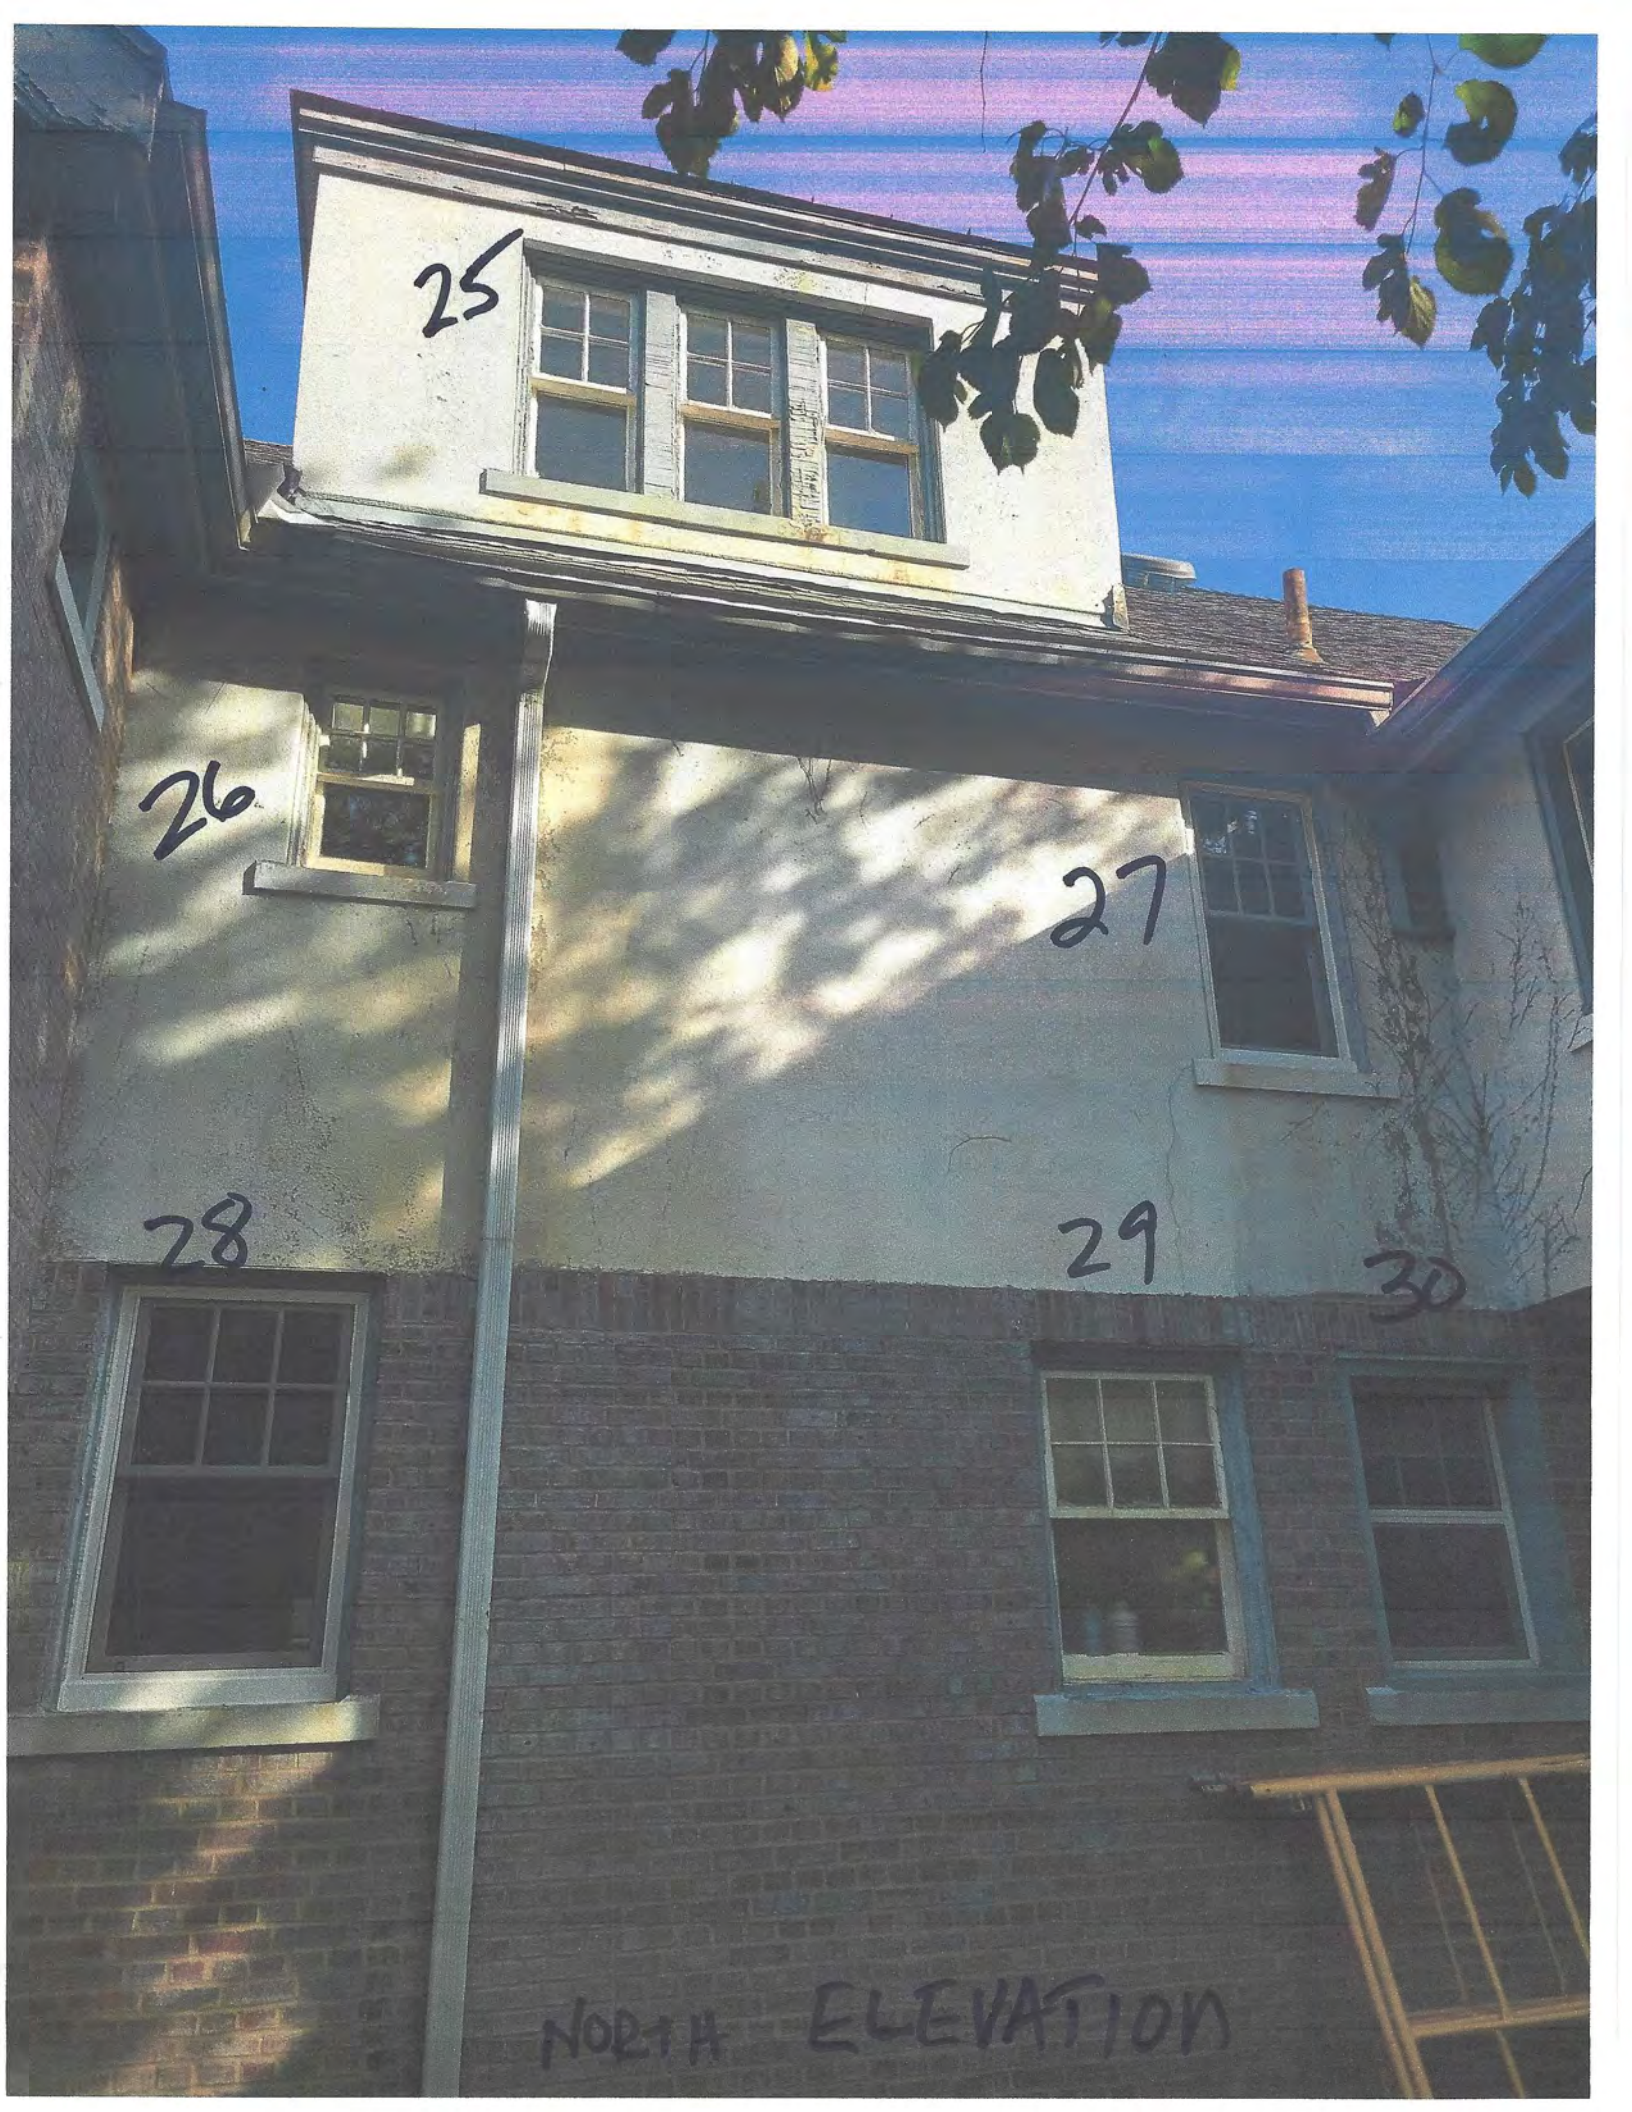
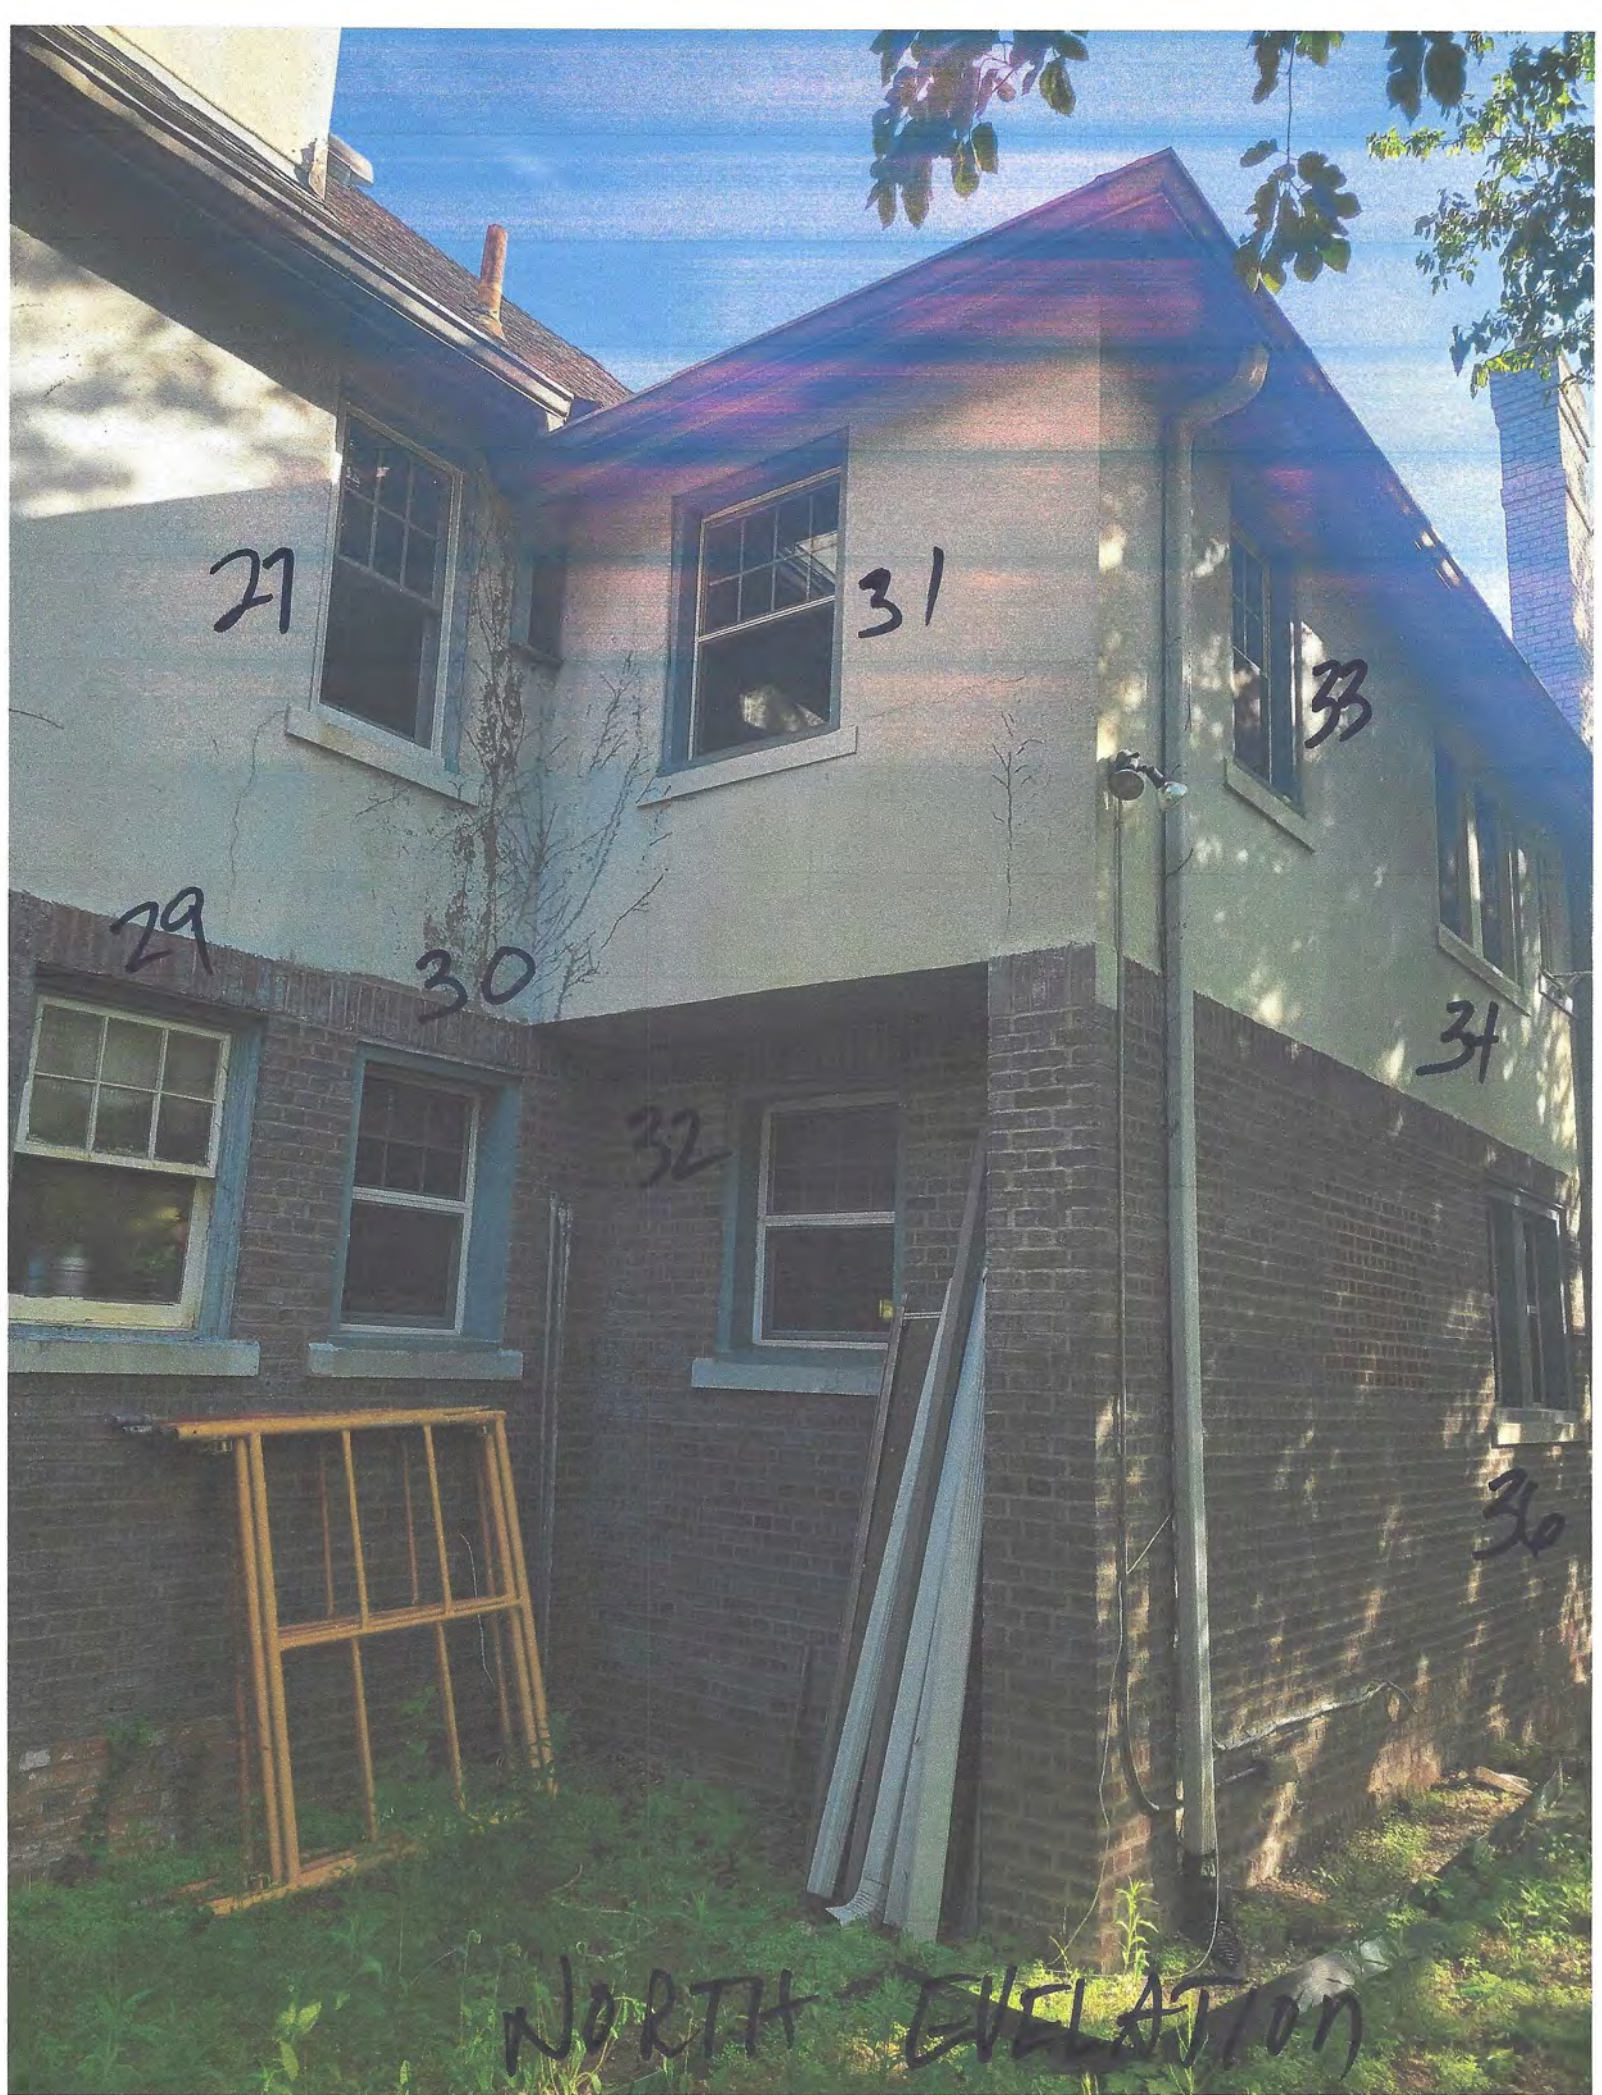
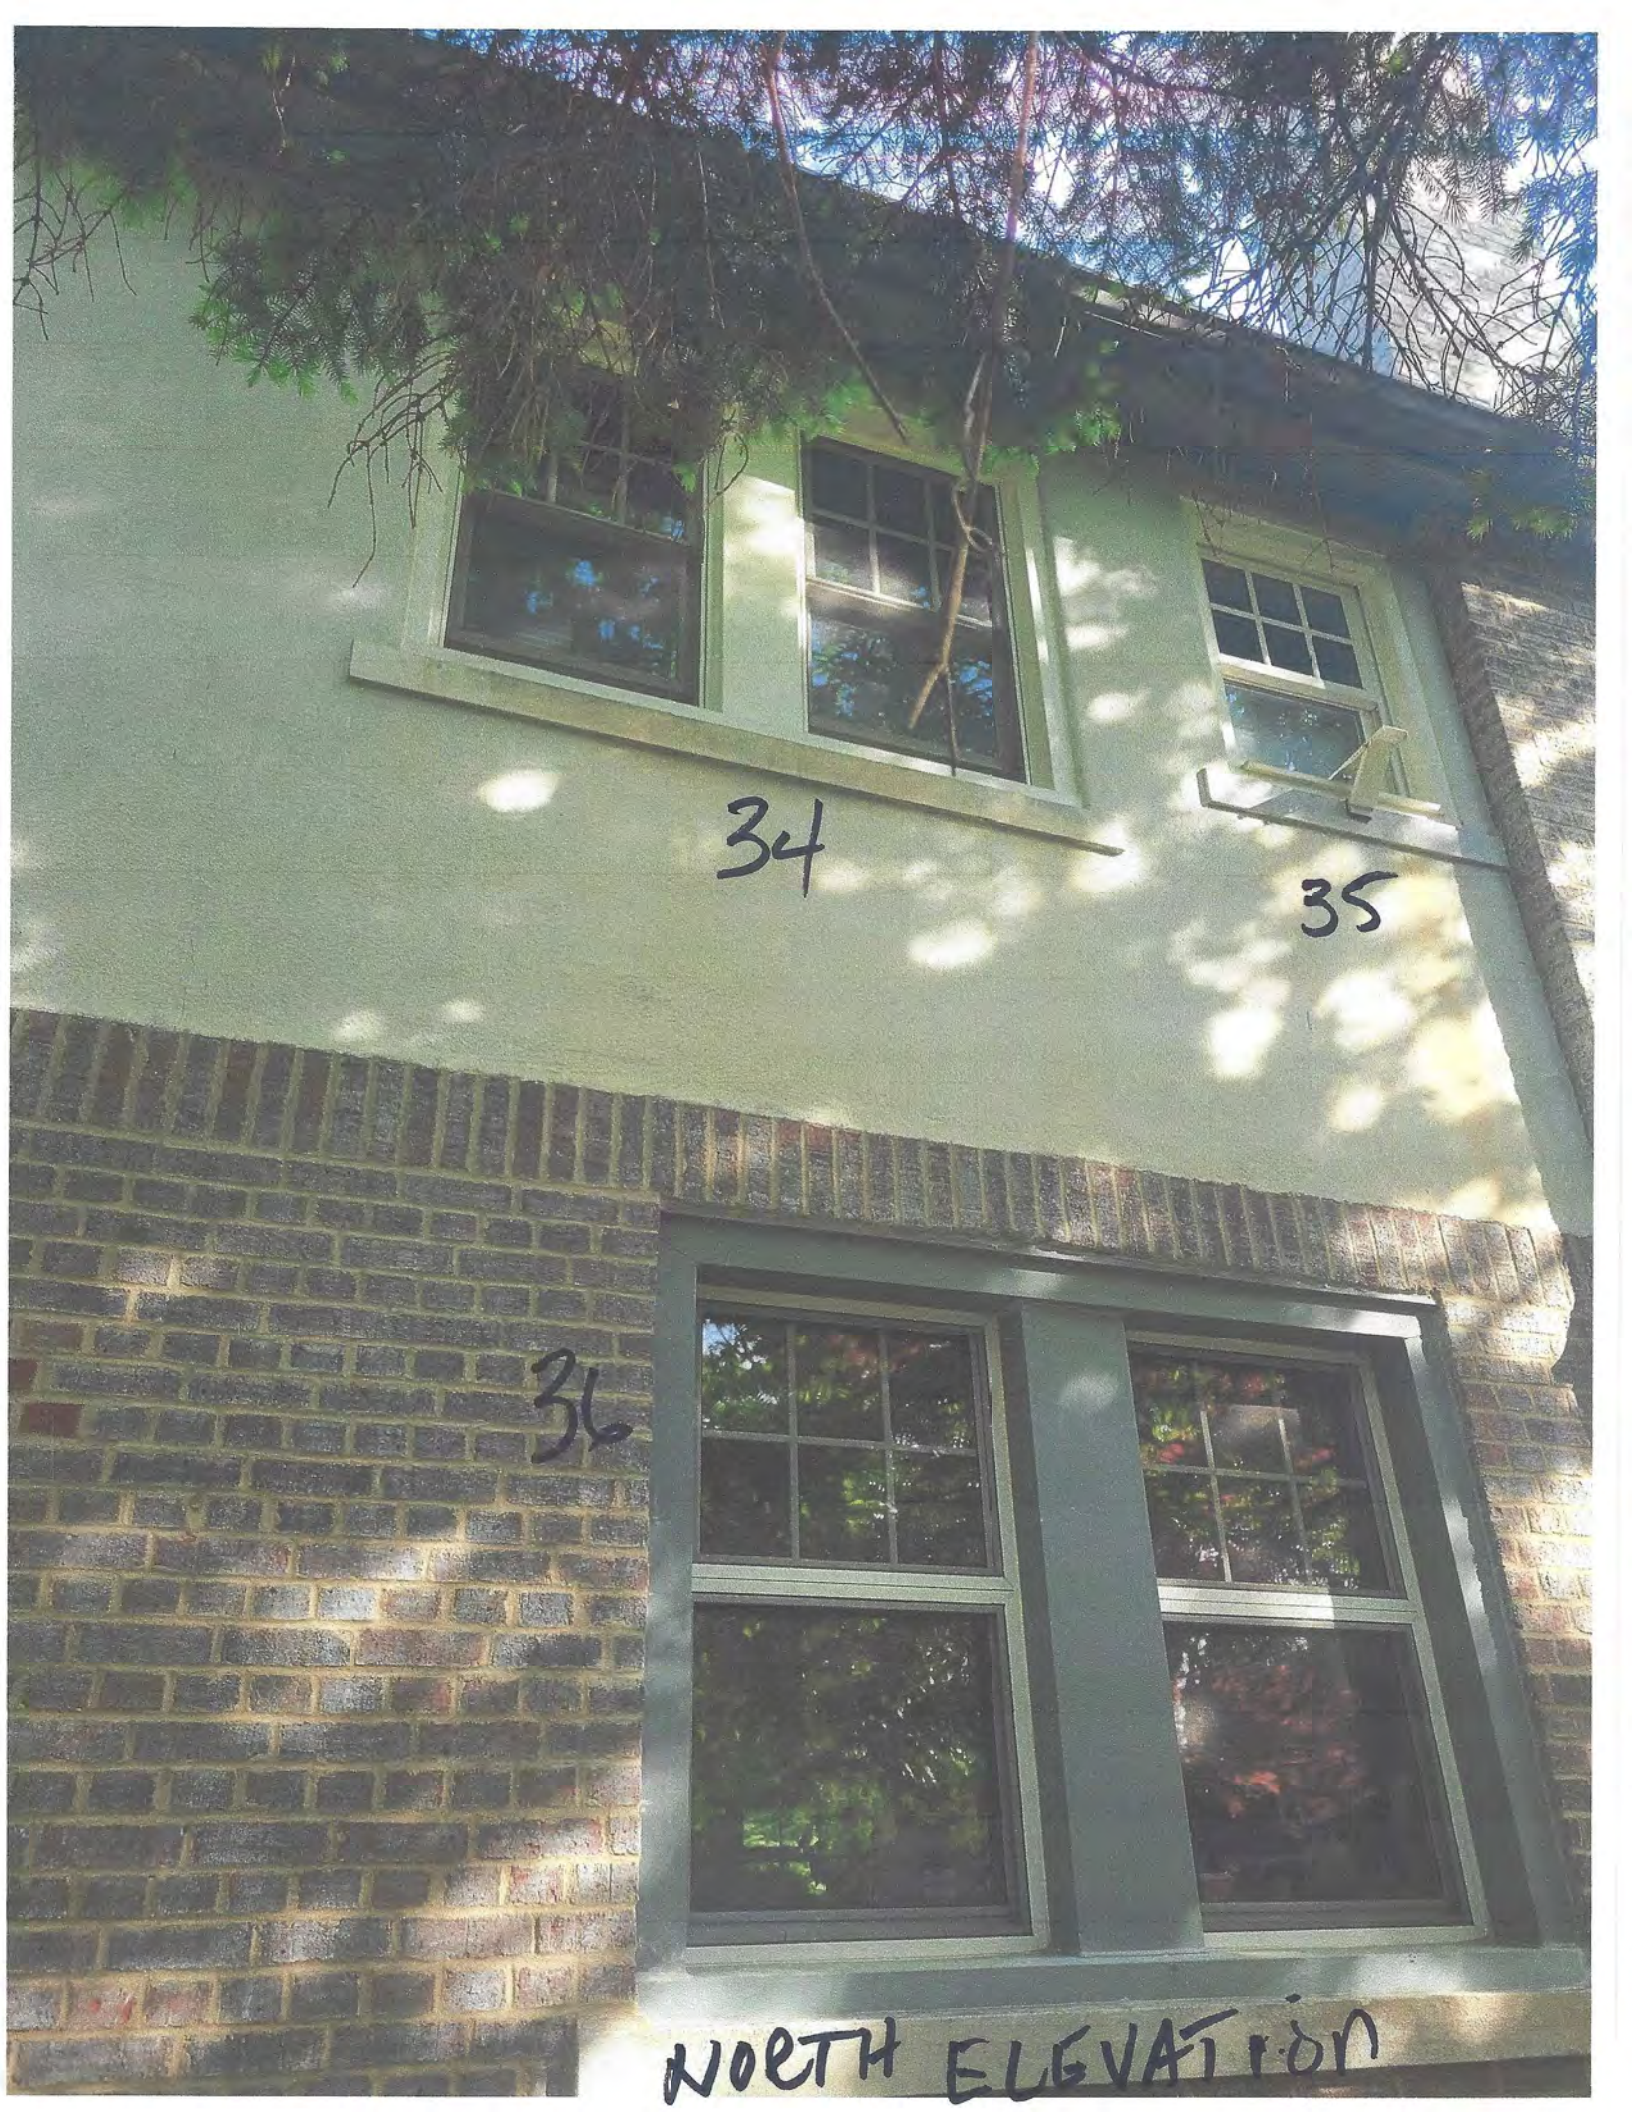
NORTH ELEVATION

25, 26, 29, 38, 40, 41 – Original windows still installed, will be removed and renovated.

All remaining vinyl windows on these elevations will be left as is (see note below). All break metal trim will be removed and the trim underneath will be repaired and painted.
