NOTICE OF DENIAL

RE: Application Number 23-8396; 2405 Burns St.; Indian Village Historic District

CERTIFICATE OF APPROPRIATENESS

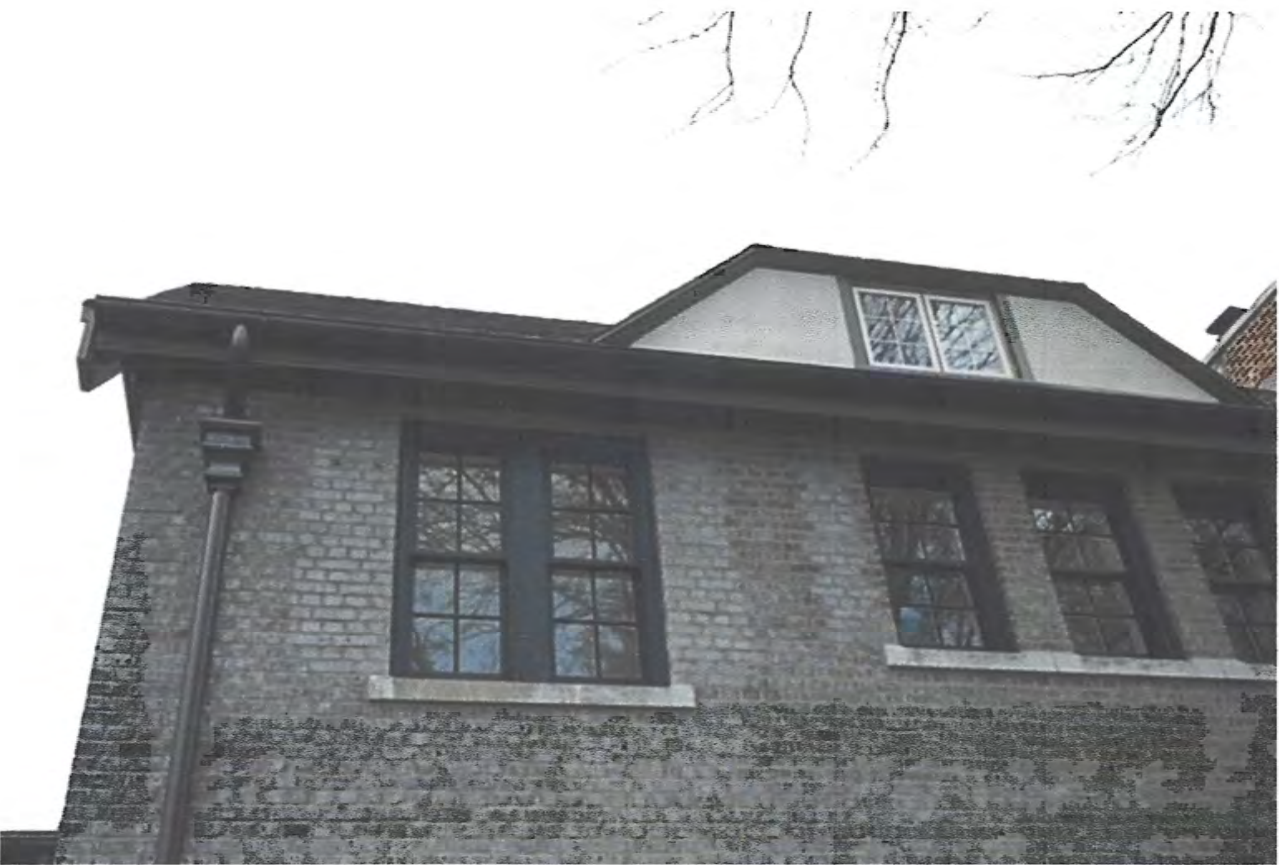
Picture 17

The remaining windows on the Vernor and Burns elevations are being removed for restoration and reinstalled (Picture 17). I am using a certified window restoration contractor. Some of the windows are complete at this time. The remaining windows on these two elevations will be done this year.

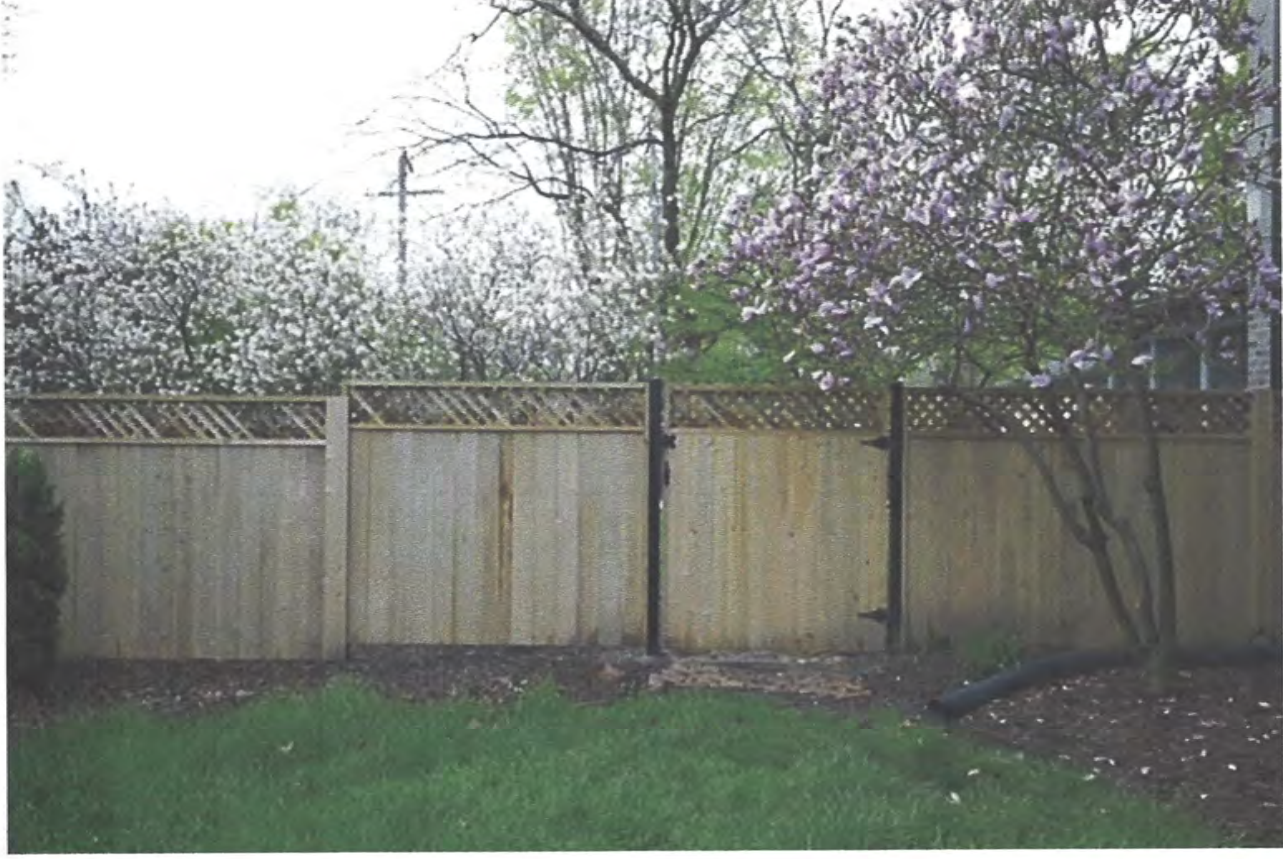
The first 4 pictures (captioned Picture 1 through Picture 4) are of the backyard privacy fence. It has been completely removed and replaced exactly as it was with new cedar construction. The previous fence was falling down and rotting in many areas. The contractor was Kimberly Fence in Warren. They did exemplarily work and I would recommend even though they were not the lowest bid. This work was completed in January.

Picture 1: Backyard fence
facing Burns on Vernor
side of house.

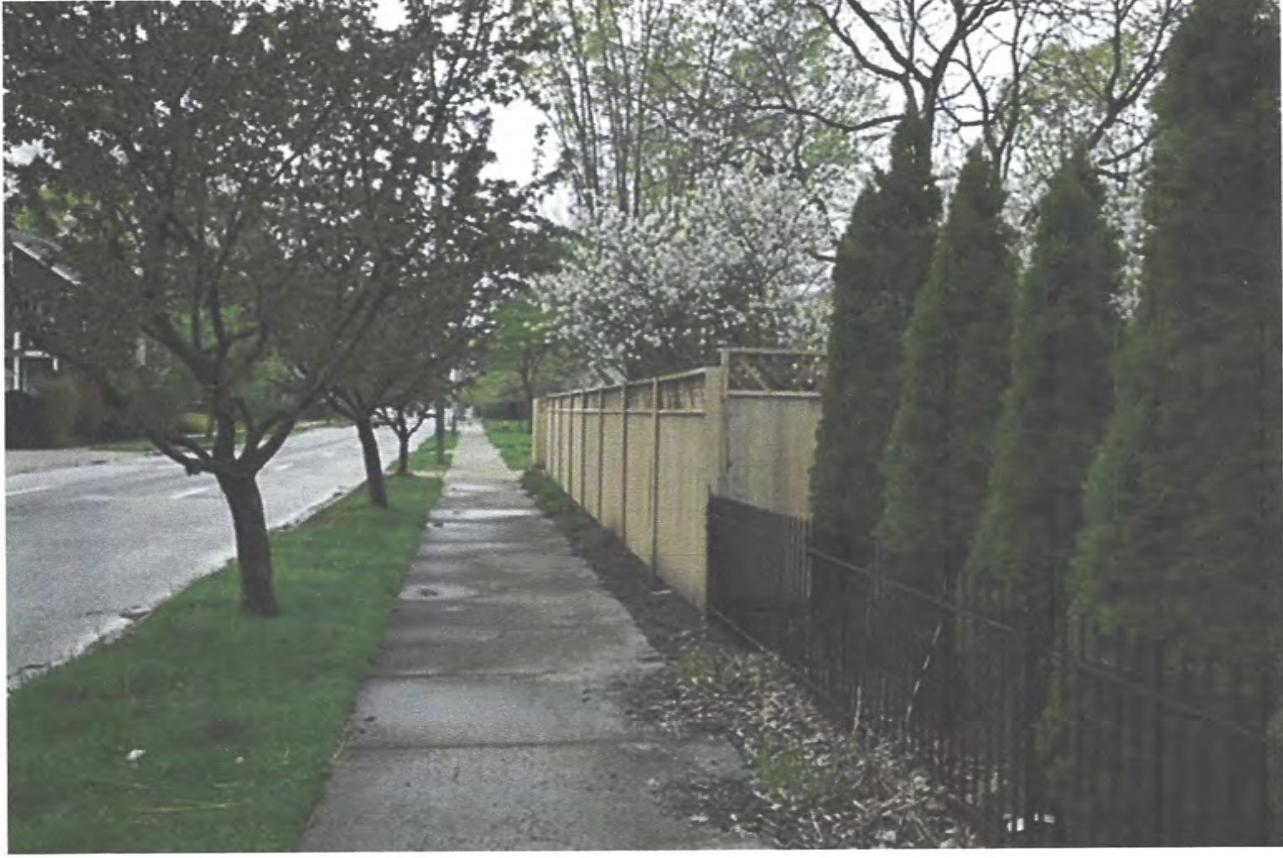
Picture 2: Verner side
of fence

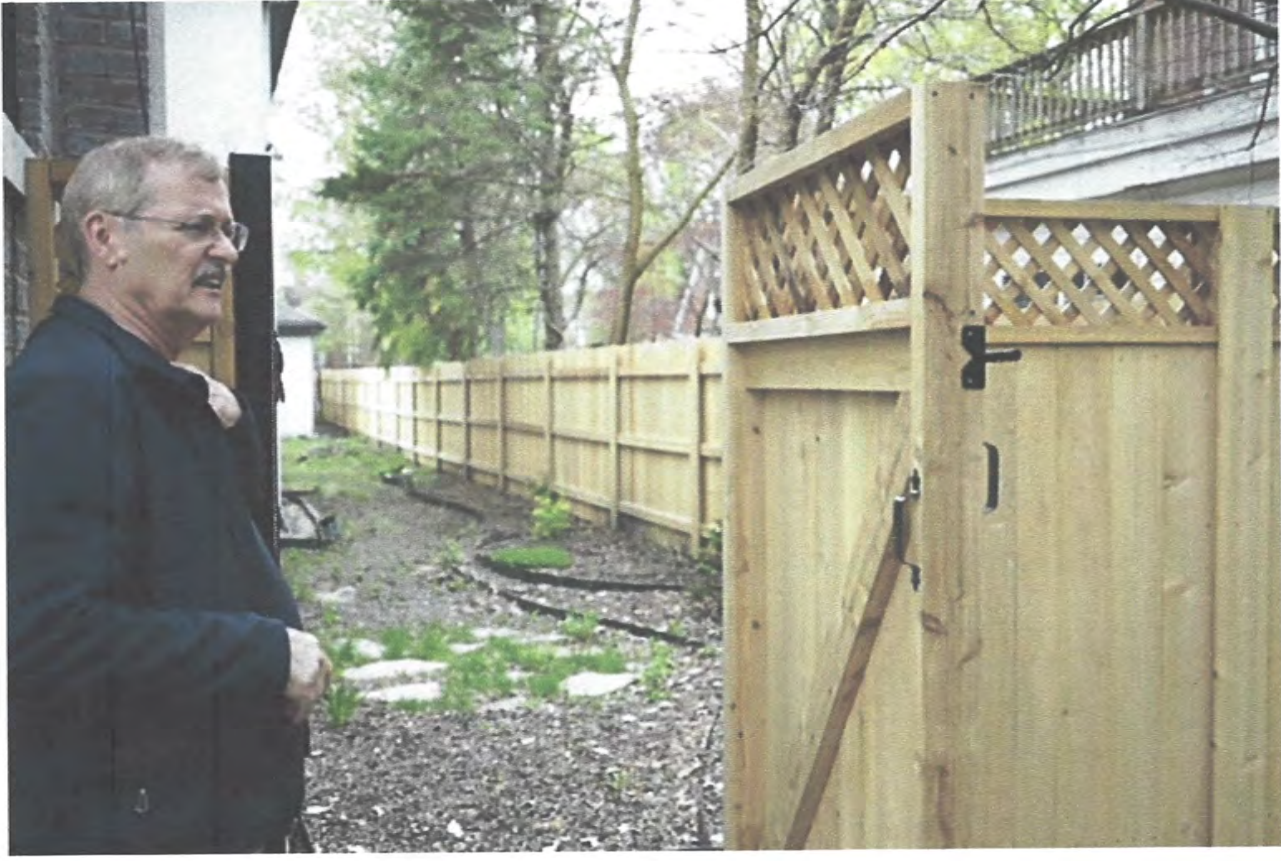
Picture 3 : Fence between
my yard and Neighbors

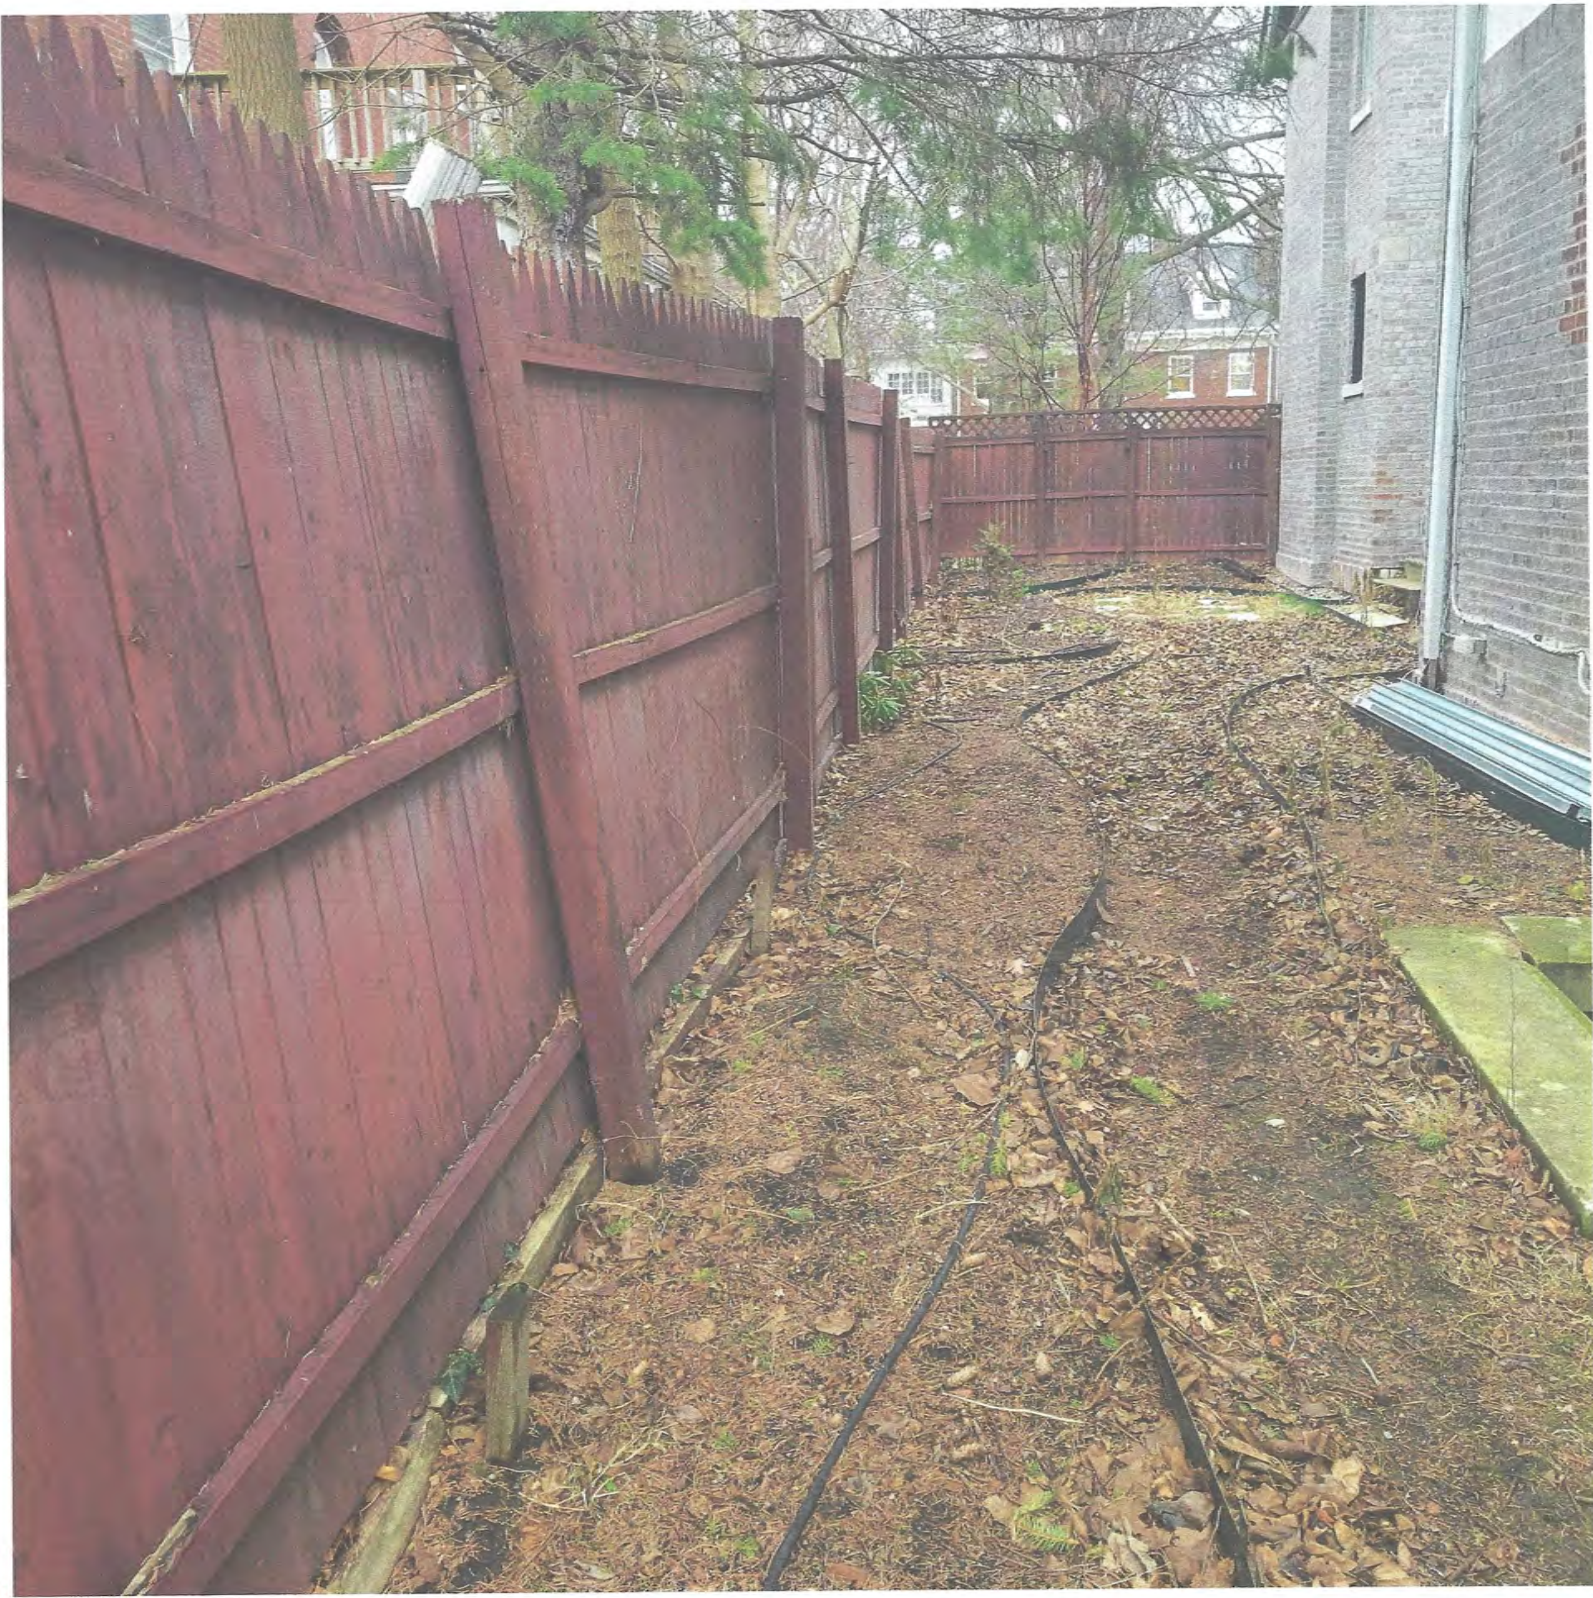
Picture 4: Same Section as
Picture 3 of old fence

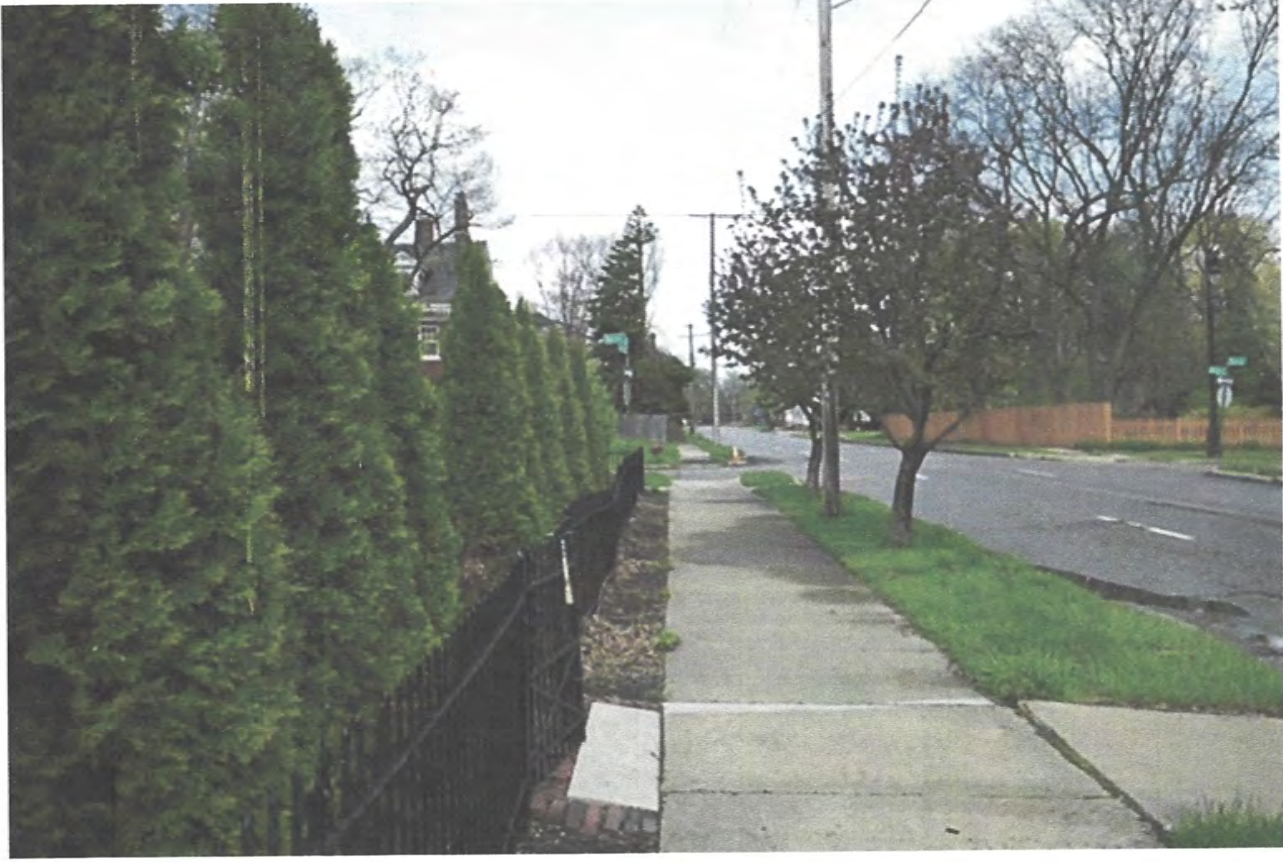
Pictures 5 through 8 are of the current iron fence on the front of the house. This is to be replaced as in Picture 7 and 8 which is an identical construction as originally put it. This work has not been started to date

Picture 5 Vernor Side
Iron fence

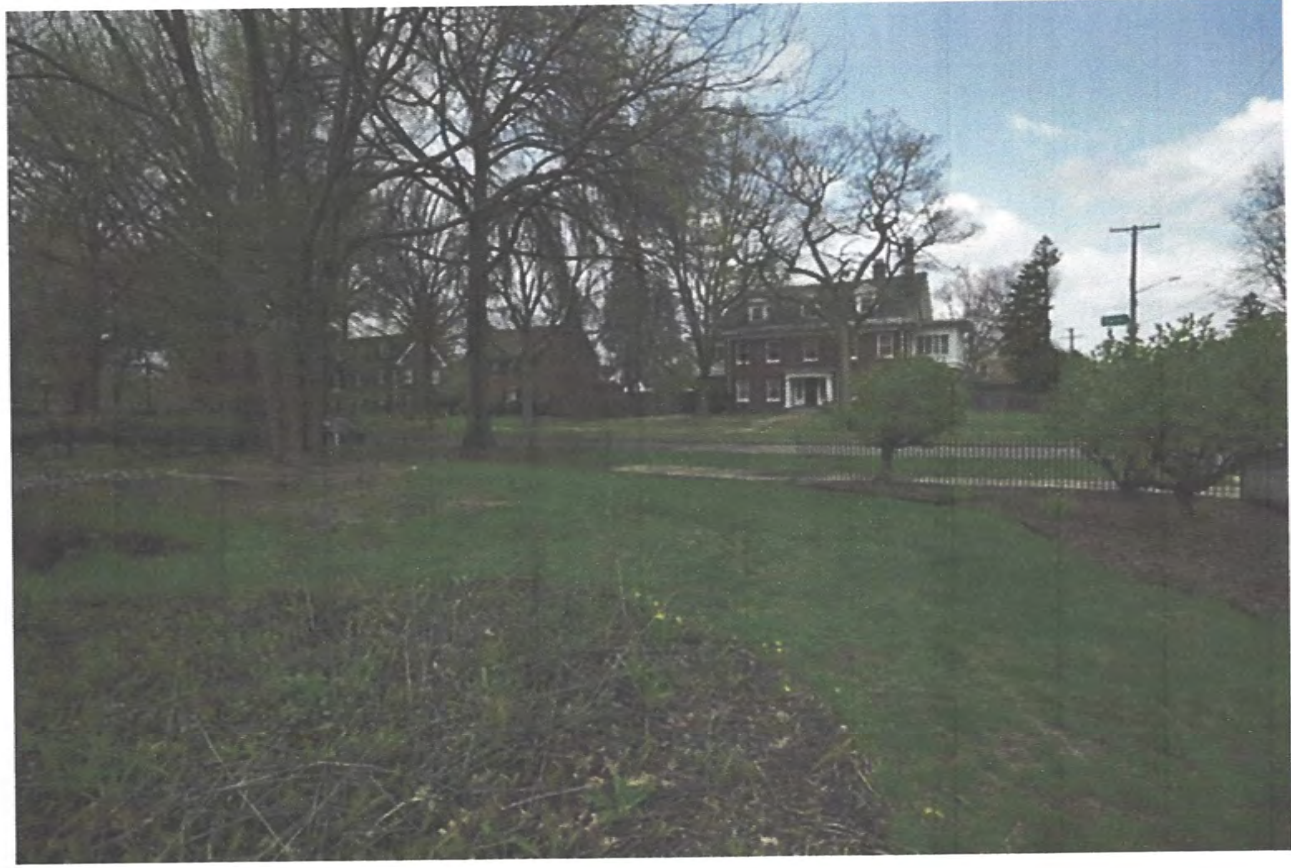
Picture 6. Verner Side
Iron fence

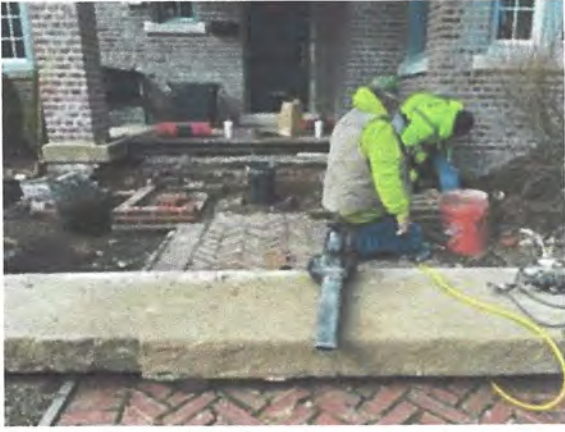
Picture 9

The front steps were falling backwards causing water to flow towards the house. This was due to the foundations had deteriorated. I hired a restoration concrete and brick contractor (Grunwell-Cashero) to do this work. The limestone steps were temporarily removed and the foundations were rebuilt. The limestone steps were placed back on the new foundations. This portion is complete. (Pictures 9 through 12)

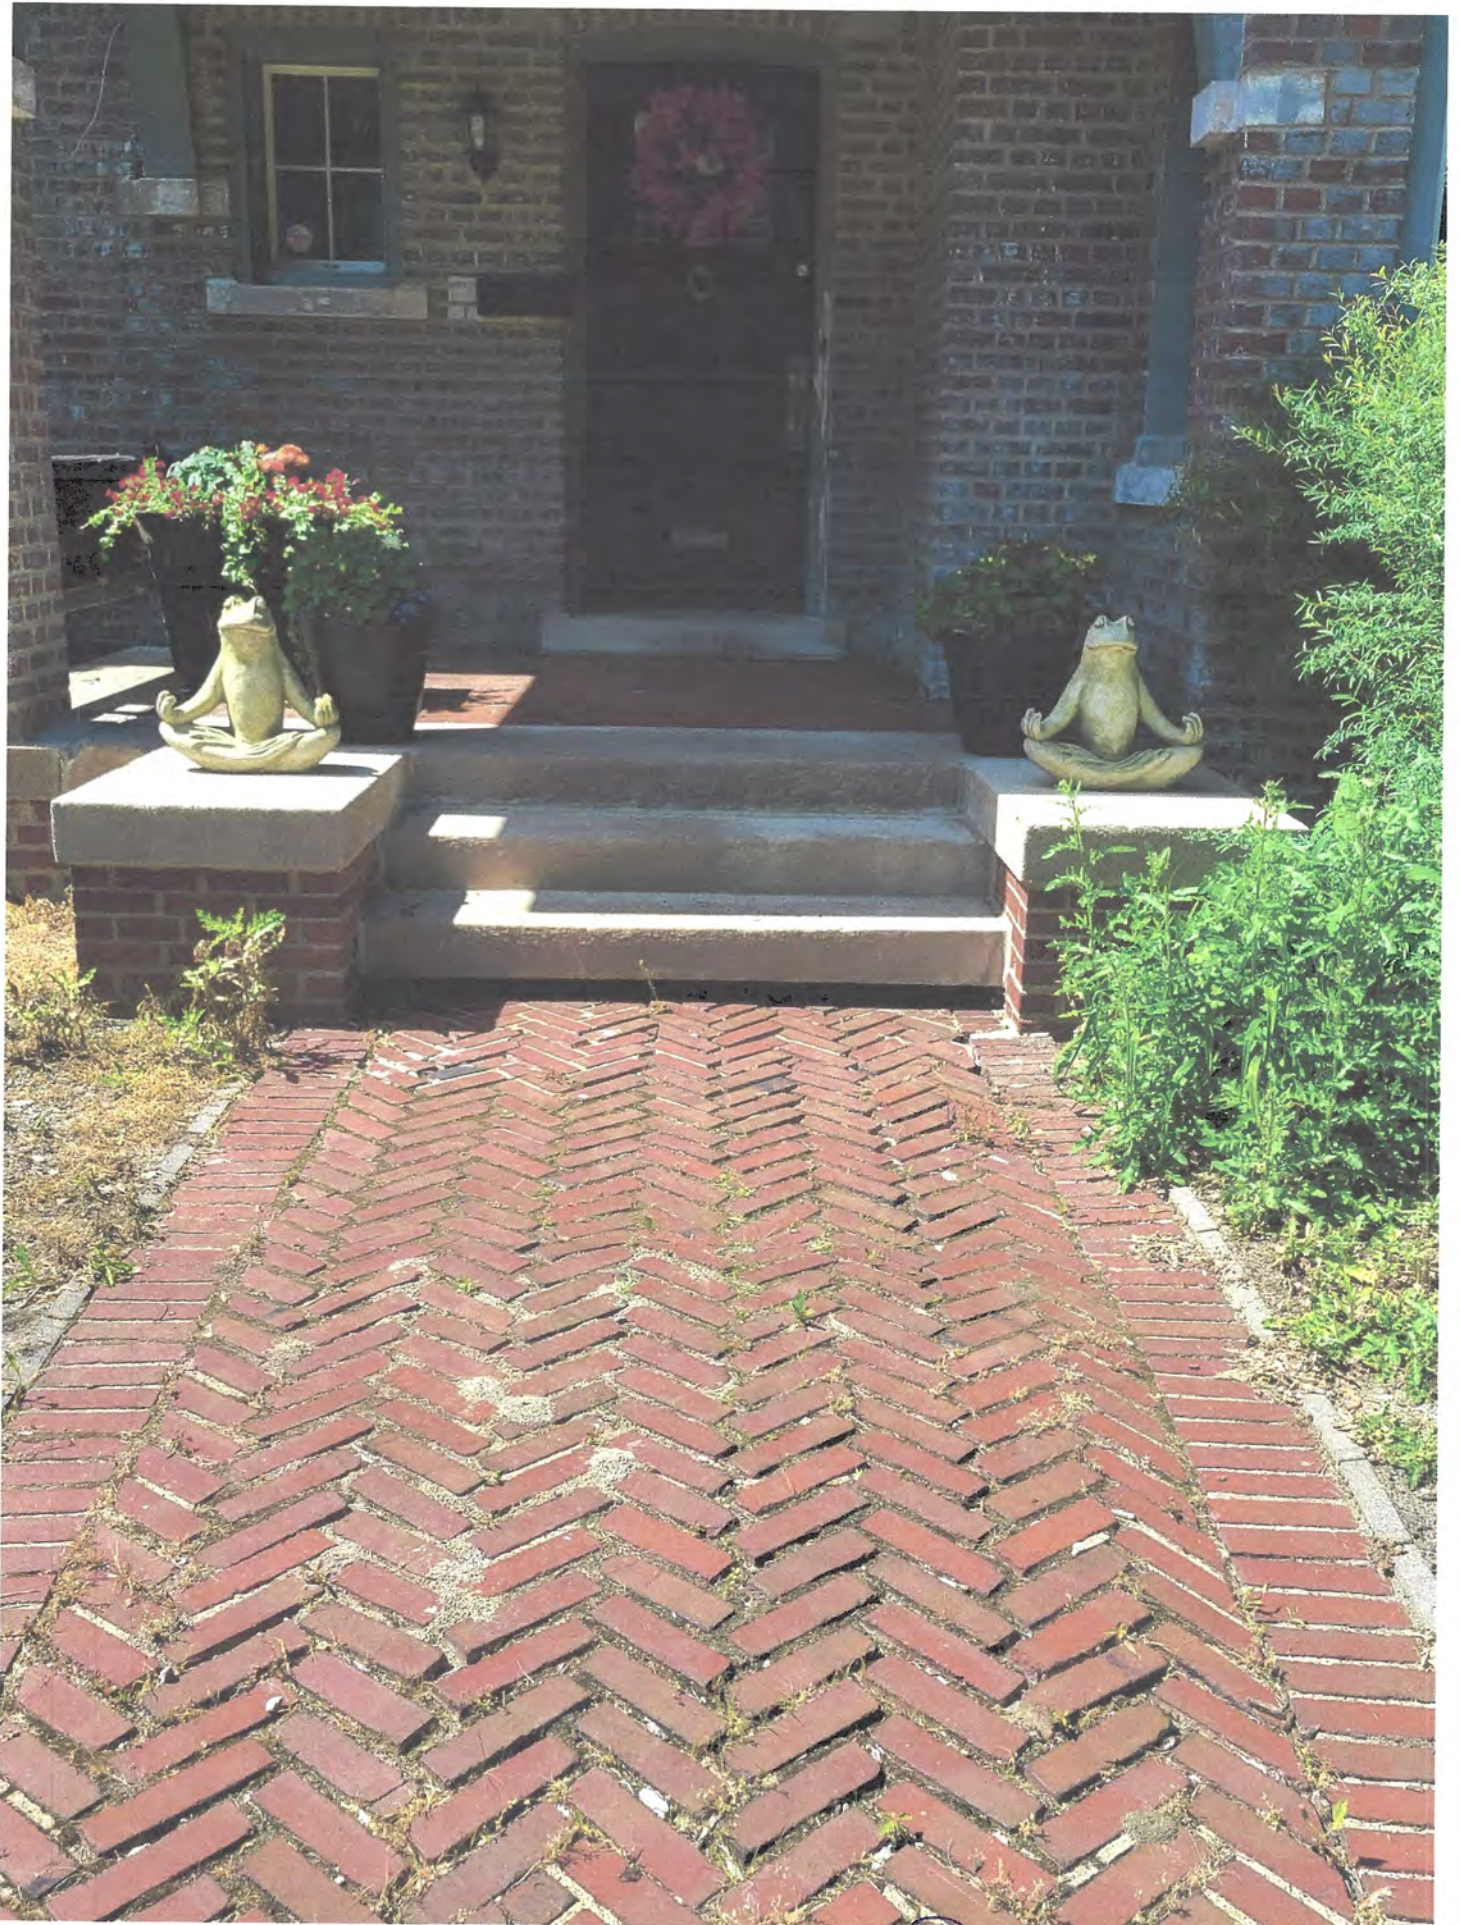
Picture 13

What remains of this project is to rebuild the walkway from the sidewalk on the Vernor side to the steps. As you can see in Picture 13, the brick sidewalk is approximately 3 inches too low to the porch step. Also, years of settling and other things has left the bricks uneven and thus a trip hazard. Plans are for a contractor to dig up and reinstall this feature evenly and at the level to meet the lower step. (Picture 13).

The walkway will be removed and all of the bricks will be cleaned. The substructure will be releveled and the bricks will be re-installed. There are currently several bricks that are broken and as discussed with Mr.

Reiden, I will be eliminating one row of bricks, making the sidewalk approximately 8 inches narrower. This way I should have enough bricks to complete the rebuild.

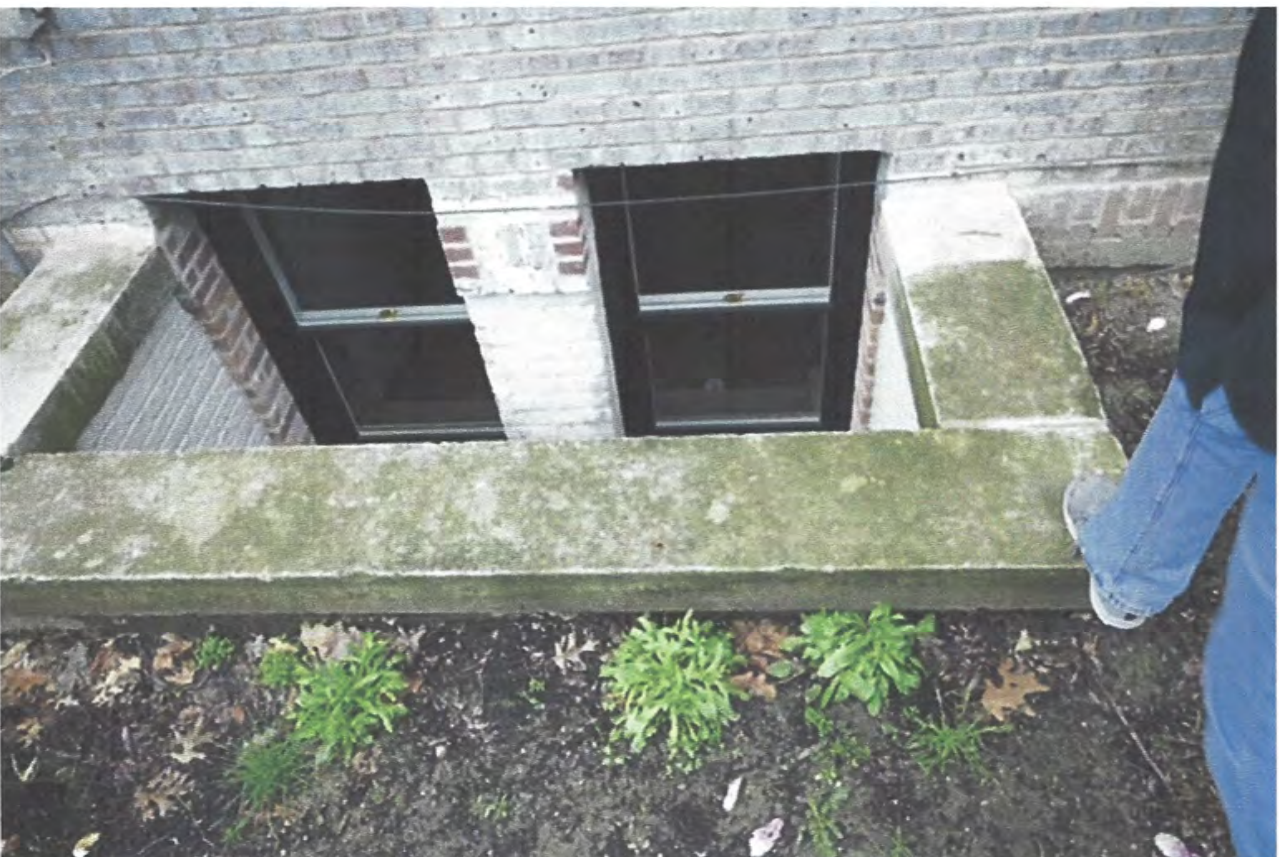
Picture 16

A basement window well on the Burns elevation was dug out and restored to original function. The walls had crumbled and fallen, the windows had been caged over and boarded up, and bricks had been layed in to cover the openings. The original windows were remarkably still in tact including the glass. All of the brickwork was repaired in both the house walls and the window pit surrounding the windows (Picture 15). Both windows were removed and completely restored. They now function normally (picture 16).
