CITY OF DETROIT
HISTORIC DISTRICT COMMISSION

NOTICE OF DENIAL AND ORDER

RE: Application Number 00-167; Submitted in Response to a Violation Notice that was Issued for the Unlawful installation of vinyl replacement windows at 1971 Chichago in the Boston Edison Historic District

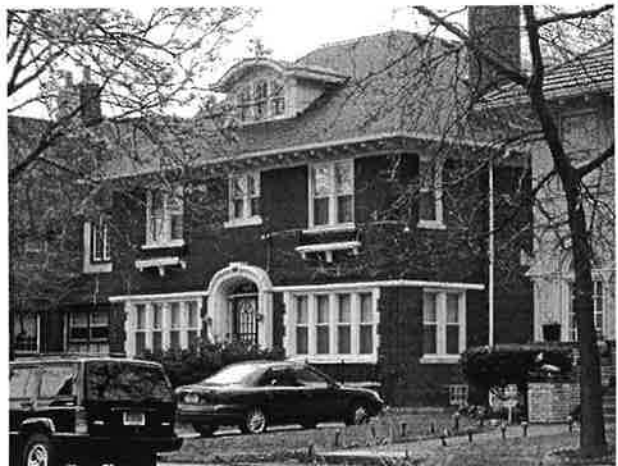
This application was written in response to a violation letter dated April 20, 2000, the work has been completed. The applicant has replaced original wood windows with vinyl replacement windows. The original windows were four over four double hung painted yellow. The replacement windows are one over one white vinyl. The attic windows were not replaced.

1971 Chicago, dormer windows intact

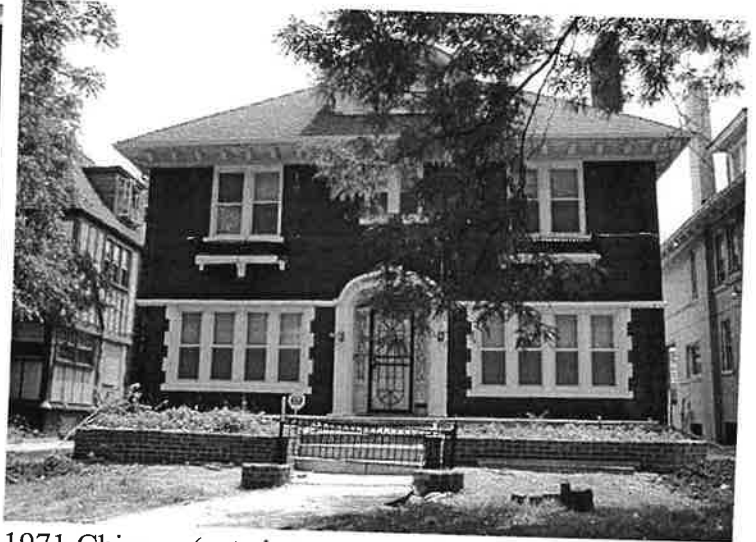
1971 Chicago (gate is temporary barrier for porch work)

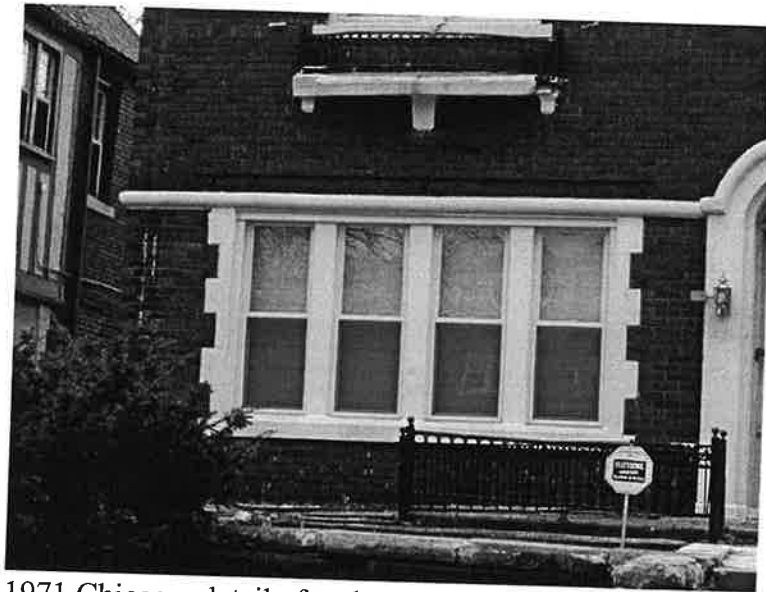
The replacement of original wood windows, particularly when the windows have muntins does not meet "The Secretary of the Interior's Standards for Rehabilitation and Guidelines for Rehabilitating Historic Buildings" standard number 6, "Deteriorated historic features shall be repaired than replaced. Where the severity of deterioration requires replacement of a distinctive feature, the new feature shall match the old in design, color, texture, and other visual qualities and, where possible, materials. Replacement of missing features shall be substantiated by documentary, physical, or pictorial evidence."

1971 Chicago, detail of replacement windows

Pursuant to MCL 399.205(12) and Section 25-2-10 of the 1984 Detroit City Code, the Commission hereby **orders a remedy to duplicate the original muntin pattern on the vinyl windows or the windows returned to wood to match the original.** The replacement and/or reconstruction of this significant architectural feature will bring your property at 1971 Chicago, into conformance with the historic character of the neighborhood, as defined by the remaining buildings in the Boston Edison Historic District.

The replacement of original windows with vinyl windows, particularly when the windows have muntins, does not meet the standards. I recommend the Commission deny the application and order the windows returned to wood windows to match the original. The work does not meet "The Secretary of the Interior's Standards for Rehabilitation and Guidelines for Rehabilitating Historic Buildings" standard number 6, "Deteriorated historic features shall be repaired than replaced. Where the severity of deterioration requires replacement of a distinctive feature, the new feature shall match the old in design, color, texture, and other visual qualities and, where possible, materials. Replacement of missing features shall be substantiated by documentary, physical, or pictorial evidence."

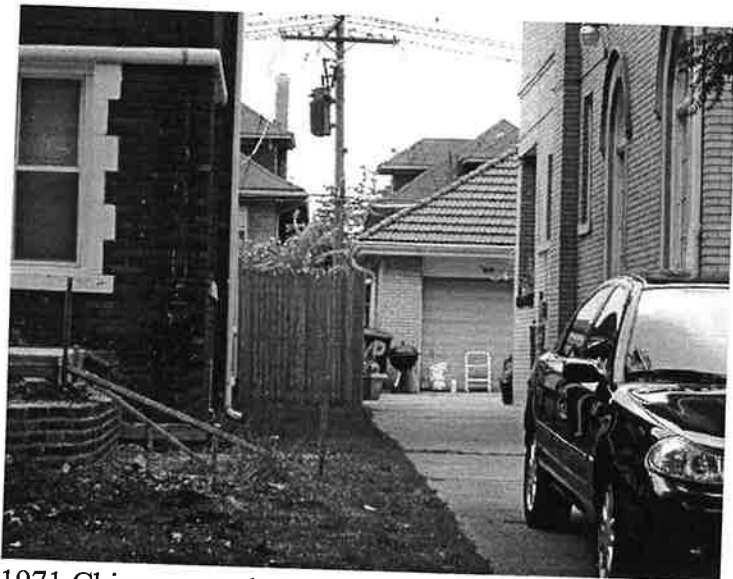
Doing the field work for this application, I noticed a stockade fence has been installed starting at the rear face of the house. The stockade fence is not appropriate and a violation notice will be issued. The porch and driveway work has been staff approved.

1971 Chicago, stockade fence at west property line

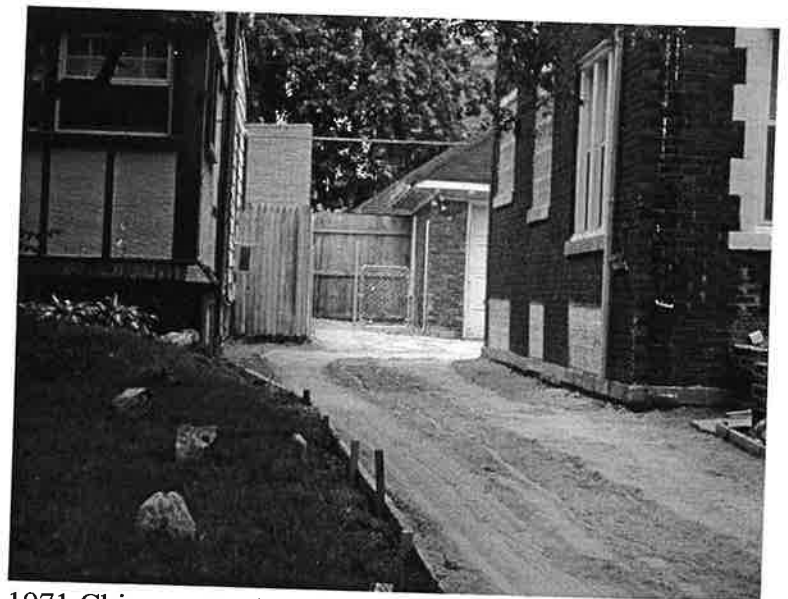
1971 Chicago, stockade fence on east property line
