HISTORIC DISTRICT COMMISSION NOTICE OF DENIAL

Application Number: HDC2025-00014

NAME: Alexander Belilovsky		COMPANY NAME: Alexandria Home Solutions	
ADDRESS: 24293 Telegraph Road	CITY: Southfield	STATE: MI	ZIP: 48033
PROJECT ADDRESS: 4071 Leslie			
HISTORIC DISTRICT: Russell Woods-Sullivan

Replace historic steel windows and associated wood trim with new aluminum-clad wood windows

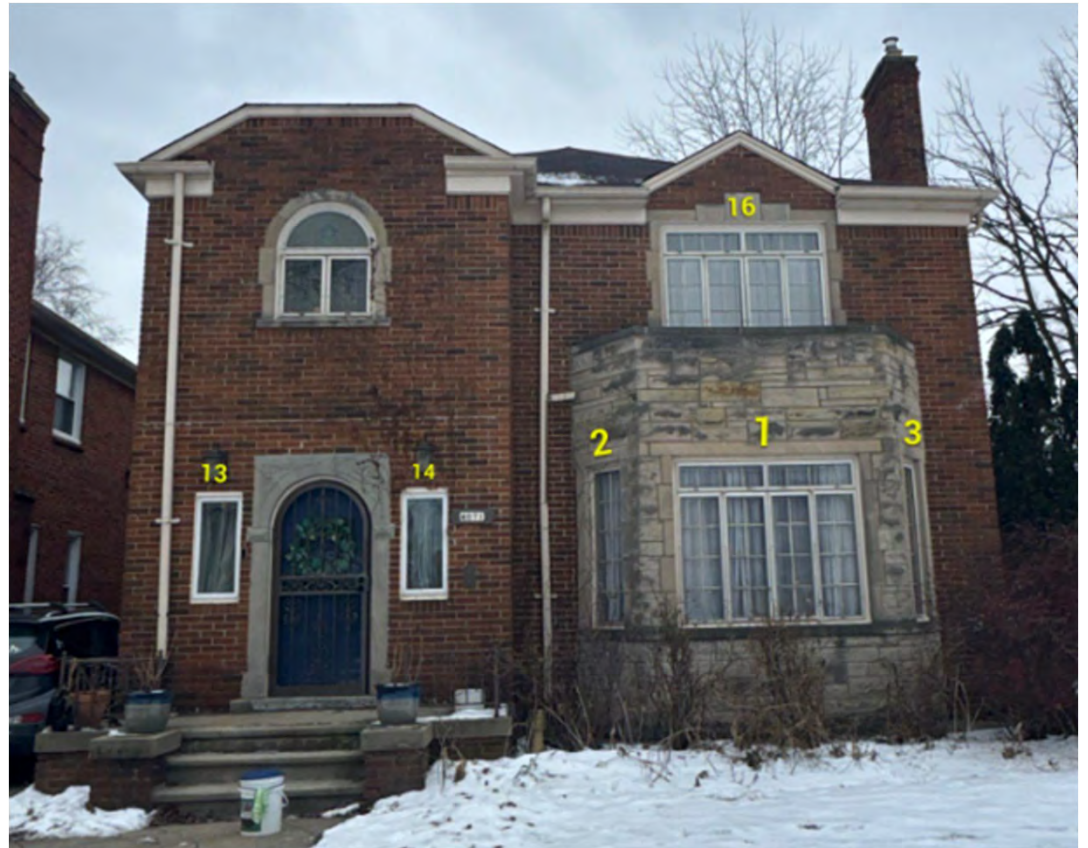
1- hardware and window rusted shut, inoperable. Fails to meet egress/code

2- Extreme structural damage from poor weatherproofing

3- Evidence of exterior wood rot, and evidence of mold

14- Vinyl: Not Historically Accurate

16- Master bedroom: substantial gaps in weather proofing, only one casement window opens due to hardware rusted shut, fails to meet egress/code

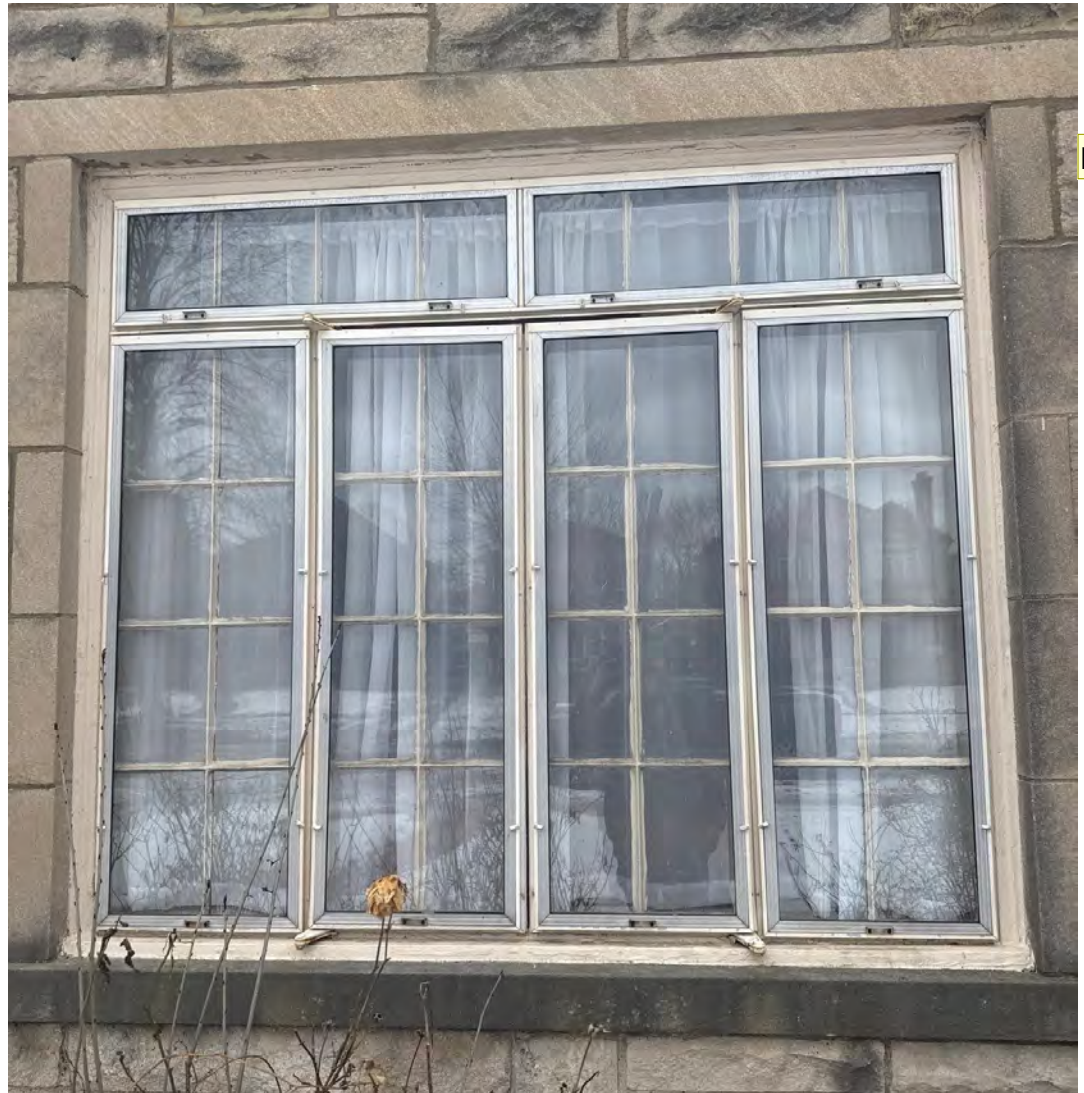
Window 1:

- Deteriorated wood in window frame compromising structural integrity
- Rusty gears in casement windows
- Inoperability: Window is sealed shut. Non-functioning windows exacerbate the non-compliance, as they cannot serve as emergency exits or provide adequate ventilation. Repair is not a feasible solution when operability cannot be restored due to structural and mechanical issues.
- Non code compliance: Failure to Meet Egress Standards: The windows do not meet egress requirements, making them unsafe and non-compliant with current building codes. This is particularly problematic for emergency escape routes.

1. Rusted Gear in Casement Window:

•**Functional Obsolescence:** A rusted gear in a casement window has lost its mechanical integrity, preventing smooth or reliable operation. Rust compromises the precise movement required for opening and closing, and repairs (e.g., lubrication or partial component replacement) often fail to restore full functionality due to corrosion spread across interconnected parts.

•**Safety Concerns:** A malfunctioning gear could lead to sudden failure, making the window unsafe for operation. As per guidelines, operability is essential to preserve the historic character of windows

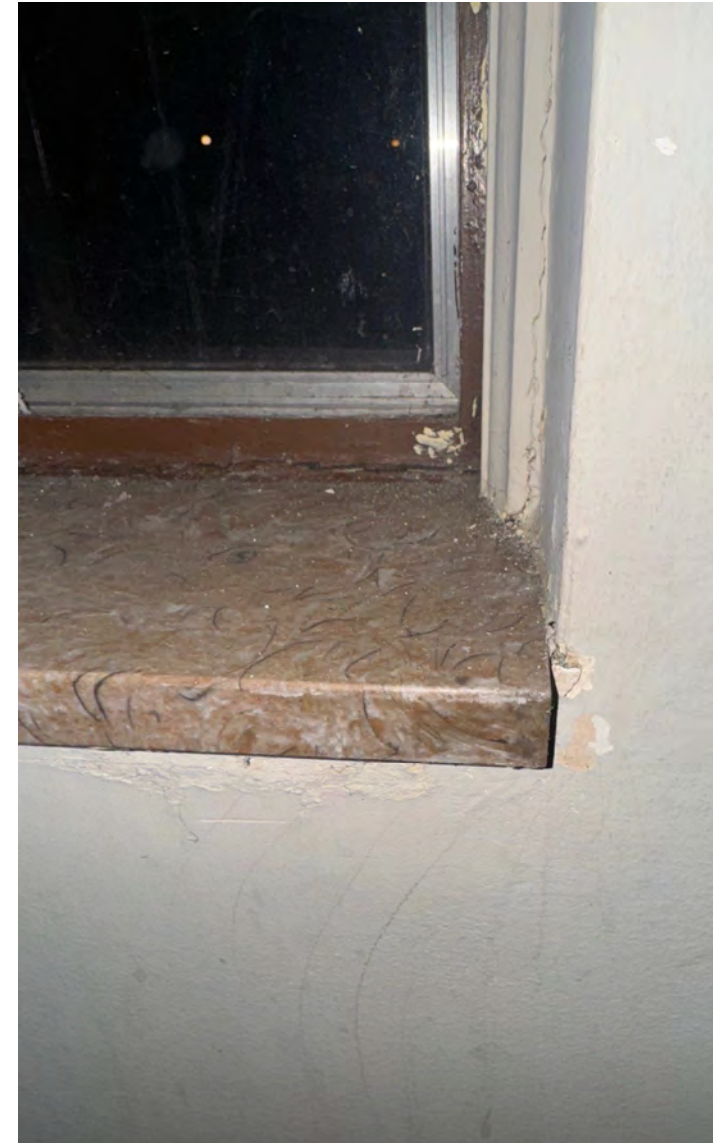
Window 3:

- Evidence of exterior wood frame rot
- Evidence of mold between storm window and original window

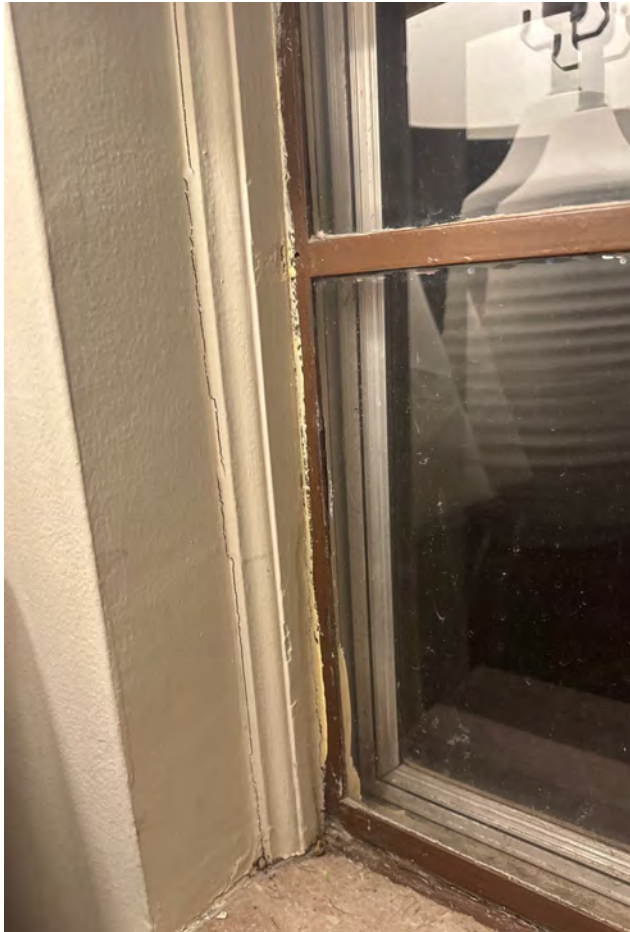
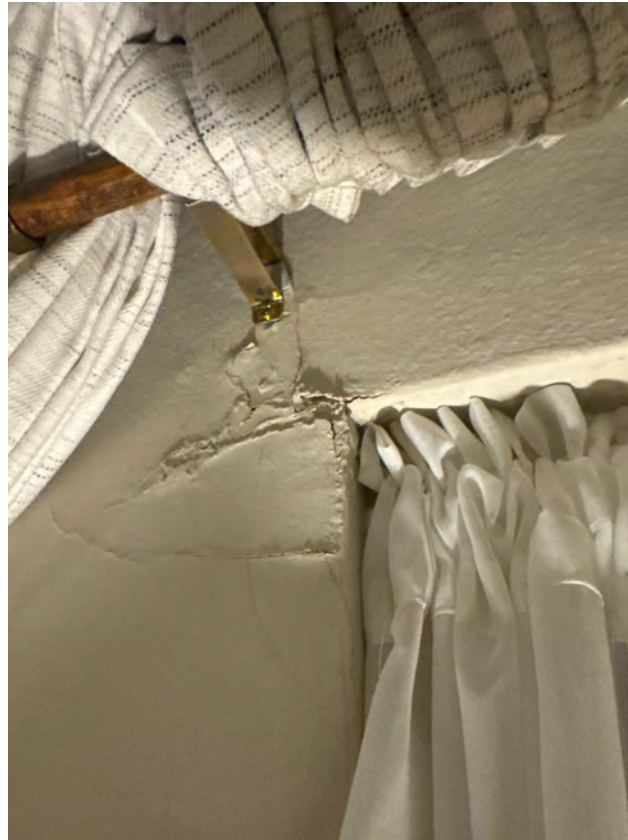
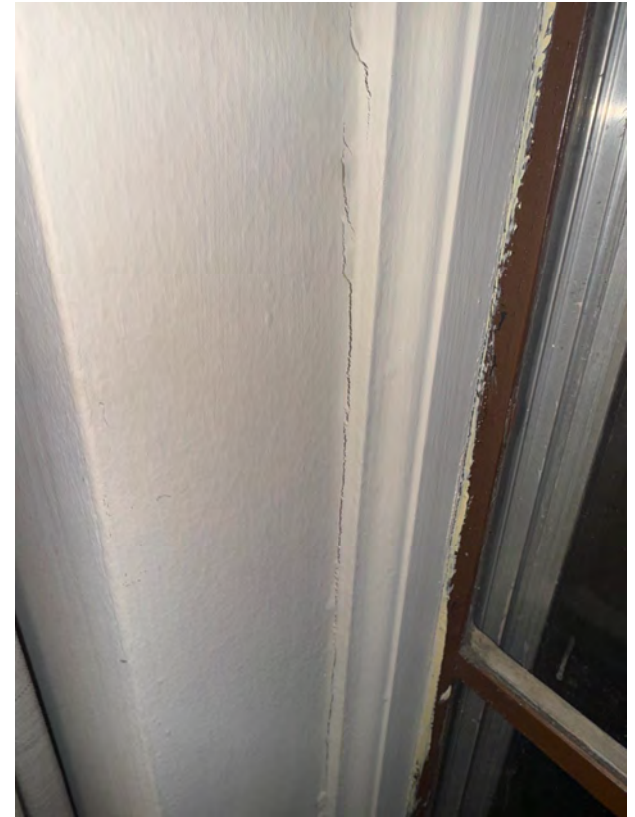
Window 3:

- **Deteriorated Wood on exterior:**
- **Loss of Structural Integrity:** Wood that has deteriorated due to moisture, mold, or rot no longer provides adequate support for the window assembly. This compromises the entire frame's stability and may pose a safety hazard.
- **Guideline Requirements:** Replacement is necessary when repair is not technically feasible or when deterioration affects the window's ability to retain its shape, support glass, and maintain weatherproofing. Aluminum-clad wrapping further ensures long-term durability by protecting against future moisture and weather-related damage

Why Mold Warrants Window Replacement Instead of Repair:

- **Compromised Integrity:** Mold indicates prolonged moisture exposure, often leading to weakened or deteriorated materials that cannot be effectively repaired, necessitating full replacement.
- **Health Hazards:** Mold poses significant health risks (e.g., respiratory issues) and can persist in porous materials, making replacement essential to fully eliminate the issue and prevent recurrence.
- **Underlying Moisture Issues:** Mold is often caused by structural defects like improper grading or seals, which require replacement to correct and ensure future moisture resistance.
- **Code and Safety Compliance:** Replacement ensures compliance with modern building codes and health standards, providing a safe, mold-free environment while preventing further damage.

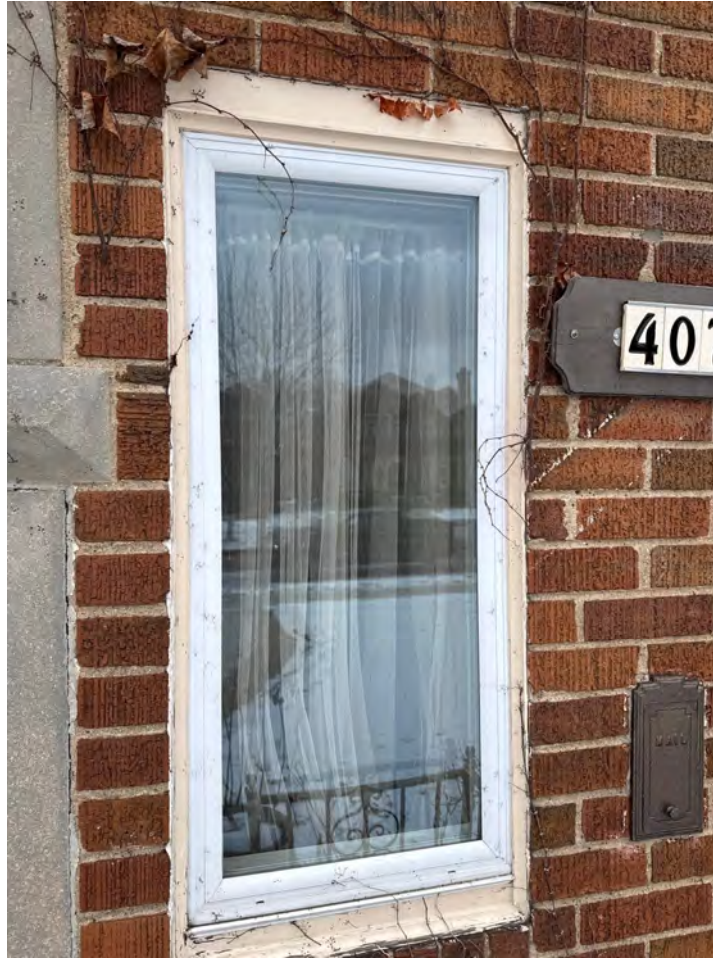
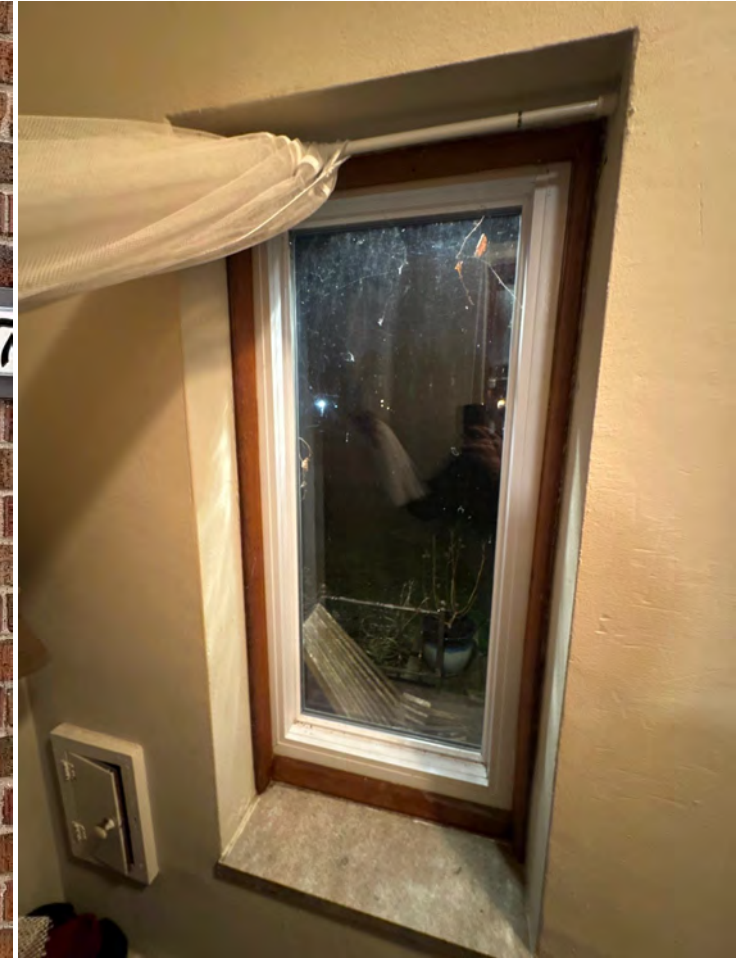
Window 14:

- Vinyl
- Marble sill will be preserved to maintain historical correctness

- Repairs with clear silicone calk were attempted
- vinyl

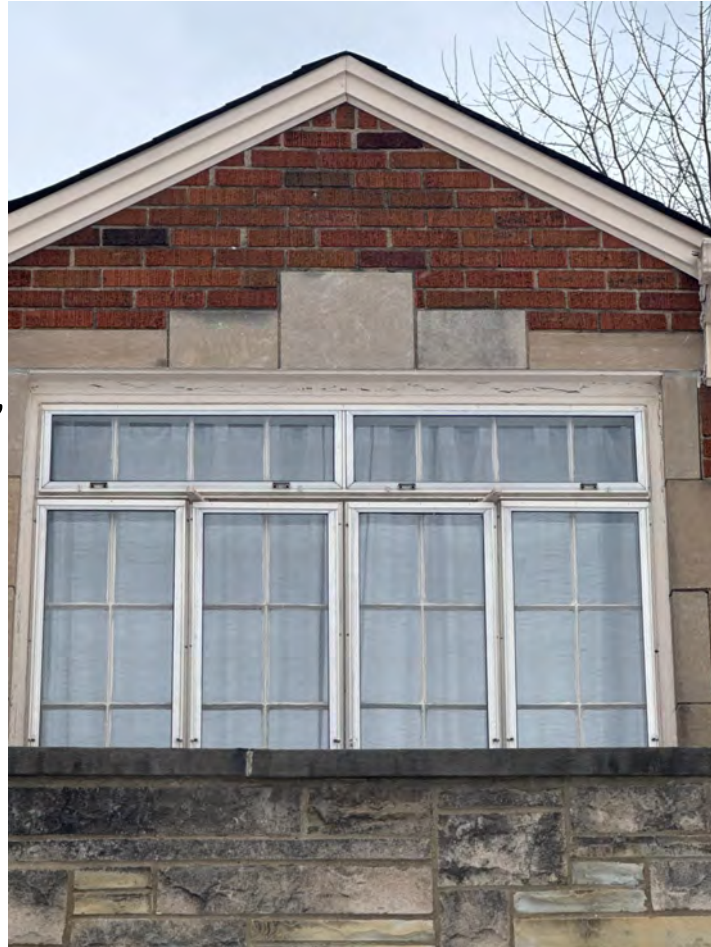
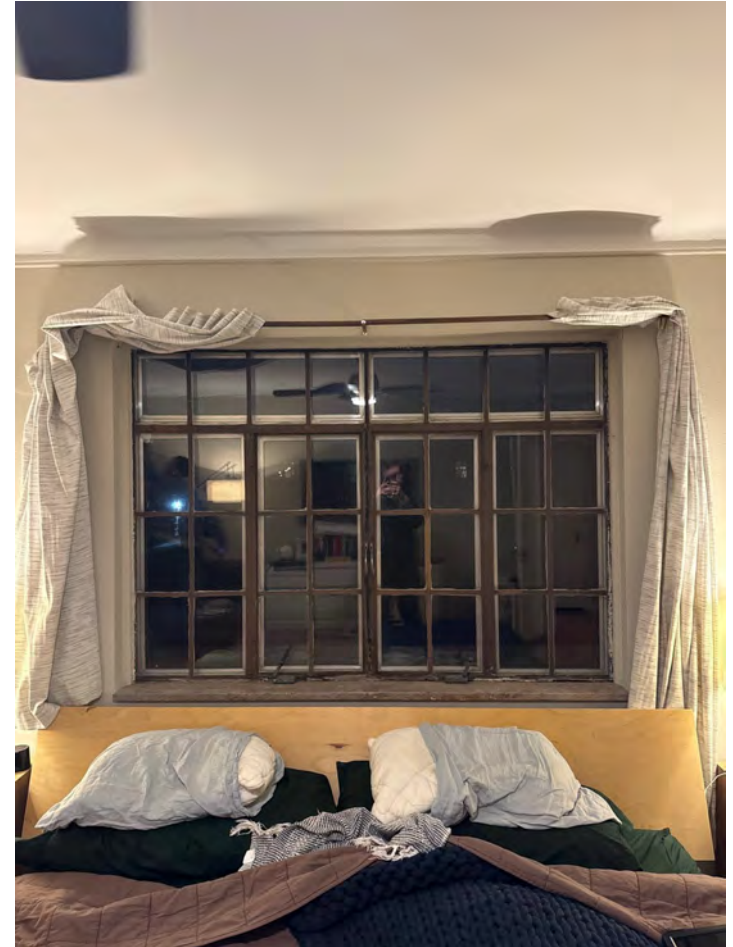
Window 16:

- substantial gaps in weather proofing,
- only one casement window opens due to hardware rusted shut,
- fails to meet egress/code

- Substantial gaps
- Substantial rusting

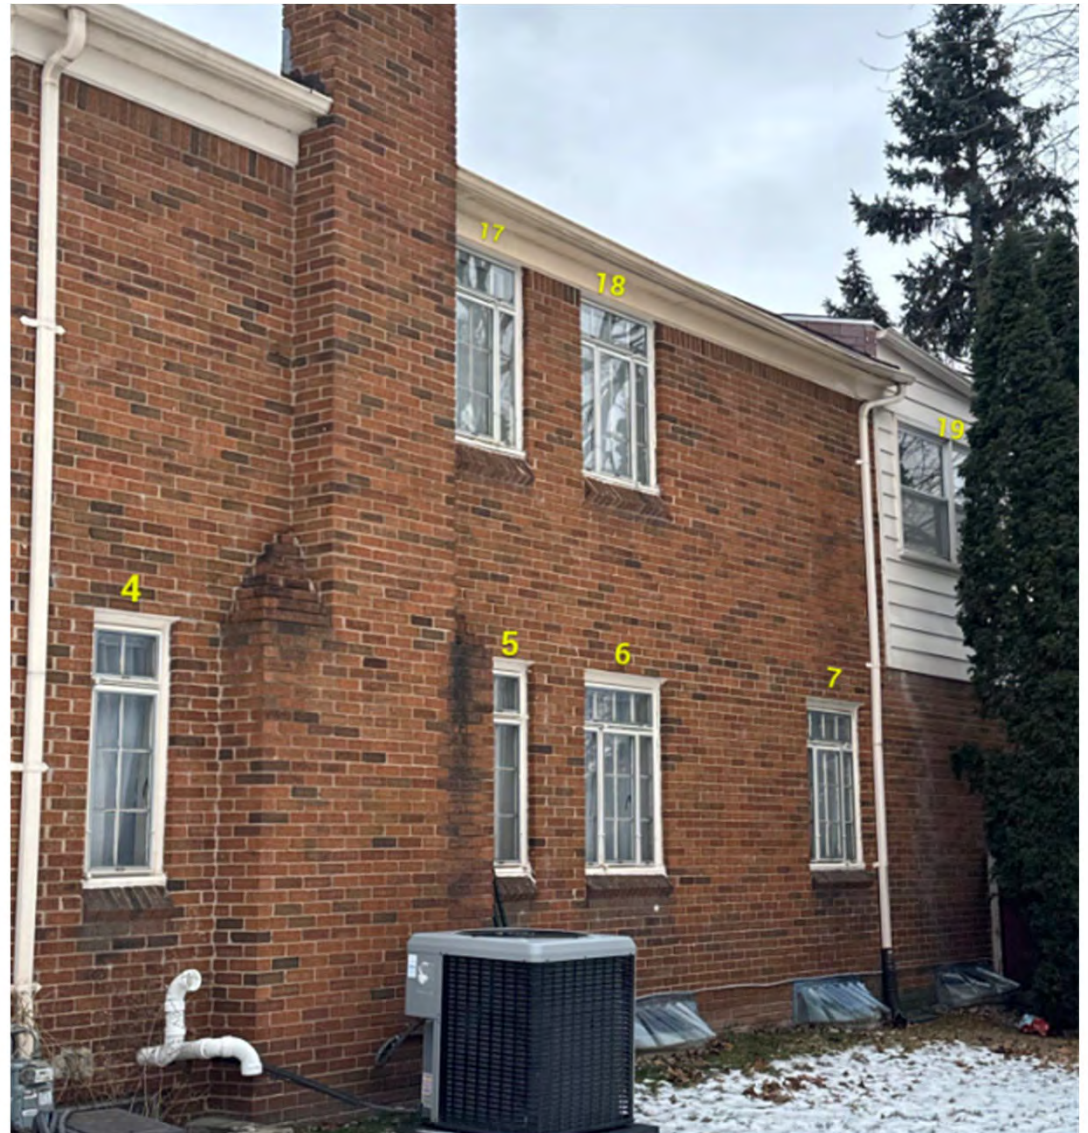
Windows –Left

- 4- sealed shut
- 5- sealed/rusted shut
- 6- structural rust, evidence of water damage
- 7- sealed/rusted shut
- 17- Worst Condition on entire floor
- 18- sealed/rusted shut
- 19- vinyl; not historically correct

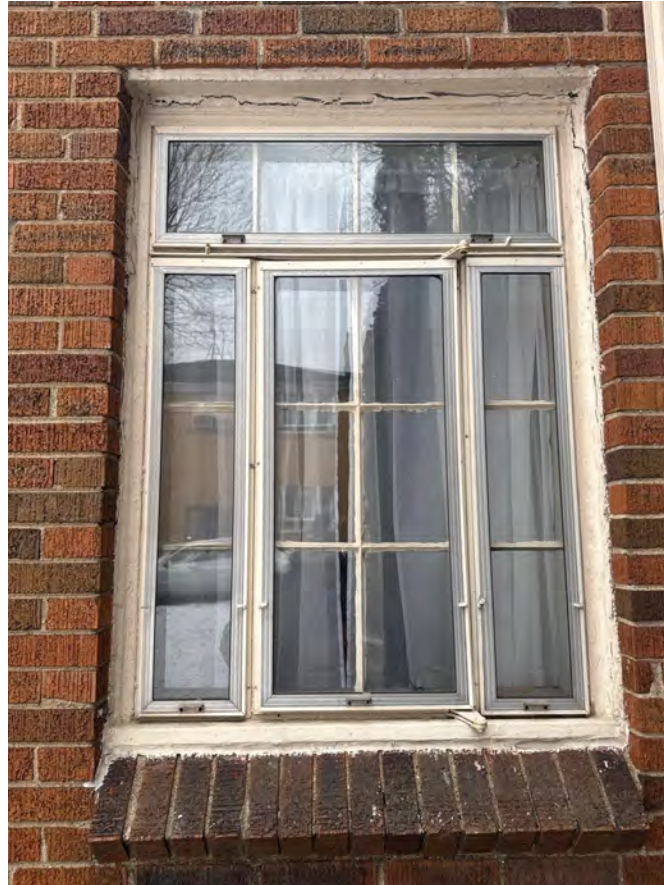
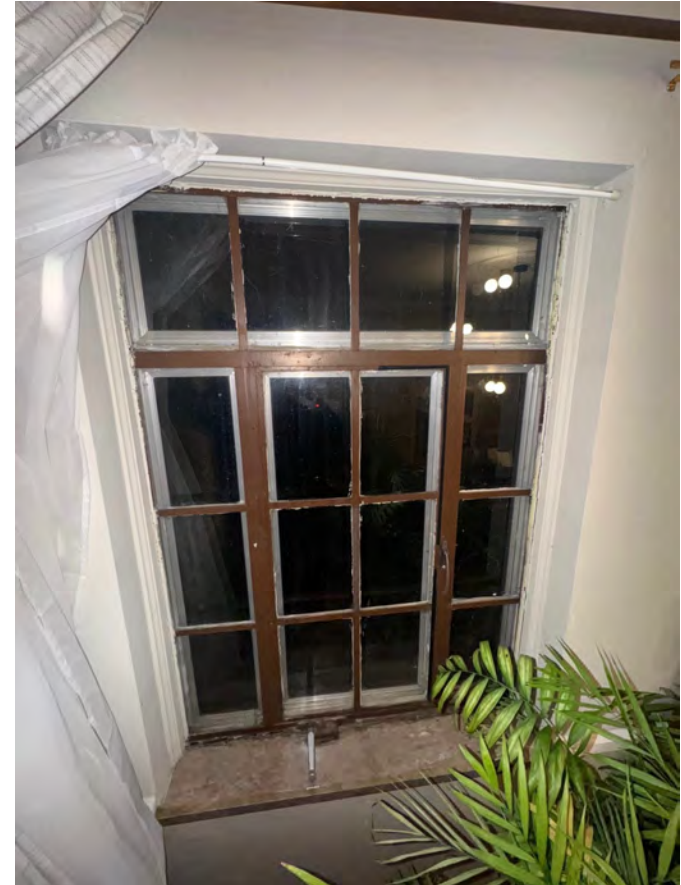
Window 7

- Handle no longer works, gears rusted shut

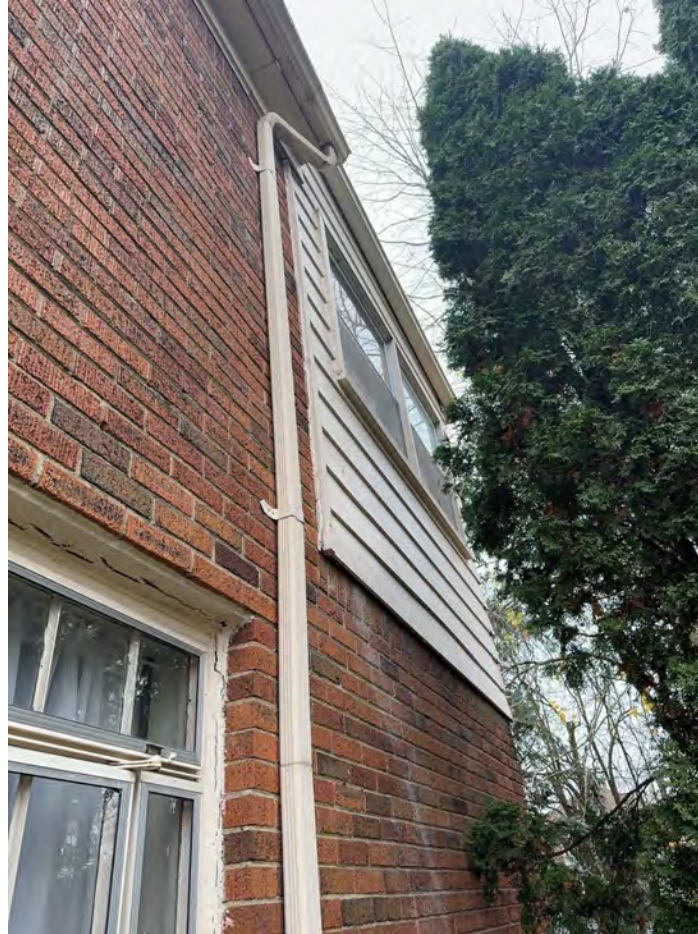
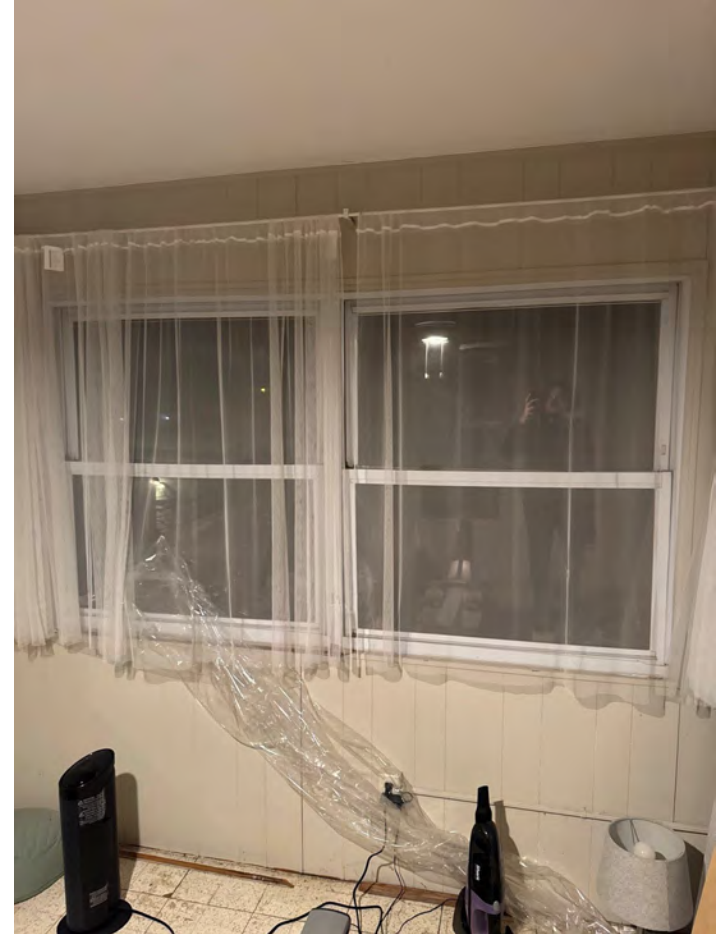
Window 19

- Vinyl, historically incorrect

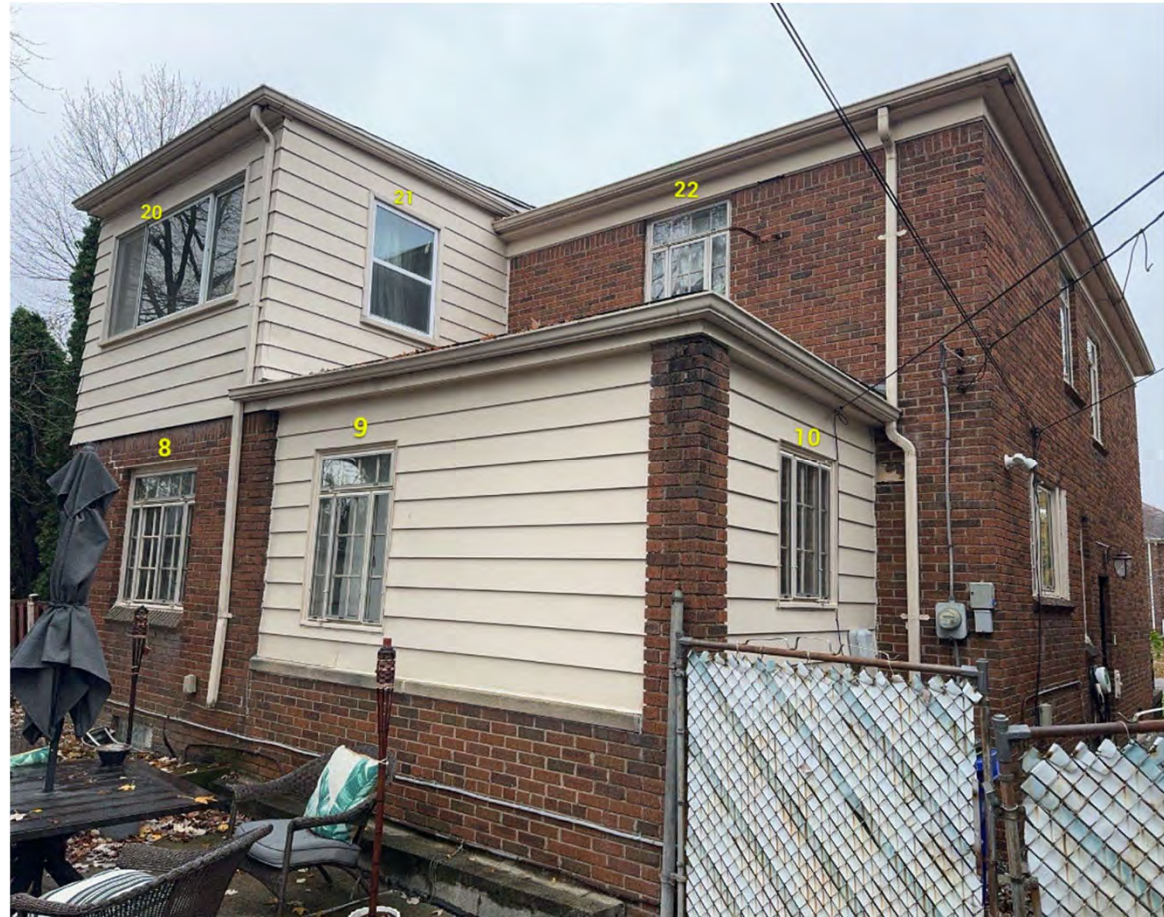
8- inward angled deteriorated sill, damaged interior sill, damaged hardware, evidence of mold, exterior hinges rusted out.

9- evidence of mold, windows not level/flush with rest of home, necessary for proper siding replacement

10- substantial rust present, substantial gaps in frame, weather stripping was attempted but did not remedy to draft.

21- Vinyl; not historically correct

22- evidence of water damage, substantial rust is present, broken glass

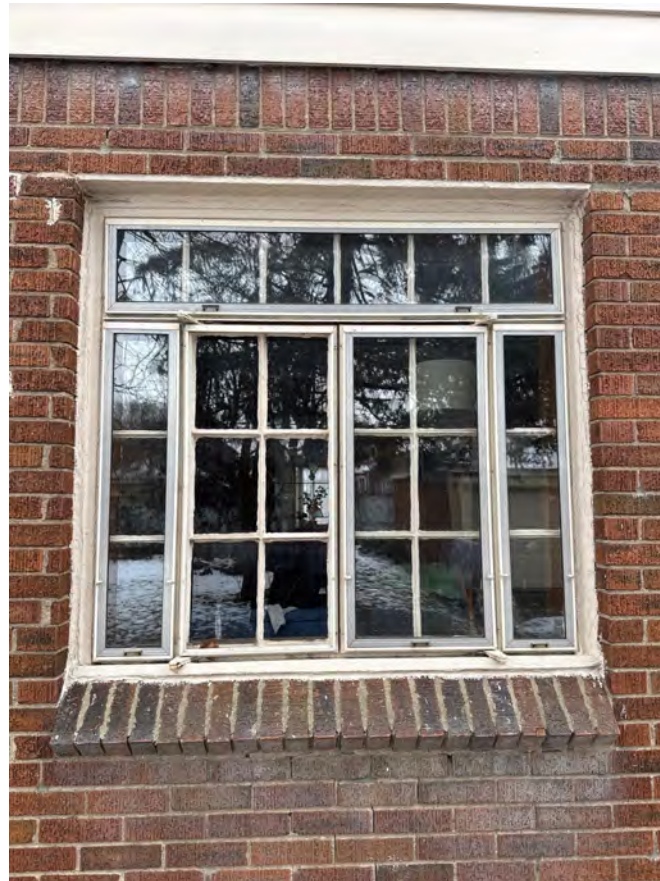
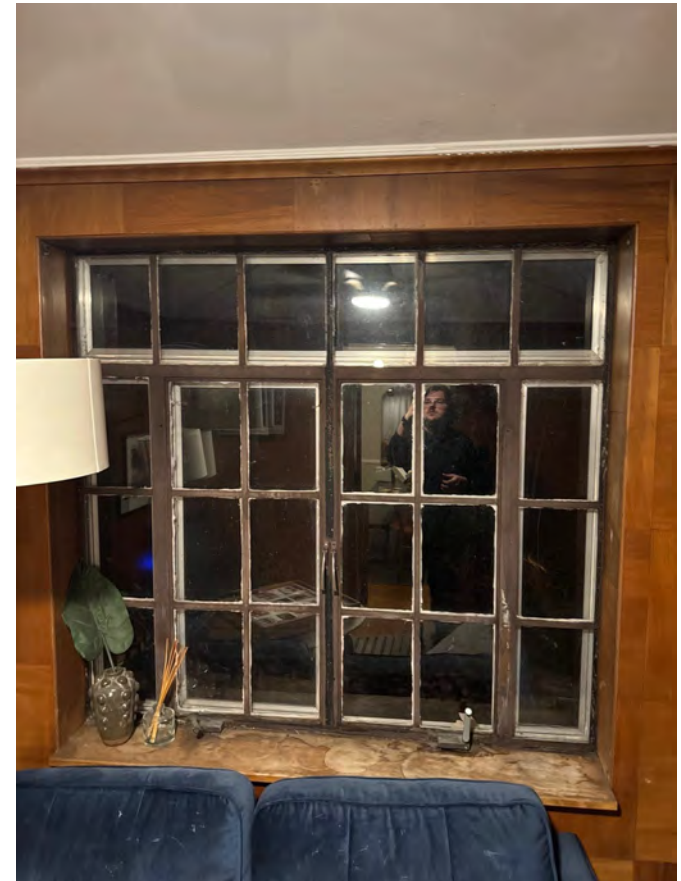
Window 8

- Exterior sill not grading water properly, caused water to damage interior sill
- Hardware receiver rusted out and stripped, repair of handle no longer possible
- Evidence of mold
- Exterior hinges all rusted out, only one casement opens. Does not meet egress/code. Extremely drafty.

Bottom Stud Not Grading Water Properly:

- **Water Pooling and Structural Risk:** The bottom stud is incorrectly angled inward, allowing water to collect rather than drain away from the window. This design flaw exacerbates water retention and encourages wood rot, mold growth, and potential damage to surrounding structures, including the interior walls.
- **Necessity of Replacement:** Adjusting the stud's angle retroactively is not a feasible repair solution due to its integration into the structural frame. Full replacement of the window frame ensures proper water grading and long-term protection against water infiltration

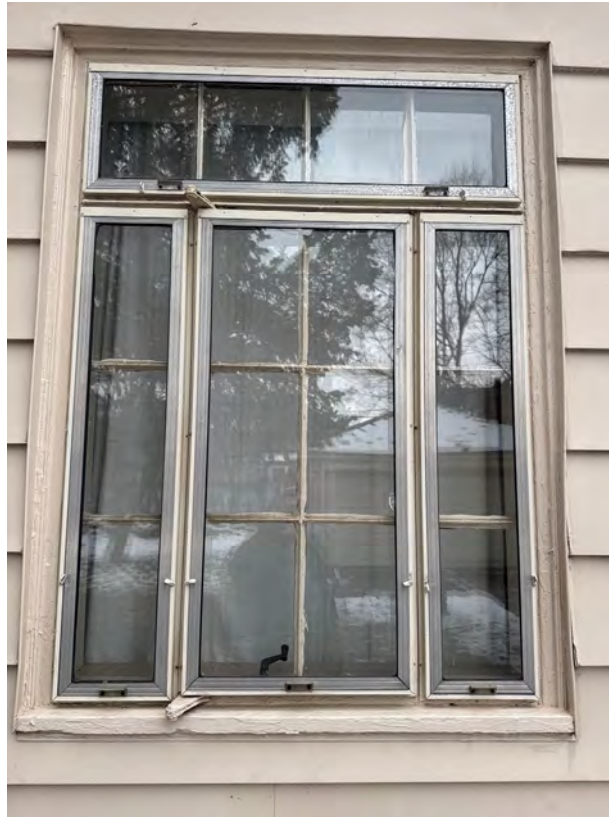
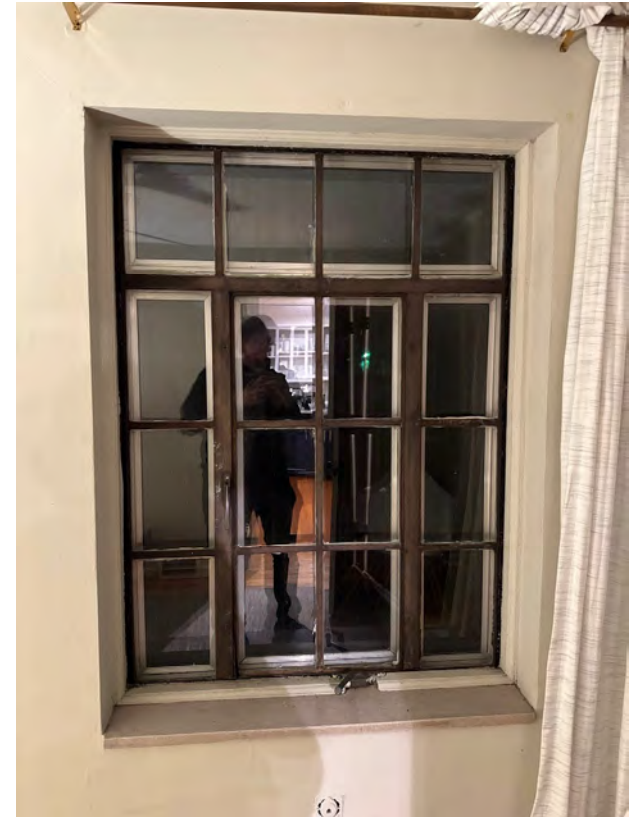
Window 9

- Deterioration of bottom exterior sill
- Evidence of mold
- Window not level with home, home has shifted, only remedy is replacement
- Window not flush, needs to be flush for proper siding replacement

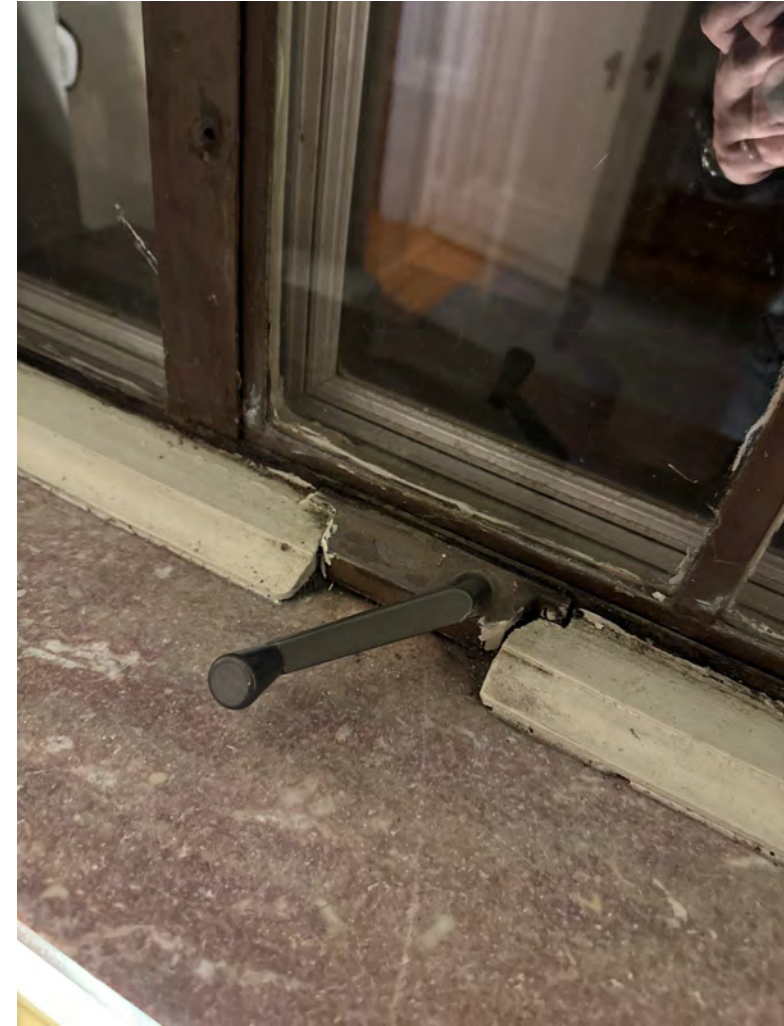
Window 10 (Continued)

- New weather stripping was attempted, did not fix the issue

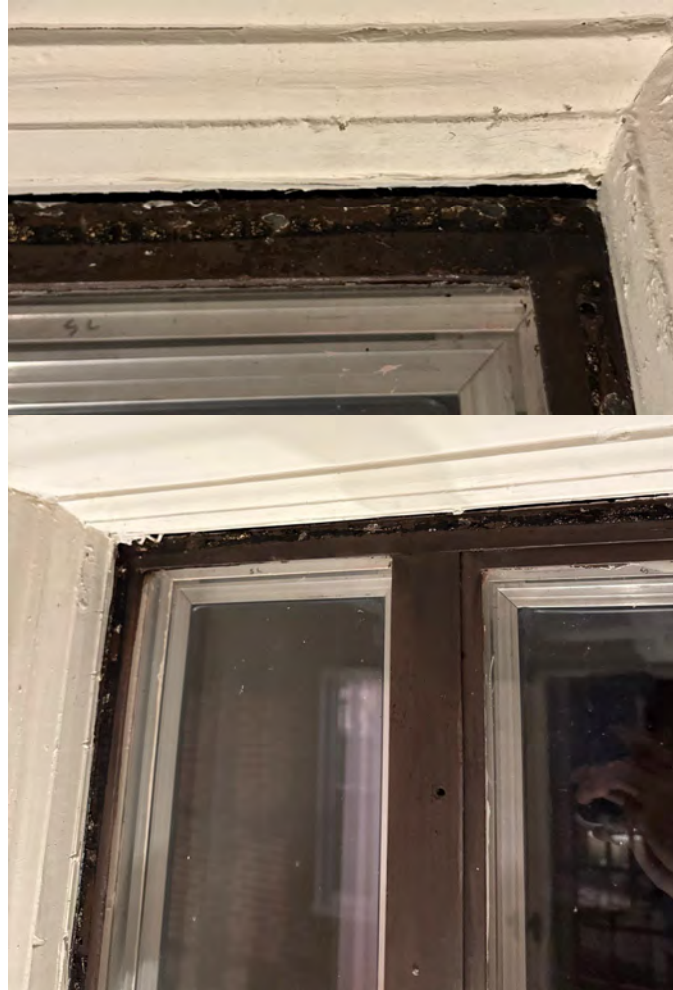
Window 10 (continued)

- Substantial gap above window; not level with home
- Gap in weather stripping
- Very rusted frame

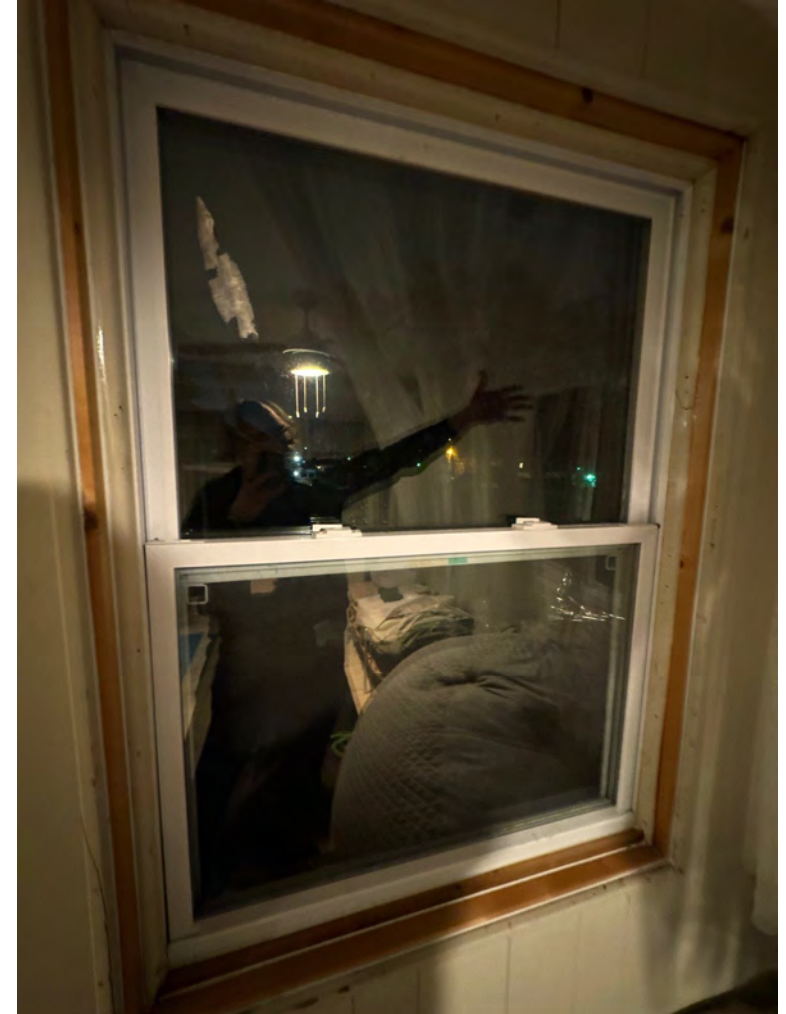
Window 21

- Vinyl; historically incorrect

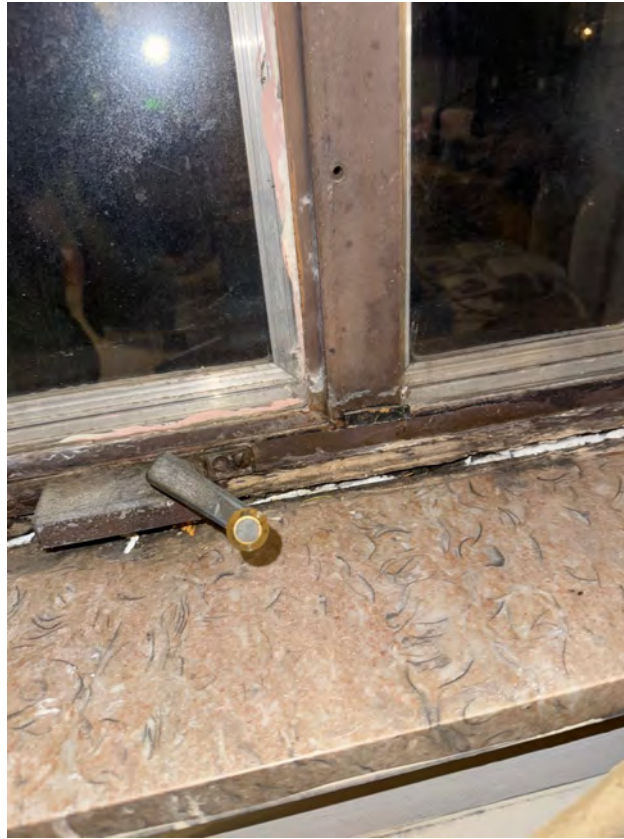
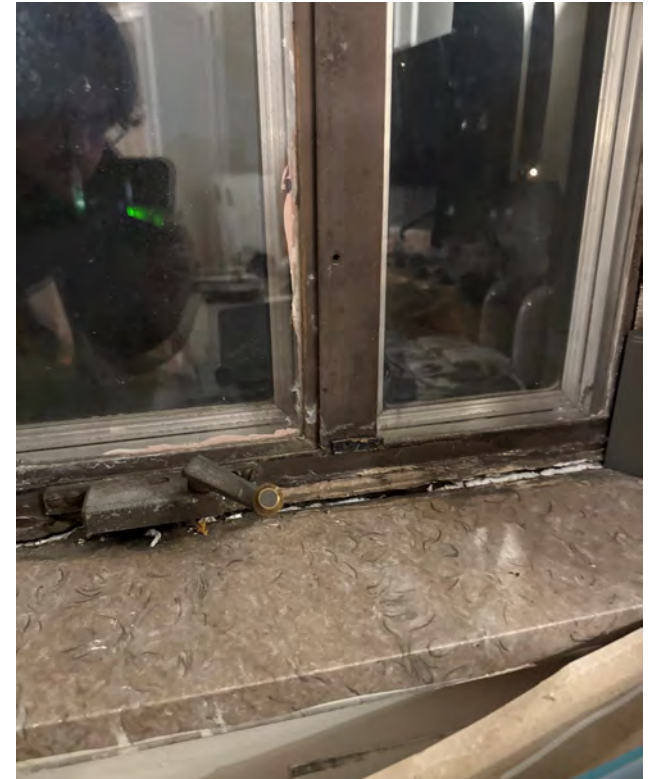
Window 22 (continued)

- Evidence of water damage present,
- Broken glass
- Substantial rust, compromising integrity of the window

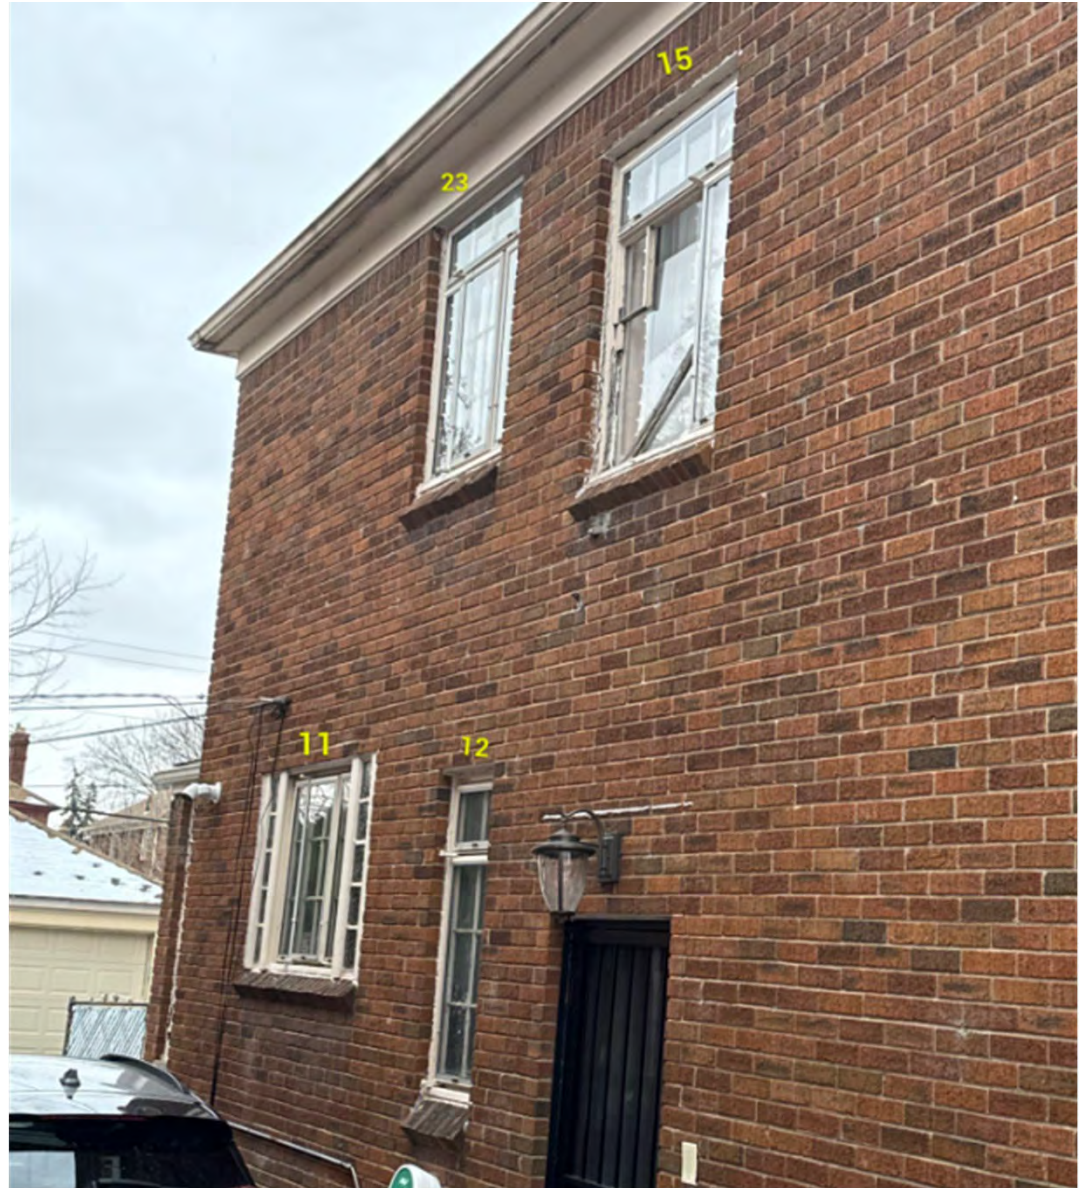
11- cant lock, doesn't seal. Draftiest window on first floor. Glass blocks are not original to historical look of the home. Glass blocks were used as an incorrect repair.

15- Most of the window is missing.

23- substantial gaps seen from interior of the window frame

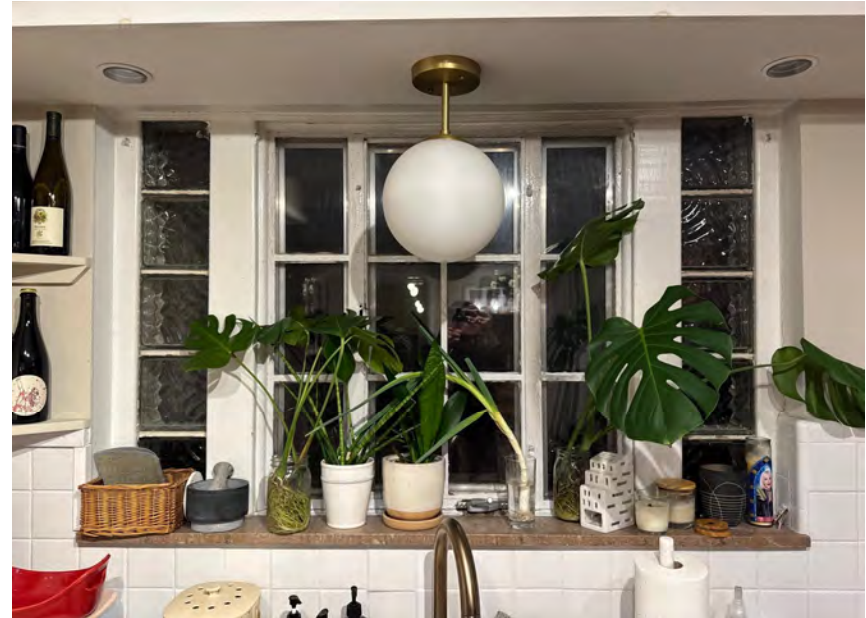
Window 11

- Glass block are not original to home, therefore not historically accurate. Requires replacement of entire opening.

Window 11 (continued)

- Hardware was repaired but can not lock.
- Substantial gaps. Draftiest window on the floor

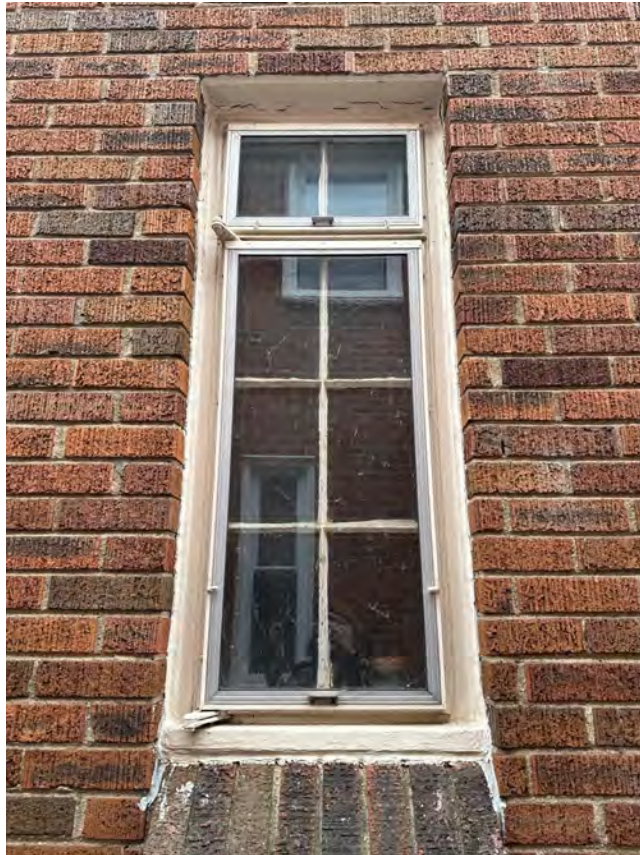
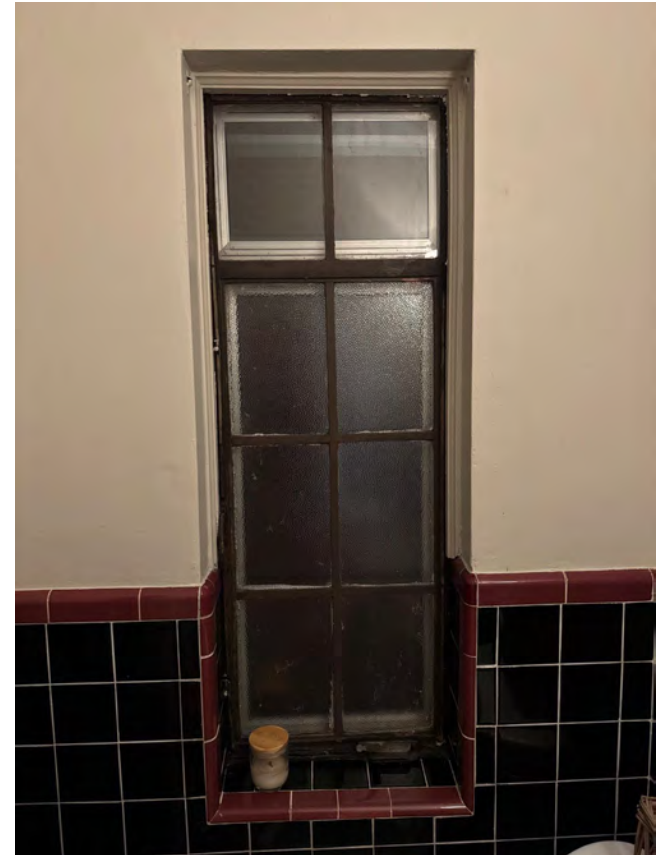
Window 12 (continued)

- Sealed shut, has never been able to be opened
- Substantial gaps, very drafty.
- Severe structural rust
