HISTORIC DISTRICT COMMISSION NOTICE OF DENIAL

Application Number: HDC2025-00014

NAME: Alexander Belilovsky		COMPANY NAME: Alexandria Home Solutions	
ADDRESS: 24293 Telegraph Road	CITY: Southfield	STATE: MI	ZIP: 48033
PROJECT ADDRESS: 4071 Leslie			
HISTORIC DISTRICT: Russell Woods-Sullivan

Replace historic steel windows and associated wood trim with new aluminum-clad wood windows

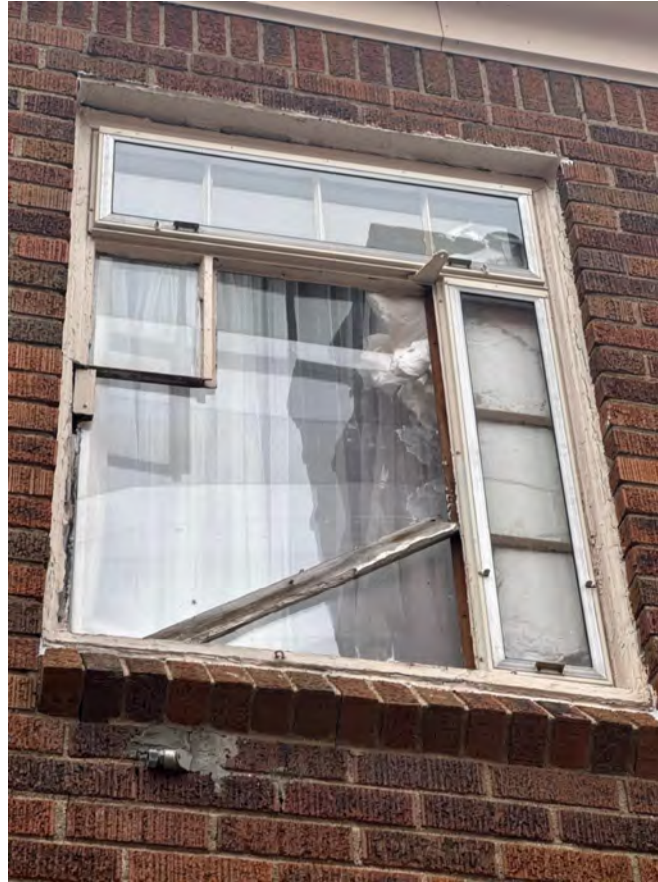
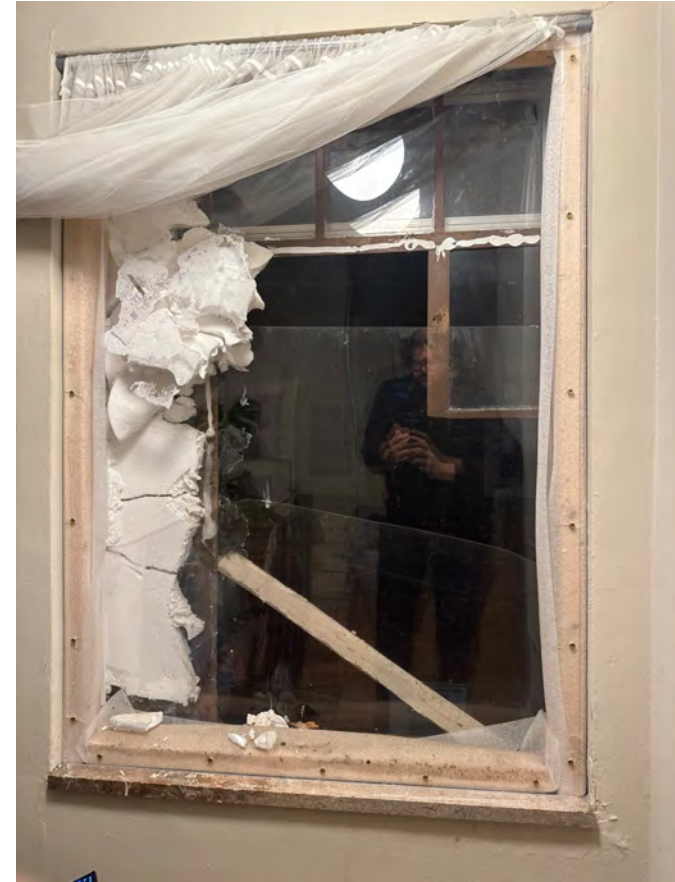
Window 15

- Beyond repair. Most of window is missing.

Window 23

- Substantial gaps in window frame. Not flush with home. Very drafty.

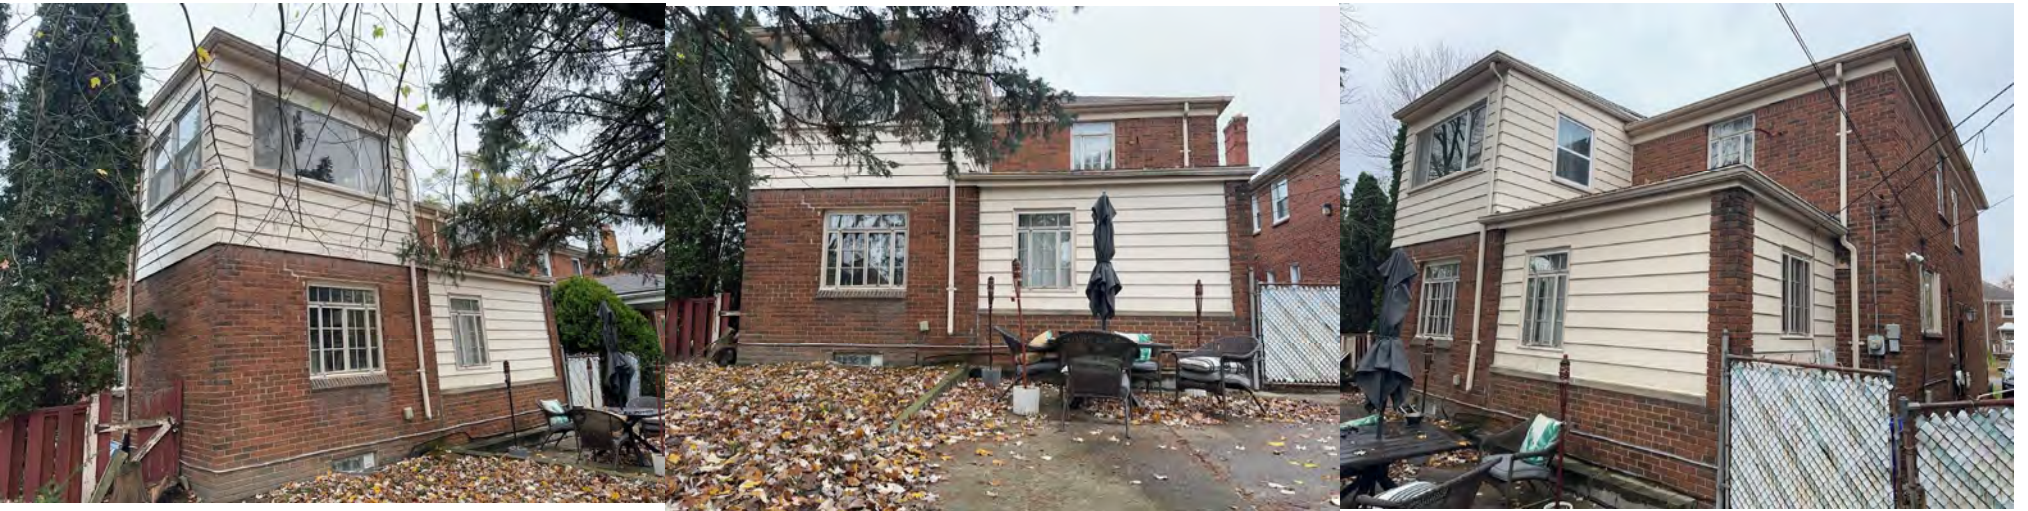
- The existing aluminum siding on the rear of the property will be removed, as it is not historically appropriate for the district. The addition was added after the home was built, therefore aluminum is not historically correct material. In its place, a fiber cement wood alternative will be installed, providing a historically accurate aesthetic while ensuring long-term durability and low maintenance. This material replicates the appearance of traditional wood siding and aligns with the district's preservation standards.
- Approximately 550 square feet of siding will be replaced, focusing on maintaining the architectural integrity of the home.

Existing Aluminum Siding – to be removed
