**STAFF REPORT: JULY 8, 2020 MEETING**

**APPLICATION NUMBER: 20-6770**

**ADDRESS: 1225 WOODWARD AKA *THE FOWLER BUILDING***

**SCOPE OF WORK: REHAB BUILDING, REPLACE WINDOWS, STOREFRONT SYSTEM**

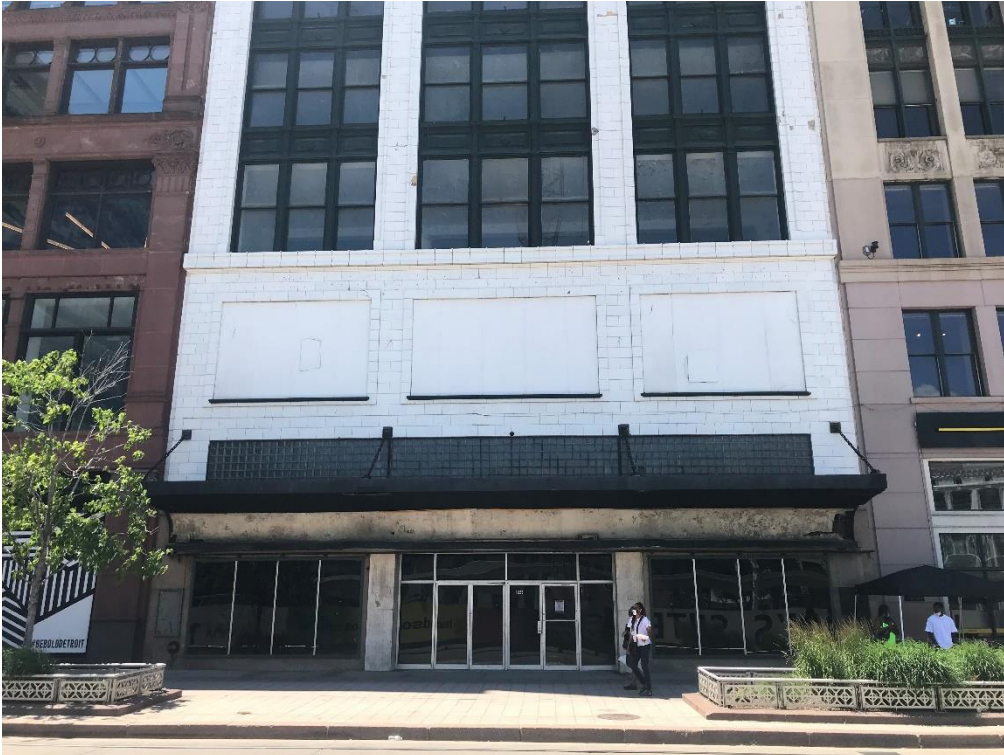
*Front of 1225 Woodward, Staff Photo (East Elevation)*

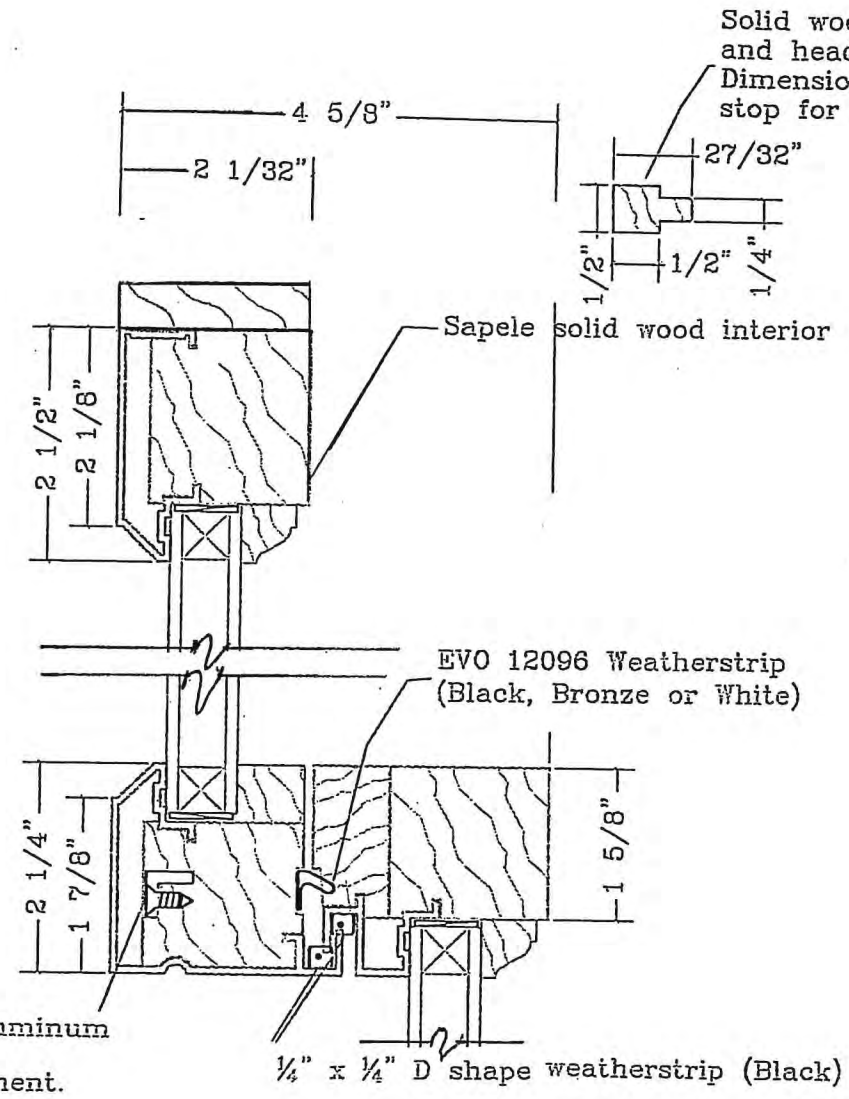
EXISTING  
"WILLIAMS PIVOT SASH"  
TO BE REMOVED.

PROPOSED  
ALUMINUM CLAD FIXED SASH  
IN EXIST'G COPPER CLAD FRAMES
