STAFF REPORT: OCTOBER 14, 2020 MEETING

APPLICATION NUMBER: 20-6863

ADDRESS: 7949 EAST LAFAYETTE

SCOPE OF WORK: REPLACE WINDOWS, REHAB EXTERIOR, REMOVE EXTERIOR BASEMENT ENTRANCE ENCLOSURES

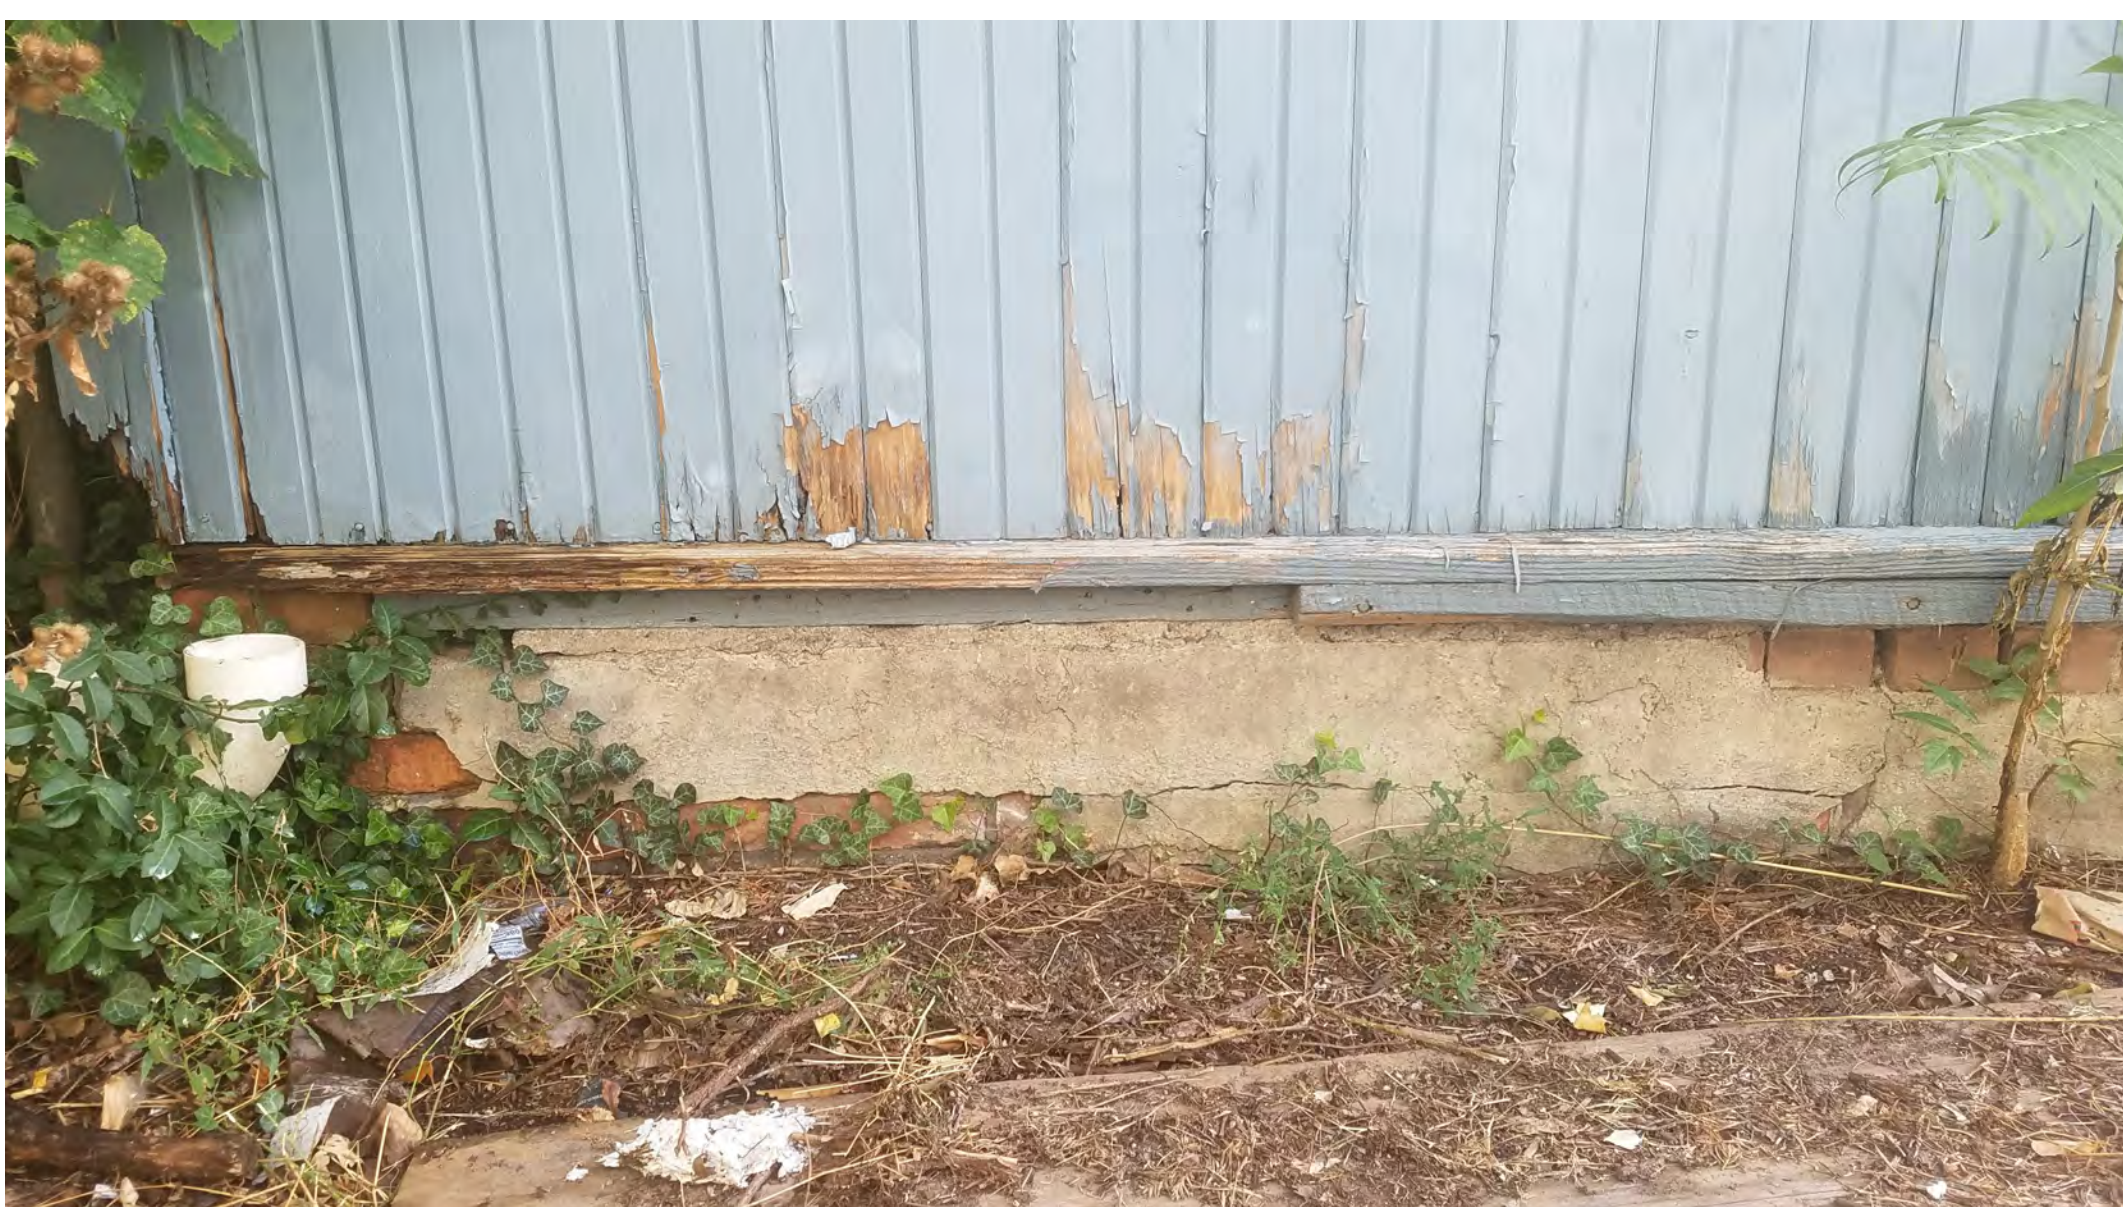
BASEMENT STAIR ENCLOSURE CLADDING TO BE REMOVED

BASEMENT STAIR BRICK ENCLOSURE/FOUNDATION

THE PROPOSAL IS TO REMOVE THE REAR ENCLOSURES OF THE BASEMENT STAIRS AND INSTALL A LIMESTONE CAP ON TOP OF THE BRICK STAIR ENCLOSURE FOUNDATION.

THE EXISTING VESTIBULE AND COVERED PORCH WILL BE REPAIRED AS REQUIRED.

A NEW CODE-REQUIRED GUARDRAIL AND HANDRAIL WILL BE INSTALLED AT THE PORCH AND STAIR. THE DETAILING WILL REMAIN SIMPLE, WITH RECTANGULAR AND SQUARE PROFILES USED FOR THE RAILS AND BALUSTERS, RESPECTIVELY. ALL WILL BE PAINTED TO MATCH THE PORCH AND VESTIBULES.

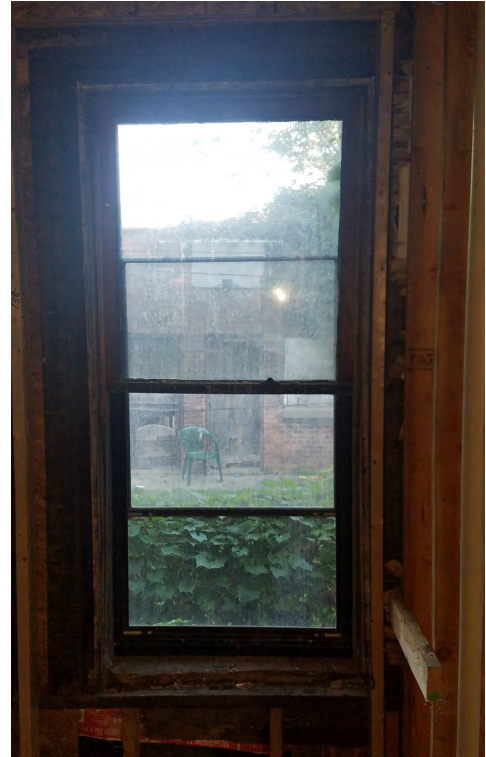
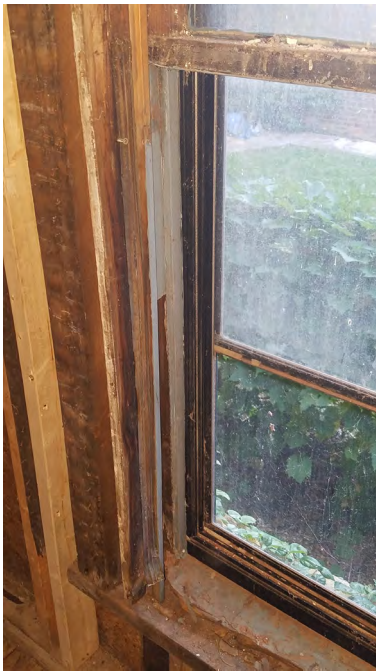
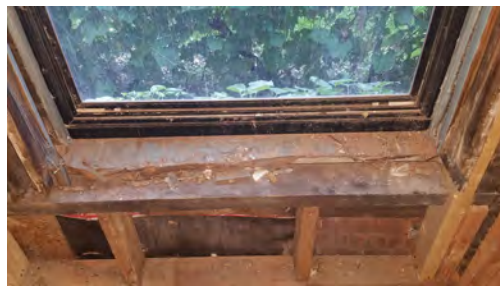
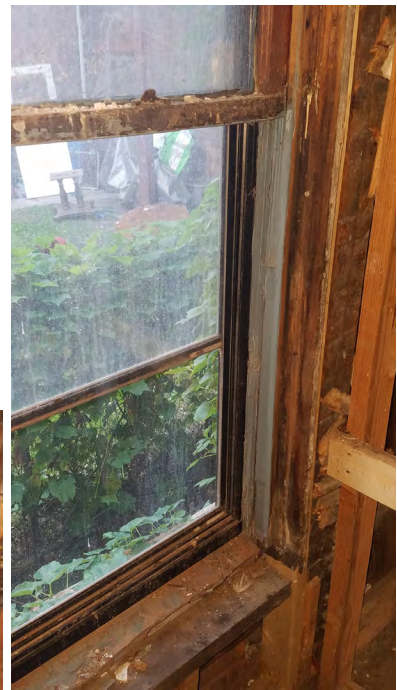
- Missing lower sash
- Deteriorated/rotted sill
- Broken/split left jamb framing
- Missing rope/counterweights

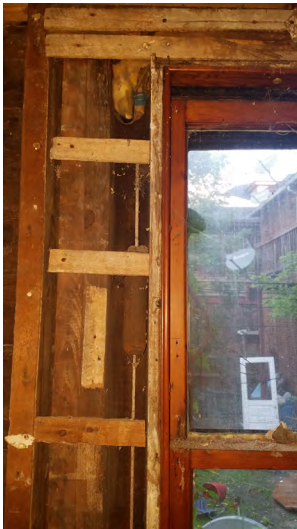
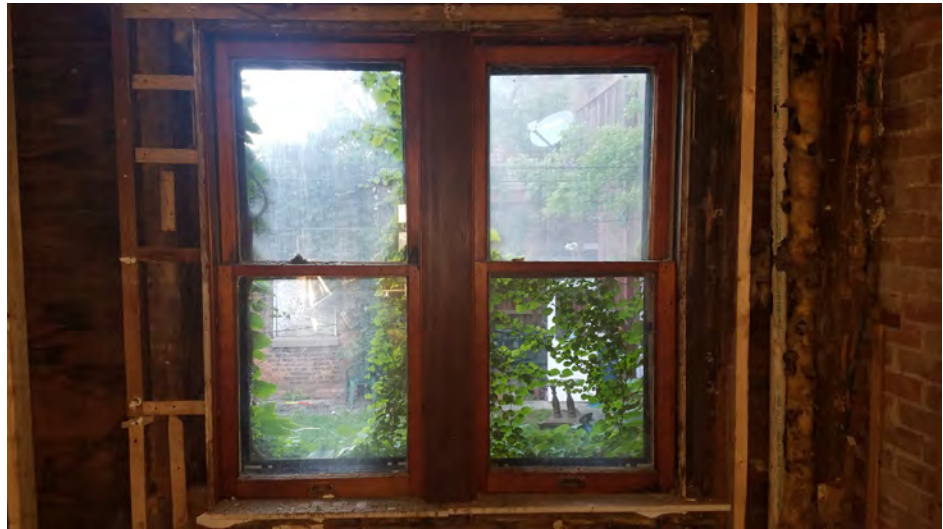
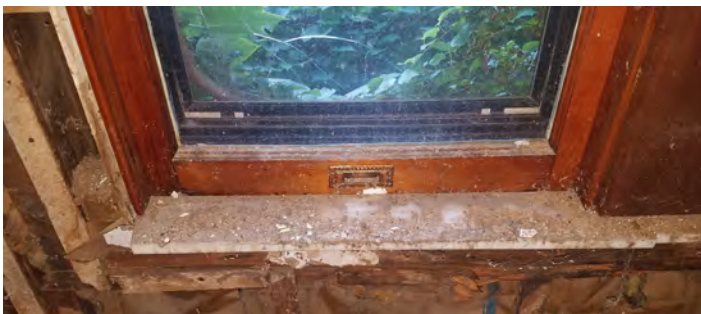
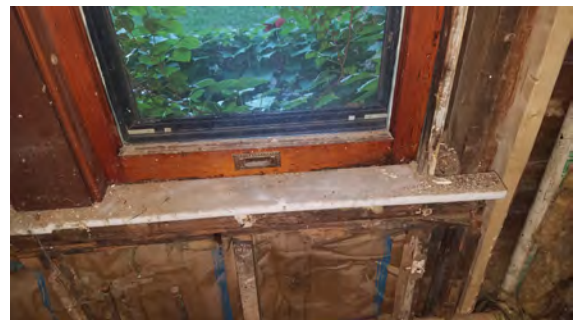
- Rotted/split left-top jamb framing
- Center mullion will be retained and repaired as required. Proposal is to replace each double hung unit individually.

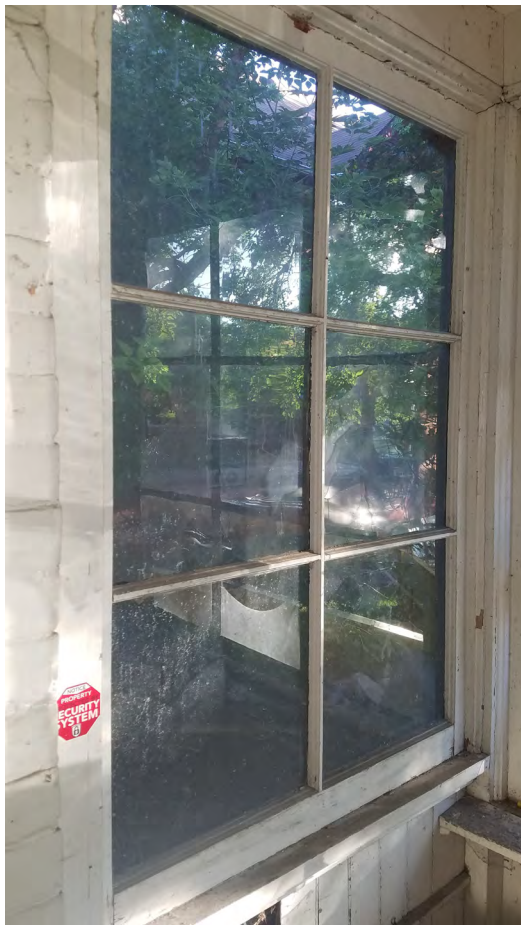
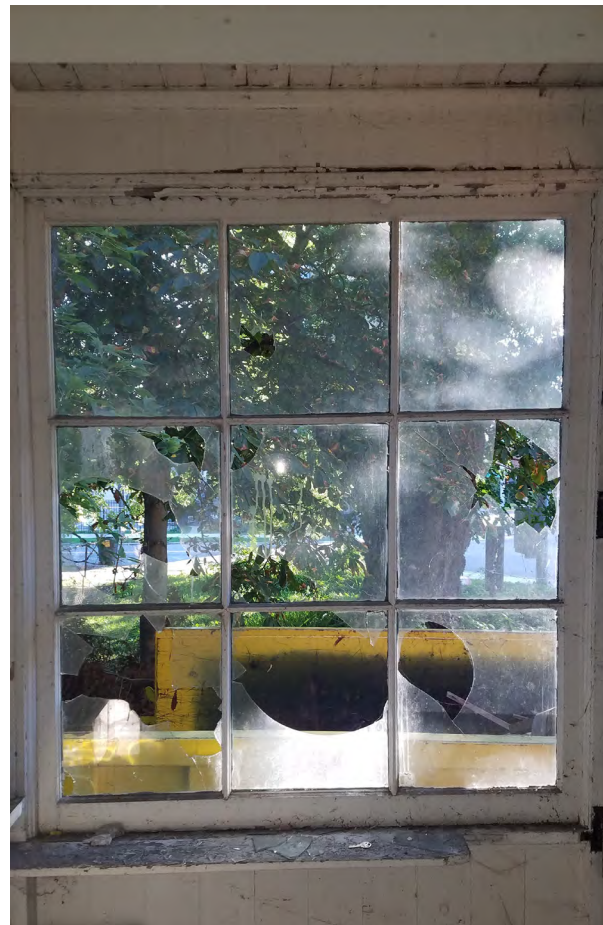
- Broken glazing
- Single pane glazing, no insulation value

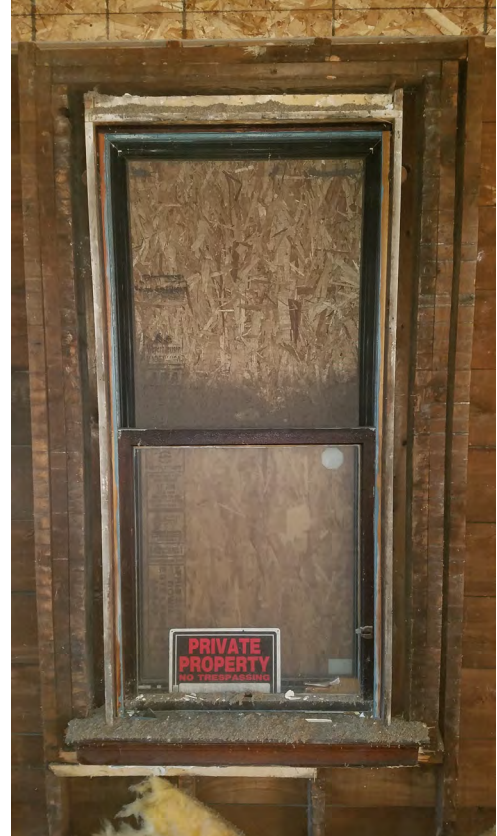
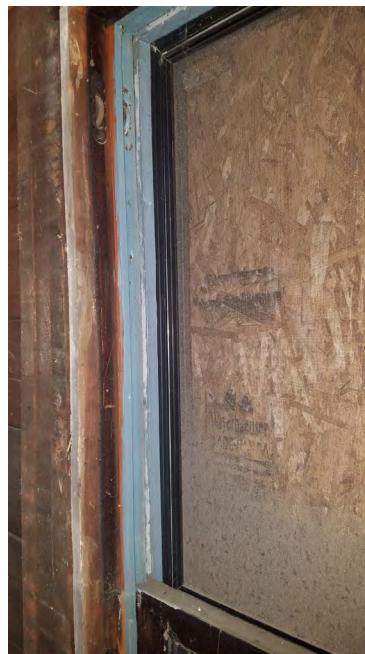
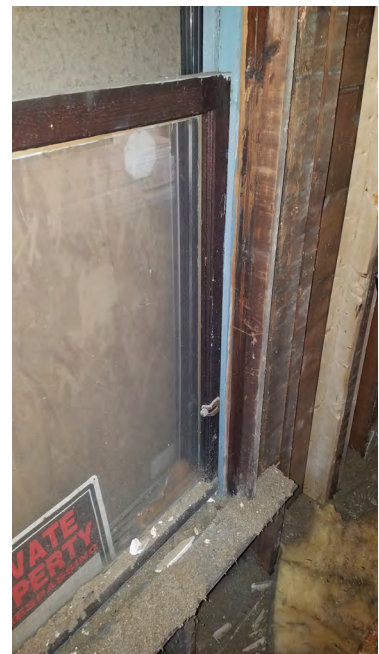
- Missing lower sash
- Missing rope/counterweights

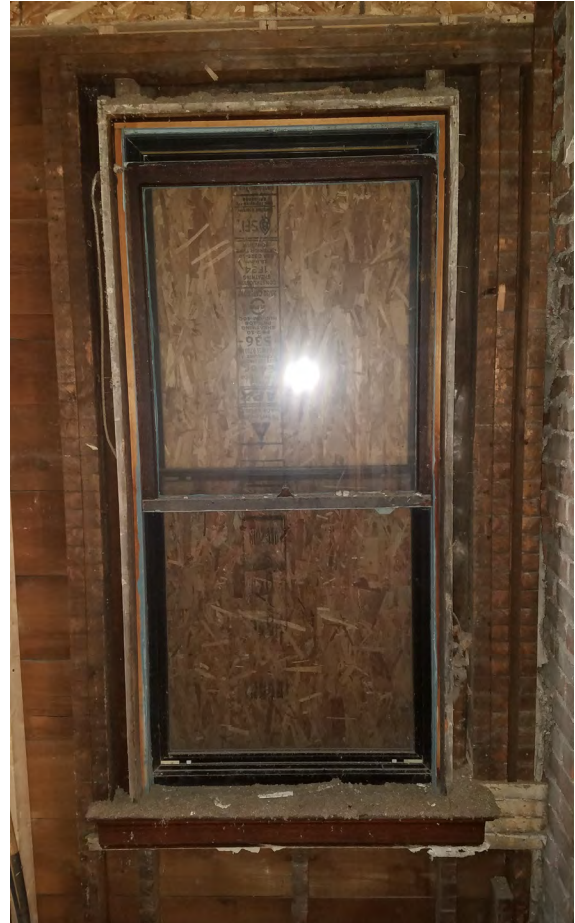
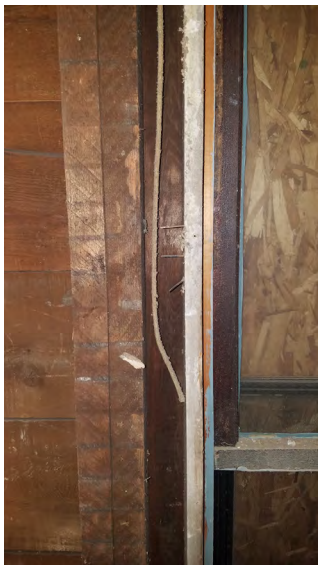
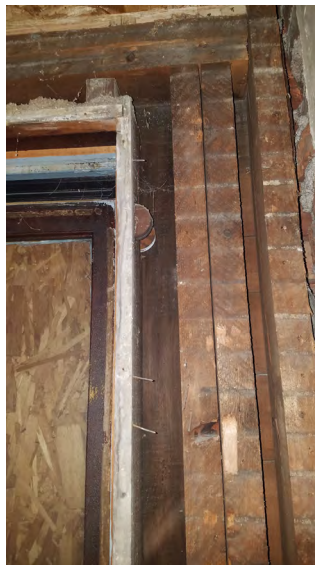
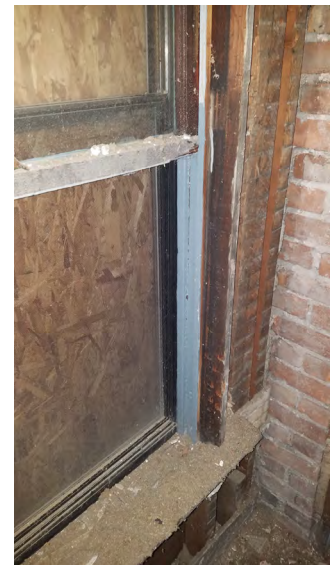
- Missing lower sash
- Missing counterweights

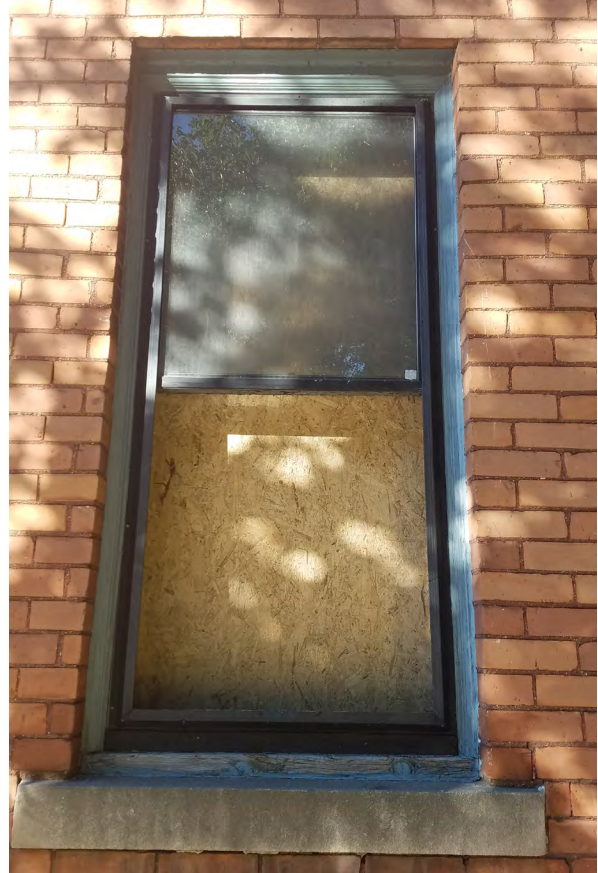
E1-08 (East Unit, East Elevation)

- Entire Window Missing (only half of storm window in place).

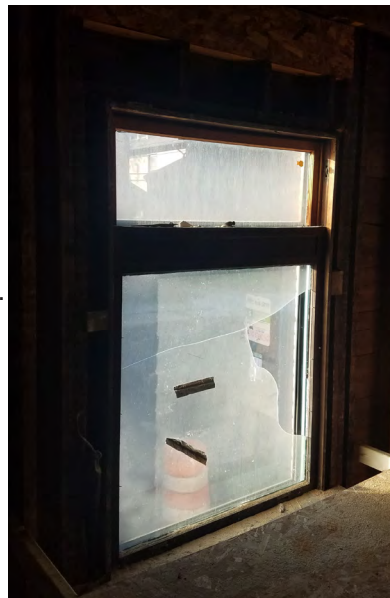
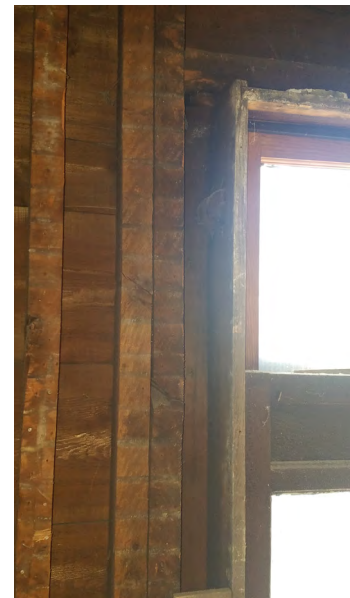
E1-09 (East Unit, South Elevation)

- Broken Glazing
- Rot at upper left corner of casement
- Horizontal mullion will be retained and repaired as required. Proposal is to replace each window unit (transom above, double hung below) individually.

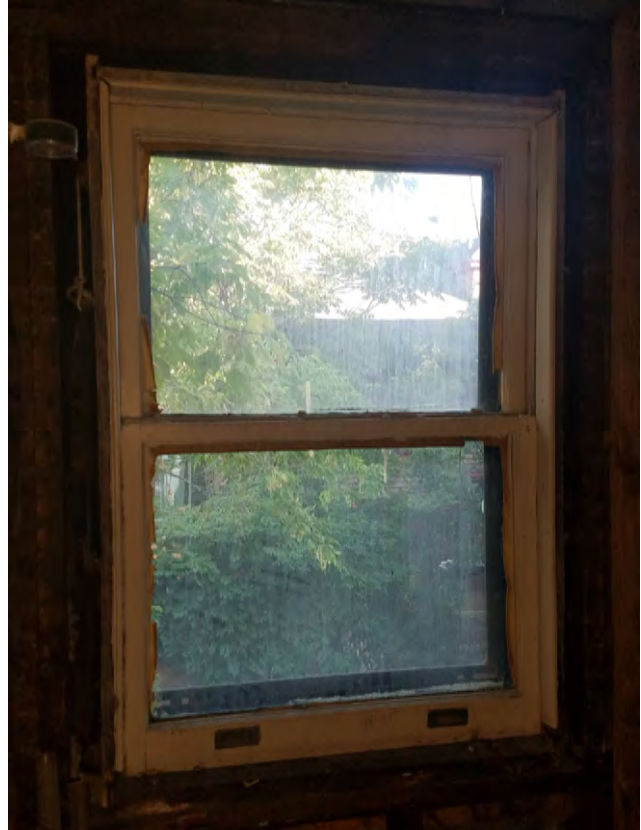
E2-01 (East Unit, North Elevation)

- Missing rope and counterweight (right side)
- Rot/gouges at joints of lower sash

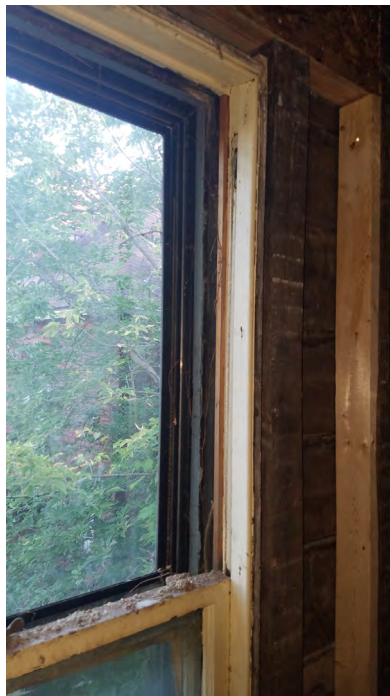
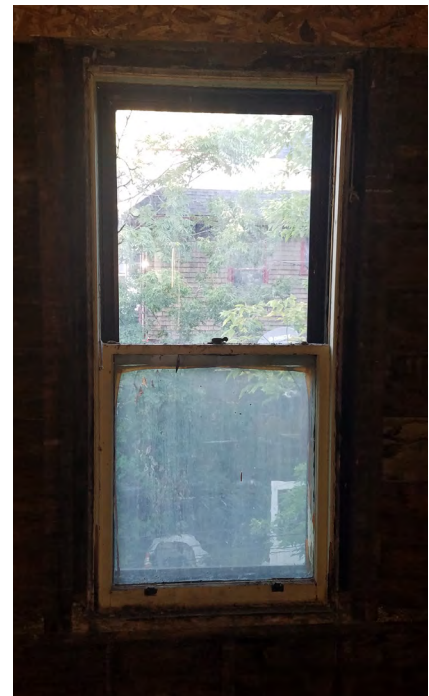
E2-02 (East Unit, North Elevation)

- Missing upper sash
- Rot observed on frame

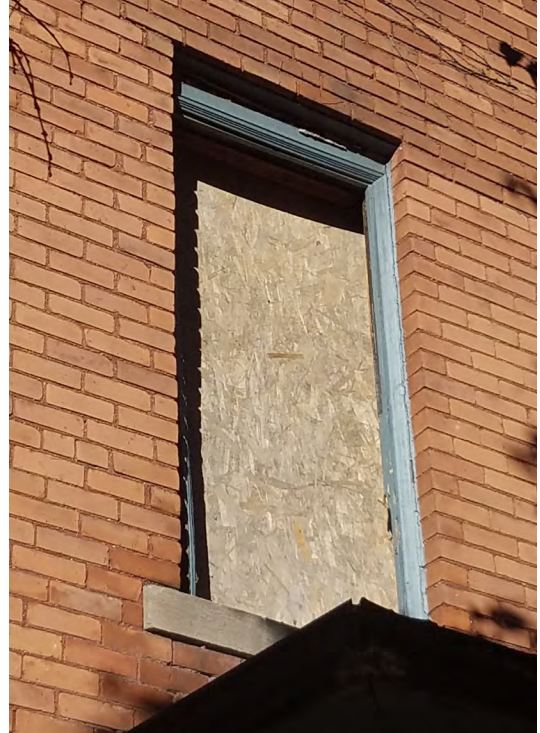
- Missing entire window

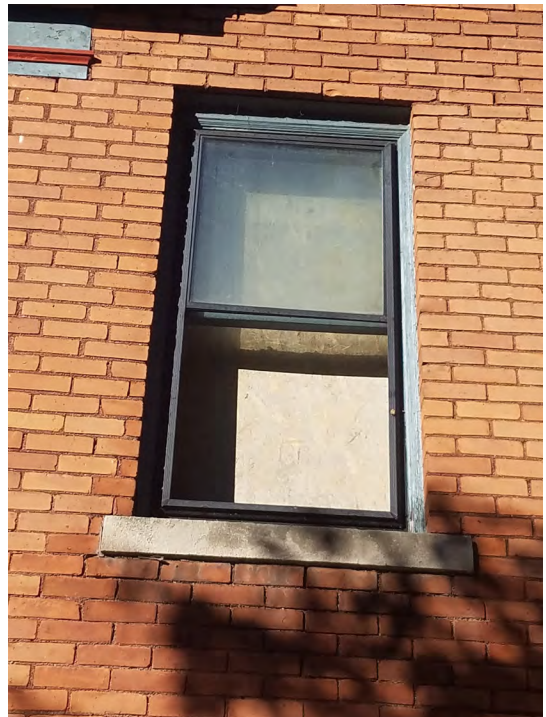
E2-04 (East Unit, East Elevation)

- Missing lower sash

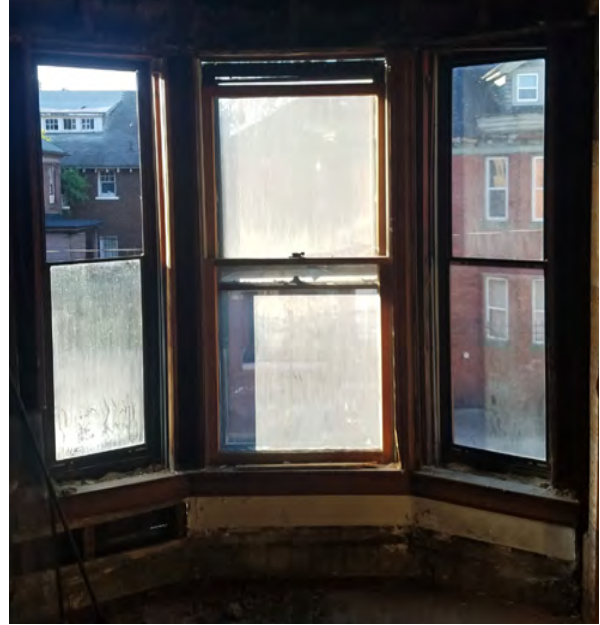
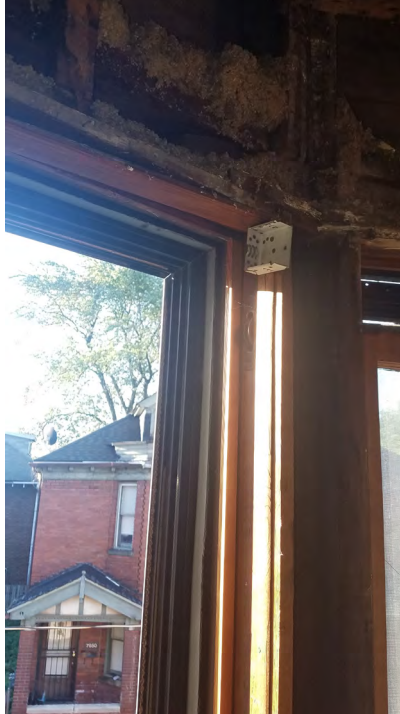
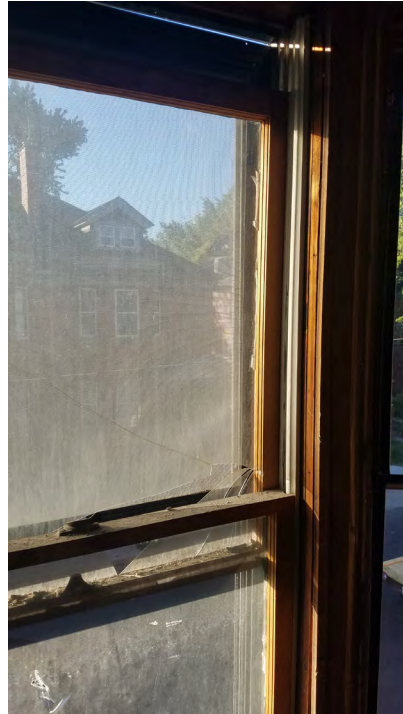
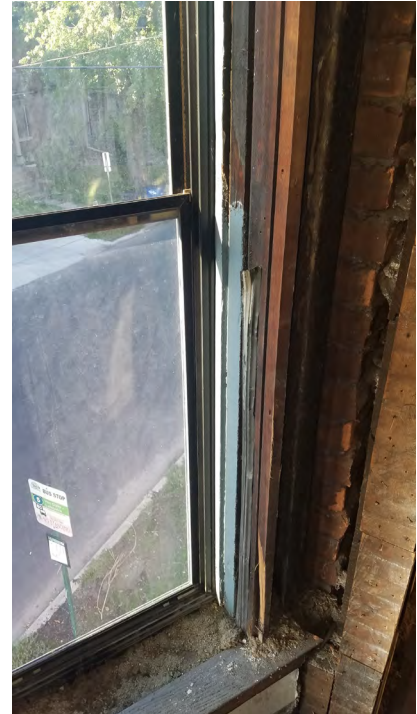
- Missing entire windows (left and right)
- Broken Glazing (center window)
- Split/damaged wood (right jamb)
- Missing ropes and counterweights

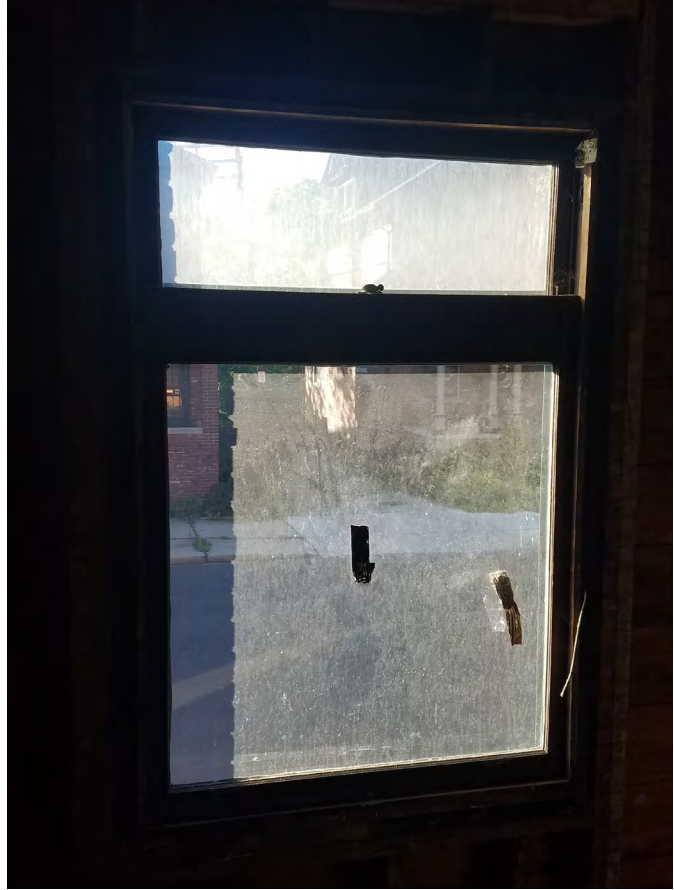
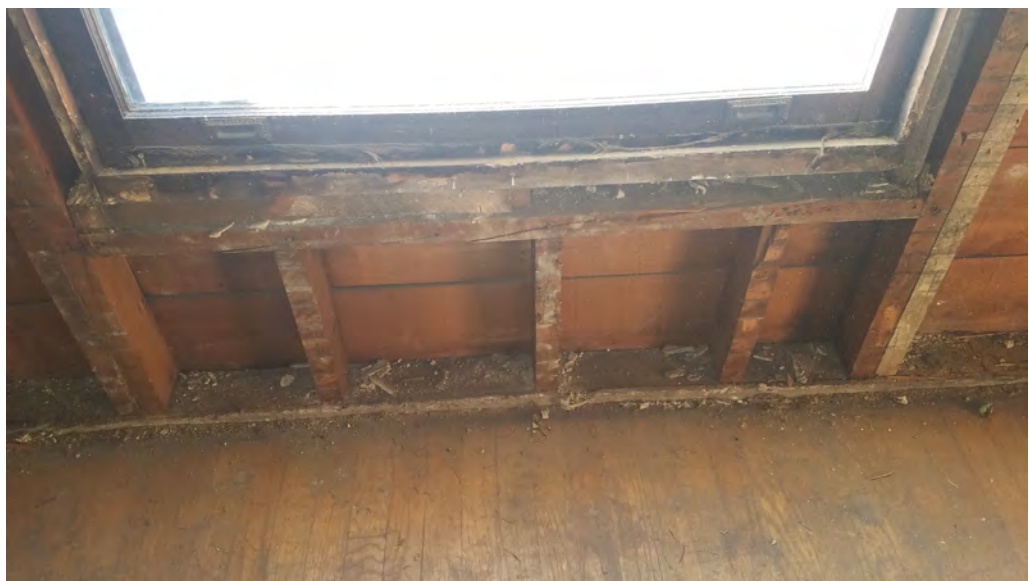
W1-01 (West Unit, South Elevation)

- Rot/damage at sill
- Horizontal mullion will be retained and repaired as required. Proposal is to replace each window unit (transom above, double hung below) individually.

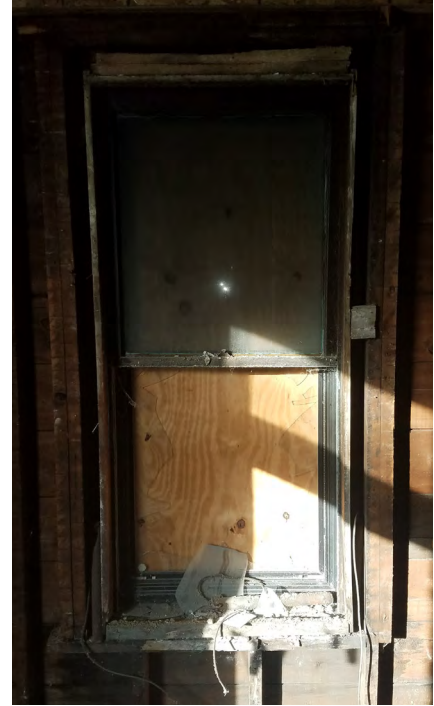
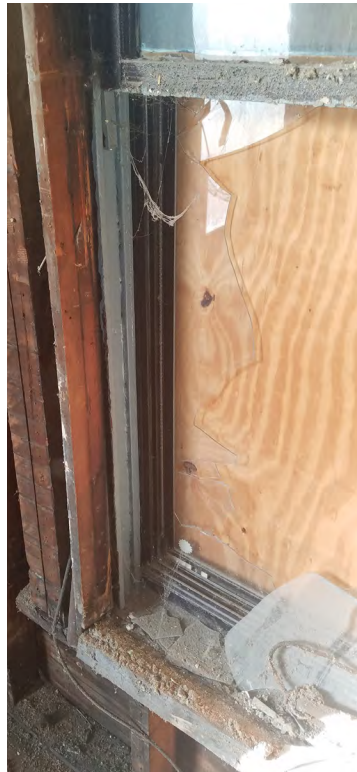
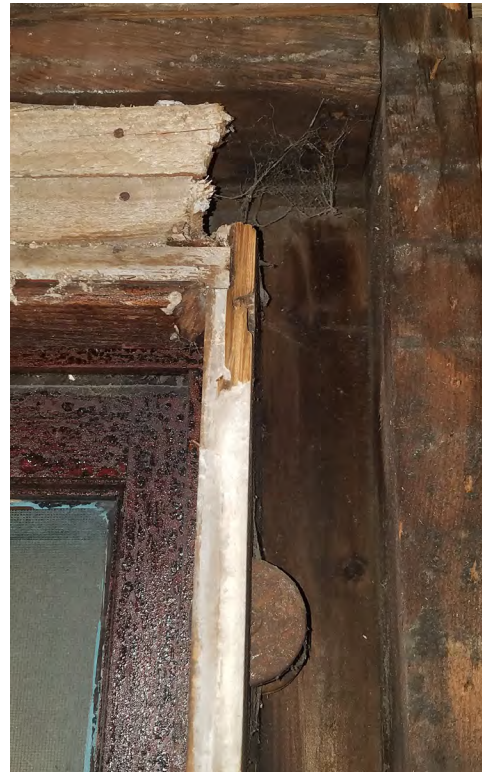
- Missing lower sash
- Rot/damage at frame

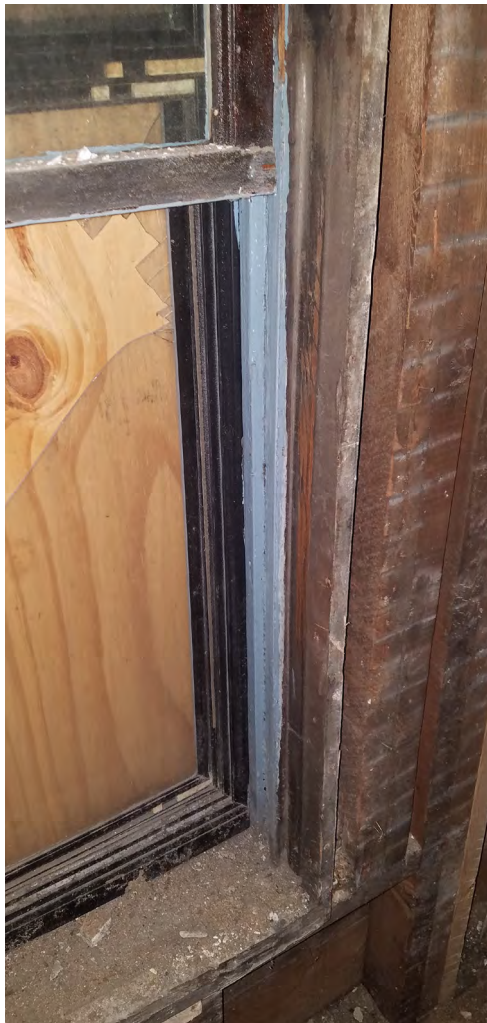
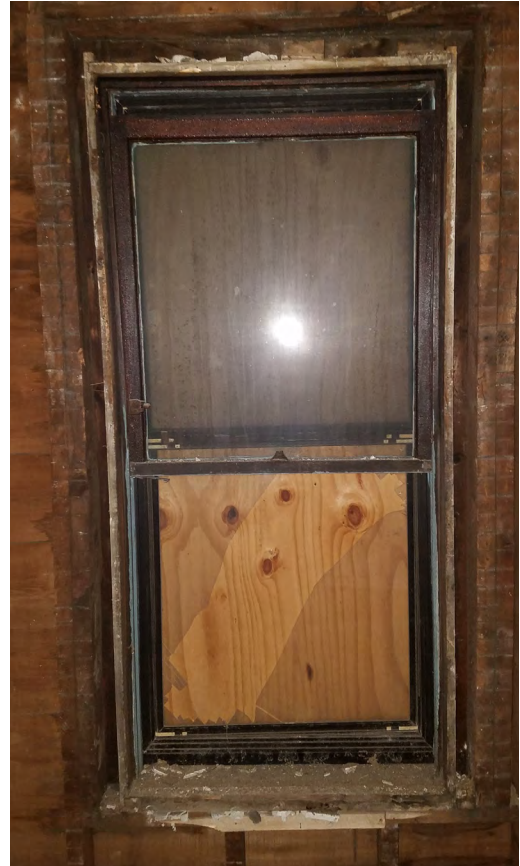
W1-03 (West Unit, West Elevation)

- Missing lower sash
- Missing ropes/counterweights
- Broken glazing in storm window

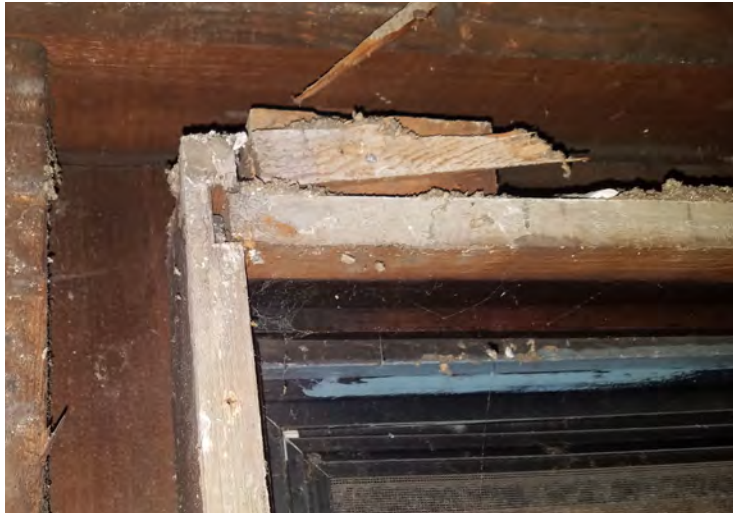
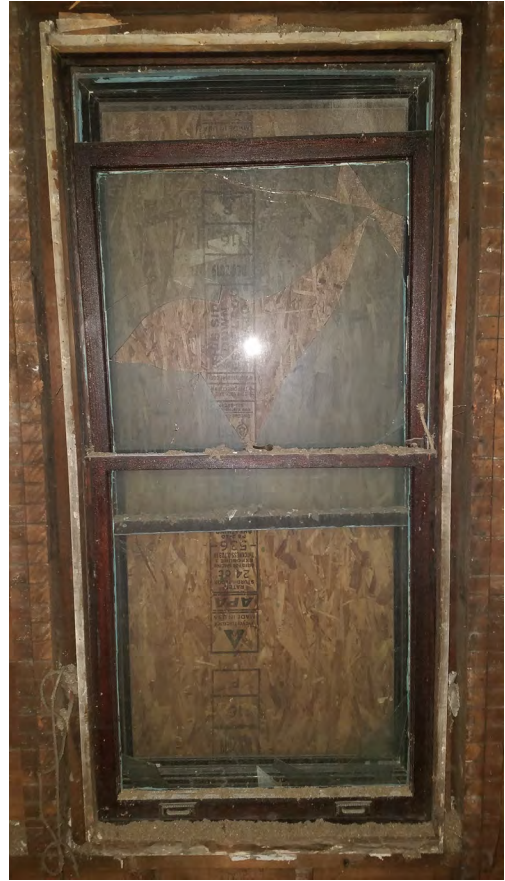
W1-04 (West Unit, West Elevation)

- Broken glazing (upper and lower sash)
- Damaged frame
- Missing rope/counterweights

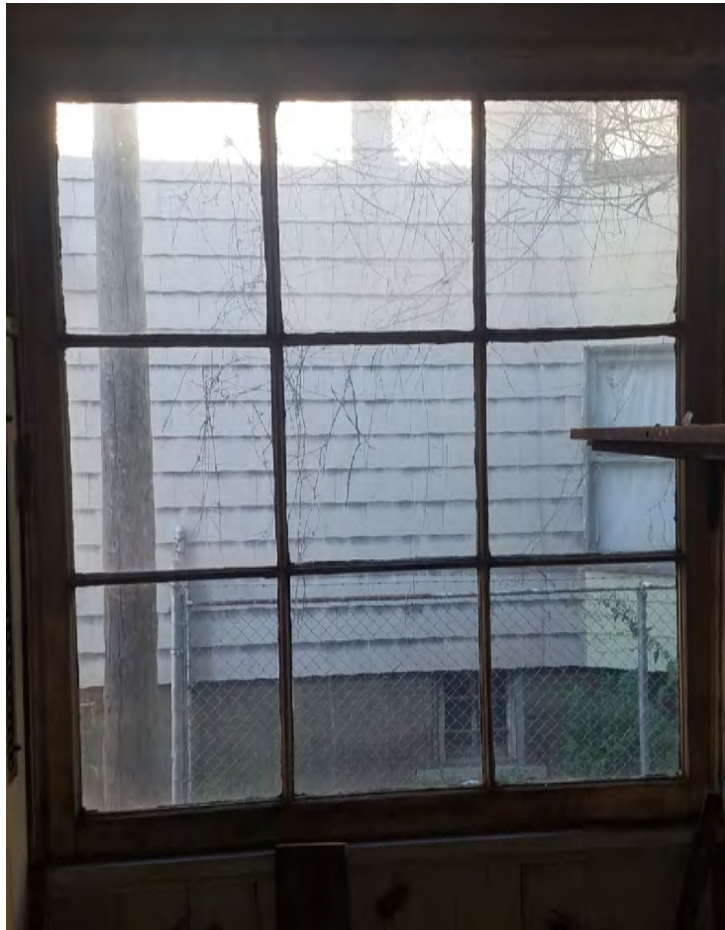
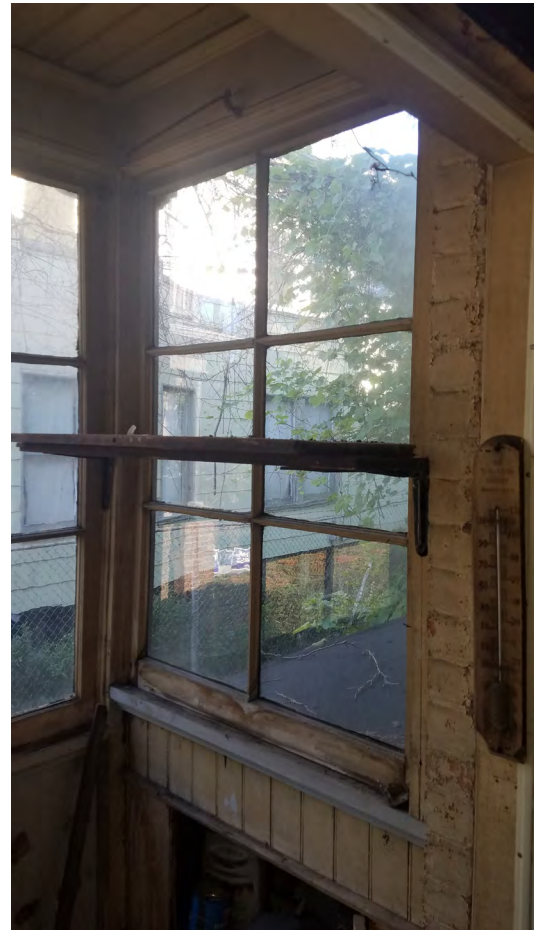
- Single pane glazing, no insulation value

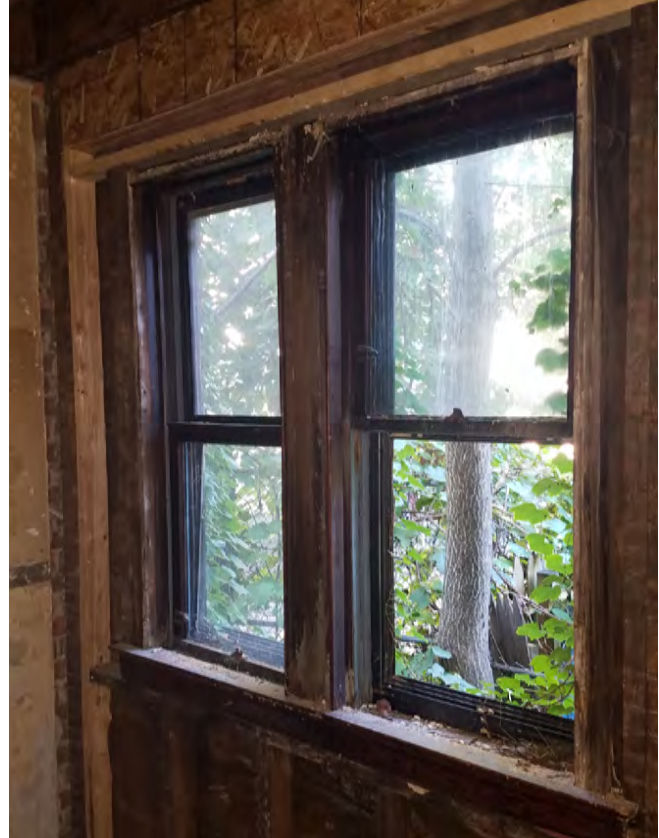
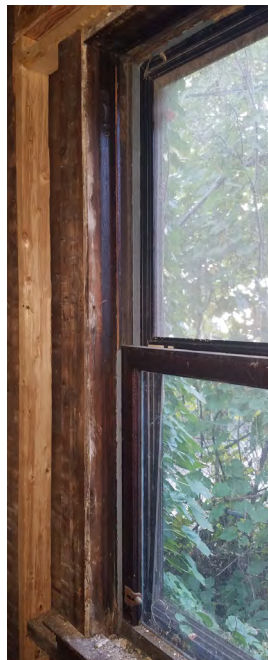
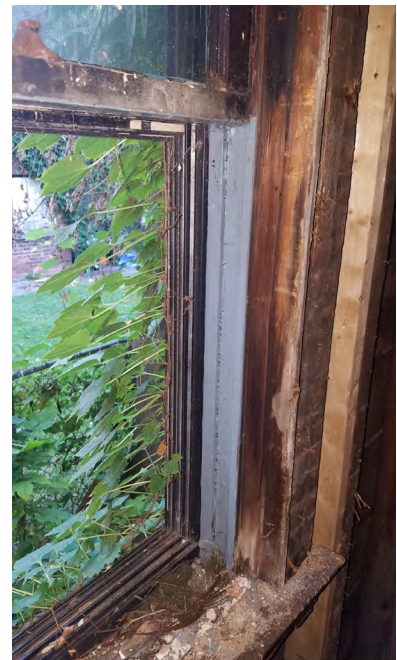
- Missing lower sash (left and right windows)
- Missing glazing (right storm window)
- Rot at sill, head framing
- Center mullion will be retained and repaired as required. Proposal is to replace each double hung unit individually.

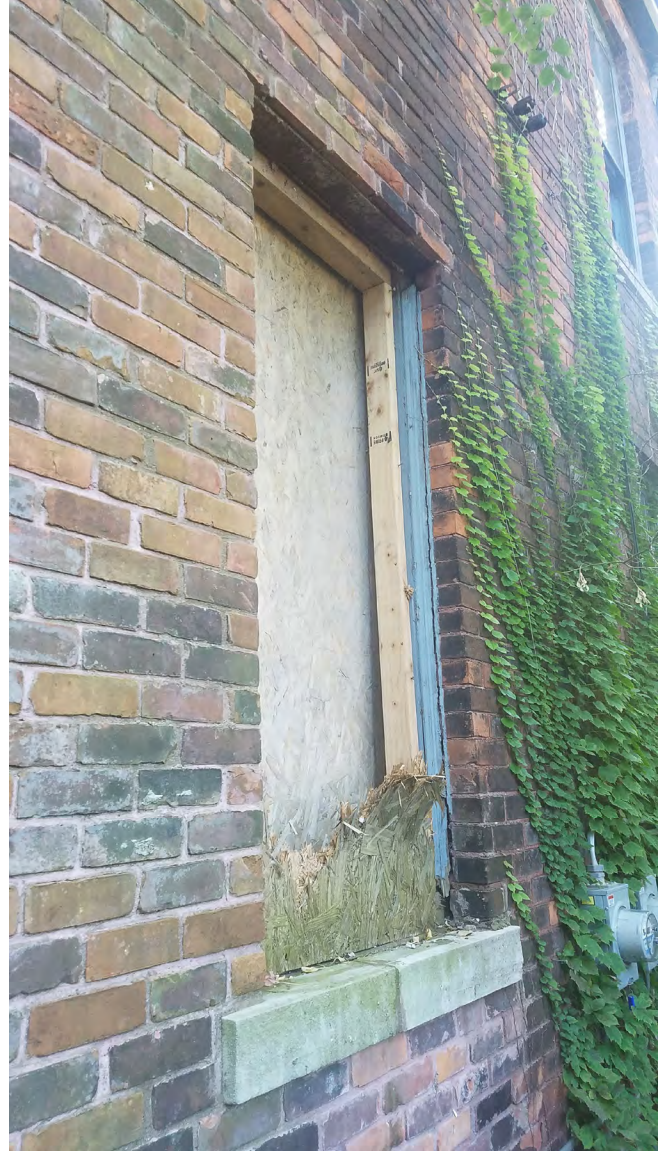
W1-09 (West Unit, North Elevation)

- Missing entire window unit
- Existing sill height will be raised to match adjacent windows, W1-07,08.
- Existing stone sill will be salvaged and reinstalled at new height.
- remaining opening will be infilled with brick to match existing.

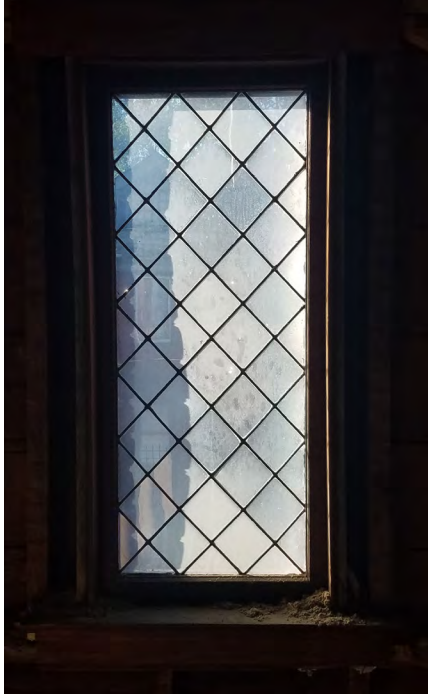
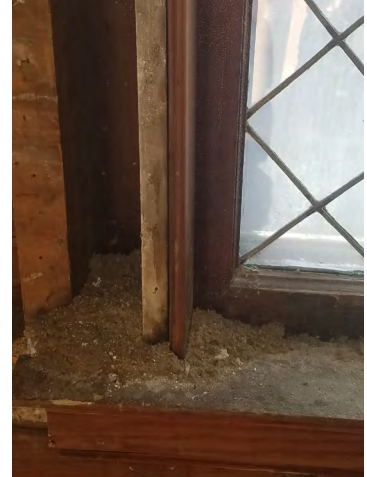
W2-01 (West Unit, South Elevation)

- Leaded single plane glazing with diamond pattern (fixed window)
- These windows will be retained and repaired as required.

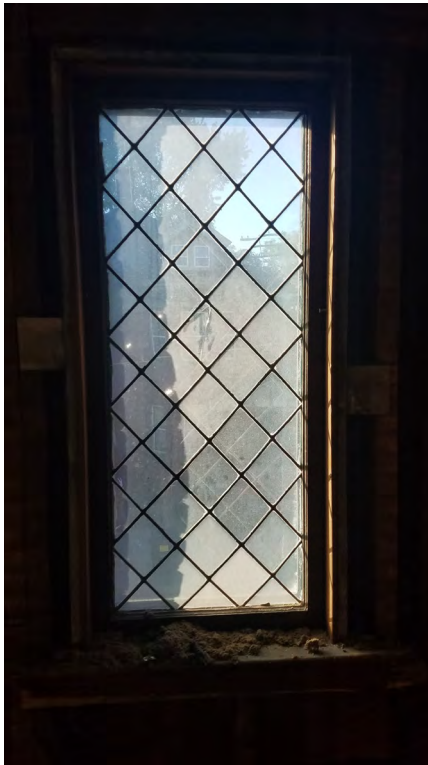
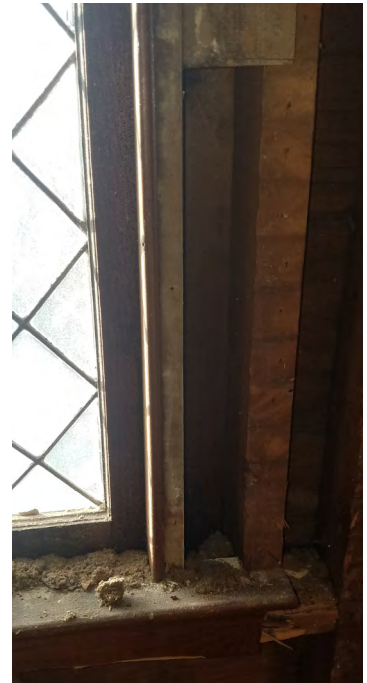
W2-02 (South Unit, South Elevation)

- Leaded single plane glazing with diamond pattern (fixed window)
- These windows will be retained and repaired as required.

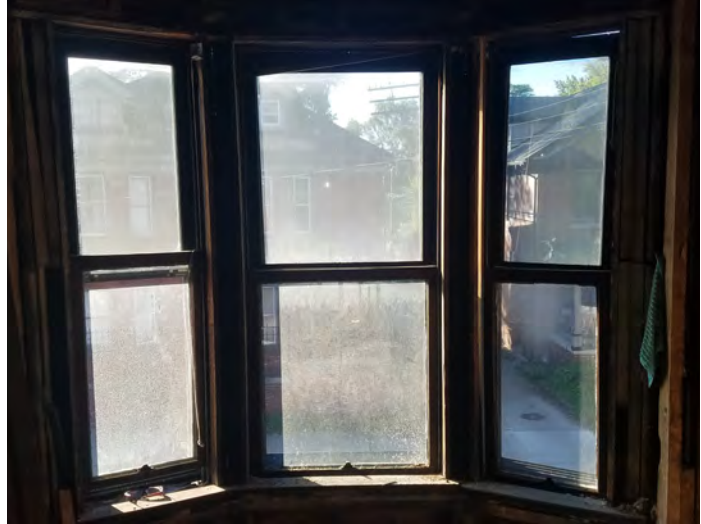
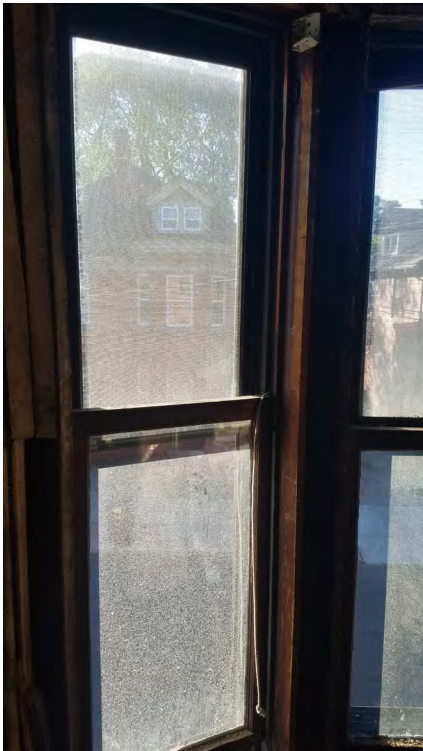
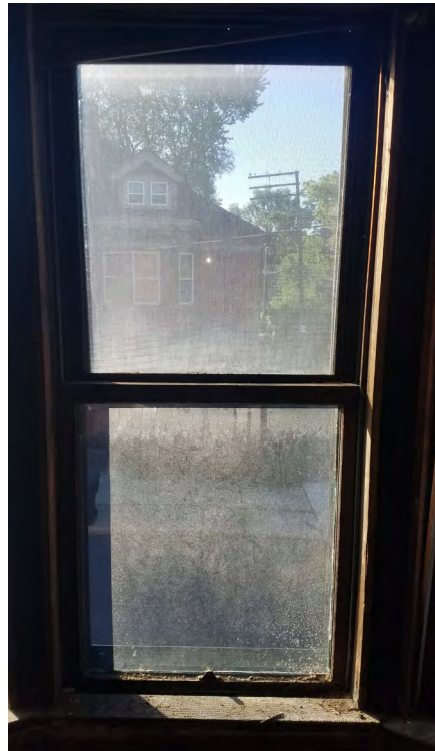
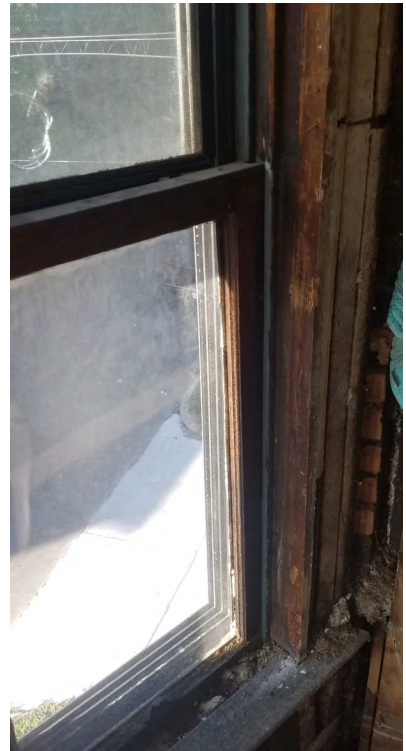
- Missing lower sash (all windows)
- Storm window is pulling away from rotted frame (right side)
- Missing counterweights

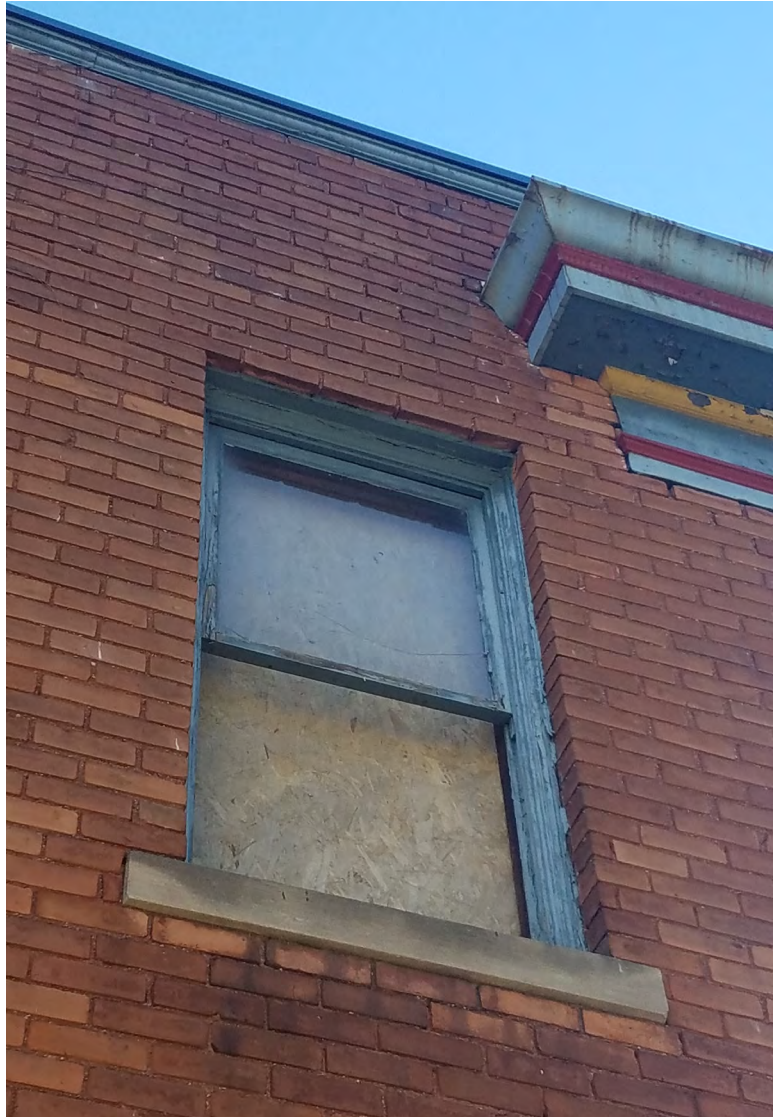
- Missing lower sash
