STAFF REPORT: OCTOBER 14, 2020 MEETING

APPLICATION NUMBER: 20-6863

ADDRESS: 7949 EAST LAFAYETTE

SCOPE OF WORK: REPLACE WINDOWS, REHAB EXTERIOR, REMOVE EXTERIOR BASEMENT ENTRANCE ENCLOSURES

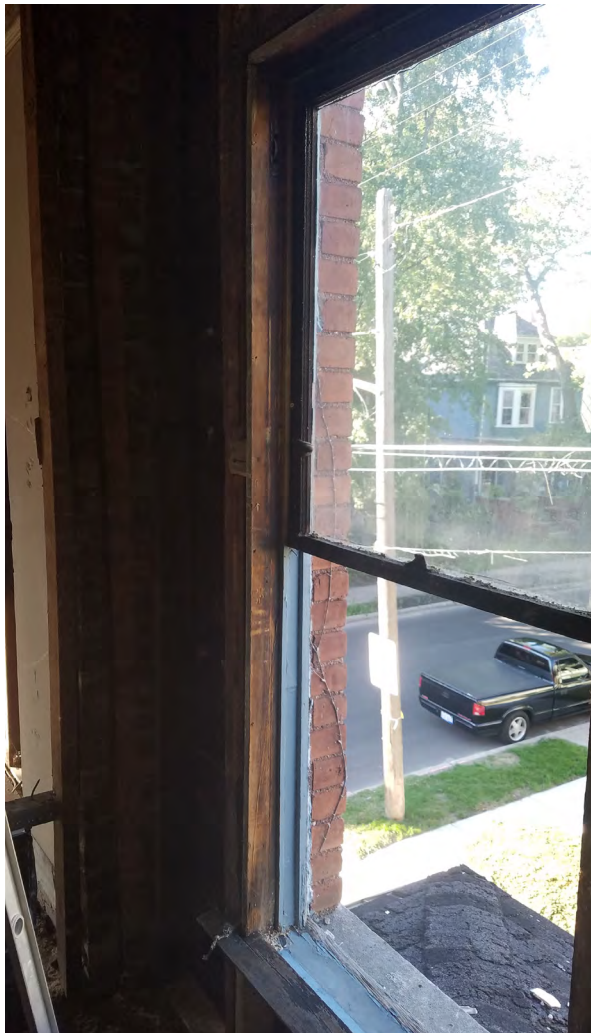
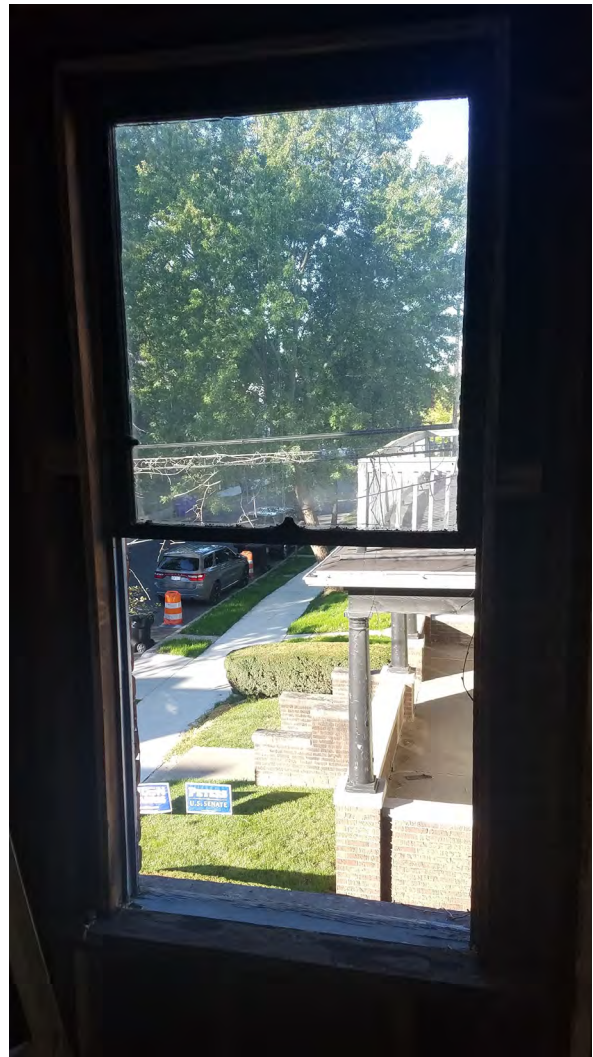
- Missing entire window
- Missing lower sash of storm window

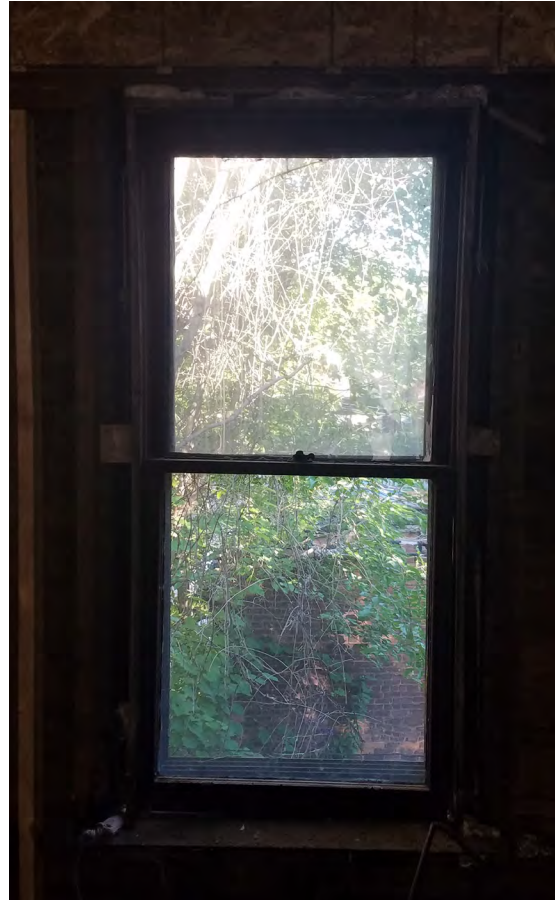
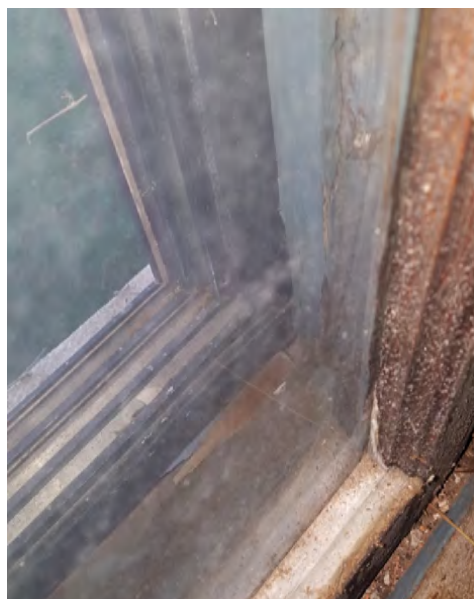
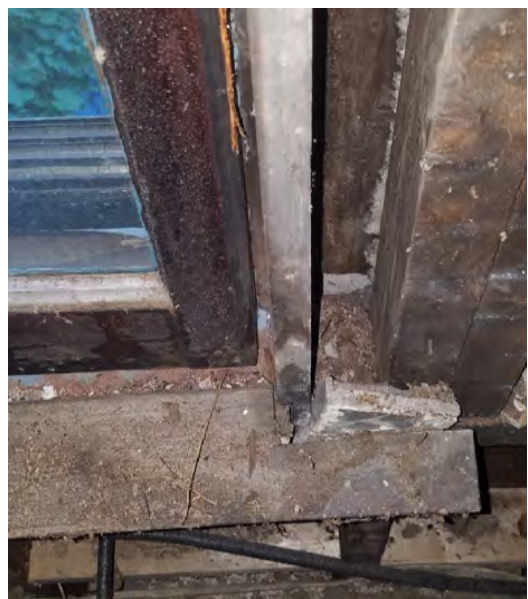
- Missing upper sash
- Damage at sill

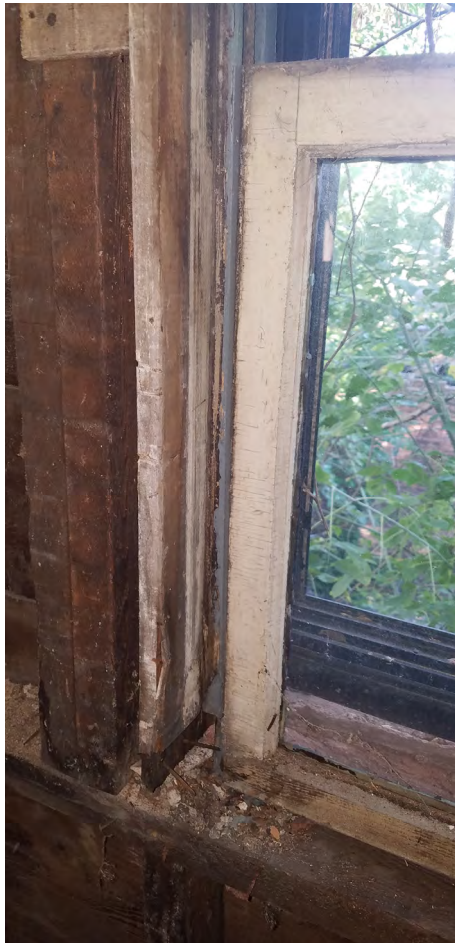
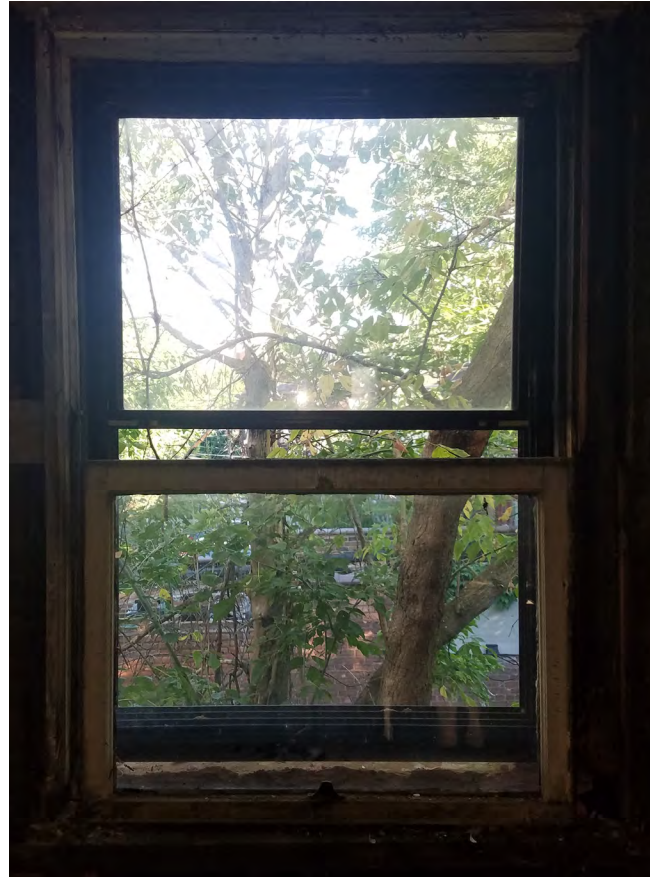
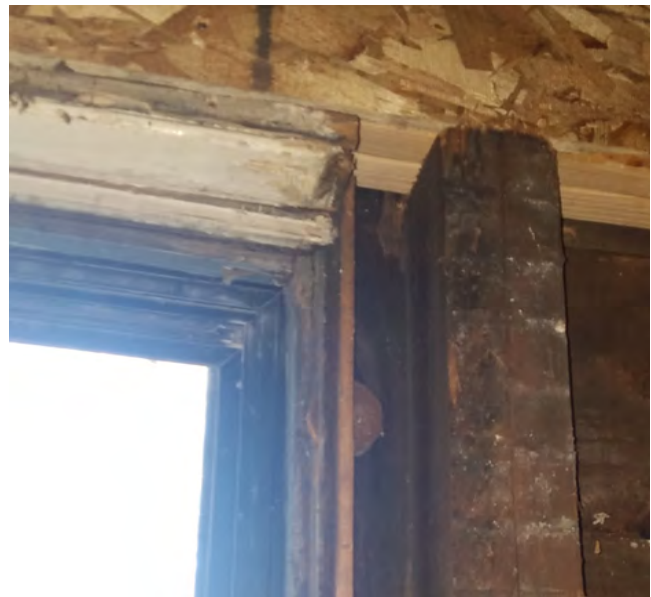
- Missing lower sash
- Missing lower sash of storm window
- Rot observed at bottom of upper sill
- Missing right jamb frame
-

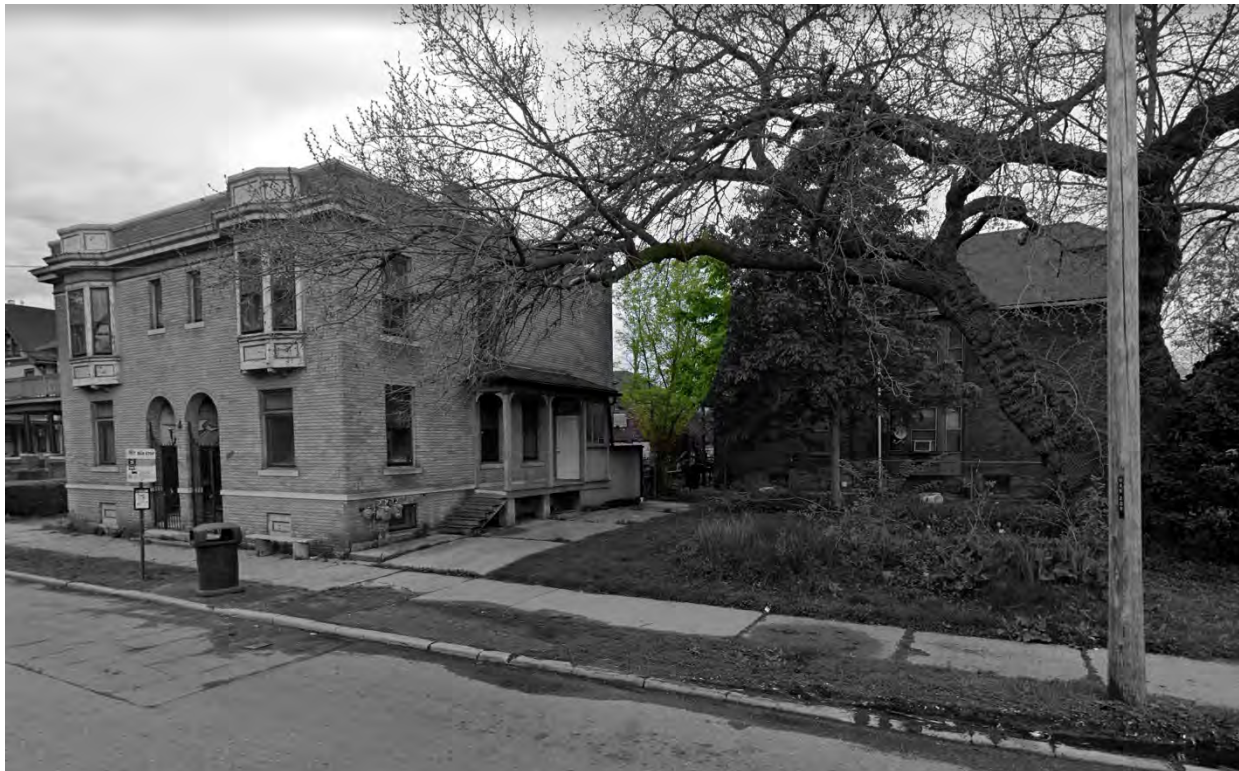
Tree at Northeast Corner of Building (view from South)

- a. Remove (3) trees along the rear property line.
 - Two trees are located at the Northeast and Northwest corners of the building, close to the foundations, between the building and the north property line. Since the building sits so close to the rear property line, these trees inhibit access to the rear of the building and to the exterior stairwells that provide access to the basement.
 - A third tree is a small Ohio Buckeye tree to the East of the building. This tree is behind, and dwarfed by the large, character defining Oak tree that is planted in the center of the yard to the East of the building.
