STAFF REPORT 12-9-2020 REGULAR MEETING

APPLICATION NUMBER: 20-6968

ADDRESS: 691 W. ALEXANDRINE STREET

SCOPE: REHABILITATE EXISTING BUILDING; ERECT NEW BUILDING

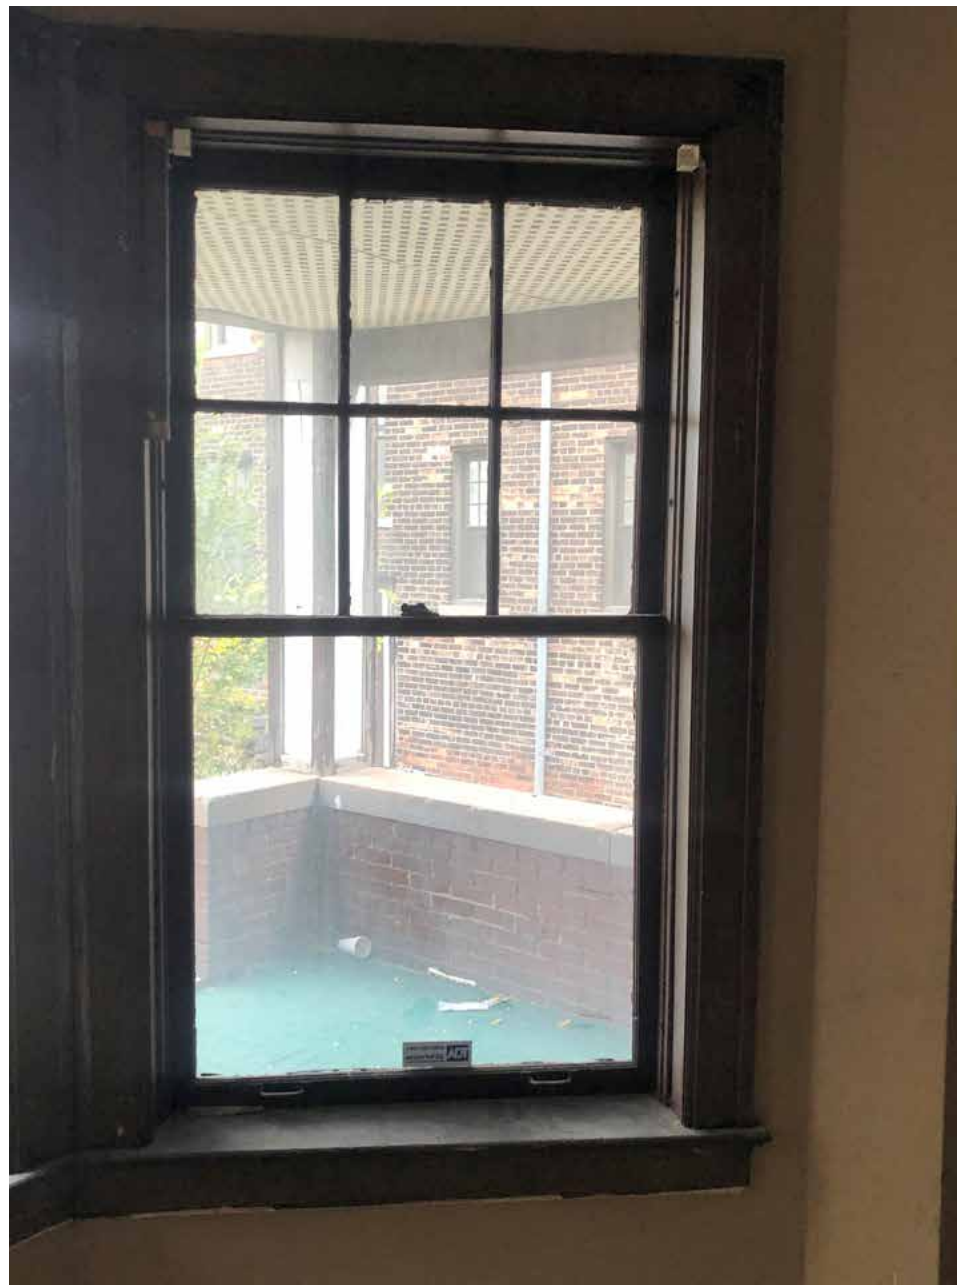
F-1

- WINDOW IS SEALED SHOUT
- EXTERIOR WINDOWSILL HAS SOME ROT
- ONE OF THE LEAD WEIGHTS IS MISSING
- WINDOW IS COCKED IN OPENING
- WINDOW WILL NOT LOCK
- WINDOW NEEDS TO BE RE-PUTTED
- WEATHER STRIPPING MISSING

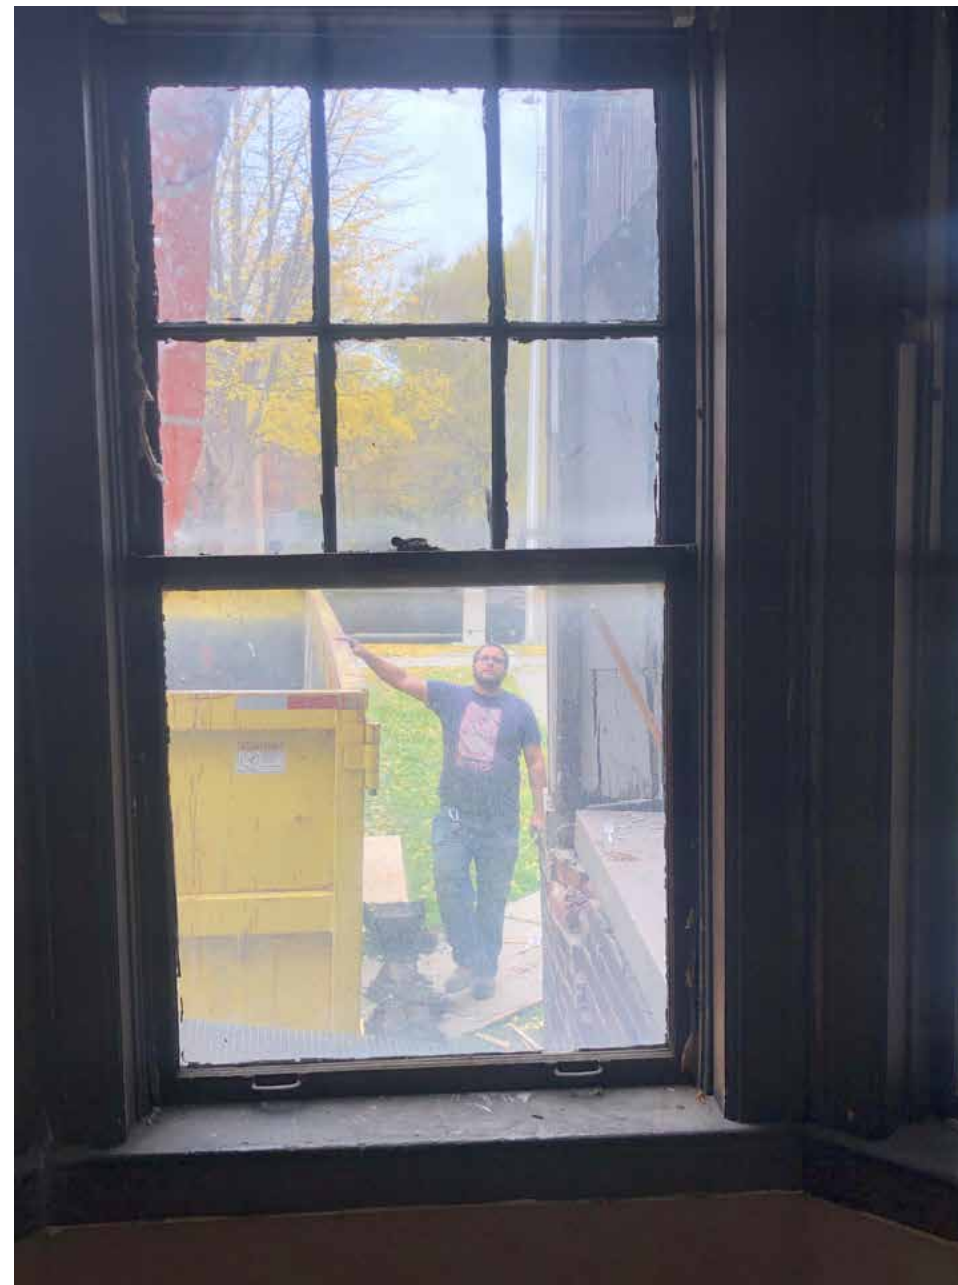
F-2

- WINDOW OPENS BUT THE LEAD COUNTERWEIGHTS ARE MISSING
- INTERIOR SILL IS ROTTEN
- ONE STOP IS MISSING, AND THE OTHER STOP IS MISSING ALL BUT ONE OF THE SCREWS
- WINDOW NEEDS TO BE RE-PUTTED
- WEATHER STRIPPING MISSING
- JAMB ON RIGHT SIDE HAS ROT

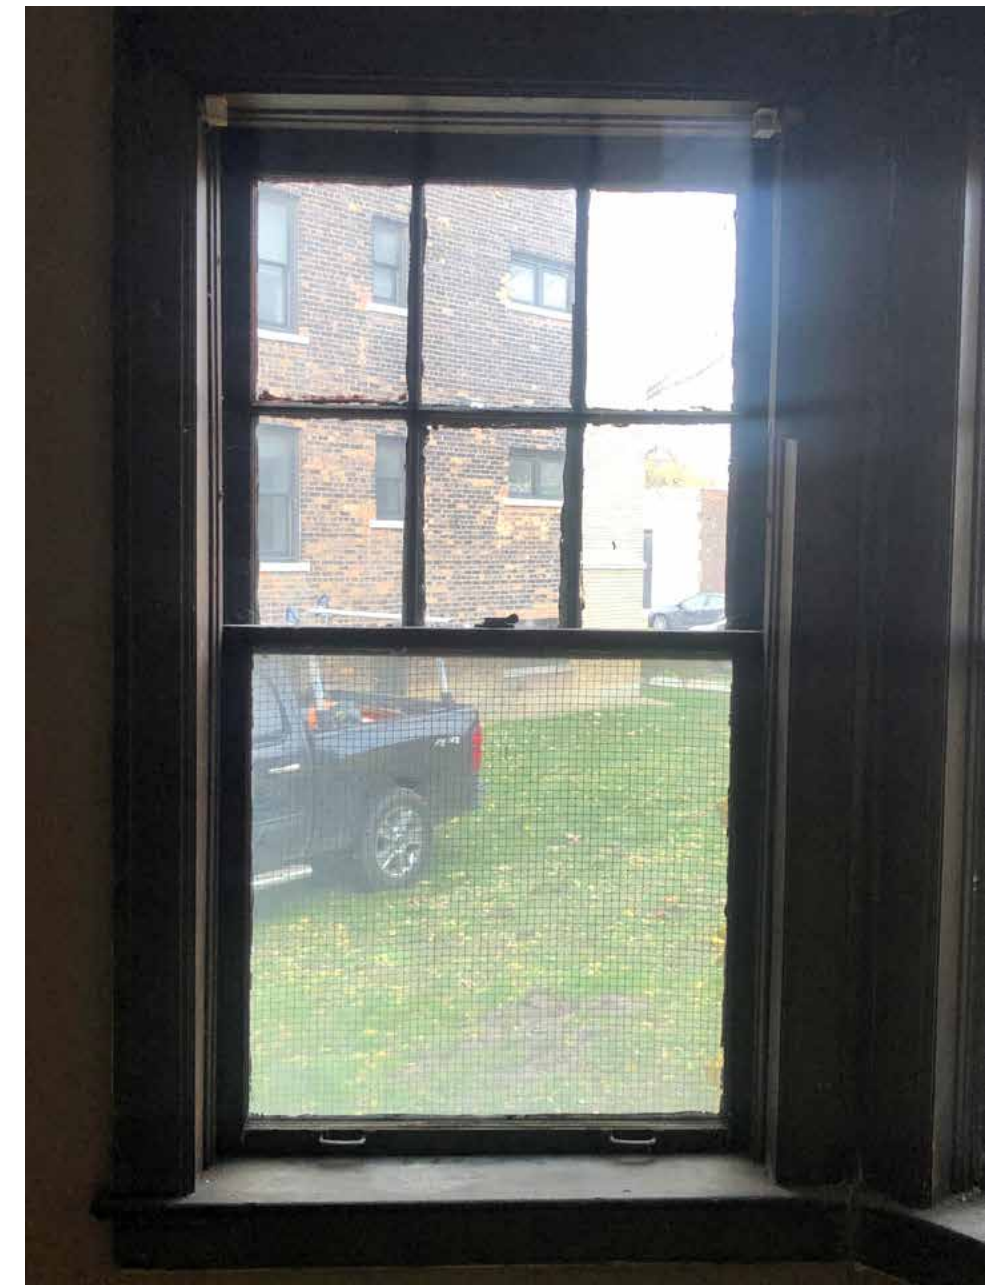
F-3

- WINDOW IS SEALED SHOUT
- EXTERIOR WINDOWSILL AND JAMB HAVE SOME ROT
- GLASS IS BROKEN IN BOTTOM SASH
- BOTH LEAD WEIGHTS ARE MISSING
- BOTTOM SASH HAS ROT RIGHT SIDE
- TRIM AT BOTTOM OF WINDOW HAS ROT
- WEATHER STRIPPING MISSING
- WINDOW NEEDS TO BE RE-PUTTED

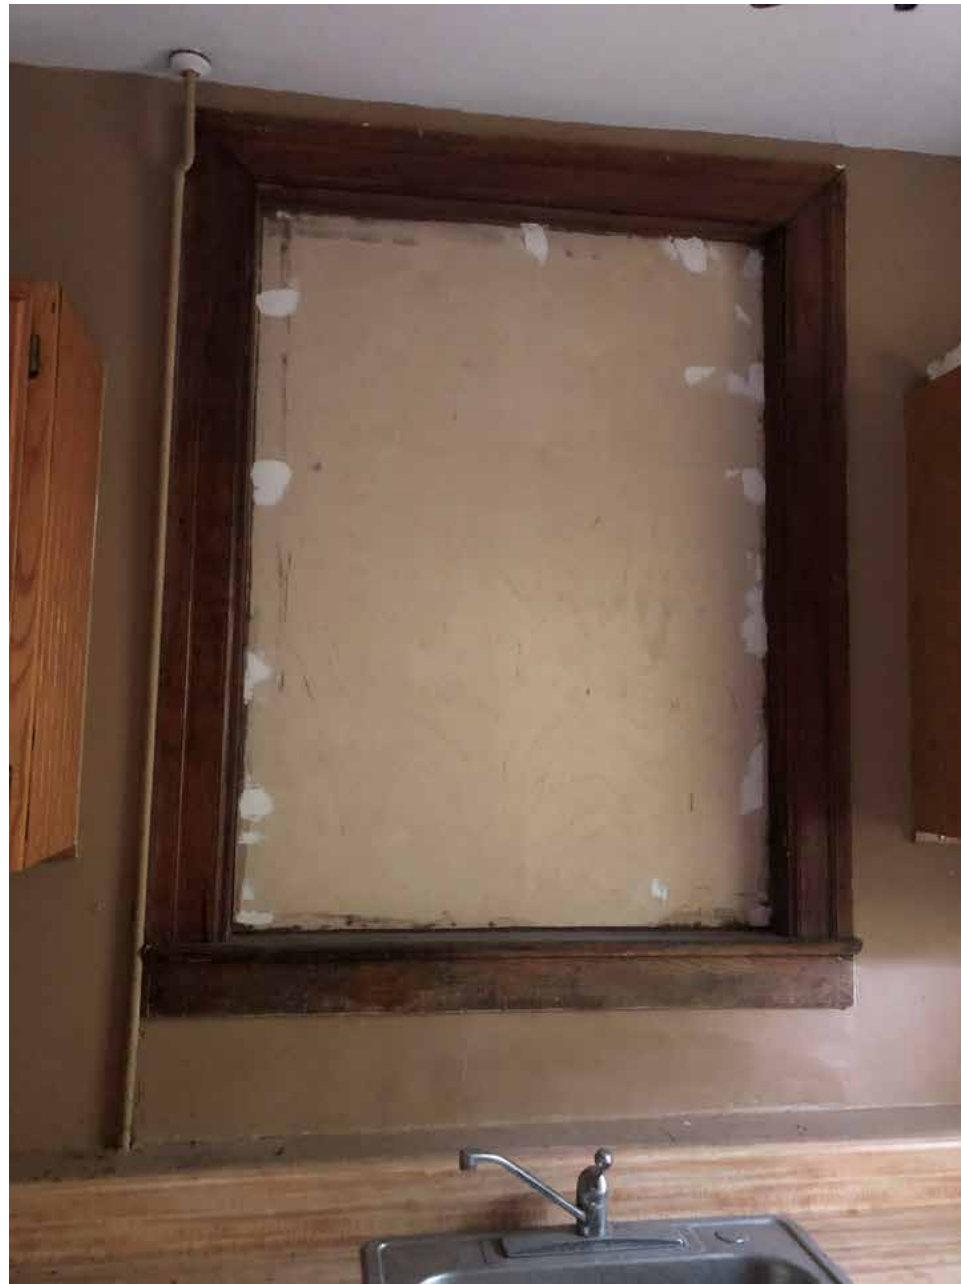
- SASHES' AND STOPE HAVE BEEN REMOVED AND THE WINDOW IS BOARDED UP INSIDE AND ON THE OUTSIDE.

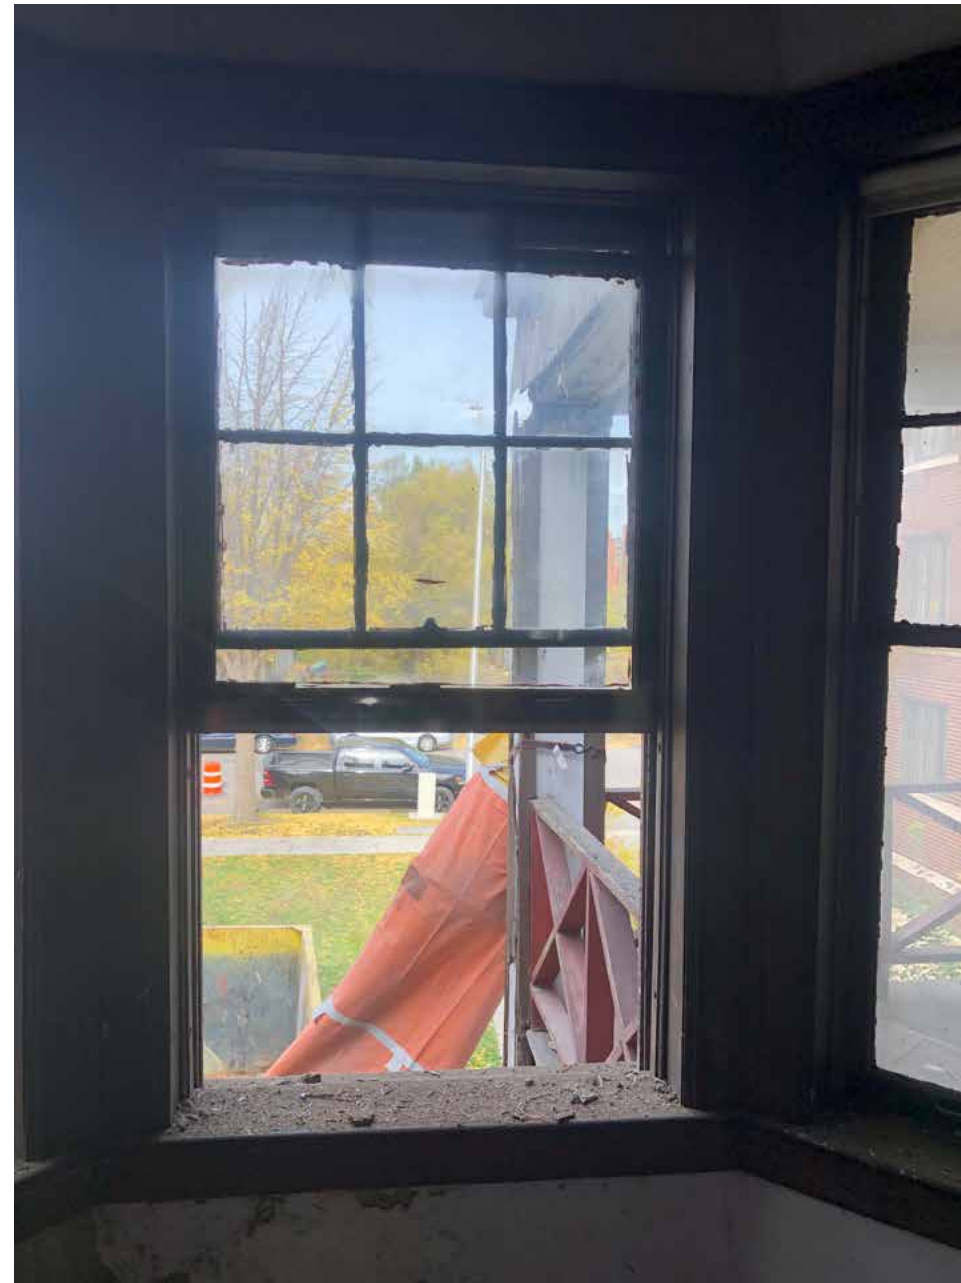
- WINDOW WILL OPEN
- LEAD WEIGHTS ARE IN PLACE, BUT CORDS NEED REPLACING
- BOTTOM SASH HAS SOME ROT
- STOPES ARE MISSING SCREWS
- SASHES WILL NOT LINE UP OR LOCK
- WEATHER STRIPPING MISSING
- WINDOW NEEDS TO BE RE-PUTTED
- INTERIOR SILL IS ROTTEN AND LOOSE
- BRICK MOLDING ON RIGHT SIDE HAVE SOME ROT

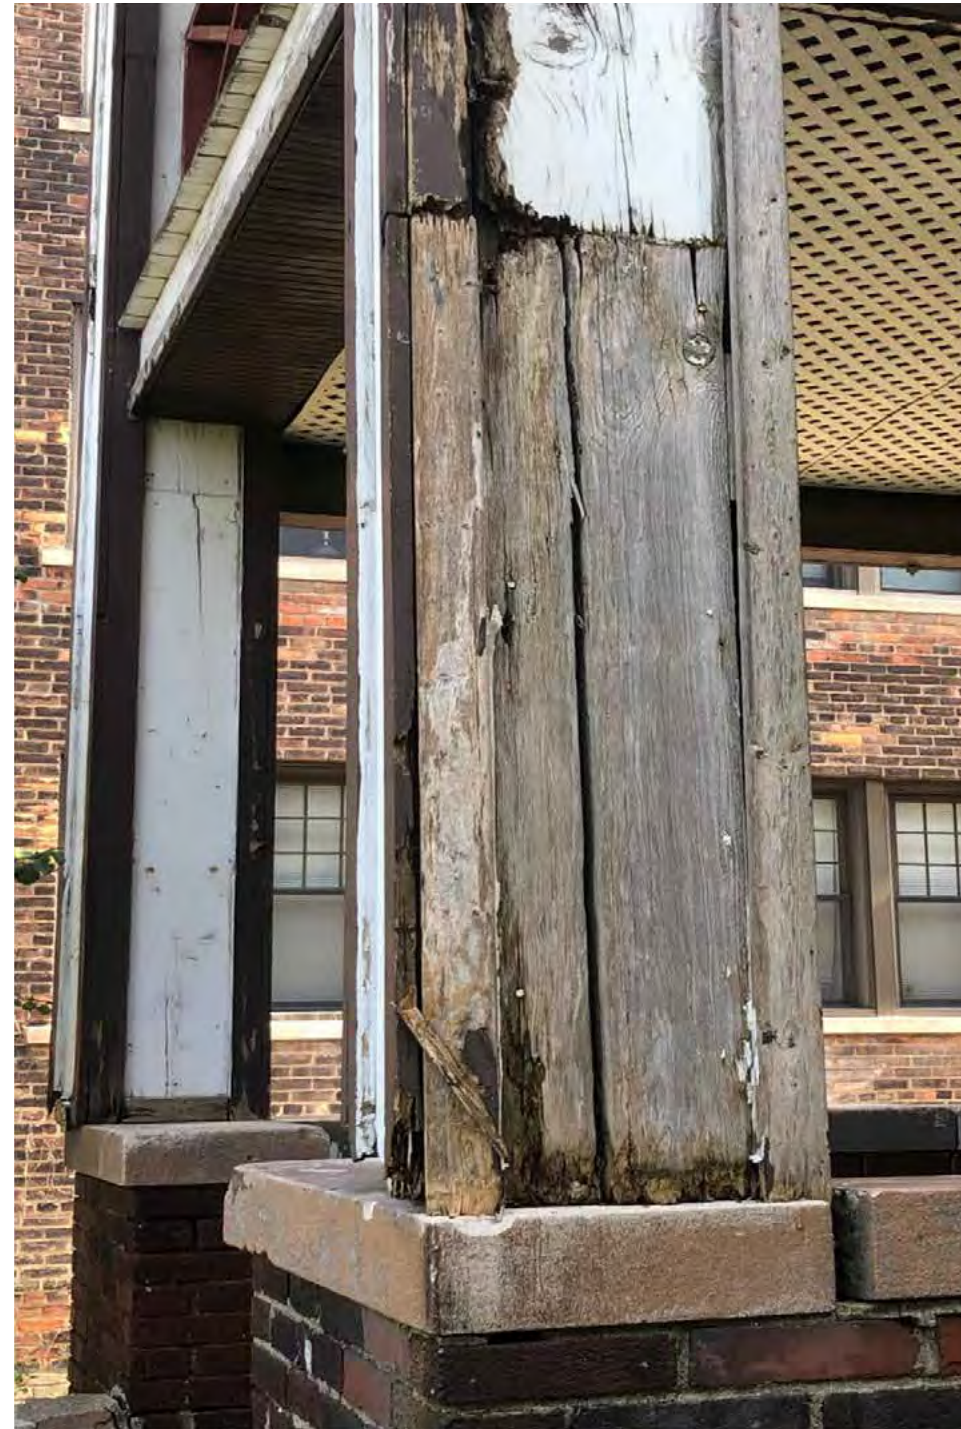
- BOARDS HAVE BEEN REPLACED
- COLUMNS HAVE SEVERE ROT AND DECAY
- SUPPORT FOR THE UPPER PORCH IS IN RISK

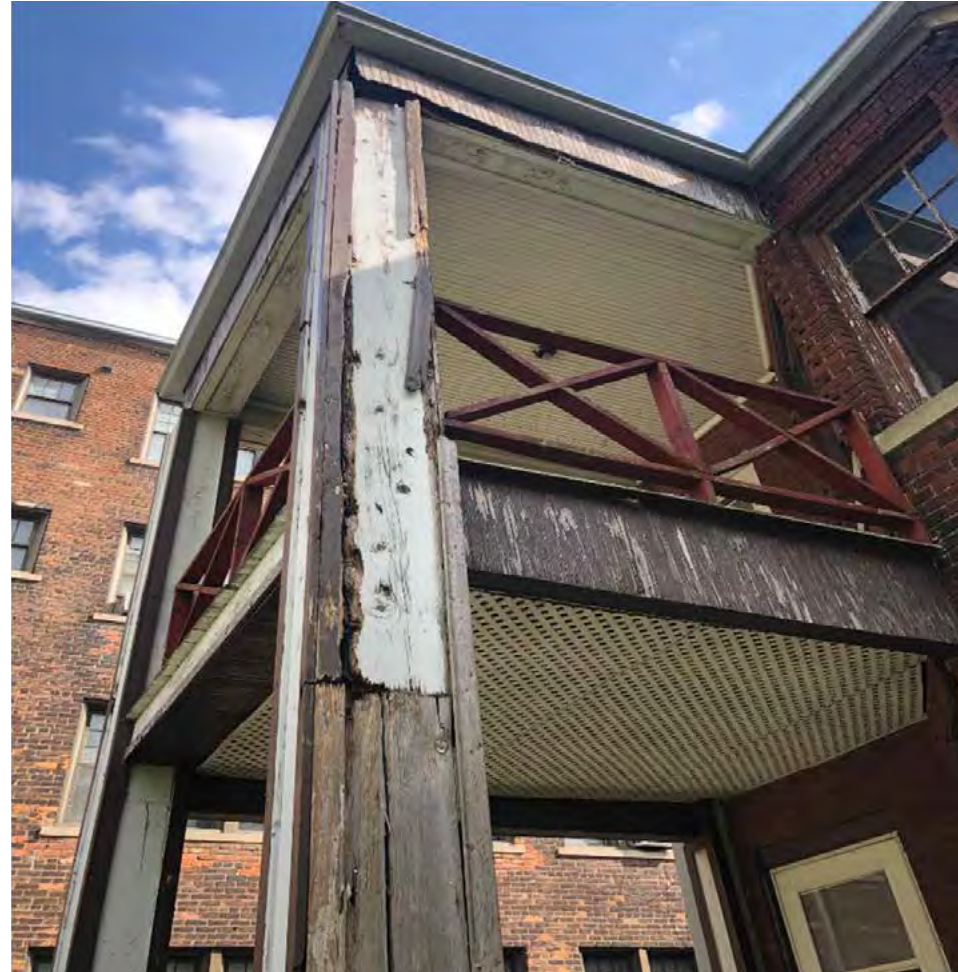
- UPPER PORCH HAS SOME ROT IN THE SUPPORTS
- THE FLOORING HAS A LOT OF ROT (WOULD NOT RECOMMEND ANYONE VENTURE ONTO THE PORCH)
- THE CEILING OF THE LOWER DECK HAS BEEN REPLACED WITH VINYL LATTICE.

- UPPER PORCH CEILING IS BEADBOARD AND IN GOOD CONDITION. WOULD SUGGEST REMOVING AND REINSTALL ON REBUILT PORCH.

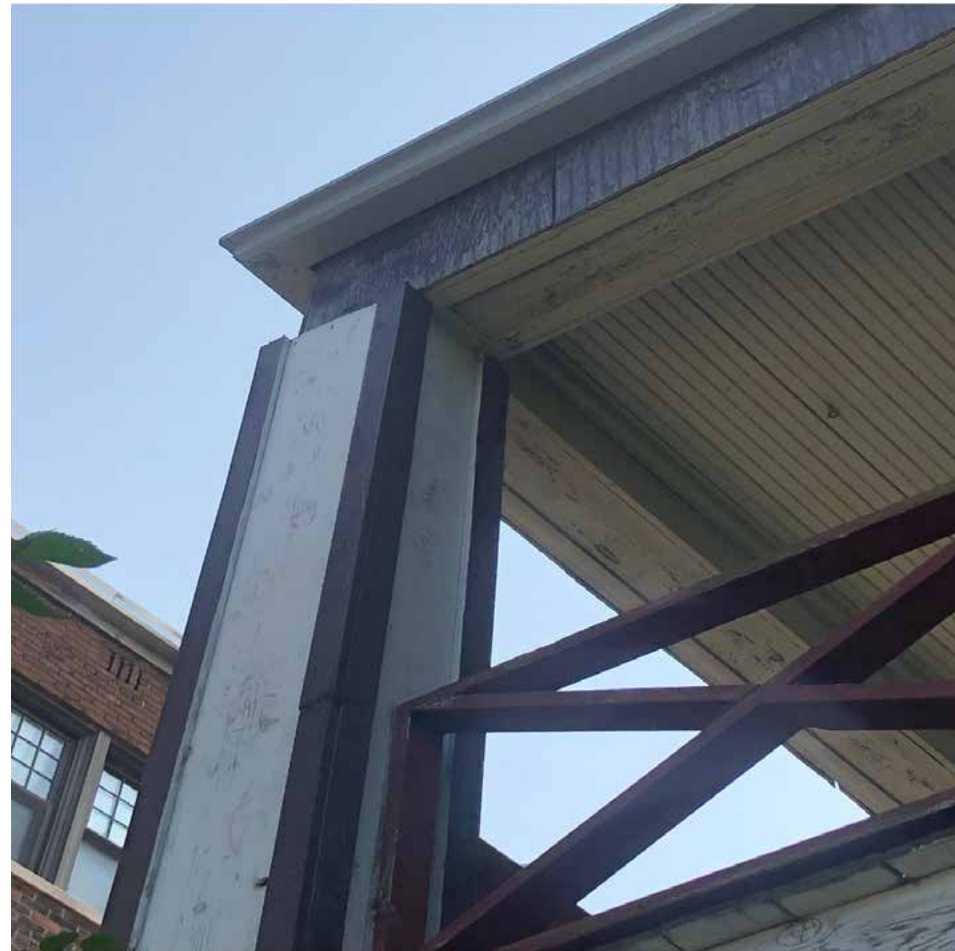
IT IS OUR OPINION THAT THE WOOD ON THE PORCH HAS SEVER ROT AND IS IN DISARRAY. THE UPPER PORCH IS DANGEROUS AND SHOULD NOT BE USE. THE WOOD ON THE PORCH NEEDS TO BE DISASSEMBLED WHILE SUPPORTING THE ROOF. THE PORCH TO BE REBUILT USING NEW WOOD AND SUPPORT COLUMNS. TRIM BOARD TO BE INSTALLED TO MATCH EXISTING AND PAINTED TO REDUCE THE CHANCE OF ROT.

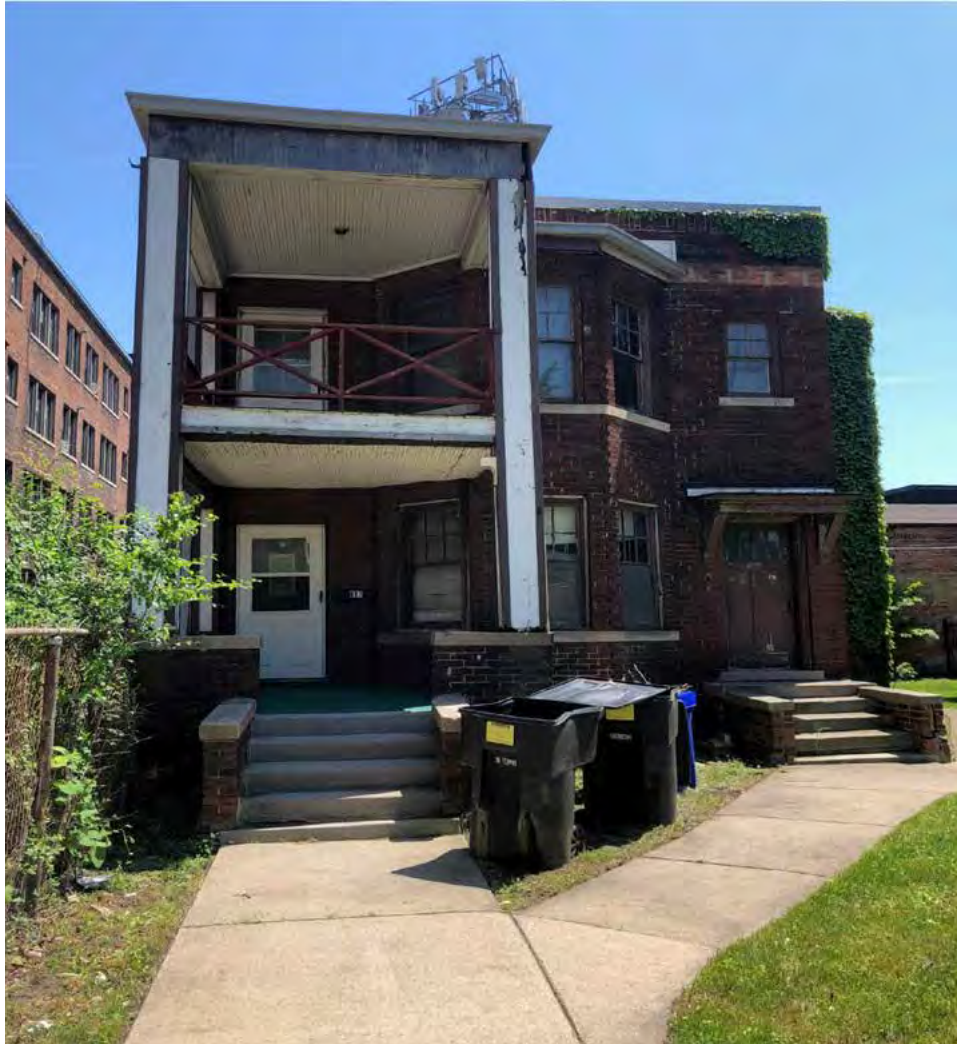
- STEPS HAVE PULLED AWAY FROM THE PORCH AND WAS IMPROPERLY FILLED
- WALL HAS PULLED AWAY FROM THE PORCH AND WAS IMPROPERLY FILLED
- STEPS ARE NOT TO CODE OR ADA COMPLIANCE.
- THERE ARE GAPS BETWEEN THE STEPS AND HAVE BEEN FILLED

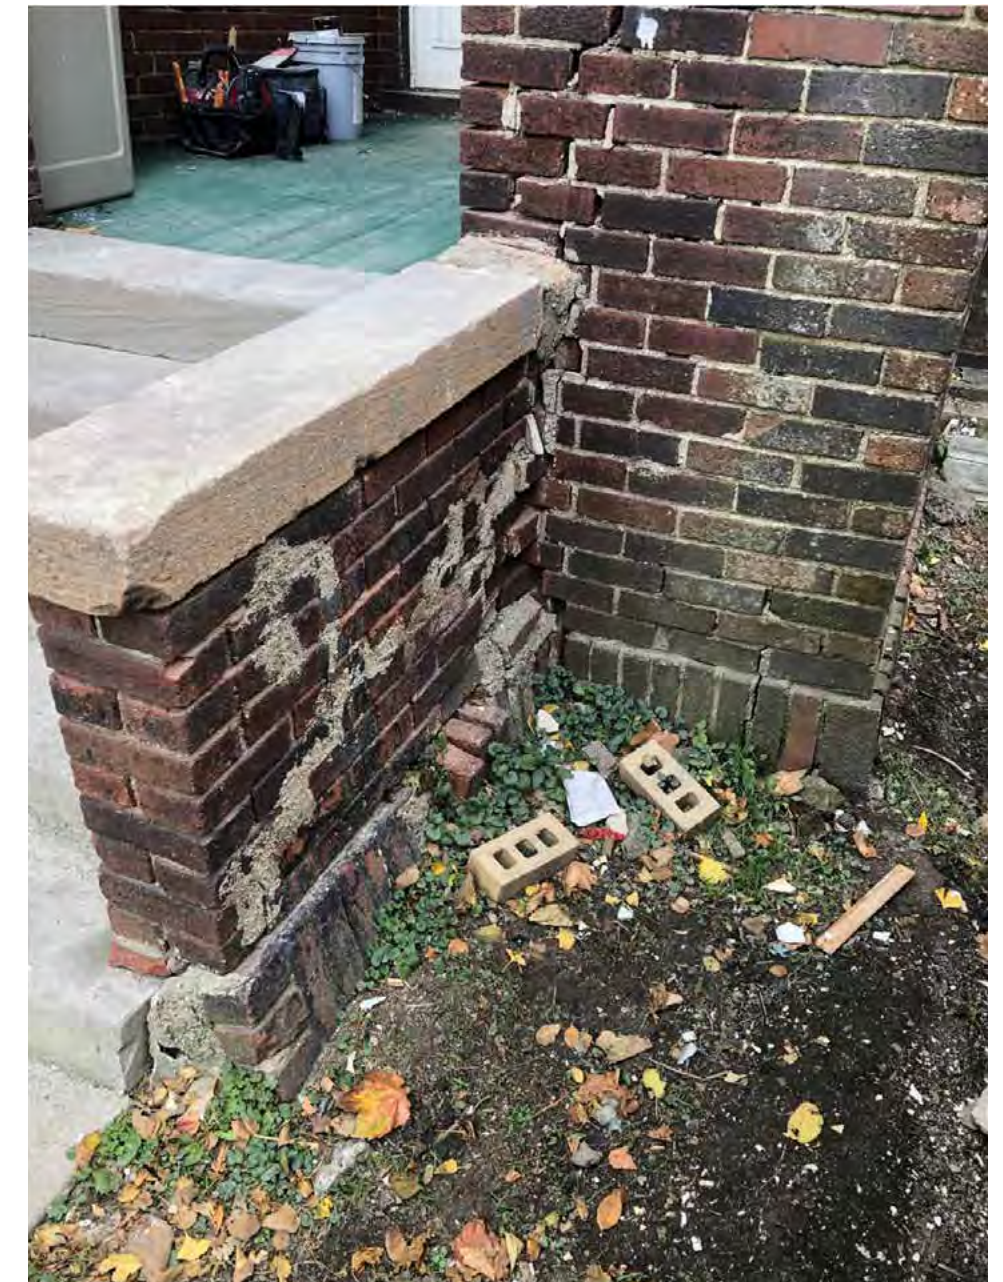
- WALL IS 2 LAYERS OF BRICK
- WALL HAS PULLED AWAY FROM THE PORCH AND WAS IMPROPERLY FILLED
- WALL IS FALLING APART. WILL NEED TO BE TORN DOWN AND REBUILT TO MAKE RIGHT.
- THE GAPS IN THE BRICK HAVE BEEN IMPROPERLY FILLED AND LOOK BAD.
- BRICKS ARE LOOSE AND FALLING OUT

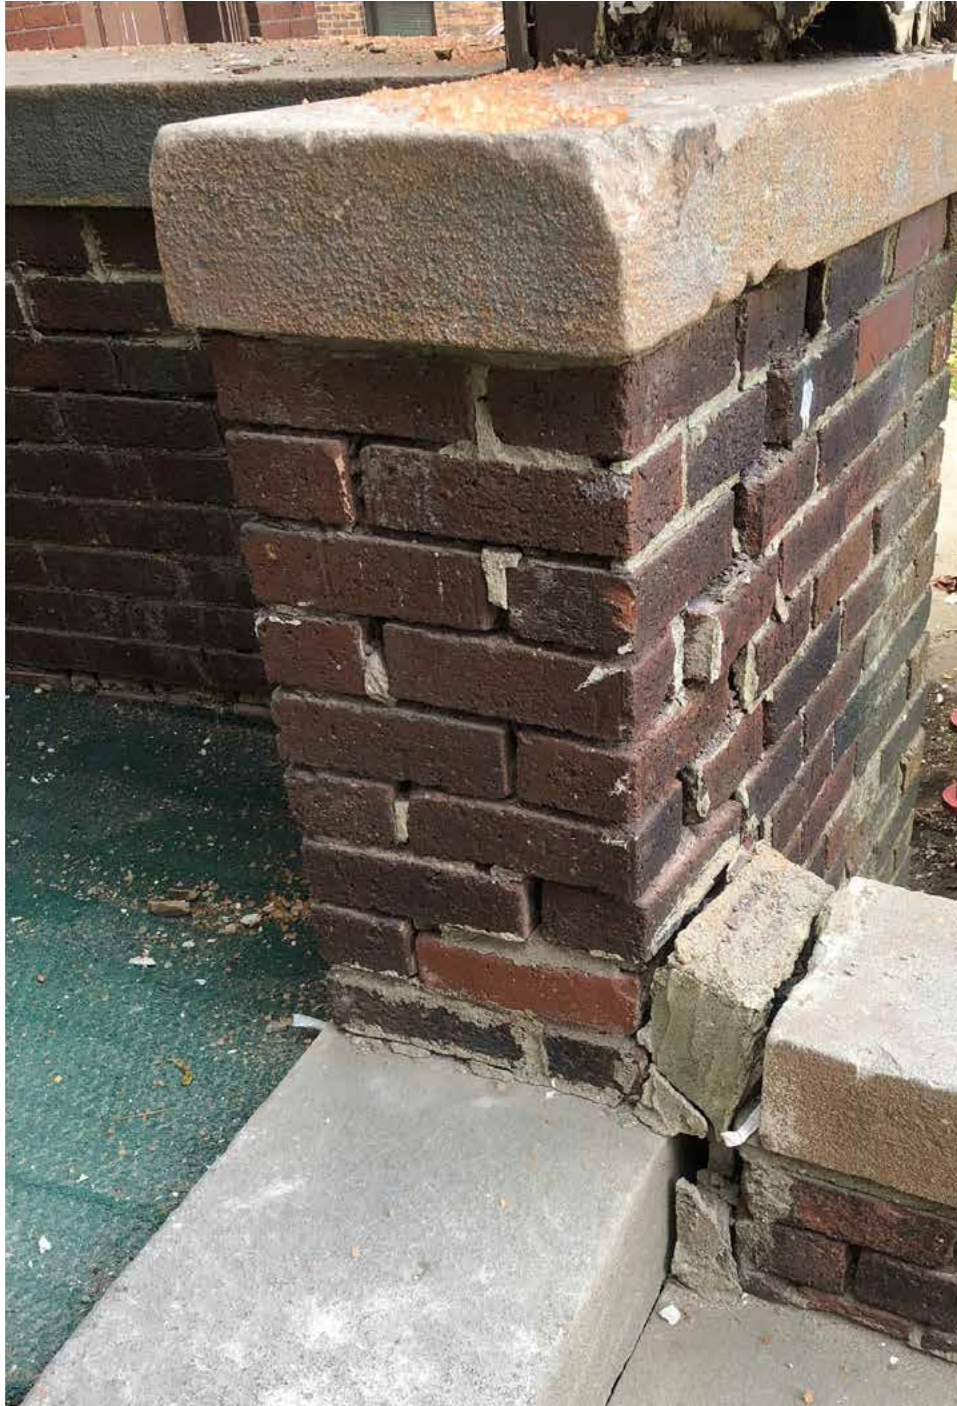
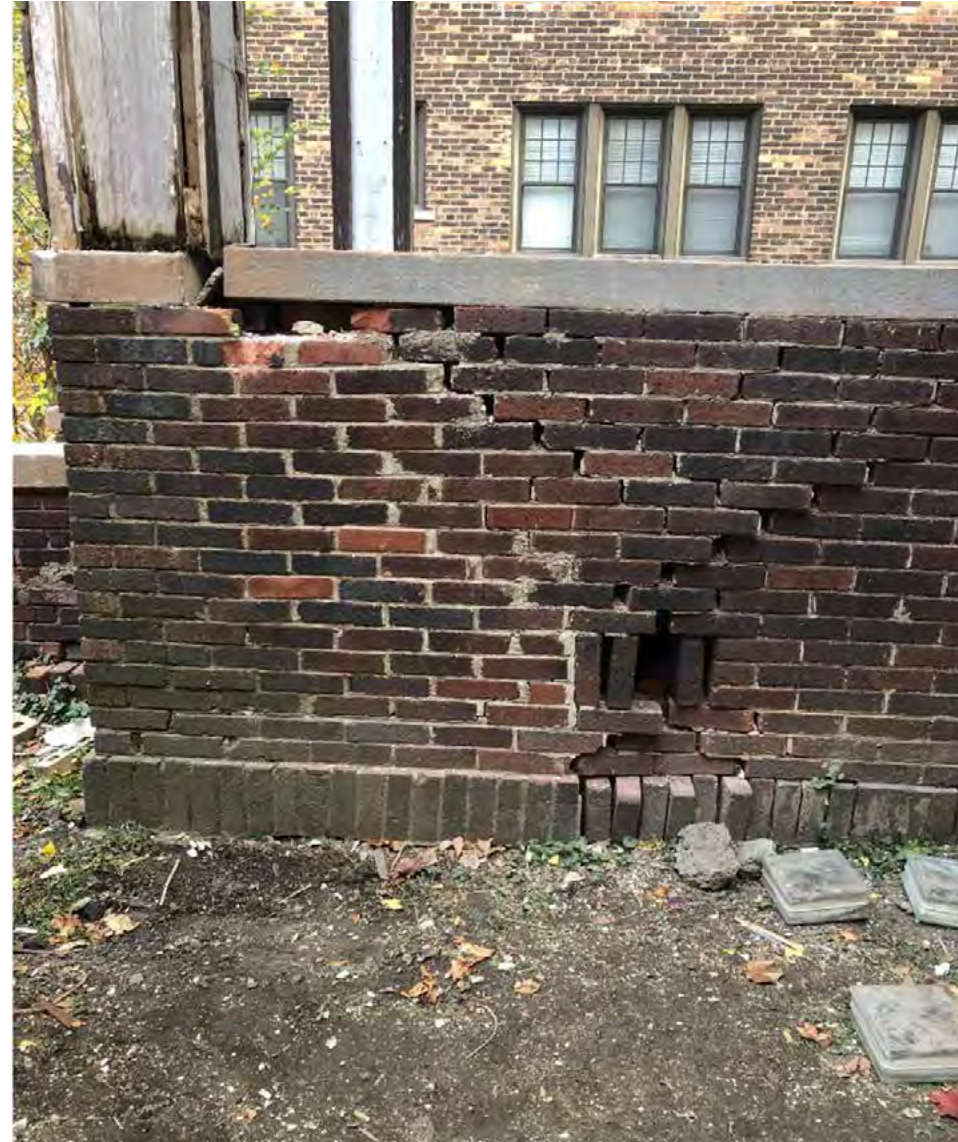
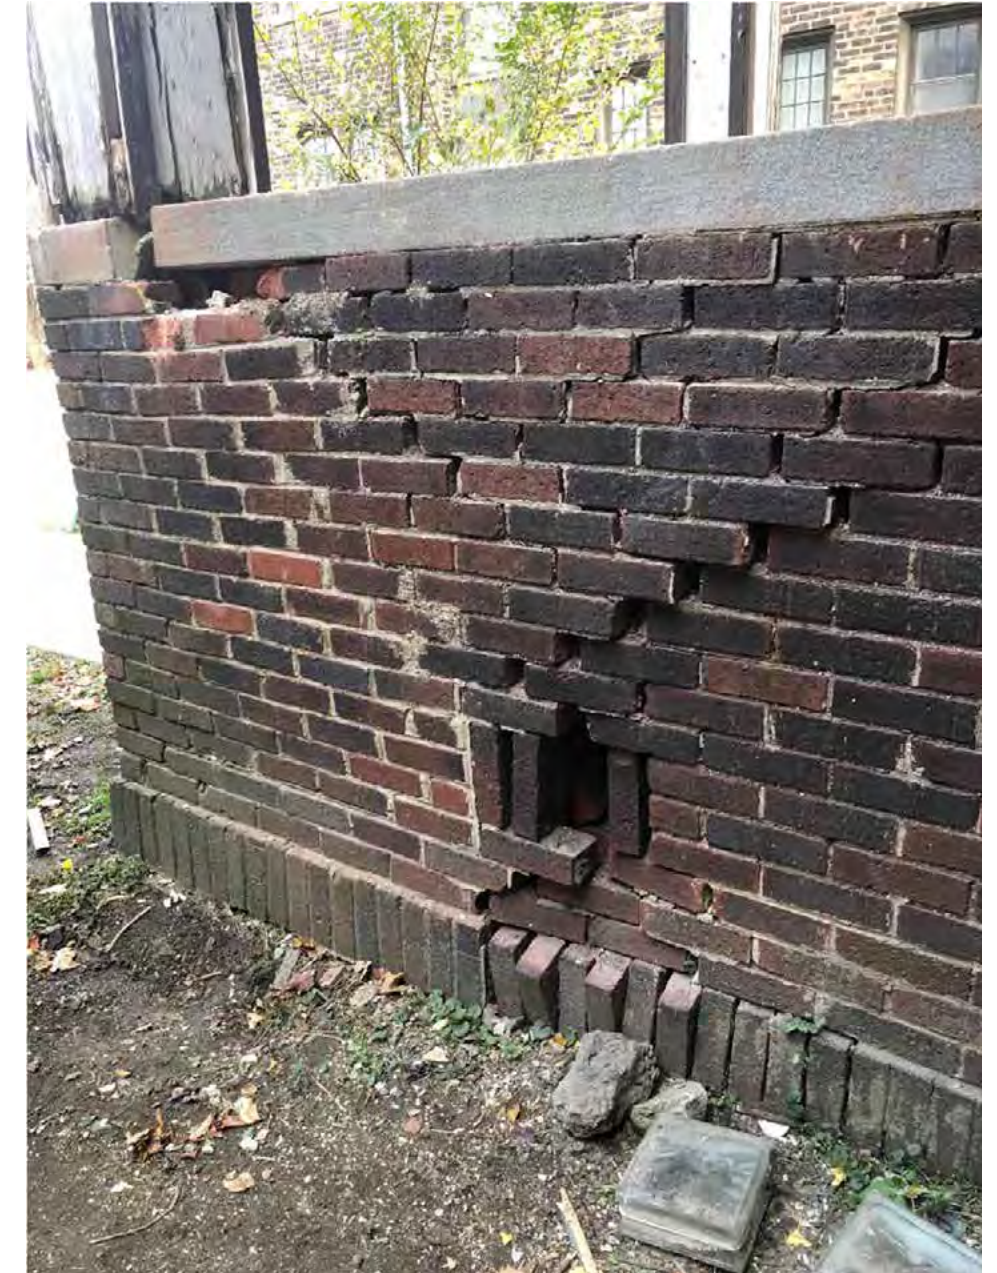
- WALL IS 4 LAYERS OF BRICKS
- THE GAPS IN THE BRICK HAVE BEEN IMPROPERLY FILLED AND LOOK BAD.
- BRICKS ARE LOOSE AND FALLING OUT
- WALL IS FALLING APART. WILL NEED TO BE TORN DOWN AND REBUILT TO MAKE RIGHT.
- SOME BRICKS HAVE BEEN REPLACED WITH NON-MATCHING BRICKS.

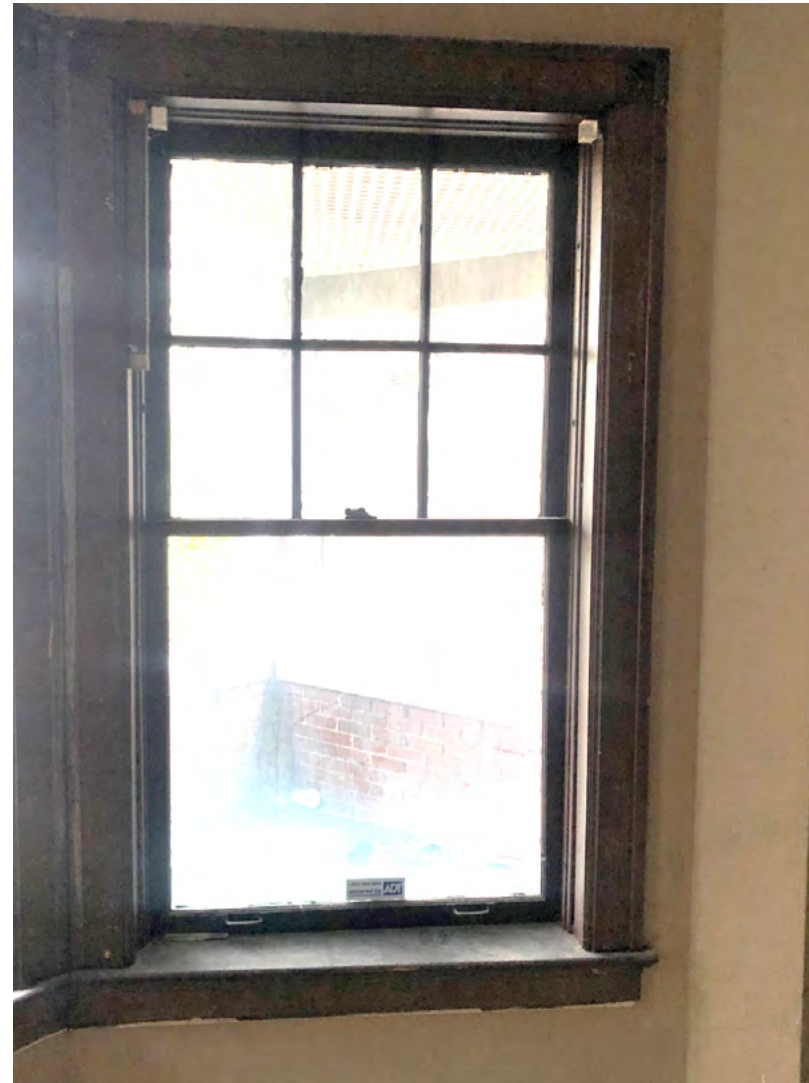
- Window is sealed shut
- Exterior windowsill has some rot
- One of the lead weights is missing
- Window is cocked in opening
- Window will not lock
- Window needs to be re-putted
- Weather stripping missing

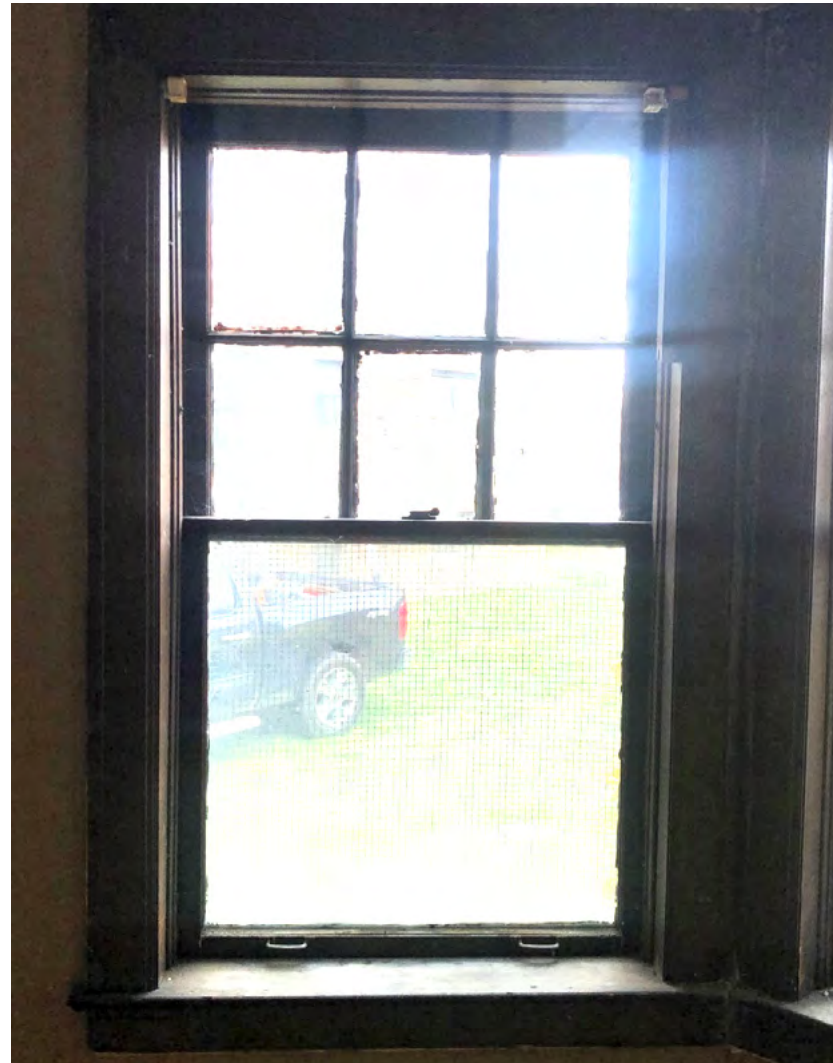
- Window is sealed shut
- Exterior windowsill and jamb have some rot
- Glass is broken in bottom sash
- Both lead weights are missing
- Bottom sash has rot right side
- Trim at bottom of window has rot
- Weather stripping missing
- Window needs to be re-putted

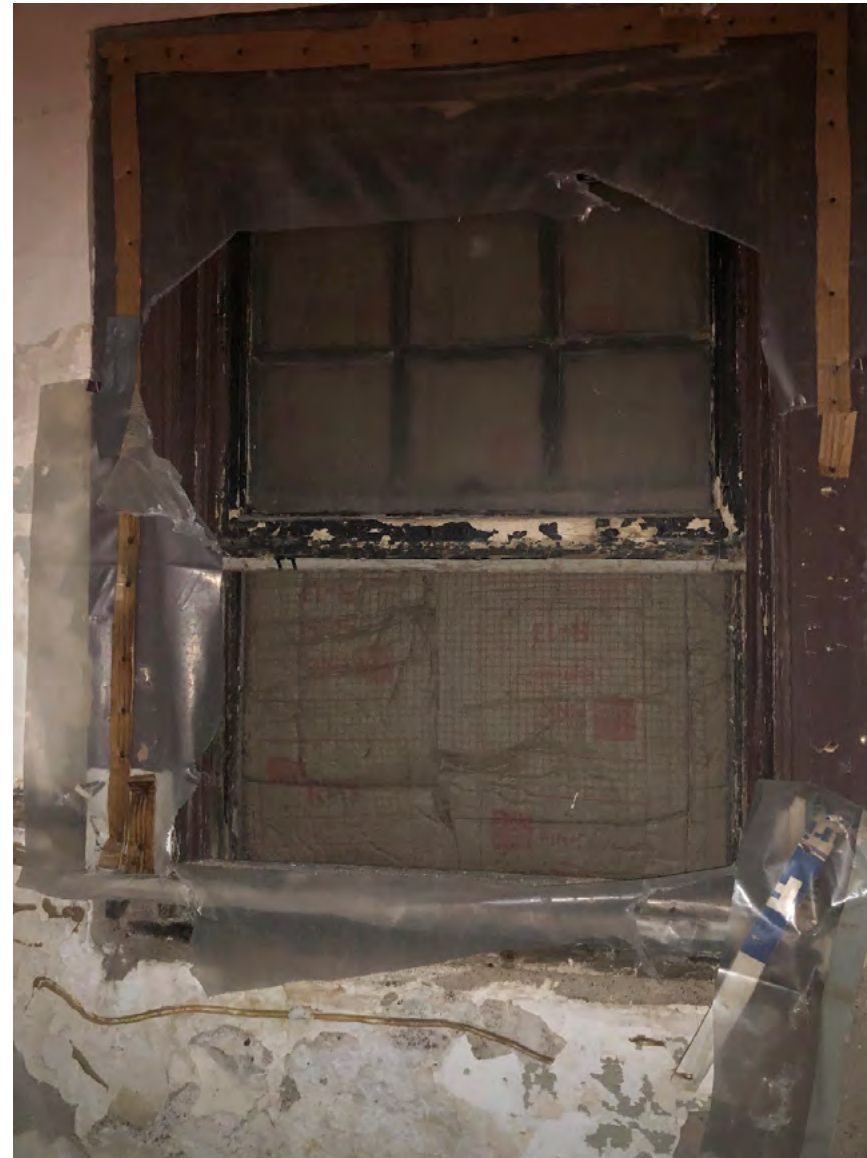
- Internal sill is missing
- Window was boarded up on the outside
- Bottom sash missing
- Stops are broken on both sides
- Sever rot on jambs

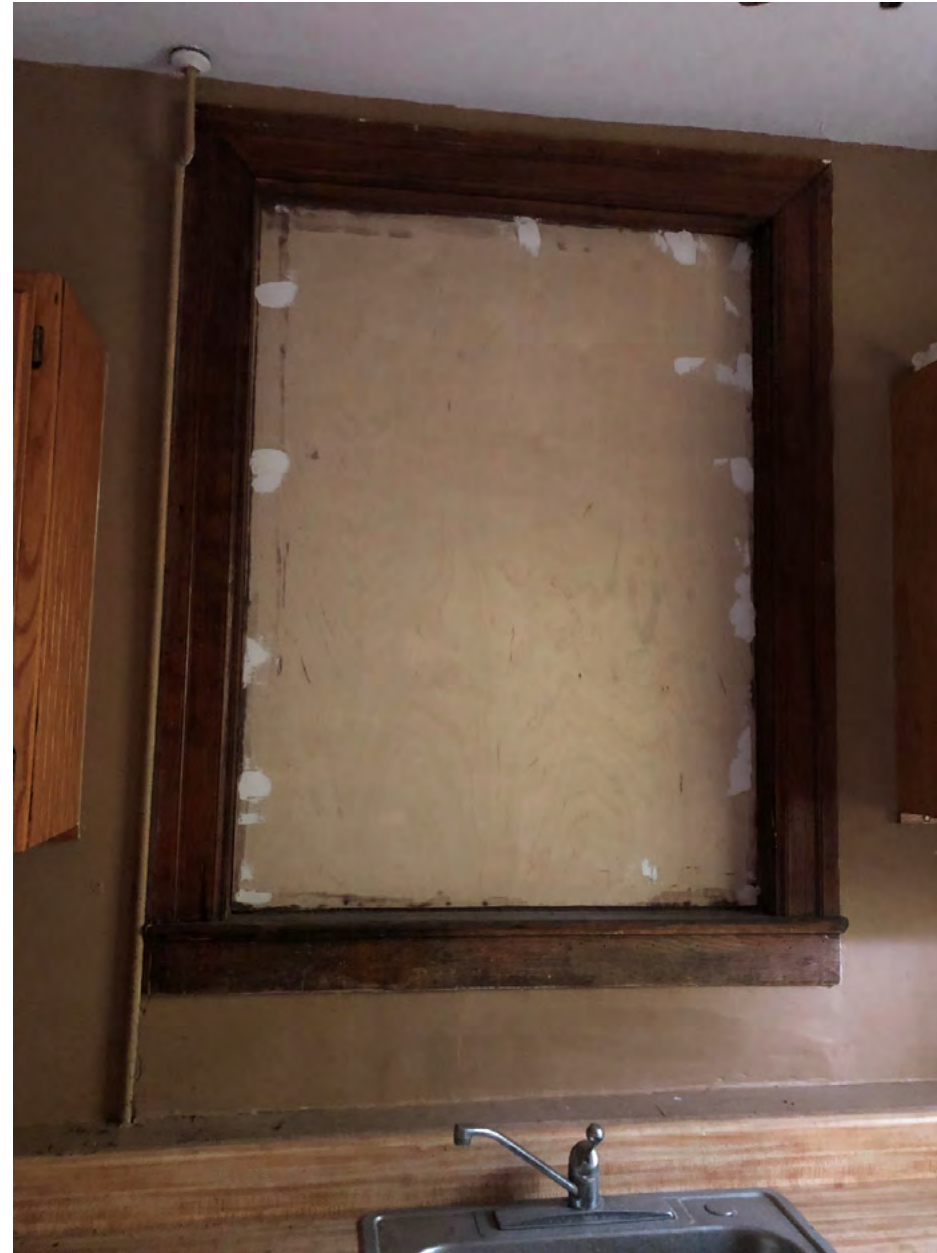
- Sashes' and stop have been removed and the window is boarded up inside and on the outside.

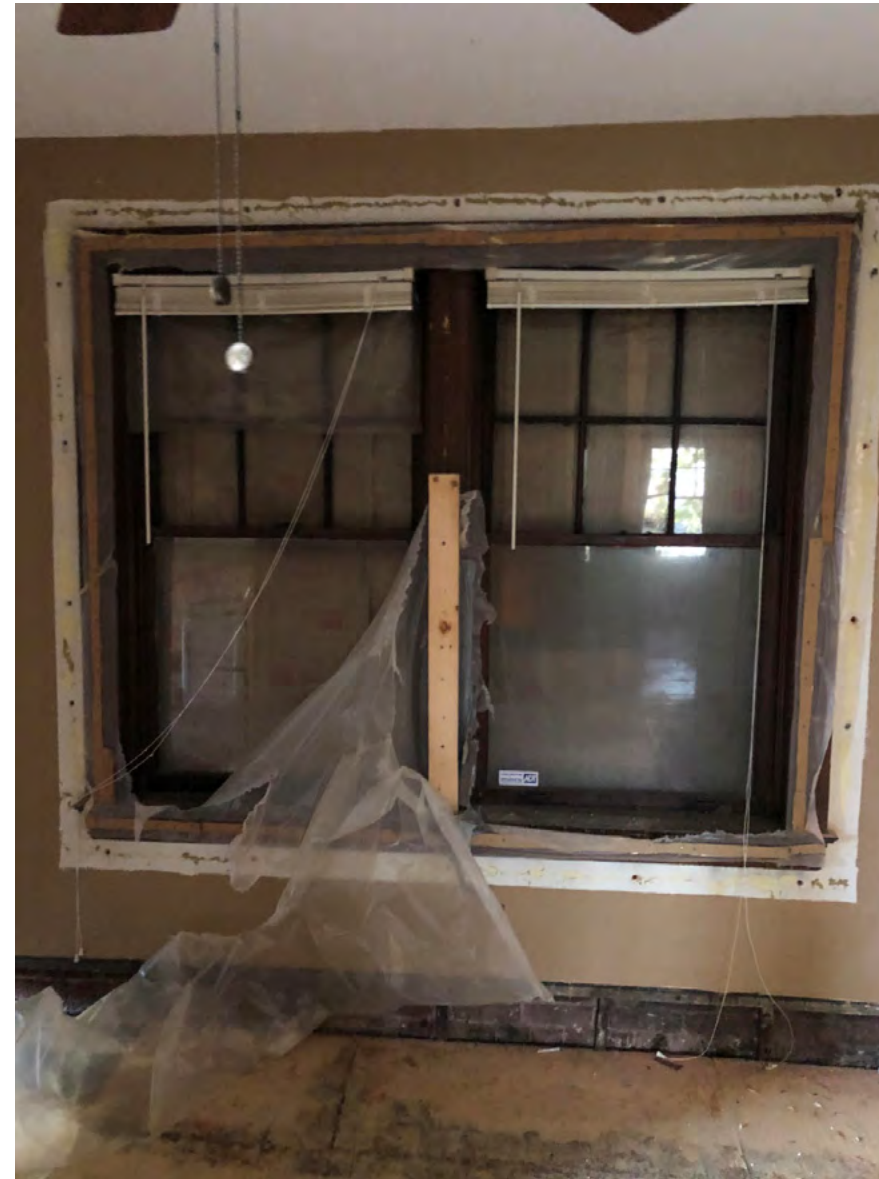
- The window is boarded up on the outside.
- Exterior sill has extensive rot
- Both sashes' have severe rot
- Windows need to be re-putted
- Weather stripping missing
- Lead weights are missing in both windows

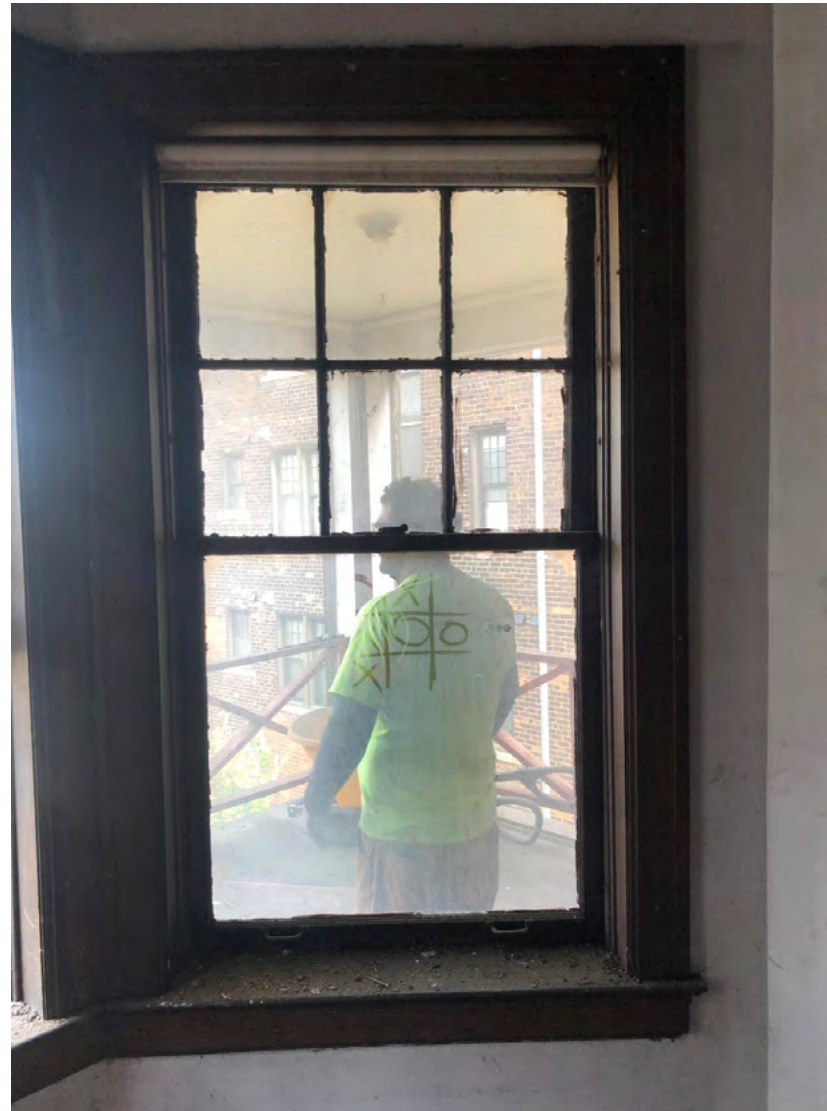
- Window will open
- Exterior sill has rot
- Sashes will not line up or lock
- Weather stripping missing
- Interior sill is rotten
- Window needs to be re-putted
- Lead weights are in place, but cords need replacing
