STAFF REPORT 12-9-2020 REGULAR MEETING

APPLICATION NUMBER: 20-6968

ADDRESS: 691 W. ALEXANDRINE STREET

SCOPE: REHABILITATE EXISTING BUILDING; ERECT NEW BUILDING

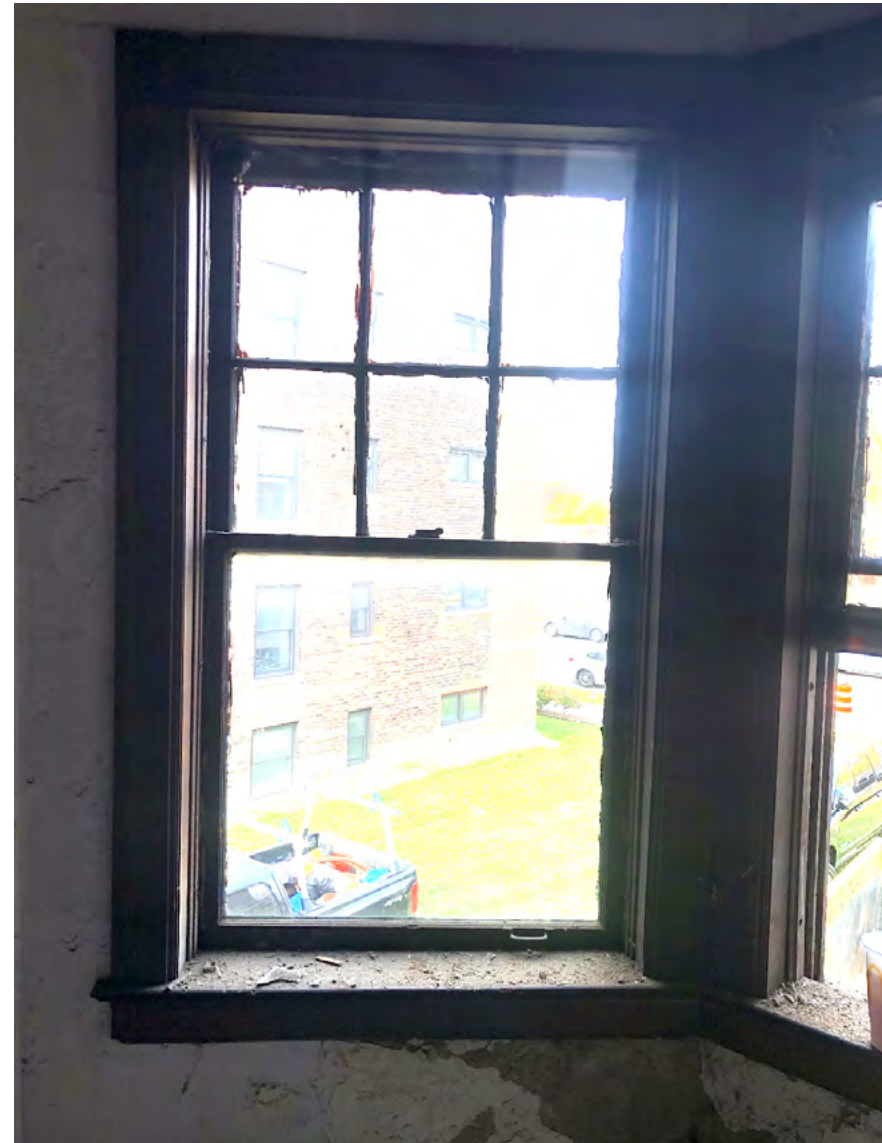
- Right lead weight is missing
- Exterior Sill is broken
- Brick molding on left side has severe rot
- Window will only open halfway
- Missing one handle
- Weather stripping missing
- Bottom sash has rot at bottom

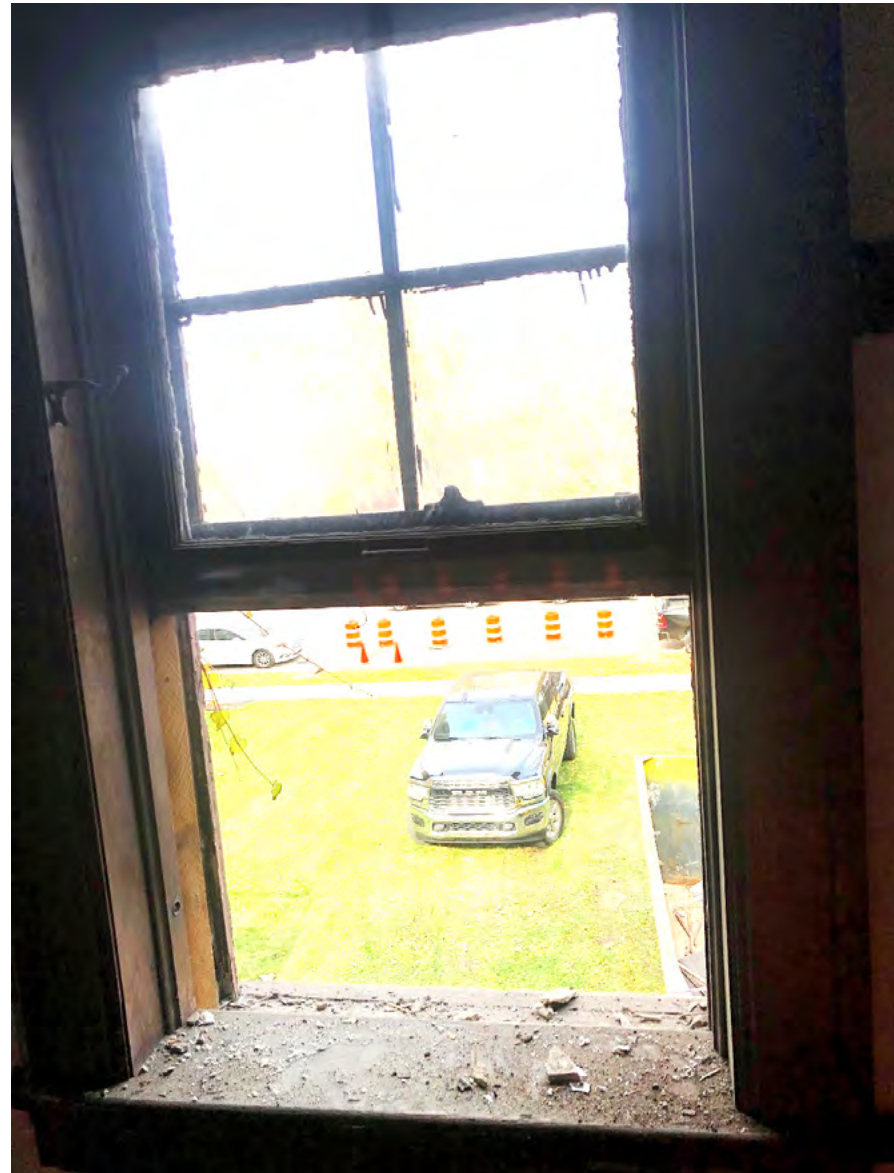
- Window will open
- Lead weights are missing in both sides
- Exterior sill is broken and has rot
- Interior Jamb has water damage
- Window needs to be re-putted
- Weather stripping missing

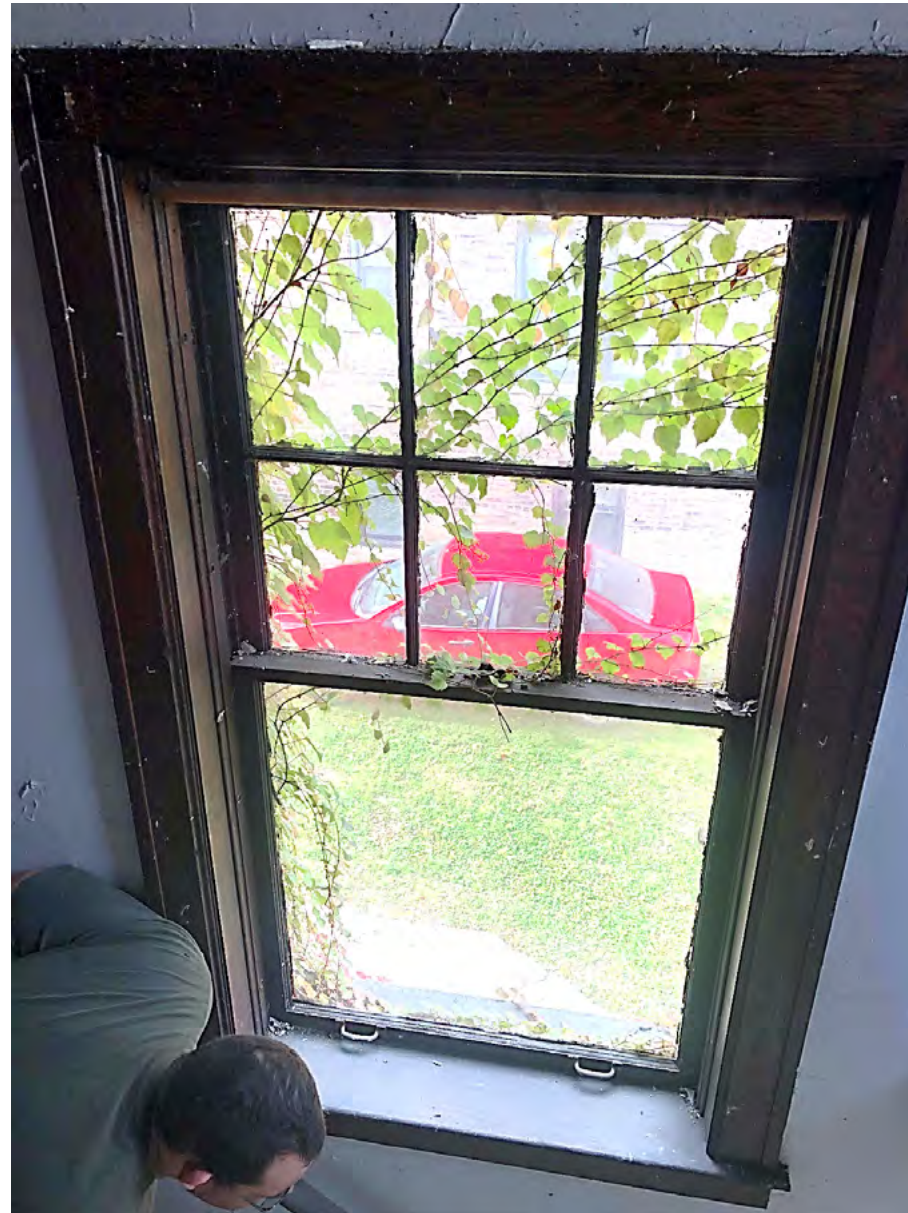
- Missing both weights
- Exterior sill has extensive rot
- Window will not open
- Weather stripping missing
- Window needs to be re-putted

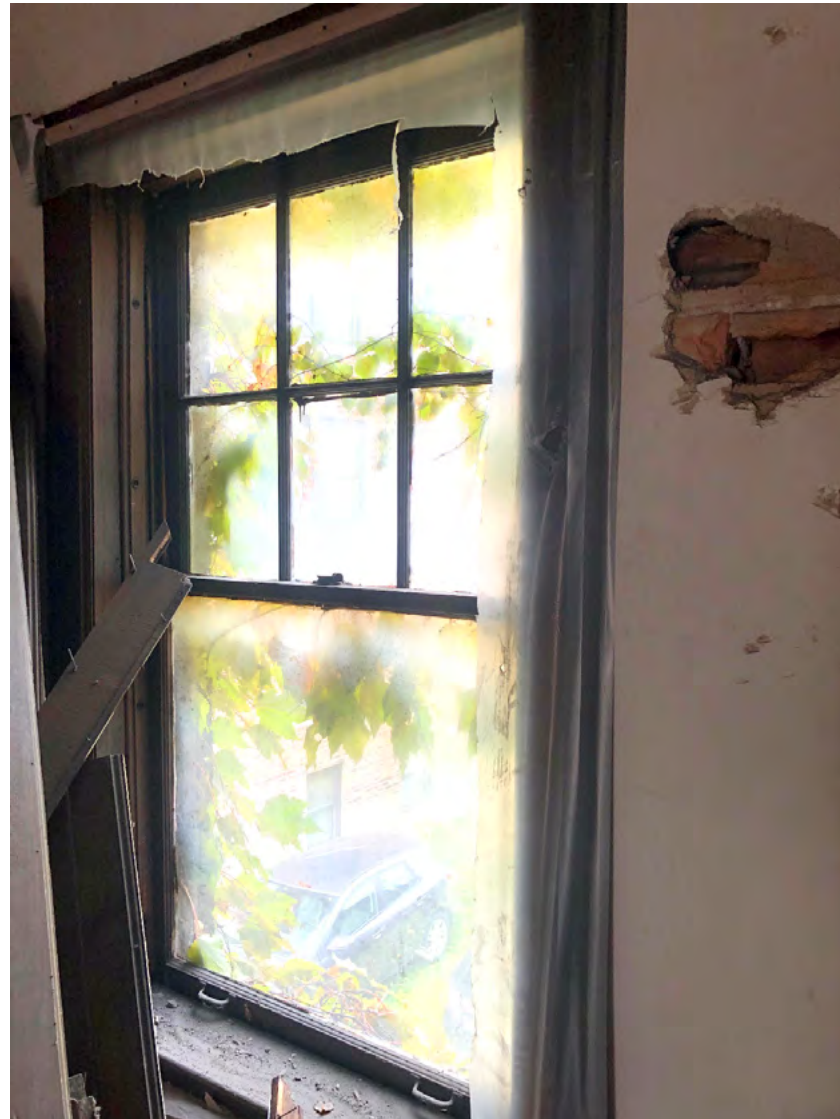
- Window will not open
- Missing one lead weight
- Vines are growing thru window
- Bottom sash is rotten
- Interior sill has damage
- Weather stripping missing
- Window needs to be re-putted

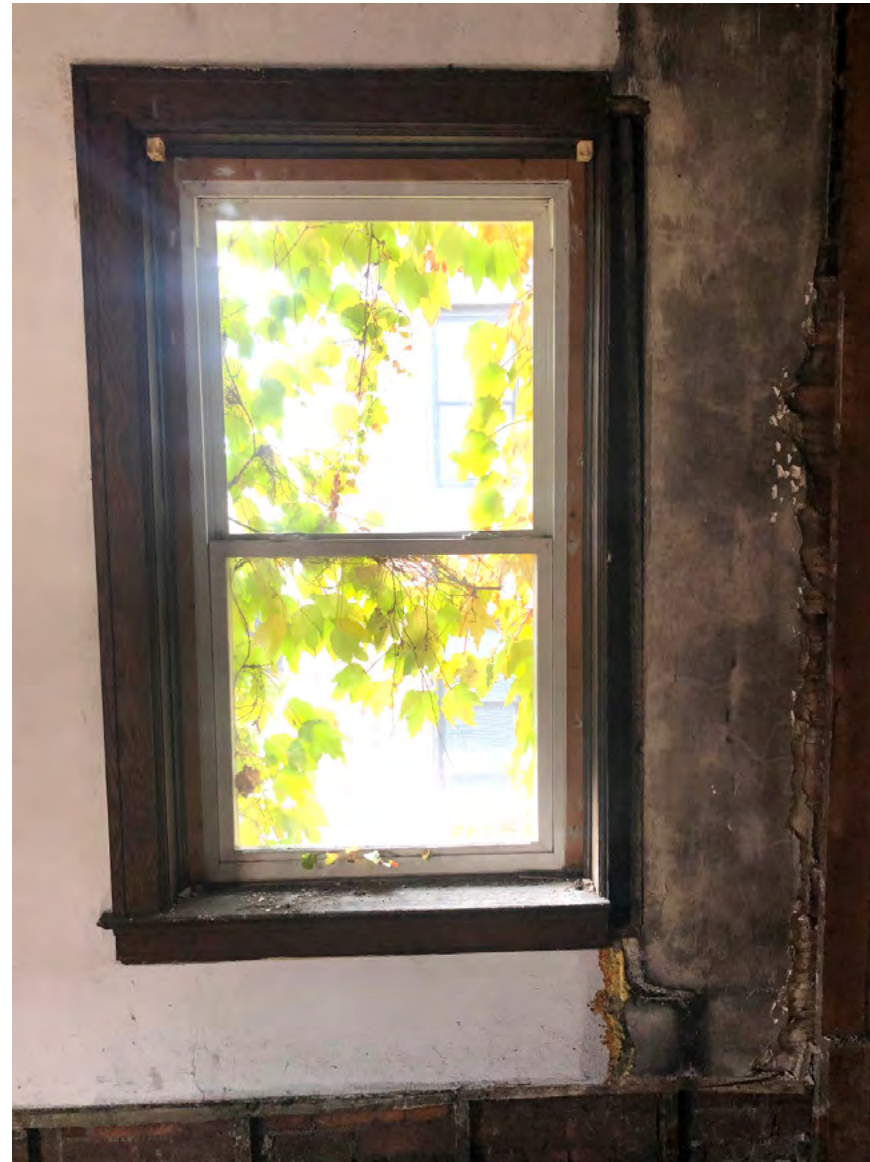
- Window has been replaced with a vinyl replacement that does not fit in opening
- Wood was used to infill the gapes
- Stops are missing
- Sashes are missing
- Lead weights are missing
- Exterior sill is rotten

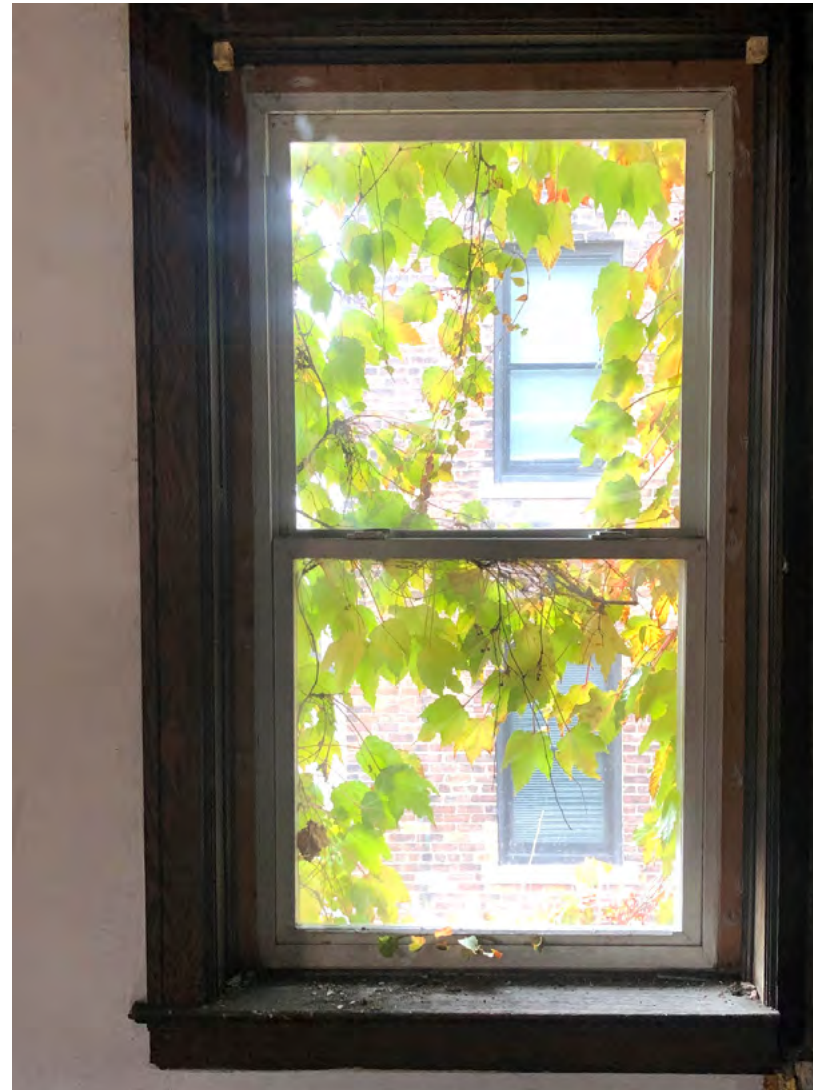
- Windows has been replaced with a vinyl replacement that does not fit in opening
- Wood was used to infill the gapes
- Stops are missing
- Sashes are missing
- Lead weights are missing
- Exterior sill is rotten
- One window is missing trim on right side

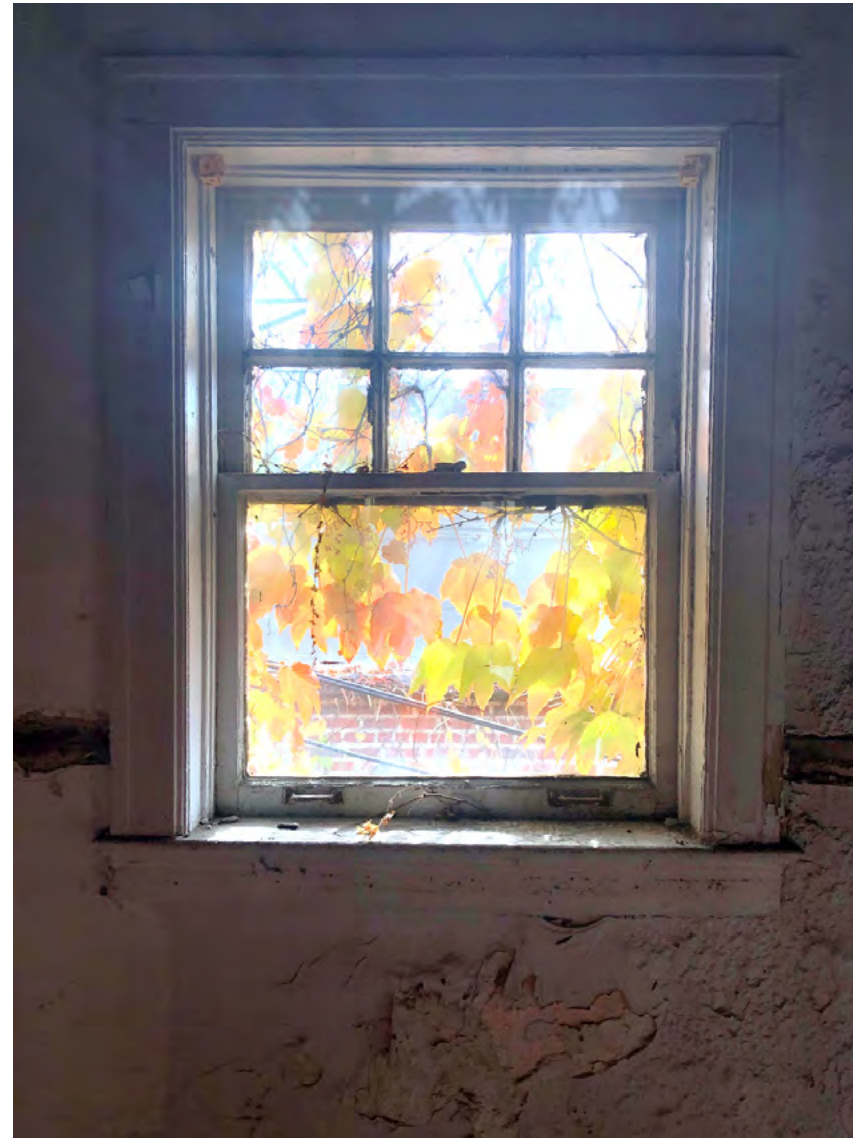
- Window will not open
- Lead weights are in place, but cords need replacing
- Exterior sill has massive rot
- Interior sill is rotten and loose
- Weather stripping missing
- Window needs to be re-putted
- Bottom sash has extensive rot

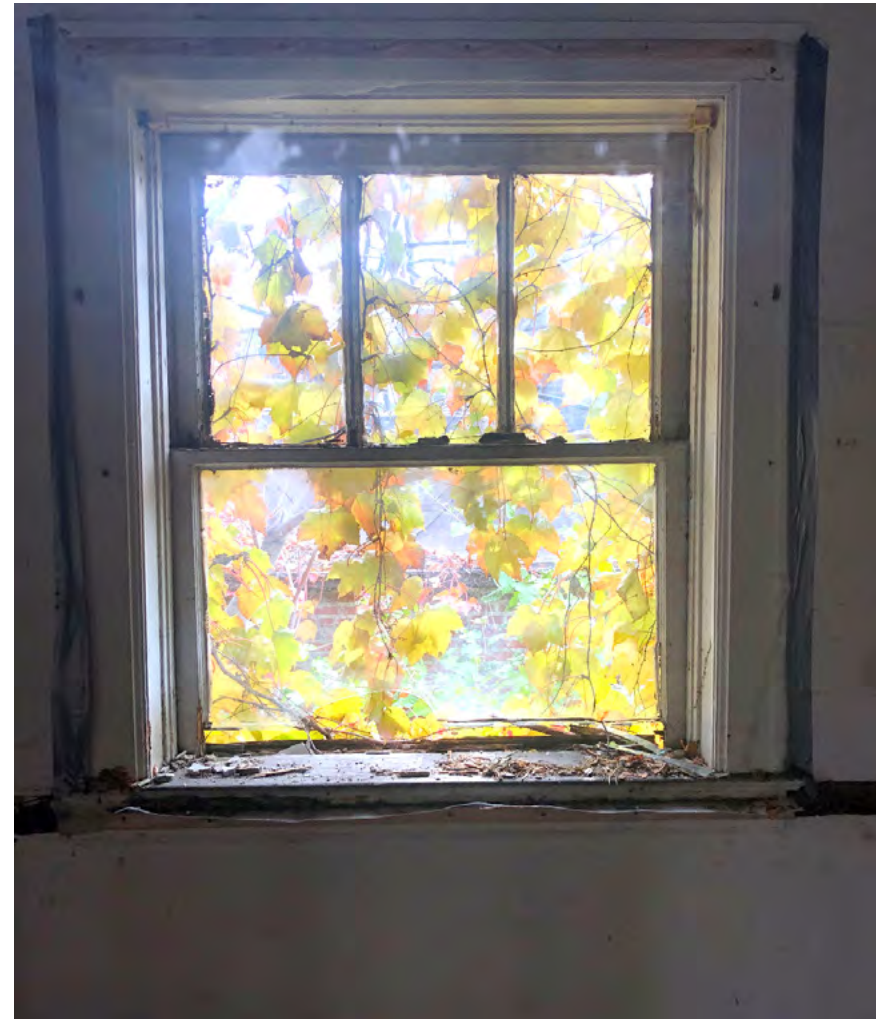
- Window will not open
- Window is three over one
- Bottom sash has extensive rot
- Glass in upper sash is broken on left side
- Interior sill has massive rot
- Exterior sill has massive rot
- Window needs to be re-putted
- Lead weights are missing
- Weather stripping missing
- Brick molding has extensive rot

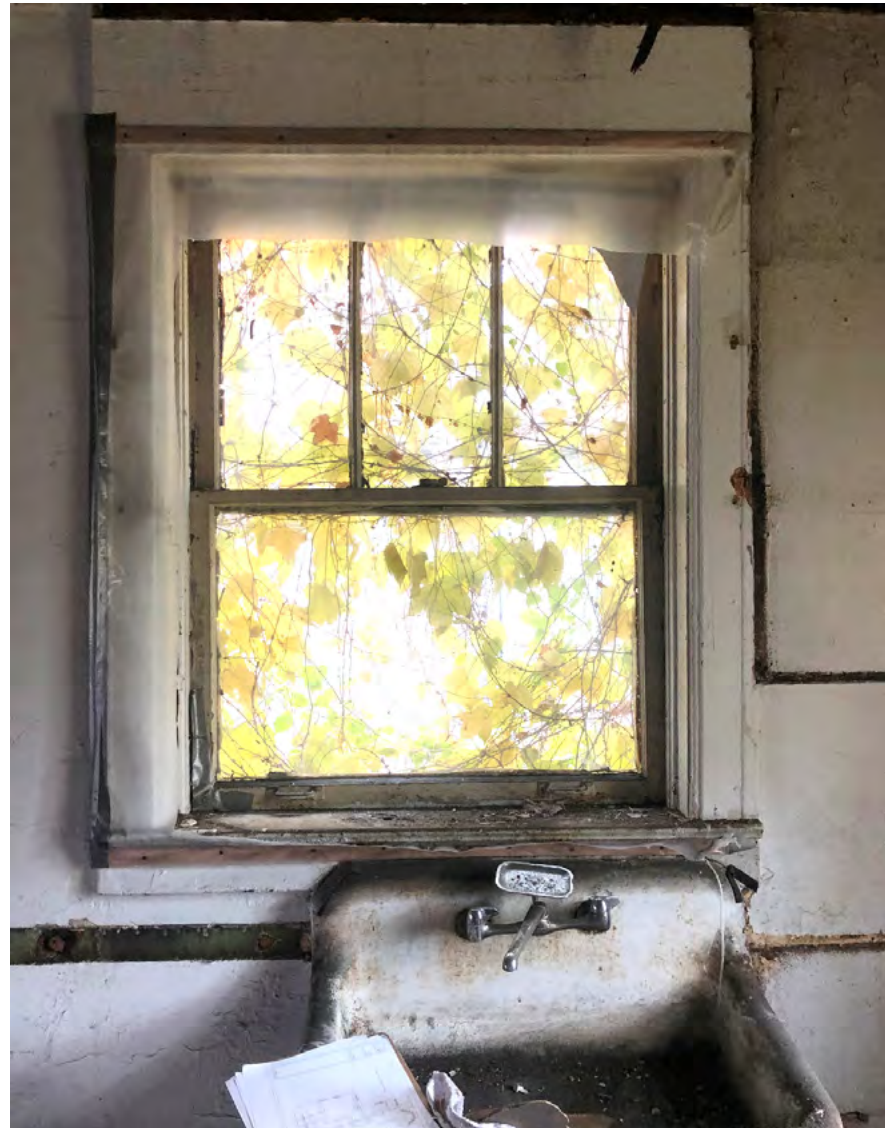
- Window will not open
- Both Lead weights are missing
- Bottom sash has extensive rot
- Window needs to be re-putted
- Lower sash glass is falling out
- Weather stripping missing
- Interior sill has massive rot

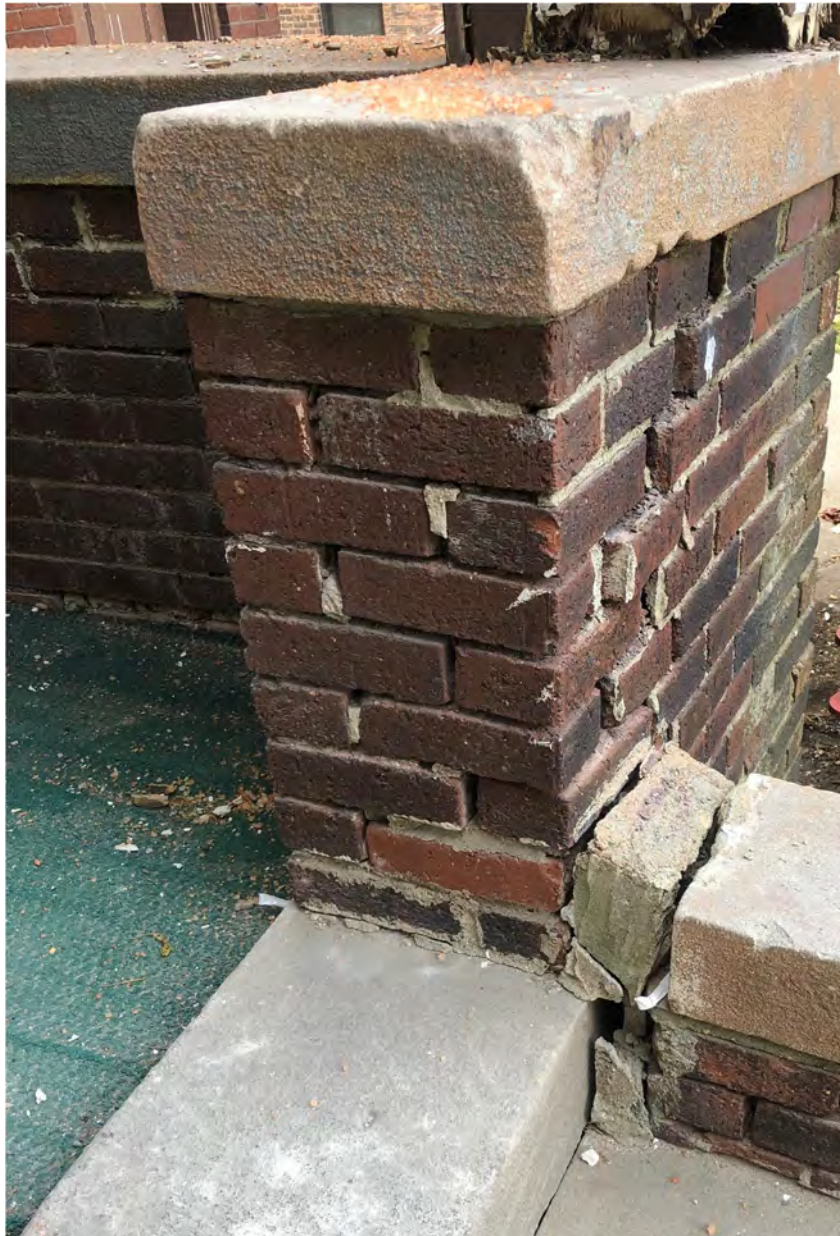
- Wall is 4 layers of bricks
- The gaps in the brick have been improperly filled and look bad.
- Bricks are loose and falling out
- Wall is falling apart. Will need to be torn down and rebuilt to make right.
- Some bricks have been replaced with non-matching bricks.
