STAFF REPORT: 12/16/2020 MEETING

APPLICATION NUMBER: #20-6988

ADDRESS: 701 W. CANFIELD

SCOPE: REPLACE EXISTING VINYL AND WOOD WINDOWS WITH ALUMINUM CLAD WOOD WINDOWS

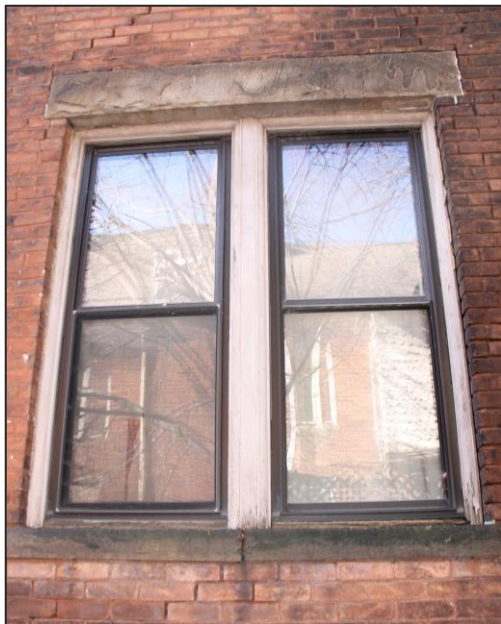
1st Floor East Elevation, vinyl window replaced original sash

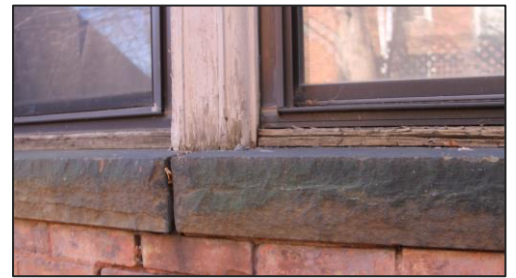
1st floor window, viewable sill condition - poor

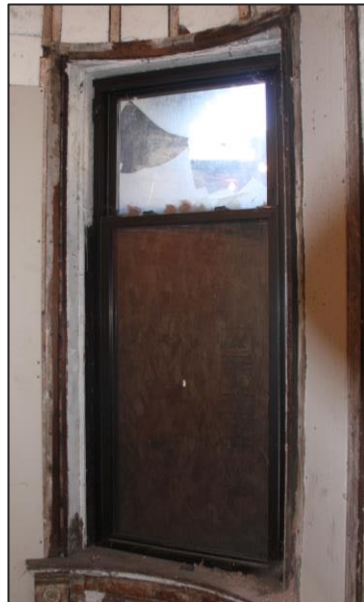
Front Elevation, 1st Floor, Typical view vinyl replacement windows

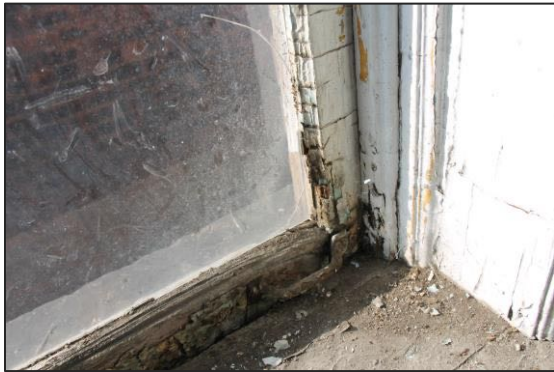
Failed Corner Joinery, Bottom Rail

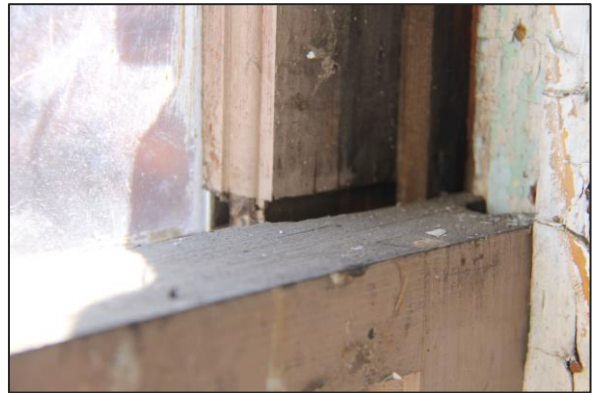
Failed Sash Joinery

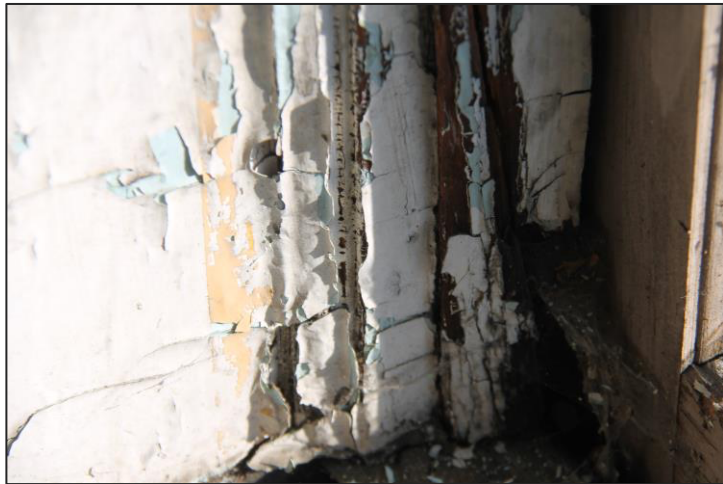
Rotted jamb behind board-up that was removed

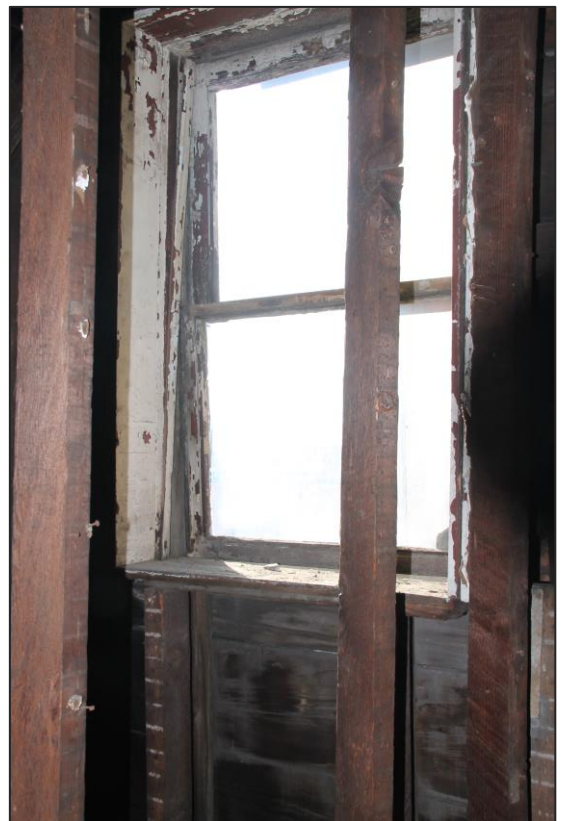
Spilt Jamb Frame

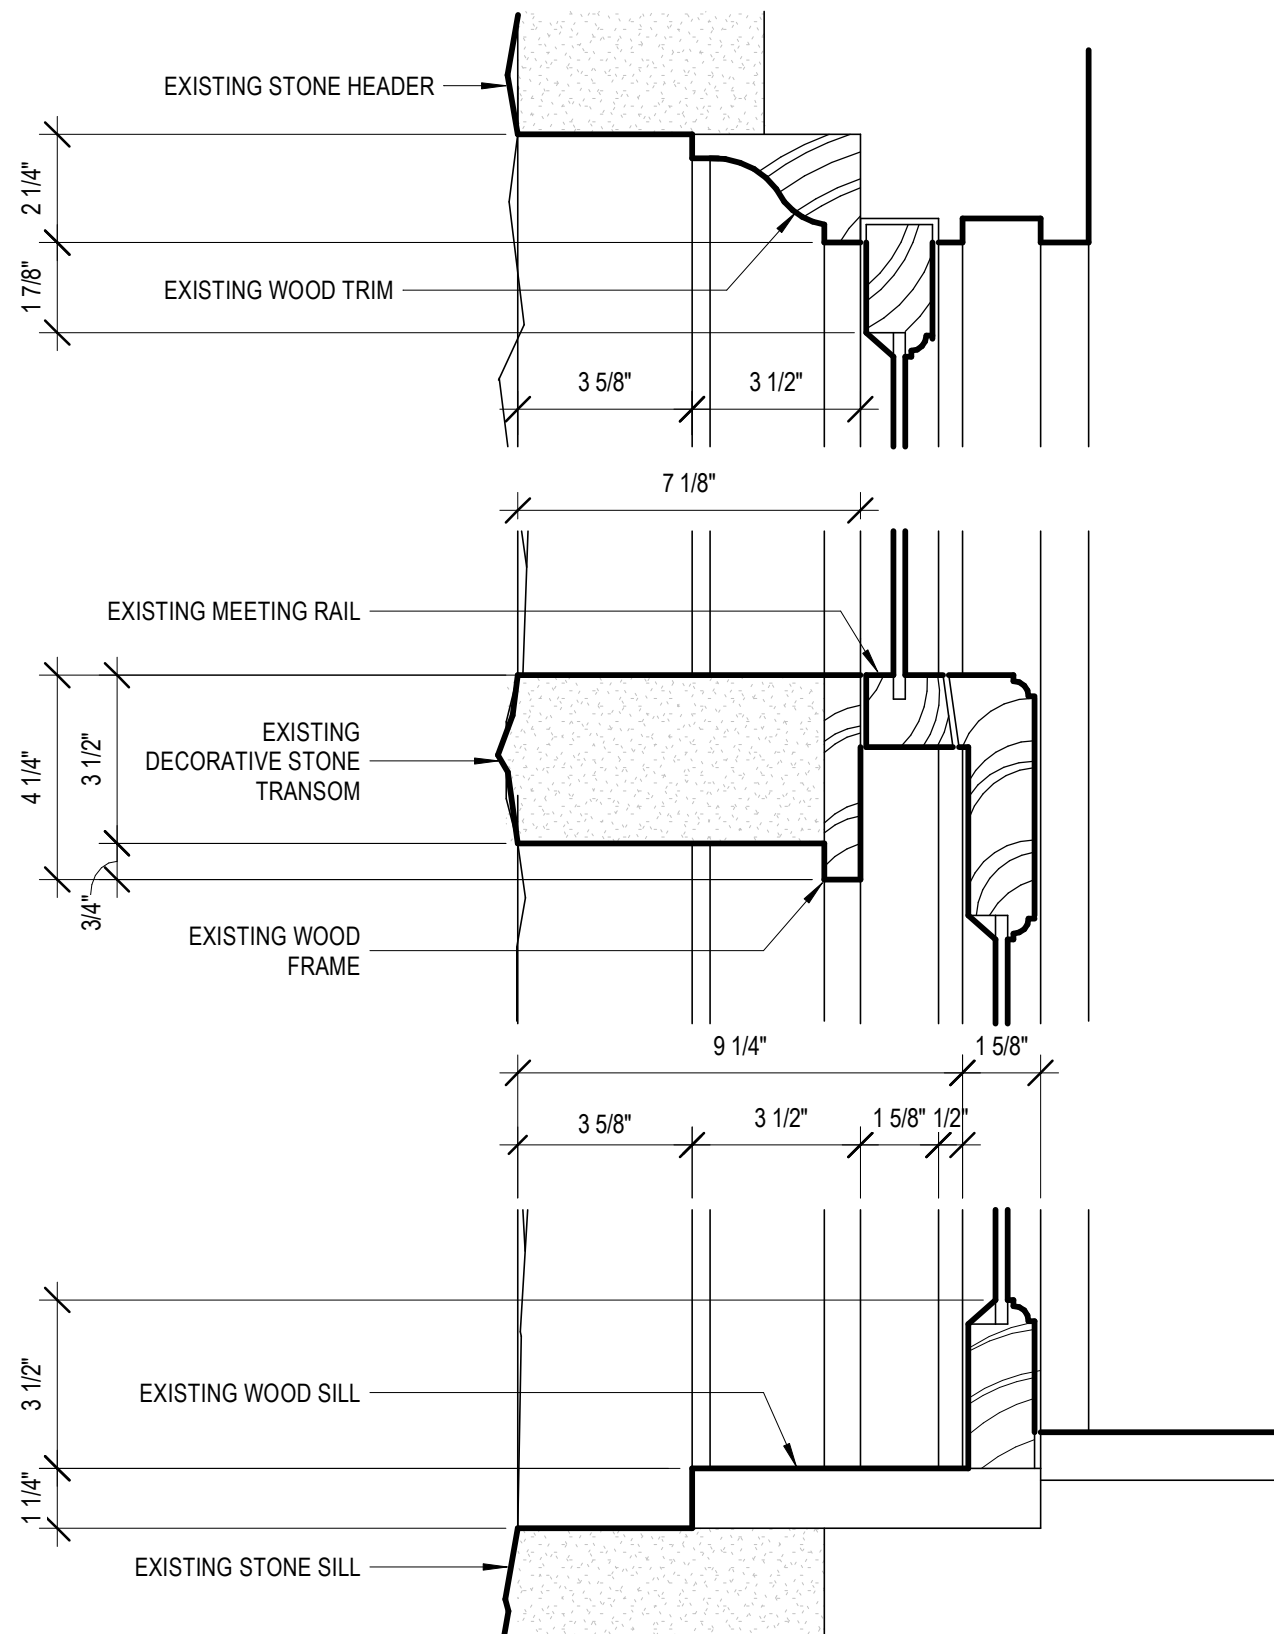
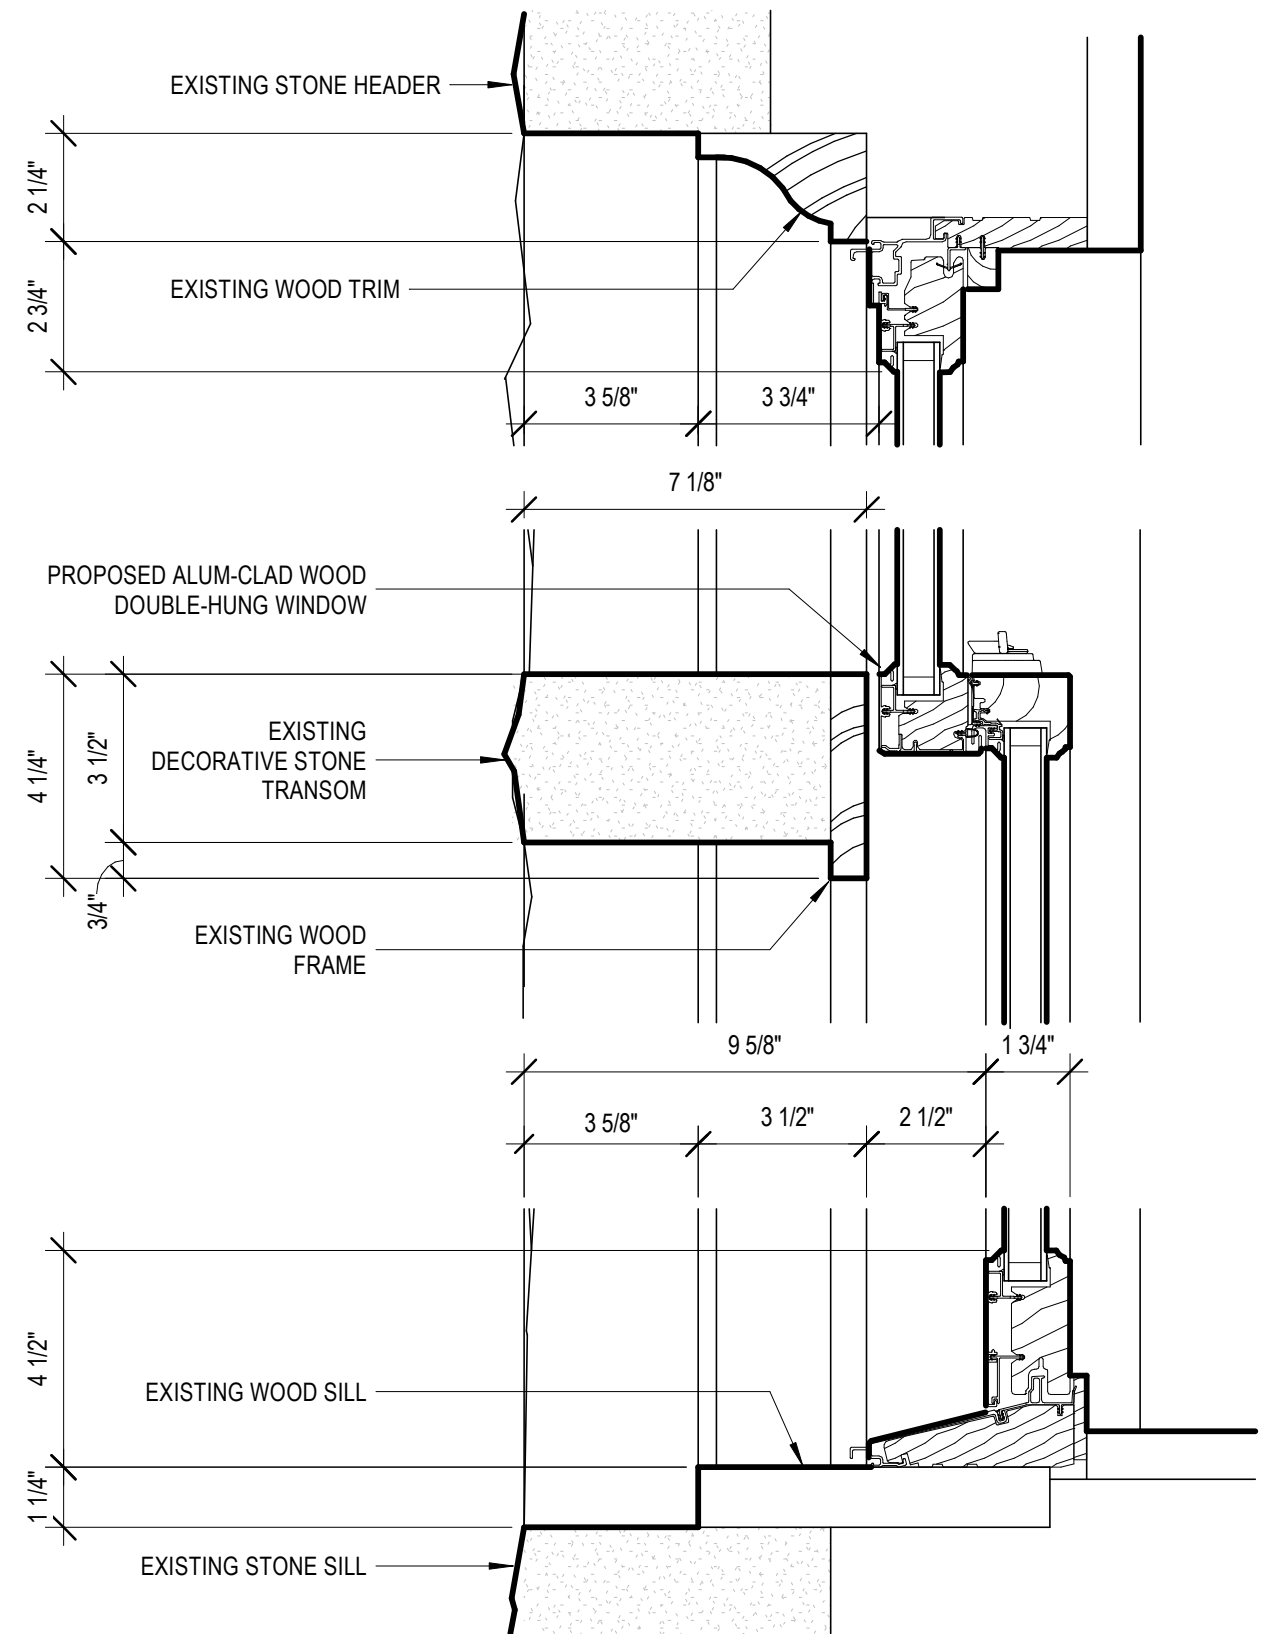
1 EXISTING WINDOW DETAIL - DH WITH TRANSOM

- The brick mold shown in the cross sections (See Sheets H25) are labeled in the drawings as “existing wood trim”, and are proposed to be retained.
- Although replacement of wood windows does remove and alter distinctive features or finishes of the property, aluminum-clad windows are a reasonable and economically feasible product for the replacement of wood windows that are demonstrably beyond repair.

- The brick mold identified in the drawings be retained. If areas of the brick mold have deteriorated beyond repair, the applicant may replace with in-kind material, per staff review of replacement confirming match in material, profile, and dimension
- The wood mullions at the windows are retained
