**STAFF REPORT: FEBURARY 17, 2021 MEETING**

**APPLICATION NUMBER: 21-6997**

**ADDRESS: 14935 WESTWOOD**

**SCOPE OF WORK: REPLACE EXISTING WINDOWS, ADD ALUMINUM TRIM TO SOFFITS, FASCIA**

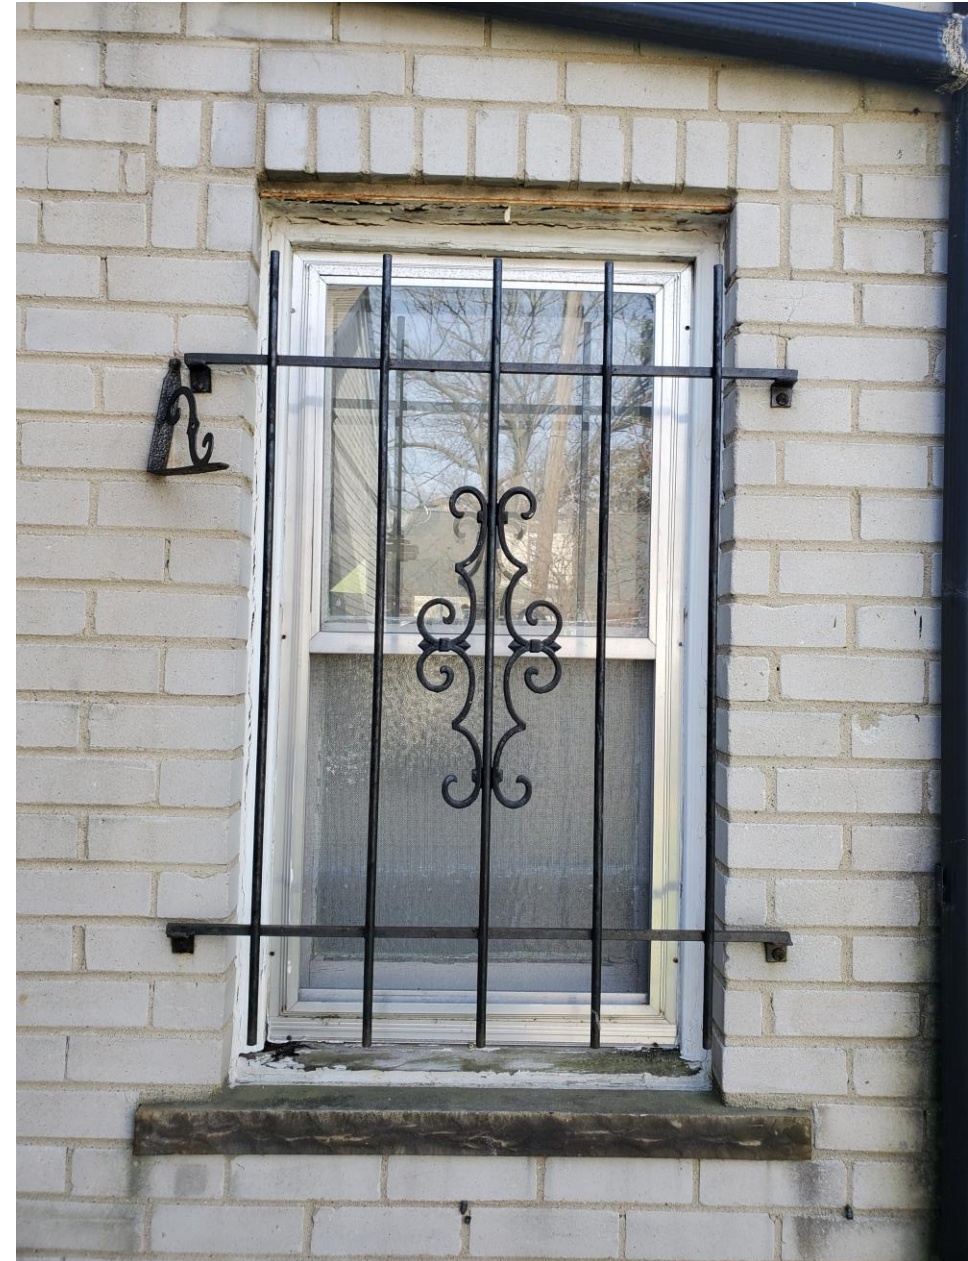
# Diningroom Windows

Exterior view of Rear side C

Old Aluminum storm windows are present but in poor and non-working condition. Only frame is existing

Paint is flaking off areas where trim is missing

Window bars will be removed

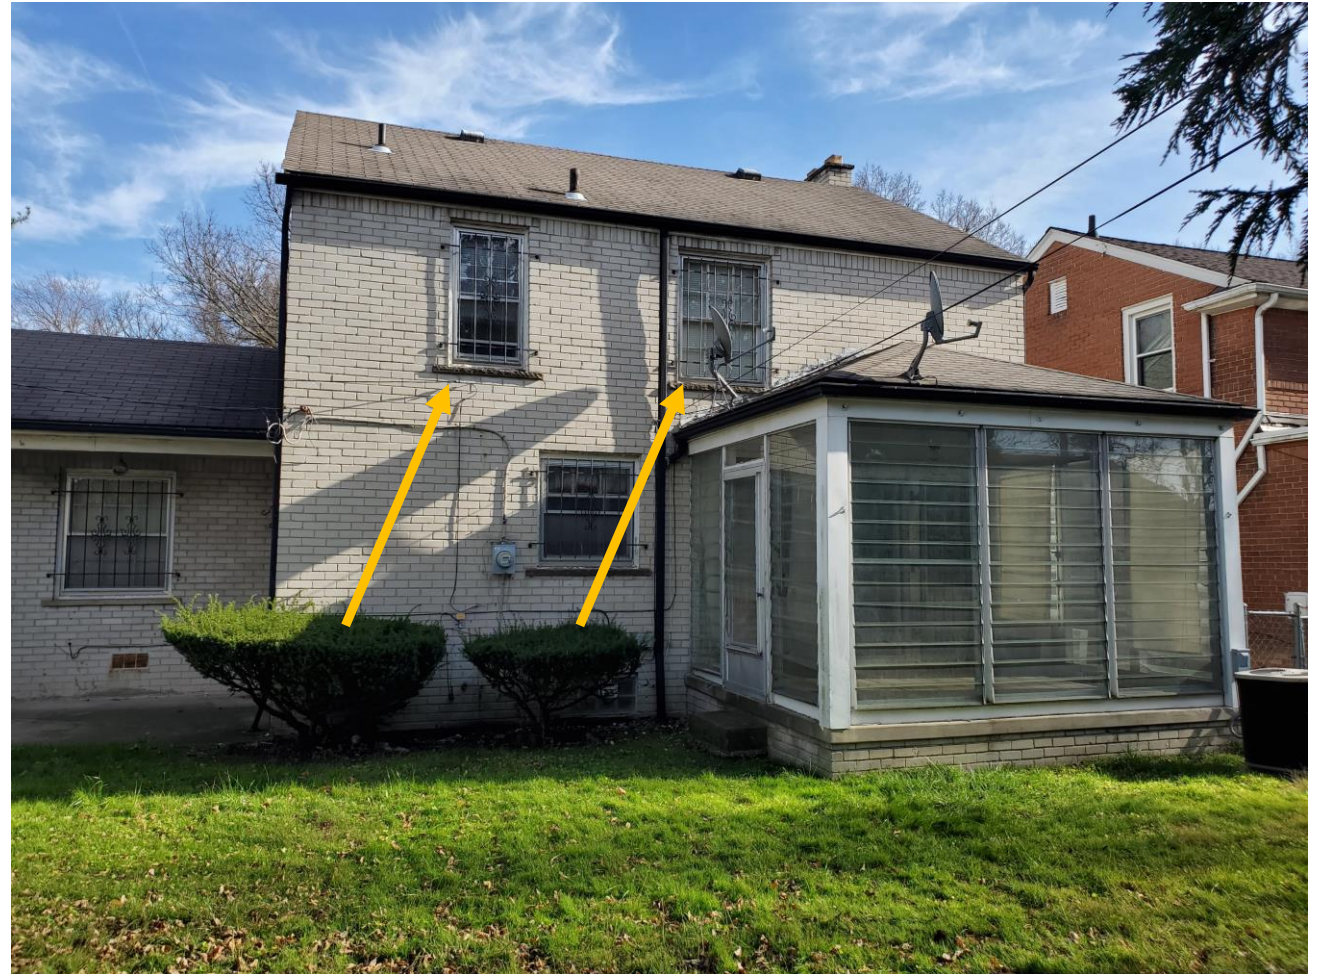
## Rear Livingroom 2 / Family room area

Rear lower livingroom / familyroom side C on the home, but on rear side

Old Aluminum storm windows are not present only frame. Frame in poor and non-working condition

All windows are trimmed with aluminum coil trim, white in color

Existing soffit & fascia and gutters are all aluminum, but were painted over

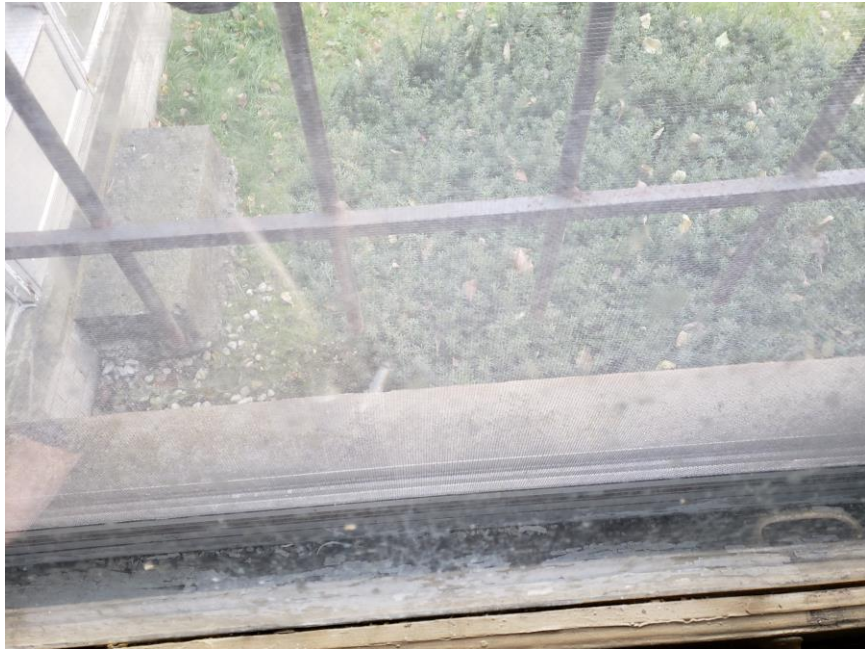
- Old Wood Windows

Paint Chips &  
Lead Dust.

High Levels of  
Lead Dust  
were found  
and is  
considered  
Hazardous

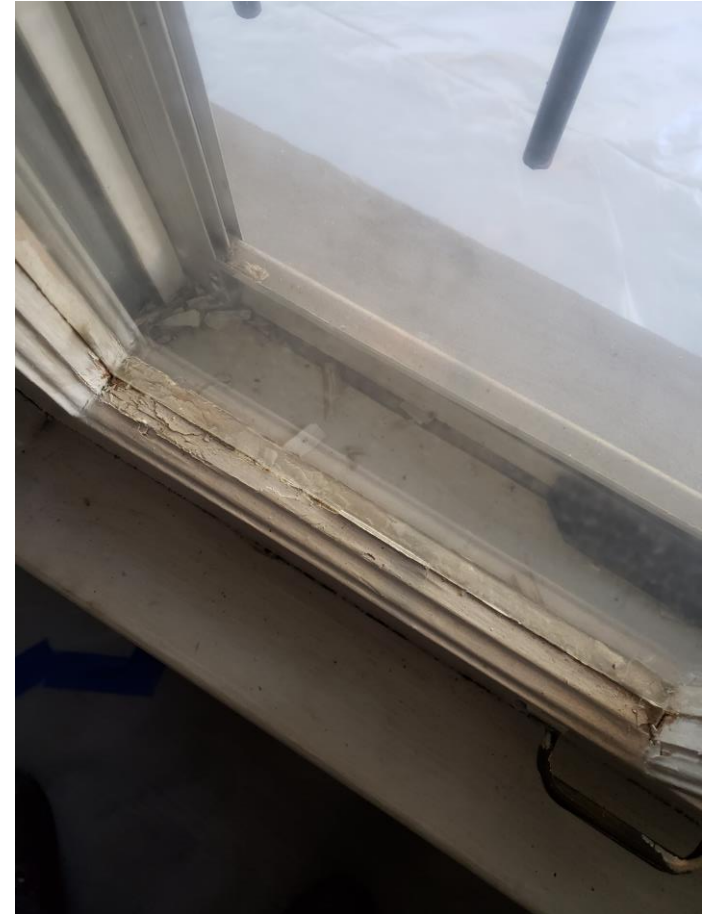
- Old Wood Windows

Paint Chips & Lead Dust.

High Levels of Lead Dust were found and is considered Hazardous

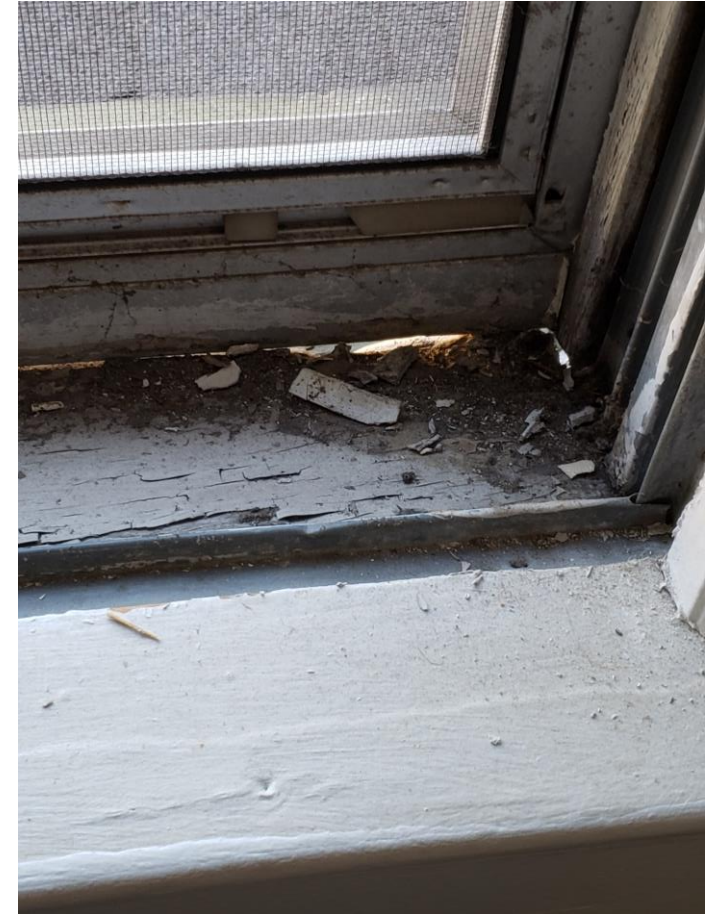
Front Livingroom windows

Center Double Hung unit  
painted shut

Locks on other flanker  
units do not work

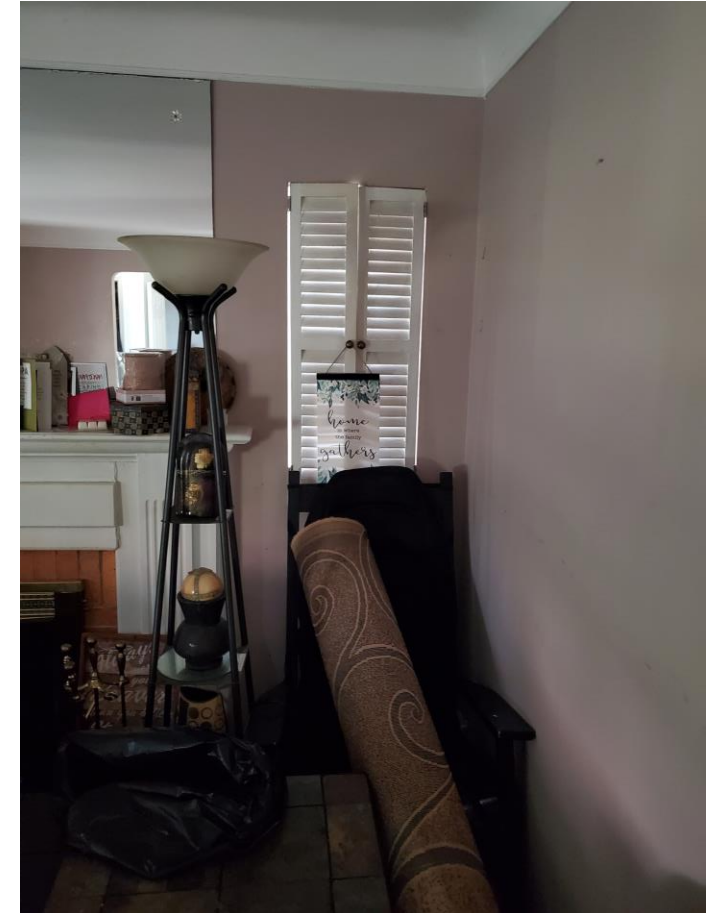
painted shut

Locks on both units do not work

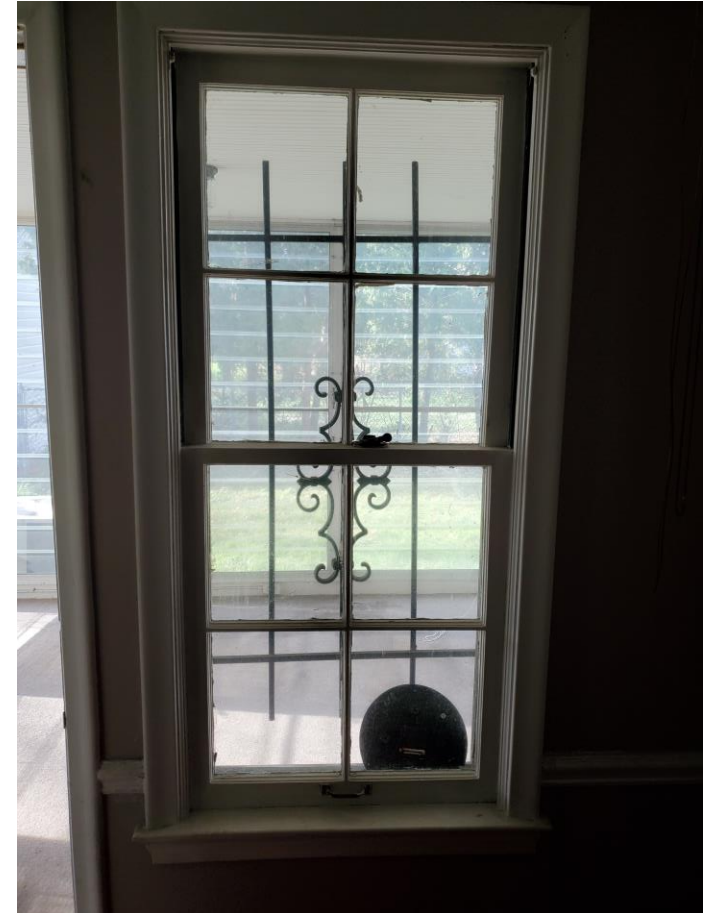
Locks on units do not work

Storm is missing pieces and  
does not work

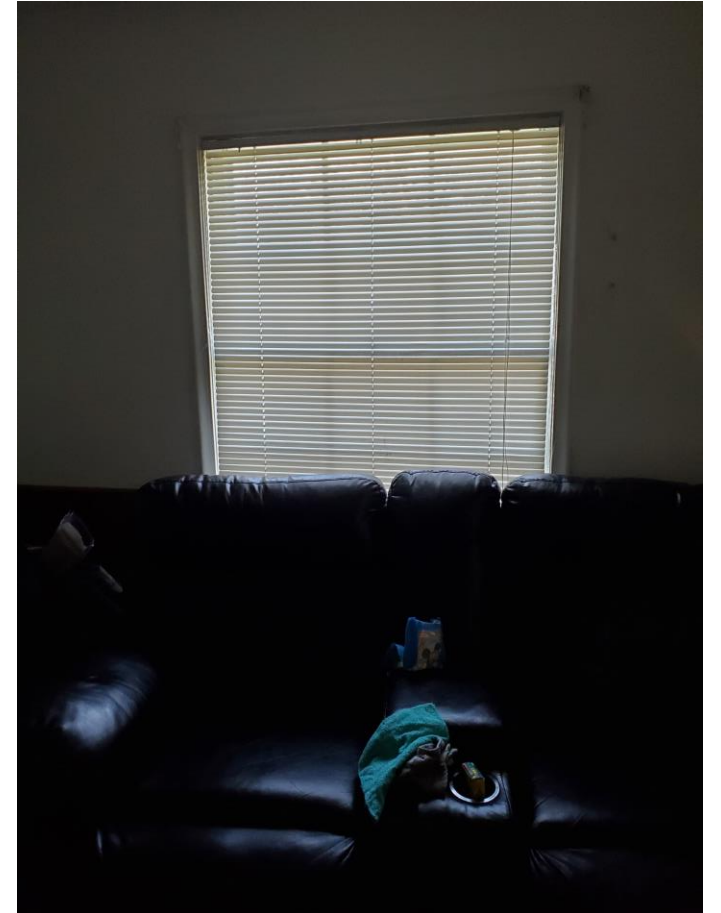
Locks on unit do not work

Glass panes loose and  
glazing bad

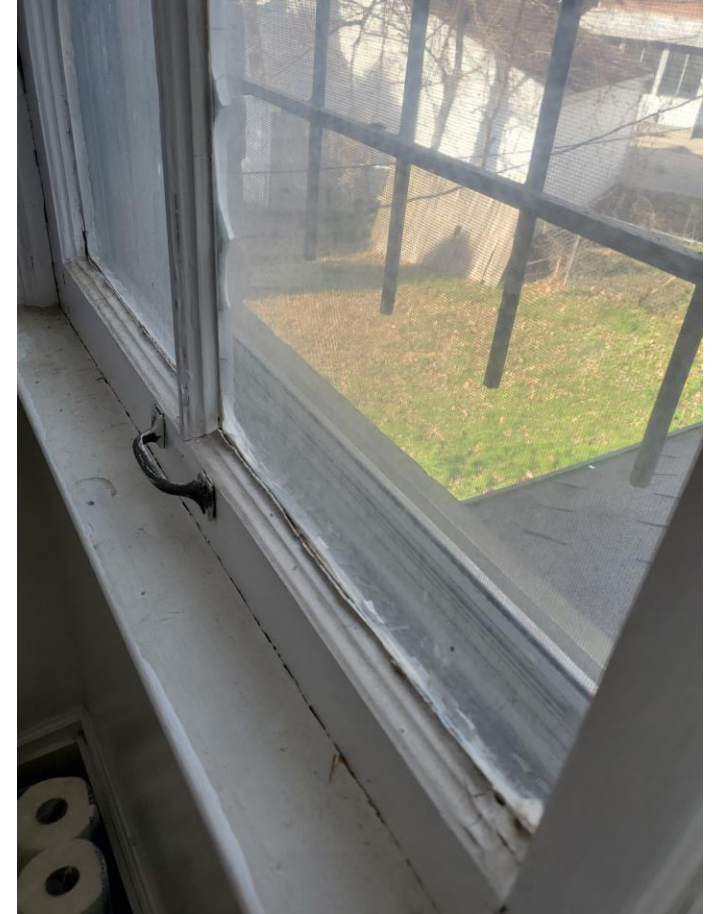
Locks on unit do not work

Glass panes have been  
changed and muntin bars  
removed on lower unit

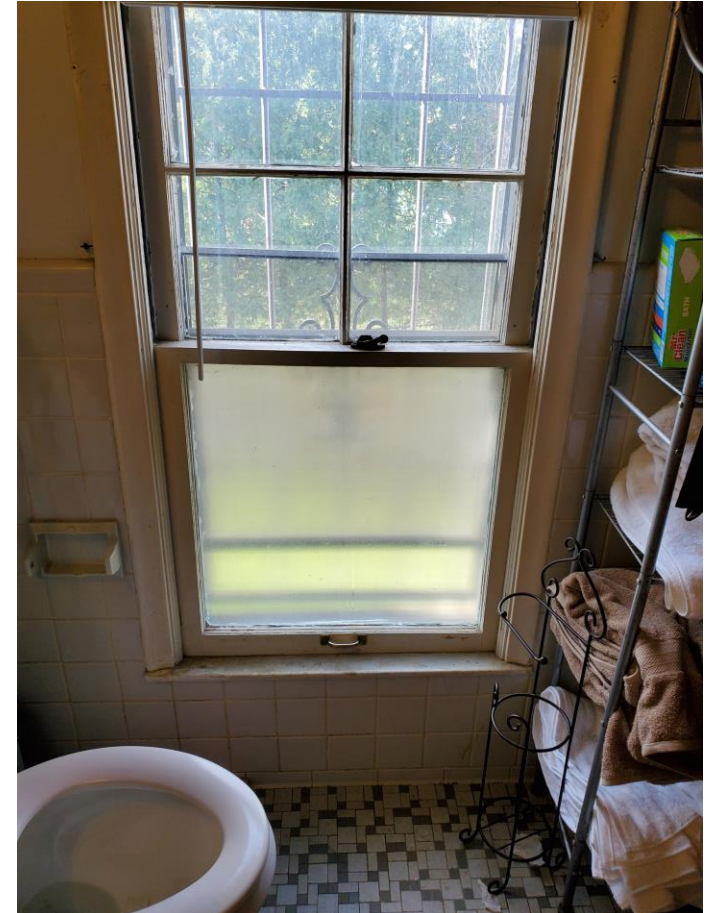
Glass are un poor condition

Storm windows are broken
