**STAFF REPORT 02/17/2021 MEETING**

**APPLICATION NUMBER: #21-7098**

**ADDRESS: 4221 CASS (STUBER AND STONE BUILDING)**

**SCOPE: REPLACE WINDOW AT NORTH/SIDE ELEVATION, SECOND STORY; REPLACE CONCRETE LINTELS**

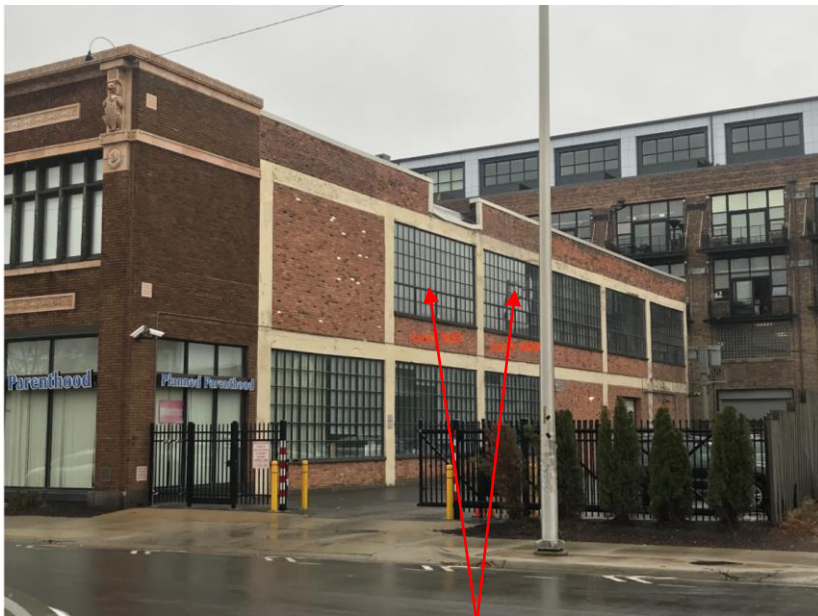
4221-4229 Cass, **NORTH ELEVATION**, current elevation. The current windows at Units #300 and #400 are at this location

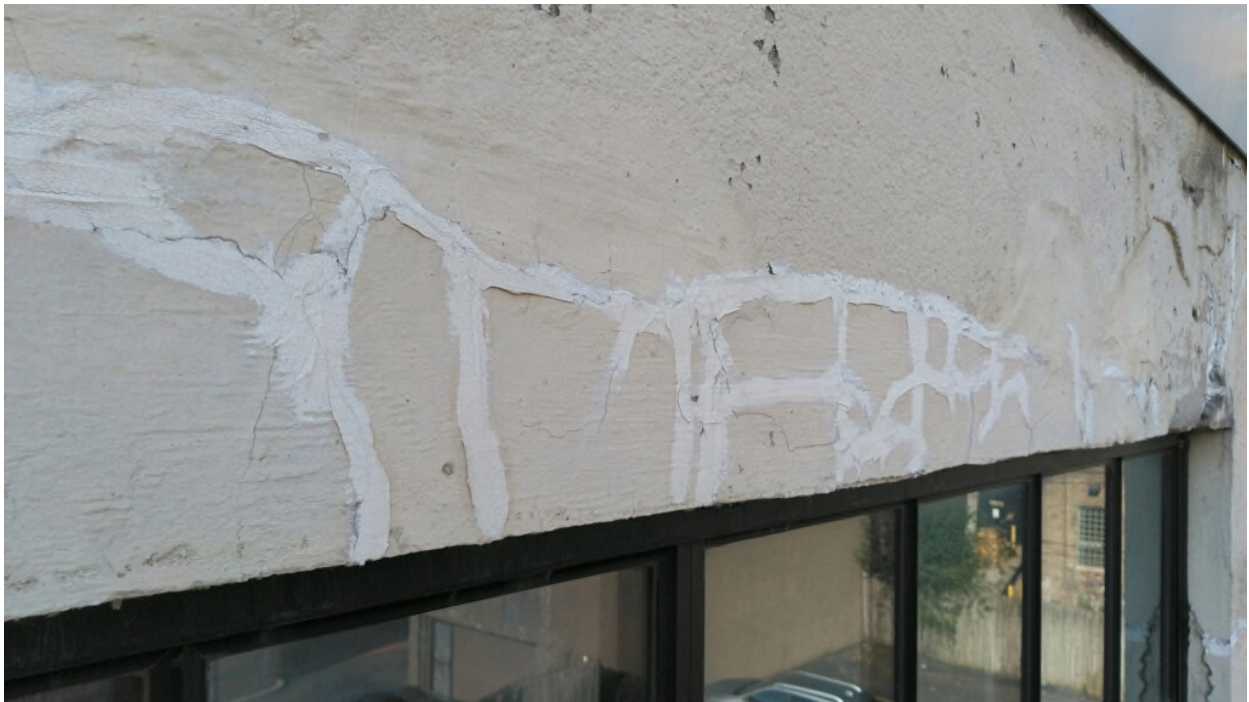
**Unit #300:**

Unit #300 was visually inspected from the interior and hammer sounded from the exterior. During the survey, we noted severe deterioration at the entire bottom of the beam (above the window), with moderate damage observed at the surrounding concrete members (beam below window and adjacent column 300/400). This includes widespread cracking and spalling concrete. Large crack separation at bottom of beam. No steel reinforcement was visible but it should be assumed that the crack has developed from steel corrosion and a structural repair is required. Pullman recommends fixing these areas to eliminate falling debris hazards (both inside and outside) and the potential for growth of the deteriorated areas.

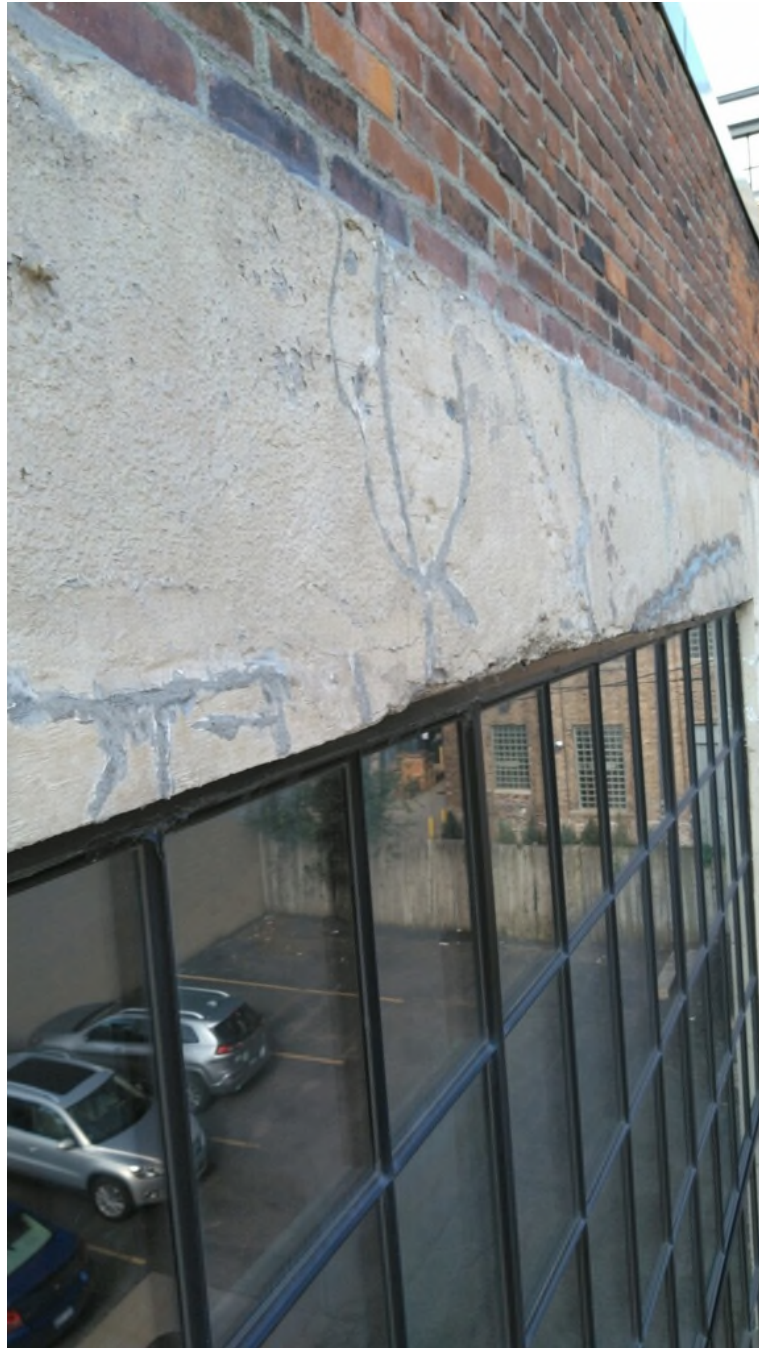
**Unit #400:**

Unit #400 was visually inspected from the interior and hammer sounded from the exterior. During the survey, we noted severe deterioration at majority of the bottom of the beam (above the window). Large crack separation at bottom of beam. No steel reinforcement was visible but it should be assumed that the crack has developed from steel corrosion and a structural repair is required. Pullman recommends fixing these areas to eliminate falling debris hazards (both inside and outside) and the potential for growth of the deteriorated areas.

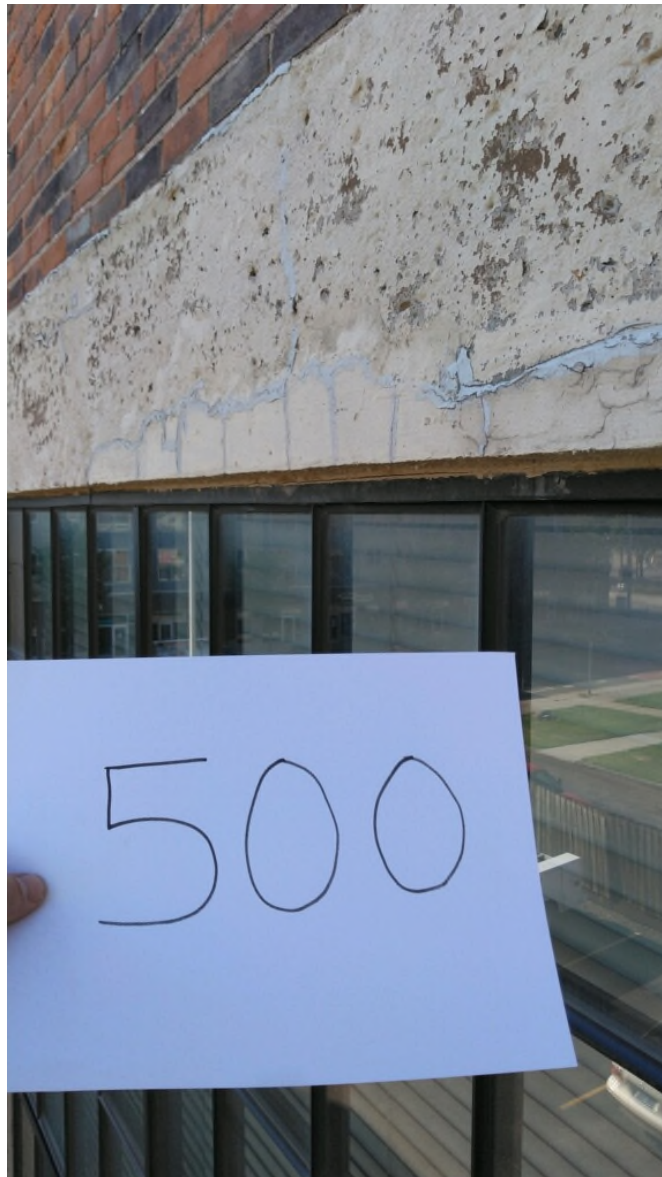
**Unit #500:**

Unit #500 was not visually inspected from the interior, but was hammer sounded from the exterior. During the survey, we noted a small amount of deterioration at an area of the bottom of the beam (above the window). A small amount of crack separation at bottom of beam. No steel reinforcement was visible. Pullman recommends fixing these areas early to stop the potential for growth of the deteriorated areas.

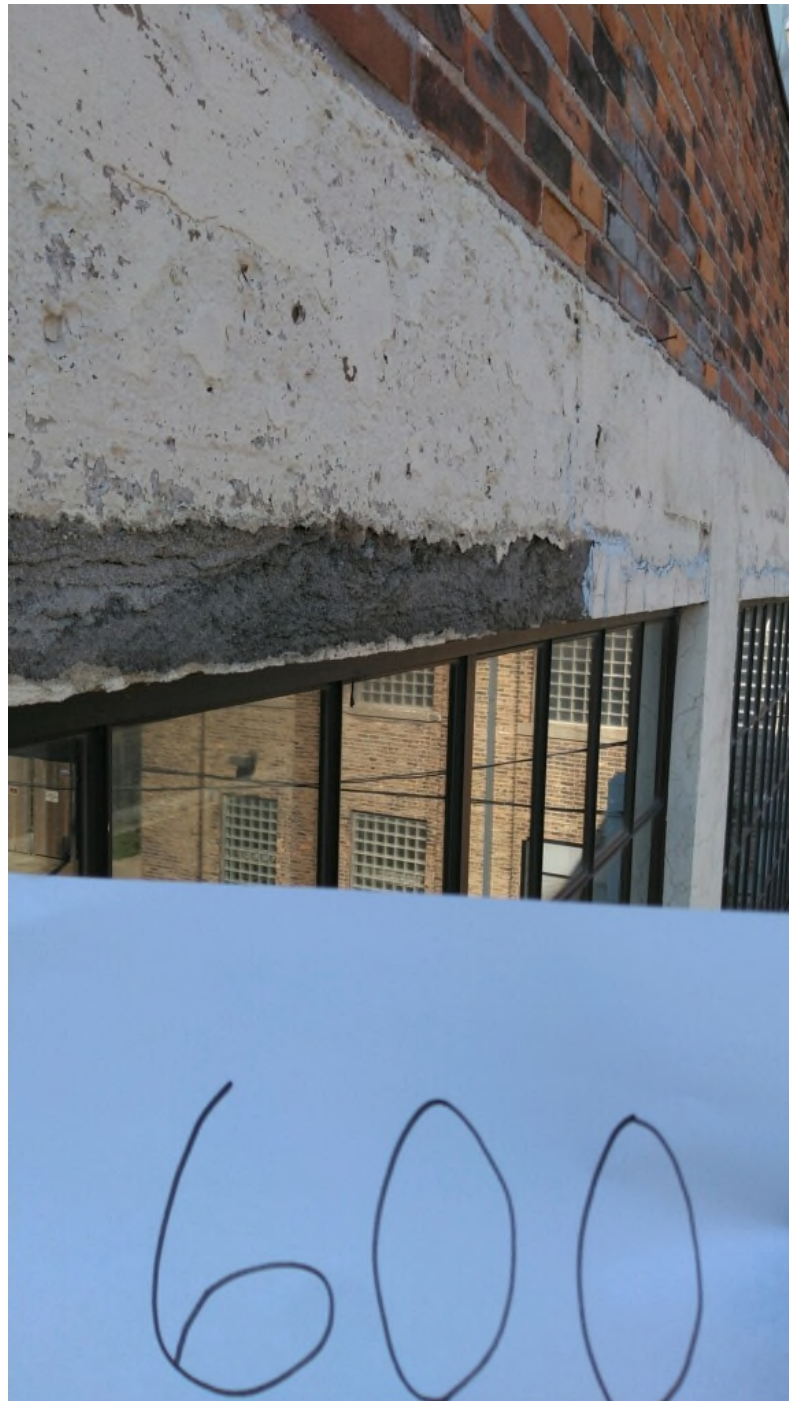
**Unit #600:**

Unit #600 was visually inspected from the interior and hammer sounded from the exterior. During the survey, we noted an area of severe delamination at a location near the bottom of the beam (above the window). No large crack separation was visible; however, there were several locations of small cracks near the damaged concrete. Pullman recommends fixing these areas to eliminate falling debris hazards (both inside and outside) and the potential for growth of the deteriorated areas.

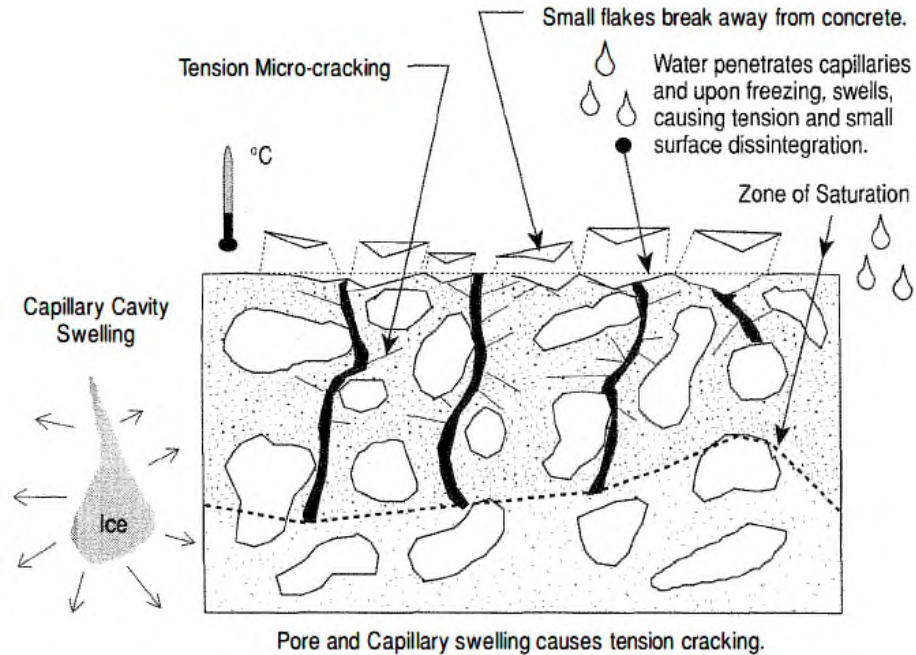
The extent of deterioration varies by each unit. While some specific areas display a large amount of deterioration, no reinforcement steel was discovered during the delamination survey. Exterior concrete structures are extremely susceptible to deterioration due to their exposure to moisture, deicing salts, and temperature changes. In this case, the primary cause of concrete deterioration across the dock is freeze-thaw disintegration. Freeze-thaw disintegration or deterioration takes place when freezing and thawing temperature cycles occur within the concrete and when porous concrete starts to absorb water through its capillary openings. Freeze-thaw damage is commonly seen as scaling of the top of the concrete's surface, caused by small-to medium sized flakes that break away from concrete. Freeze-thaw deterioration generally occurs on horizontal surfaces that are exposed to water, or on vertical surfaces that are at the water line in submerged portions of structures. The freezing water contained in the pore structure expands as it is converted into ice. The expansion causes localized tension forces that fracture the surrounding concrete matrix. The fracturing occurs in small pieces, working from the outer surfaces inward, creating shallow depressions along the concrete surface.

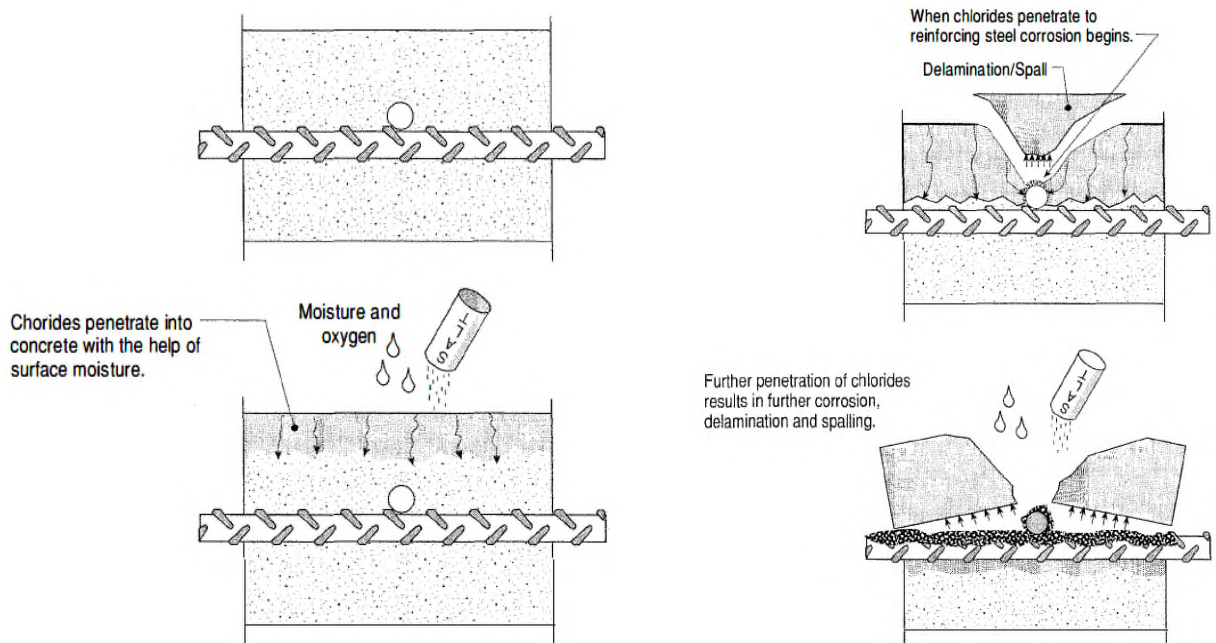
The damage caused by freeze-thaw damage can eventually lead to more harmful causes of concrete deterioration by eventually exposing reinforcement steel and enhancing the corrosion process. Often, this corrosion is accelerated by exposure to moisture, chloride contamination and carbonation. The volume of steel corrosion byproduct (i.e. rust) is up to ten times larger than the steel, and the forces incurred when the embedded steel corrodes causes concrete distress in the form of cracks, delamination, or spalls within the concrete.

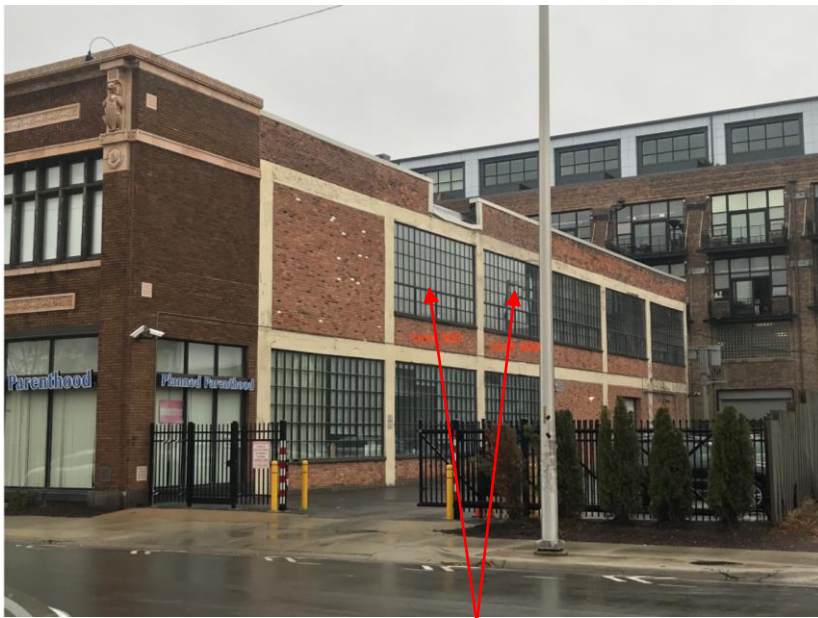
4221-4229 Cass, **NORTH ELEVATION**, current elevation. The current windows at Units #300 and #400 are at this location
