**STAFF REPORT:** 4/14/2021 MEETING

**APPLICATION NUMBER:** 21-7172

**ADDRESS:** 791 SEMINOLE

**SCOPE:** REHABILITATE HOME; REPLACE WINDOWS & REPIAR AND REPLCE SIDING AND TRIM

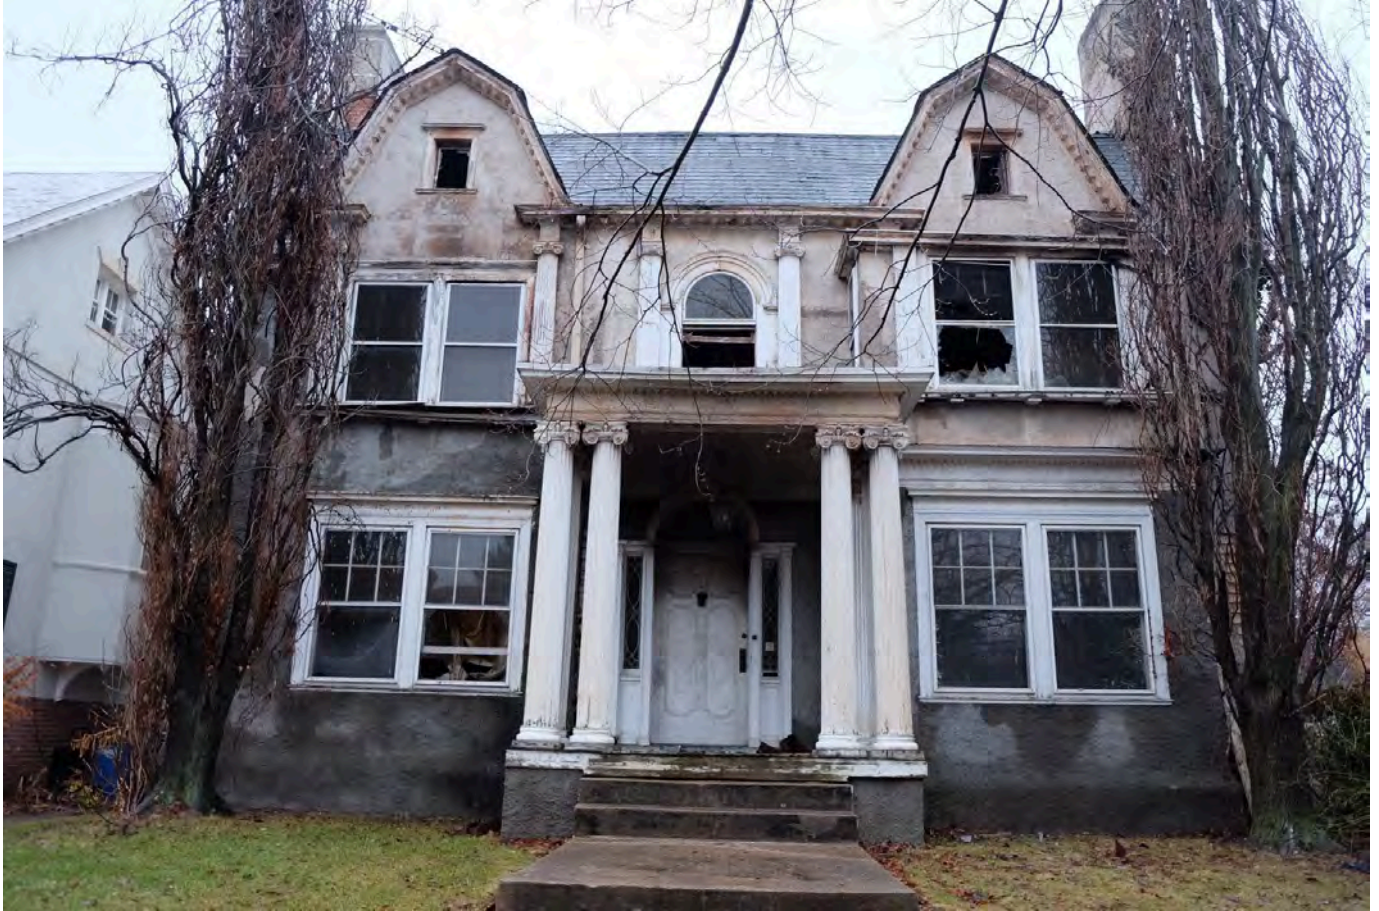
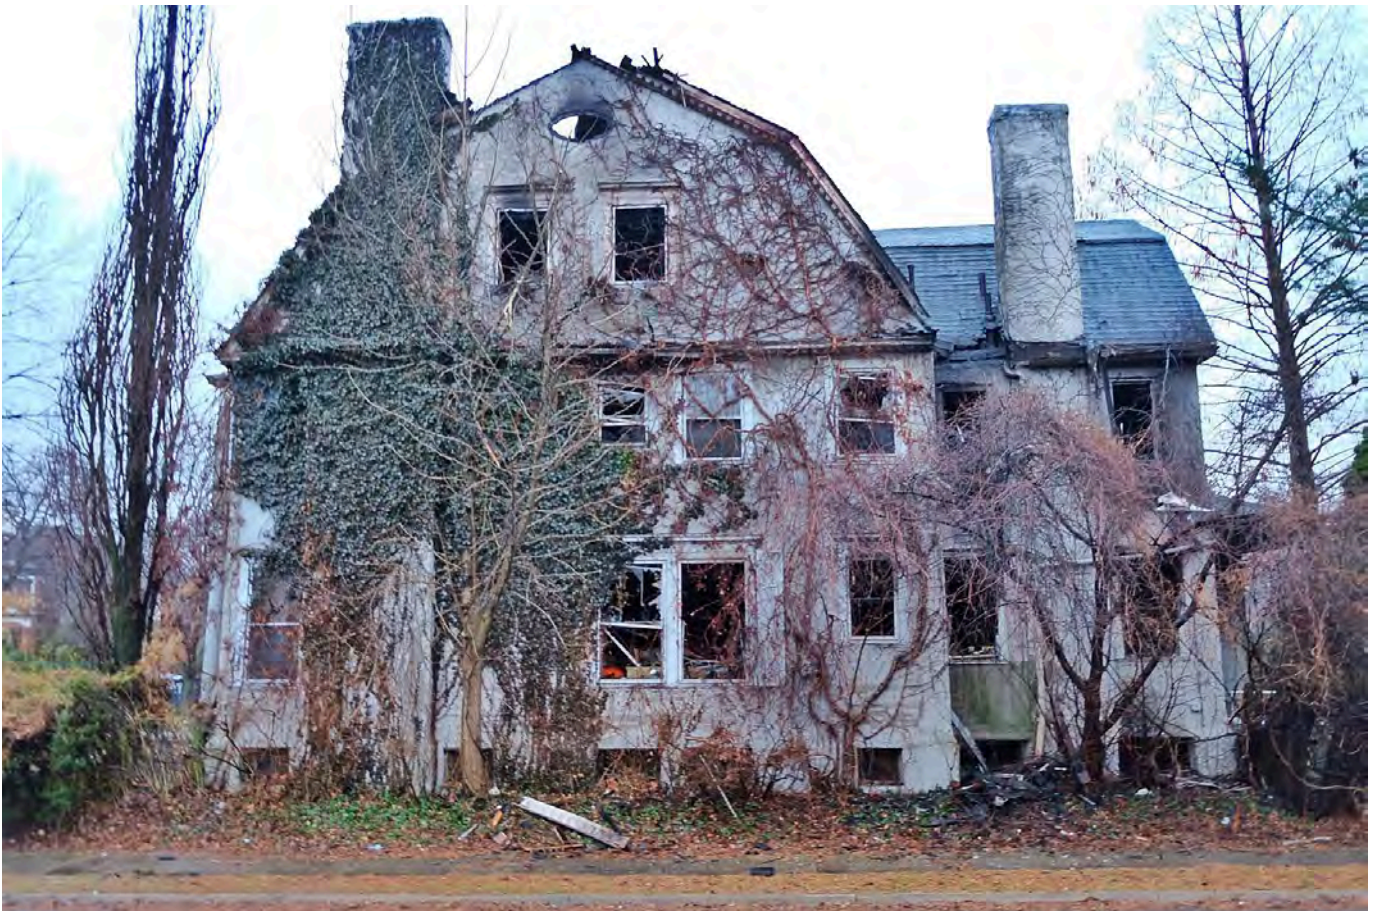
FEBRUARY 21, 2018

- Please note that this property caught fire/burned on 2/22/2018. As reported by the Detroit Building, Safety, Engineering, and Environmental Department (BSEED), the fire was concentrated in the rear wing of the property, leading to extensive damage to the interior and the roof at that location. A review of the photos of the property which were submitted to staff immediately after the fire indicates that the then owner boarded up the windows.

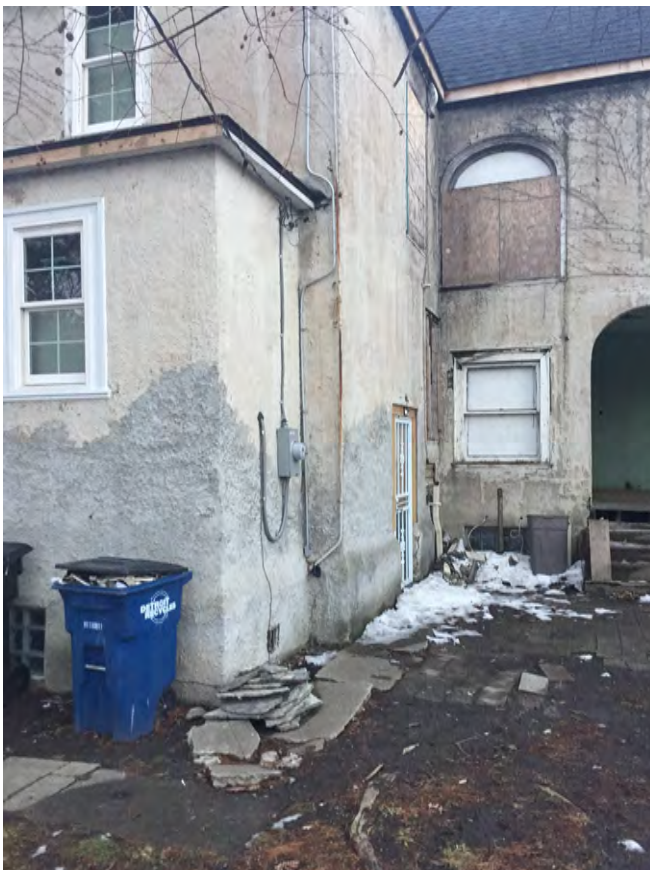
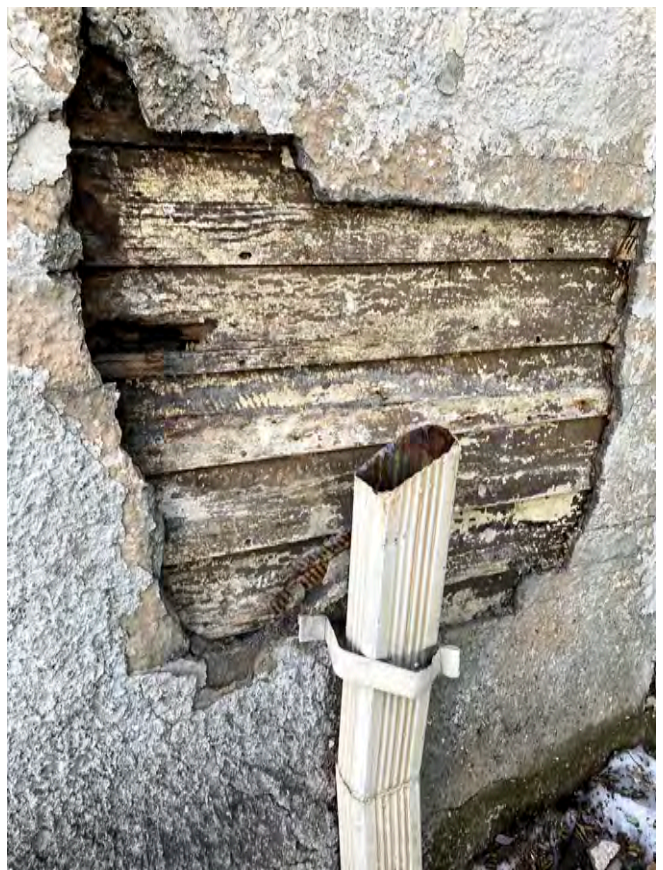
STUCCO DETERIORATION AT SW CORNER OF BUILDING

All layers of stucco are failing, and the walls show signs of heavy staining, cracking, bulges, and missing stucco. Water intrusion behind the stucco is apparent, and field investigation shows that the stucco was

Because the home was not originally designed to support the weight of stucco, the cost, extent, and nature required to properly replace the stucco, the owner is proposing to fully remove all non-original stucco and return to the original design intent through rehabilitating the underlying original wood clapboards. Indications are that the wood clapboards are in generally good condition, with the expectation that some areas will be fair or poor, with rotting wood requiring replacement. Missing or damaged clapboards will be replaced in kind, with new horizontal lap siding matching the existing historic siding in material, dimension, appearance, reveal and texture. Field investigations show that the original clapboards were installed with a 4 5/8" reveal and were 7/16" at the butt dimension of the clapboard. New clapboards will be 1/2" x 6" beveled lap siding and will be installed with a 4 5/8" reveal to match the existing historic siding to remain.

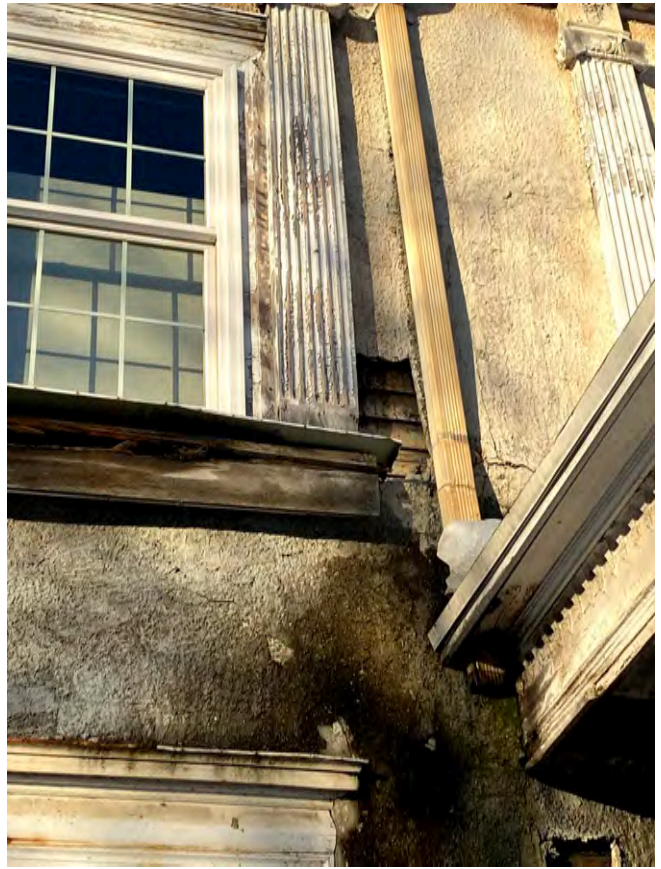
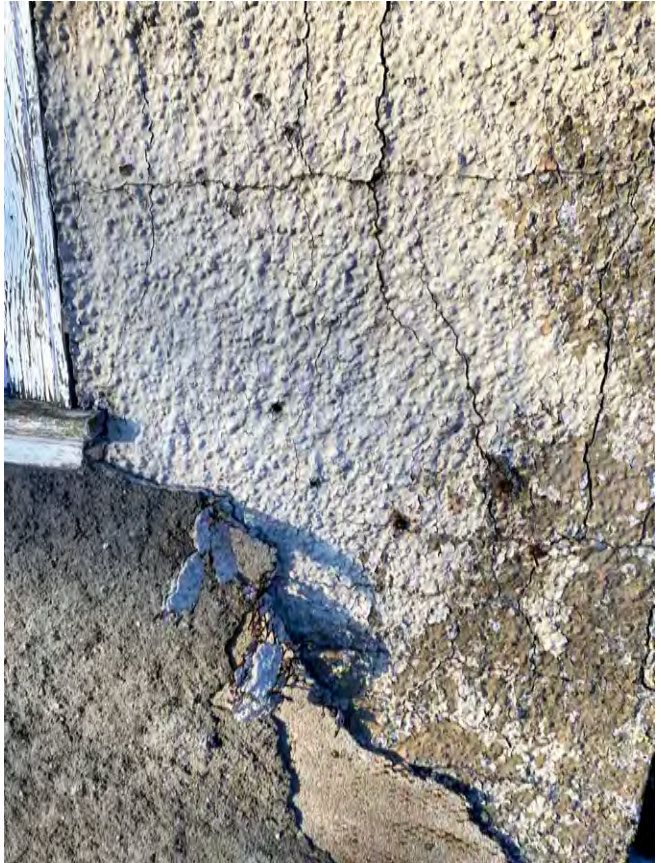
STUCCO DETERIORATION AT EAST FACADE

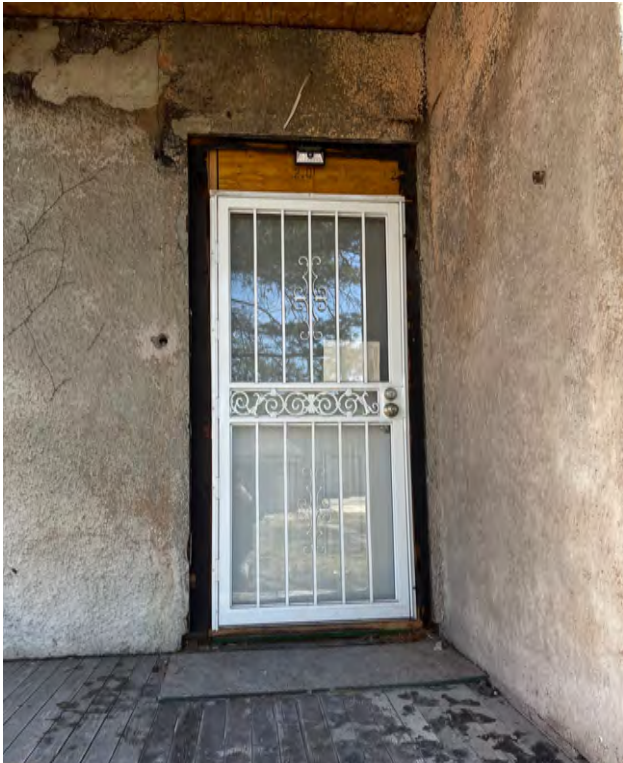
EXISTING KITCHEN DOOR & SECURITY DOOR PROPOSED FOR REPLACEMENT (WEST FACADE)

The owner proposes to replace two non-historic age insulated steel doors and steel security doors, one at the rear facade (kitchen porch), and the other on the south elevation of the service wing (grade entry leading to the basement) with new, fiberglass doors with an insulated glass vision lite. Please refer to the attached cut sheet. All exterior doors will be painted Black.

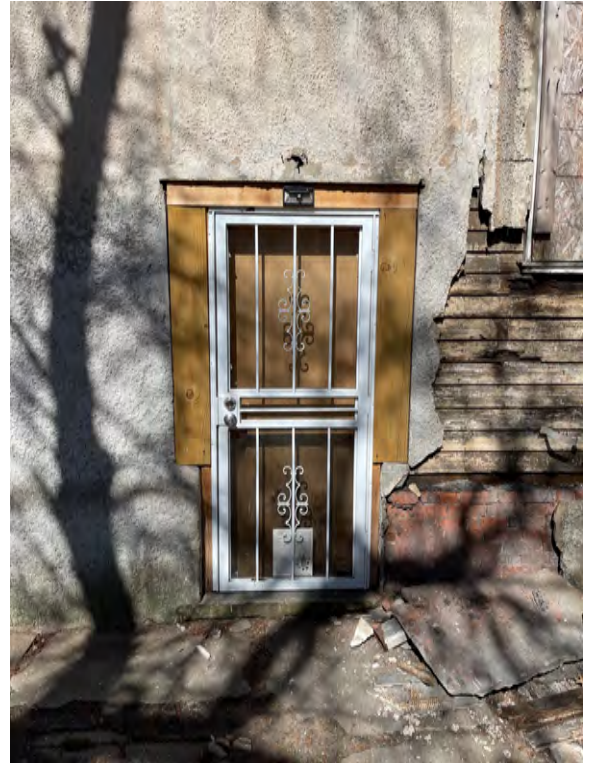
EXISTING GRADE DOOR TO BASEMENT W/ SECURITY DOOR PROPOSED FOR REPLACEMENT (EAST FACADE)
