STAFF REPORT 9-8-2021 REGULAR MEETING

APPLICATION NUMBER: 21-7395

ADDRESS: 4784 STURTEVANT STREET

SCOPE: DEMOLISH EXISTING GARAGE, REPLACE COLUMNS AND RAILING AT FRONT PORCH

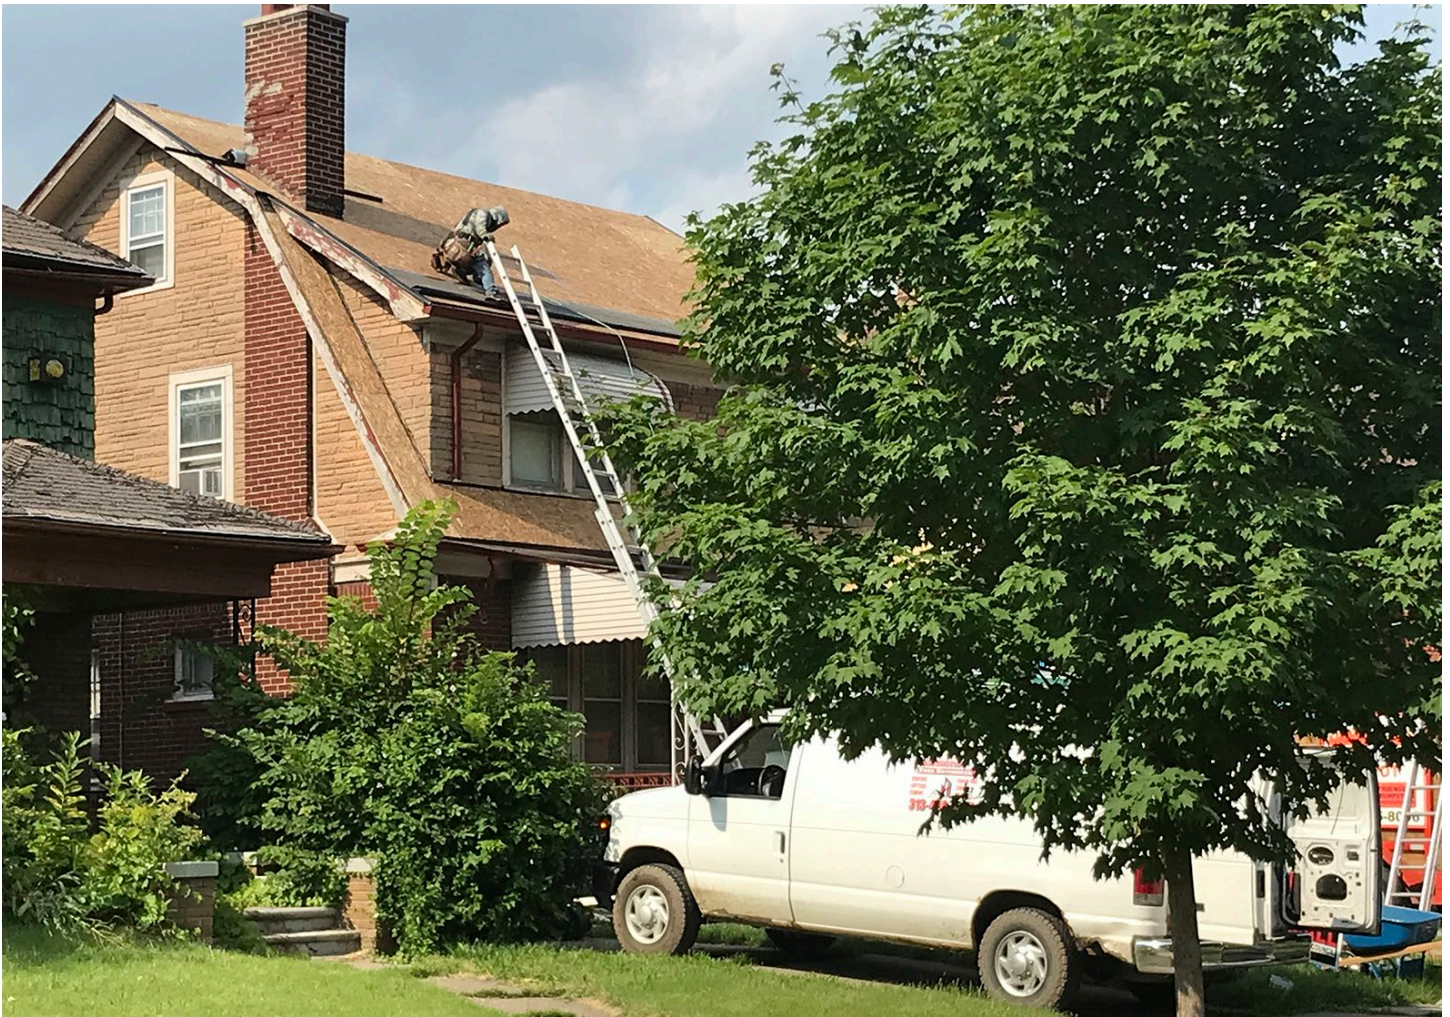
4784 Sturtevant. View from Sturtevant Street looking northeast. Roof replacement started and in progress on July 28, 2021 without COA and completed by July 31, 2021. The work was pending an administrative approval when it was started and when HDC staff documented the work in progress on July 28th. A COA for the roof along with miscellaneous other scope items was issued by staff on July 30th, 2021. Photo taken by HDC staff, July 28, 2021.

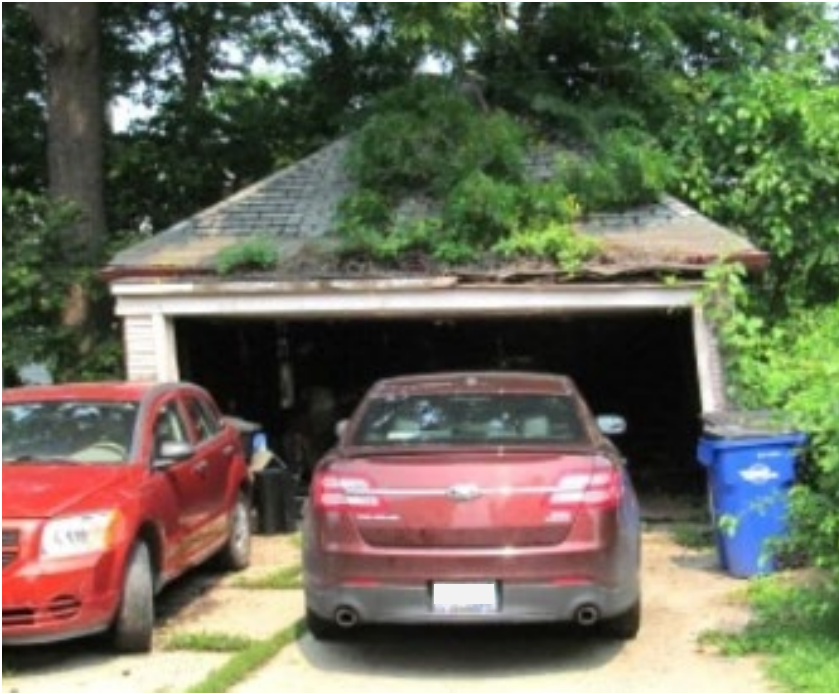
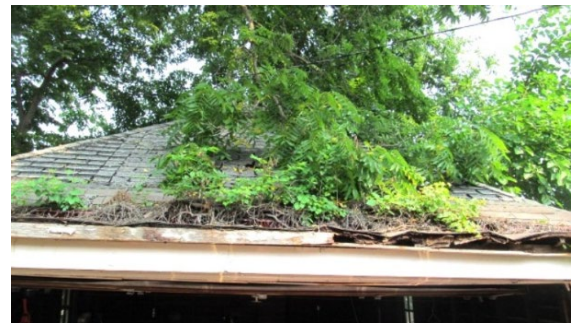
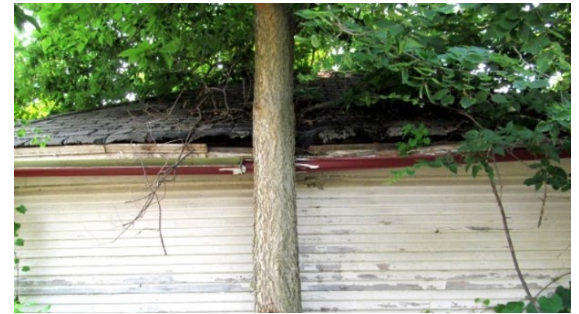
Existing conditions at garage. Applicant photos.

- Russell Woods – Sullivan Historic District was designated in 1999.
- It is staff’s opinion that the existing garage has lost historic integrity and no longer contributes to the overall historic character of the property.

- **Reason for Demolition:** Garage is in a total state of disrepair. Currently all (4) walls are leaning, side to side & front to rear. The (2) side walls & (1) rear wall are not seated on the concrete slab and are sitting alongside it on clay. The roof shingles are rotted & worn, with large tree branches touching in a few areas. I found several holes in the roof and a considerable amount of rotted wood in areas including the wood siding on the walls. All exterior painted surfaces are covered with peeling LBP. **There is a large tree that has grown directly into & penetrated the rear wall on the alley side that will not be cut or removed and remain in place.** The garage is missing the vehicle bay door & is open to trespass. **See Attached photos of all exterior sides of the garage as well as interior photos:**

It is staff's opinion that the proposal to demolish the existing garage by dismantling and removing all construction debris and the proposal to retain the existing concrete slab and surrounding trees should qualify for a Certificate of Appropriateness. Staff recommends that the Commission approve a COA for the proposed application, as it meets the Secretary of the Interior's Standards and the Russel Woods – Sullivan Elements of Design.

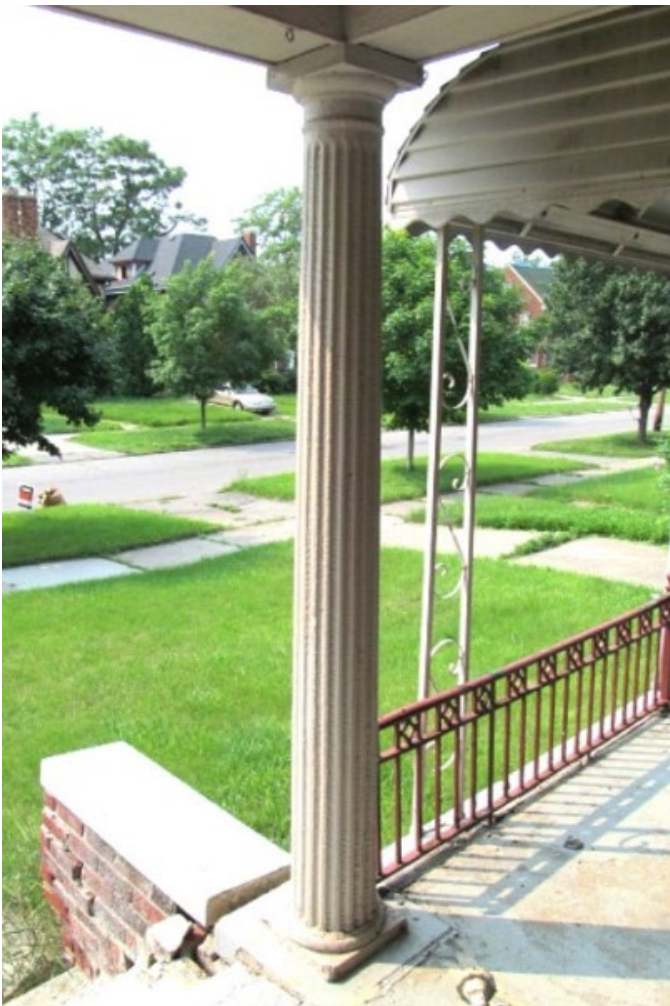
Existing conditions at west (left side) porch column. Applicant photo.

- The tapered, fluted wood columns are distinctive and important character-defining features of the property. It is staff’s opinion that the east column (right side) appears to be beyond repair and may require replacement. It is staff’s opinion that although the west column (left side) demonstrates the need for repair at the base, does not appear to be beyond repair.

- The proposal to replace the west column (left side) does not meet Standard 6 as it does not appear beyond repair. It is staff’s opinion that the west column (left side) should be repaired rather than replaced. While the east column (right side) may require replacement, the material and size (16” diameter) of the proposed replacement columns (fiberglass reinforced polymer) is an inappropriate material as it does not match the existing material or diameter of the distinctive feature.
- The proposed removal and replacement of the existing 24” high decorative wrought iron railing removes historic materials that characterize the property.

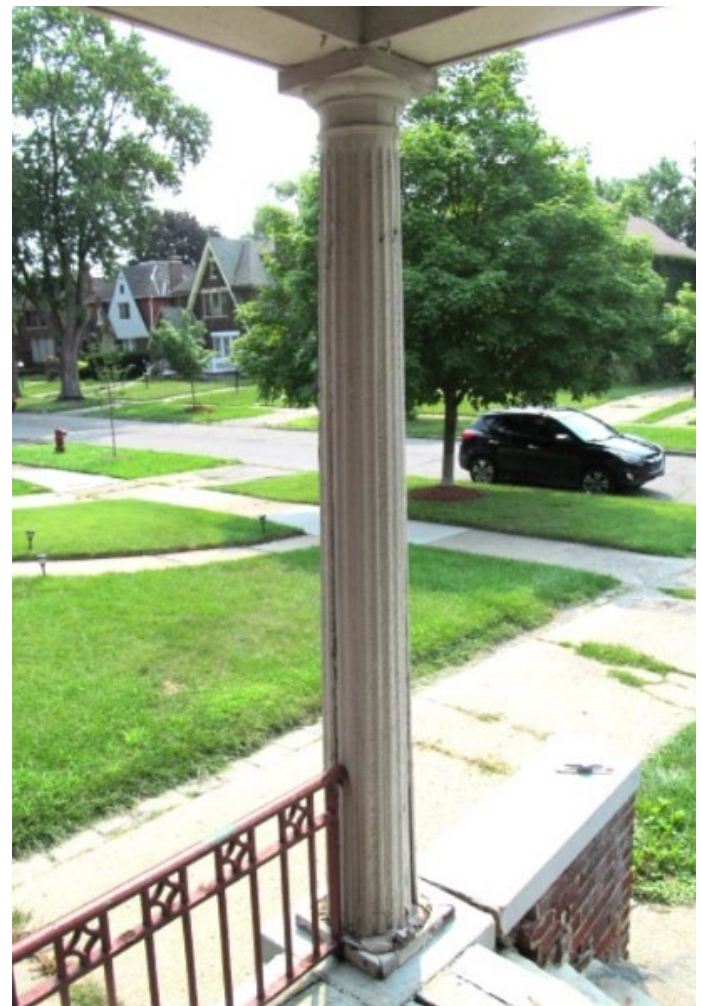
Existing conditions at east (right side) porch column. Applicant photo.

- **Reason for replacement:** Current columns including the cap & base at front porch have extensive rotted wood covered with lead based paint. (1) column is completely separated & split open. The other column is water saturated rotting wood with missing pieces and holes. Both columns are compromised and not providing proper support for the front porch overhang. **See attached photos of existing columns & front porch overhang.**

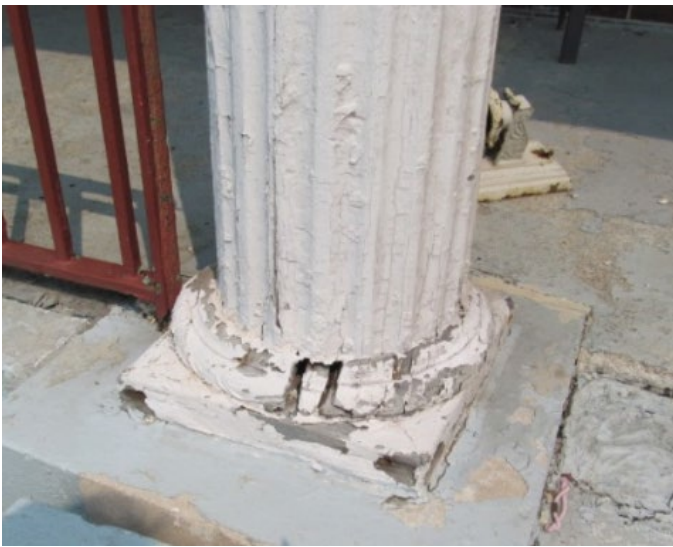
Existing conditions at west (left side) porch column. Applicant photos.

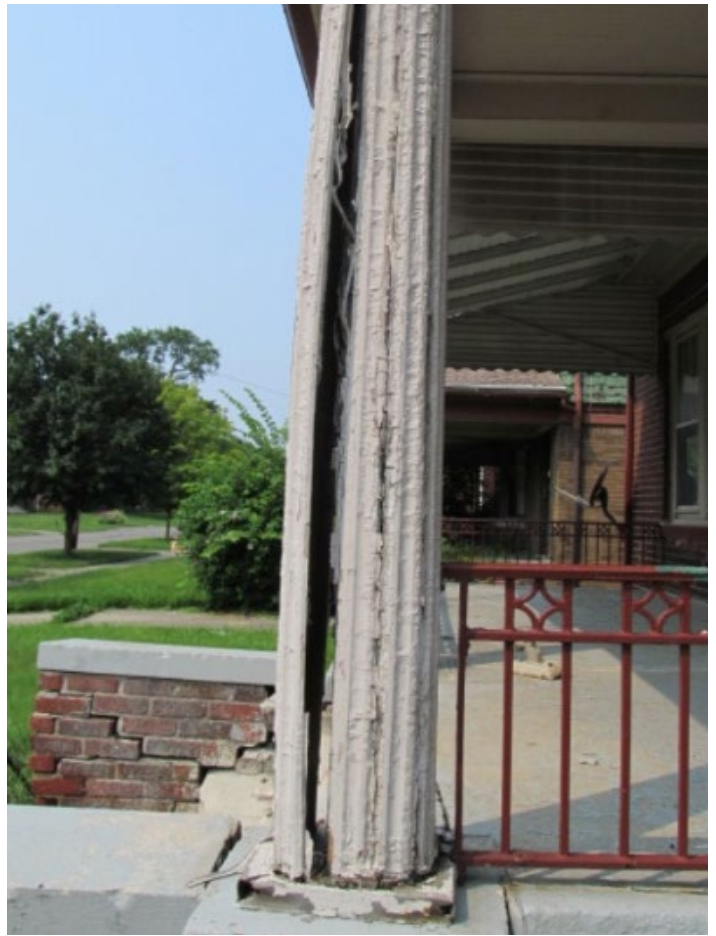
Existing conditions at west (right side) porch column. Applicant photo.

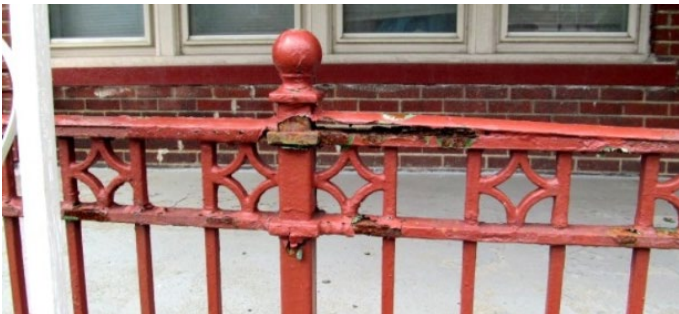
Existing conditions at porch railing. Applicant photo.

- The existing 24” high decorative wrought iron porch railing is also a distinctive and important character-defining feature of the property. The materiality, design, and height of the existing railing all contribute to the historic character of the property. It is staff’s opinion that although portions of the railing appear to be rusted, the railing is not beyond repair and therefore does not require replacement.

- Existing railings that line the perimeter of front porch in 3 separate areas are made of wrought iron and are painted, rusted, separated and only 24" high which does not meet code. The measurements are as follows: 1-1/2" square posts with 1/2" ballusters, an R3 radius top rail for a total of approximately 27 feet. There is a custom shaped star inserted in areas. **See attached photos of existing railings.**

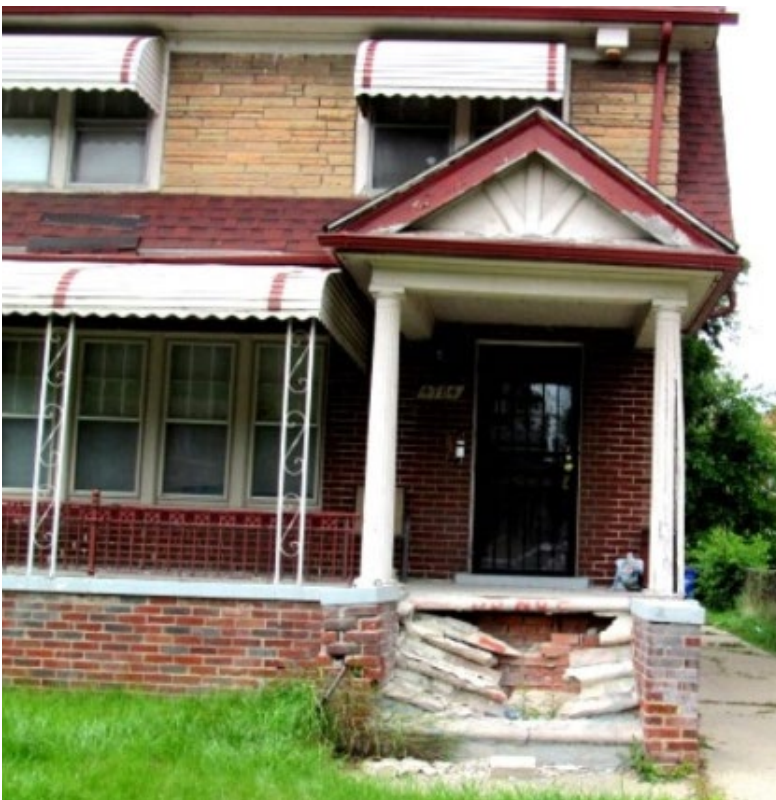
Existing conditions at porch columns and railing. Applicant photo.

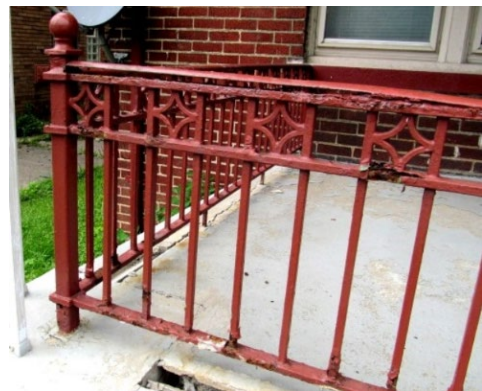
Existing conditions at porch railing. Applicant photo.

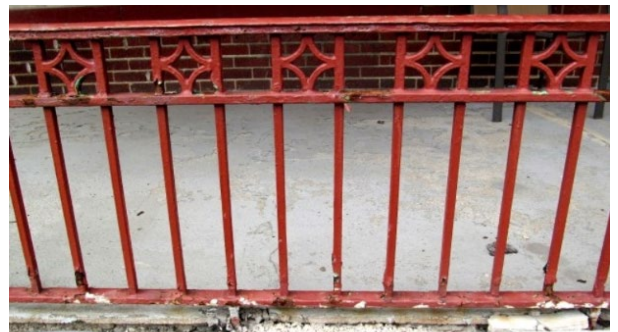
Existing conditions at porch railing. Applicant photo.
