STAFF REPORT: 09-08-2021 MEETING

APPLICATION NUMBER: 21-7400

ADDRESS: 630 VIRGINIA PARK

SCOPE OF WORK: REPLACEMENT OF HISTORIC WINDOWS* (WORK COMPLETED WITHOUT APPROVAL)

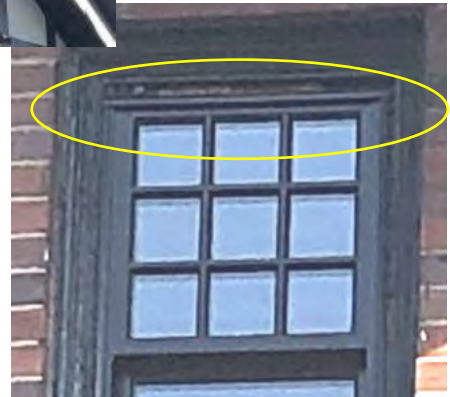
- The two small nine-over-one double-hung windows at the second floor do not fit the existing openings. Infill material has improperly filled the gap between the top sash and window frame.

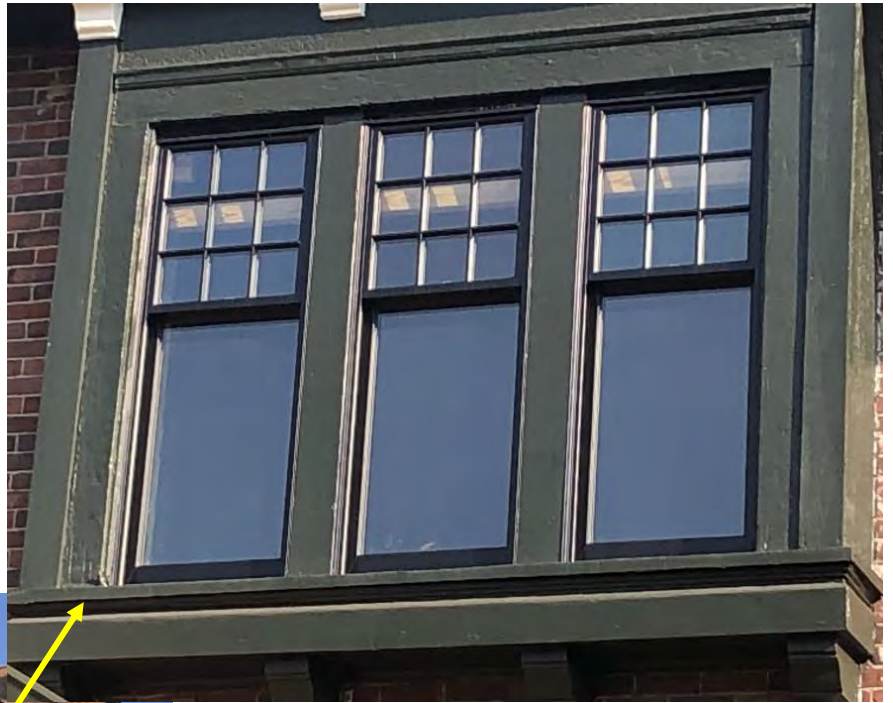
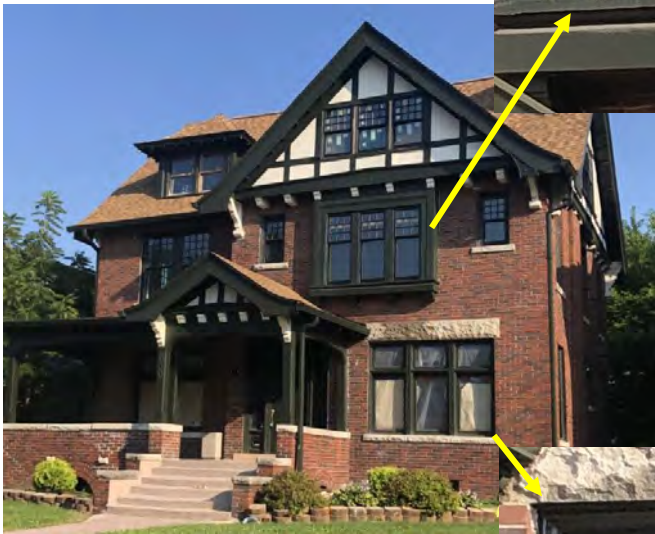
*Front elevation, HDC staff photo
Close-ups show replacement windows
in second floor box bay, and historic
sash remaining in first floor openings.*

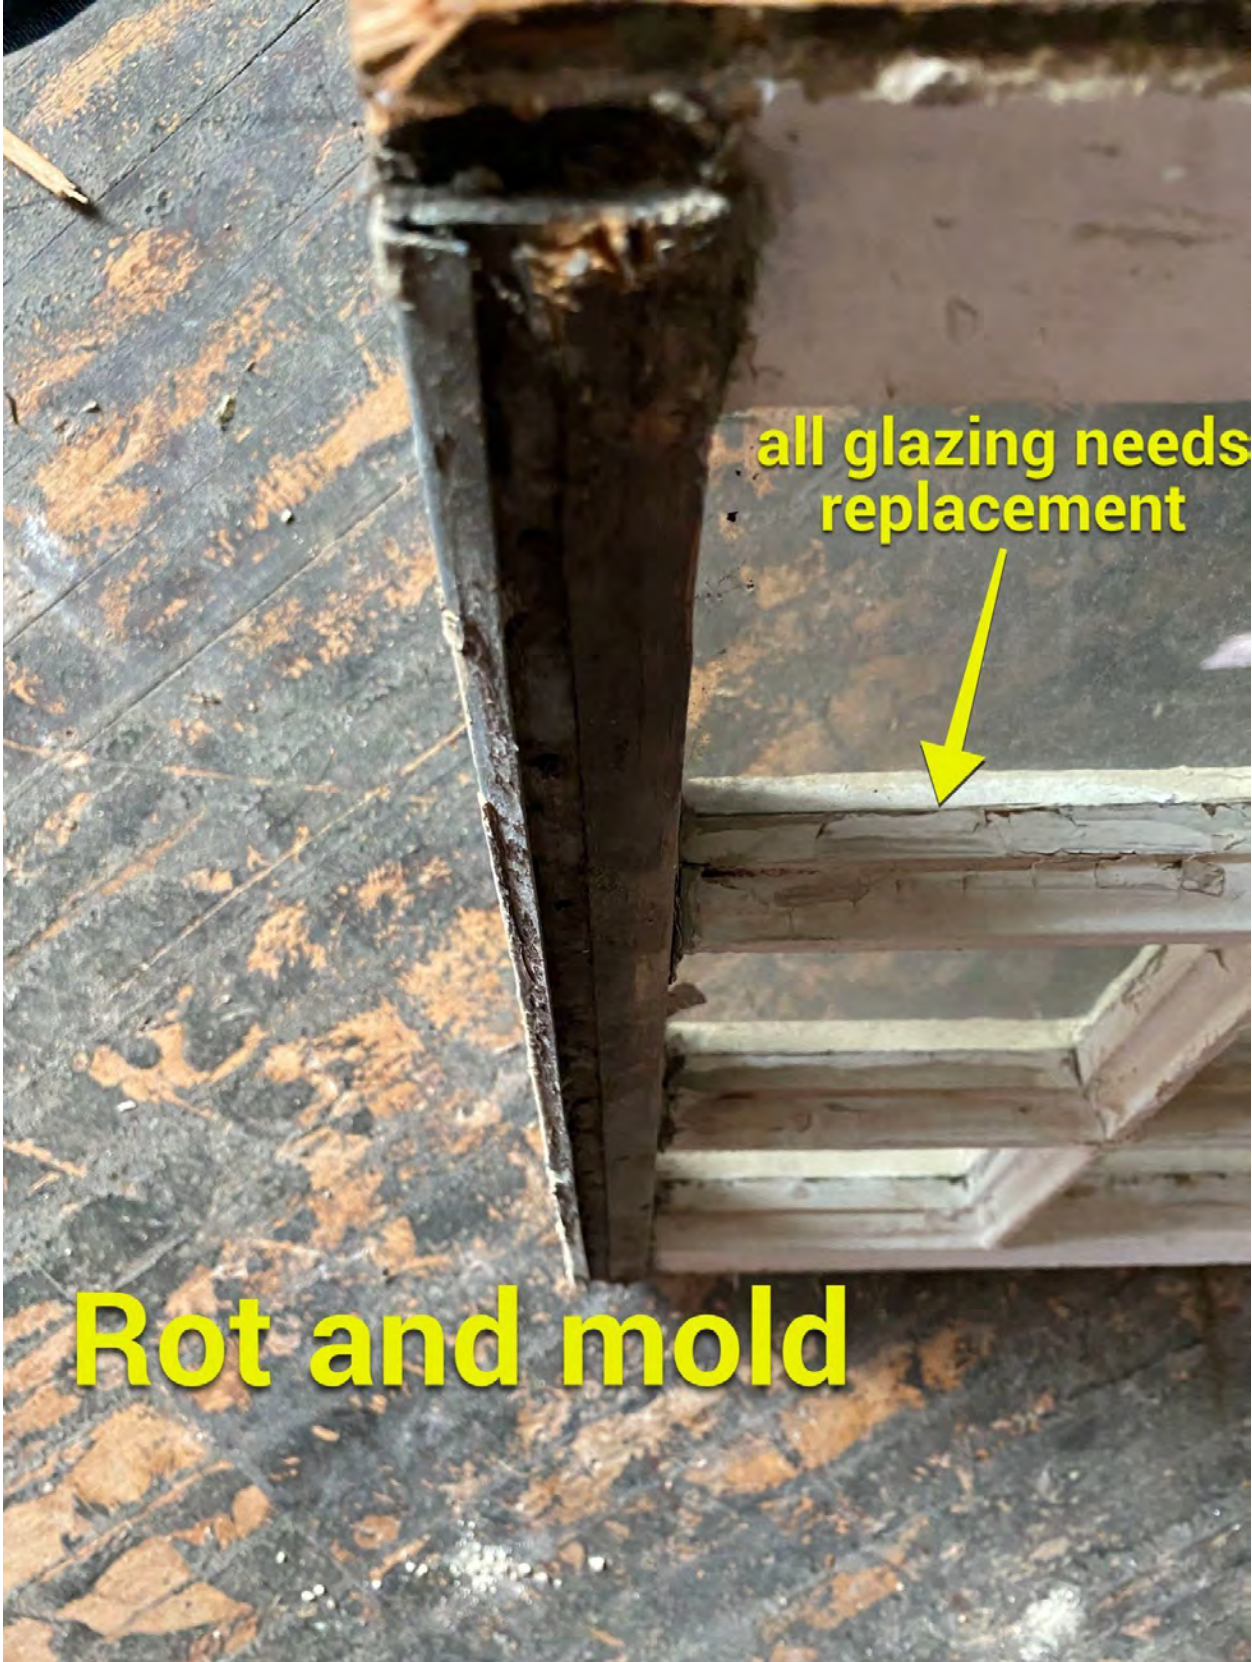
Window 5, 9/1divided light South Elevation

all glazing needs replacement

Rot and mold

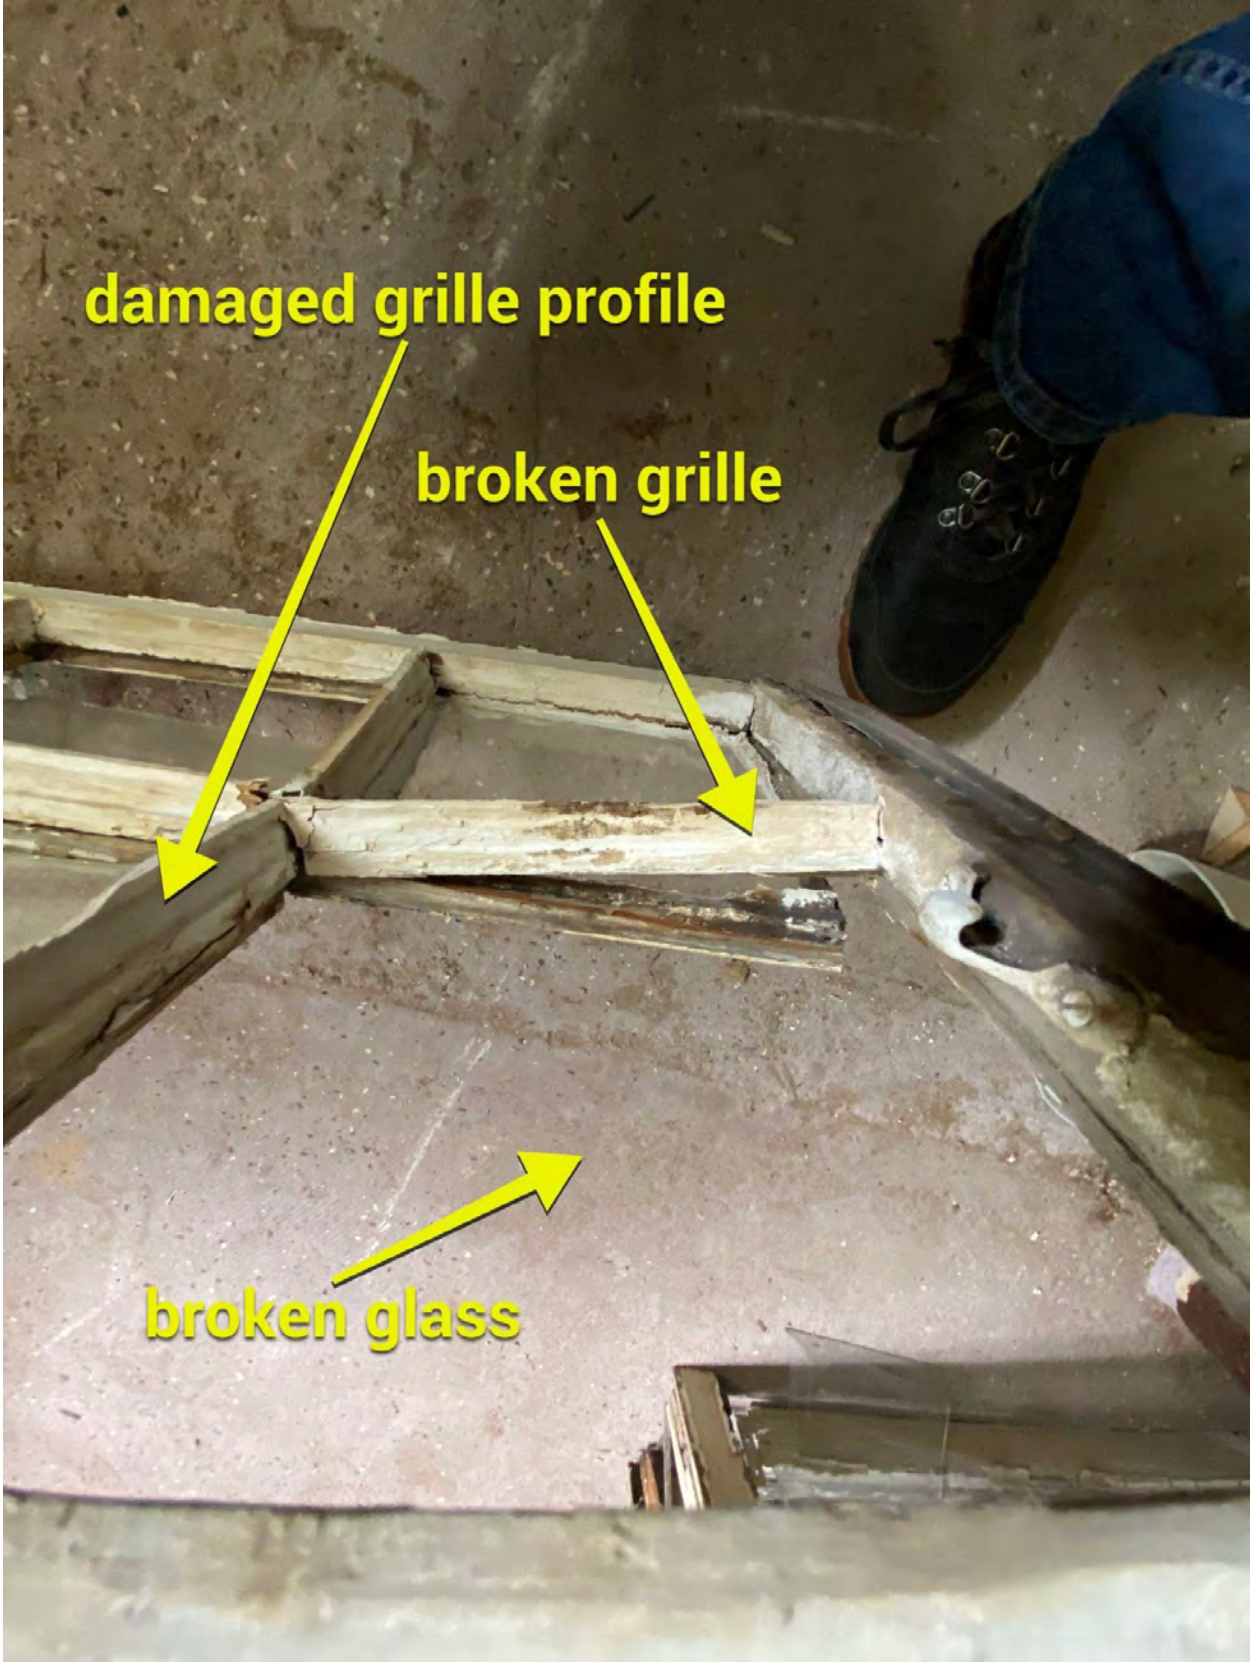
Window 5 , 9/1 divided light South Elevation

damaged grille profile

broken grille

broken glass

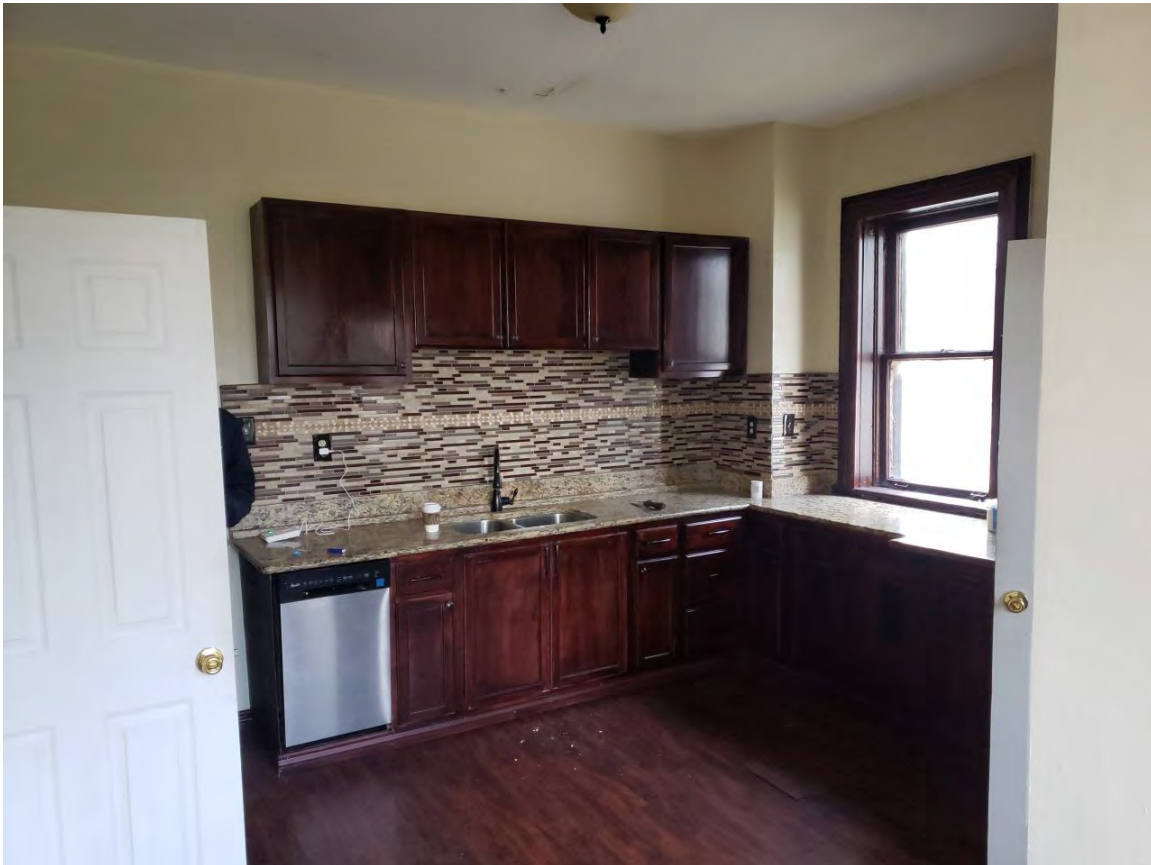
Window 1-01 (First Floor, West Elevation, Kitchen)

- Painted shut on inside and outside

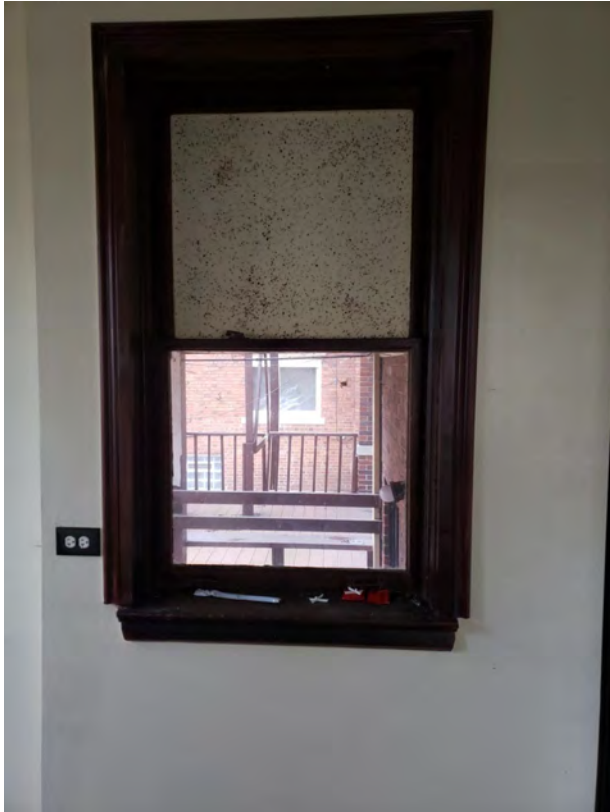
Window 1-02 (First Floor, East Elevation, Kitchen)

- Glass missing in upper Sash
- Upper sash blocked by existing addition (to be demolished)

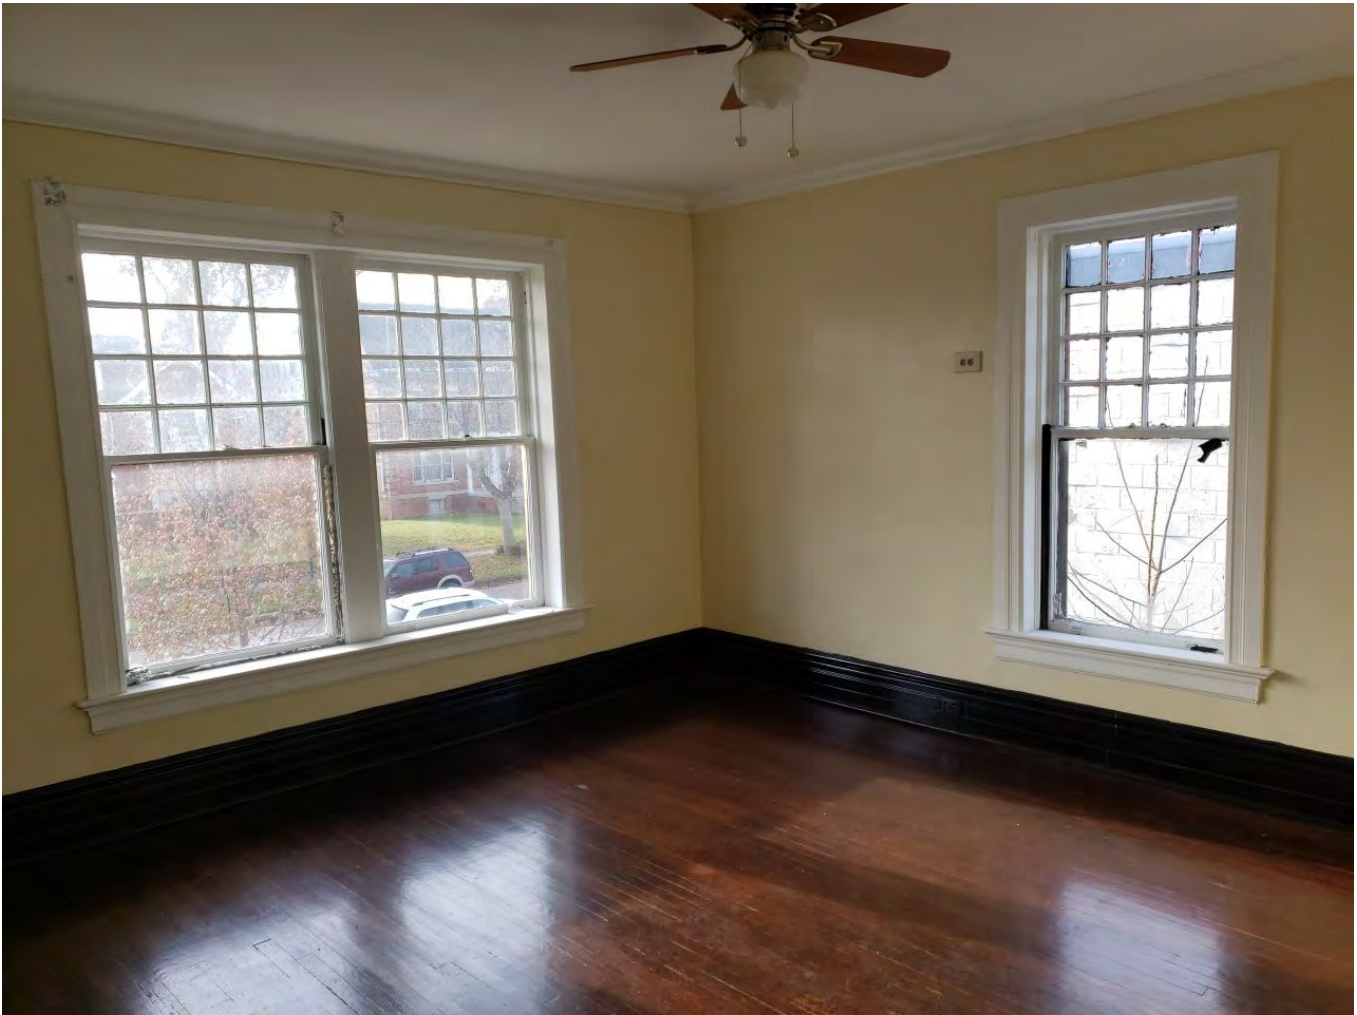
Window 2-01-03 (Second Floor, South/West Elevation)

- Double Hung, 16 over 1
- Weak weather seal due to rot
- Extensive rot at sills and vertical framing

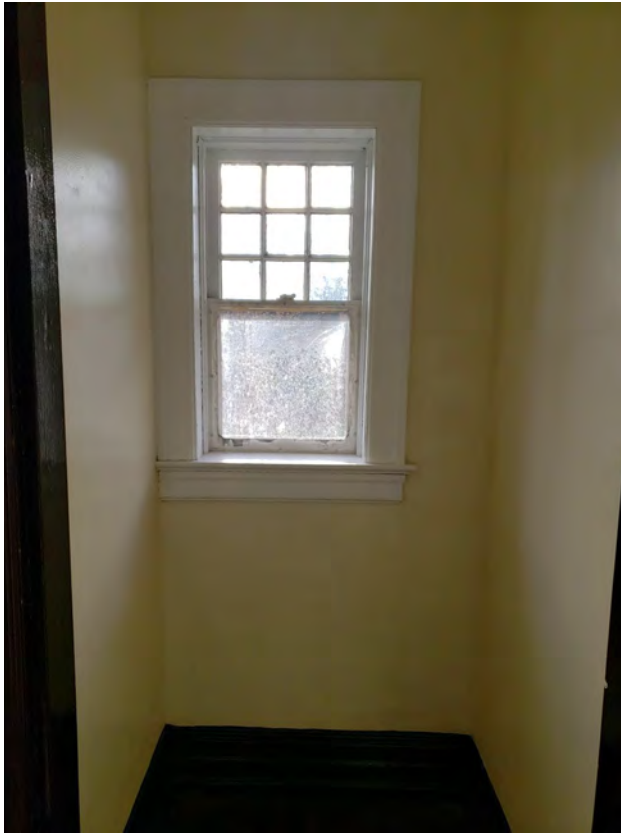
Window 2-04 (Second Floor, South Elevation)

- Double Hung, 9 over 1
- Extensive rot at sills and vertical framing

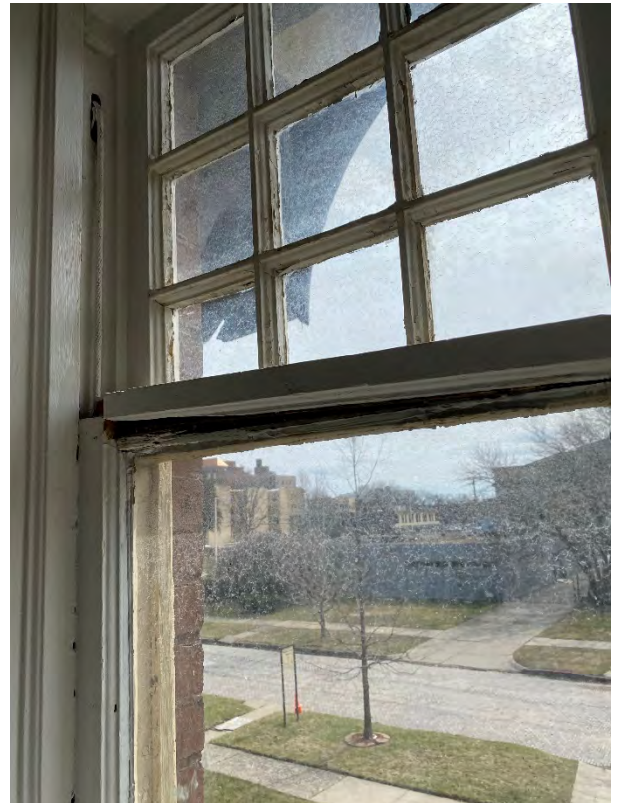
Window 2-05 (Second Floor, South Elevation)

- Double Hung, 9 over 1
- Extensive rot at sills and vertical framing
- Opening mechanism inoperable (painted shut)
- Broken lower sash

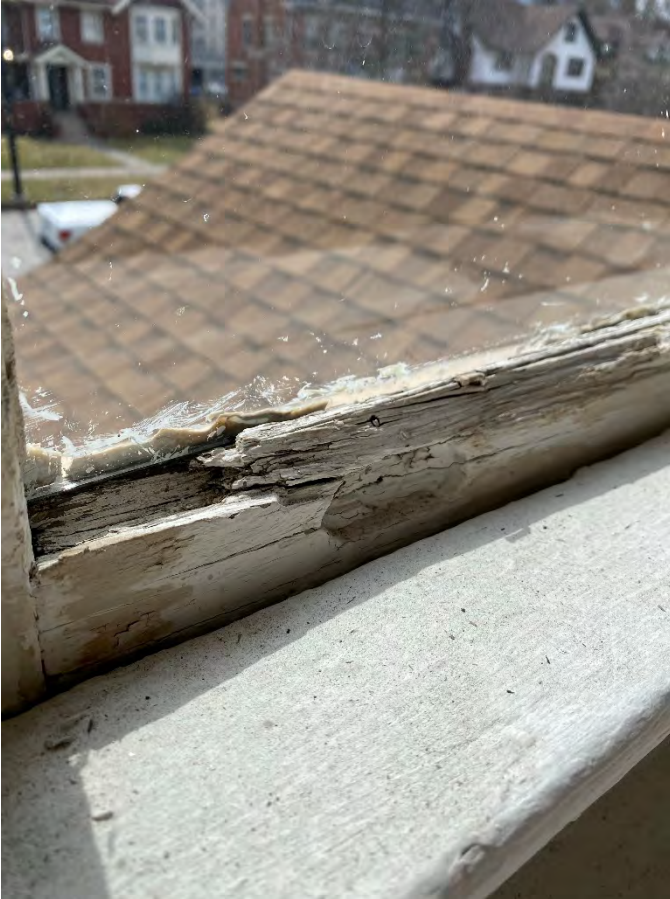
Window 2-06 (Second Floor, South Elevation)

- Double Hung, 9 over 1
- Extensive rot at sills and vertical framing

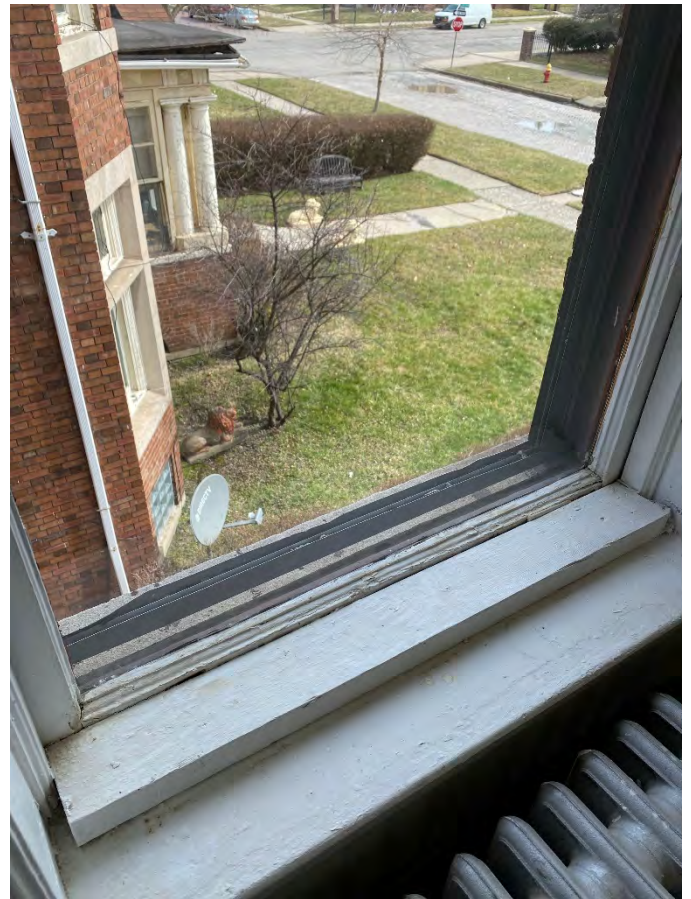
Window 2-07 (Second Floor, East Elevation)

- Double Hung, 1 over 1
- Extensive rot at sills

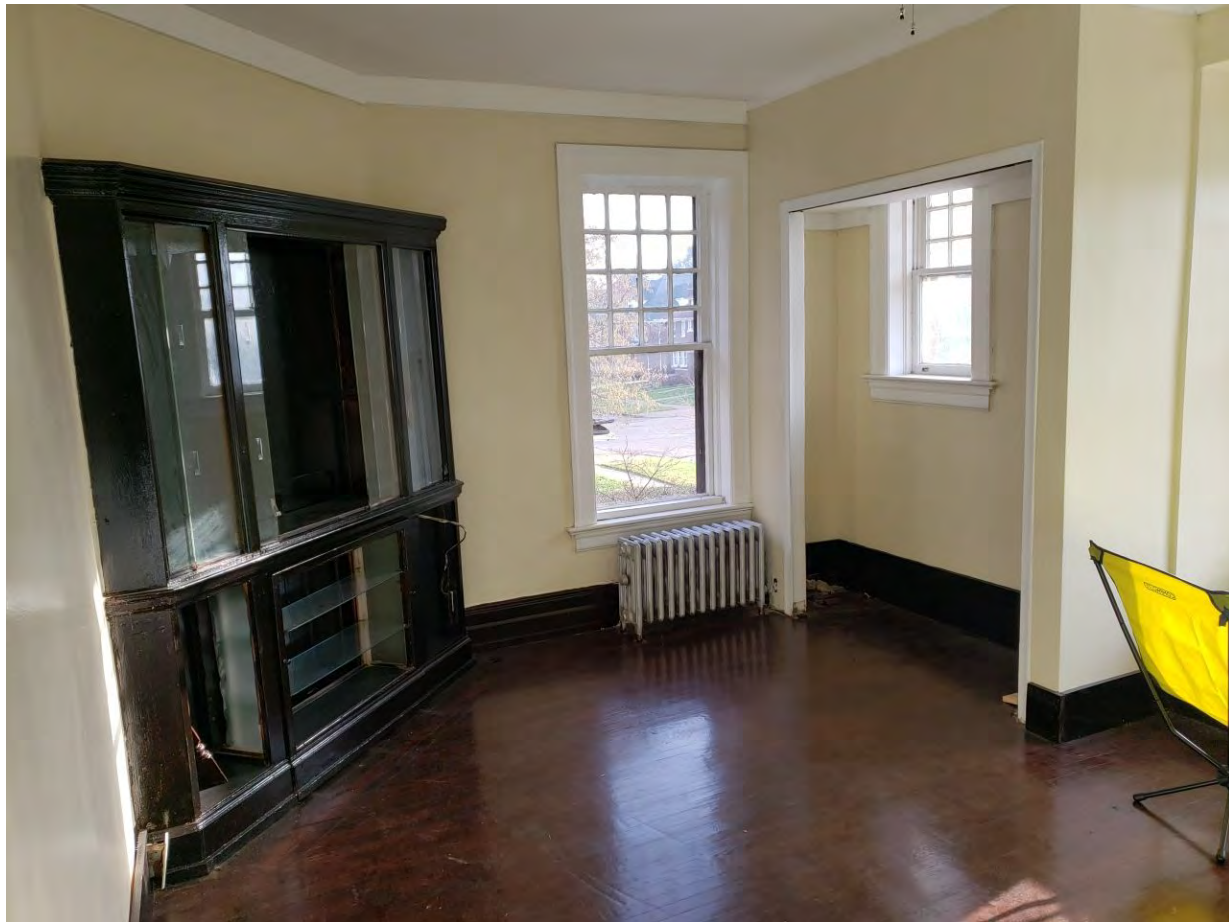
Window 2-08-09 (Second Floor, East/South Elevation)

- Double Hung, 16 over 1, 9 over 1
- Extensive rot at sills

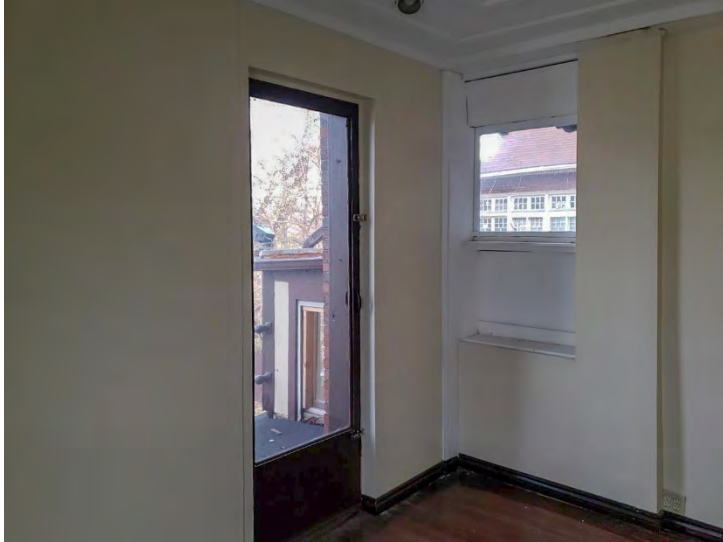
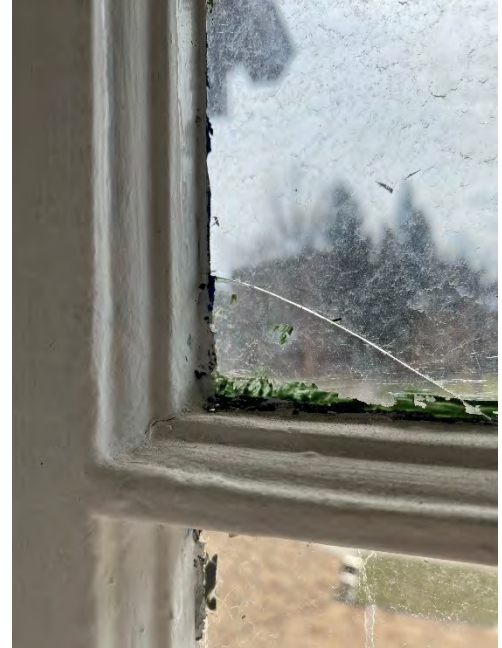
Broken Glass

Examples of typical damage

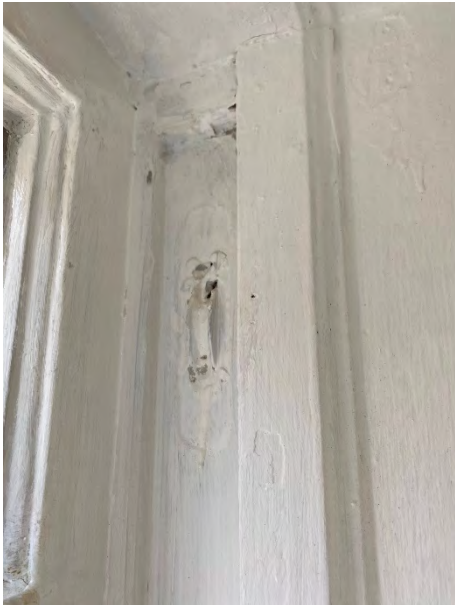
Operating hardware missing or inoperable
