STAFF REPORT: 9-08-2021 MEETING PREPARED BY: D. RIEDEN

APPLICATION NUMBER: #21-7393

VIOLATION NUMBER: #378 ADDRESS: 2071 LONGFELLOW

SCOPE: PAINTING OF PREVIOUSLY PAINTED MASONRY (WORK DONE WITHOUT PERMIT)

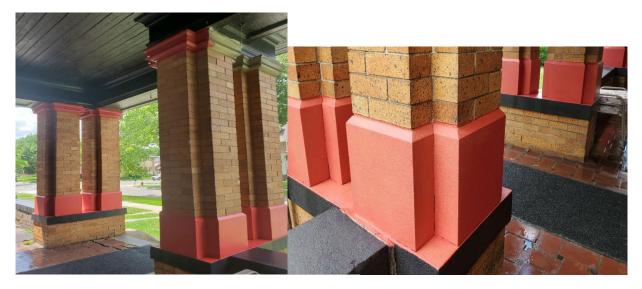
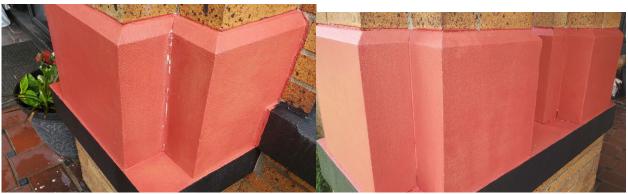
I am following up with you to let you know where I am at in the process of removing the paint on the concrete, and adding the "cream" color that was approved for specific areas. During spring and up until now I was working on making these two changes so here is where I am at today.

I used the entire container of Sure Klean Heavy Duty Paint Stripper. I applied the stripper on May 16^{th} , May 23^{rd} , May 30^{th} , June 5^{th} , June 19^{th} , and June 26^{th} . From my observations, the paint stripper slightly lightened the paint color however no paint was removed. Here are some recent pictures of the areas that I took today for your review.

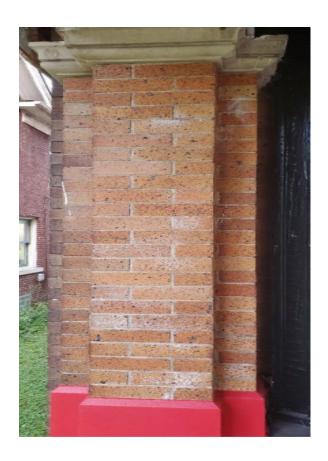
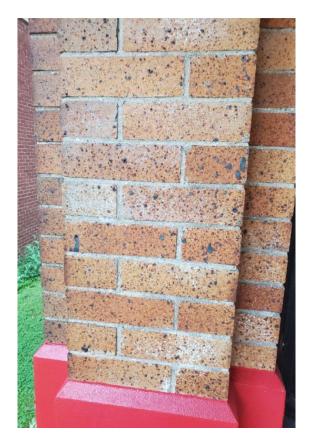
This is a follow up to our telephone conversation today, July 29, 2021. I want it to be known that I did attempt to remove the paint off the other area of the house, the area where the brick is an orange like color. The directions recommended that I test an area first, so I did. After applying the recommended paint stripper, I noticed how the stripper damaged the surface of the brick so I did not use it anymore on those areas. Here is a picture, and then a closer up picture of that same area that I applied the paint stripper to. This area is left of the three dining room windows.

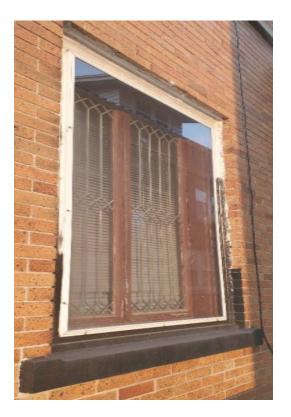
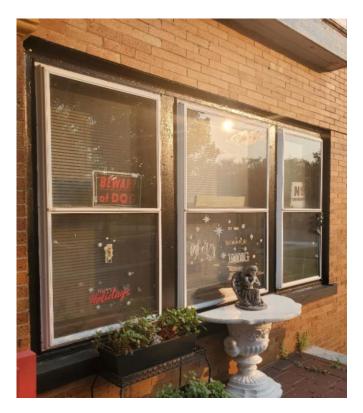
Some areas of the concrete around the windows were painted black because other paint from prior paintings were there. For example, white paint along the front windows and side windows were on the brick. To have a better appearance, the concrete that had white paint were painted black to give a uniform look. Here are two pictures to demonstrate what I am describing. The first picture is a living room window on the side of the house and the second is three living room windows on the front of the house.
