STAFF REPORT: 12/8/2021 MEETING

APPLICATION NUMBER: #21-7612

ADDRESS: 2522 W BOSTON BLVD

SCOPE: REPLACE ALL WINDOWS AND SHUTTERS, RESTORE ORIGINAL WINDOW OPENINGS (WORK COMPLETE WITHOUT APPROVAL)

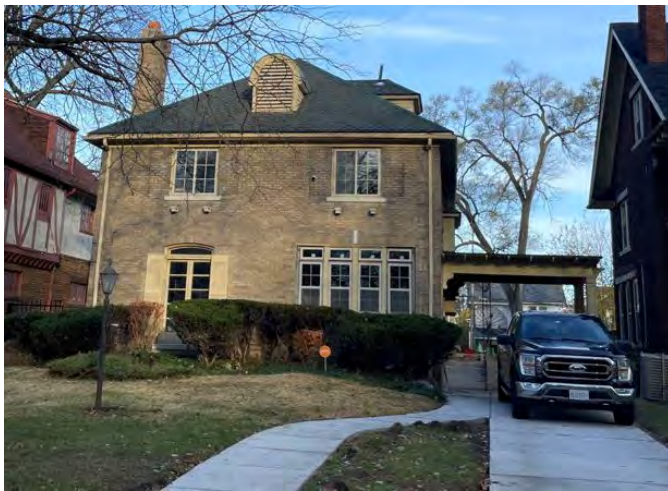
Site Photo 1, by Staff November 18, 2021: (South) front elevation.

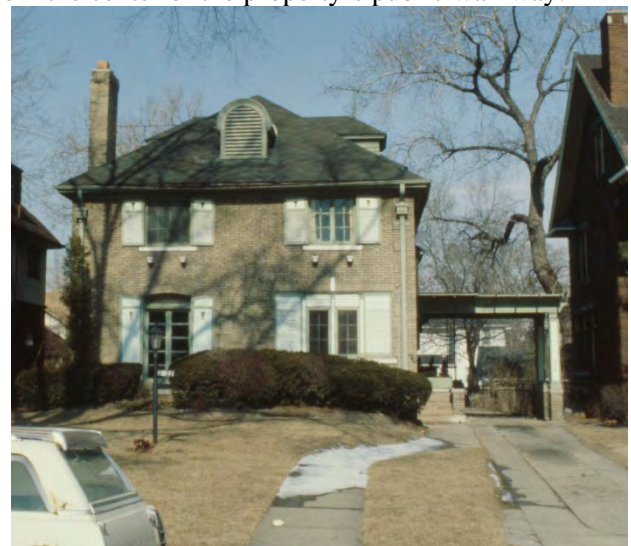
Site Photo2, designation slide 1980: (South) front elevation.

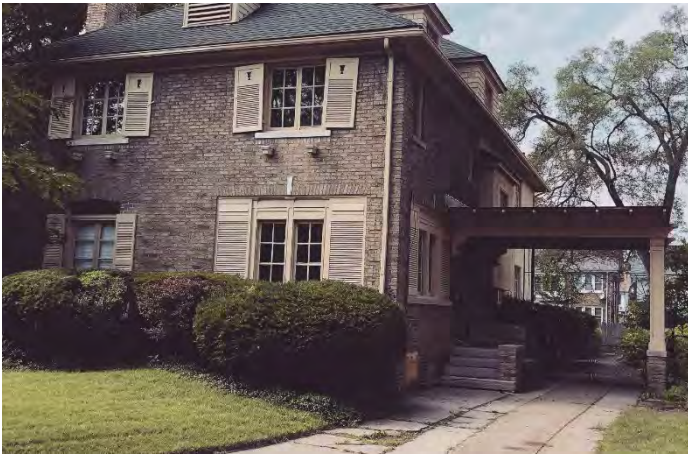
Site Photo 3, Real estate photo (date unknown): (Southeast) front/side elevation showing original window detailing

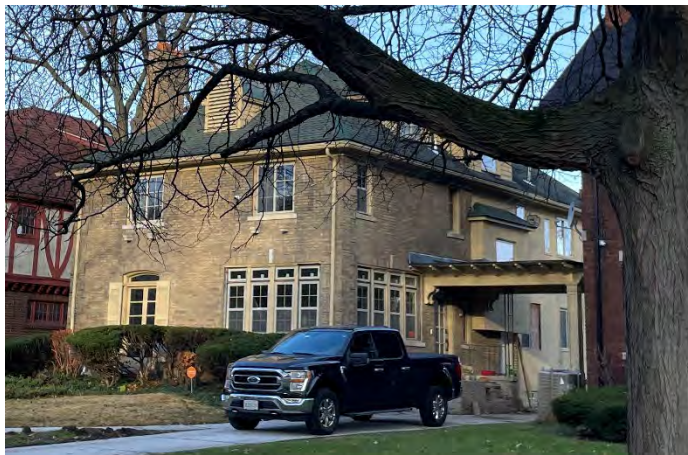
Site Photo 4, by Staff November 18, 2021: (Southeast) front/side elevation showing windows replaced.

- Staff observed that the vinyl replacement windows did not match in the operation, light configuration, or materiality, all of which Staff finds are not appropriate replacements. It is staff’s opinion that replacement of casement windows with sliders or picture windows on all elevations are inappropriate in type and scale and destroy character-defining features.

Staff finds that the replacement of forty-one (41) original windows with vinyl windows introduction of new operations of windows, such as the double hung windows replacing casement windows, destroys the historic character of this property and removes distinctive, character-defining features.

- The applicant replace the vinyl windows in these openings with wood or aluminum-clad-wood that matches in design, operation, dimension of the original windows and submitted to HDC Staff for review and approval.
- The applicant produce drawings or other documentation that show how the final dimensions, design, material and color are to match historic design of the original shutters as shown in the designation photo and submitted to HDC Staff for review and approval.

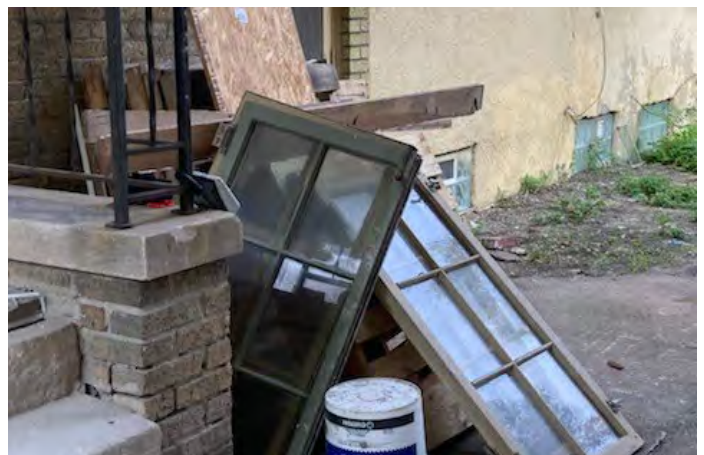
Site Photo 5, by Staff August 5, 2021: (Southeast) front/side showing original wood casement windows.

- It is Staff’s opinion that the original wood 6-light casement windows, especially on the front and side elevations were distinctive character-defining features of the house.

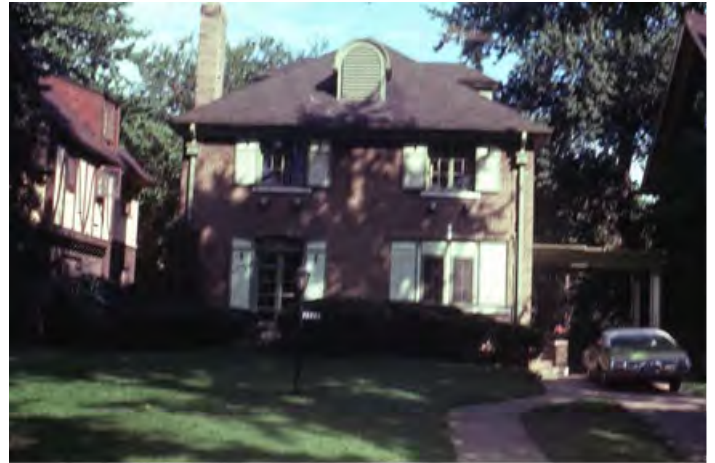
Site Photo6, designation slide 1974: (South) front elevation showing front elevation shutters and wood paneling.

- Staff observed that the wood panels, which appeared as “shutters” in the mullied windows, on the front and side elevations were a careful intervention that occurred before the district was designated. These detailed wood panels were observed in place since the 1974 historic designation photo. The quality, craftsmanship and wear over time matches the proportions and details of the shutters. Staff received a photo from the Applicant that reveals windows and transoms under the interior drywall or plaster of the walls (see Photo 8). Despite the unknown status of this installation and the rationale for covering these transoms and windows, it is staff’s opinion that these panels were not distinctive character-defining features as they did not acquire their own historic significance under Standard 4. The restoration of the original windowed openings would instead be appropriate, especially since the original fabric was found present beneath this wood paneling and hidden in the wall.

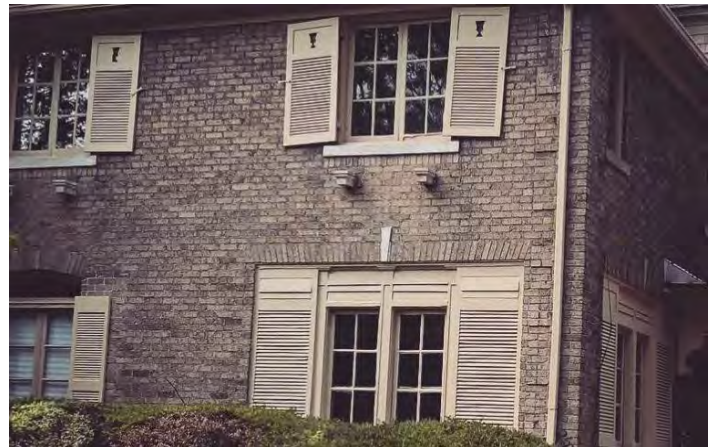
Site Photo7, close up of photo 3: (South) front elevation showing details of front elevation shutters and wood paneling.

- Staff confirmed that the applicant intends to replace the shutters, which have been removed. Staff observed that there is an original “butterfly shape” of the first-floor casement that remains, which had a version of shutter replacement that did not match the original size and did not have the top portion of the original shutters that would fit the arch of this window’s opening. Both designation photos of 1974 and 1980 show this feature of the shutters. (See photos 2 and 6.) It Staff opinion that these and the matching shutters of the front elevation contribute to the colonial architecture of this house and are therefore distinctive character-defining features of this historic building and that any replacement of new shutters should match in dimension, material and design of these original shutters.

- Replace six (6) front elevation shutters with six (6) wood shutters of same design and dimensions.

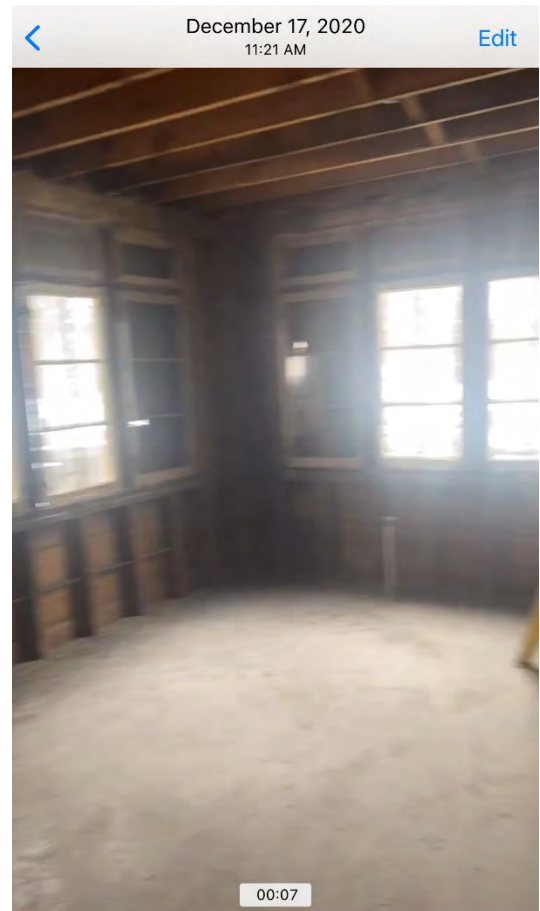
- Because this work was done without approval. staff made several attempts to determine the original count, operation, condition and material of the original windows. Staff asked for photos of the original windows but received the response from the Applicant that there were no photos and that all original windows were disposed. Staff did take photos that showed some original windows under the carport (see photo 5). Therefore, staff’s best determination is that all windows were wood framed with true divided light, usually in the form and operation of 6-light casements. The applicant has stated there is a video of some of these conditions, but has only provided a few screen shots, such as that shown in photo 8.

Site Photo 8 by Applicant, December 2020, showing interior of wood-paneled windows of first floor front and side elevations.
