**STAFF REPORT 02-09-2022 MEETING**

**APPLICATION NUMBER: 22-7669**

**ADDRESS: 1405 GRISWOLD**

**SCOPE: REPLACE STOREFRONT SYSTEM (WORK COMPLETED WITHOUT APPROVAL)**

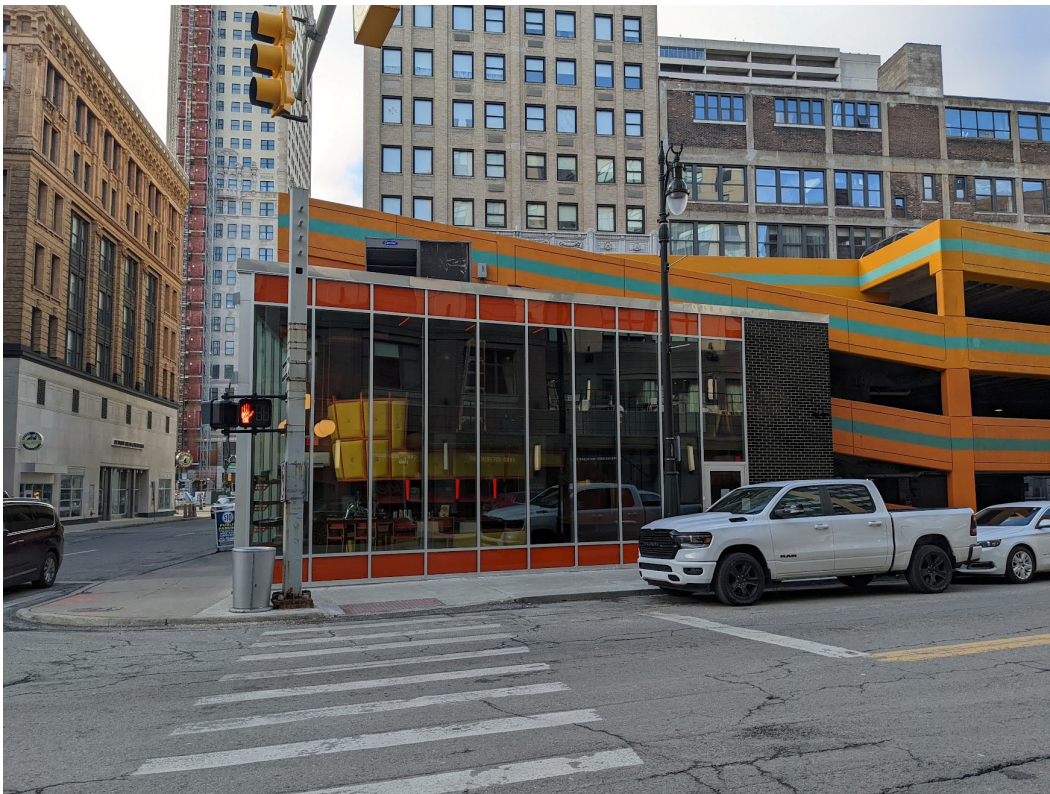
*Current view towards the west of 1405 Griswold, at Grand River, showing work already completed. Griswold Street Elevation shown. Staff photo, January 14, 2022.*

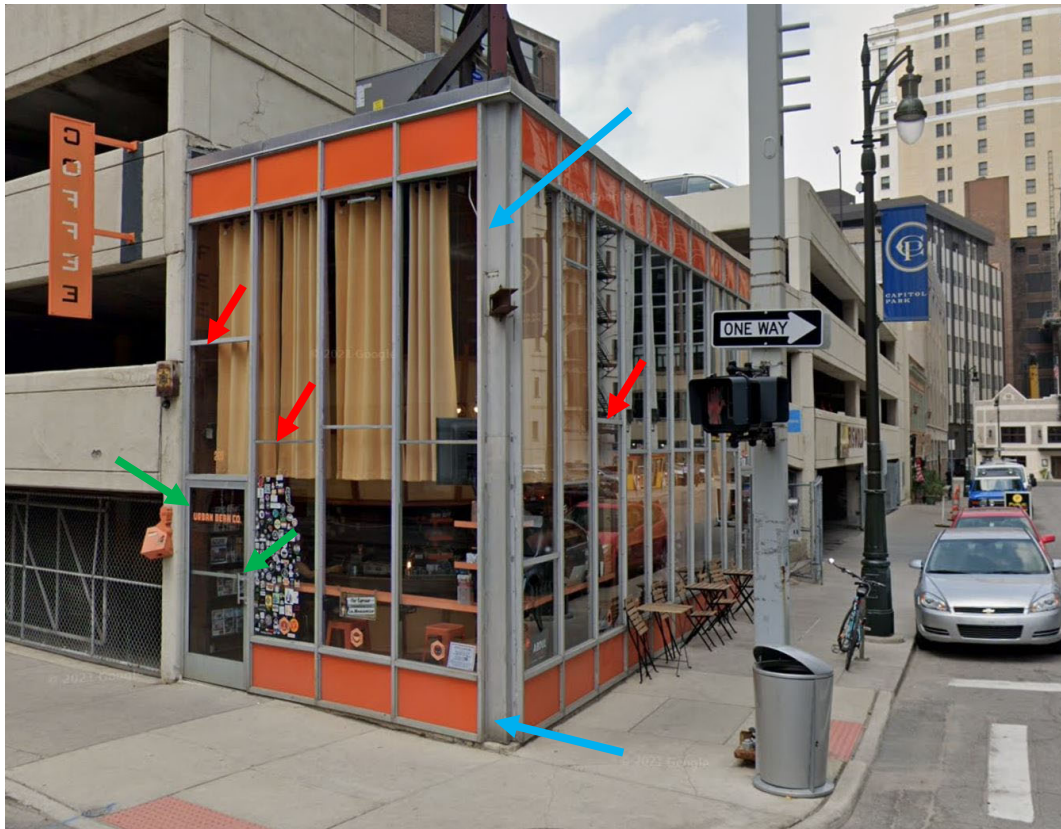
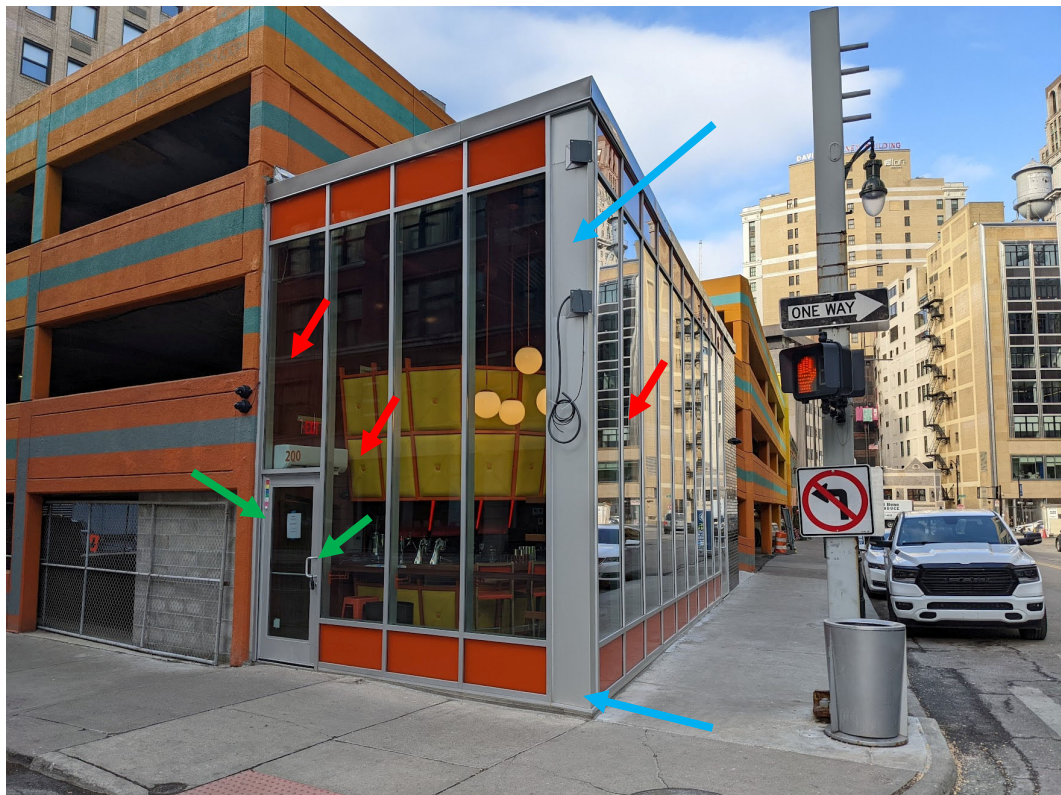
1. Delicate horizontal framing members previously dividing the columns of glass in varying patterns, and contributing a certain looseness to the overall expression, are now missing. In the shop drawings depicting the existing conditions, these are described as "random horizontal aluminum extrusions ½"-1" wide." Staff has identified that thirteen (13) of these are missing; four (4) at the Grand River side and nine (9) at the Griswold side, affecting nearly every "column" of glass. **See red arrows on photos, showing 3 of 13.**

2. The vertical mullion element at the intersection of the Griswold and Grand River elevations, at the corner, is now substantially wider, flattened out and bulky, whereas the original was recessed with complex geometry, showing additional vertical detail/shadow lines, and balanced between the Grand River and Griswold Elevations. The element is now heavily "weighted" towards the Grand River side. **See blue arrows on photos.**

3. The doors are set not into the plane of the storefront system, but markedly recessed when compared to the original planar expression. **See green arrows on photos.**

View **BEFORE** alterations. Google Street View, August 2018.

View **AFTER** alterations. Staff photo, January 14, 2022.

- As the original fabric has been lost, it is staff's opinion that the Commission should only approve an exact match, conditioned on mitigation of most of the disparities outlined above (additional horizontal members, corner mullion issue, etc., numbered 1-8). Per Standard 6, replacement elements "*shall match the old in design, color, texture, and other visual qualities and, where possible, materials.*"

Staff therefore recommends that the Commission deny the proposal, as it fails to meet the Secretary of the Interior's Standards and the Capitol Park Historic District's Elements of Design, specifically Standard 2, 5, and 6:
