STAFF REPORT 03-16-2022 SPECIAL MEETING

PREPARED BY: A. PHILLIPS

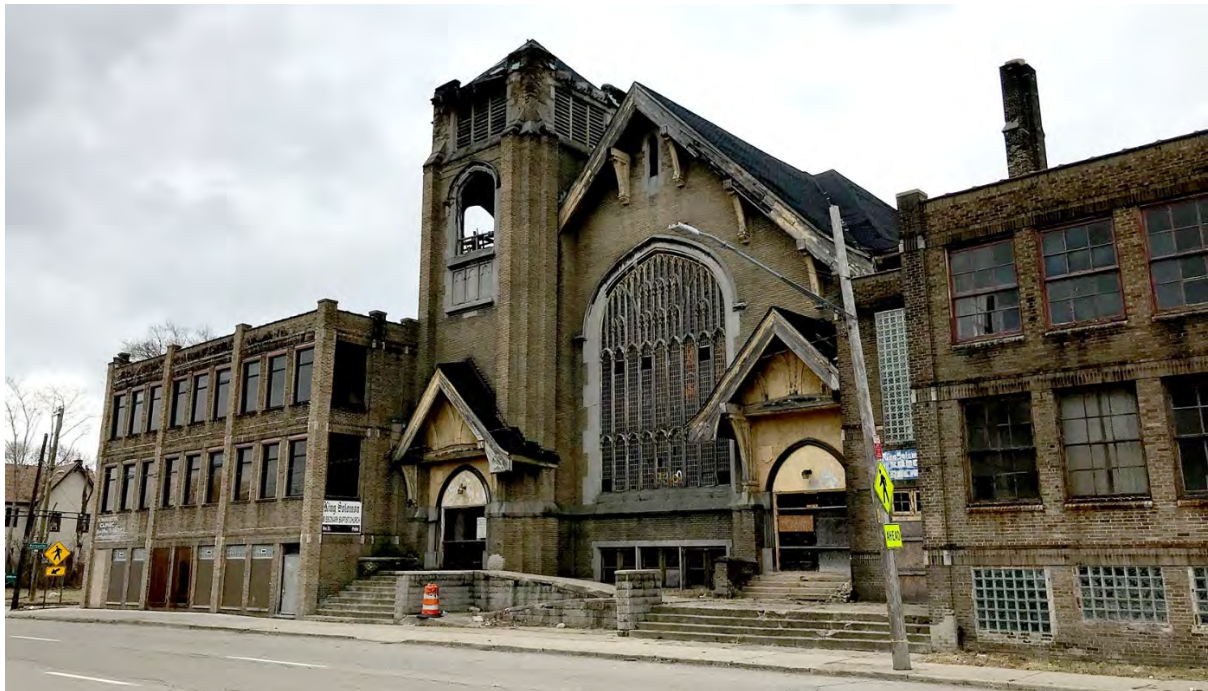
View of existing conditions at front elevation of 6125 14th, view from 14th St. looking southwest. Staff photo, March 8, 2022.

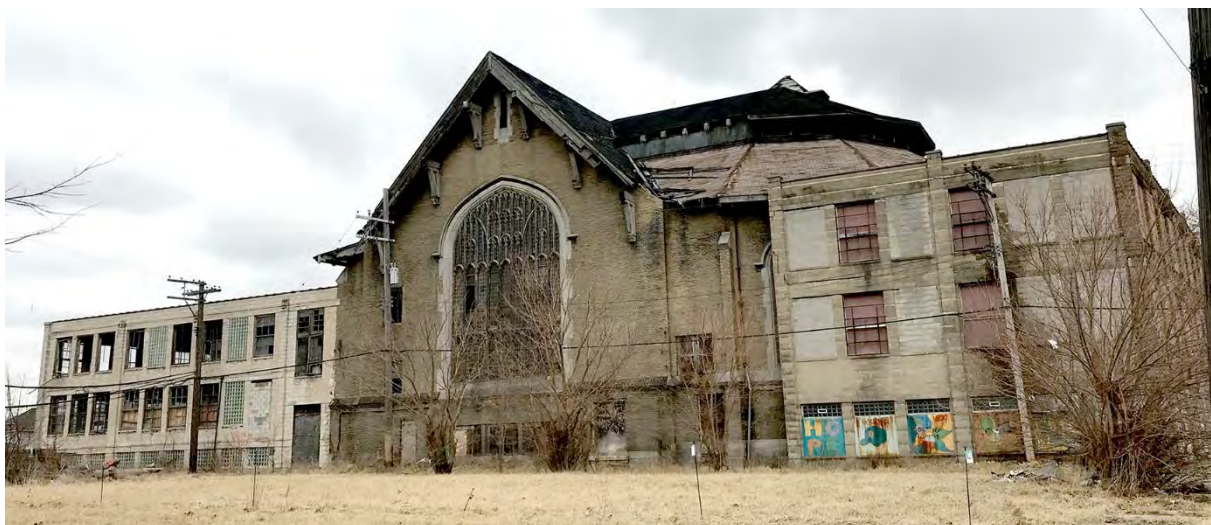
View of existing conditions at rear elevation of 6125 14th, view from Marquette St. looking northeast. Staff photo, March 8, 2022.

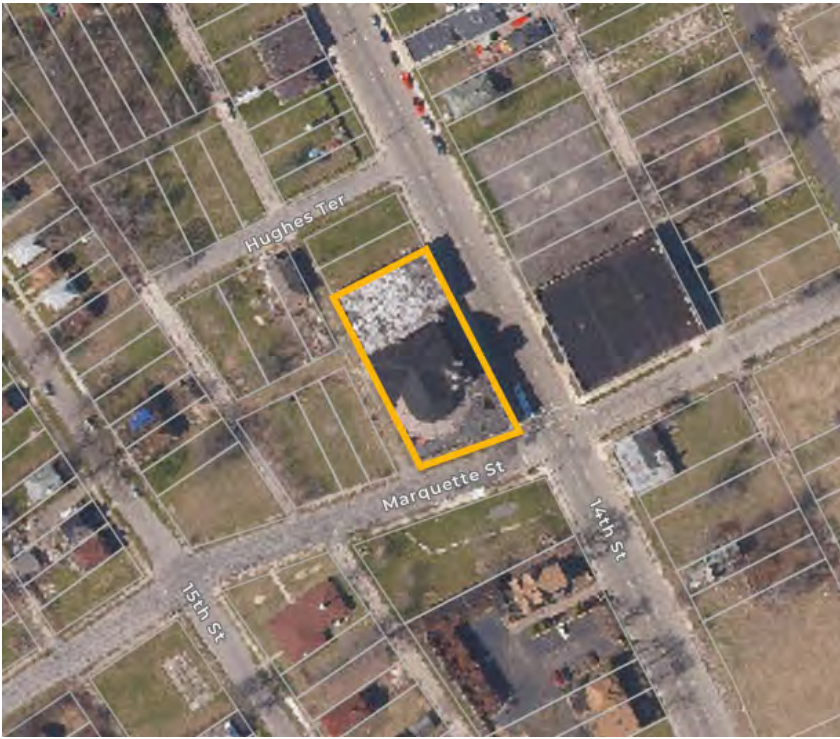
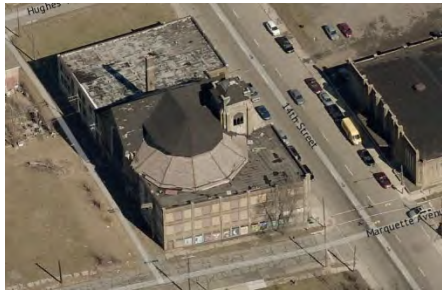
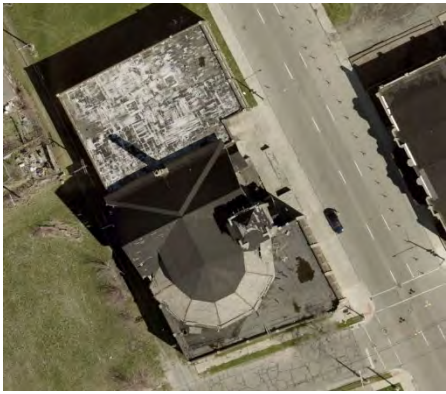
Parcel view of vicinity, 6125 14th Street is outlined in yellow.

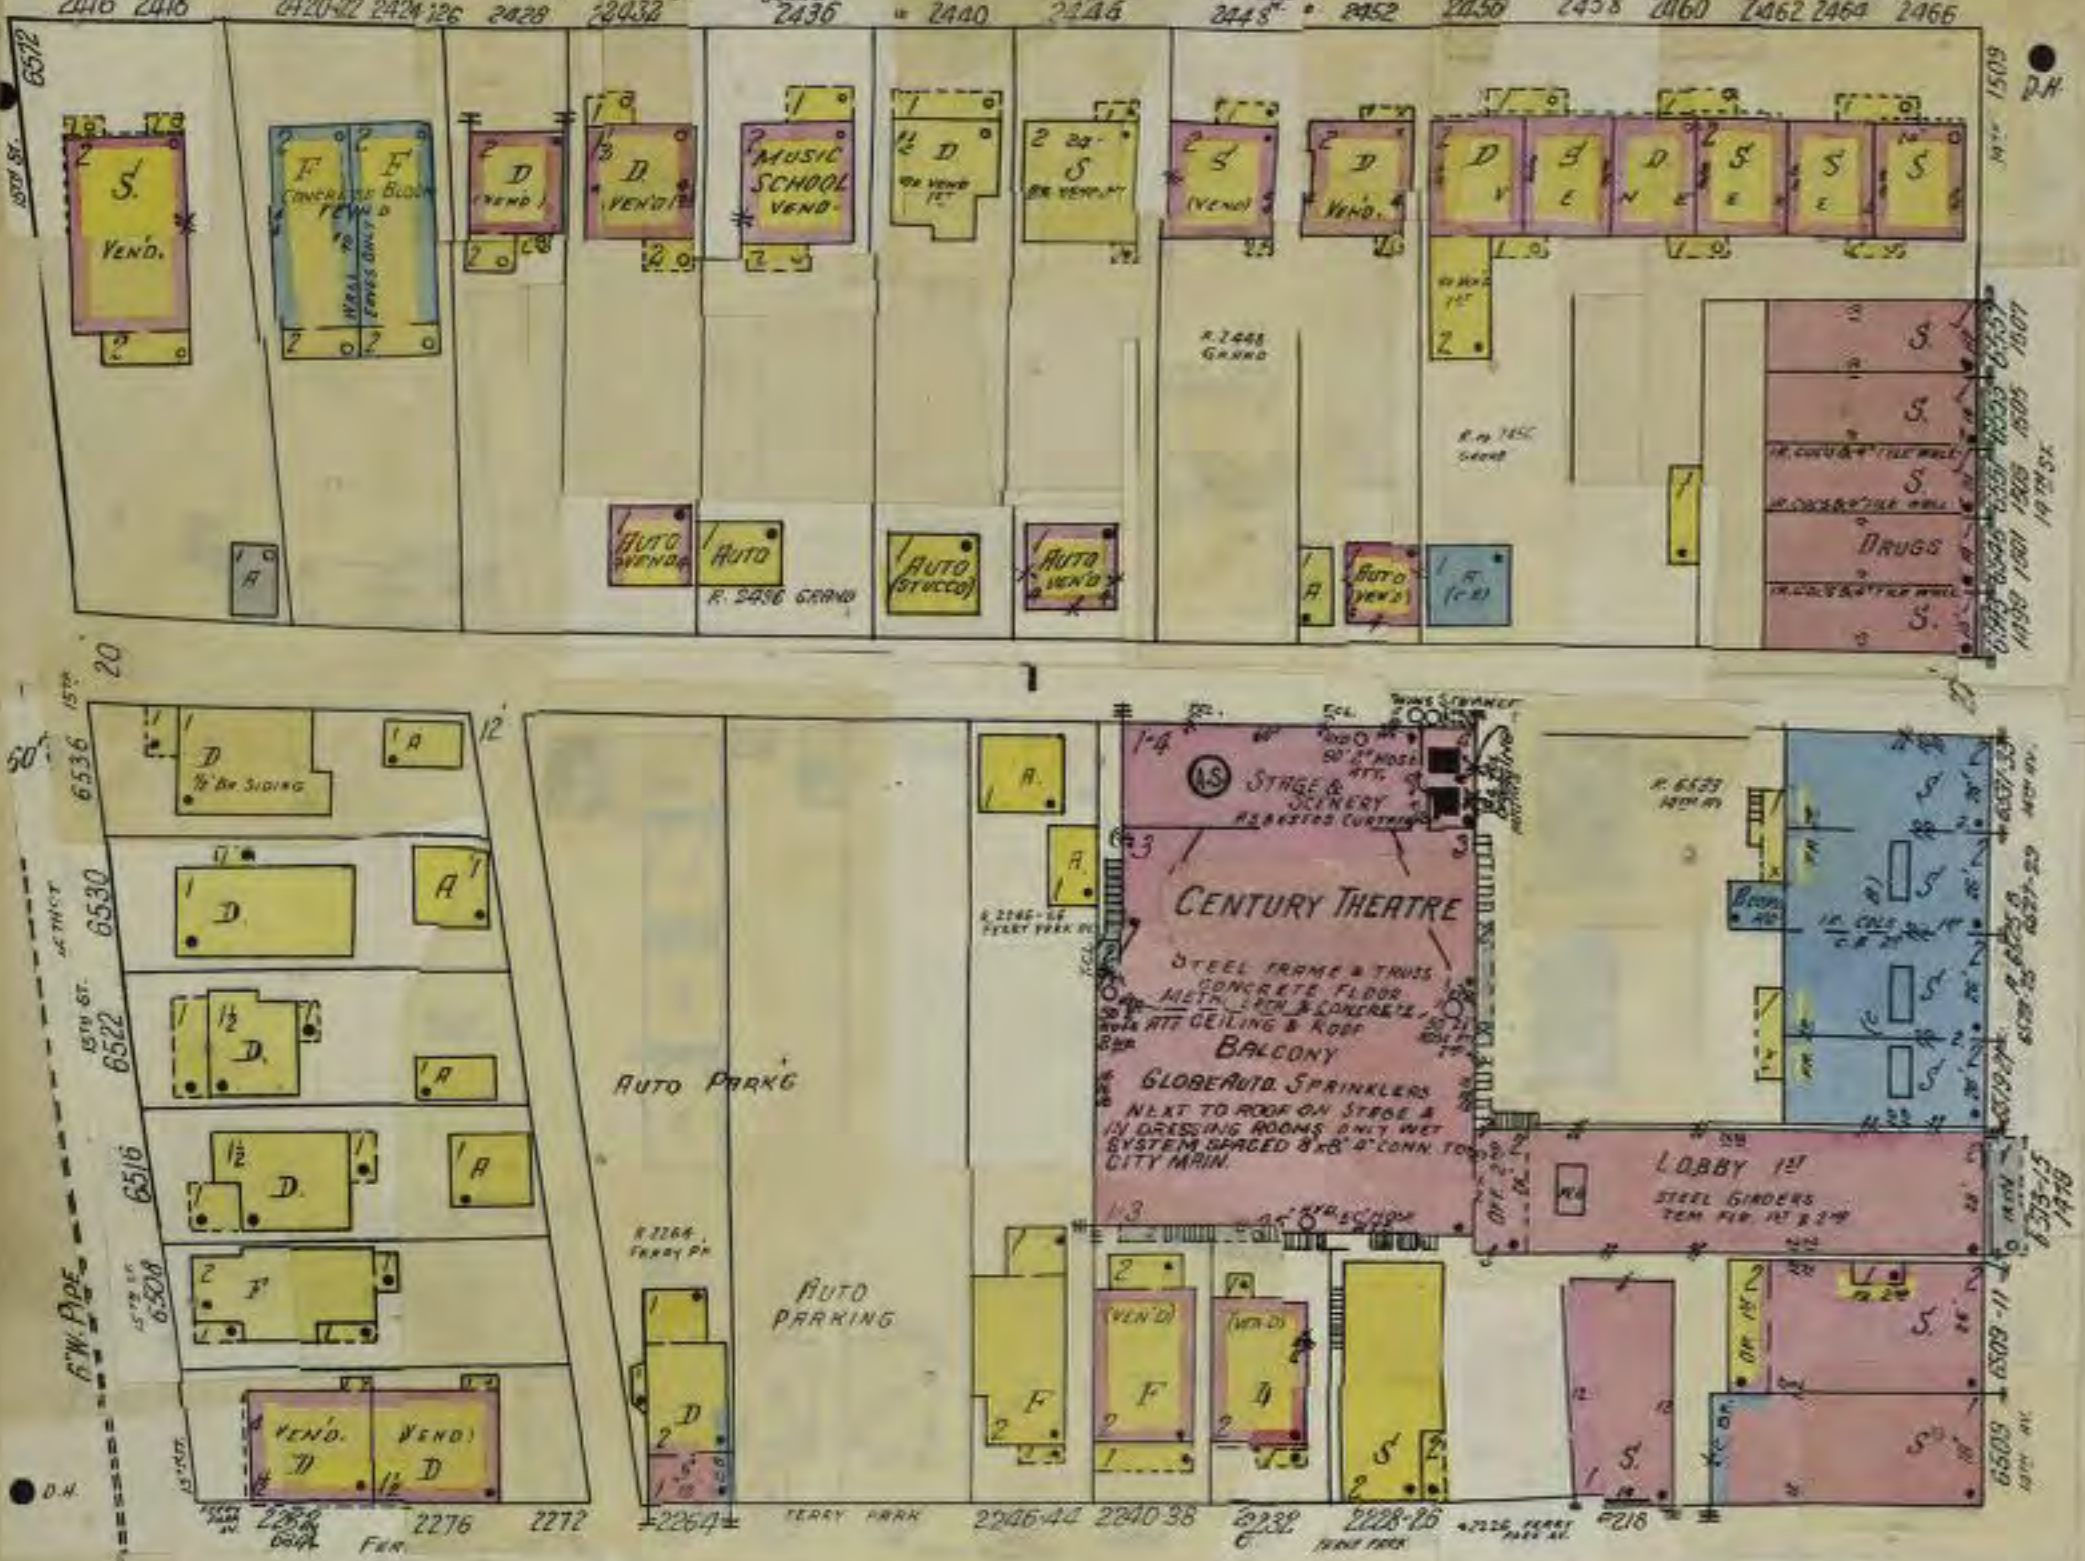
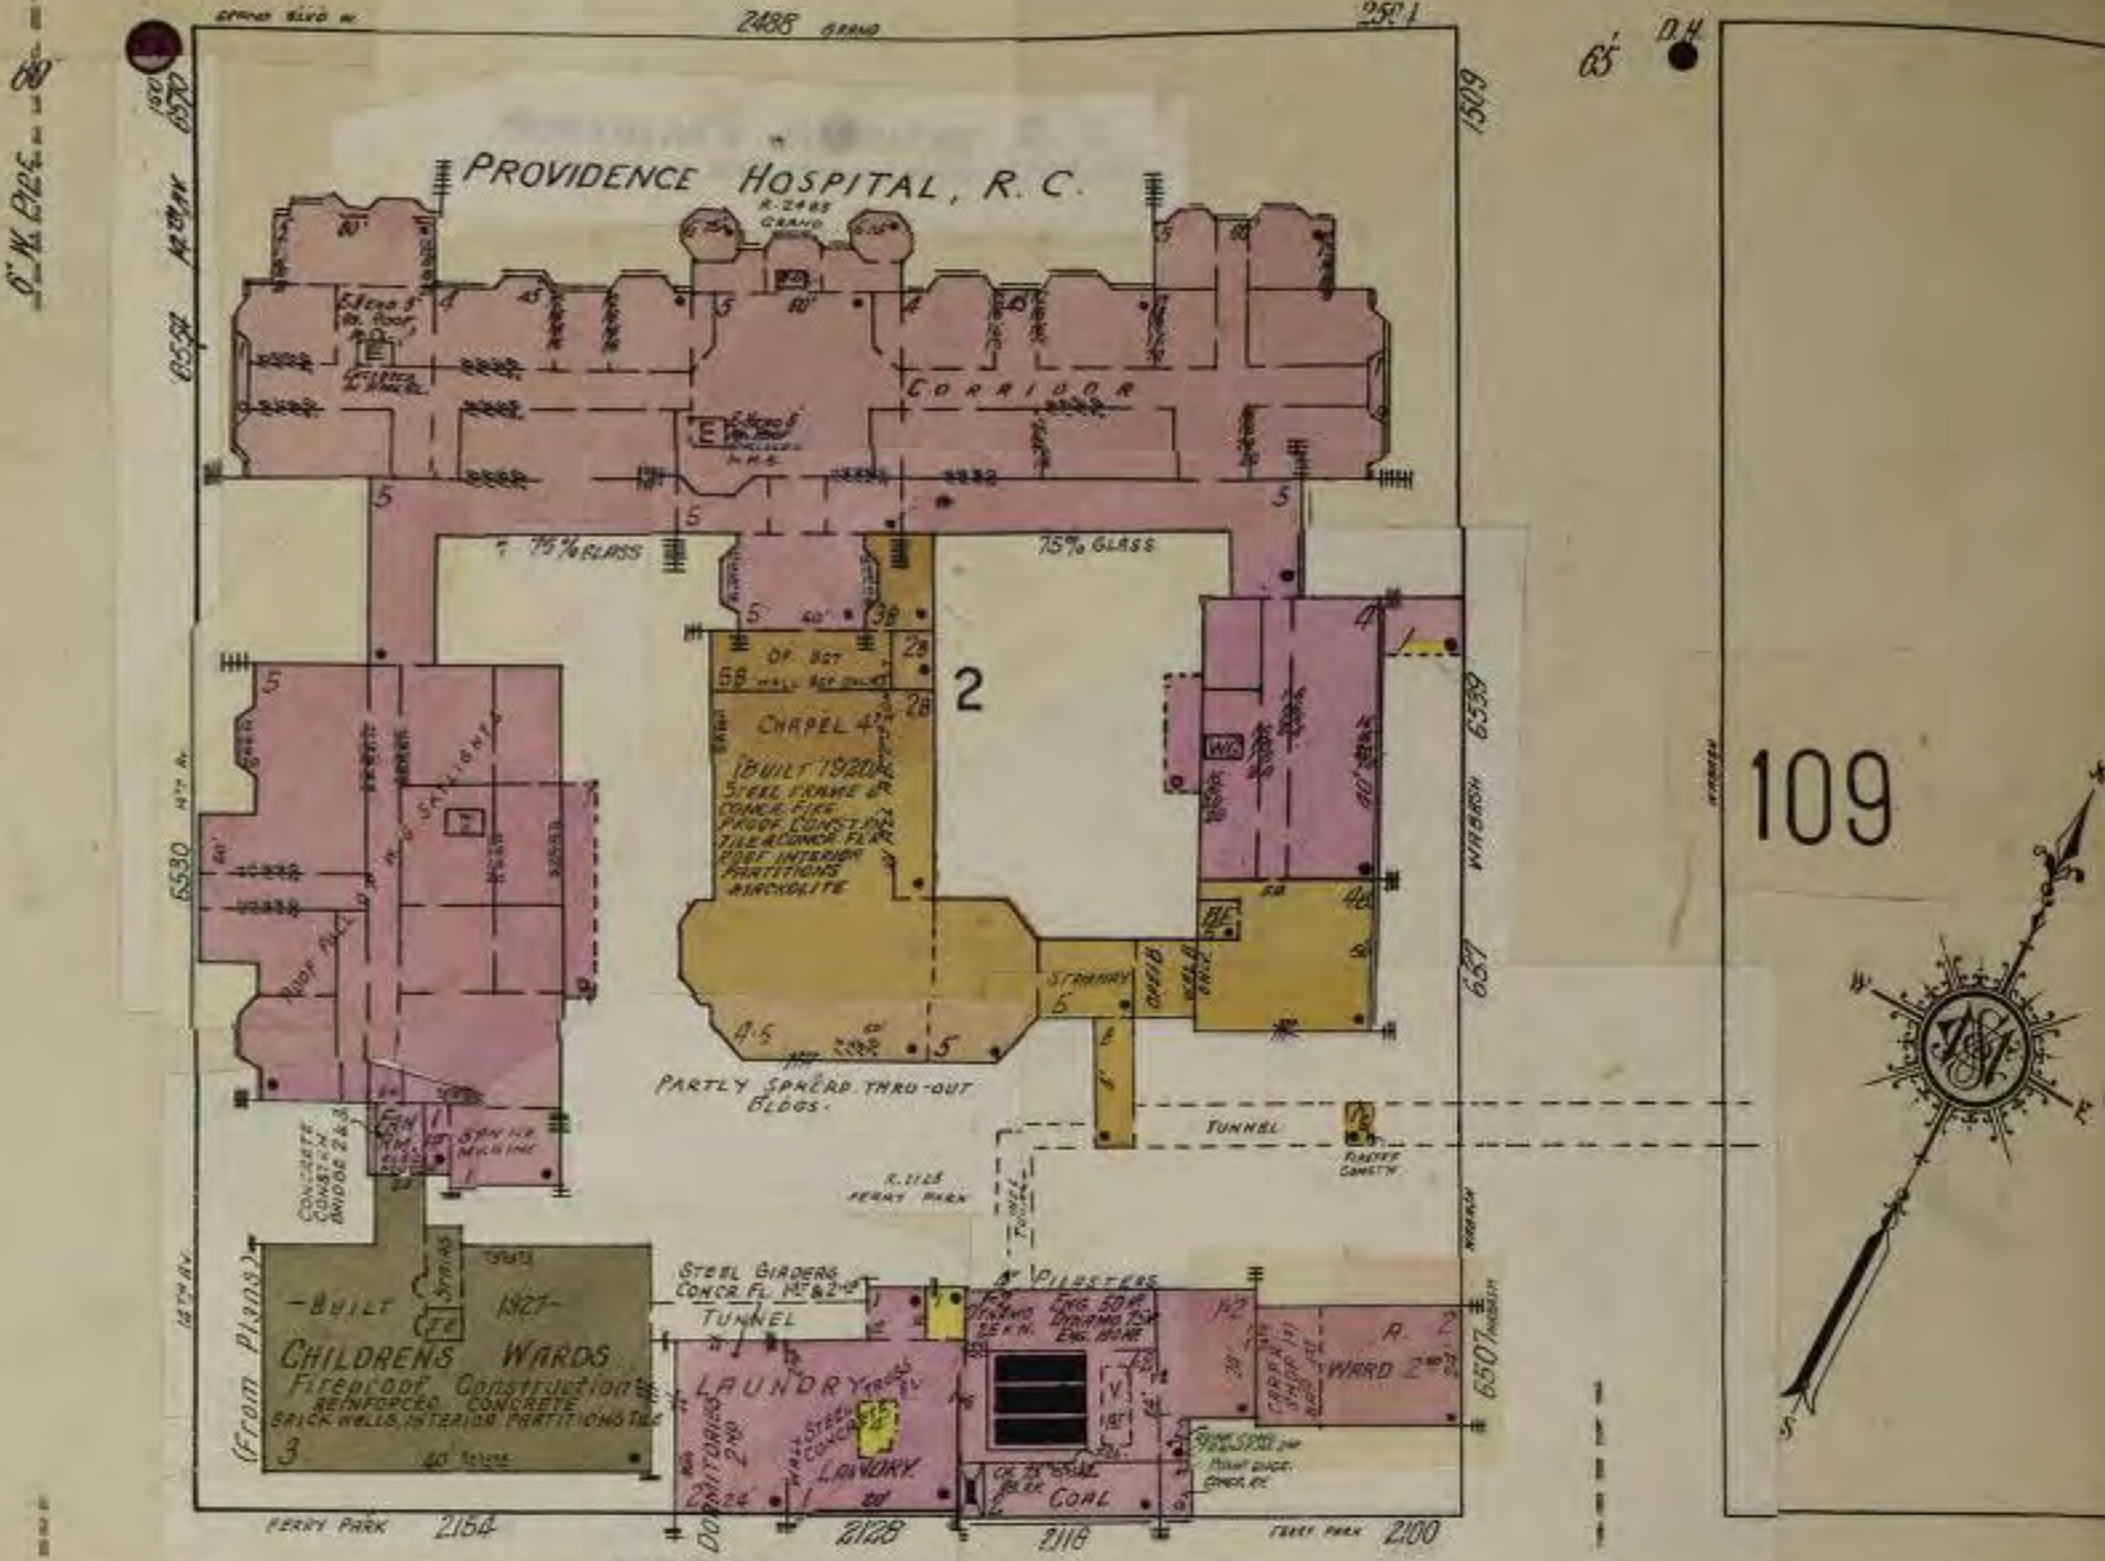
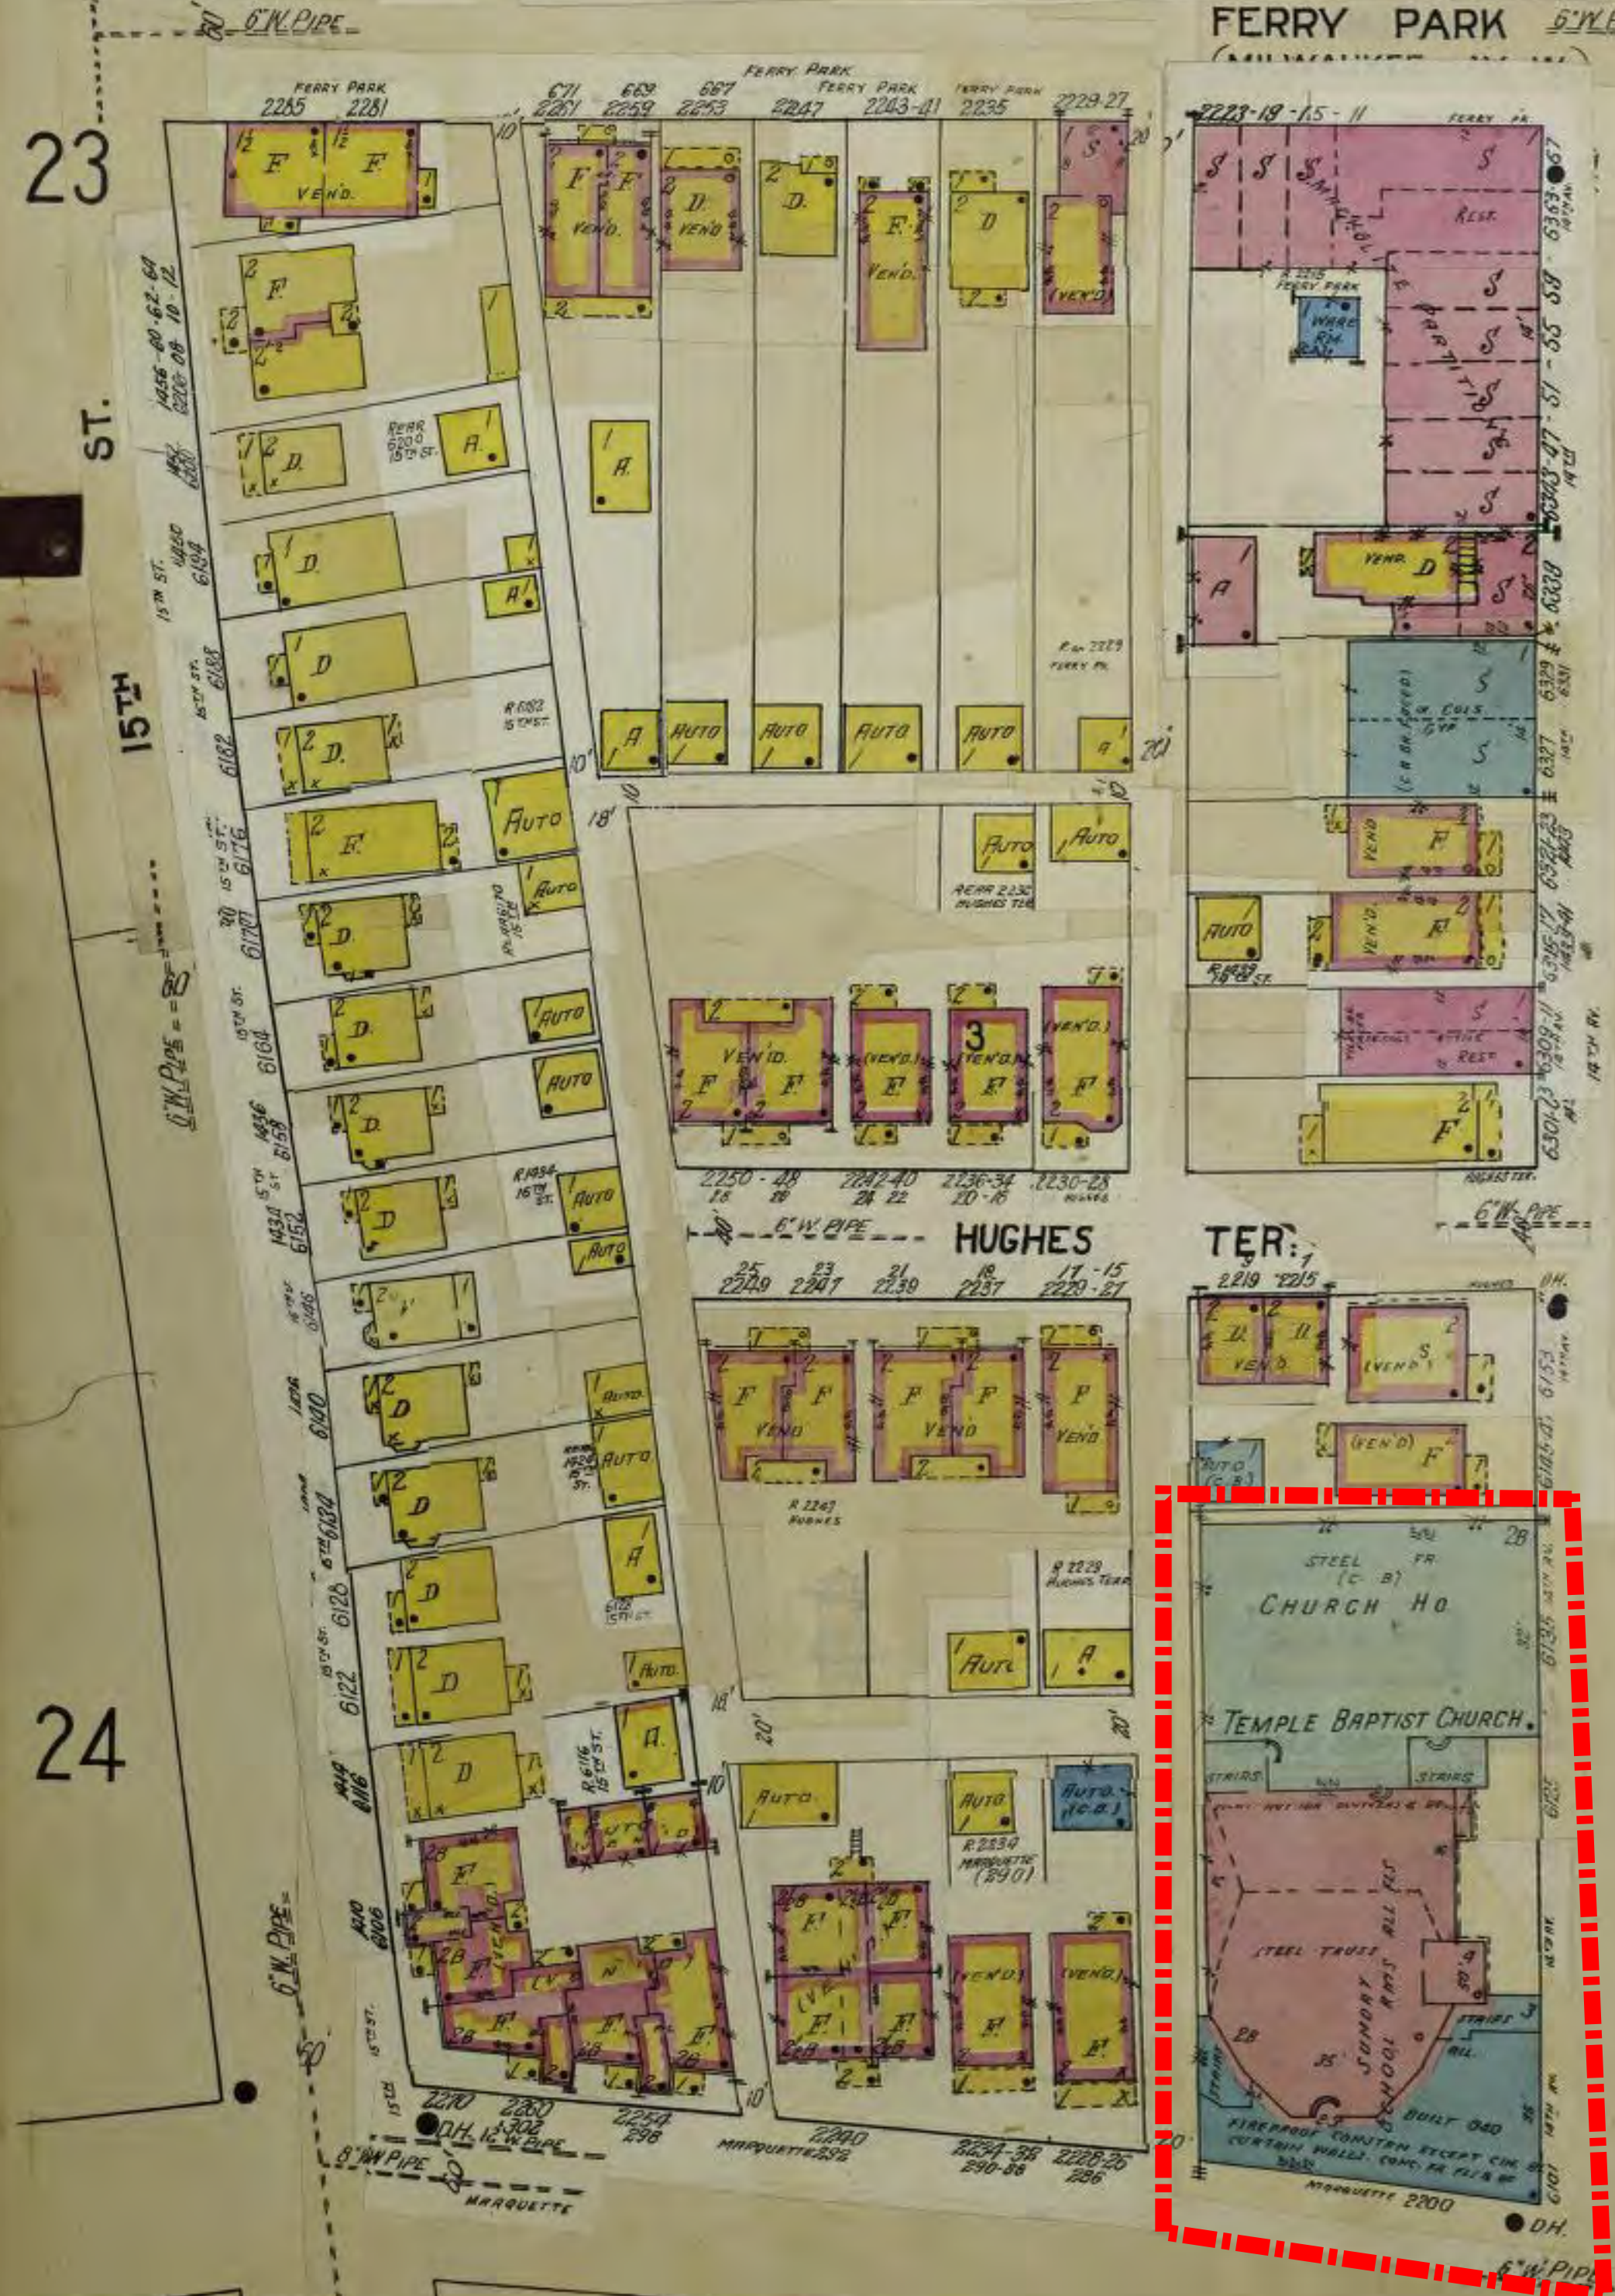
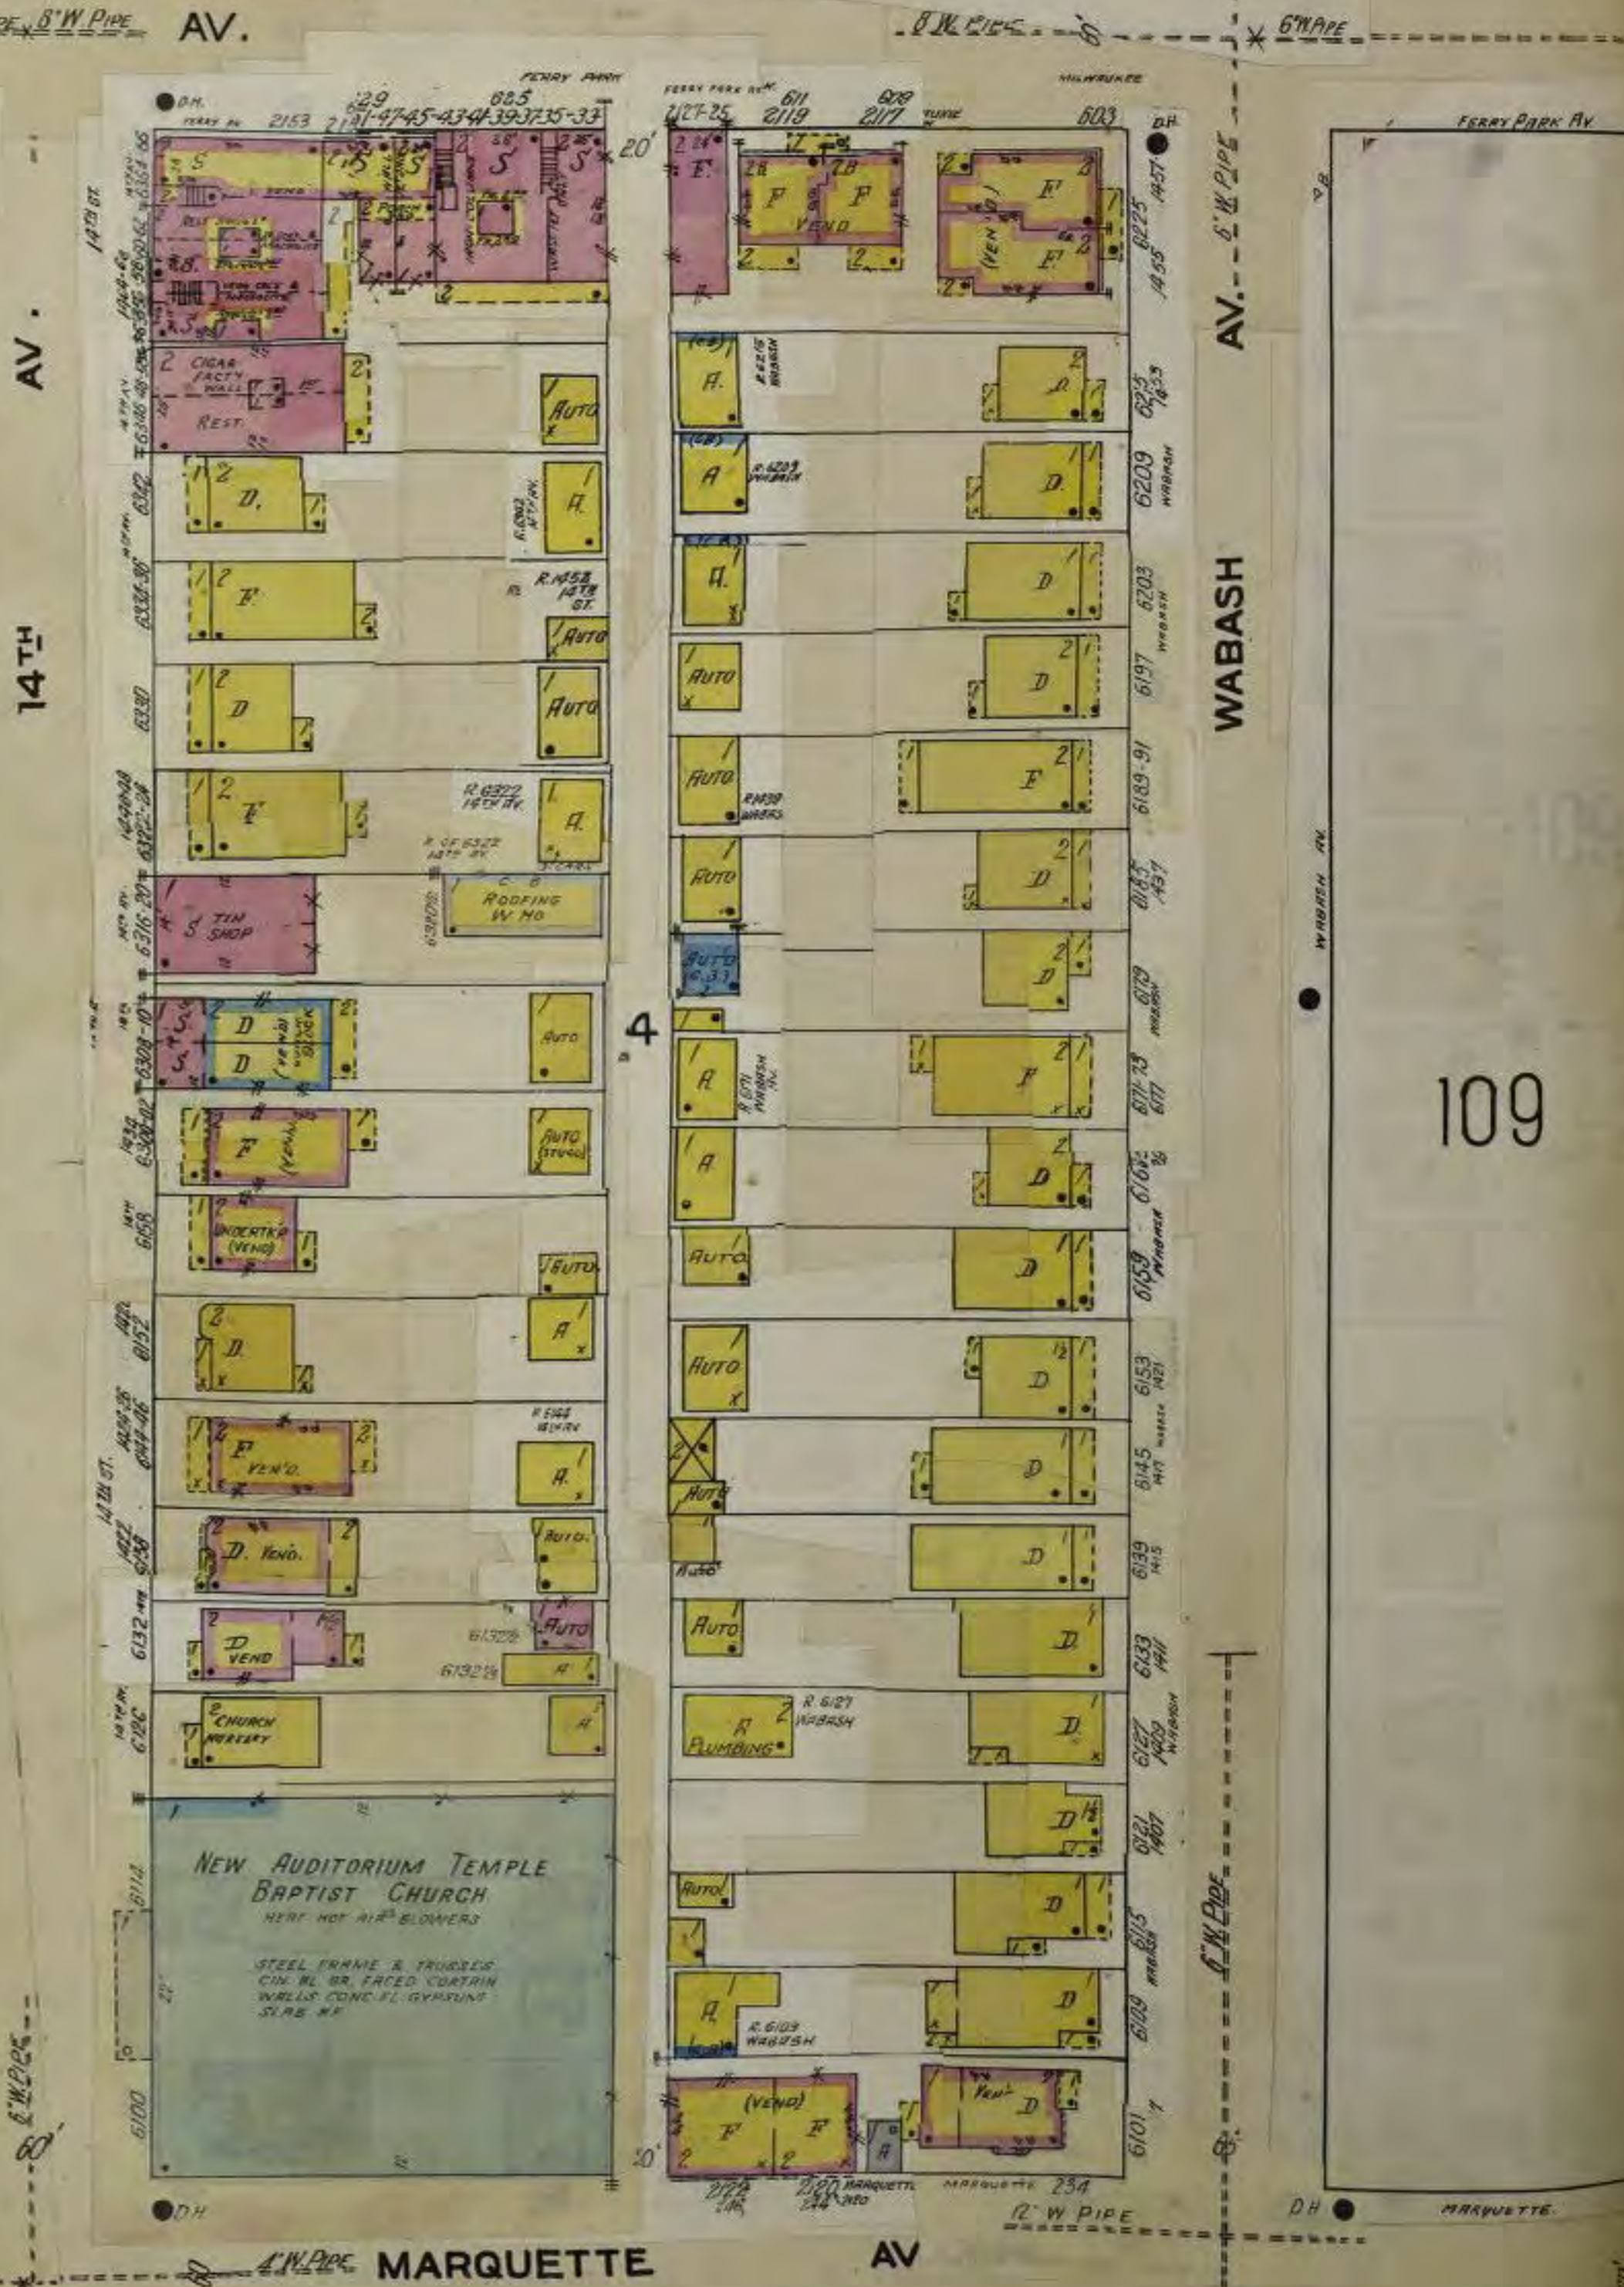
- The removed ornament is to remain and be preserved on-site for future reproduction.
- Once additional funding is in place, a new application is to be submitted to the Commission to complete an historically appropriate rehabilitation of the building.

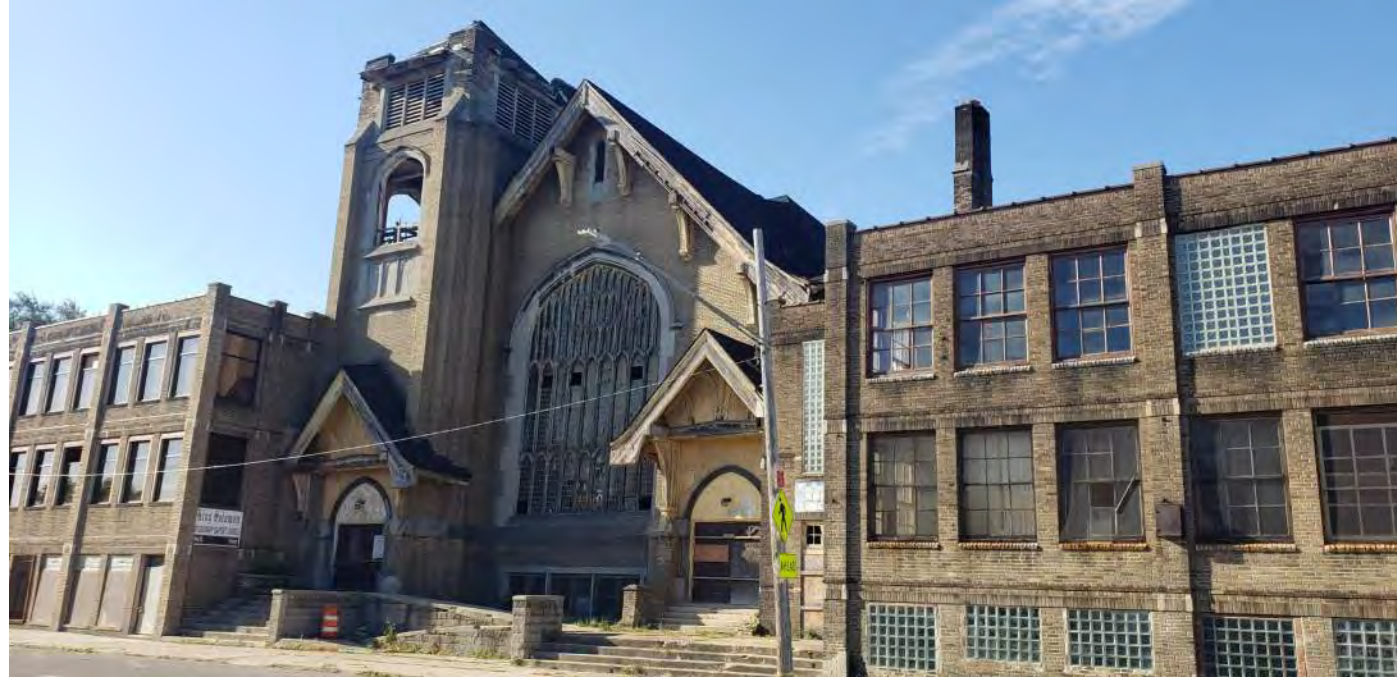
FIGURE EAST ELEVATION

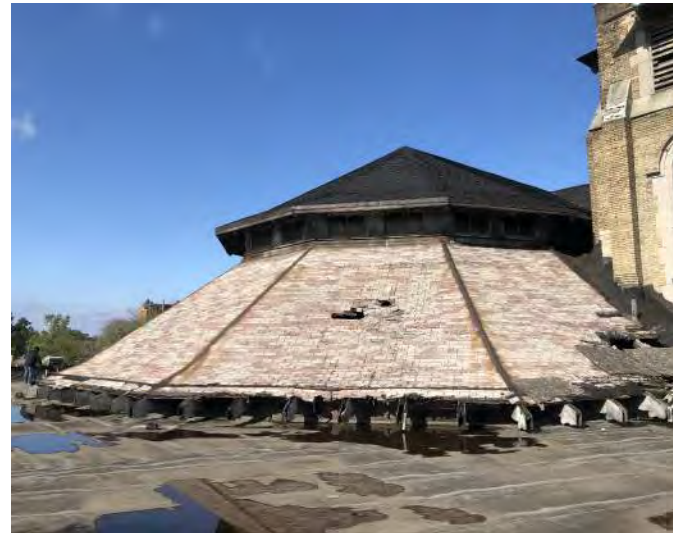
FIGURE A2.1 OVERVIEW OF THE TWO TIERED HEPTAGON ROOF; ROOF DECAY AND WATER INFILTRATION, WORN AND MISSING ASPHALT TILES, WEATHERED AND ROTTED DECORATIVE EAVE OUTRIGGERS/RAFTER TAILS.

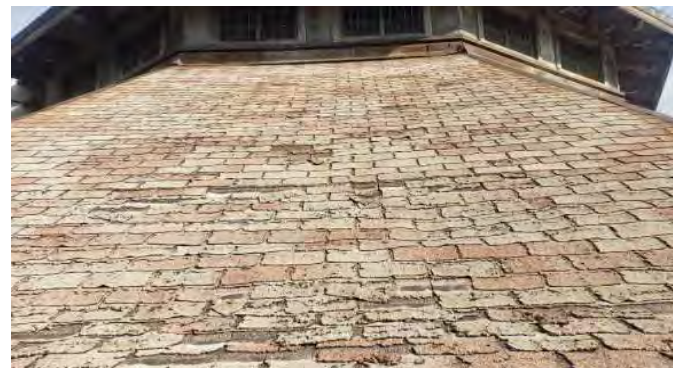
FIGURE A2.2 SURFACE DEPRESSIONS ALONG THE ROOF; CURLED, DISCOLORED AND FRAYED ASPHALT SHINGLES; RUSTED METAL FLASHING UNDER THE UPPER WINDOWS

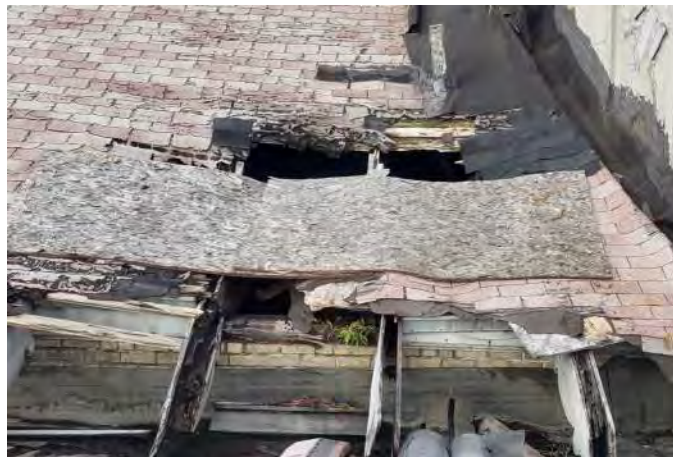
FIGURE A2.7 COMPLETE DETERIORATION AND DECAY OF THE DECORATIVE WOOD EAVES AND DECORATIVE RAFTER TAILS; THE LEVEL OF DETERIORATION MAY REQUIRE LOCALIZED REPAIRS TO ADJACENT ELEMENTS SUCH AS THE BRICK WALL BELOW

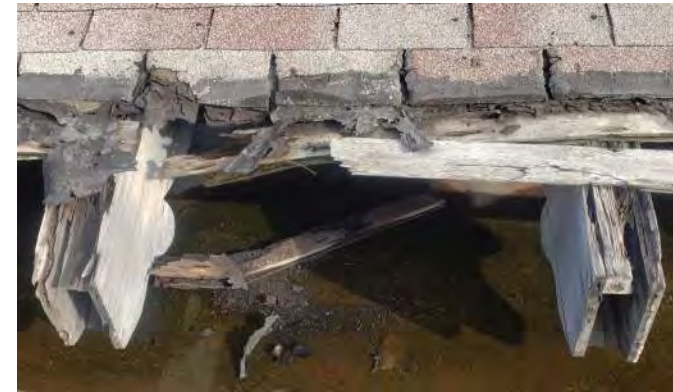
FIGURE A2.8 SIGNIFICANT DETERIORATION AT THE PERIMETER (TERMINATION OF DECORATIVE EAVES); EXTENSIVE WOOD ROT OF THE DECORATIVE EAVE OUTRIGGERS/RAFTER TAILS; PONDING WATER BELOW

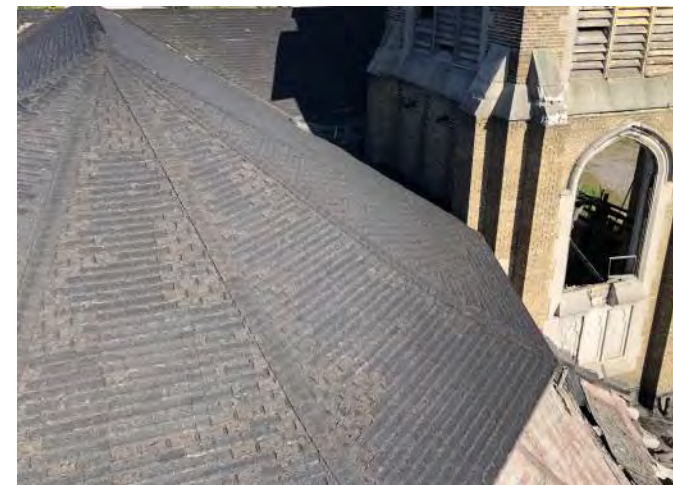
FIGURE A2.10 UPPER TIER OF HEPTAGON ROOF; WORN, MISSING CURLED, DISCOLORED, AND FRAYED ASPHALT SHINGLES

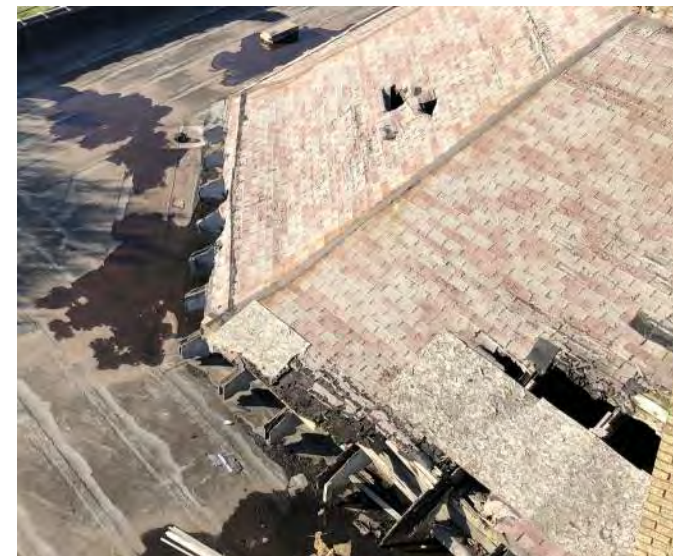
FIGURE A2.12 OVERVIEW OF THE HEPTAGON ROOF ABOVE, SHOWS THE EXTENT OF THE ROOF DETERIORATION WITH VARIOUS HOLES ALONG THE SURFACE

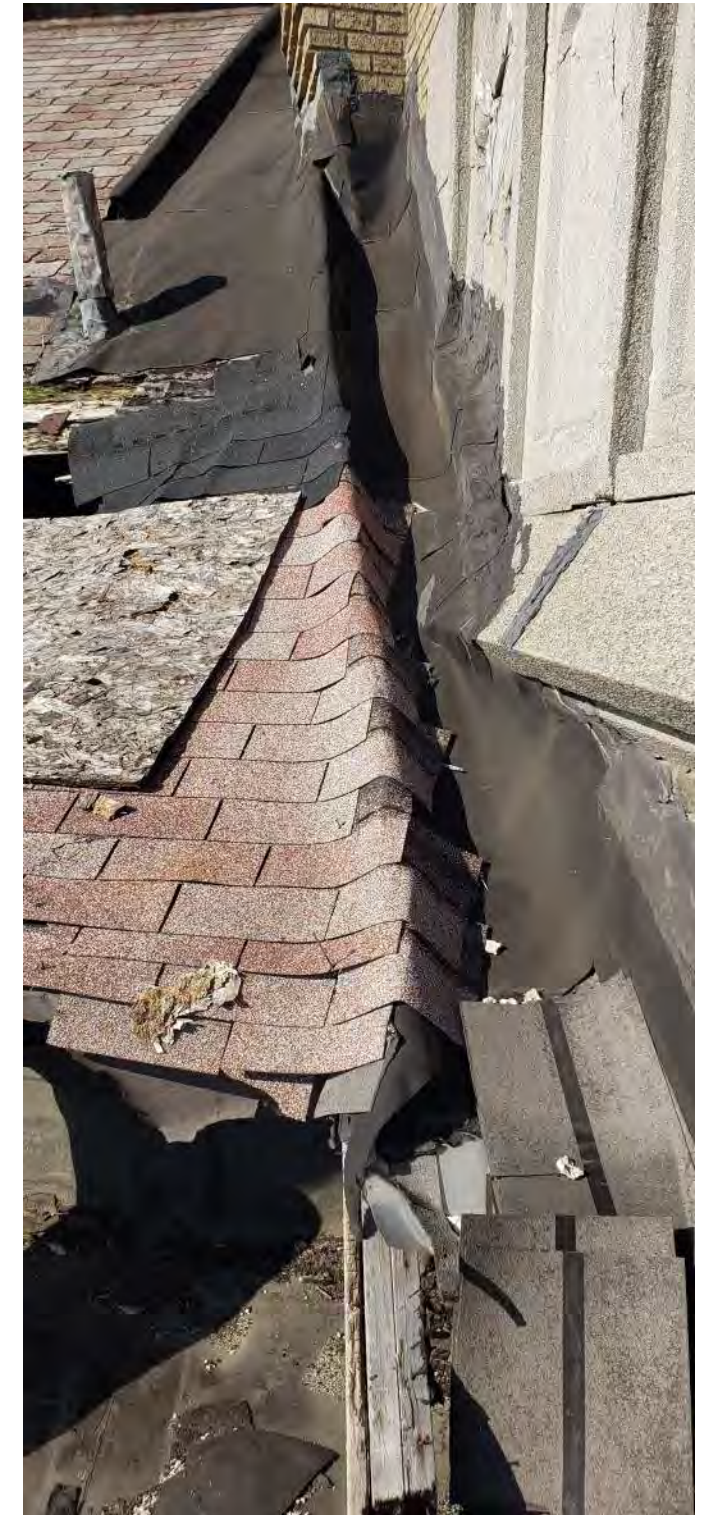
FIGURE A2.13 IMPROPER FLASHING AND PATCHING AT THE VALLEY JUNCTION BETWEEN THE POLYGONAL ROOF AND BELL TOWER; THE ASPHALT SHINGLES ARE NOT PROPERLY TERMINATED; EXCESSIVE USE OF ROOFING MASTIC ALONG THE BELL TOWER WALL; DETERIORATED ROOF VENT NEAR THE LARGE HOLE IN THE ROOF.

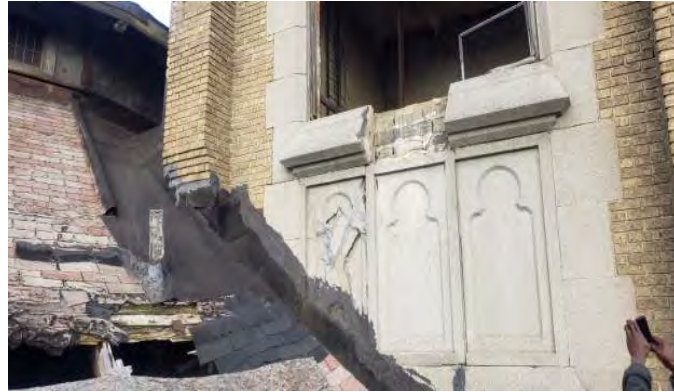
FIGURE A2.6 FAILURE OF THE FLASHING AT THE INTERSECTION WHERE THE POLYGONAL ROOF INTERSECTS WITH THE BELL TOWER; STAINING OF THE DECORATIVE STONE BY FLASHING SEALANT

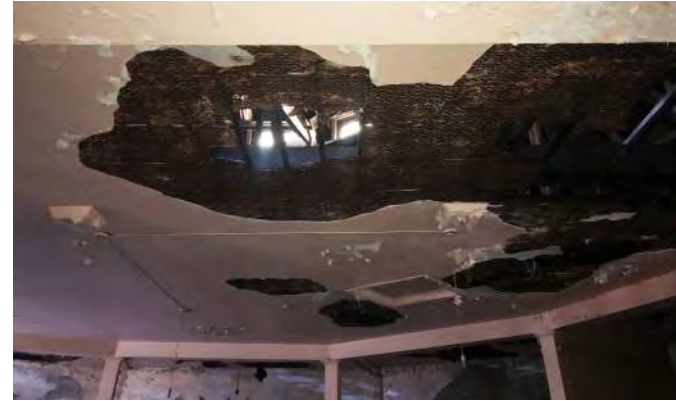
FIGURE A2.14 DETERIORATING INTERIOR PLASTER BELOW THE HEPTAGONAL ROOF STRUCTURE; SUN LIGHT IS VISIBLE THROUGH THE HOLE IN THE ROOF ABOVE

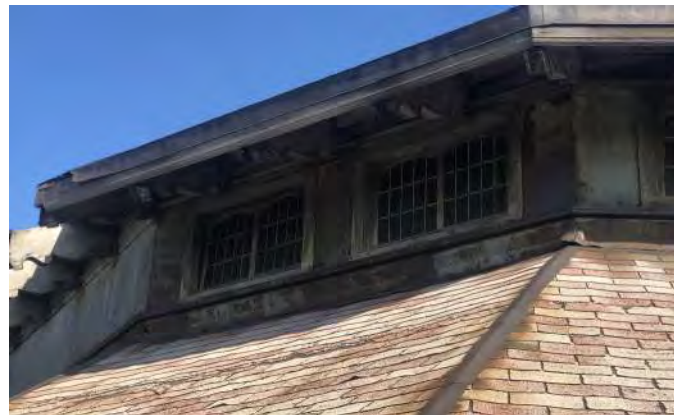
FIGURE A2.11 THE UPPER TIER OF THE POLYGONAL ROOF; VISIBLE RUST ON THE METAL WINDOW FRAMING AND ROOF HIP; METAL FLASHING IS CORRODING AND DETACHING FROM THE FASCIA BOARD AND HEAD OF LOWER ROOF

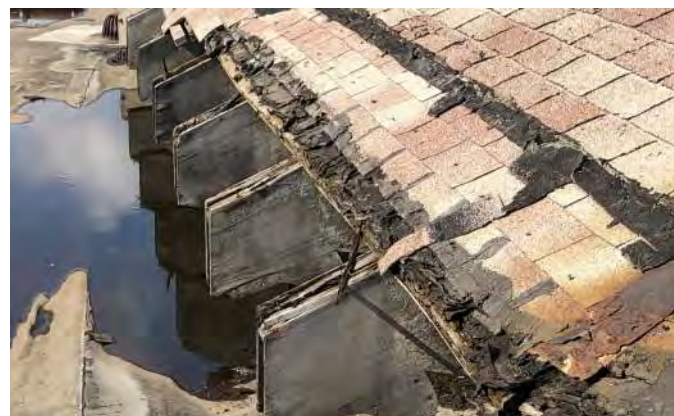
FIGURE A2.13 DECORATIVE WOOD EAVE SHOW SIGNS OF DECAY AND ROT; SIGNIFICANT DETERIORATION OF THE ROOF PERIMETER EDGE; WITH POOLS OF WATER GATHERING UNDER THE EAVES

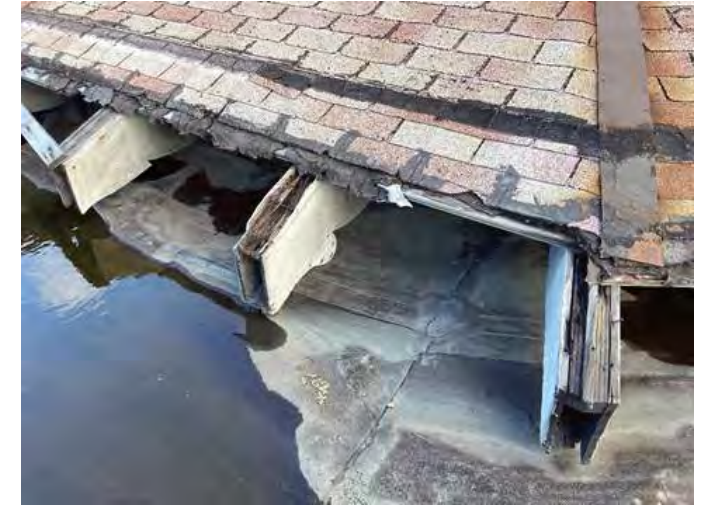
- Upper tier roof area appears in better condition than the lower roof. Localized deterioration of sheathing and rafters can be anticipated above the area with exposed overhang brackets. (see figure S2.5)

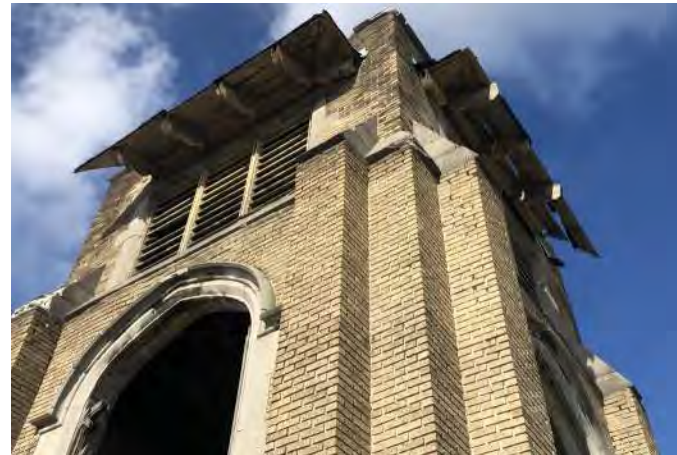
FIGURE A3.2 THE EAVE OVERHANG SHOWS EXTENSIVE WOOD DECAY AND DETERIORATION

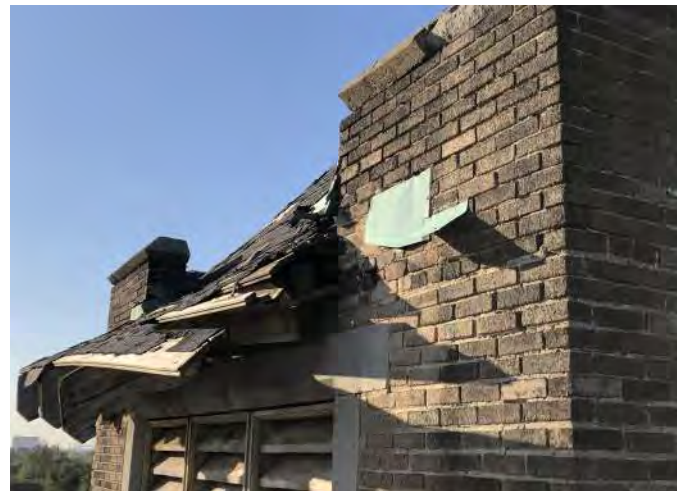
FIGURE A3.4 DECORATIVE WOOD OVERHANGS COLLAPSING AND OPEN AT ENDS TO INTERIOR; BRICK MASONRY SHOWS SIGNS OF DIFFERENTIAL MOVEMENT; REMAINING STEPPED COPPER FLASHING (EAST ELEVATION)
