STAFF REPORT 03-16-2022 SPECIAL MEETING

PREPARED BY: A. PHILLIPS

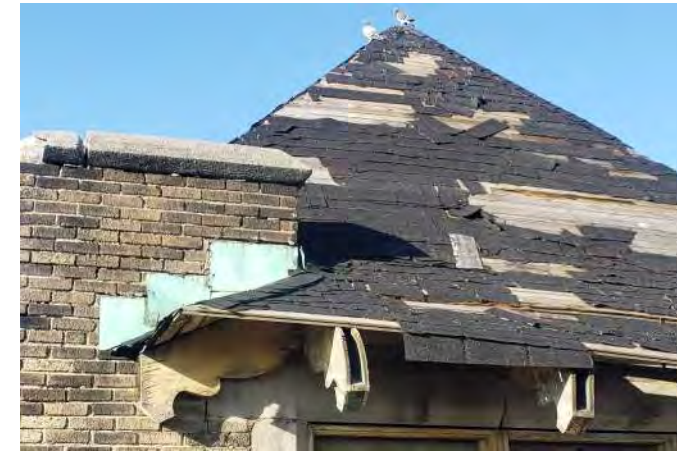
FIGURE A3.7 HIP ROOF IS IN VERY POOR CONDITION; WEATHERED AND DECAYED WOOD DECKING, MISSING/FALLEN SHINGLES AND EXPOSED DECKING AND ORIGINAL STEPPED COPPER FLASHING (EAST ELEVATION)

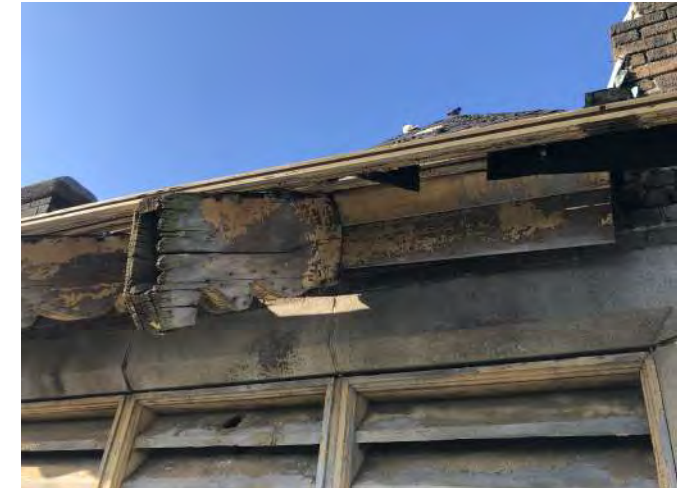
FIGURE A3.8 ROTTED DECORATIVE WOOD RAFTER TAIL AND DETACHING FRIEZE BOARD TRIM

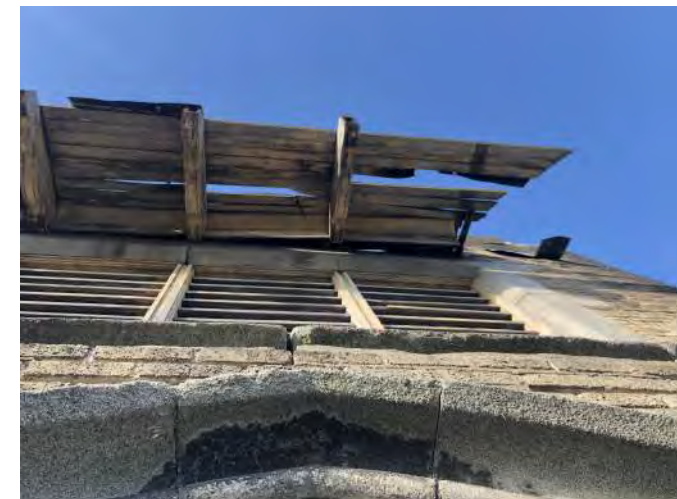
FIGURE A3.9 UNDERSIDE OF THE PAINTED DECORATIVE OVERHANGS; WEATHERED DETERIORATED WOOD DECKING (EAST ELEVATION)

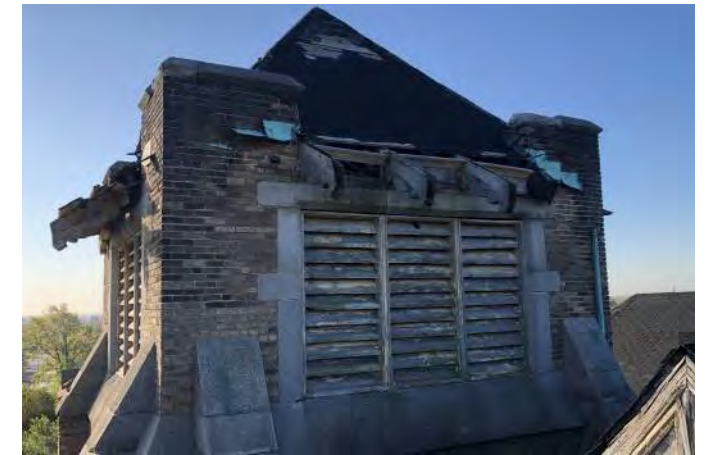
FIGURE A3.10 OVERVIEW OF THE BELL TOWER'S ROOF AND DECKING; THE DECKING ON TOP OF THE DECORATIVE EAVE HAS COMPLETELY DECAYED AND DETACHED FROM THE ROOF ASSEMBLY (NORTH ELEVATION)

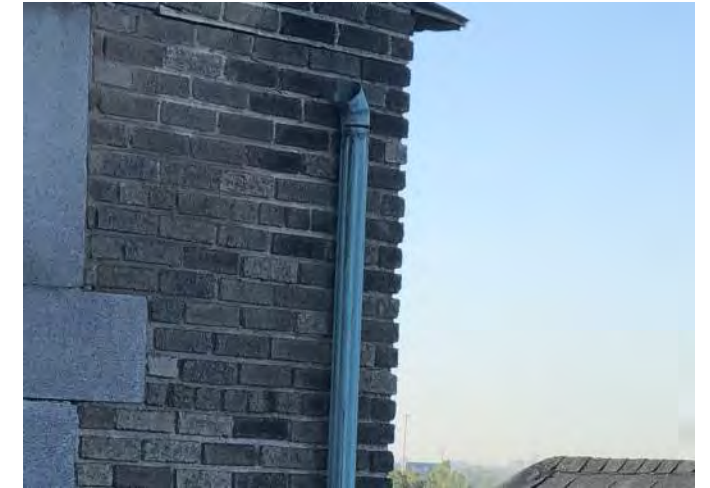
FIGURE A3.11 DETACHED COPPER DOWNSPOUT AND MISSING ASSOCIATED COPPER GUTTER

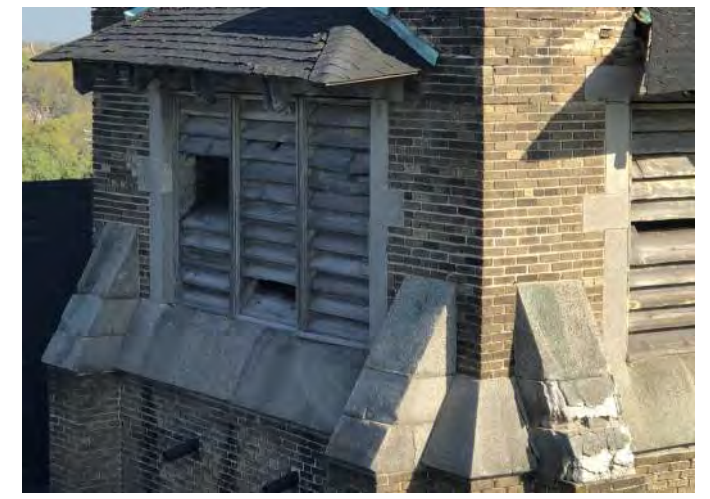
FIGURE A3.12 SOUTH WEST ELEVATION OF BELL TOWER; CRUMBLING STONE AT THE COLUMN CAP; BRICK MOVEMENT DIRECTLY UNDER THE ROOF

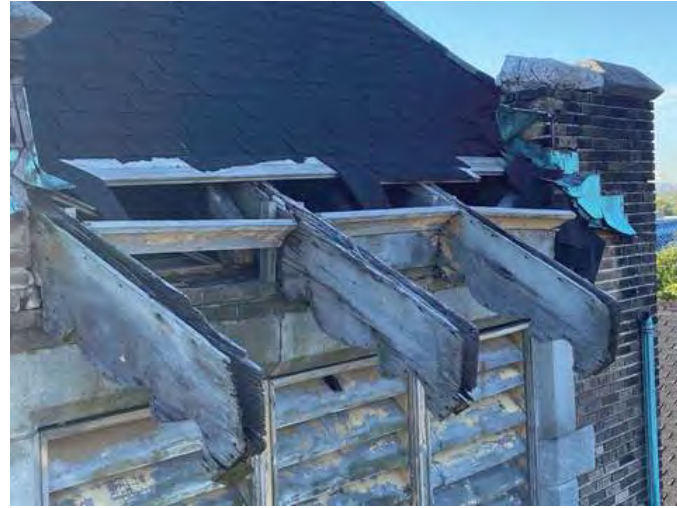
- The entire roof structure is in very poor condition and beyond serviceable condition. Large portions of the roof overhang area and support brackets are missing. The plank sheathing on the pyramid roof is exposed and is in poor condition. The nearby areas are badly deteriorated or missing. (see figure S3.1)
- The masonry piers and masonry below the roof support zone has limited cracking, moderate mortar joint deterioration and visible spalling. There is a significant risk of damage to people and property from falling debris due to the condition of the masonry. (see figure S3.2)
- There are large openings in the bell tower where the original windows and louvers have been removed or are damaged. These openings should be closed off as part of the roofing solution. (see figure S3.3)

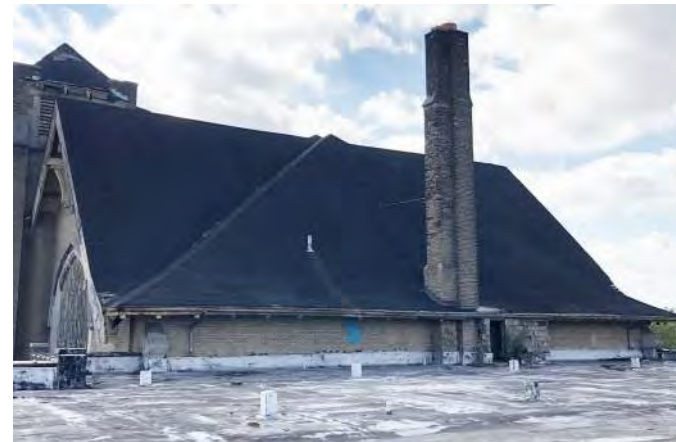
FIGURE A4.00 OVERVIEW OF NORTHERN SIDE OF THE CROSS GABLE ROOF

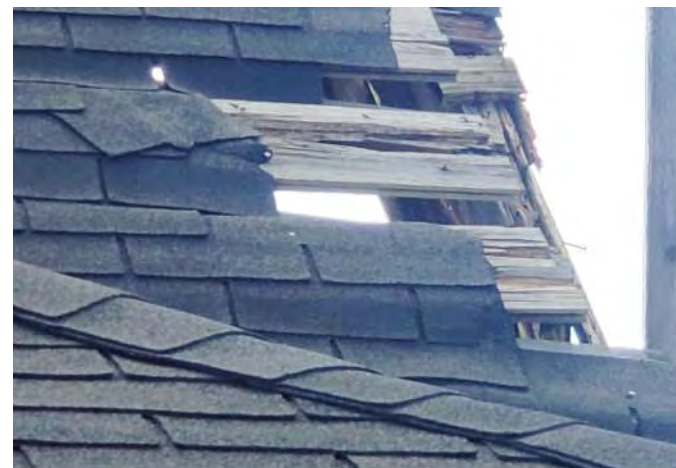
FIGURE 4.1 DETERIORATED WOOD DECKING, MISSING/FALLEN SHINGLES AT THE EAVE (WEST ELEVATION)

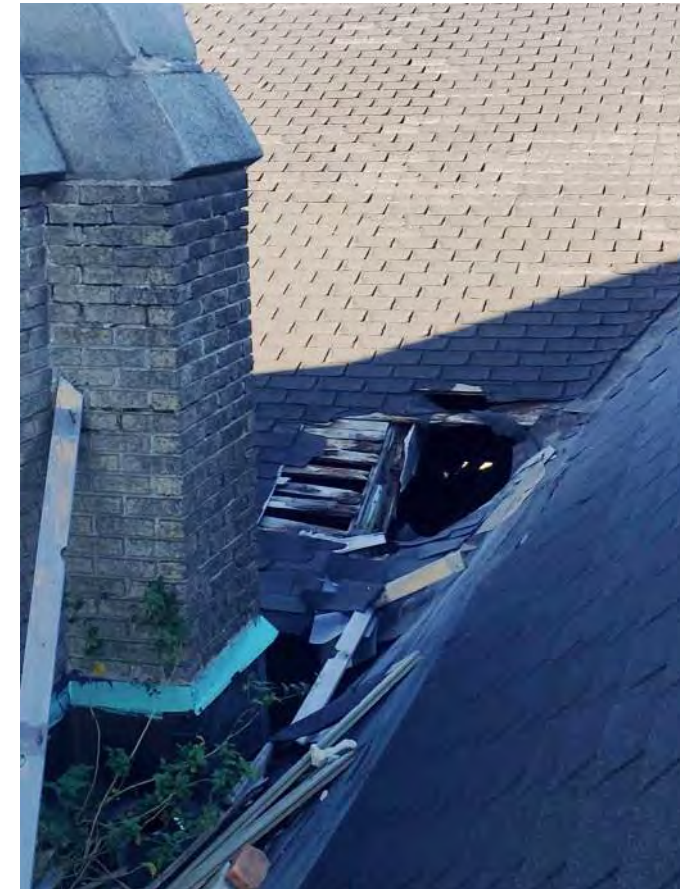
FIGURE A4.17 LARGE HOLE IN THE ROOF; DETERIORATED SHINGLES, WOOD DECKING AT THE ROOF VALLEY; FALLEN WOOD DECKING FROM THE BELL TOWER ROOF ABOVE

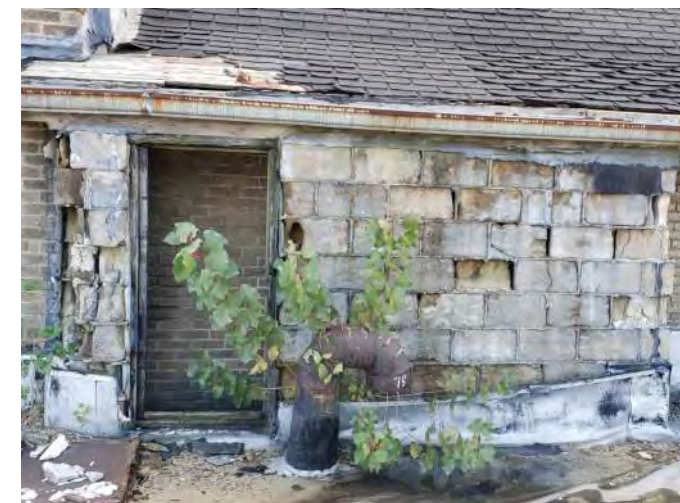
FIGURE A4.23 EXTENSIVE EXTERIOR MASONRY DETERIORATION AT ROOFTOP STAIR ENTRY/EXIT; MISSING AND DETERIORATED MORTAR JOINTS; DETACHED ROOFTOP STAIR ENTRY DOOR; DAMAGED DOOR FRAMING. DETACHED FLASHING AT THE UPTURN OF THE NORTH MEMBRANE ROOFING

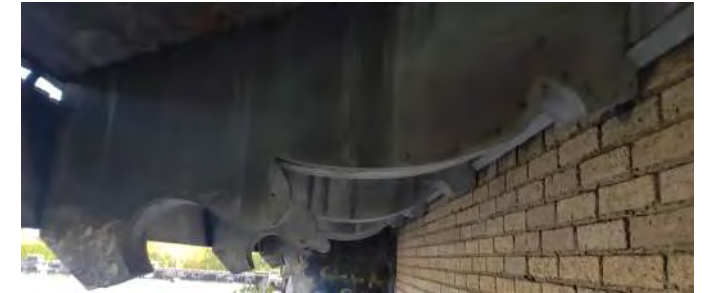
FIGURE 4.2 DECORATIVE WOOD EAVE, SIDE ELEVATION APPROX. LENGTH 3'-4"; IN FAIR CONDITION

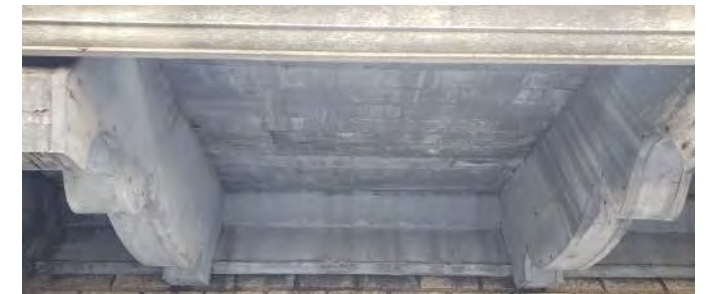
FIGURE A4.3 DECORATIVE WOOD EAVE IN FAIR CONDITION; (NORTH ELEVATION)

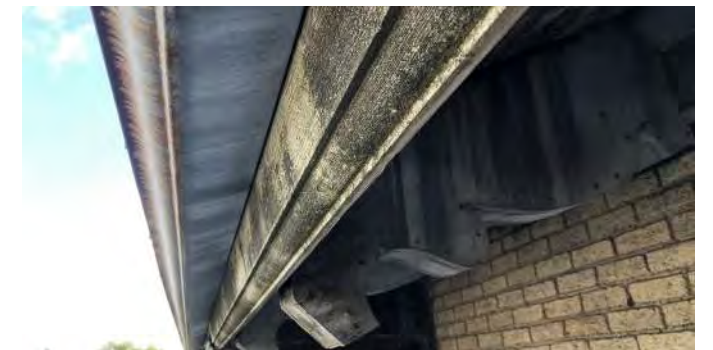
FIGURE A4.4 WEATHERED FASCIA BOARD WITH ATTACHED METAL GUTTER

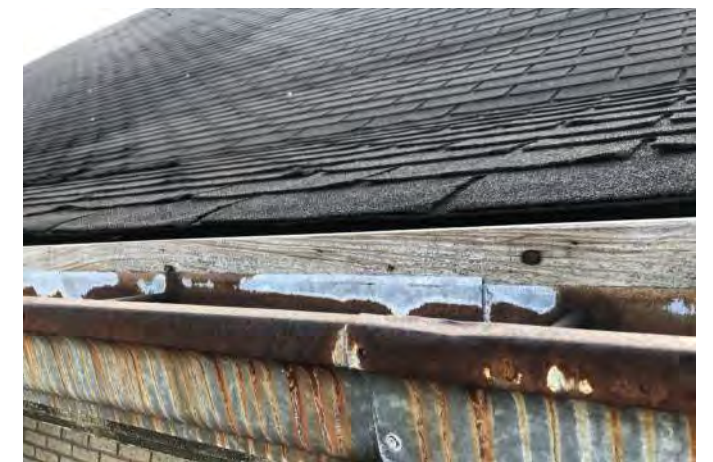
FIGURE A4.5 RUSTED GUTTER, CURLLED AND FRAYED ASPHALT SHINGLES

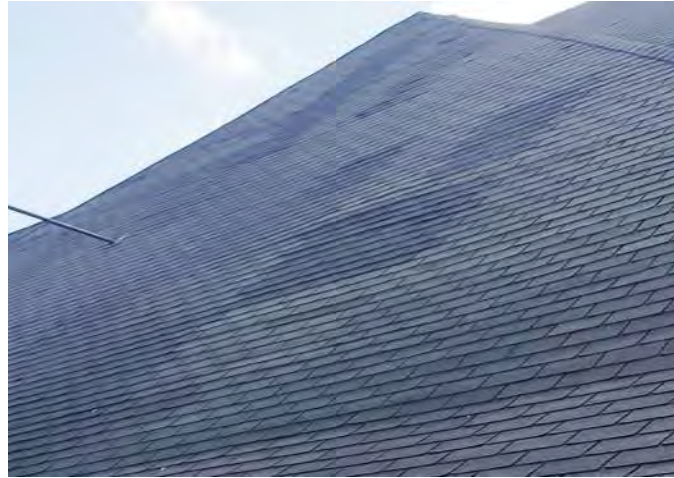
FIGURE A4.6 OVERVIEW OF NORTHERN ROOF; CURLED, DISCOLORED, AND FRAYED ASPHALT SHINGLES; SHOW SIGNS OF DEPRESSIONS AND UNEVEN SURFACES ALONG THE ROOF

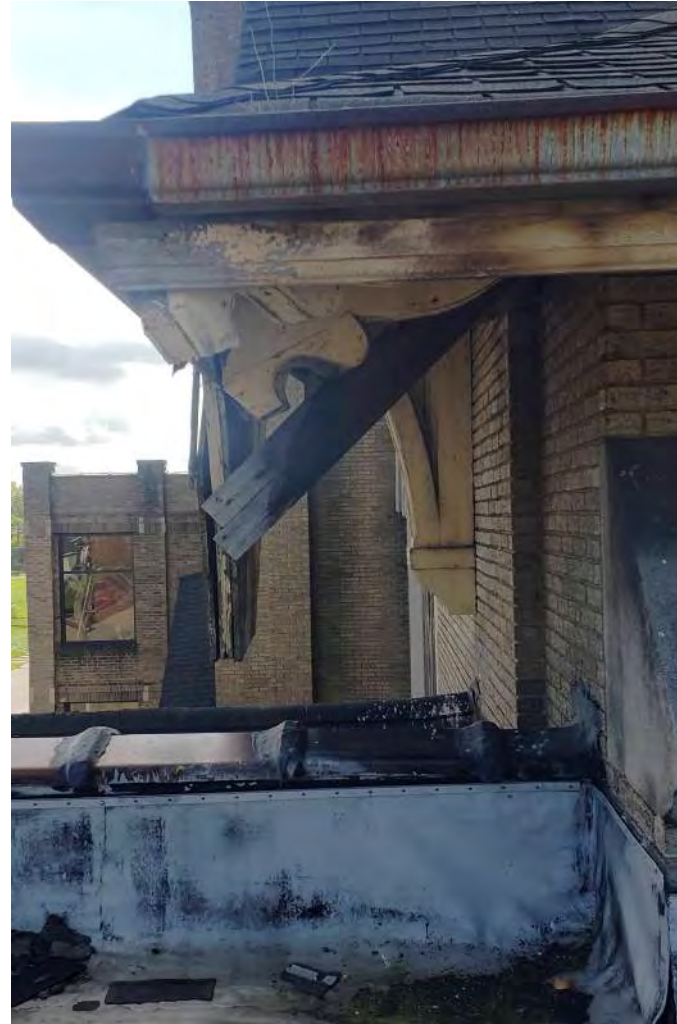
FIGURE A4.12 WEATHERED, FADED EAVES; RUSTED GUTTER (EAST ELEVATION)

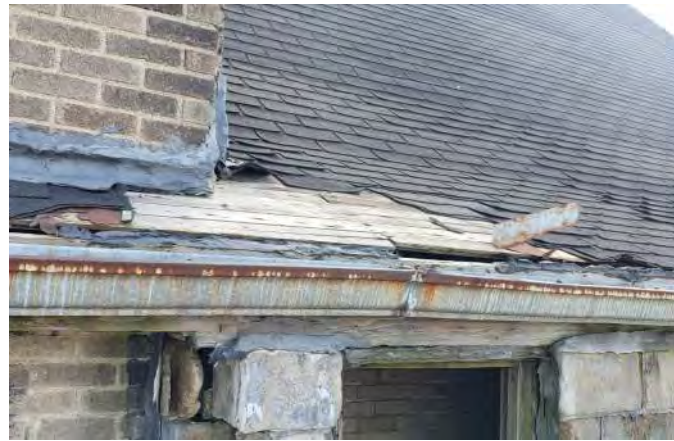
FIGURE A4.9 WEATHERED FASCIA BOARD; DECAYED WOOD DECKING; CURLED, FRAYED AND MISSING ASPHALT SHINGLES ABOVE ROOFTOP STAIR ENTRY.

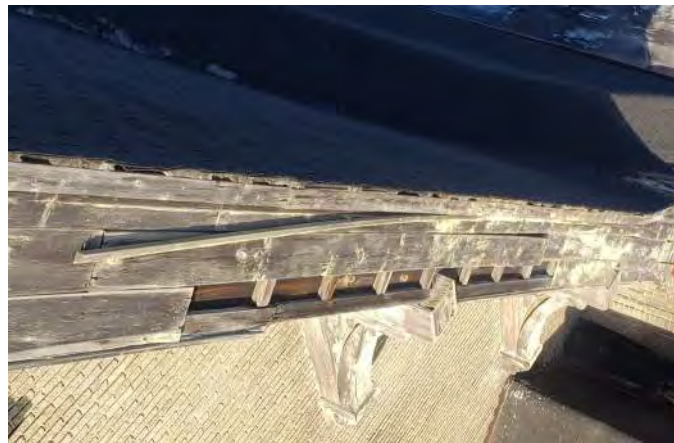
FIGURE A4.14 MISSING WOOD FASCIA BOARDS AT EAST ELEVATION

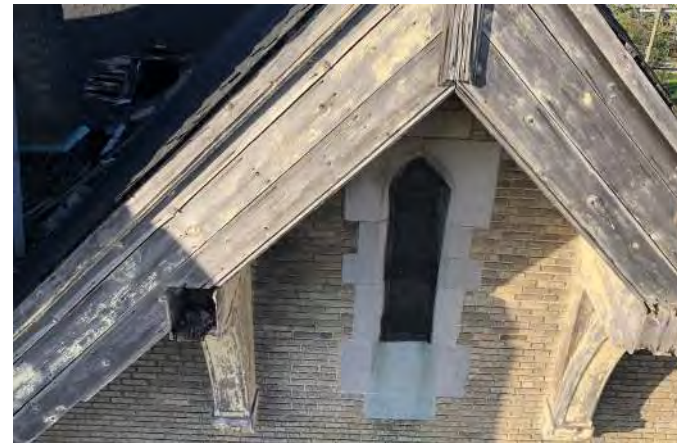
FIGURE A4.24 WEATHER AND FADED FASCIA BOARDS; DECAYED HOLLOWED WOODEN SUPPORT BRACKET

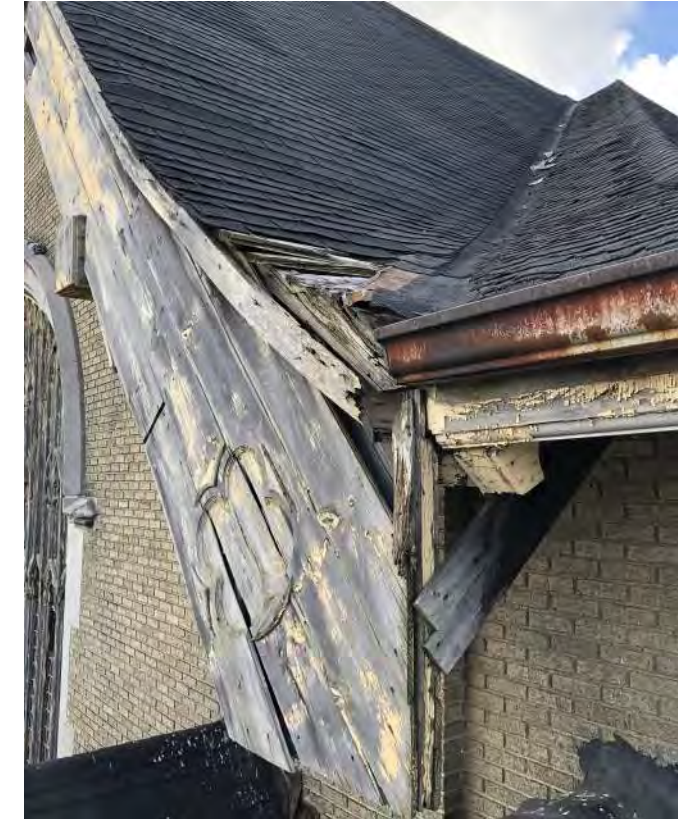
FIGURE 4.13 DECORATIVE FASCIA BOARDS ARE WEATHERED AND FADED; THEY ARE DETACHING FROM THE SUBSTRUCTURE. WOOD DECKING AT VALLEY TERMINATION IS EXPOSED, DECAYED WITH MISSING SHINGLES

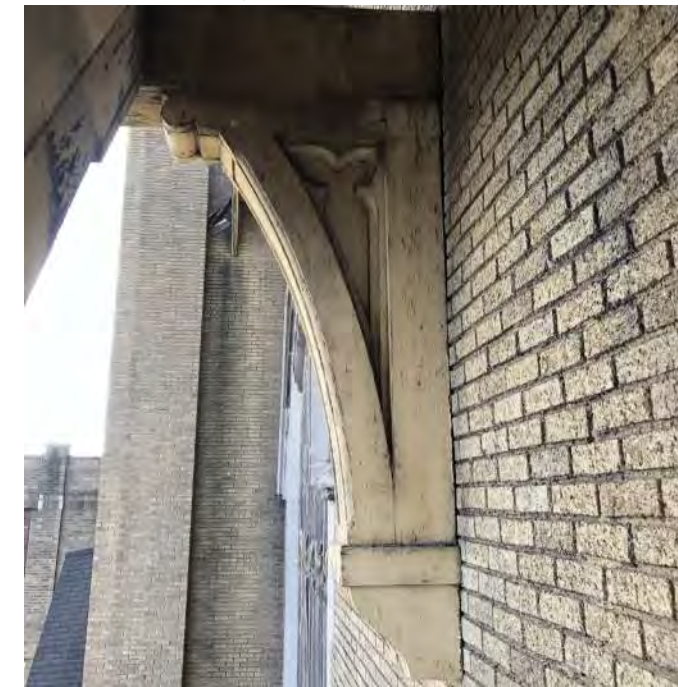
FIGURE A4.15 UNDERSIDE OF THE EAVES; PAINTED WOODEN BRACKET EAVE SUPPORT; (EACH BRACKET SHOULD BE INDIVIDUALLY EVALUATED)

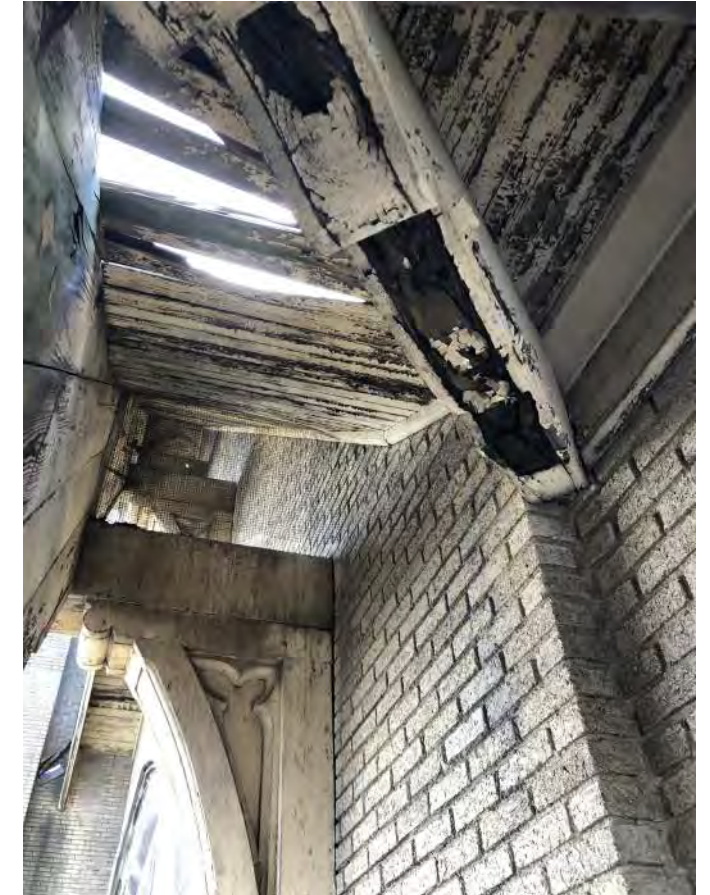
FIGURE A4.16 UNDERSIDE OF EAVES ON THE EAST ELEVATION AT THE MAIN ENTRANCE; WOOD DECKING IS DETERIORATION AT THE EAVE; MISSING WOOD DECKING; WEATHERED AND DECAYING SUPPORT BRACKETS

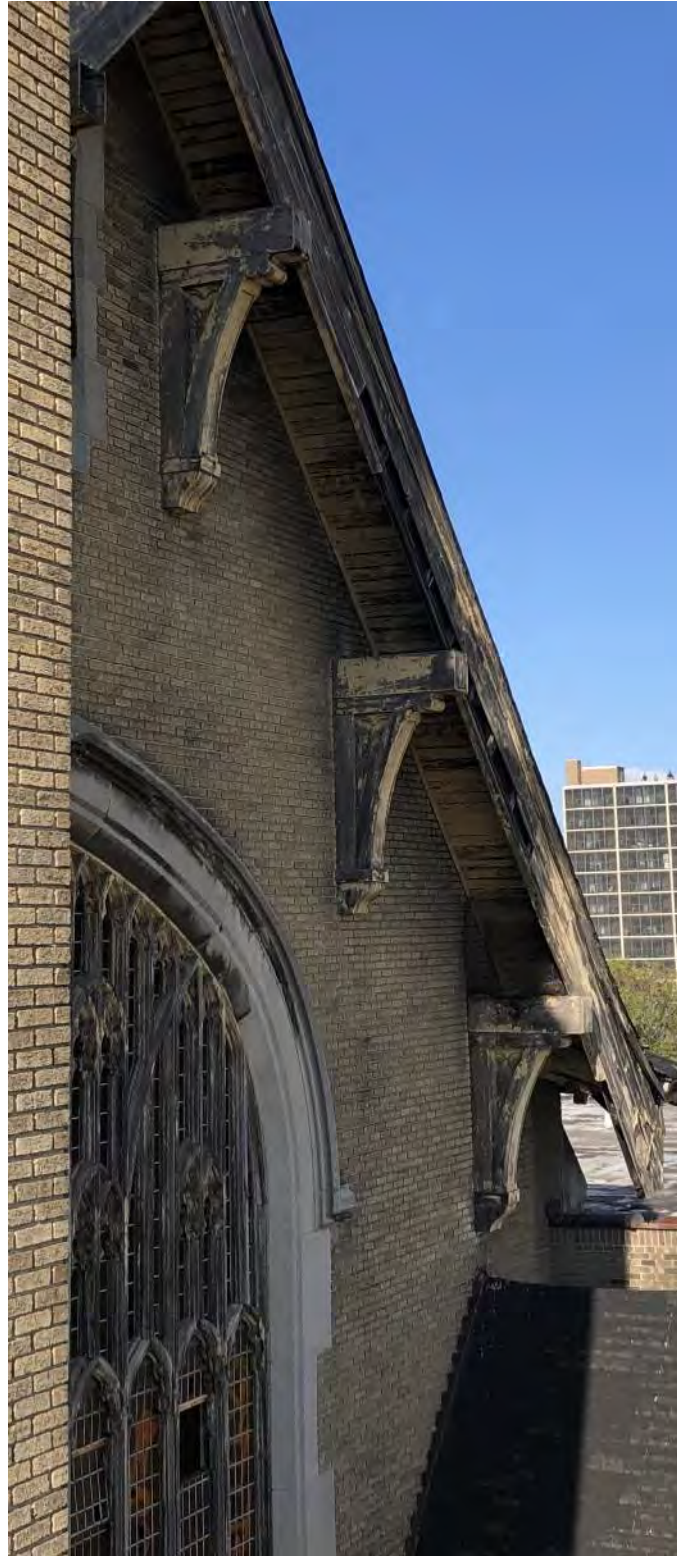
FIGURE 4.22 WEATHER AND FADED FASCIA BOARDS, FADED WOOD DECKING AT THE UNDERSIDE OF THE EAVES ON THE EAST ELEVATION AT THE MAIN ENTRANCE

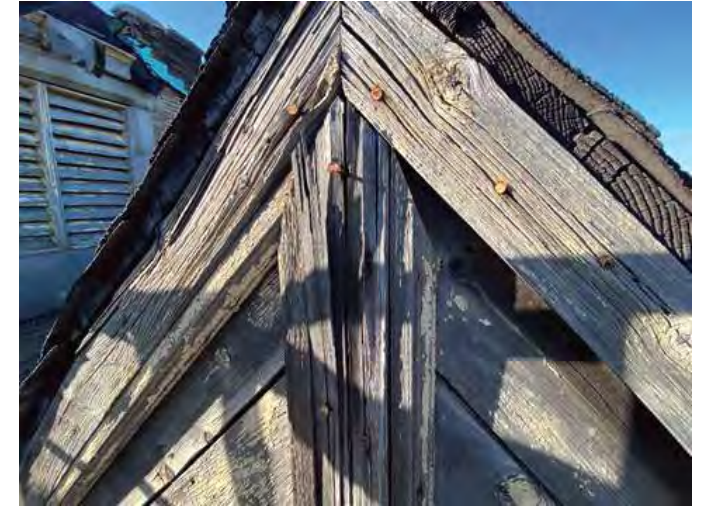
- The condition of the east overhang varies. The sheathing and a sloping beam that appears to be in moderate condition. The top members and inside structural members within the decorative brackets are in poor condition due to water leaking into the top of the brackets. (see figure S4.1)
- The main roof structure beyond the east overhang appears in moderate condition at the north and southeast slopes. The area at valley between the sloped roof and the bell tower is damaged, the structural members below the roofing may show some level of deterioration. (see figure S4.2)
- The southwest slope of the main roof area is in poor condition with many holes and areas of deteriorated sheathing and rafters. (see figure S4.3)
- The west overhang is in poor condition. The decorative support varies in condition. (see figure S4.4)

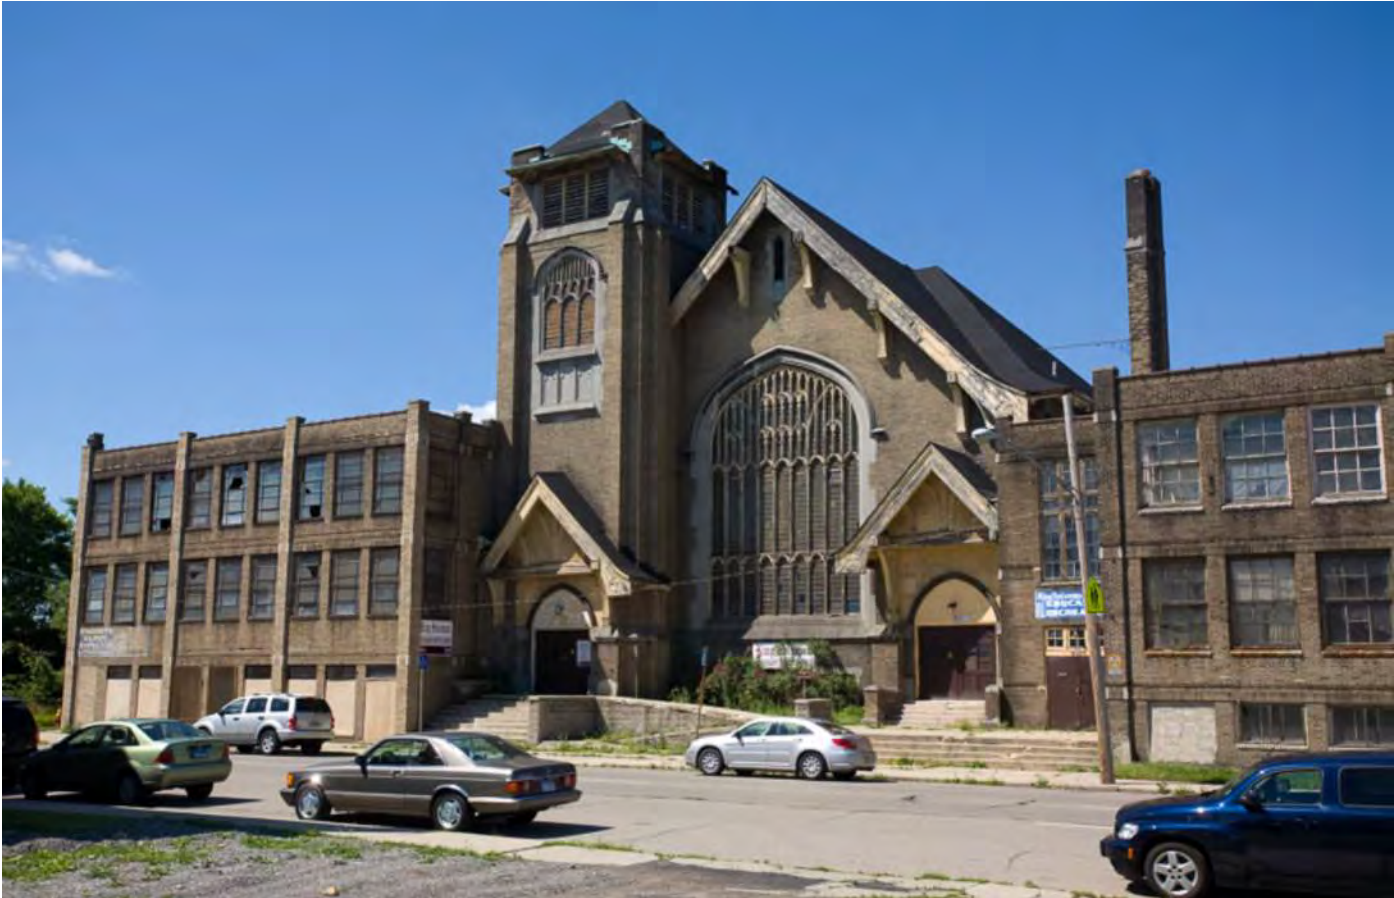
KING SOLOMON BAPTIST CHURCH

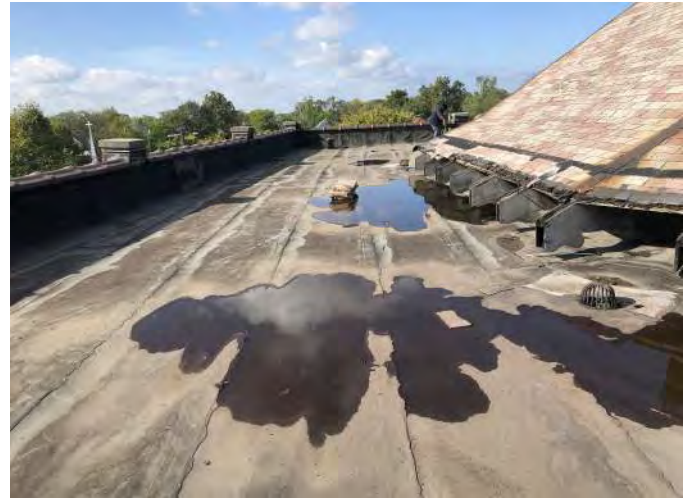
FIGURE A1.1 OVERVIEW LOOKING WEST AT VARIOUS POOLS OF STANDING WATER; FRAYED WARPED ROOFING MEMBRANE SEAMS; NO INDICATION OF ROOF INSULATION OR TAPERING

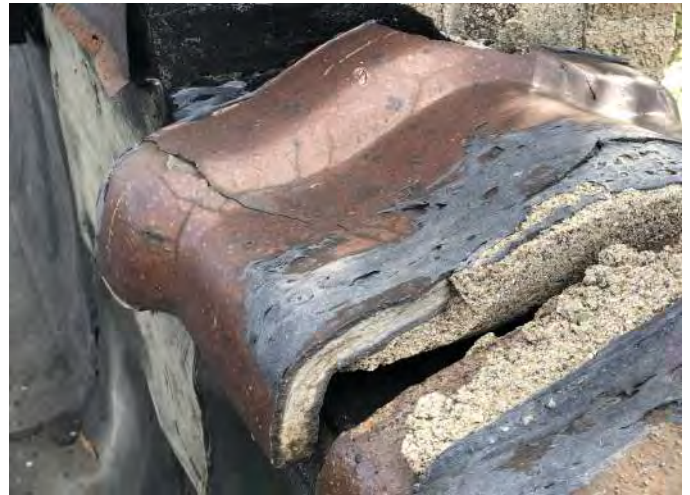
FIGURE A1.9 CRACKED AND DETACHED CLAY TILES AT THE PARAPET

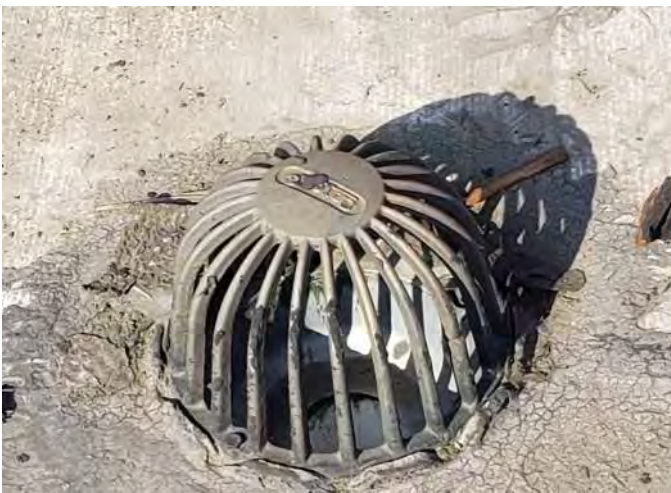
FIGURE A1.6 EXISTING ROOF DRAIN CAP BODY

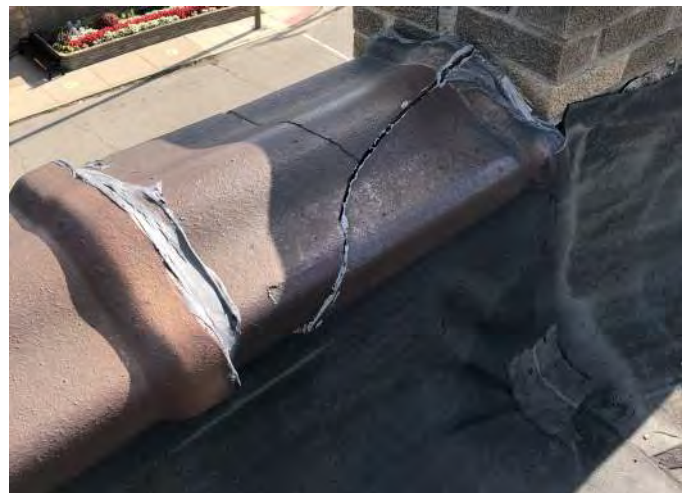
FIGURE A1.10 CRACKED CLAY TILES ALONG EAST ELEVATION

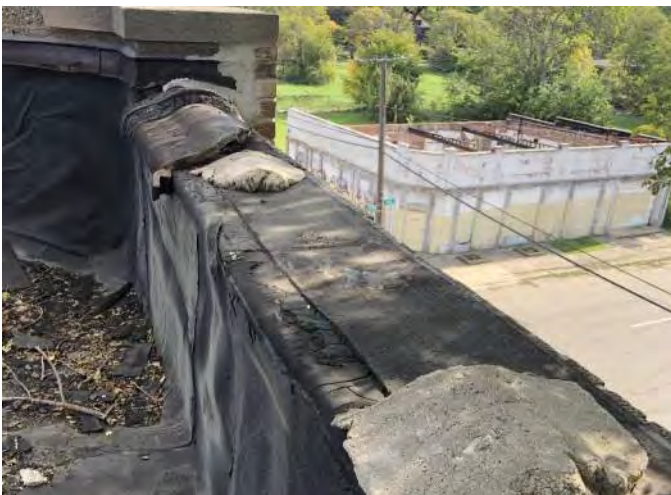
FIGURE A1.8 MISSING AND DAMAGED PARAPET CLAY TILES (SOUTHEAST CORNER)

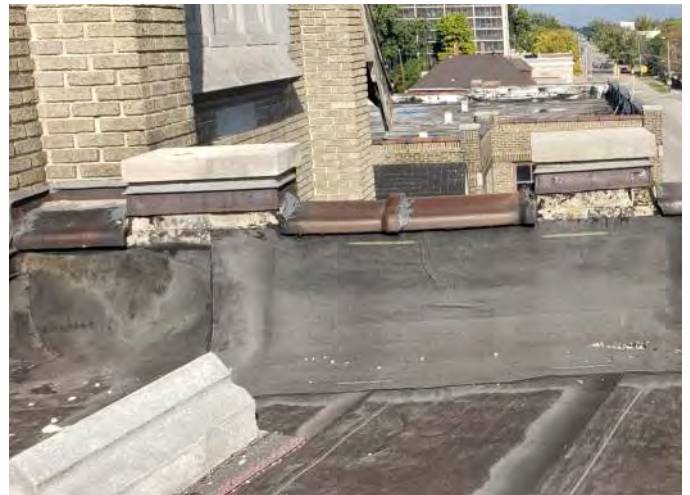
FIGURE A1.11 FLASHING MISSING UNDER COLUMN CAP

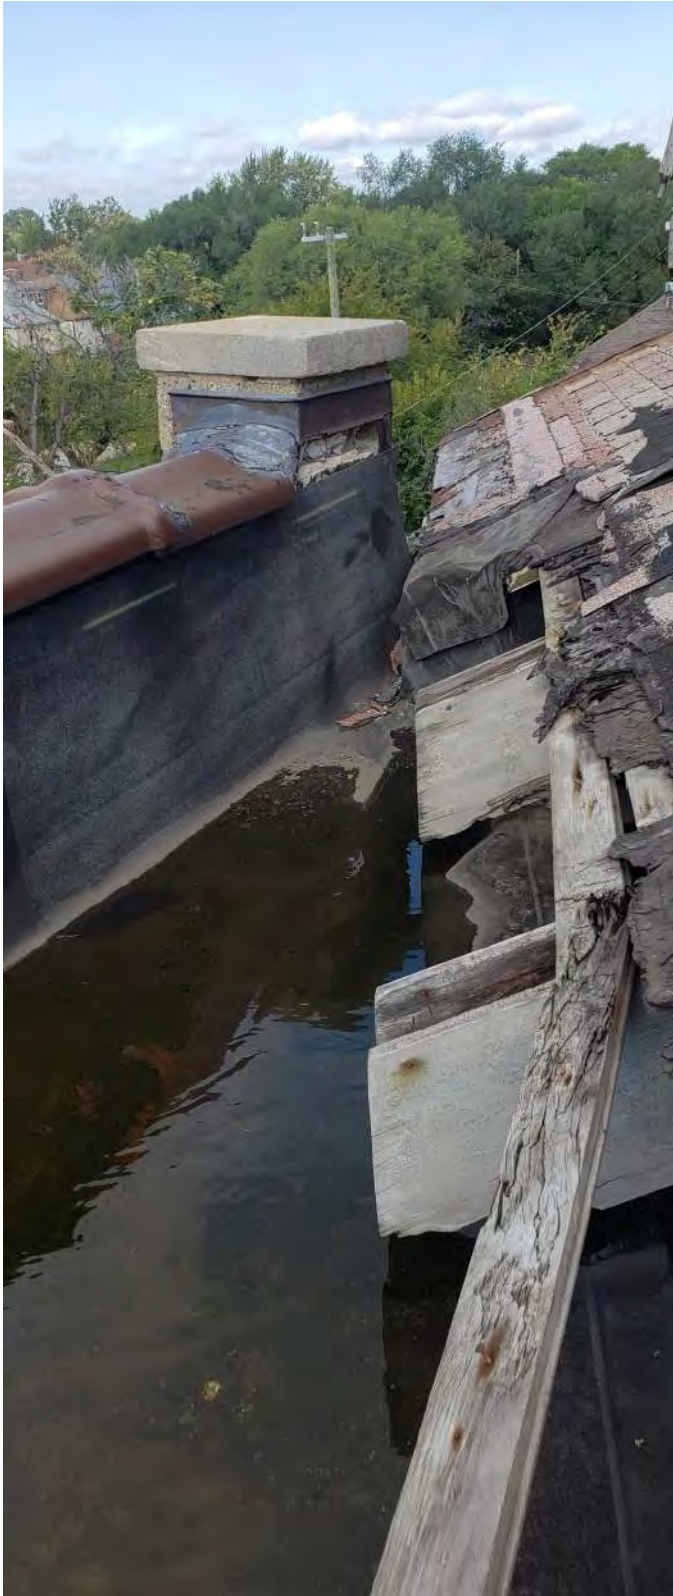
FIGURE A1.15 DETERIORATING CORNER COLUMN, UNFLASHSED MASONRY AT PIER COLUMN; 3" OR MORE PONDING WATER AT SOUTHWEST CORNER

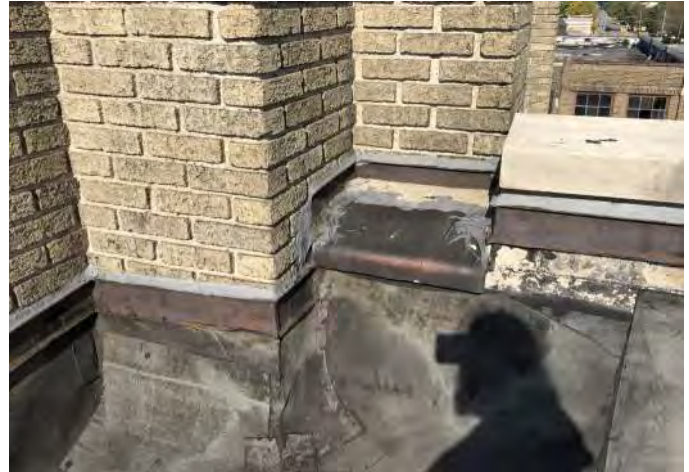
FIGURE A1.12 RUSTED FLASHING; WEATHERED SEALANTS, FLASHING MISSING AT THE UNDERSIDE OF THE COLUMN CAP

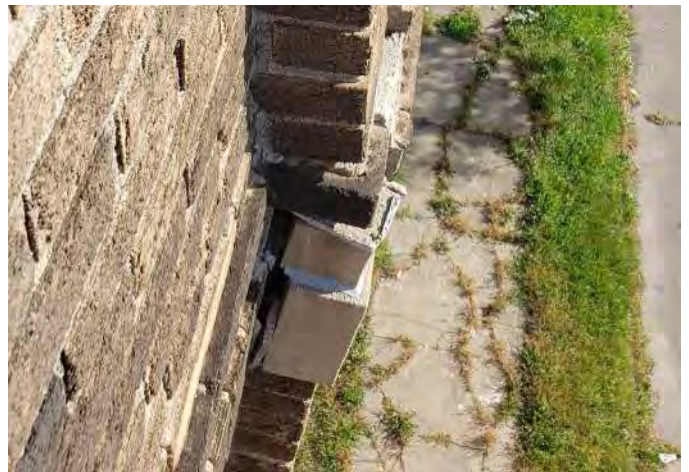
FIGURE A1.16 "ROLLING" BRICK DISPLACEMENT AT THE EXTERIOR PARAPET PIER COLUMN

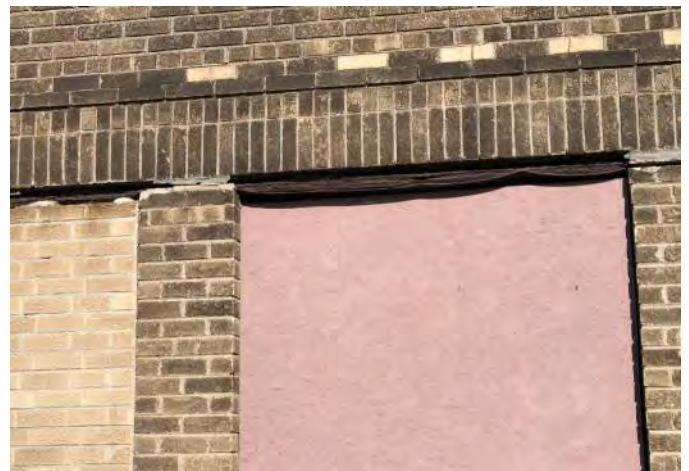
FIGURE A1.21 CORRODED AND EXPANDING STEEL LINTEL ABOVE THE WINDOWS ON THE THIRD FLOOR

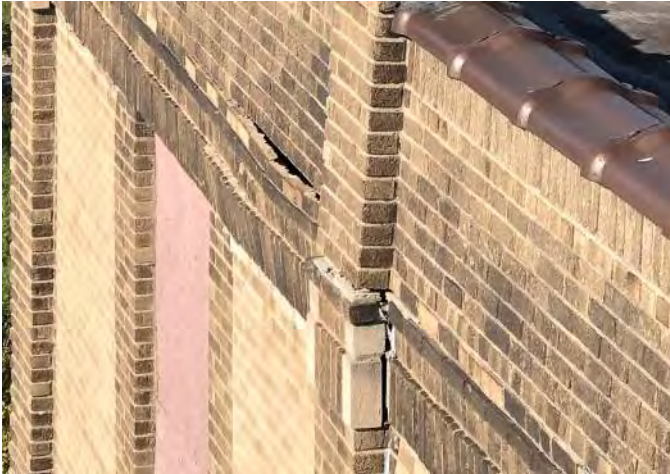
FIGURE A1.22 "ROLLING" BRICK DISPLACEMENT AT THE EXTERIOR PARAPET;
BUCKLING AT PIER COLUMN

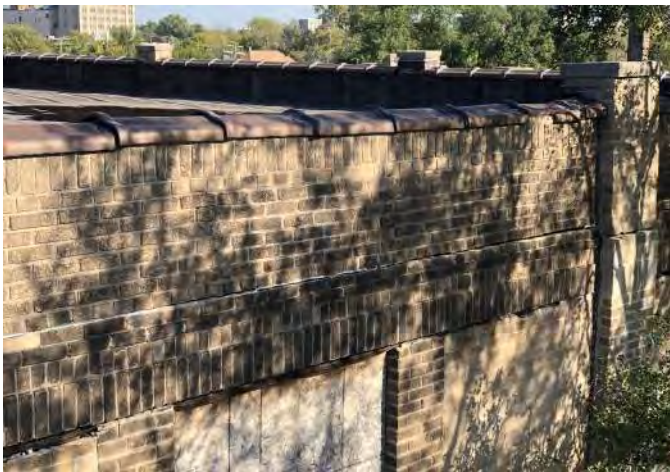
FIGURE A1.23 CORRODED AND EXPANDING LINTELS; "ROLLING" BRICK
DISPLACEMENT AT THE EXTERIOR PARAPET

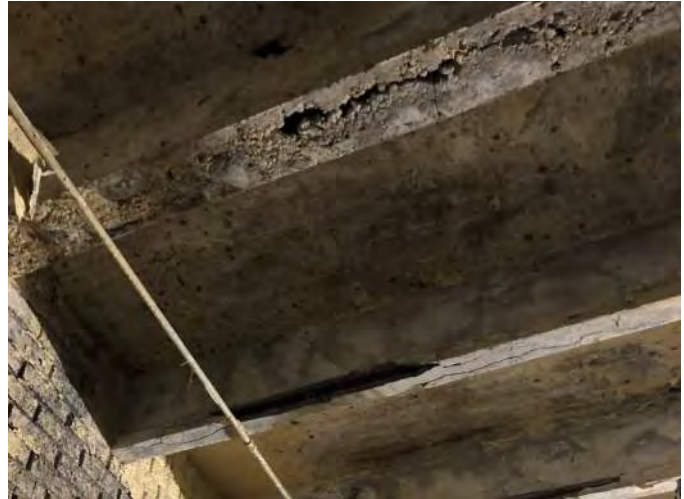
resulting movement of the parapet walls and piers could result in damage to the new roofing system or interior leaks through the masonry wall that are not associated with roofing system.

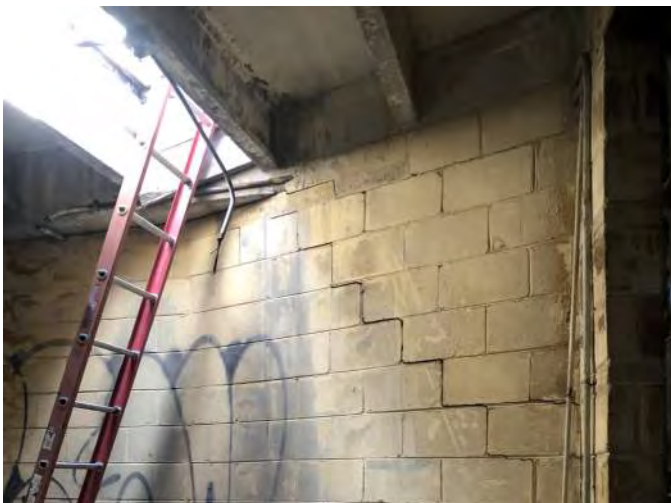
FIGURE S1.5 STAIR STEP CRACKING ALONG THE WEST WALL BEHIND THE ROOF HATCH ACCESS

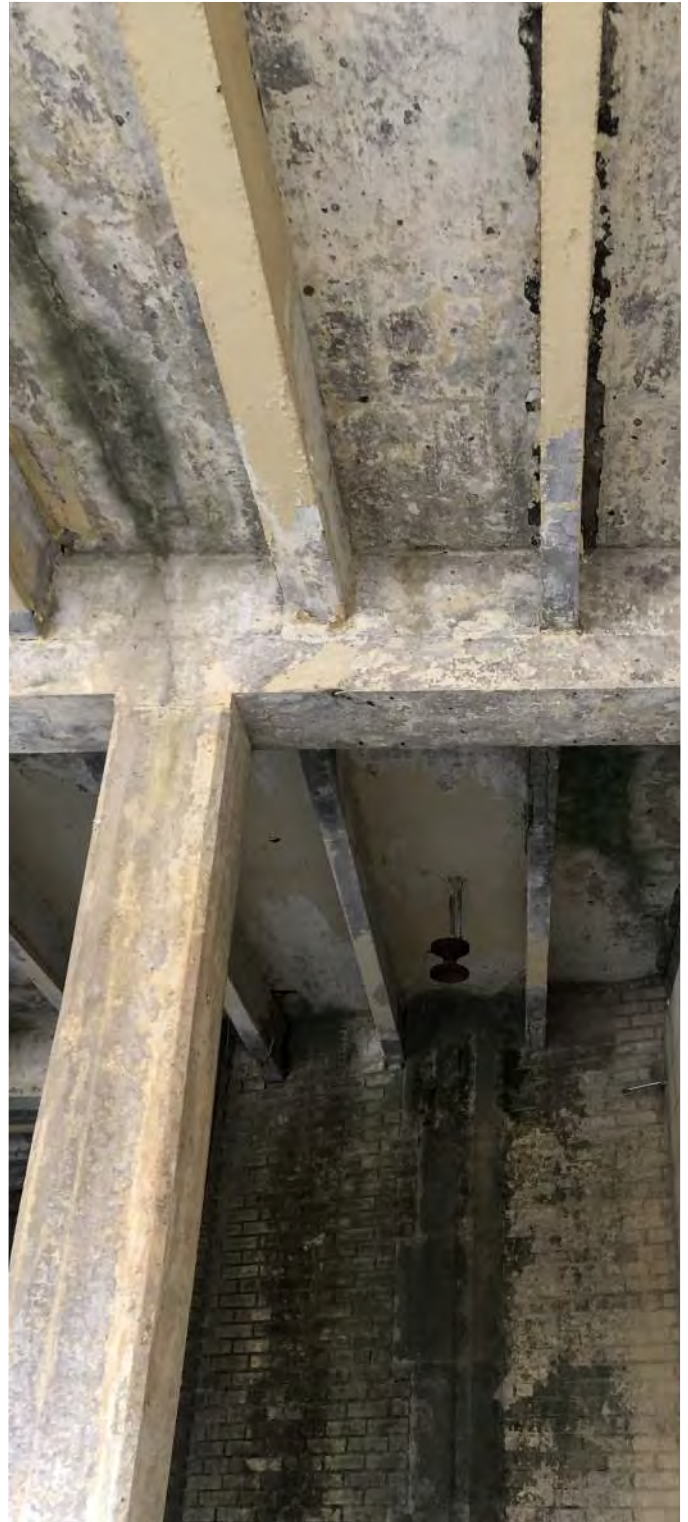
FIGURE S1.6 INTERNAL WATER DAMAGE FROM THE ROOF ABOVE; THE WATER INFILTRATION IS STARTING TO SHOW SIGNS OF FREEZE/THAW DAMAGE INCLUDE SPALLING AND SCALING OF THE CONCRETE SURFACE, SURFACE PARALLEL CRACKING, OR EXPOSED AGGREGATE.

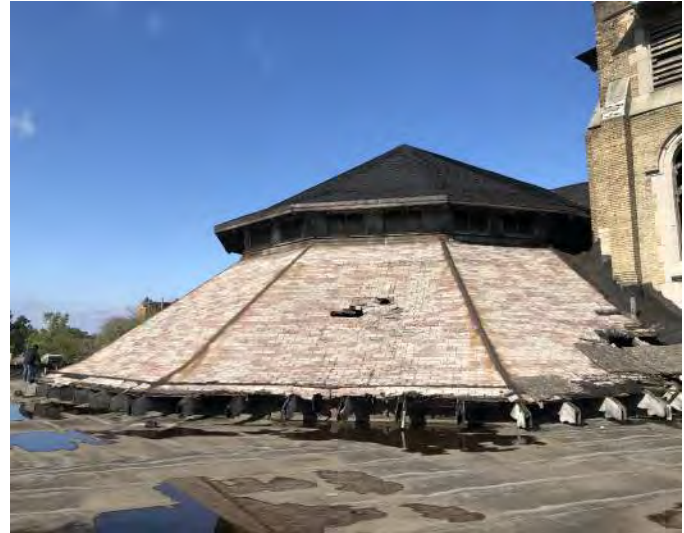
FIGURE A2.1 OVERVIEW OF THE TWO TIERED HEPTAGON ROOF; ROOF DECAY AND WATER INFILTRATION, WORN AND MISSING ASPHALT TILES, WEATHERED AND ROTTED DECORATIVE EAVE OUTRIGGERS/RAFTER TAILS.

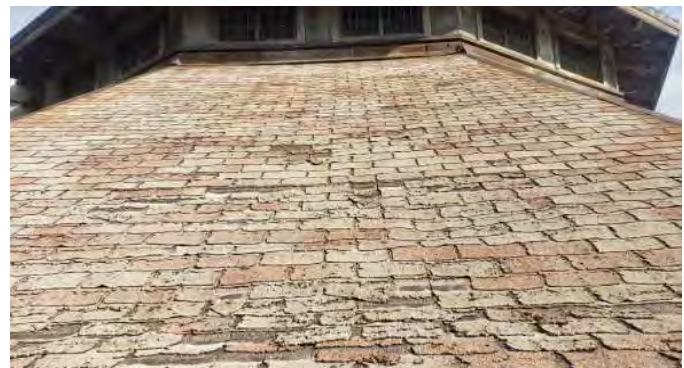
FIGURE A2.2 SURFACE DEPRESSIONS ALONG THE ROOF; CURLLED, DISCOLORED AND FRAYED ASPHALT SHINGLES; RUSTED METAL FLASHING UNDER THE UPPER WINDOWS

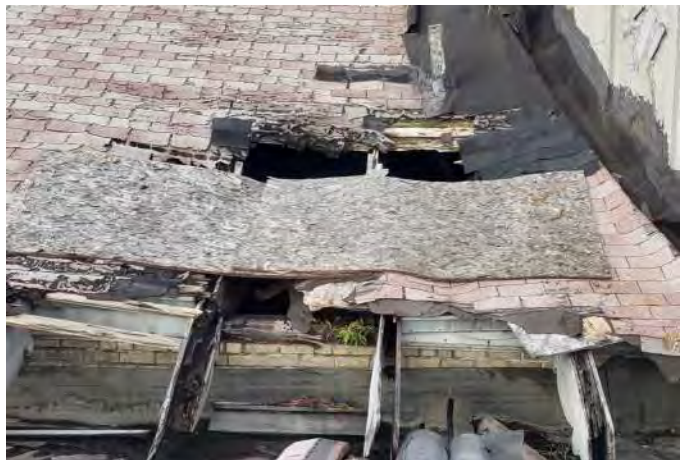
FIGURE A2.7 COMPLETE DETERIORATION AND DECAY OF THE DECORATIVE WOOD EAVES AND DECORATIVE RAFTER TAILS; THE LEVEL OF DETERIORATION MAY REQUIRE LOCALIZED REPAIRS TO ADJACENT ELEMENTS SUCH AS THE BRICK WALL BELOW

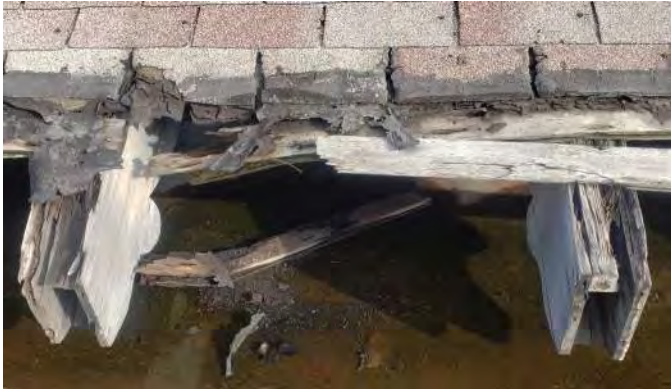
FIGURE A2.8 SIGNIFICANT DETERIORATION AT THE PERIMETER (TERMINATION OF DECORATIVE EAVES); EXTENSIVE WOOD ROT OF THE DECORATIVE EAVE OUTRIGGERS/RAFTER TAILS; PONDING WATER BELOW

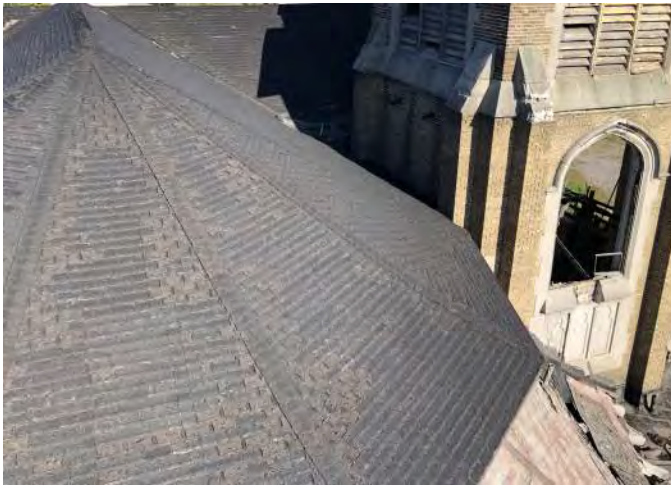
FIGURE A2.10 UPPER TIER OF HEPTAGON ROOF; WORN, MISSING CURLED, DISCOLORED, AND FRAYED ASPHALT SHINGLES

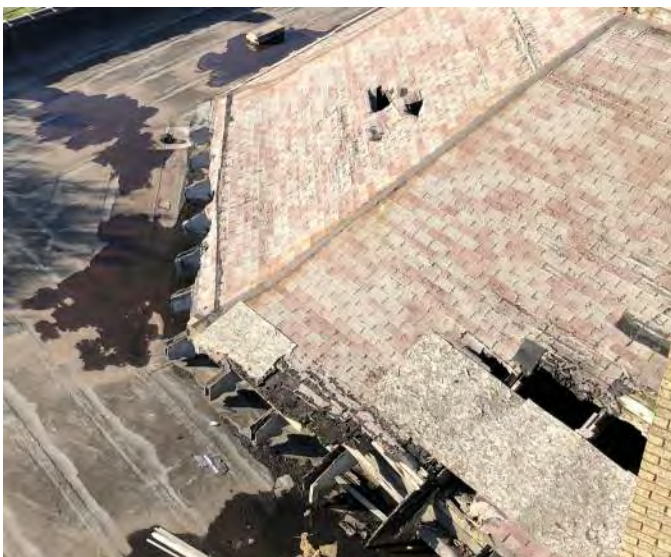
FIGURE A2.12 OVERVIEW OF THE HEPTAGON ROOF ABOVE, SHOWS THE EXTENT OF THE ROOF DETERIORATION WITH VARIOUS HOLES ALONG THE SURFACE

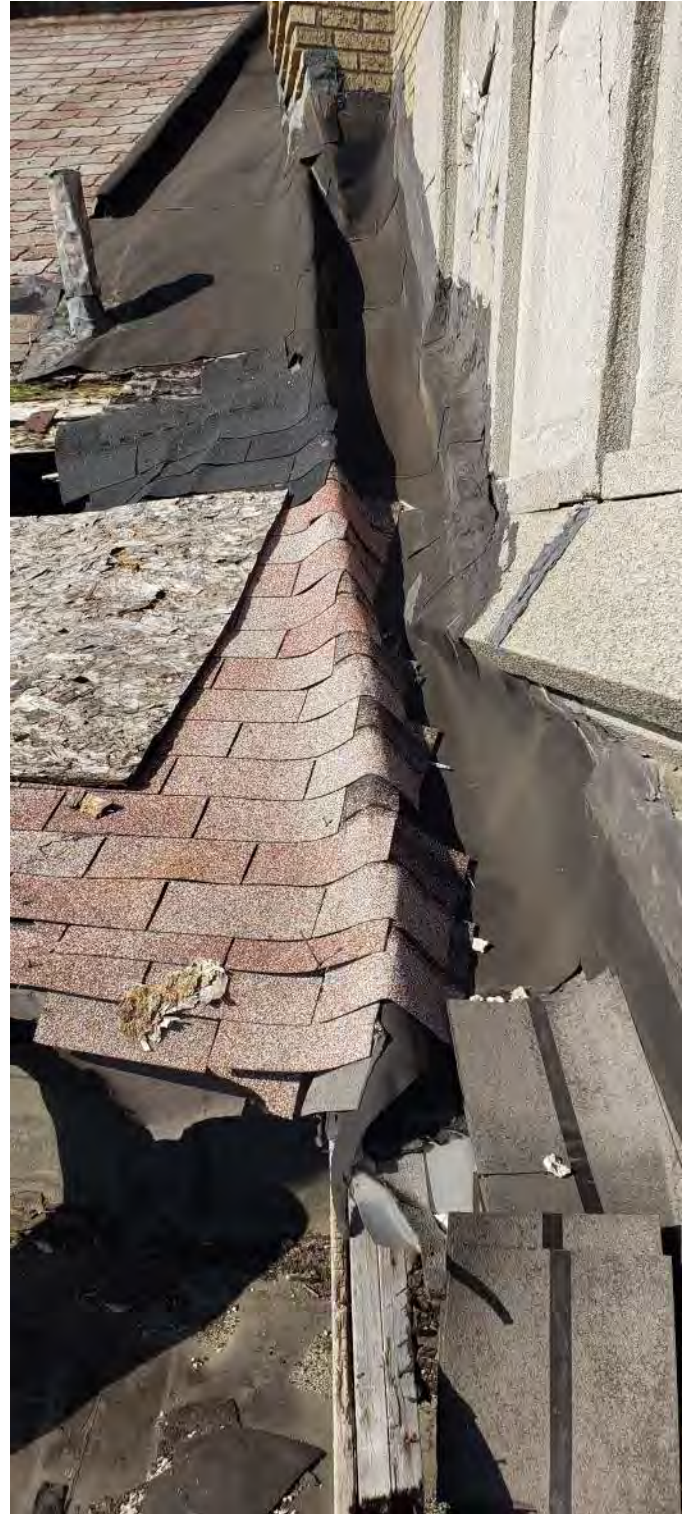
FIGURE A2.13 IMPROPER FLASHING AND PATCHING AT THE VALLEY JUNCTION BETWEEN THE POLYGONAL ROOF AND BELL TOWER; THE ASPHALT SHINGLES ARE NOT PROPERLY TERMINATED; EXCESSIVE USE OF ROOFING MASTIC ALONG THE BELL TOWER WALL; DETERIORATED ROOF VENT NEAR THE LARGE HOLE IN THE ROOF.

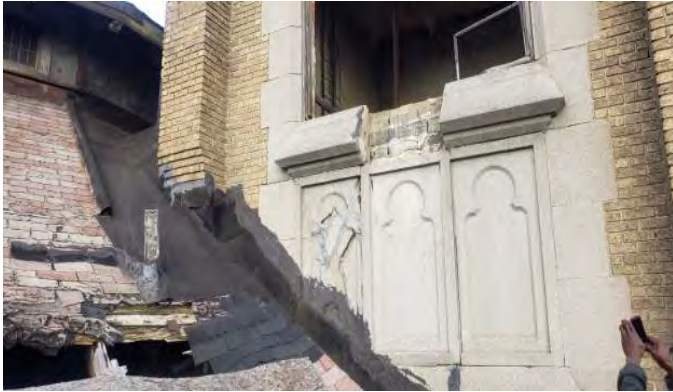
FIGURE A2.6 FAILURE OF THE FLASHING AT THE INTERSECTION WHERE THE POLYGONAL ROOF INTERSECTS WITH THE BELL TOWER; STAINING OF THE DECORATIVE STONE BY FLASHING SEALANT

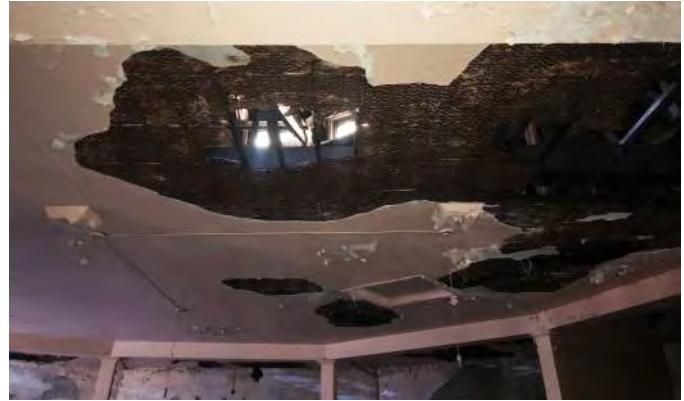
FIGURE A2.14 DETERIORATING INTERIOR PLASTER BELOW THE HEPTAGONAL ROOF STRUCTURE; SUN LIGHT IS VISIBLE THROUGH THE HOLE IN THE ROOF ABOVE
