STAFF REPORT 03-16-2022 SPECIAL MEETING

PREPARED BY: A. PHILLIPS

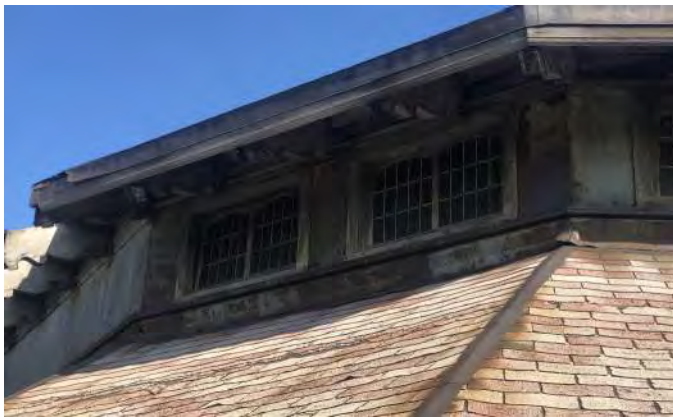
FIGURE A2.11 THE UPPER TIER OF THE POLYGONAL ROOF; VISIBLE RUST ON THE METAL WINDOW FRAMING AND ROOF HIPS; METAL FLASHING IS CORRODING AND DETACHING FROM THE FASCIA BOARD AND HEAD OF LOWER ROOF

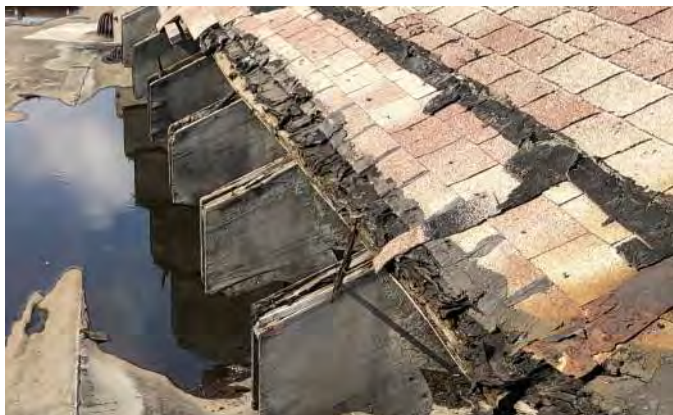
FIGURE A2.13 DECORATIVE WOOD EAVE SHOW SIGNS OF DECAY AND ROT; SIGNIFICANT DETERIORATION OF THE ROOF PERIMETER EDGE; WITH POOLS OF WATER GATHERING UNDER THE EAVES

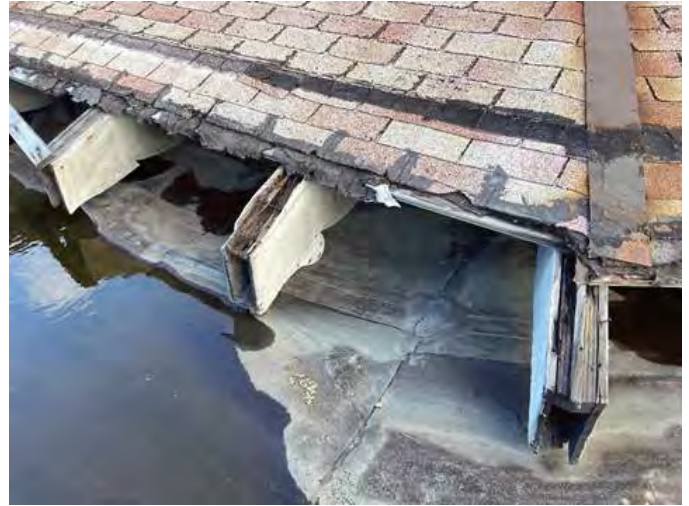
- Upper tier roof area appears in better condition than the lower roof. Localized deterioration of sheathing and rafters can be anticipated above the area with exposed overhang brackets. (see figure S2.5)

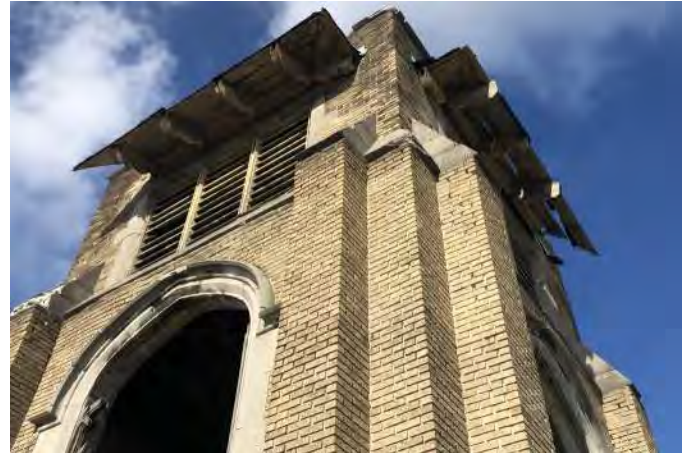
FIGURE A3.2 THE EAVE OVERHANG SHOWS EXTENSIVE WOOD DECAY AND DETERIORATION

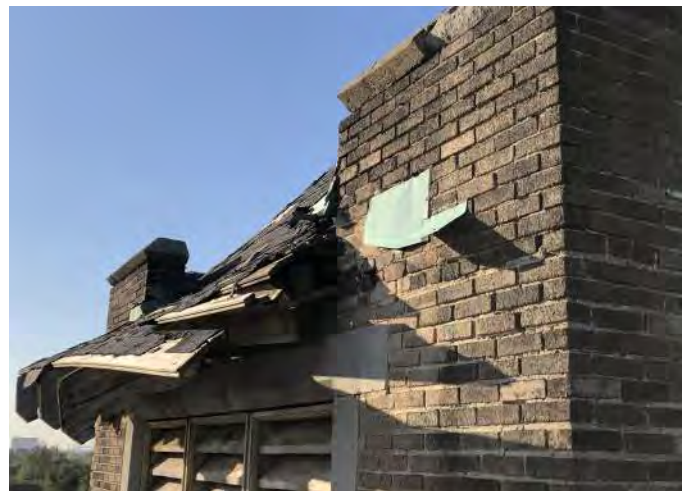
FIGURE A3.4 DECORATIVE WOOD OVERHANGS COLLAPSING AND OPEN AT ENDS TO INTERIOR; BRICK MASONRY SHOWS SIGNS OF DIFFERENTIAL MOVEMENT; REMAINING STEPPED COPPER FLASHING (EAST ELEVATION)

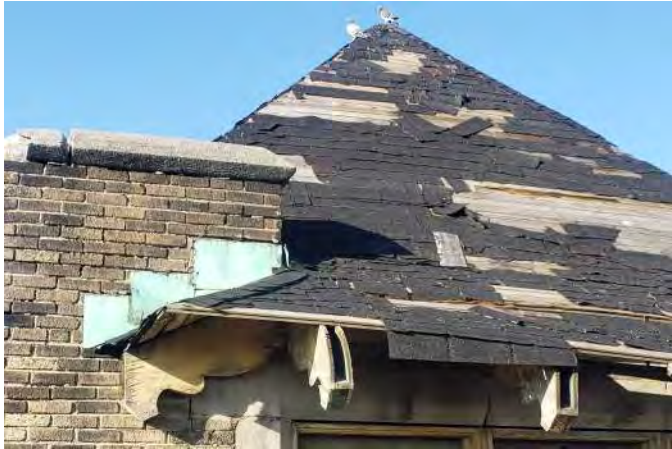
FIGURE A3.7 HIP ROOF IS IN VERY POOR CONDITION; WEATHERED AND DECAYED WOOD DECKING, MISSING/FALLEN SHINGLES AND EXPOSED DECKING AND ORIGINAL STEPPED COPPER FLASHING (EAST ELEVATION)

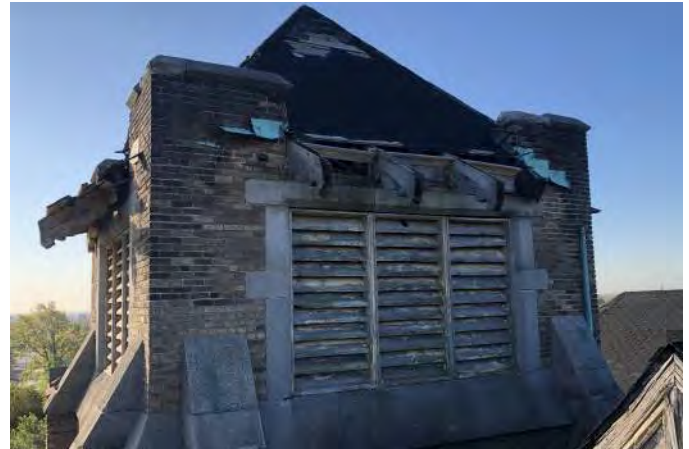
FIGURE A3.10 OVERVIEW OF THE BELL TOWER'S ROOF AND DECKING; THE DECKING ON TOP OF THE DECORATIVE EAVE HAS COMPLETELY DECAYED AND DETACHED FROM THE ROOF ASSEMBLY (NORTH ELEVATION)

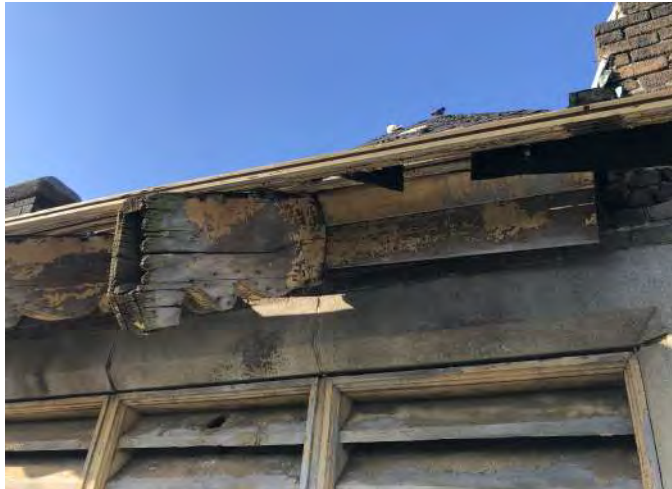
FIGURE A3.8 ROTTED DECORATIVE WOOD RAFTER TAIL AND DETACHING FRIEZE BOARD TRIM

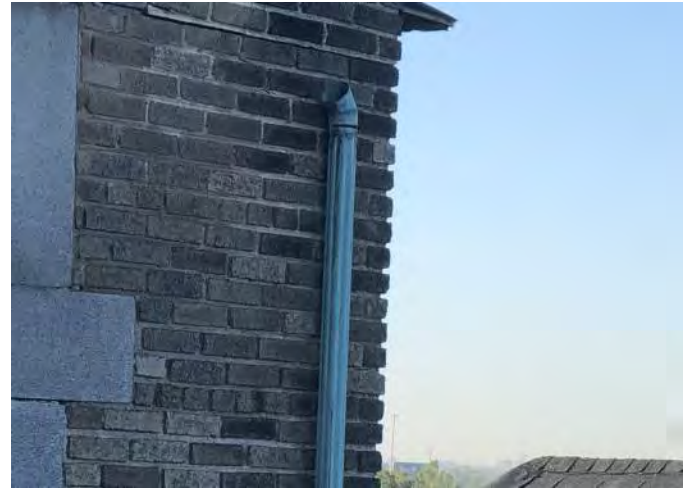
FIGURE A3.11 DETACHED COPPER DOWNSPOUT AND MISSING ASSOCIATED COPPER GUTTER

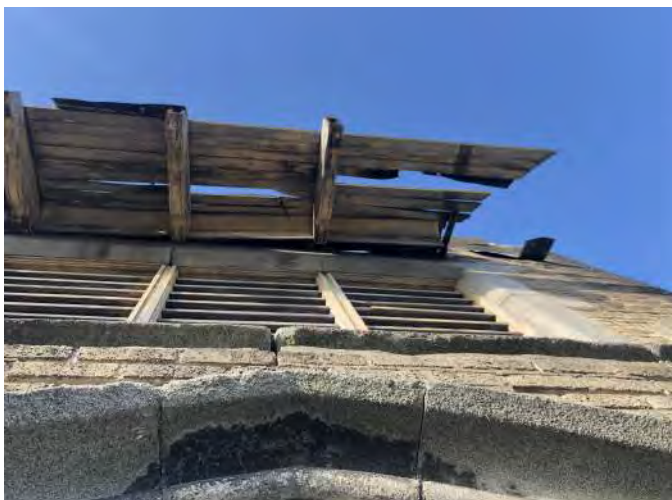
FIGURE A3.9 UNDERSIDE OF THE PAINTED DECORATIVE OVERHANGS; WEATHERED DETERIORATED WOOD DECKING (EAST ELEVATION)

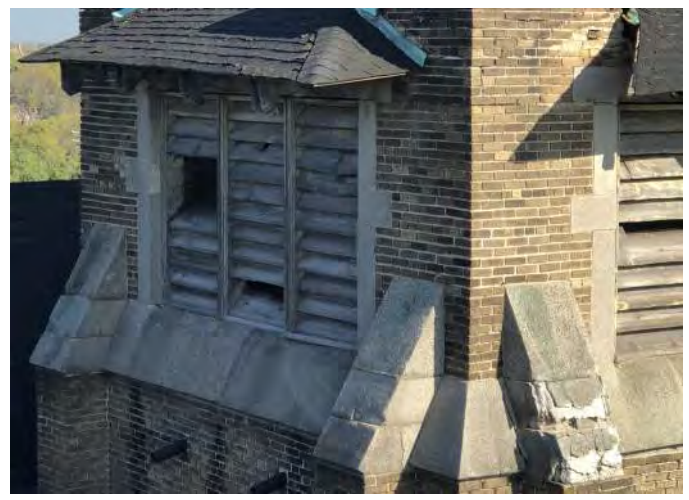
FIGURE A3.12 SOUTH WEST ELEVATION OF BELL TOWER; CRUMBLING STONE AT THE COLUMN CAP; BRICK MOVEMENT DIRECTLY UNDER THE ROOF

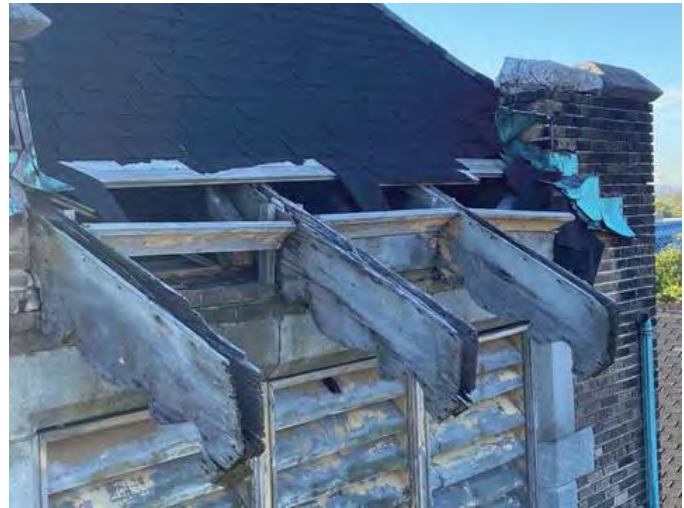
- The entire roof structure is in very poor condition and beyond serviceable condition. Large portions of the roof overhang area and support brackets are missing. The plank sheathing on the pyramid roof is exposed and is in poor condition. The nearby areas are badly deteriorated or missing. (see figure S3.1)
- The masonry piers and masonry below the roof support zone has limited cracking, moderate mortar joint deterioration and visible spalling. There is a significant risk of damage to people and property from falling debris due to the condition of the masonry. (see figure S3.2)
- There are large openings in the bell tower where the original windows and louvers have been removed or are damaged. These openings should be closed off as part of the roofing solution. (see figure S3.3)

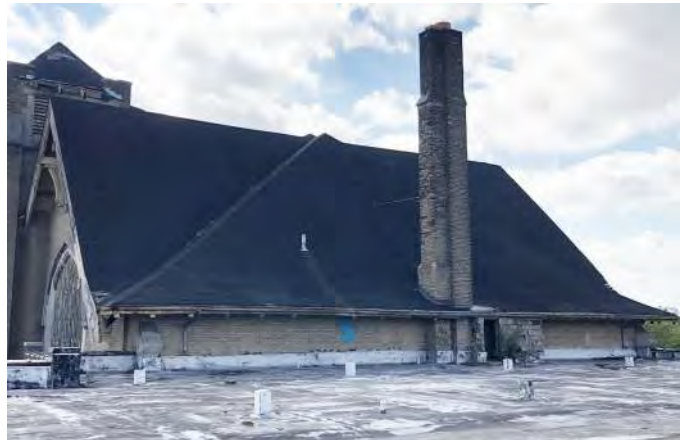
FIGURE A4.00 OVERVIEW OF NORTHERN SIDE OF THE CROSS GABLE ROOF

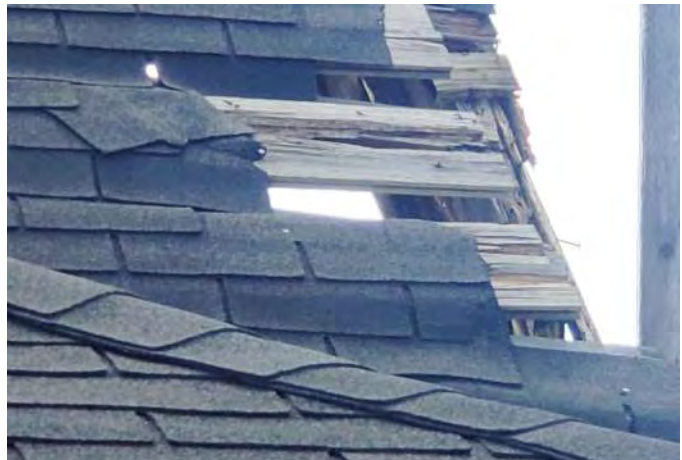
FIGURE 4.1 DETERIORATED WOOD DECKING, MISSING/FALLEN SHINGLES AT THE EAVE (WEST ELEVATION)

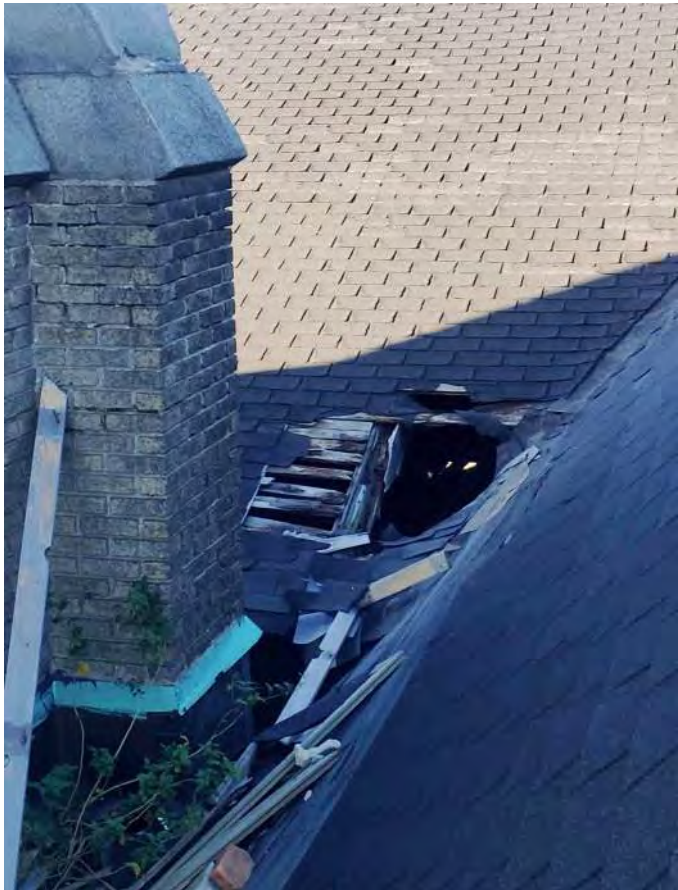
FIGURE A4.17 LARGE HOLE IN THE ROOF; DETERIORATED SHINGLES, WOOD DECKING AT THE ROOF VALLEY ; FALLEN WOOD DECKING FROM THE BELL TOWER ROOF ABOVE

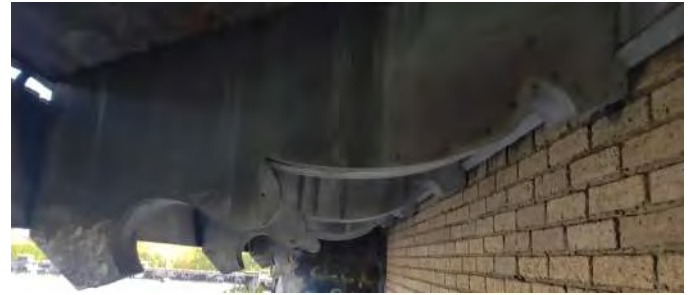
FIGURE 4.2 DECORATIVE WOOD EAVE, SIDE ELEVATION APPROX. LENGTH 3'-4"; IN FAIR CONDITION

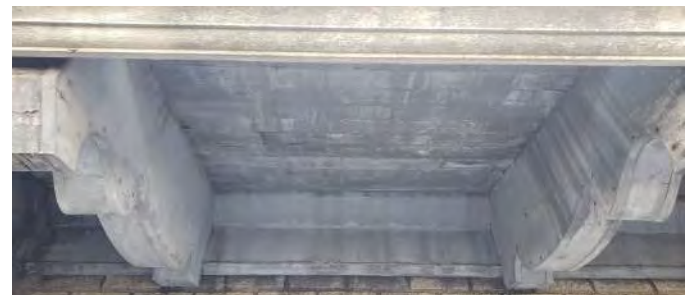
FIGURE A4.3 DECORATIVE WOOD EAVE IN FAIR CONDITION; (NORTH ELEVATION)

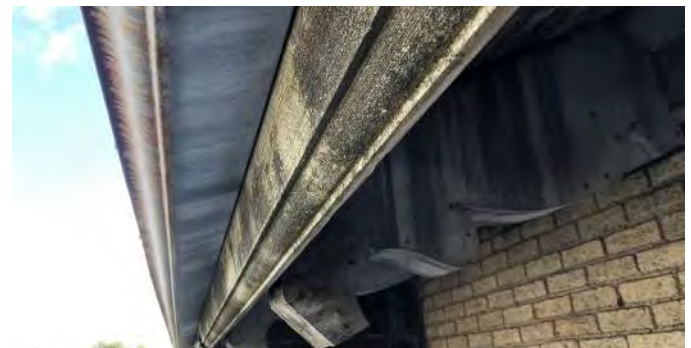
FIGURE A4.4 WEATHERED FASCIA BOARD WITH ATTACHED METAL GUTTER

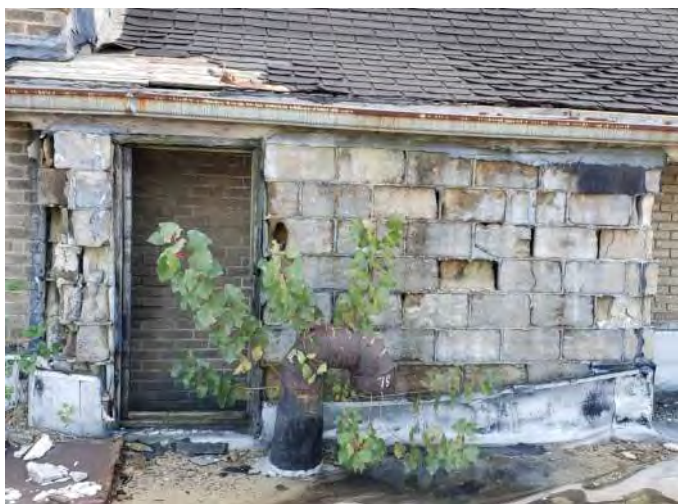
FIGURE A4.23 EXTENSIVE EXTERIOR MASONRY DETERIORATION AT ROOFTOP STAIR ENTRY/EXIT; MISSING AND DETERIORATED MORTAR JOINTS; DETACHED ROOFTOP STAIR ENTRY DOOR; DAMAGED DOOR FRAMING. DETACHED FLASHING AT THE UPTURN OF THE NORTH MEMBRANE ROOFING

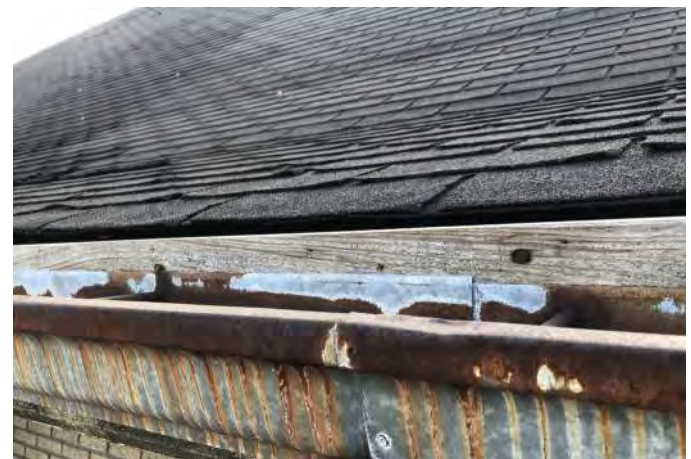
FIGURE A4.5 RUSTED GUTTER, CURLLED AND FRAYED ASPHALT SHINGLES

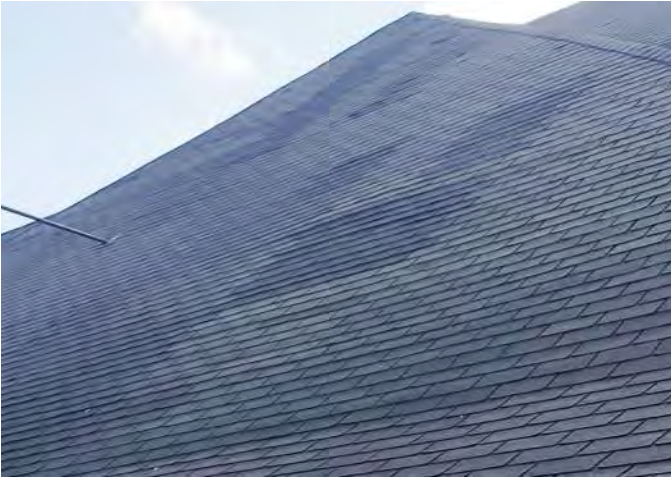
FIGURE A4.6 OVERVIEW OF NORTHERN ROOF; CURLLED, DISCOLORED, AND FRAYED ASPHALT SHINGLES; SHOW SIGNS OF DEPRESSIONS AND UNEVEN SURFACES ALONG THE ROOF

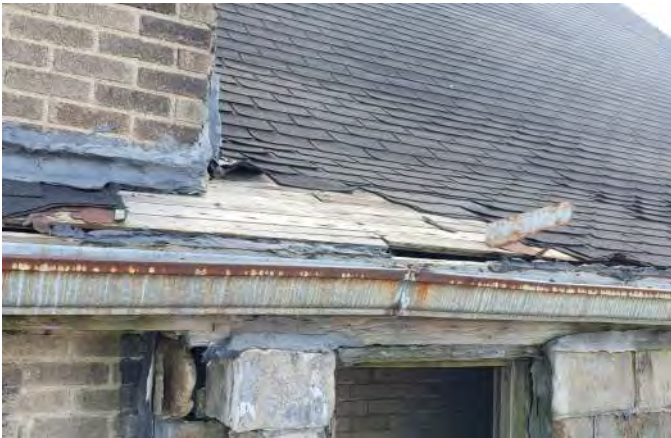
FIGURE A4.9 WEATHERED FASCIA BOARD; DECAYED WOOD DECKING; CURLLED, FRAYED AND MISSING ASPHALT SHINGLES ABOVE ROOFTOP STAIR ENTRY.

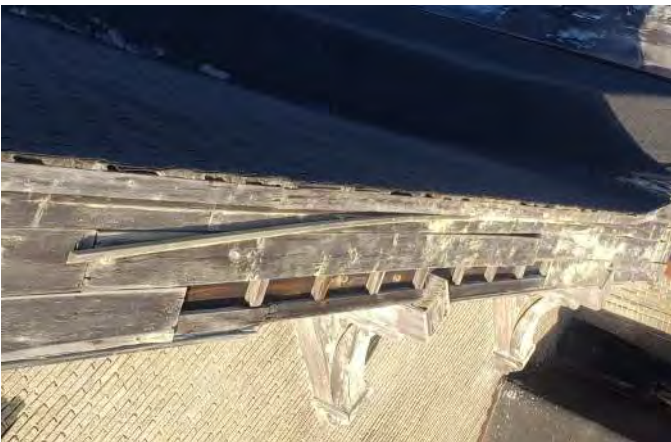
FIGURE A4.14 MISSING WOOD FASCIA BOARDS AT EAST ELEVATION

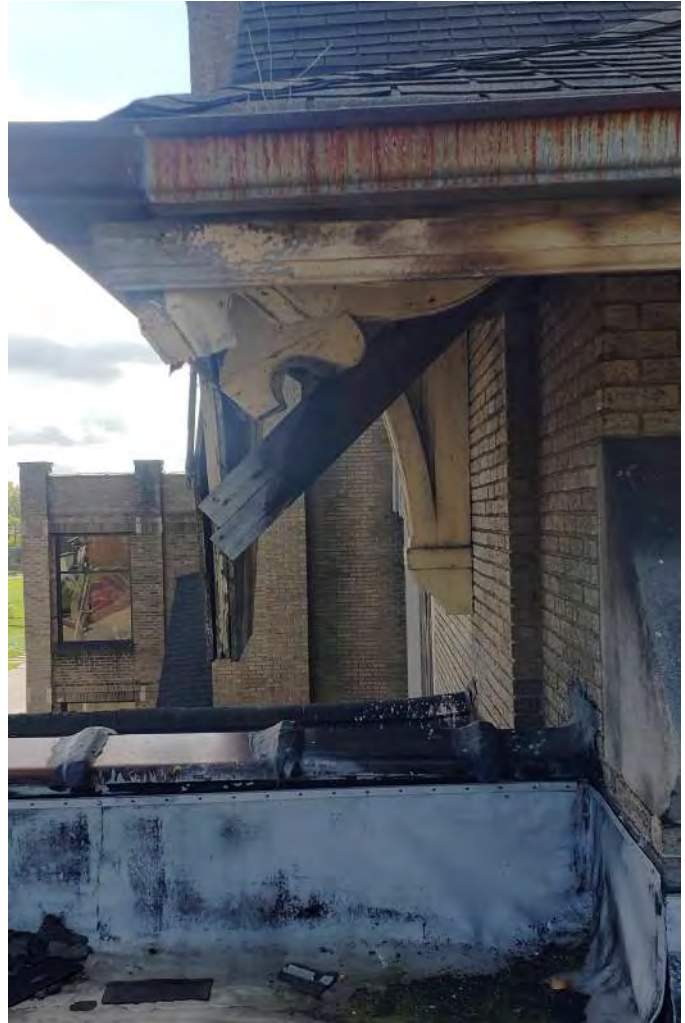
FIGURE A4.12 WEATHERED, FADED EAVES; RUSTED GUTTER (EAST ELEVATION)

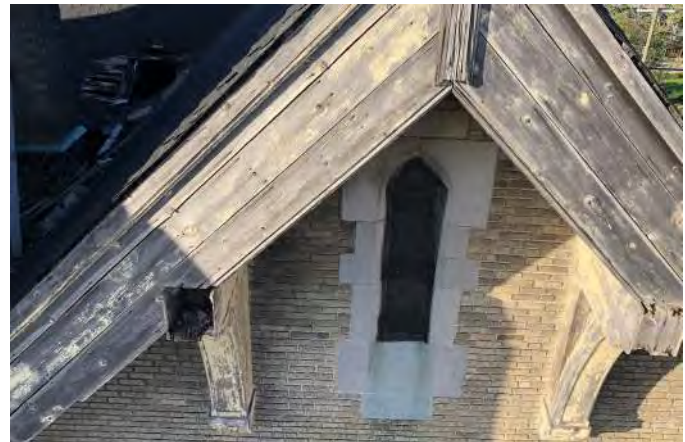
FIGURE A4.24 WEATHER AND FADED FASCIA BOARDS; DECAYED HOLLOWED WOODEN SUPPORT BRACKET

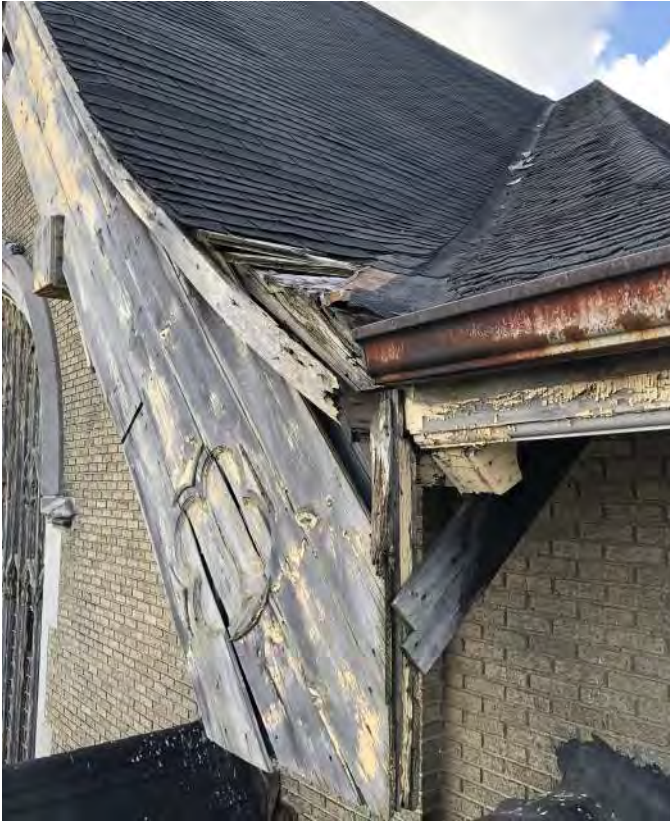
FIGURE 4.13 DECORATIVE FASCIA BOARDS ARE WEATHERED AND FADED; THEY ARE DETACHING FROM THE SUBSTRUCTURE. WOOD DECKING AT VALLEY TERMINATION IS EXPOSED, DECAYED WITH MISSING SHINGLES

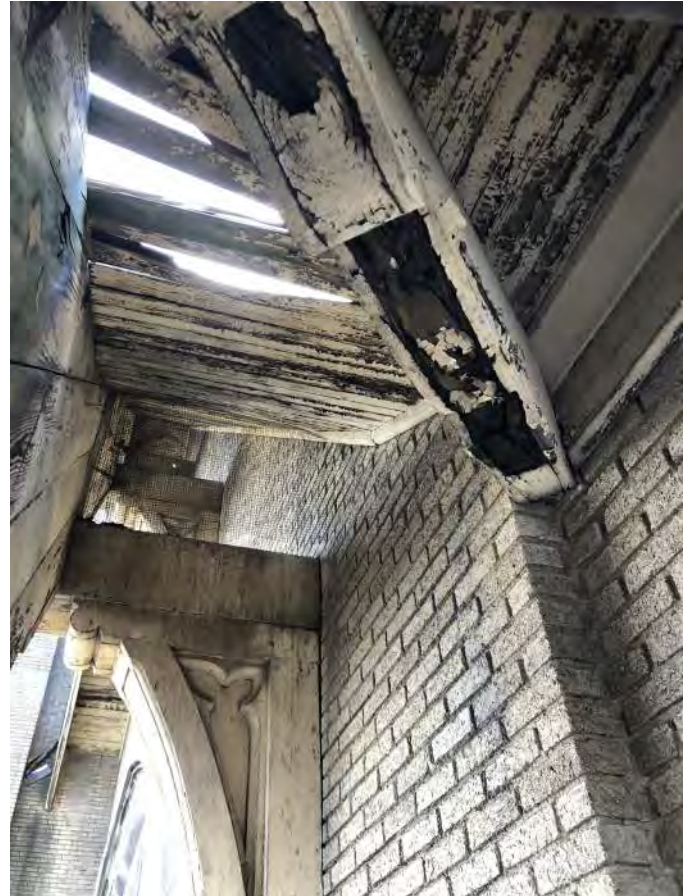
FIGURE A4.16 UNDERSIDE OF EAVES ON THE EAST ELEVATION AT THE MAIN ENTRANCE; WOOD DECKING IS DETERIORATION AT THE EAVE; MISSING WOOD DECKING; WEATHERED AND DECAYING SUPPORT BRACKETS

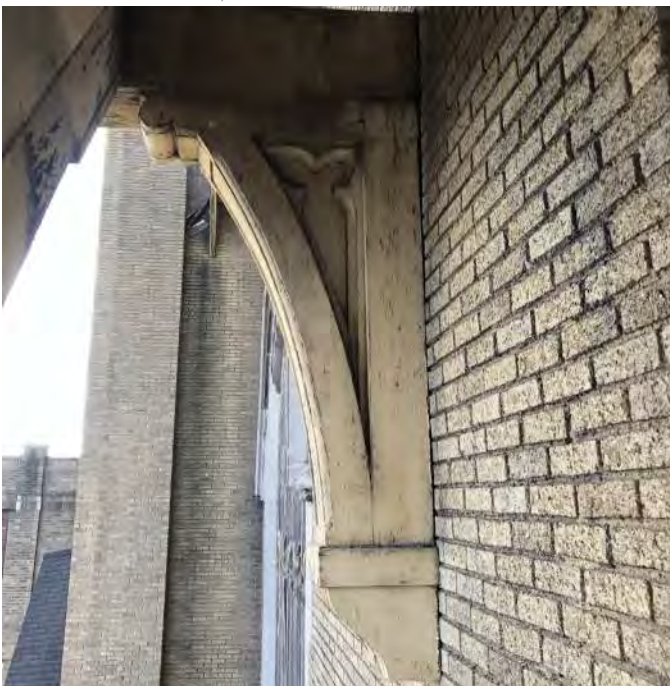
FIGURE A4.15 UNDERSIDE OF THE EAVES; PAINTED WOODEN BRACKET EAVE SUPPORT; (EACH BRACKET SHOULD BE INDIVIDUALLY EVALUATED)

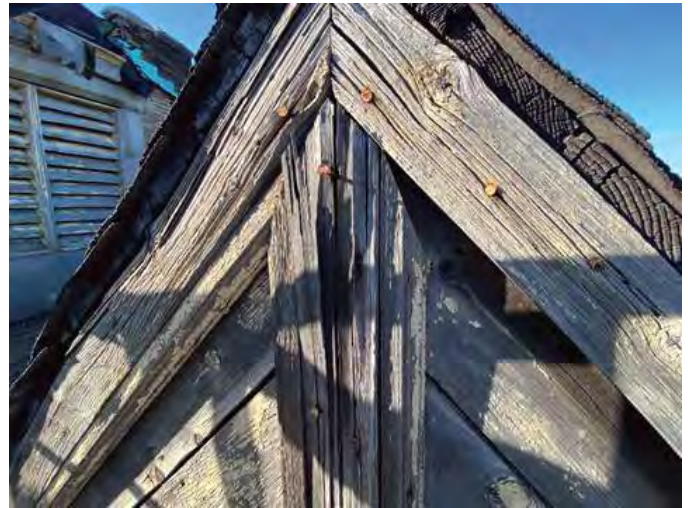
- The condition of the east overhang varies. The sheathing and a sloping beam that appears to be in moderate condition. The top members and inside structural members within the decorative brackets are in poor condition due to water leaking into the top of the brackets. (see figure S4.1)
- The main roof structure beyond the east overhang appears in moderate condition at the north and southeast slopes. The area at valley between the sloped roof and the bell tower is damaged, the structural members below the roofing may show some level of deterioration. (see figure S4.2)
- The southwest slope of the main roof area is in poor condition with many holes and areas of deteriorated sheathing and rafters. (see figure S4.3)
- The west overhang is in poor condition. The decorative support varies in condition. (see figure S4.4)

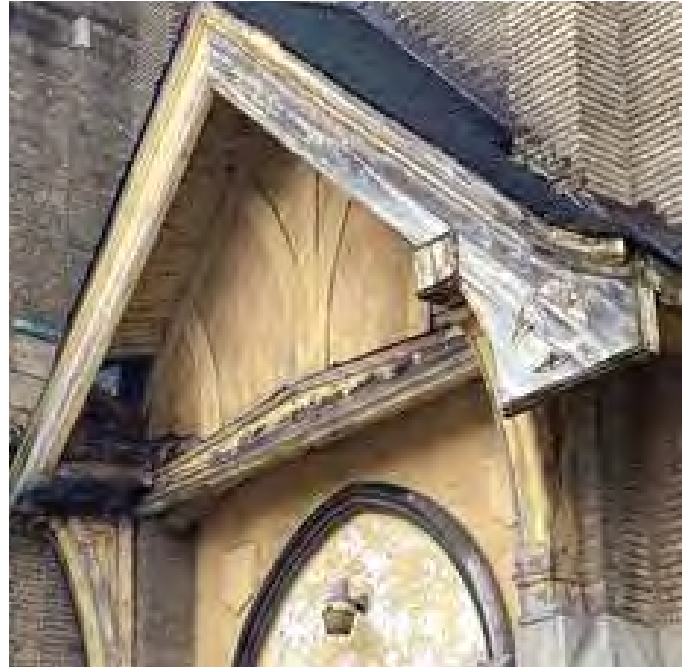
- Extreme caution is required when working on the existing roof supported by wood roofing. These areas should be considered un-safe areas with no direct access to or working on without adequate personal protective equipment secured to OSHA compliant connection point.

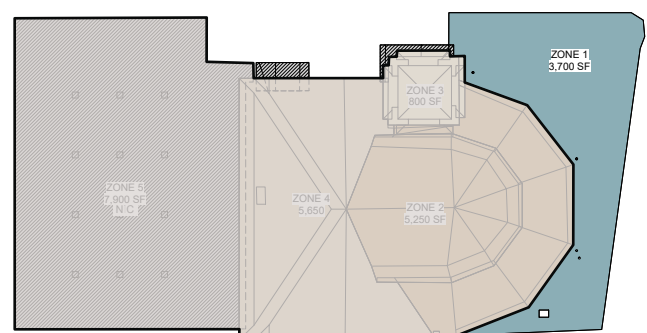
ZONE 1 FLAT ROOF (SOUTH)

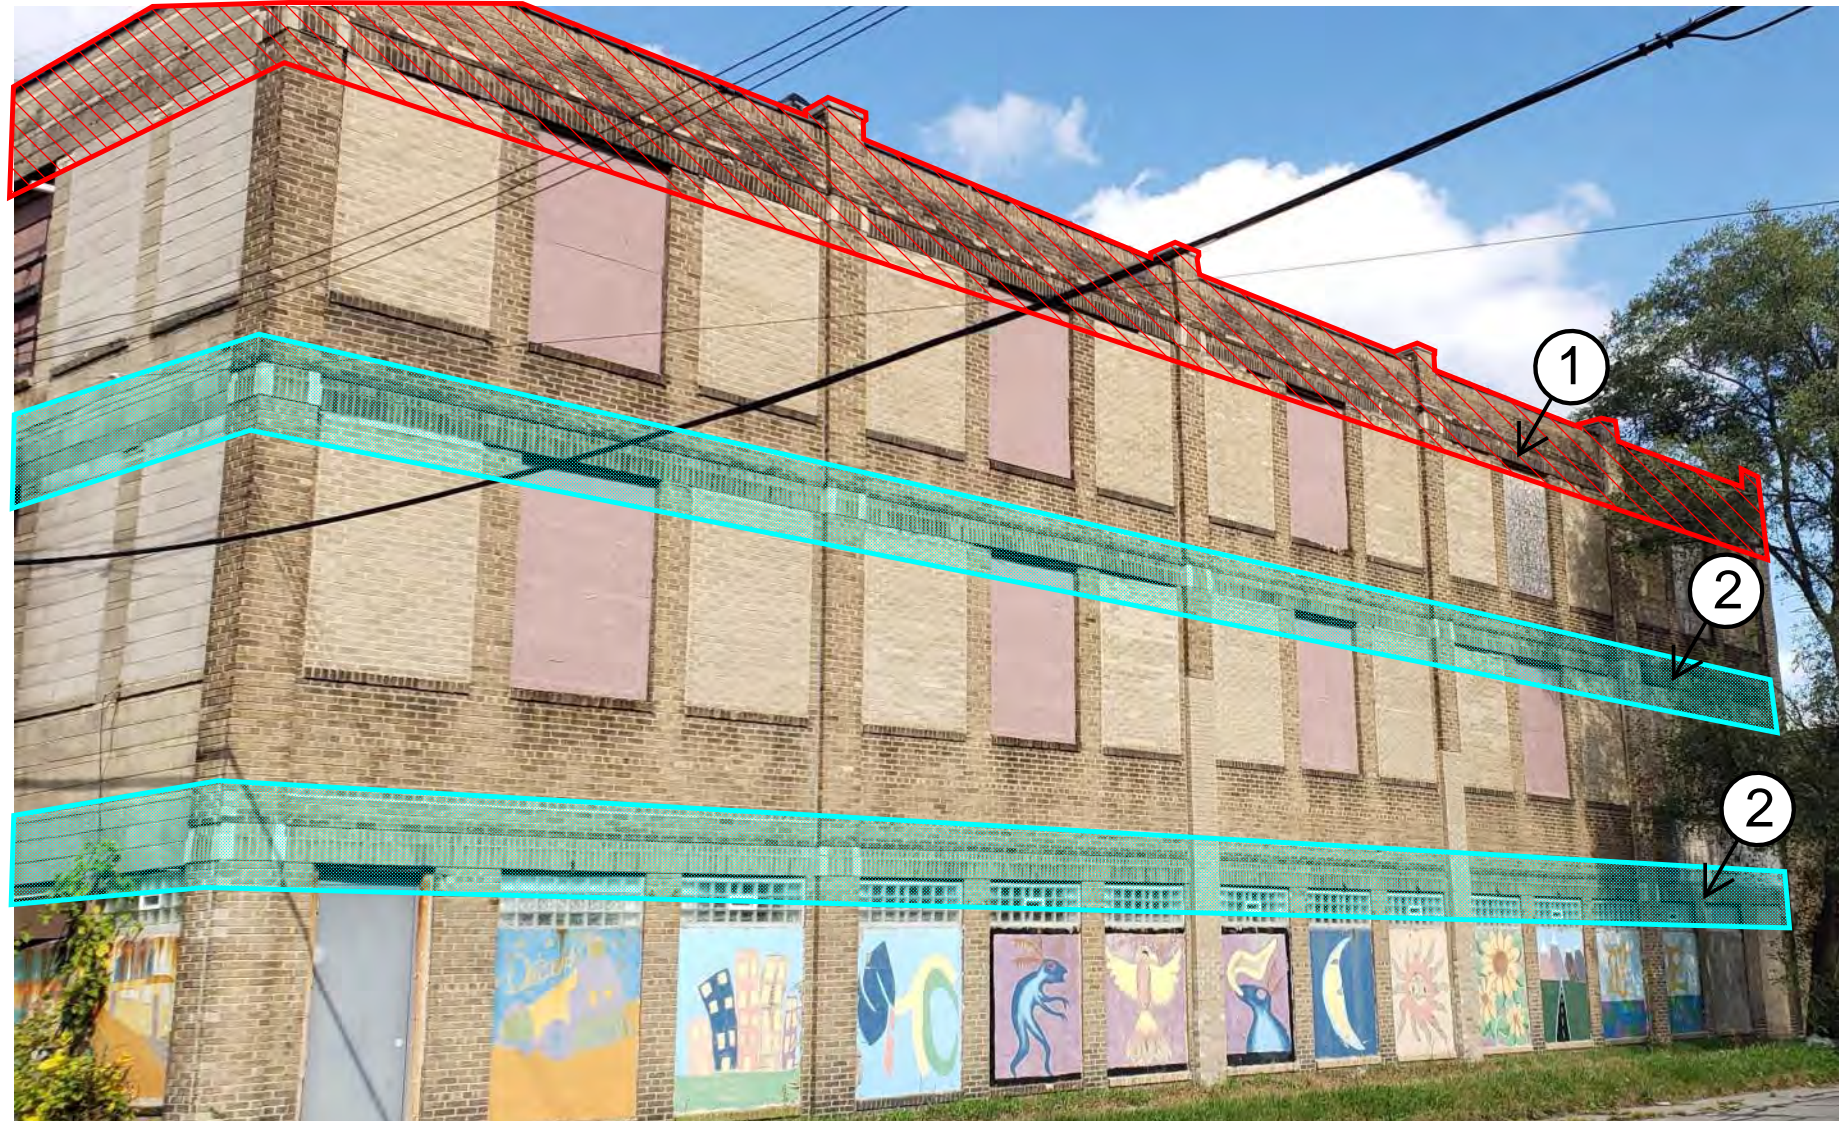
Figure A1.27 South Elevation

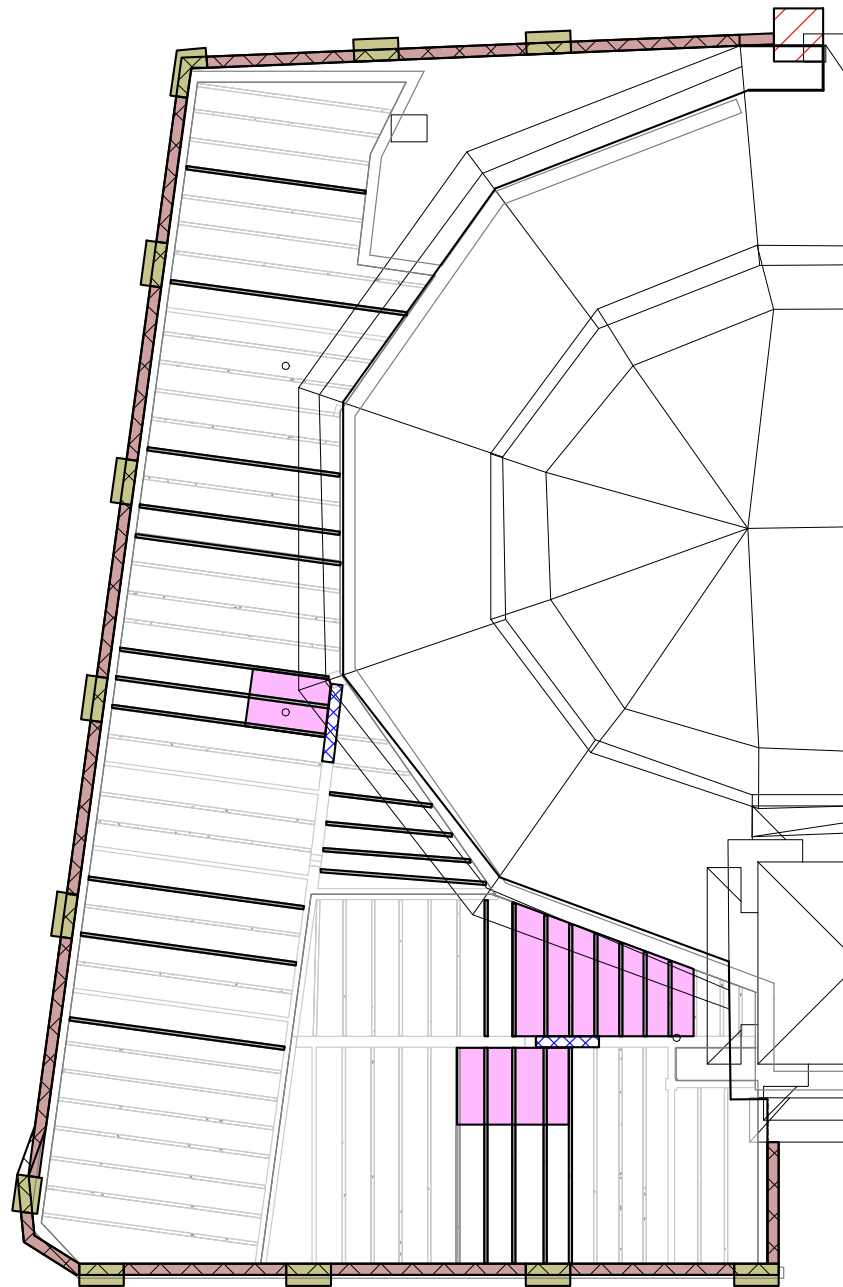
To be completed in a future phase

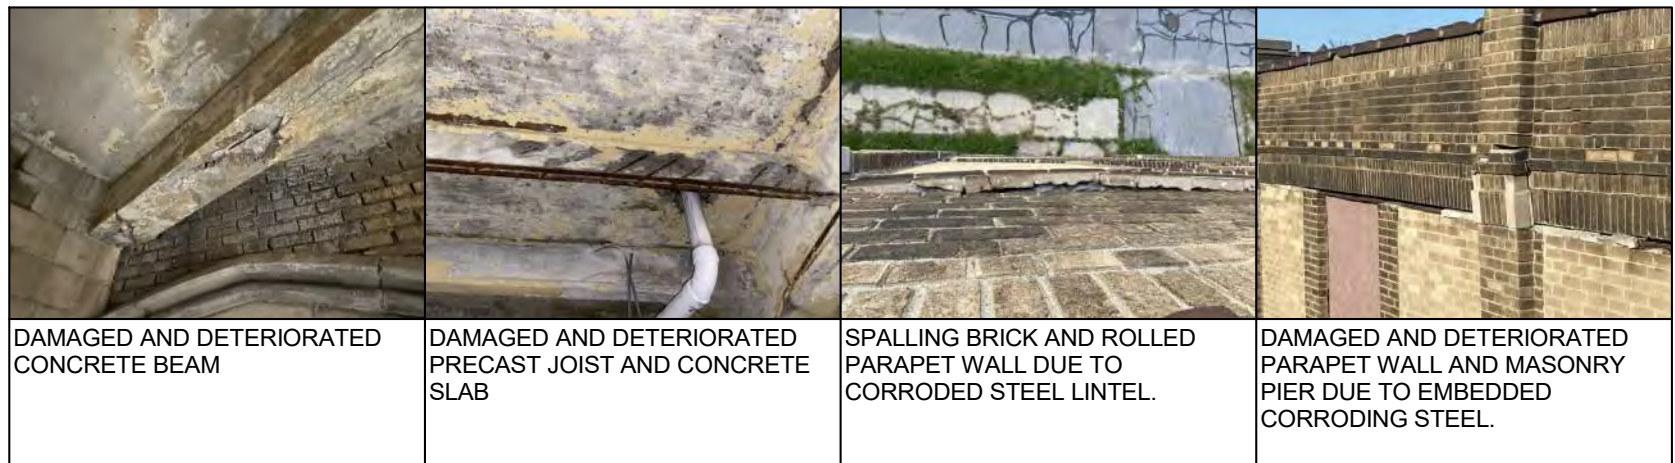
DAMAGED AND DETERIORATED CONCRETE BEAM	DAMAGED AND DETERIORATED PRECAST JOIST AND CONCRETE SLAB	SPALLING BRICK AND ROLLED PARAPET WALL DUE TO CORRODED STEEL LINTEL.	DAMAGED AND DETERIORATED PARAPET WALL AND MASONRY PIER DUE TO EMBEDDED CORRODING STEEL.
--	--	--	---

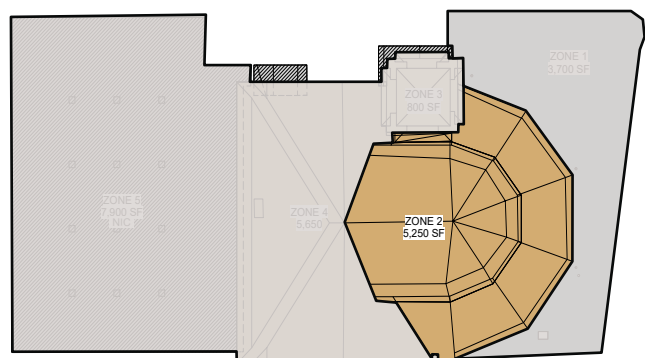
ZONE 2 HEPTAGONAL ROOF

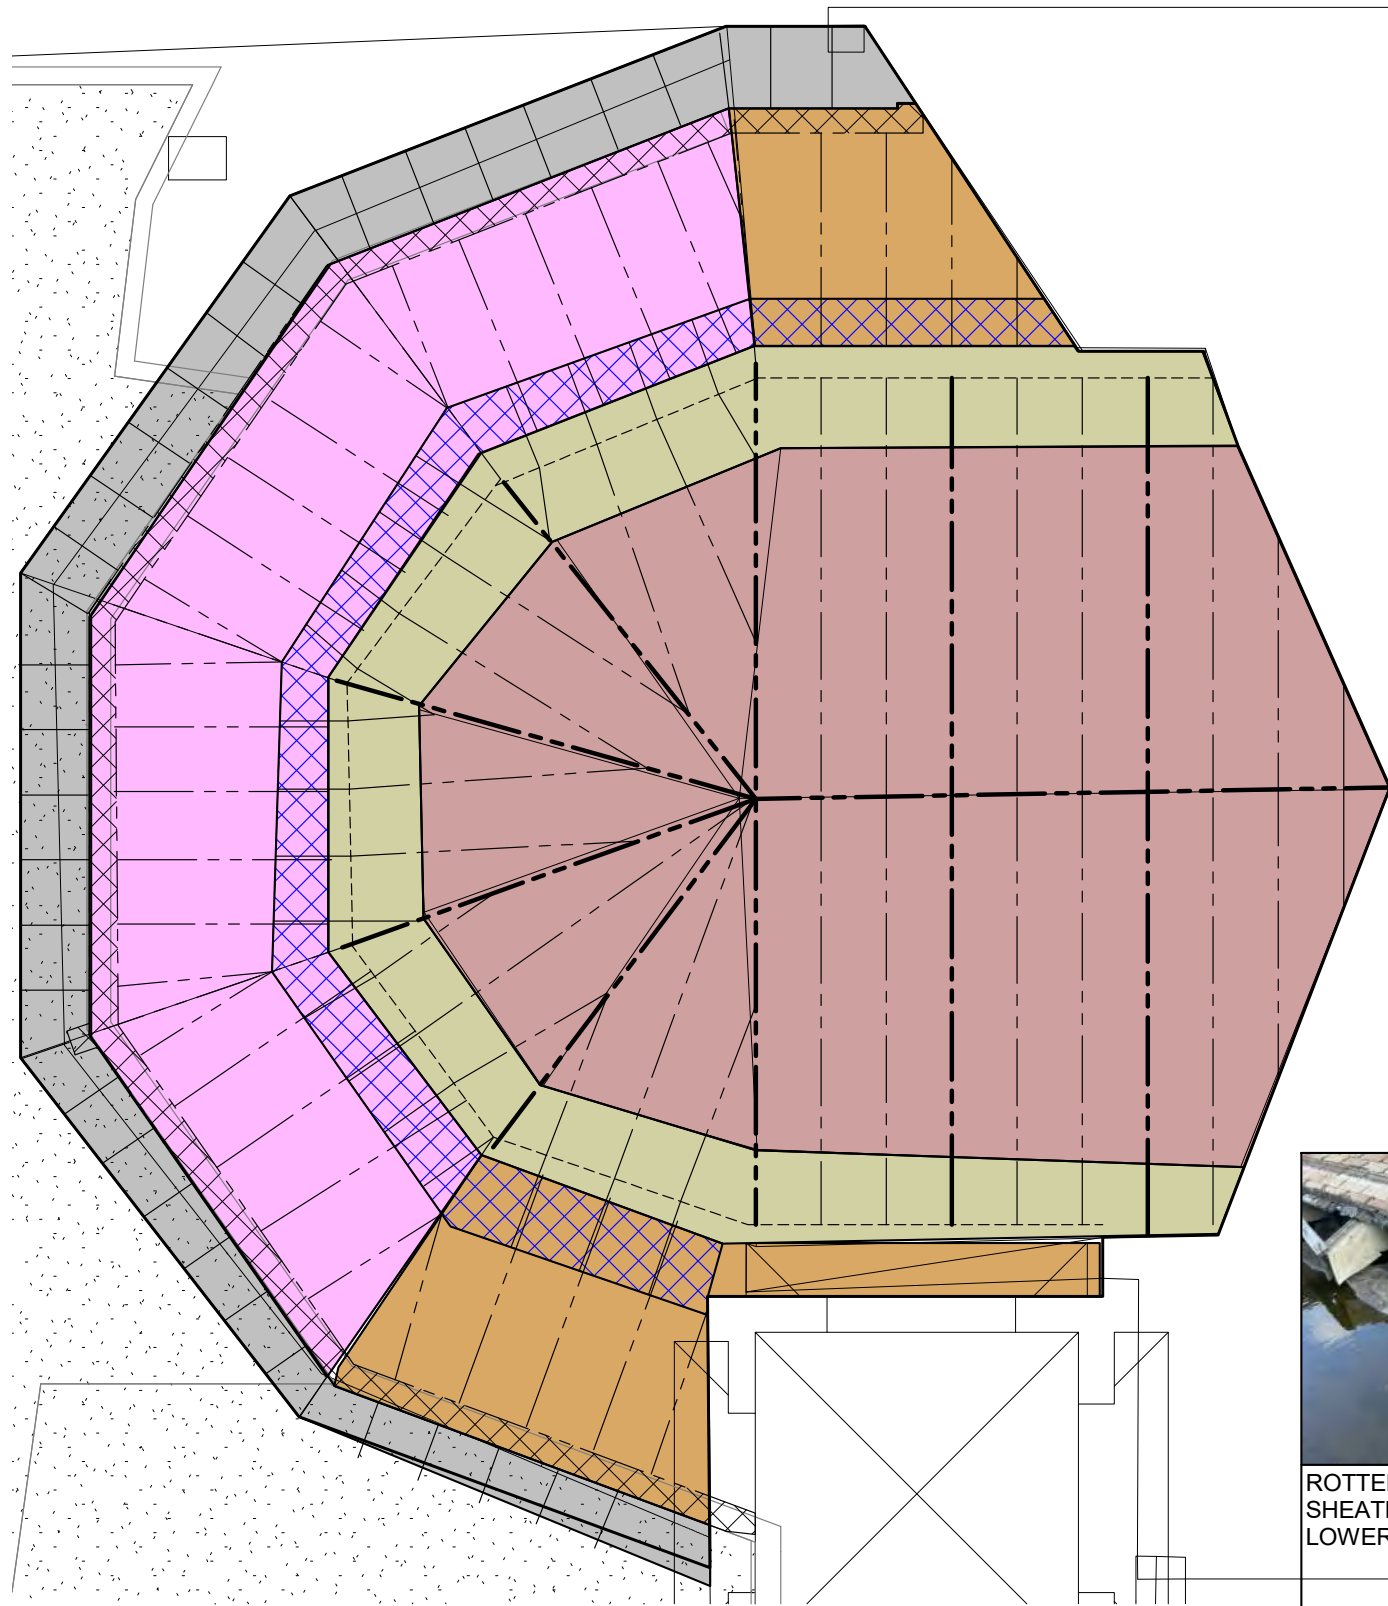
STRUCTURAL ITEMS REQUIRED FOR ROOFING INTEGRITY AND SAFETY

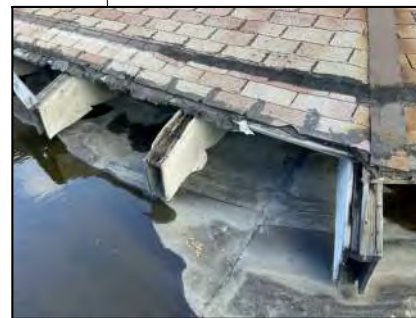
ROTTEN AND DAMAGED SHEATHING AT BRACKETS AT LOWER OVERHANG

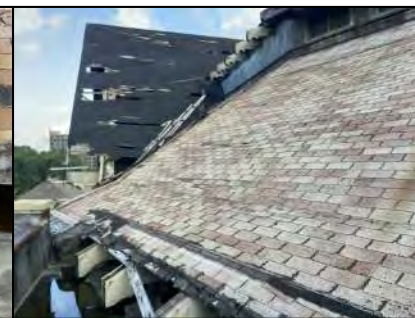
ROTTEN AND DAMAGED SHEATHING AND BRACKETS AT LOWER AND UPPER OVERHANGS

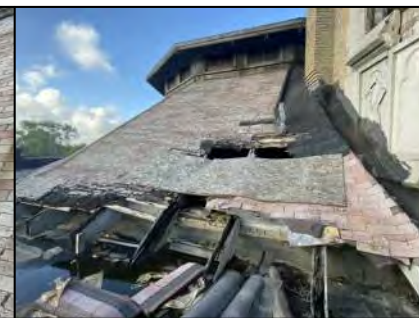
LOWER SLOPING ROOF AREA IN POOR CONDITION WITH DAMAGED SHEATHING AND SUPPORT RAFTERS

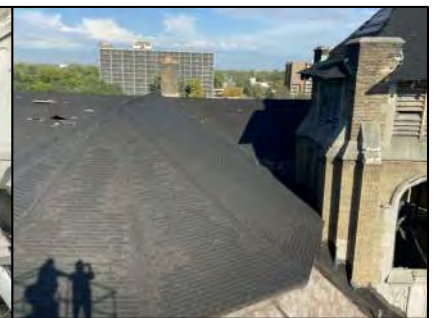
UPPER SLOPING ROOF AND OVERHANG IN MODERATE CONDITION

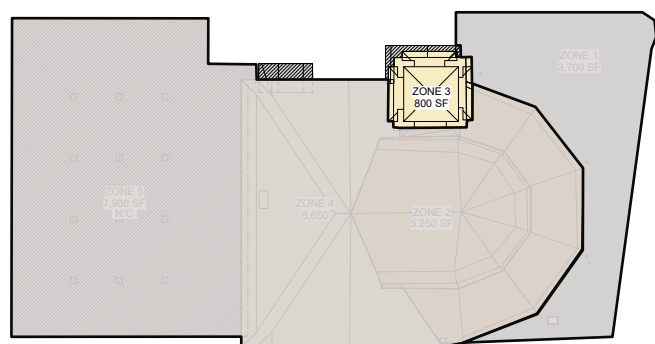
ZONE 3 BELL TOWER ROOF

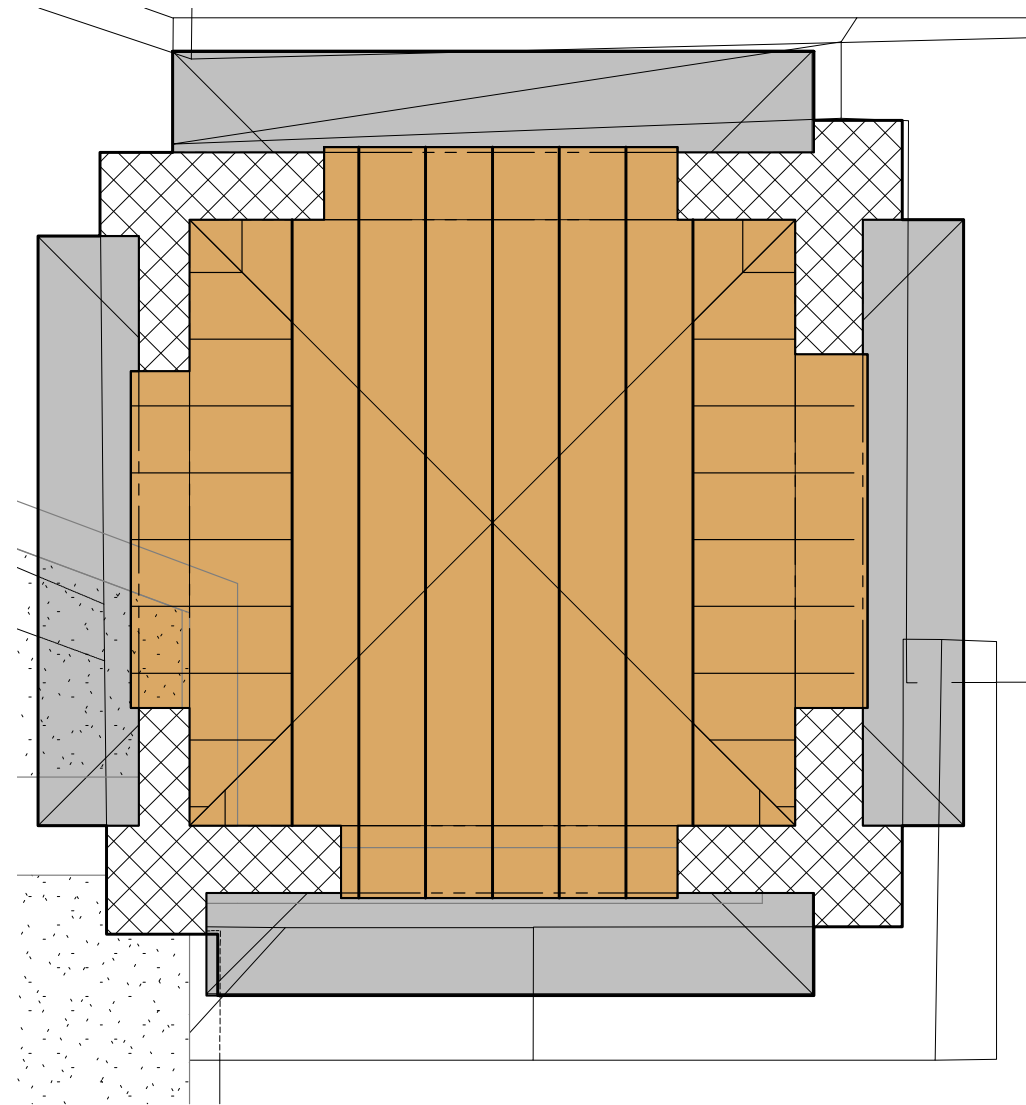
STRUCTURAL ITEMS REQUIRED FOR ROOFING INTEGRITY AND SAFETY			
HATCH AREA	DESCRIPTION	UNITS	COMMENT
	FUTURE DECORATIVE BRACKETS AND ROOF OVERHANG. NOT IN CURRENT SCOPE.	240SF	
	REMOVE EXISTING ROOF FRAMING. REPLACE WITH RE-ENGINEERED WOOD TRUSSES AT 2'-0" OC WITH 3/4" SHEATHING. REFER TO ARCHITECTURAL FOR ROOFING DETAILS AND INFORMATION.	500SF	
	MASONRY AND STONE REQUIRES STABILIZATION TO REMOVE POTENTIAL FALLING DEBRIS (4 CORNERS)		ASSUME 3 DAYS OF WORK FOR MASONRY RESTORATION CONTRACTOR TO REMOVE LOOSE MATERIALS

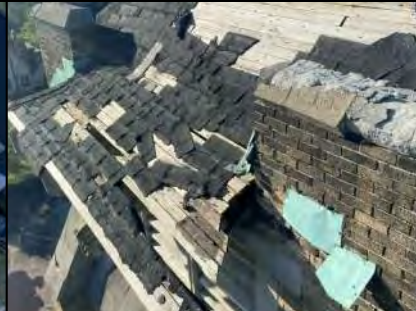
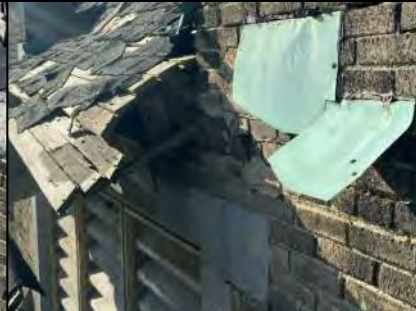
ROTTEN AND DAMAGED SHEATHING, BRACKETS AND RAFTERS	DETERIORATING MASONRY COPING. REMOVE LOOSE AND DAMAGED MATERIAL. FALLING DEBRIS HAZARD.	ROOF STRUCTURE BEYOND REPAIR.	MASONRY JOINTS REQUIRED RE-POINTING AND REPAIRS TO RESTORE FACADE. (FUTURE WORK)

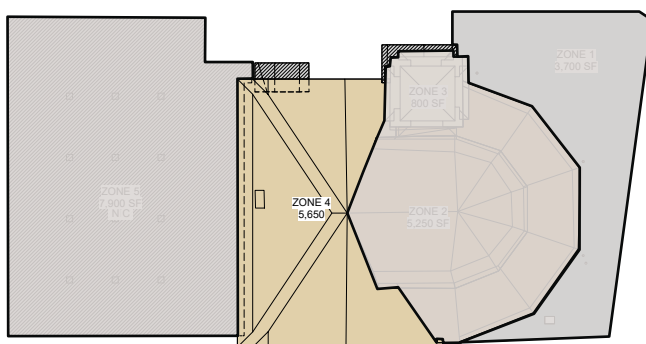
ZONE 4 CENTRAL GABLE ROOF
