STAFF REPORT 03-16-2022 SPECIAL MEETING

PREPARED BY: A. PHILLIPS

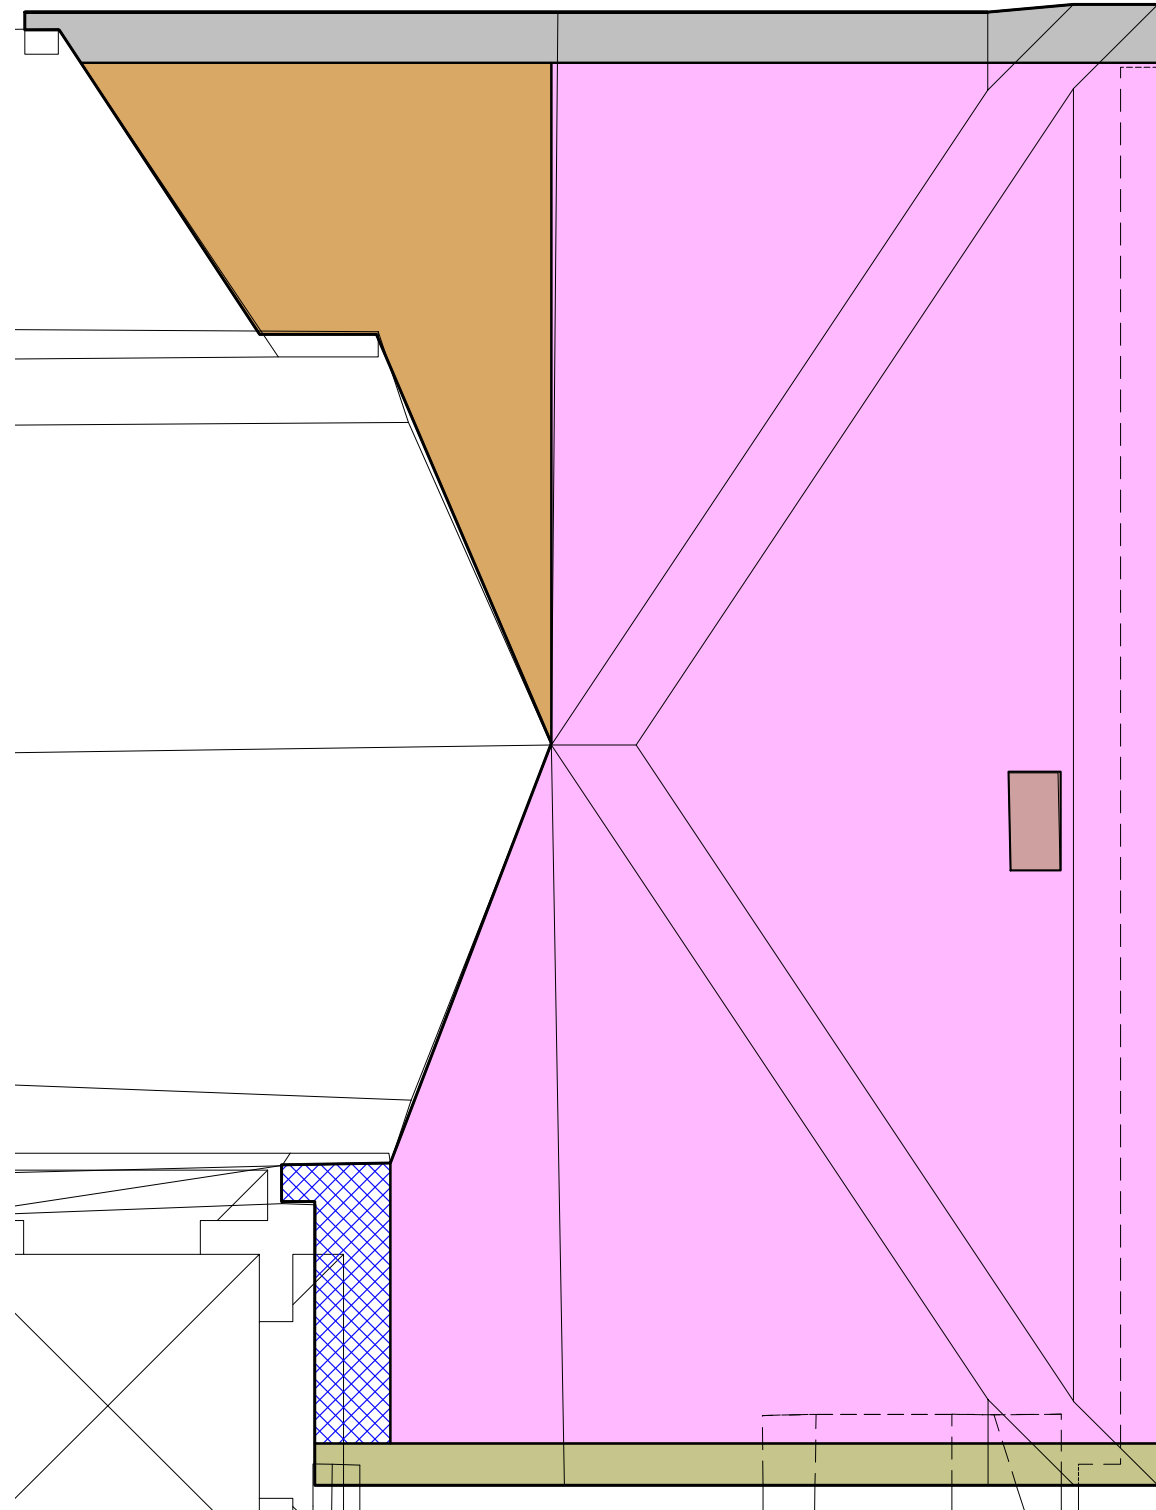
ZONE 4 CENTRAL GABLE ROOF

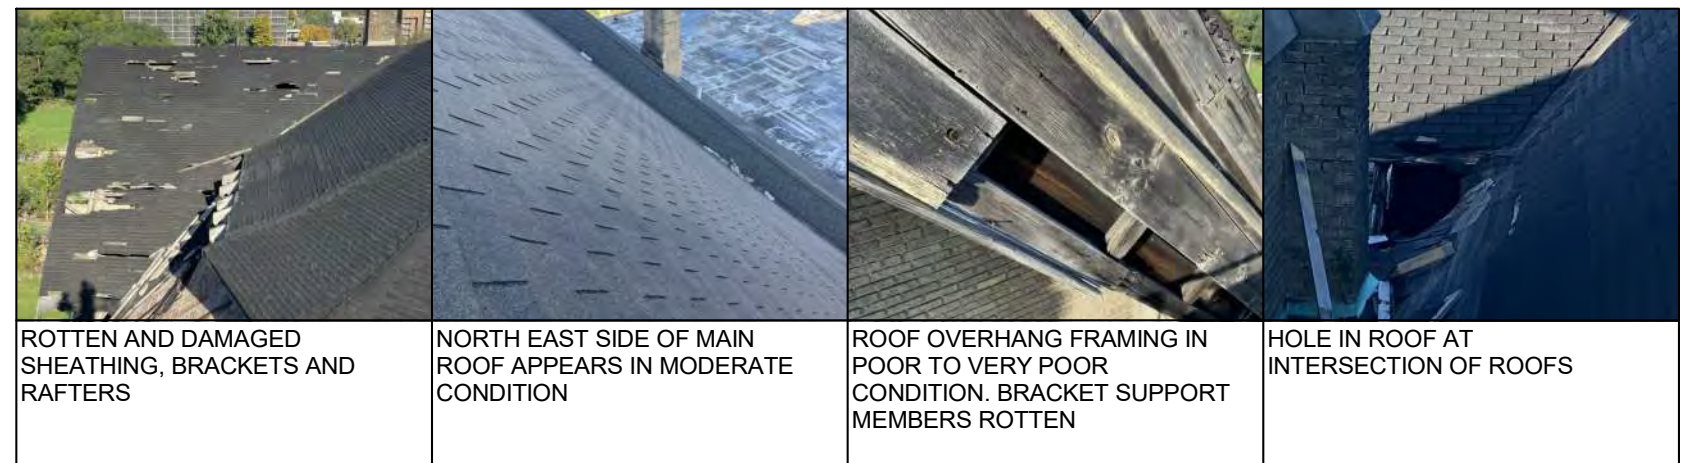
EXISTING BOTTOM BARS
FIELD VERIFY SIZE AND NUMBER
SPALLED CONCRETE WITH CORRODING
STEEL

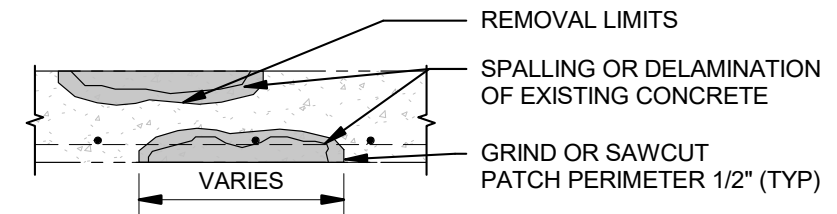
DRILL AND ADHERE REBAR DOWELS #4@18" O.C. EMBED DOWELS 6" INTO EXISTING CONCRETE
IF REINFORCING IS CORRODED MORE THAN ONE BAR SIZE. ADD NEW REINFORCING FOR SINGLE SPAN CONDITION (2)#5 CONTINUOUS
CLEAN EXPOSED REINFORCING AND DETERMINE EXTENT OF CORROSION

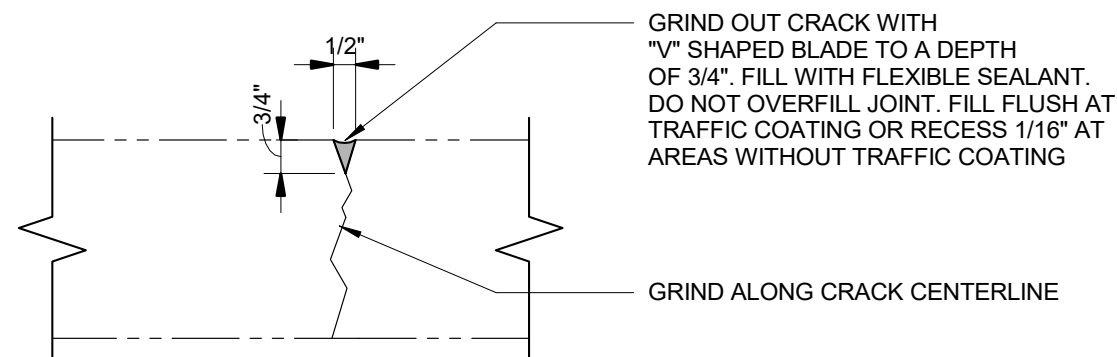
2 CONCRETE SLAB REPAIR

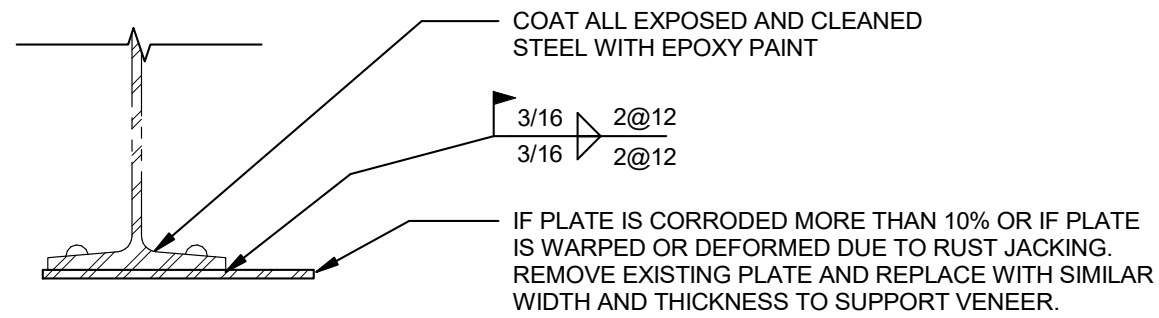
4 STEEL LINTEL PLATE REPLACEMENT
SCALE: 1 1/2" = 1'-0"

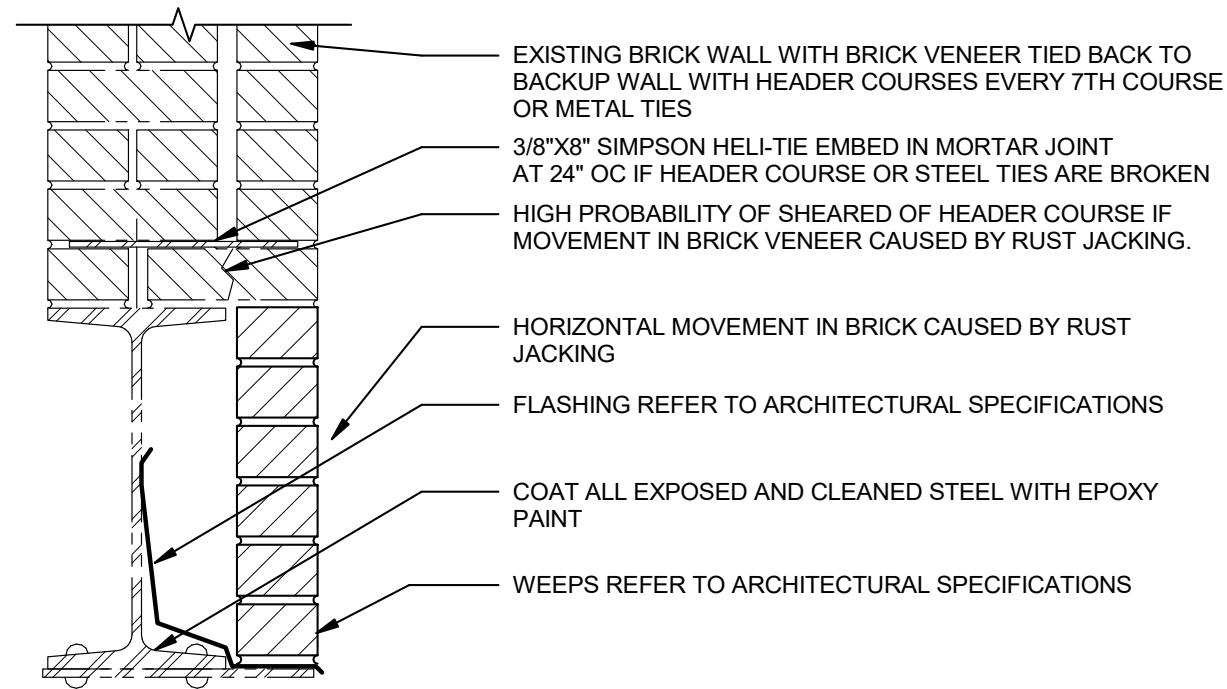
3 STEEL LINTEL REPAIR (STEP 2)
SCALE: 1 1/2" = 1'-0"

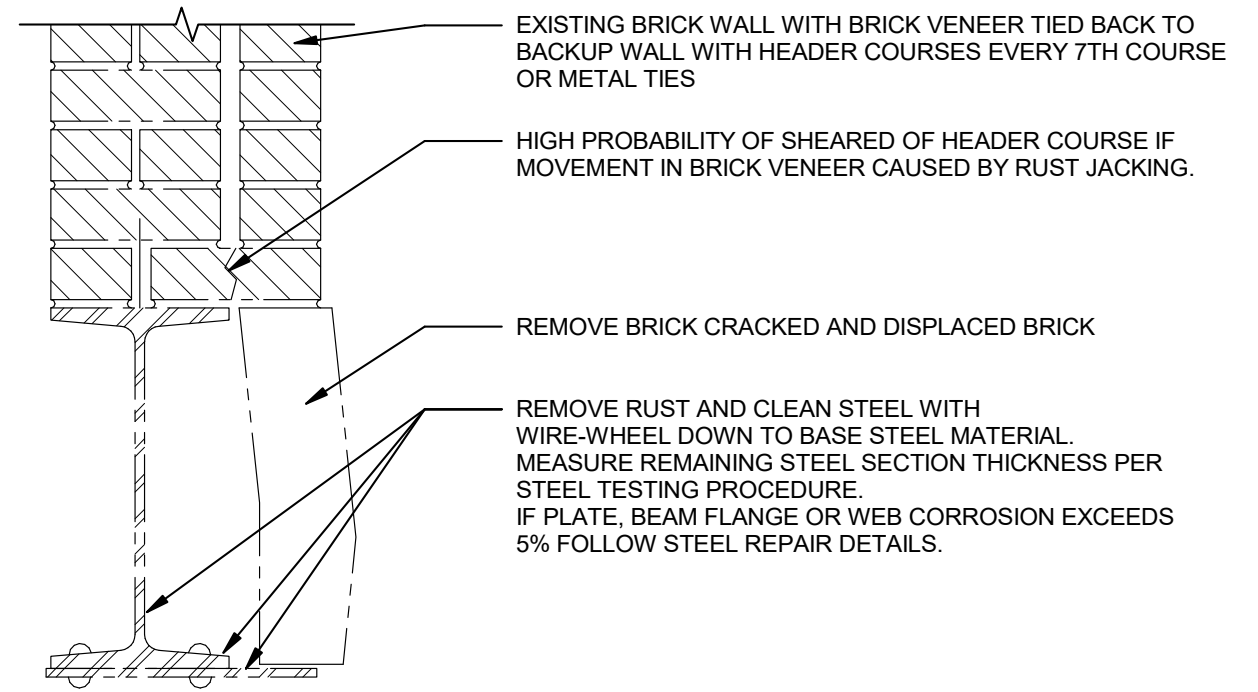
2 STEEL LINTEL REPAIR (STEP 1)
SCALE: 1 1/2" = 1'-0"

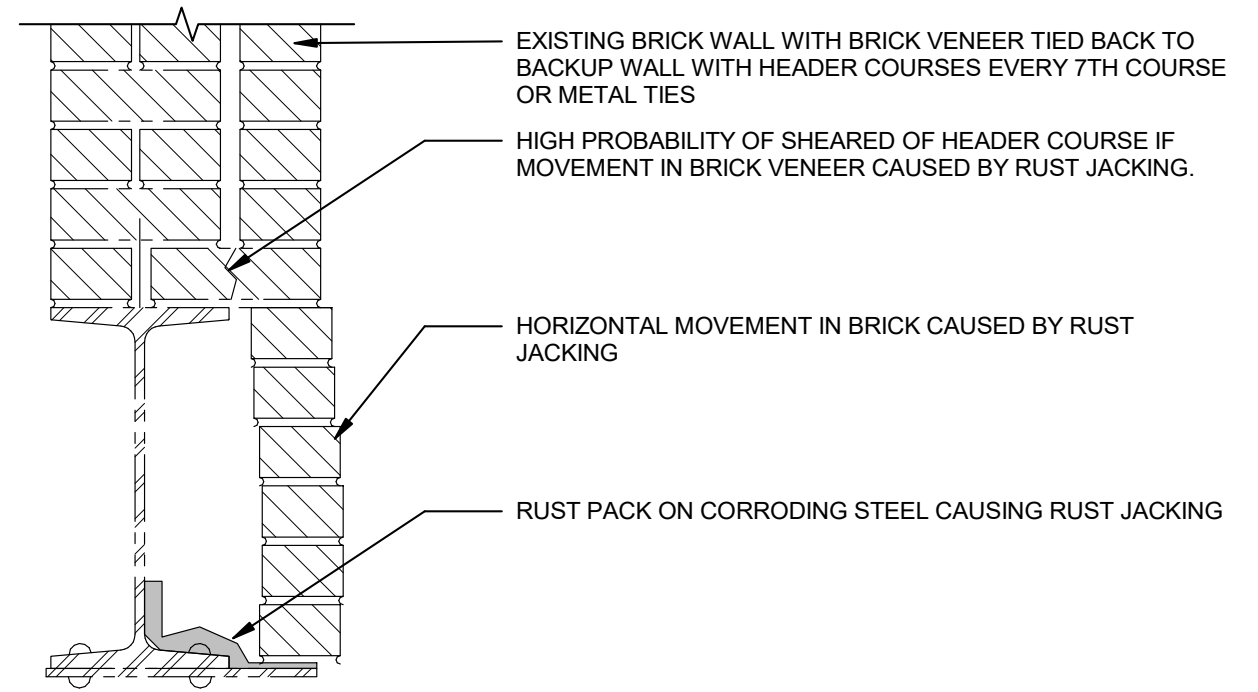
1 CORROSION AT EXISTING STEEL LINTEL
SCALE: 1 1/2" = 1'-0"

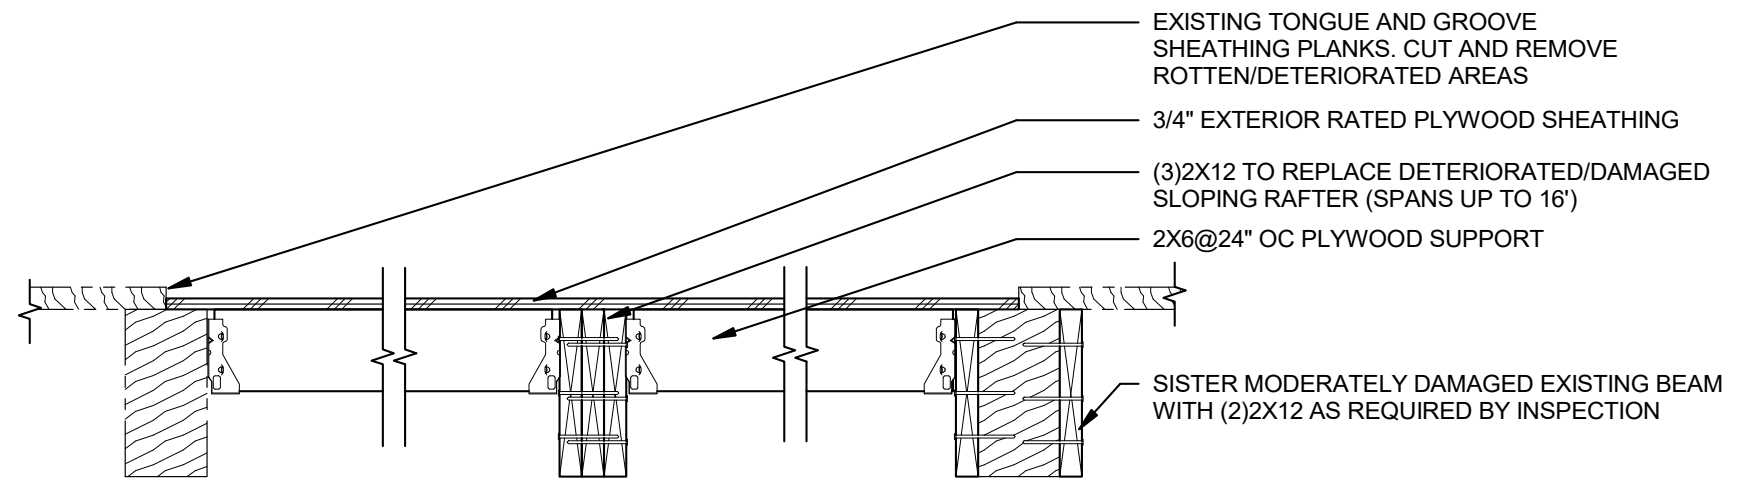
1 **WOOD REPAIR DETAIL**
 SCALE: 1" = 1'-0"

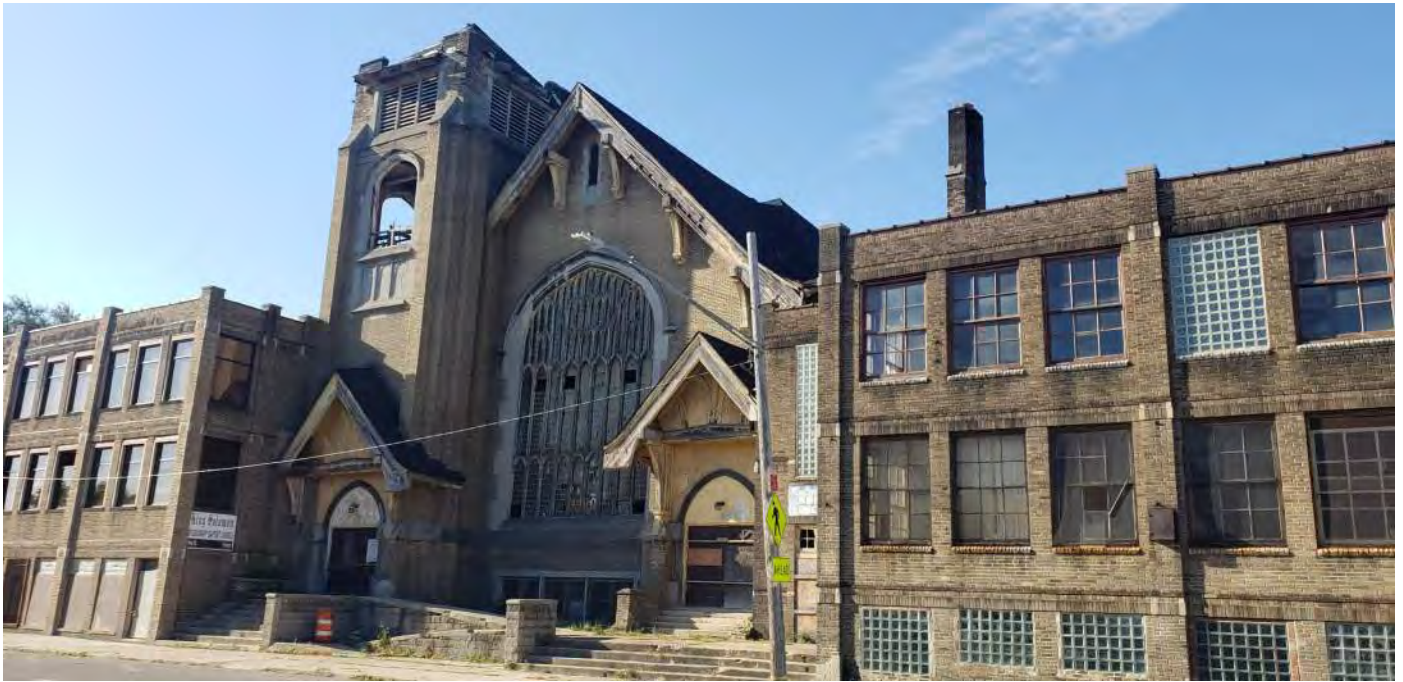
FIGURE EAST ELEVATION

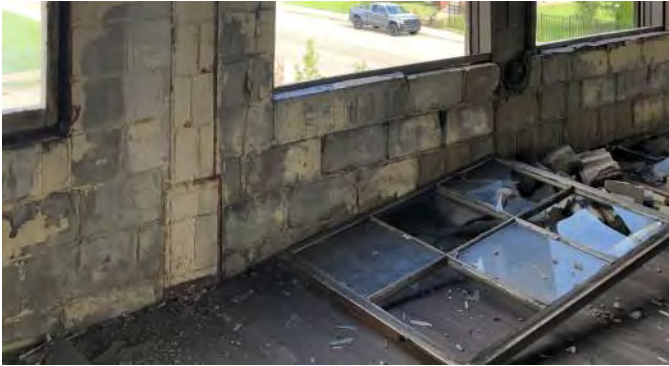
FIGURE INT 1.1 FALLEN OR MISSING WINDOWS; DETERIORATED MASONRY WALLS AND DEBRIS

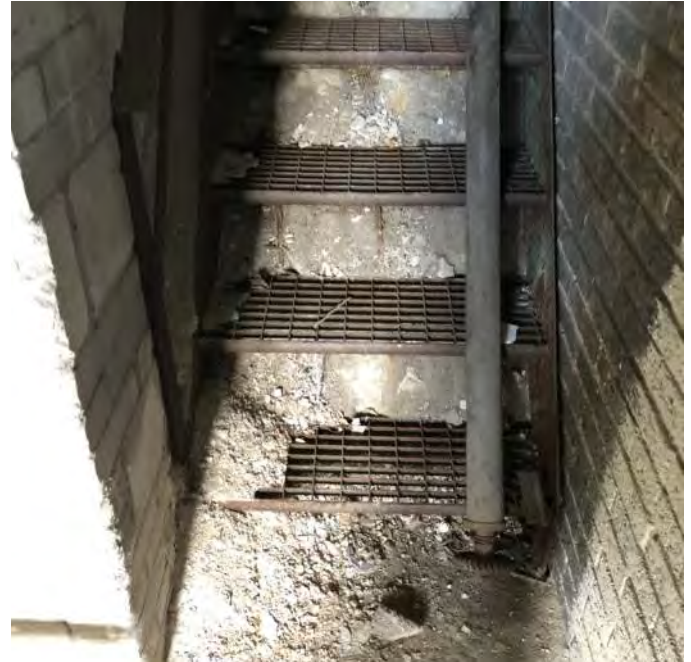
FIGURE INT 1.3 INTERIOR PLASTER HAS CRUMBLLED FROM THE WALLS, CEILING AND STRINGER BEHIND THE STAIR (LEADS TO THE ROOFTOP EXIT)

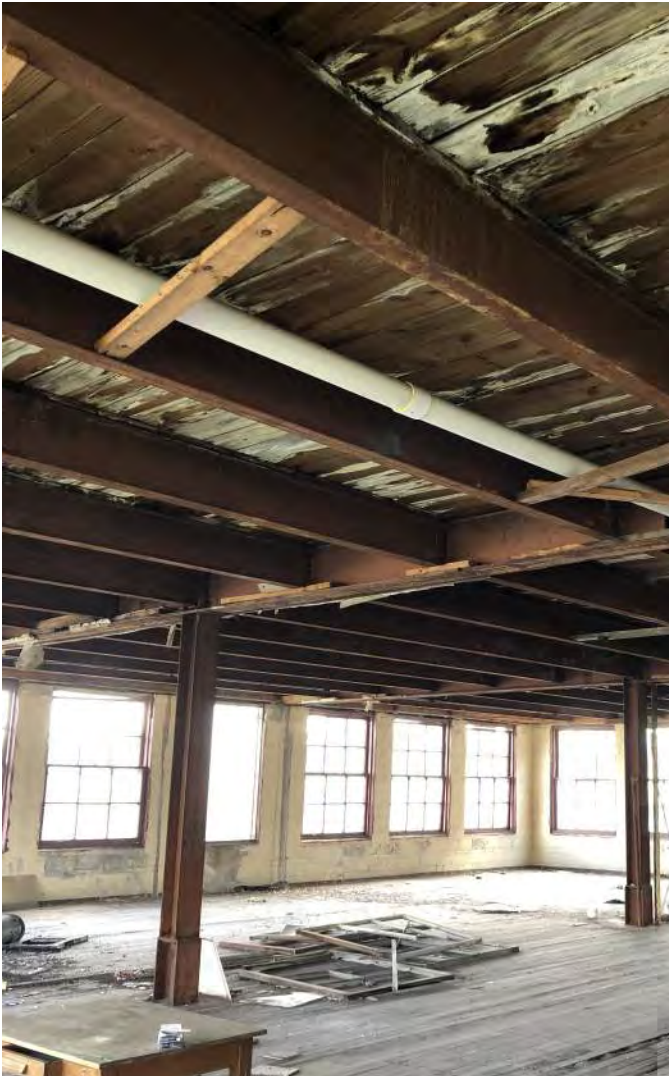
FIGURE INT 1.2 WATER STAINED AND LOOSE WOOD DECKING; OXIDIZED STRUCTURAL BEAM AND COLUMNS; VARIOUS DEBRIS; AT 1917 ADDITION INTERIORS

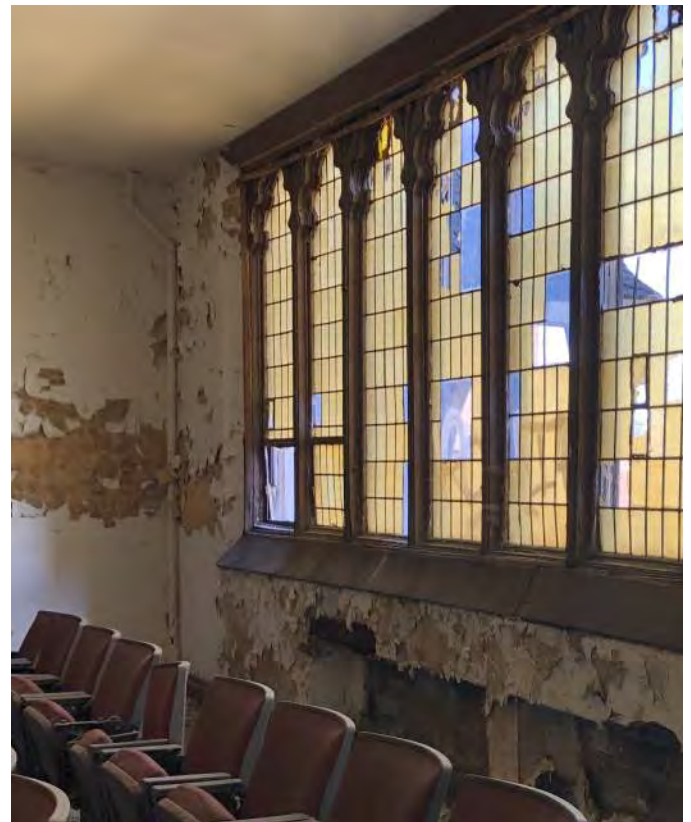
FIGURE INT 1.4 WATER DAMAGED PAINT AND PLASTER FINISHES AND FURNISHINGS. DAMAGED STAINED GLASS WINDOWS WITH MISSING GLASS AND FAILED JOINTS

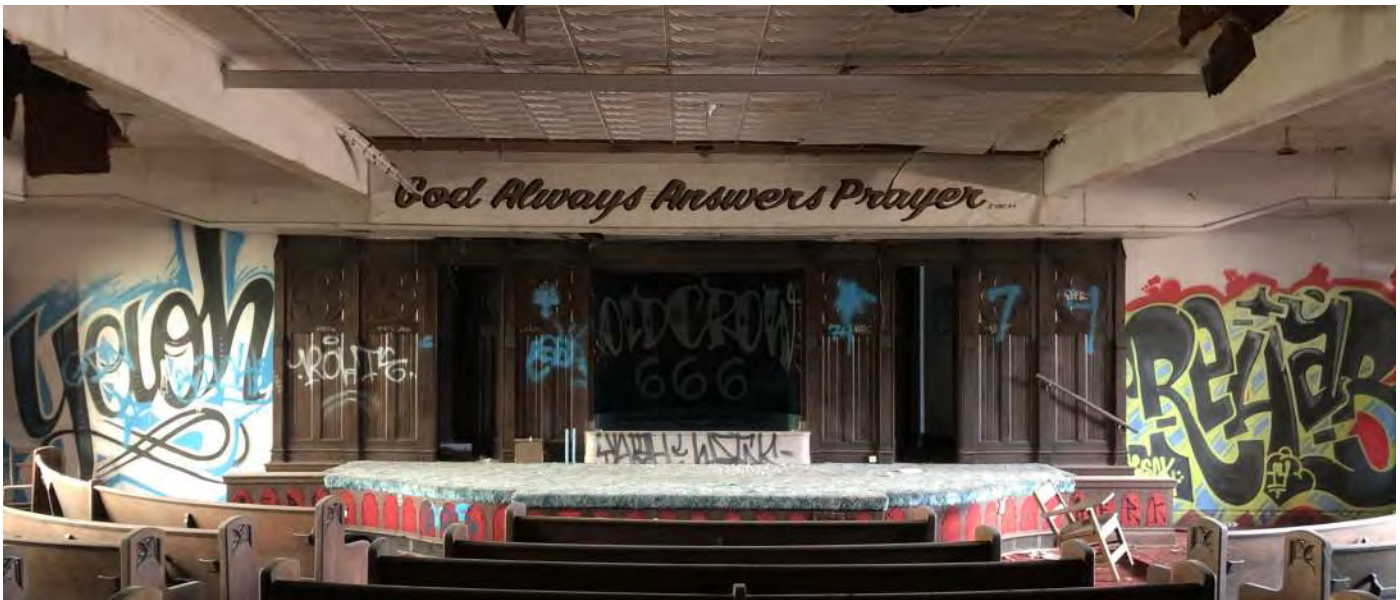
FIGURE INT.1.5 MAIN SANCTUARY ALTAR

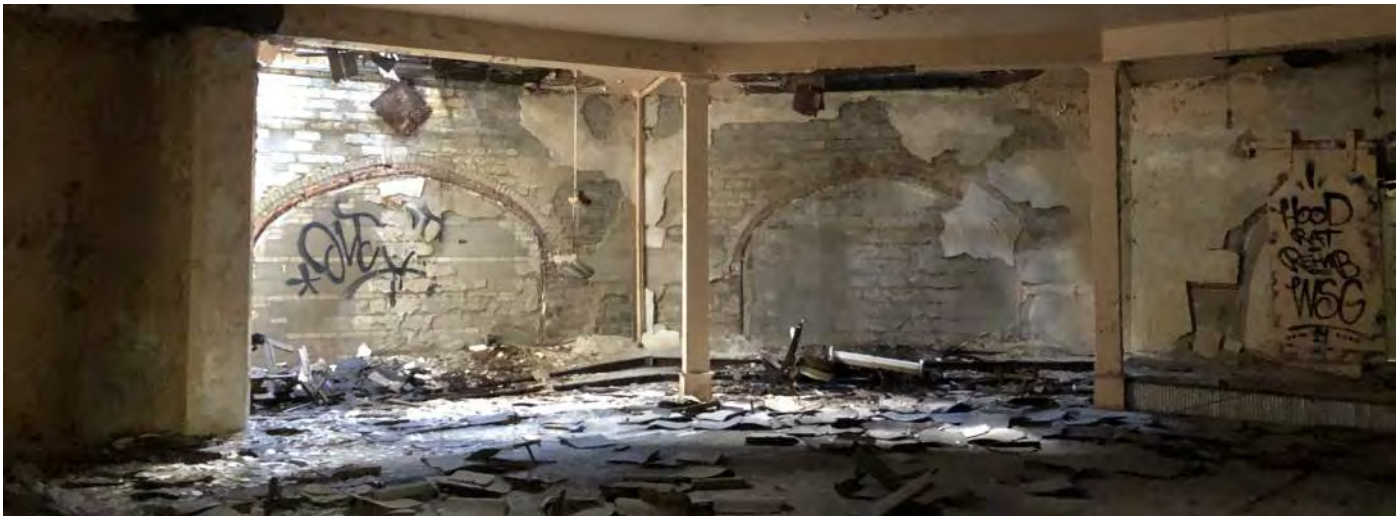
FIGURE INT.1.6 FAILED FINISHES AND DEBRIS IN CLASSROOMS OVER SANCTUARY; OPENINGS THRU ROOFS TO DAYLIGHT ABOVE

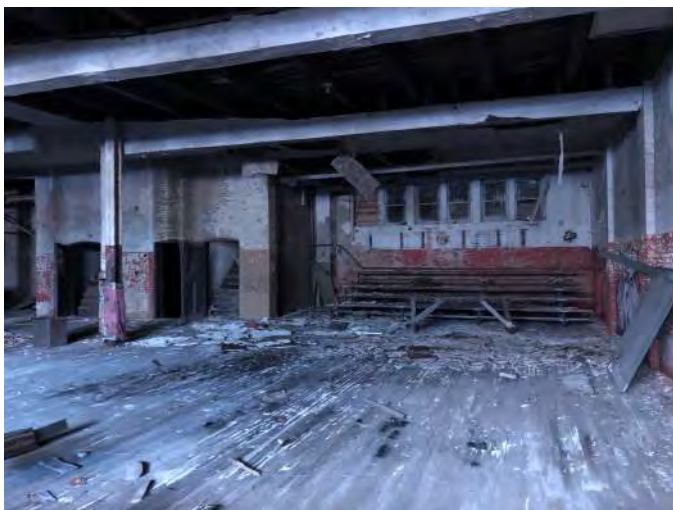
FIGURE INT.7 FAILED FINISHES AND DEBRIS IN LOWER LEVEL SPACES

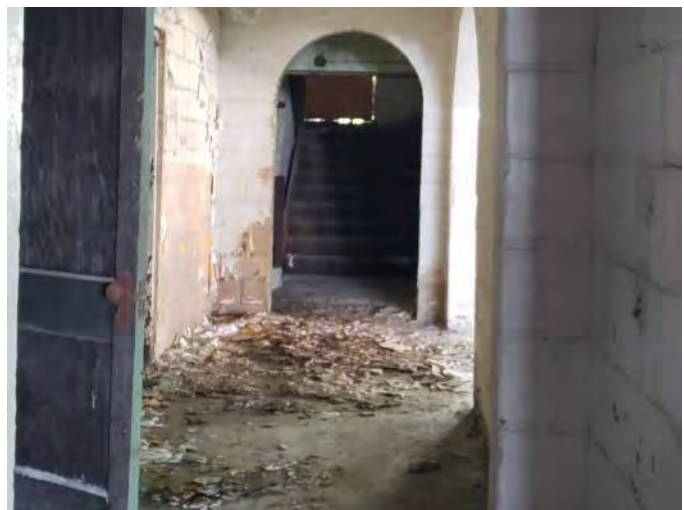
FIGURE INT.1.8 FAILED FINISHES AND DEBRIS IN ENTRYWAY AND CORRIDORS

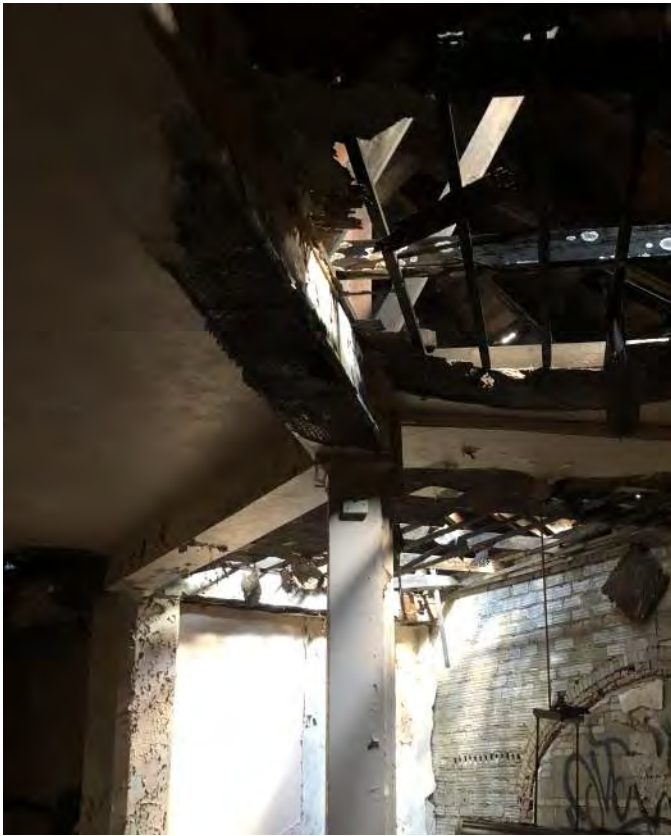
FIGURE INT 1.9 FAILED FINISHES AND DEBRIS IN CLASSROOMS OVER SANCTUARY; OPENINGS THRU ROOFS EXPOSING INTERIOR TO ELEMENTS

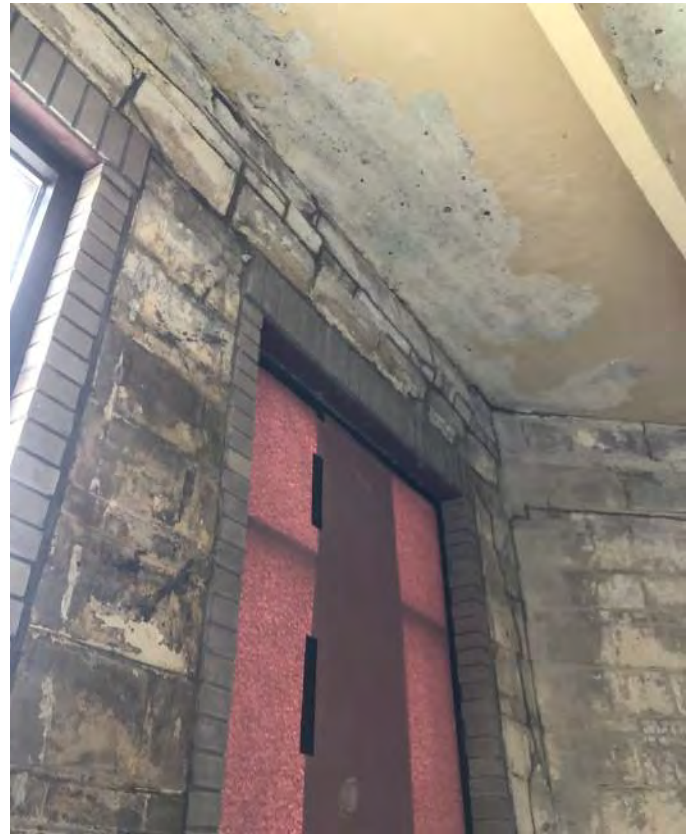
FIGURE INT 1.10 BUCKLING AND CRACKED MASONRY EXTERIOR WALLS

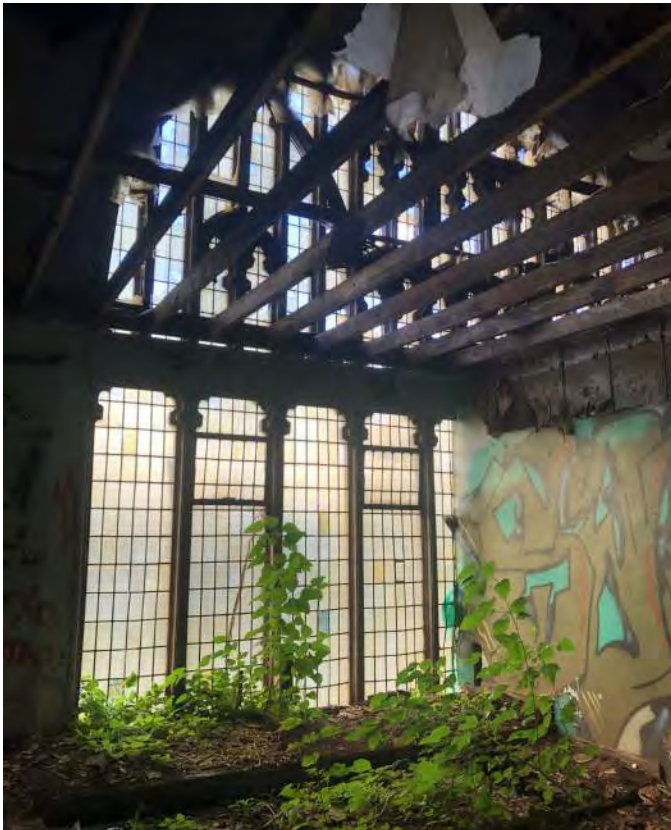
FIGURE INT 1.8 FAILED FINISHES AND VEGETATION IN SANCTUARY MEZZANINE OPEN TO THE ELEMENTS ABOVE

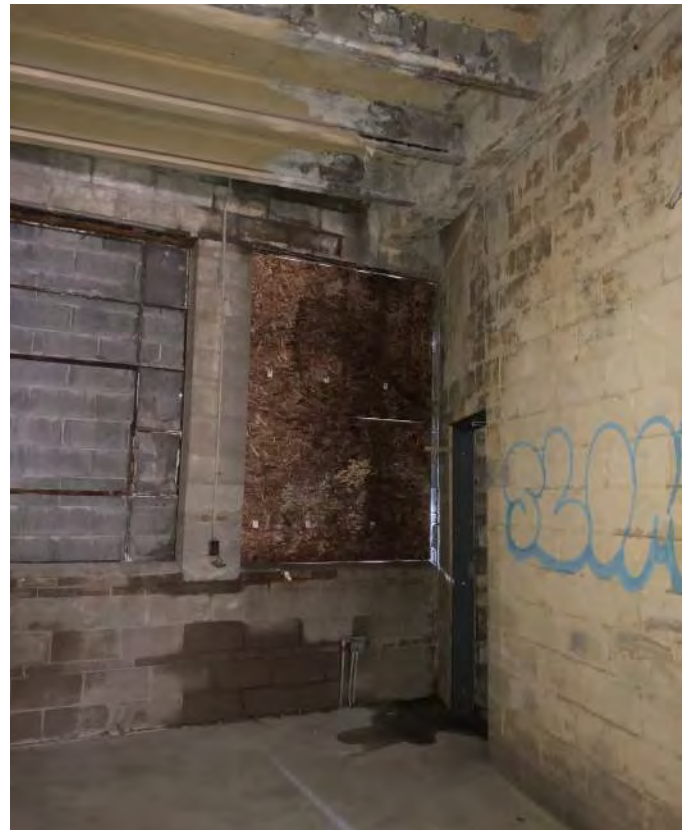
FIGURE INT 1.11 BOARDED UP FORMER WINDOW OPENINGS

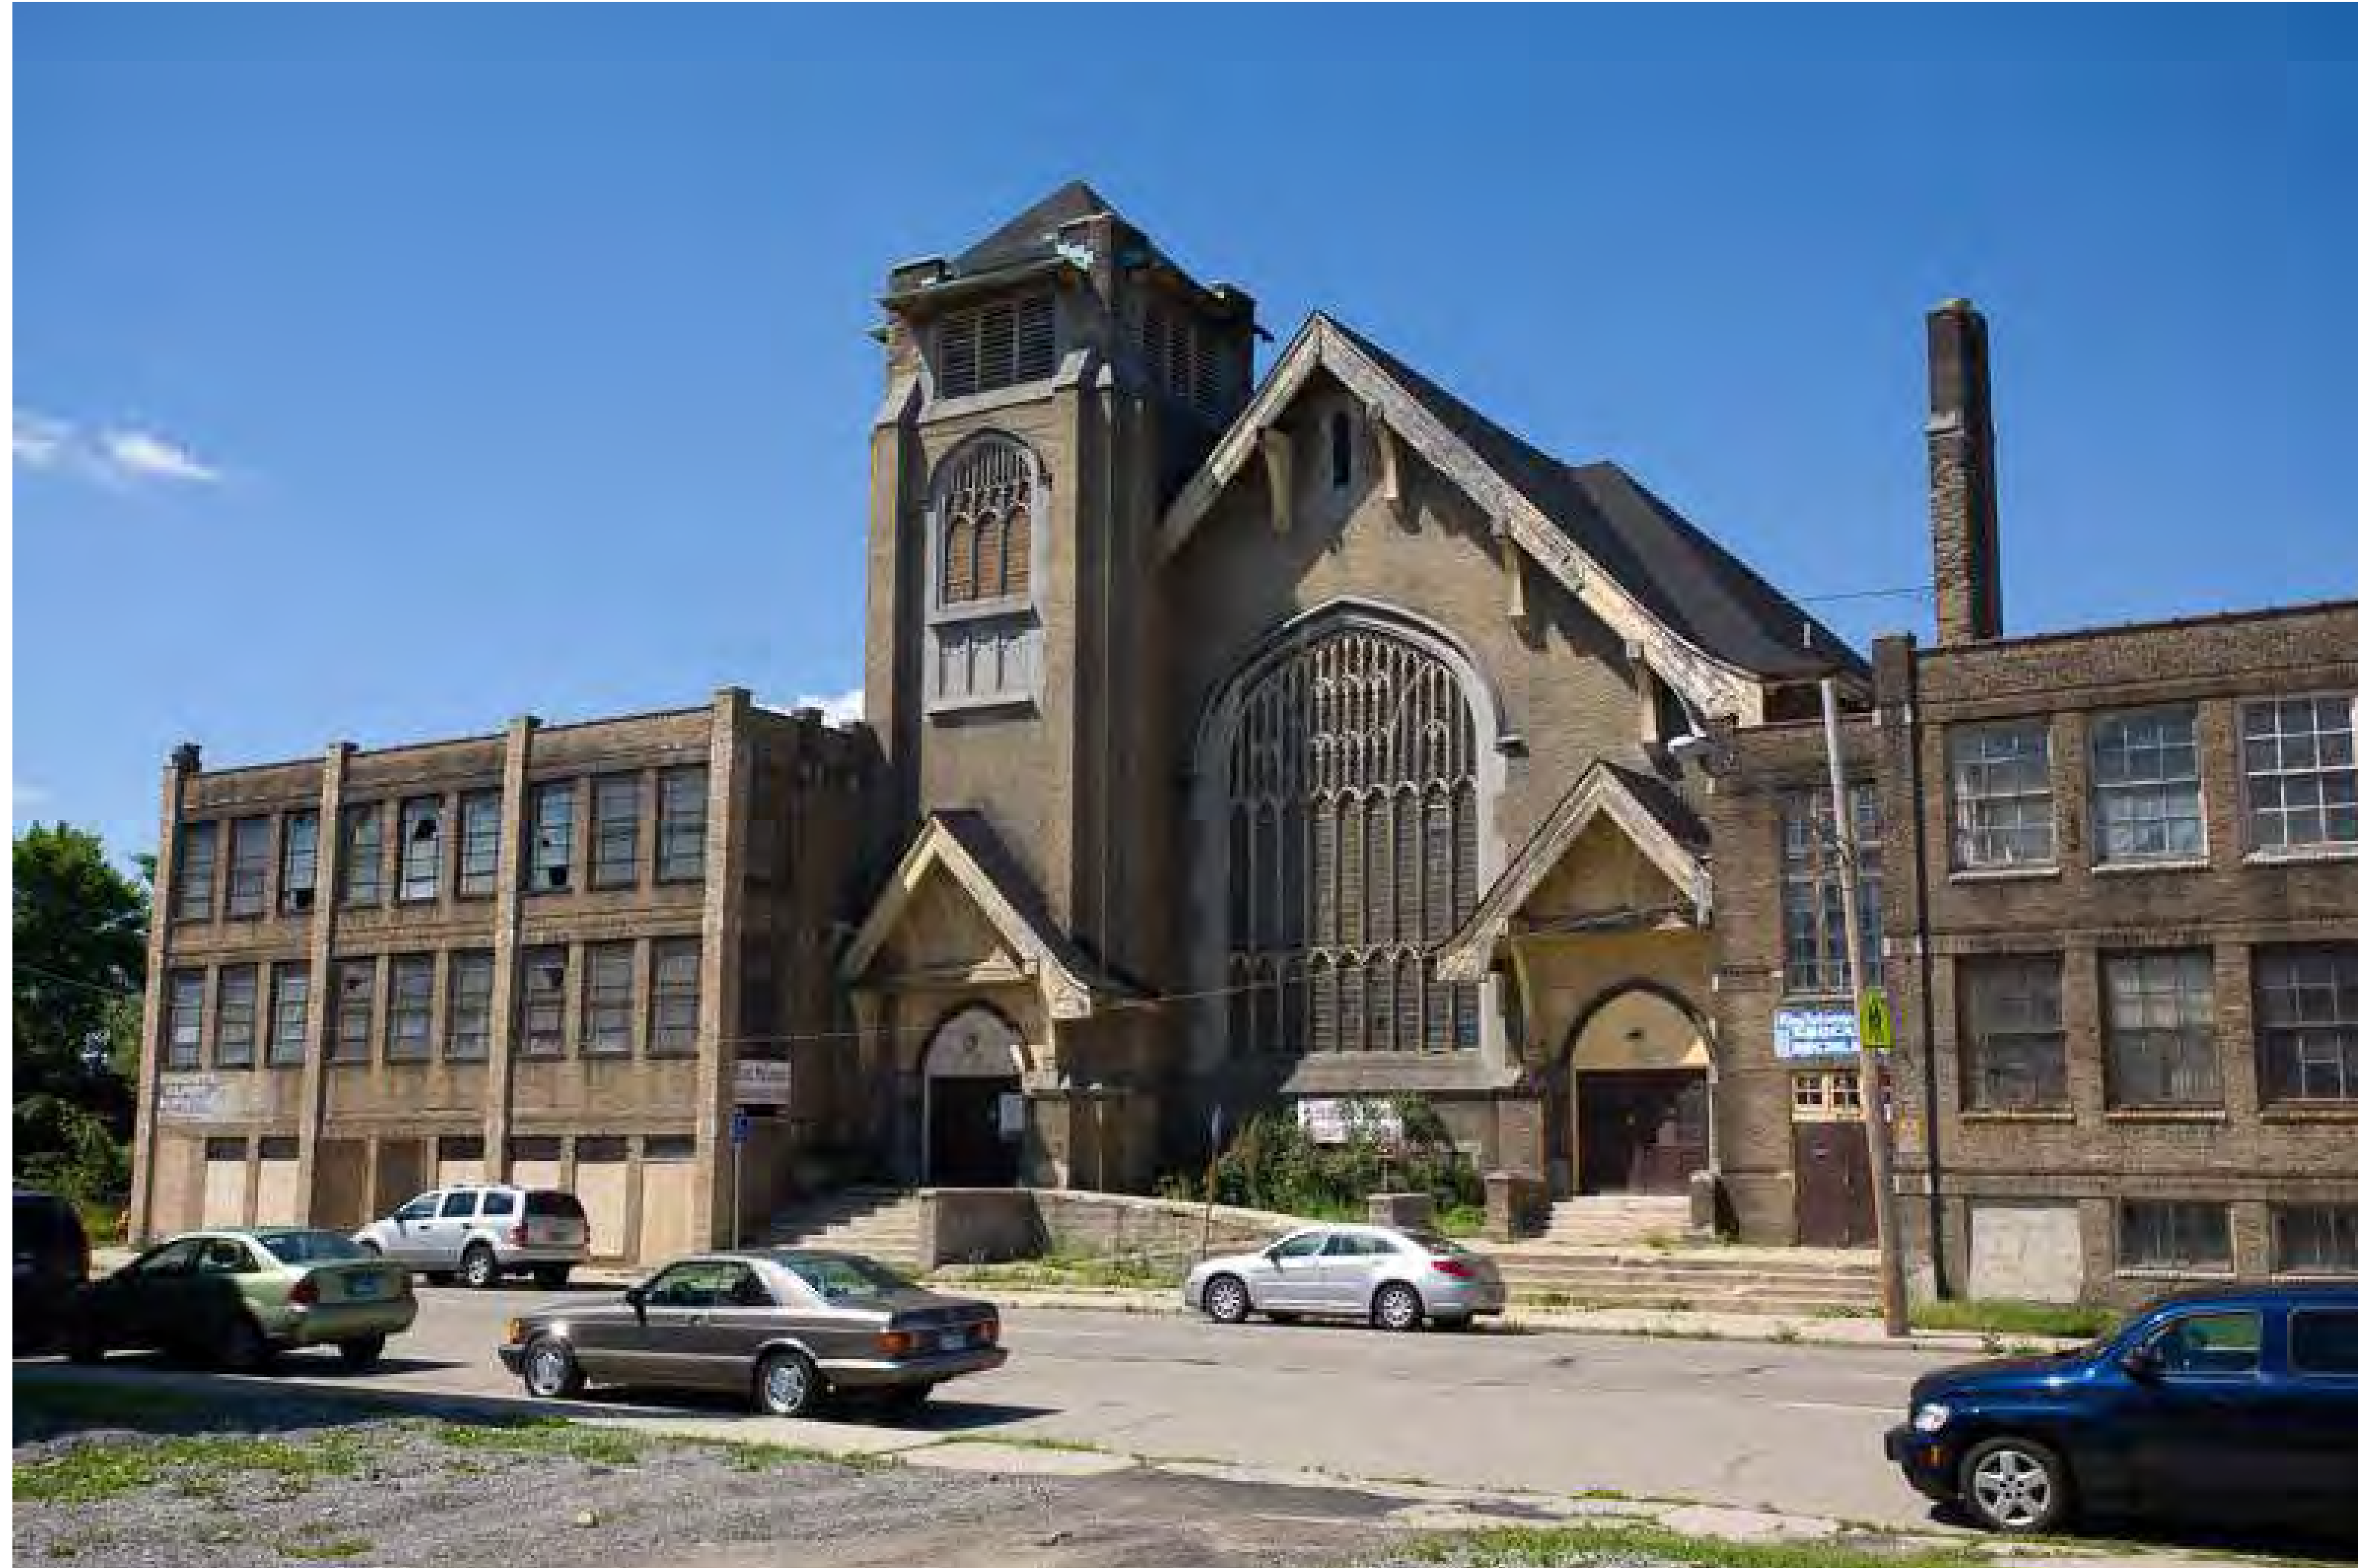
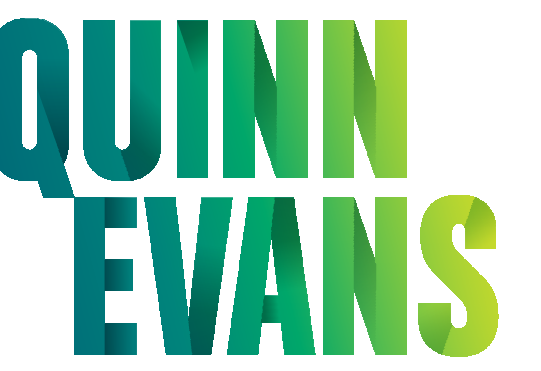
4219 WOODWARD AVE
SUITE 301
DETROIT, MI 48201
v 313.462.2550

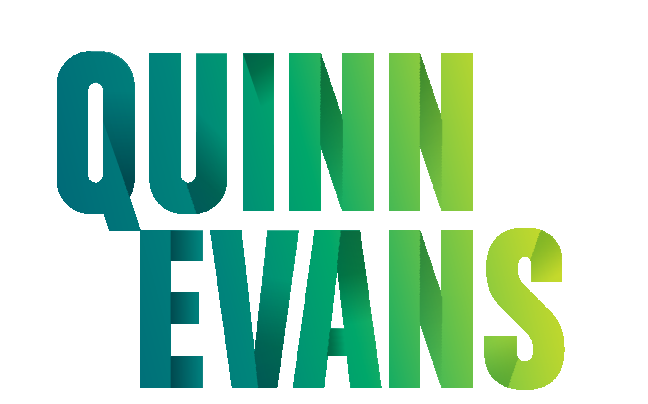
4219 WOODWARD AVE
SUITE 301
DETROIT, MI 48201
v 313.462.2550
QUINN EVANS.COM

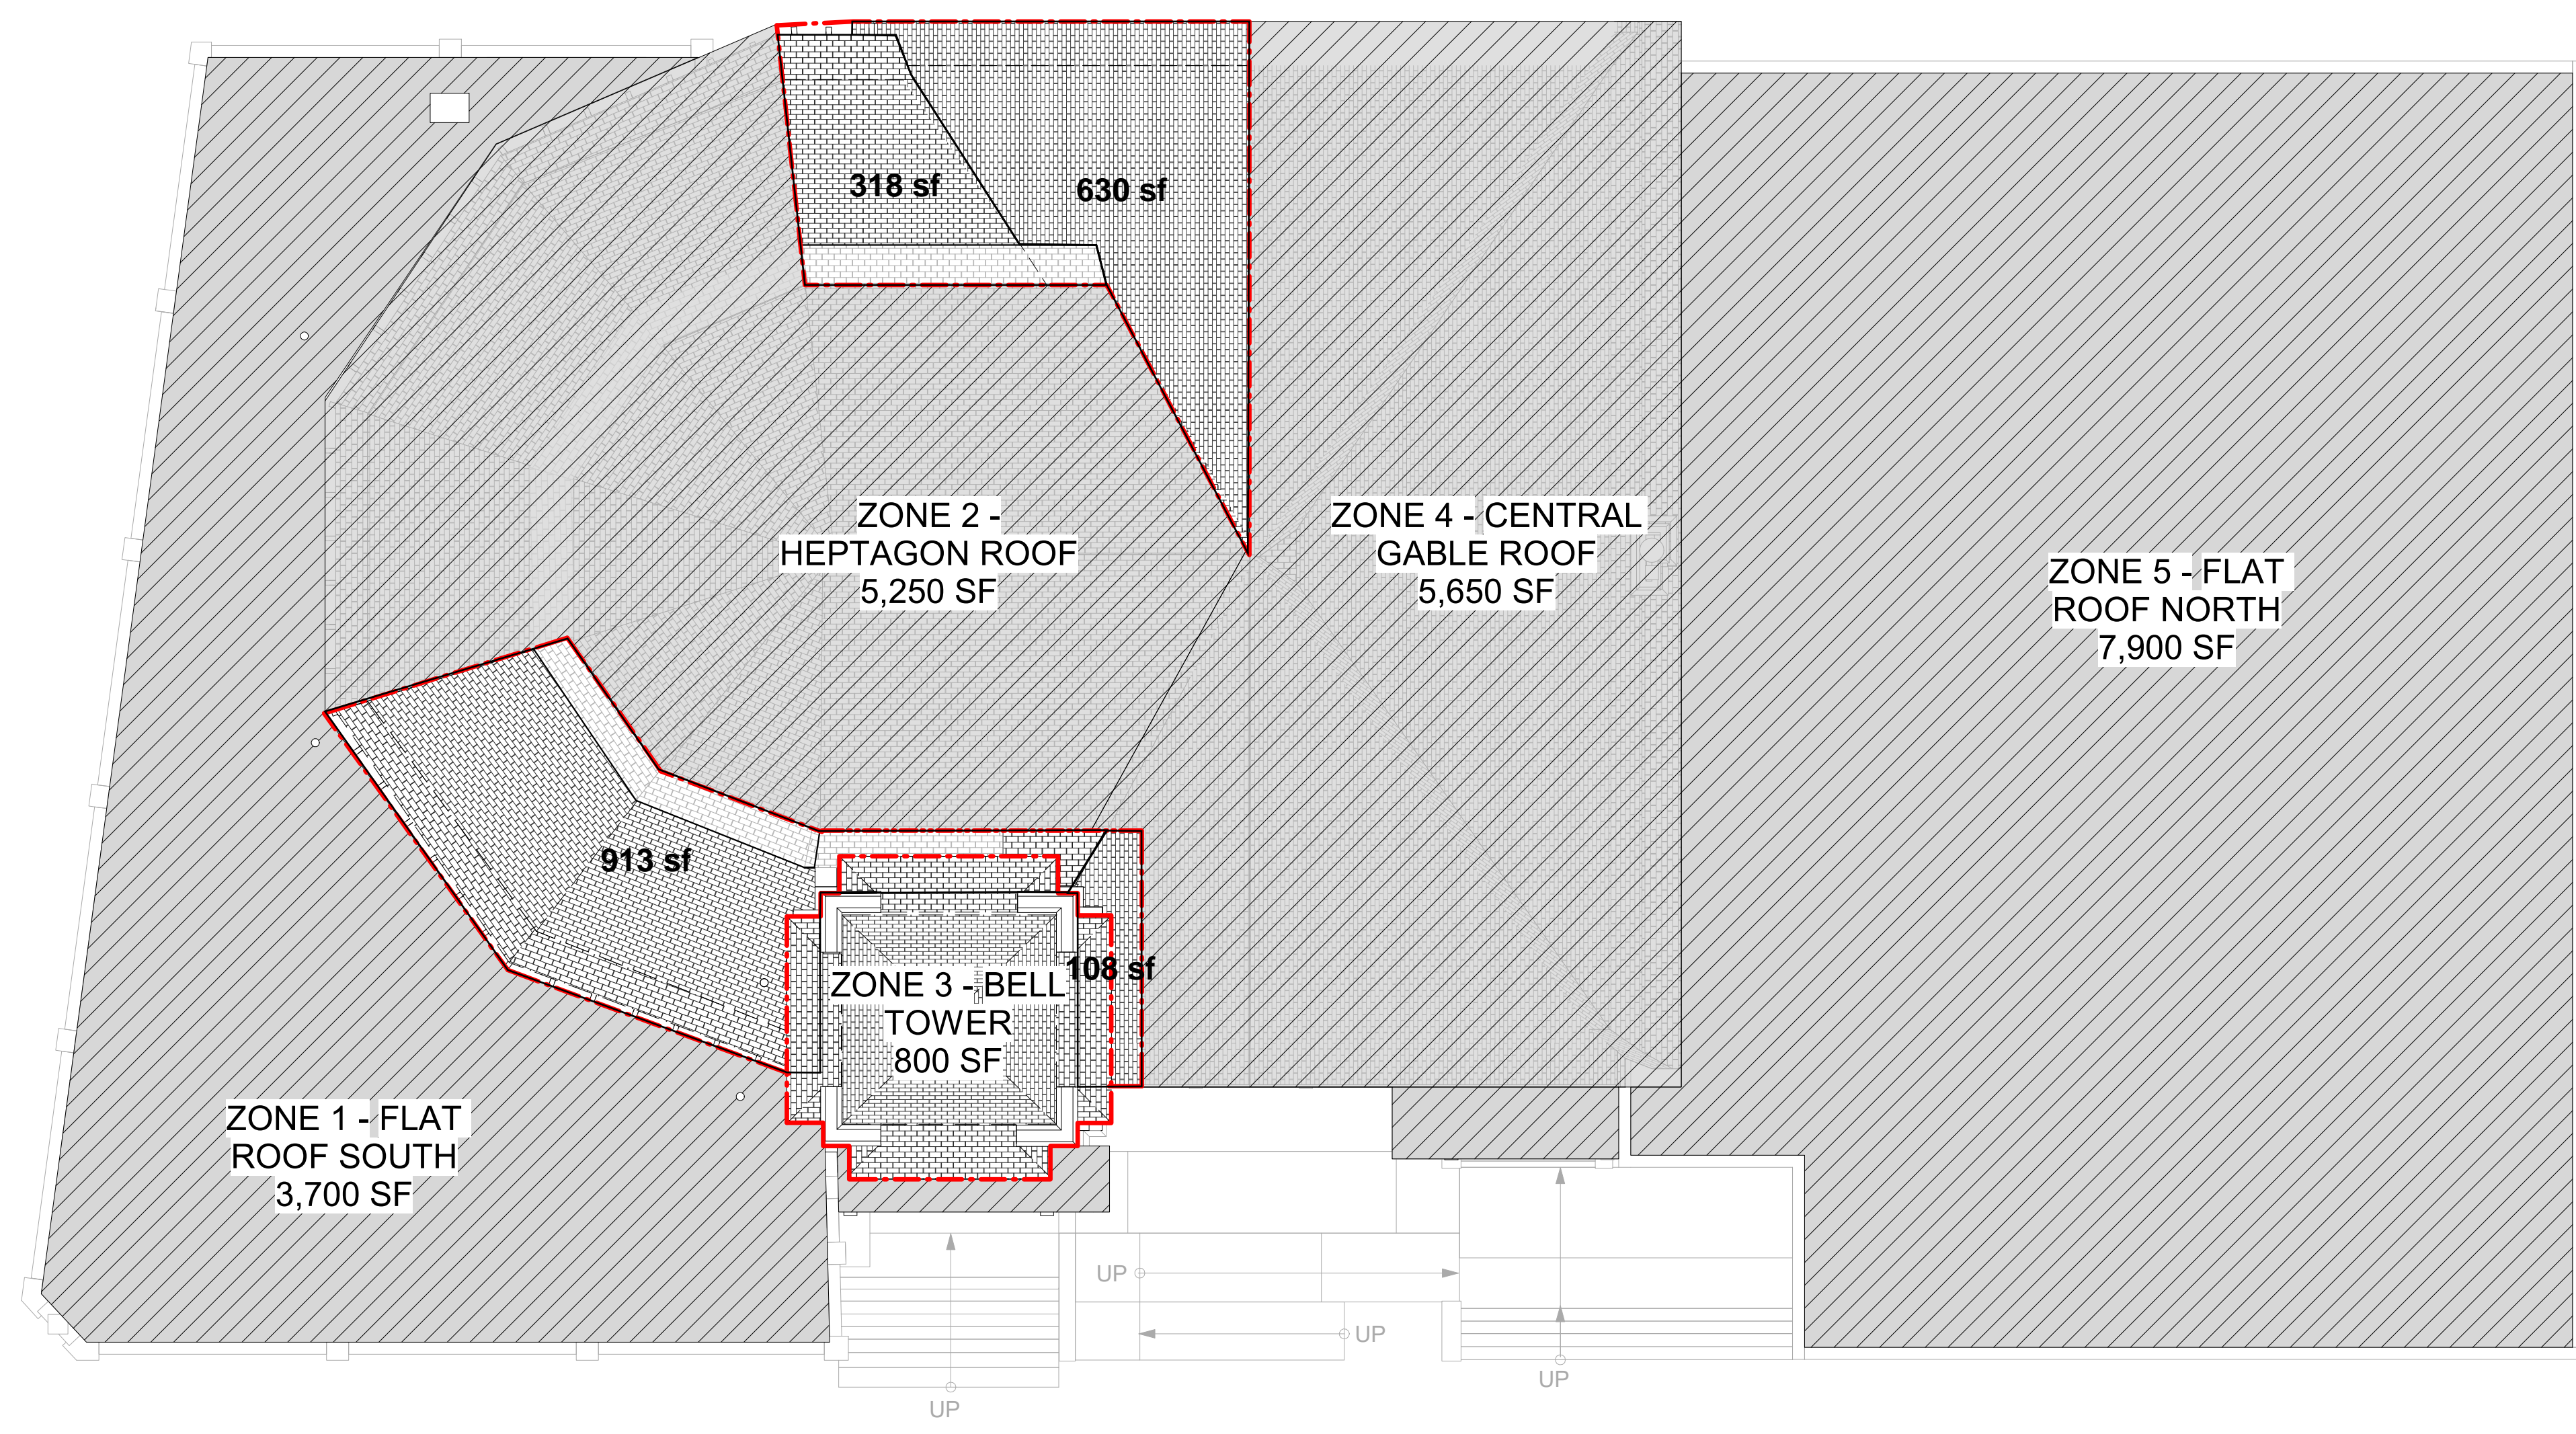
A5 COMPOSITE ROOF ZONE KEY PLAN
G003 3/32" = 1'-0" REFERRED FROM:
