STAFF REPORT 03-16-2022 SPECIAL MEETING

PREPARED BY: A. PHILLIPS

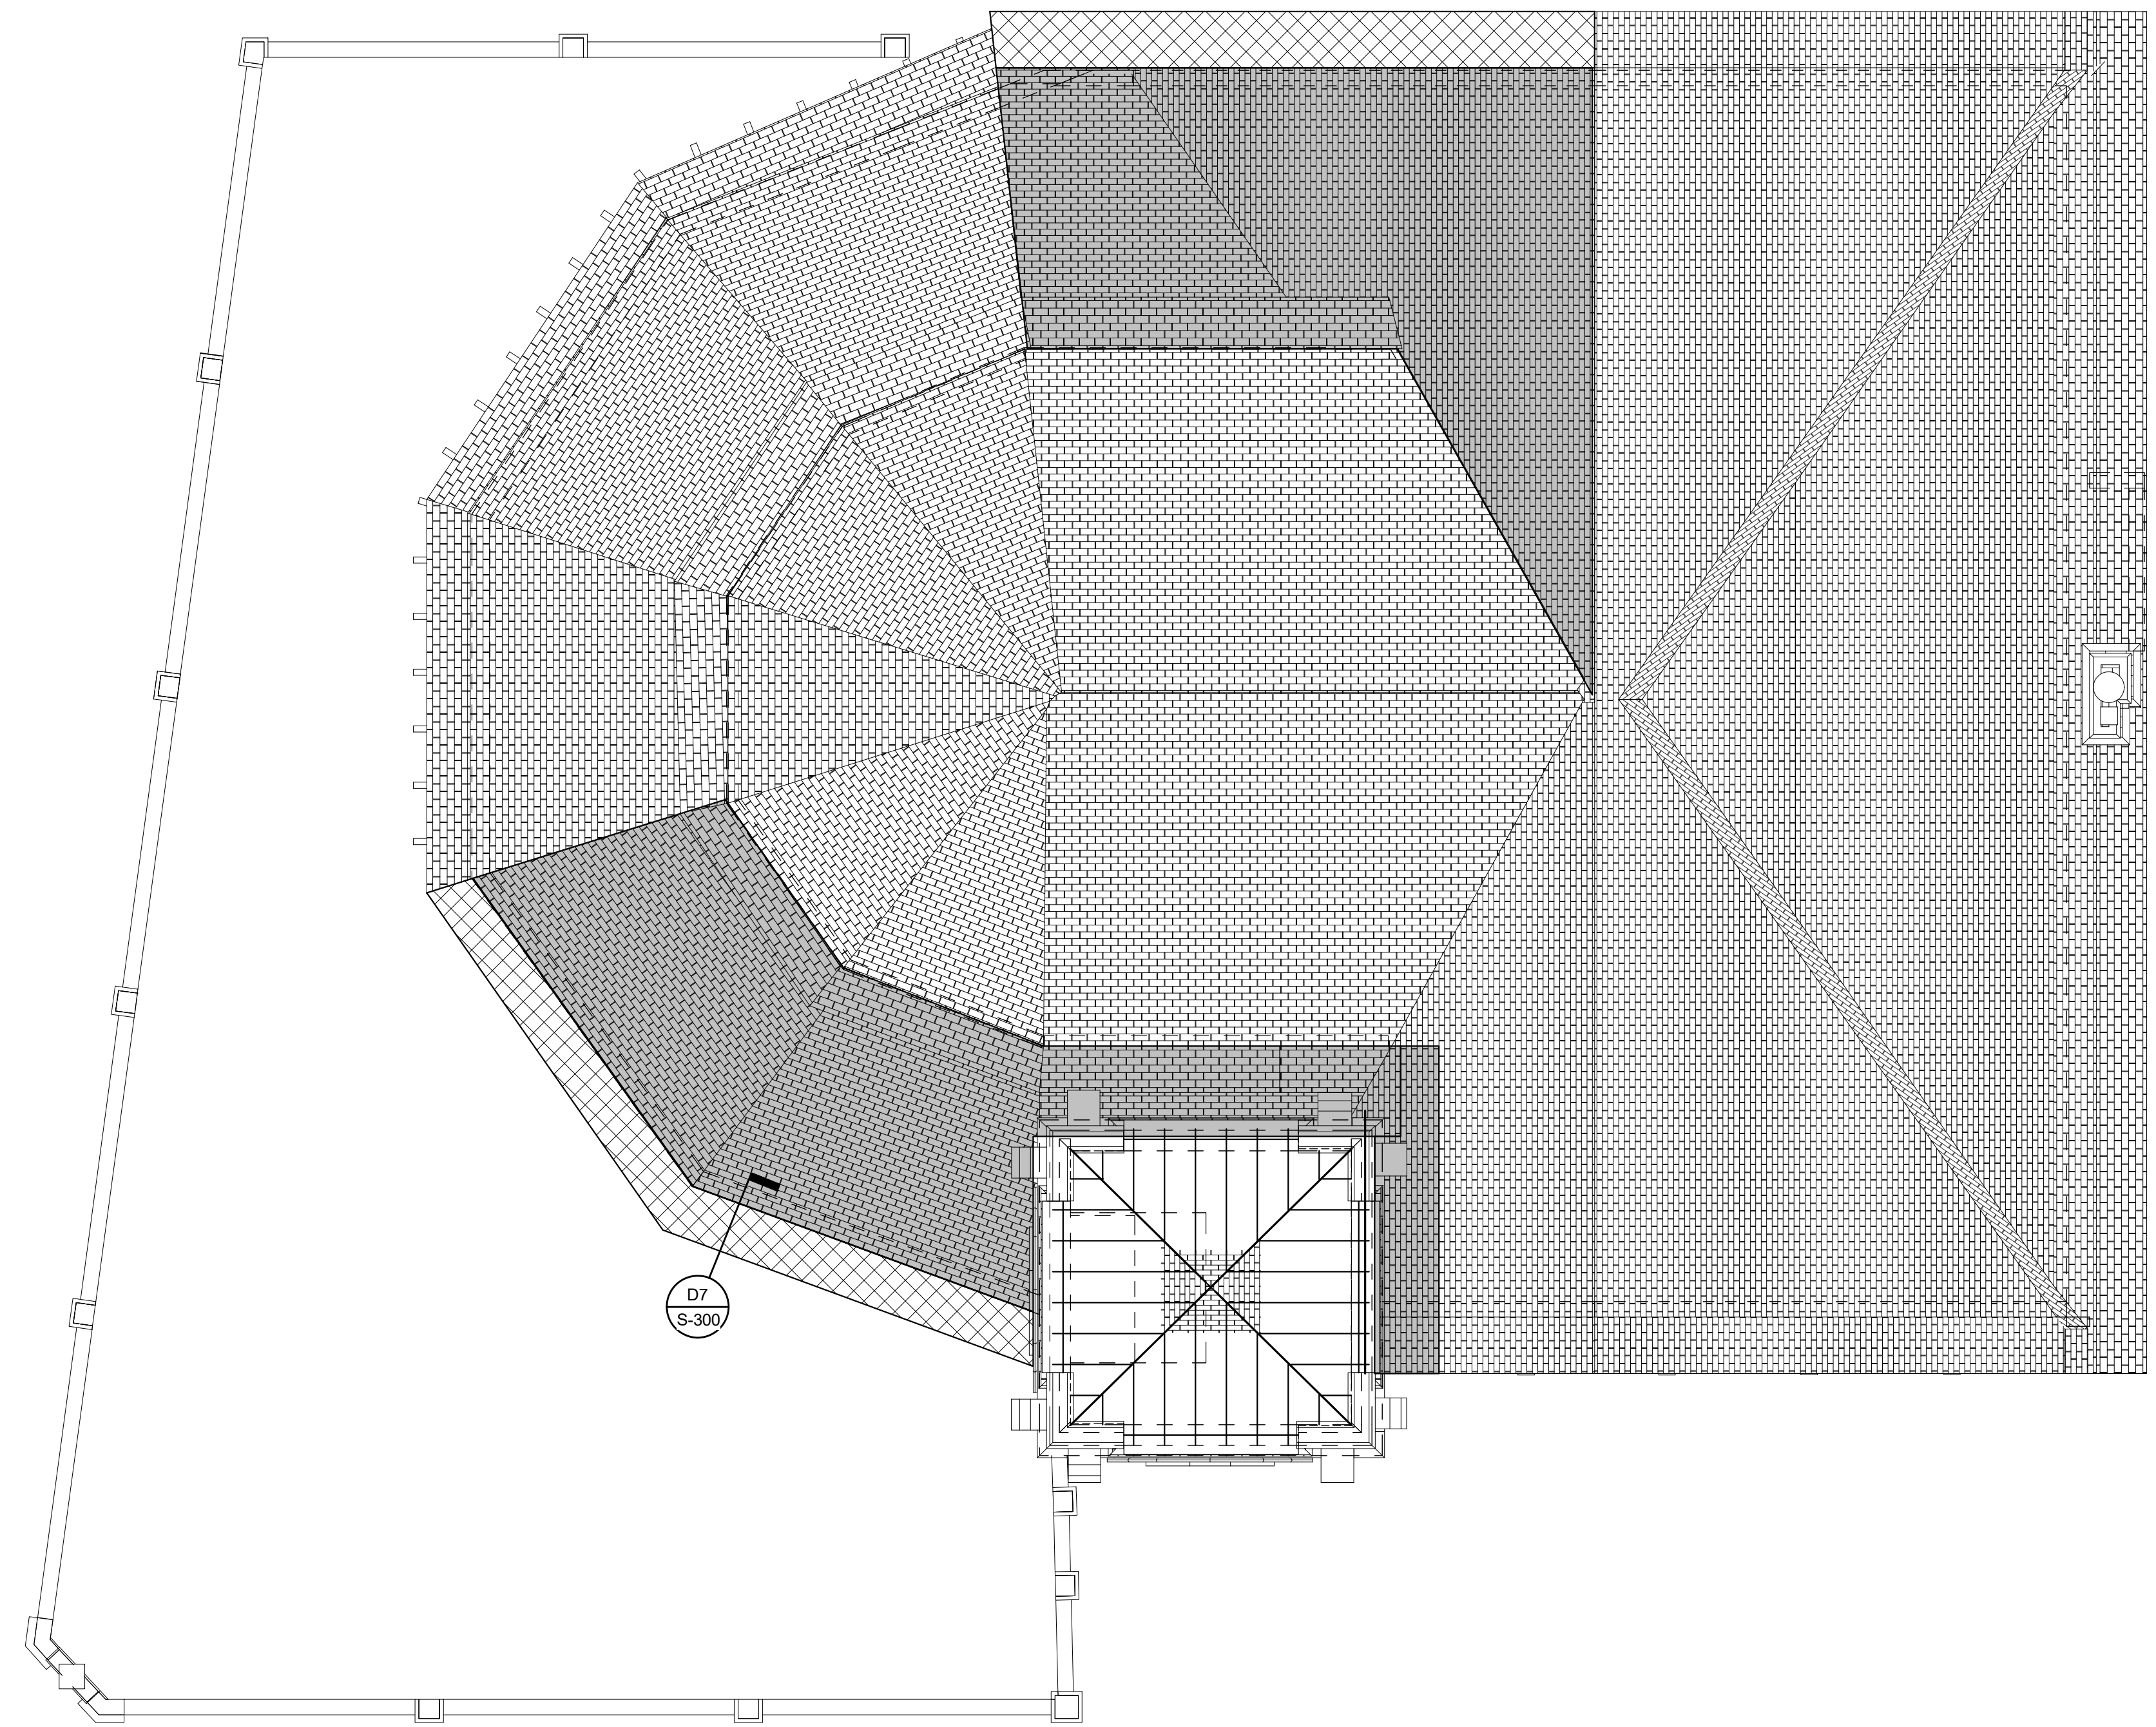
HEPTAGONAL AND CENTRAL GABLE ROOF FRAMING PLAN
SCALE: 1/8" = 1'-0"
NORTH

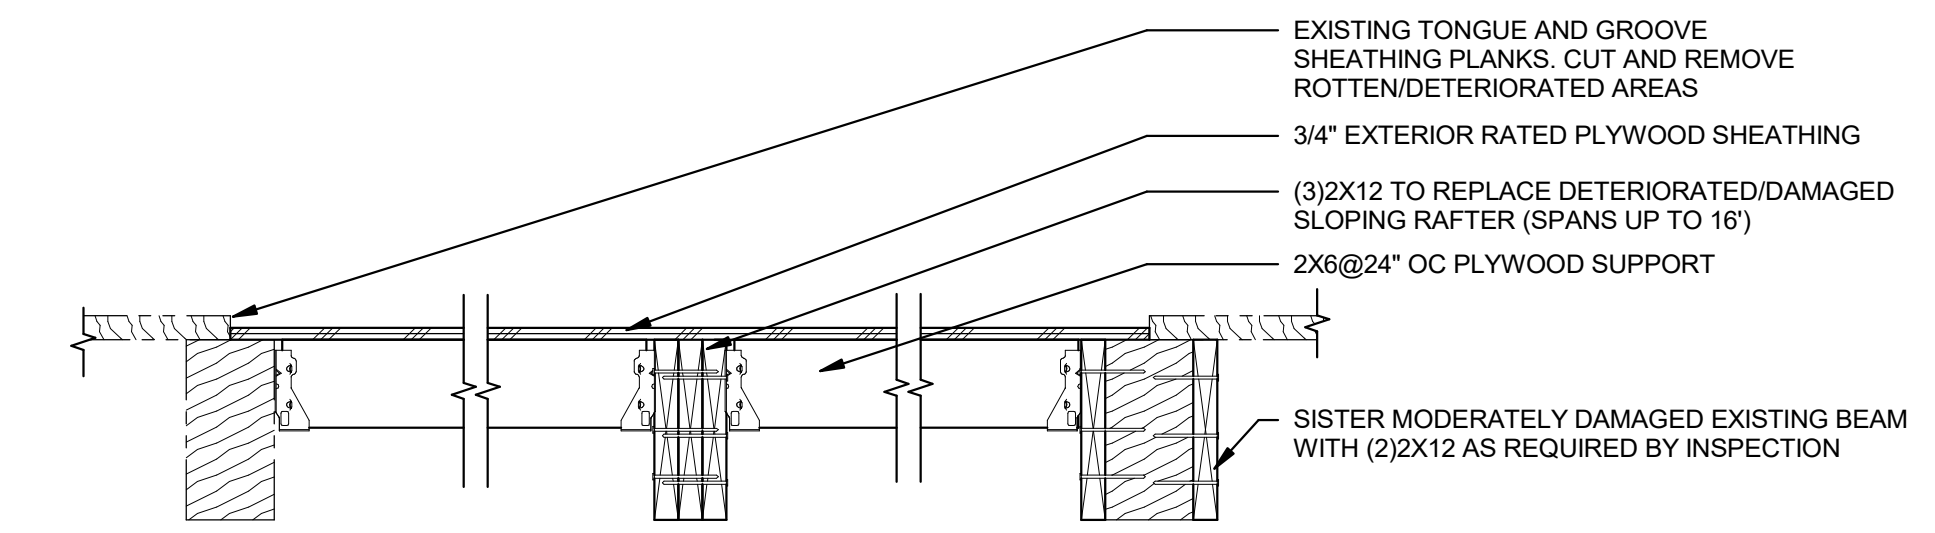
L10 WOOD REPAIR DETAIL
SCALE: 1" = 1'-0"

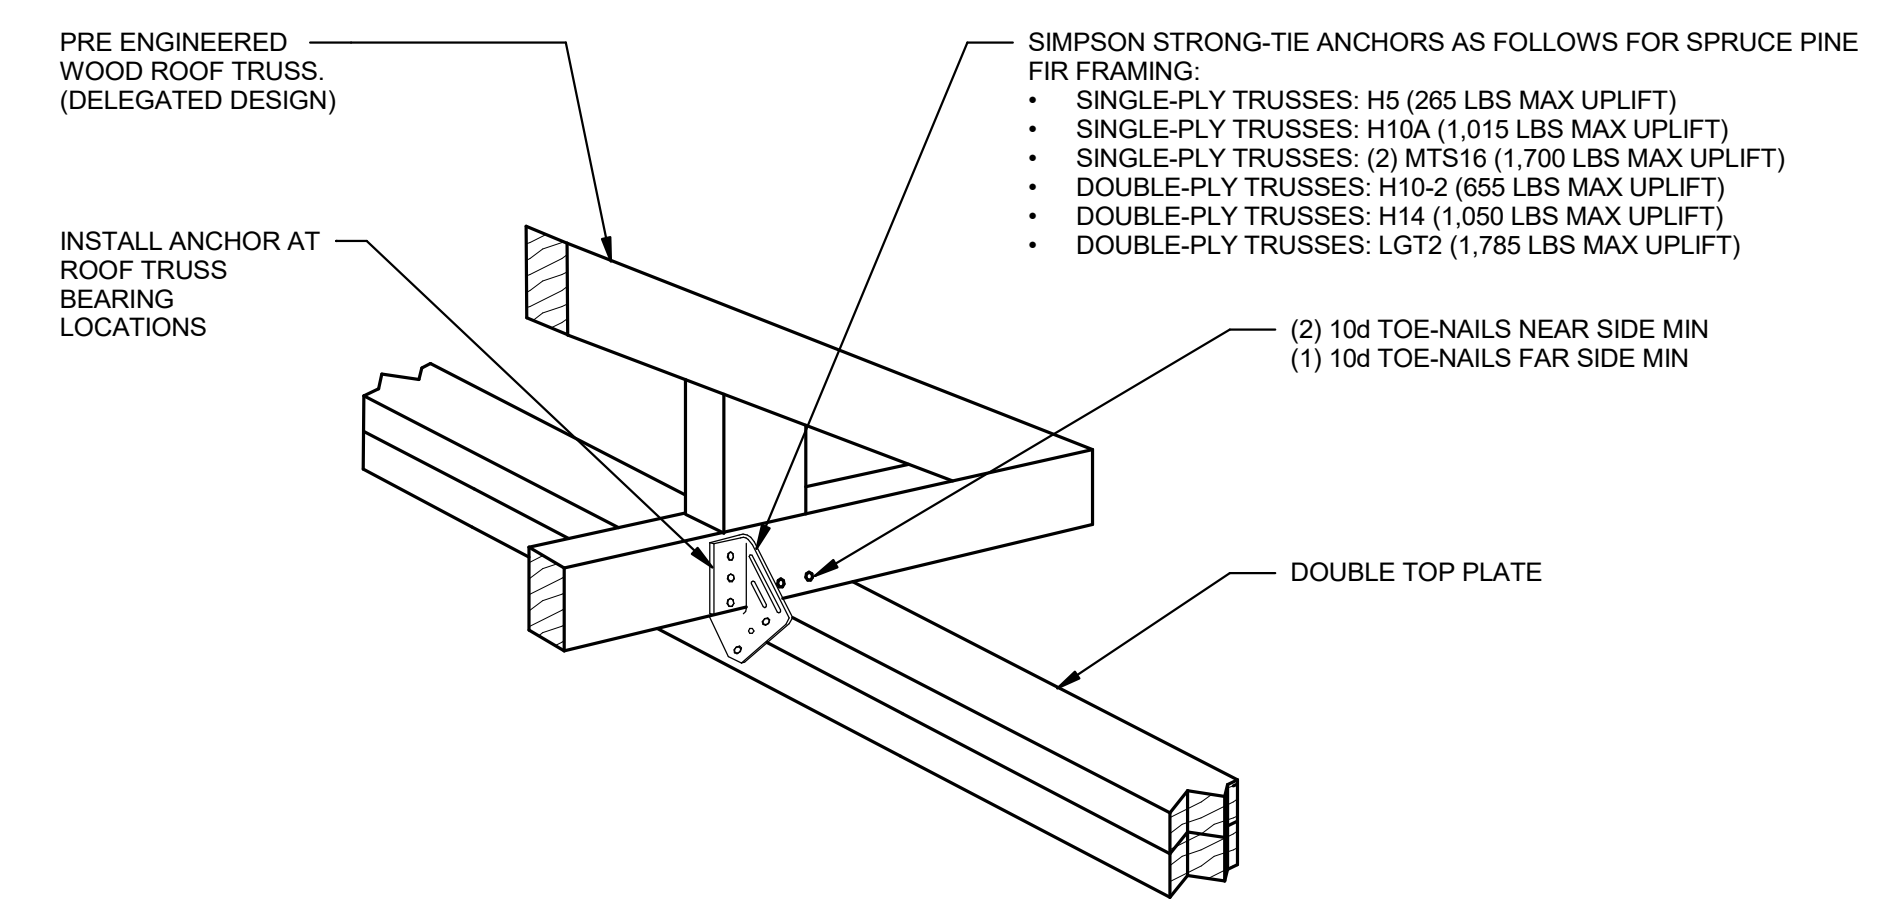
- NOTES:
1. MAXIMUM WALL STUD SPACING 16" OC
 2. SELECT TRUSS ANCHOR BASED ON APPROVED TRUSS SHOP DRAWINGS WITH TRUSS REACTIONS.
 3. TRUSS MANUFACTURER OR CONTRACTOR SHALL REQUEST FOR ADDITIONAL HOLDOWN ANCHORS AT TRUSS GIRDERS, MULTI-PLY TRUSSES, JACK TRUSSES AND HIP/VALLEY TRUSSES.
 4. MULTIPLE ANCHORS MAY BE USED (PER SIMPSON STRONG-TIE RECOMMENDED DETAILS) TO ANCHOR HIGHER UPLIFT VALUES.
 5. DETAIL APPLIES TO INTERIOR AND EXTERIOR BEARING WALLS.

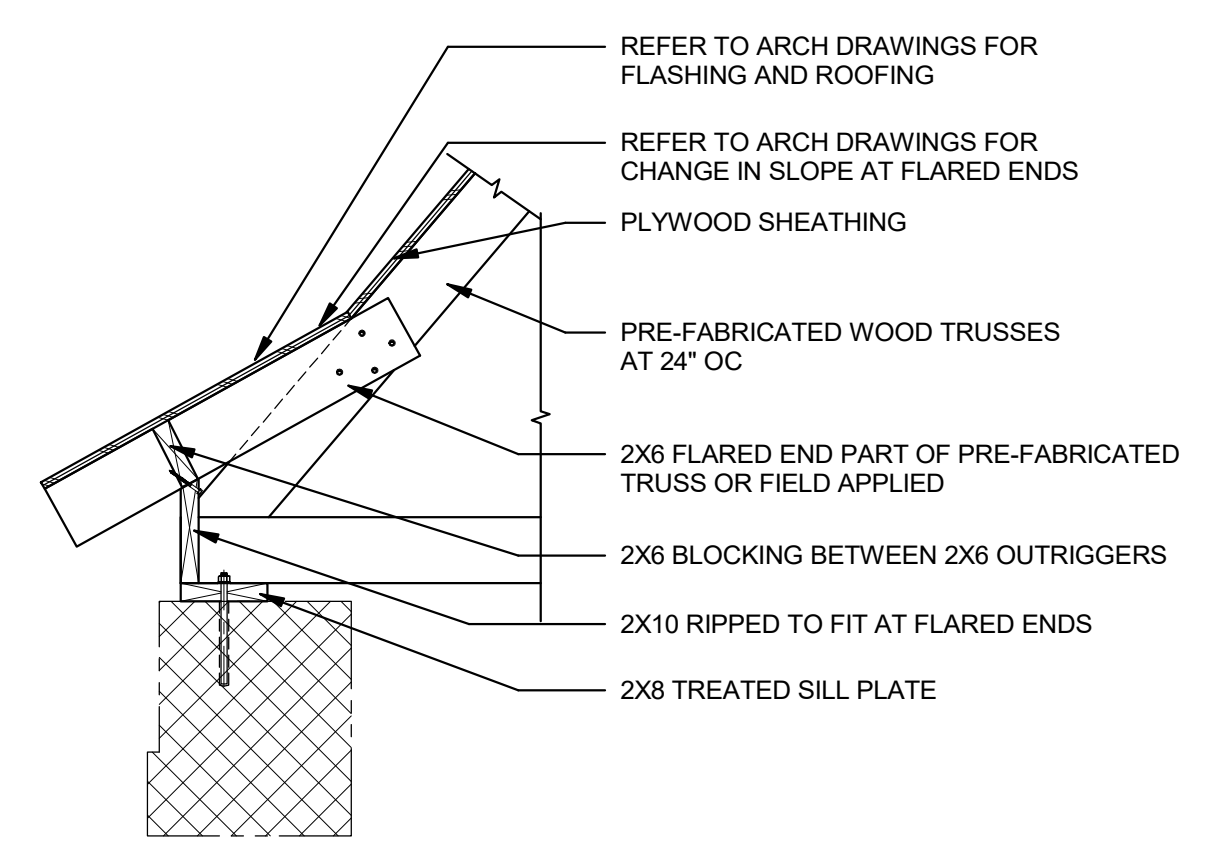
F7 FLARED TRUSS SUPPORT
SCALE: 3/4" = 1'-0"

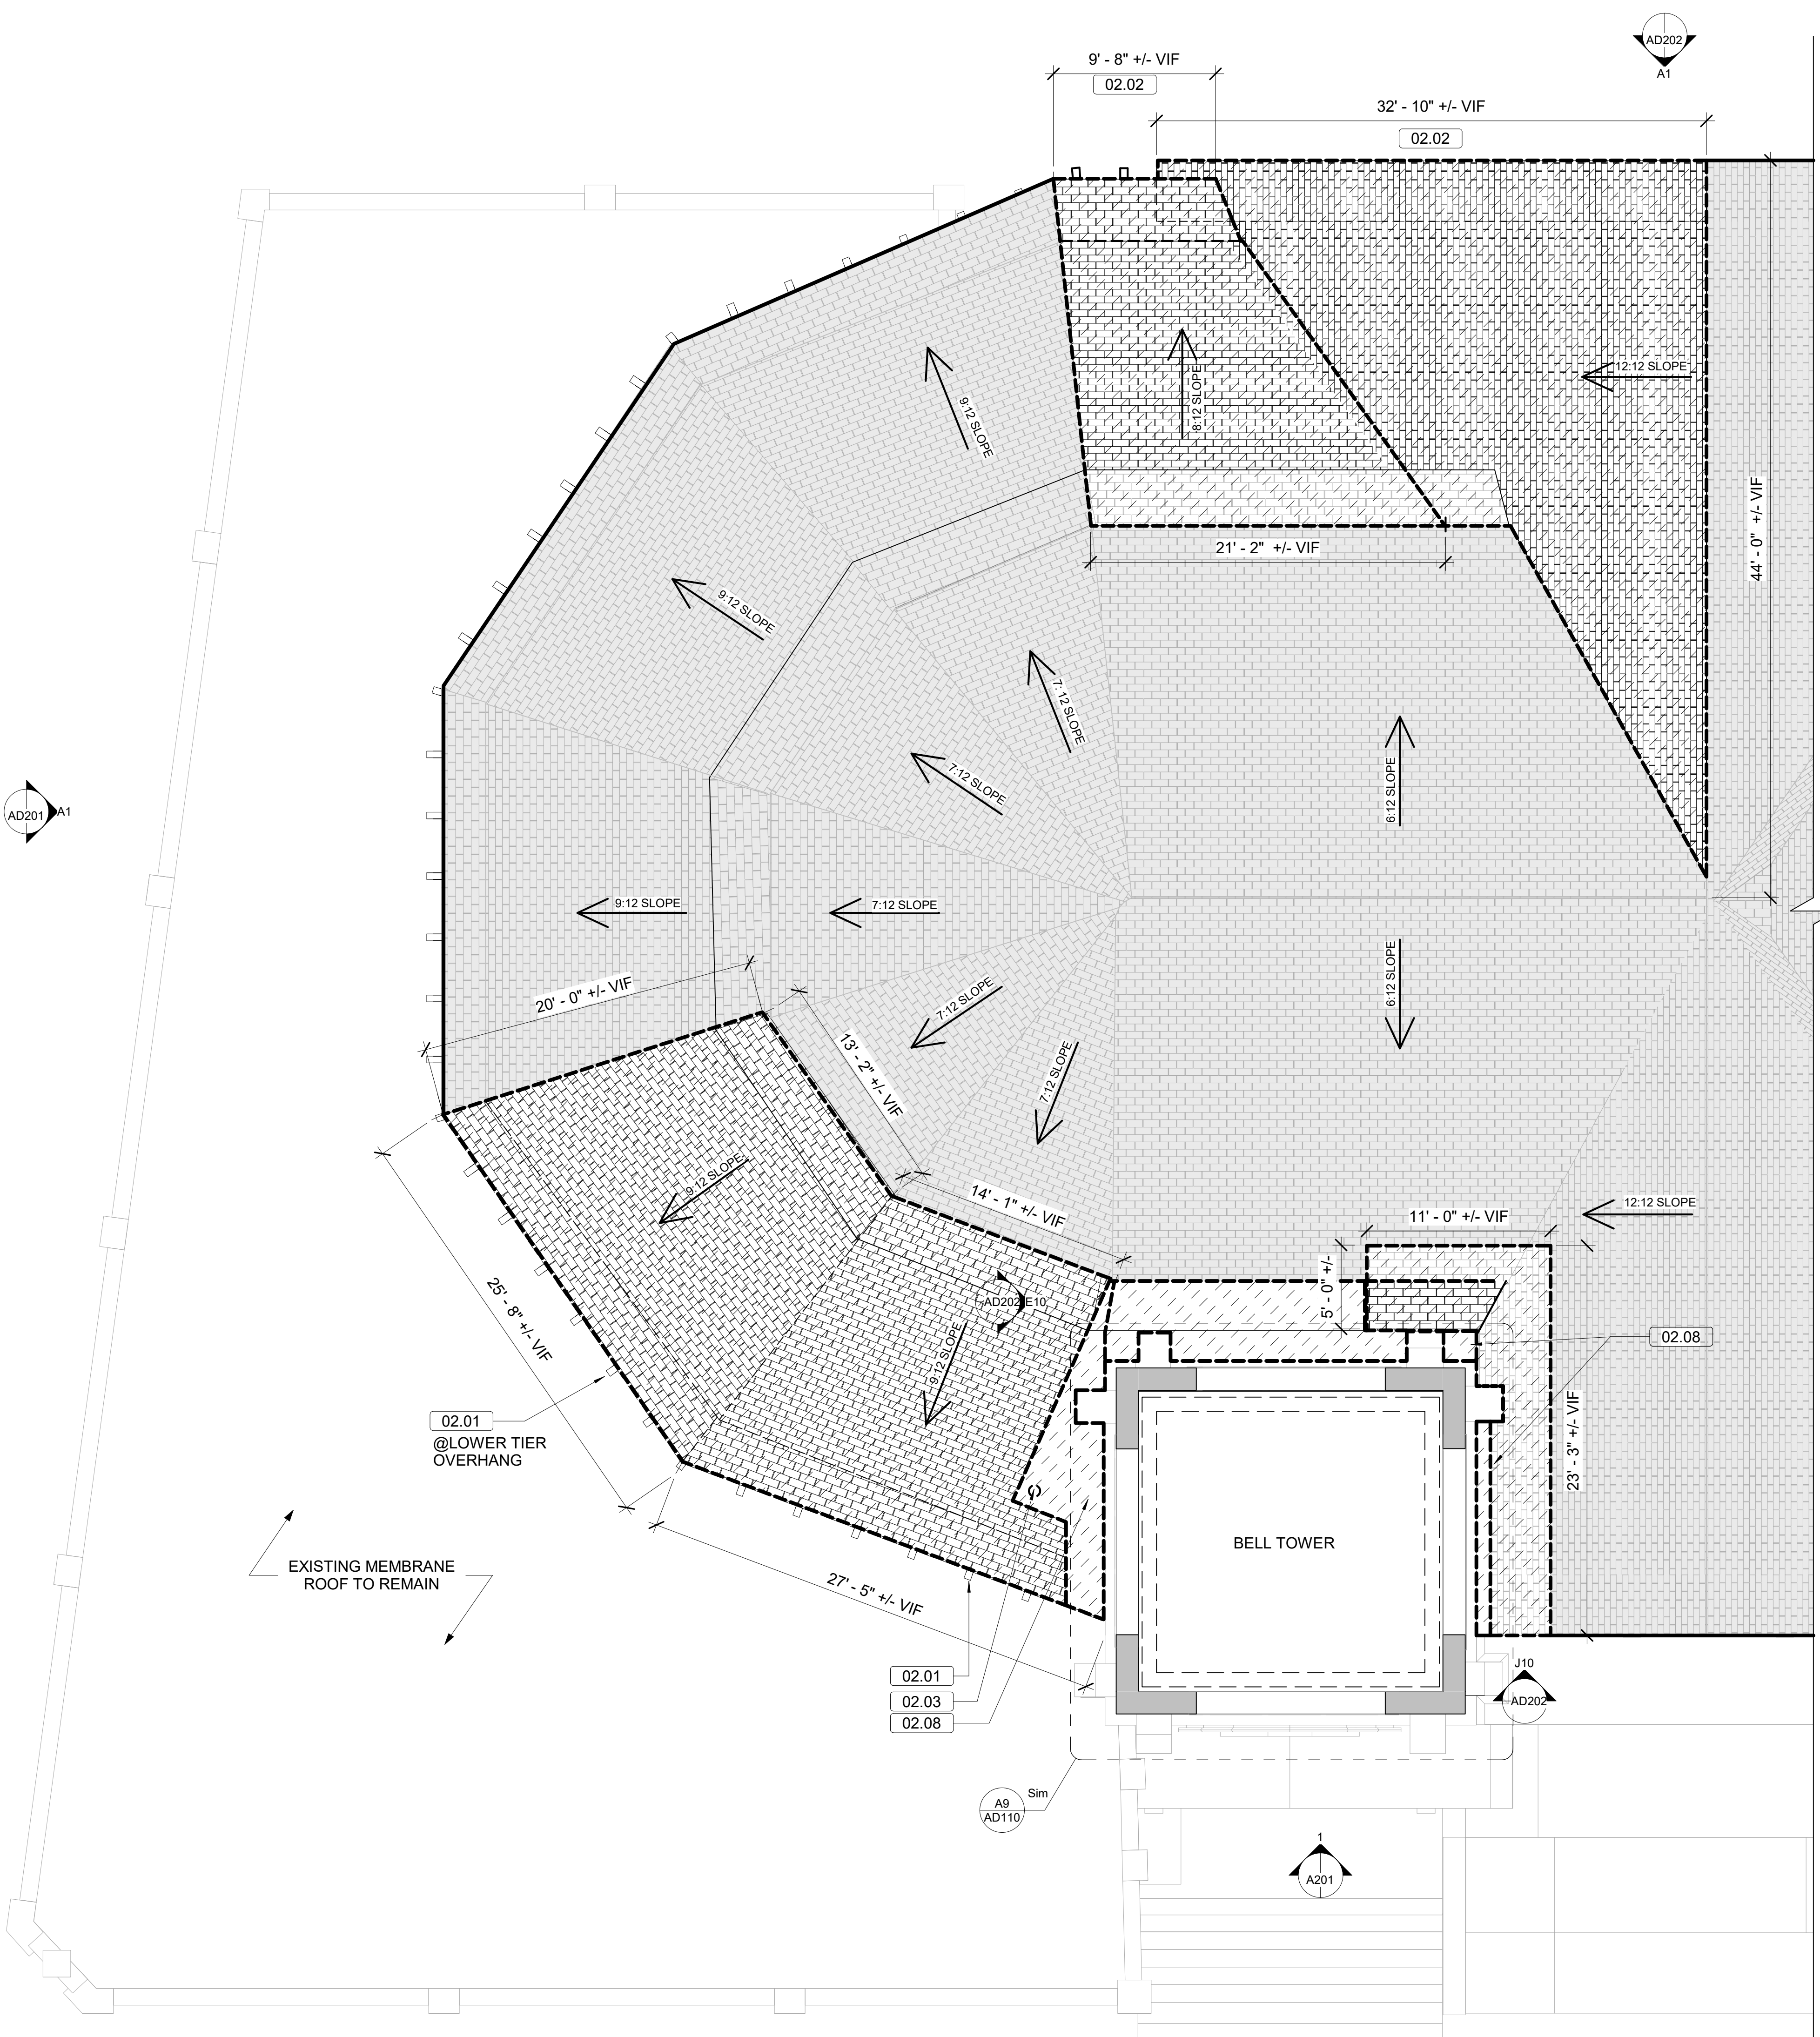
A1 HEPTAGON AND CENTRAL GABLE ROOF DEMOLITION PLAN
 3/16" = 1'-0" REFERRED FROM: AD110

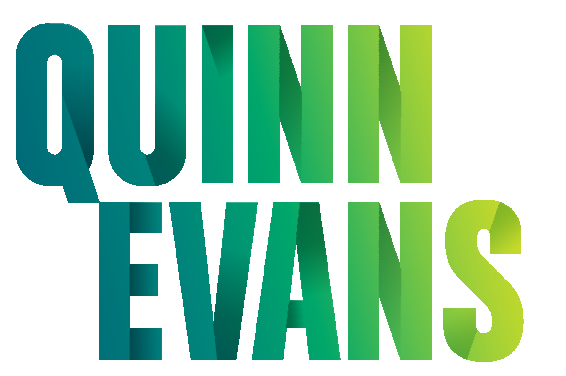
4219 WOODWARD AVE
 SUITE 301
 DETROIT, MI 48201
 v 313.462.2550
 QUINNEVANS.COM

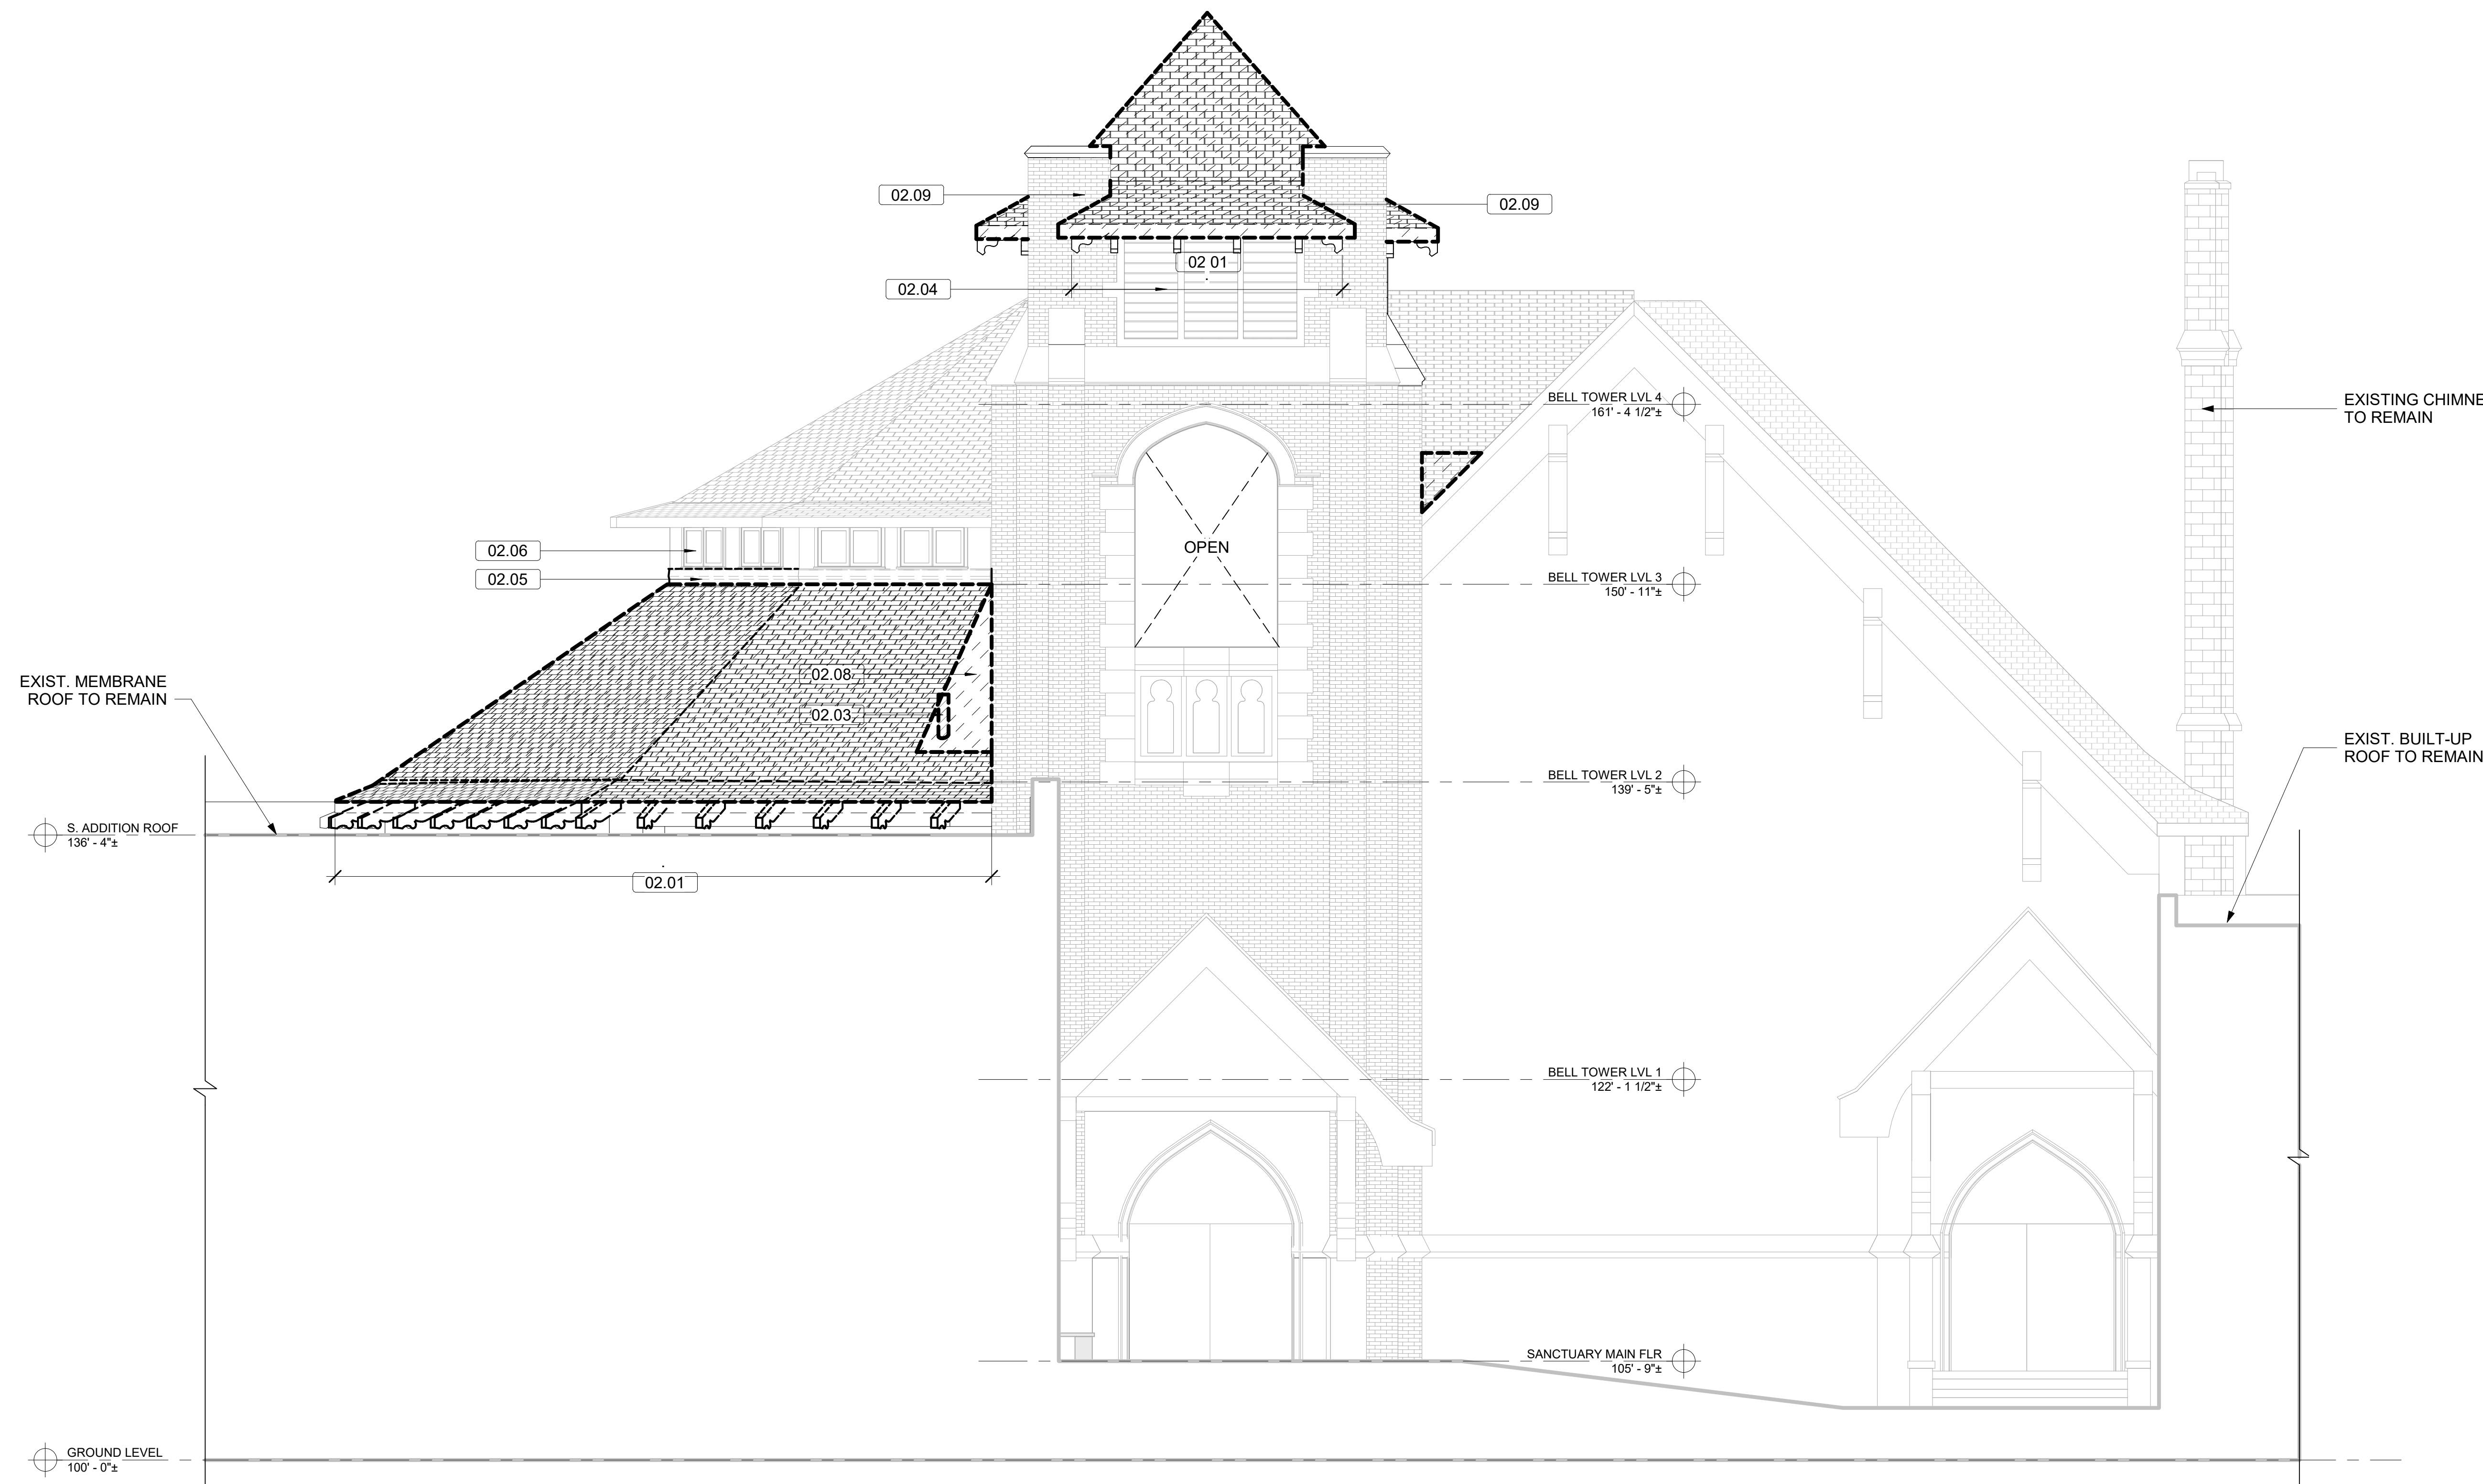
E1 EAST DEMOLITION ELEVATION

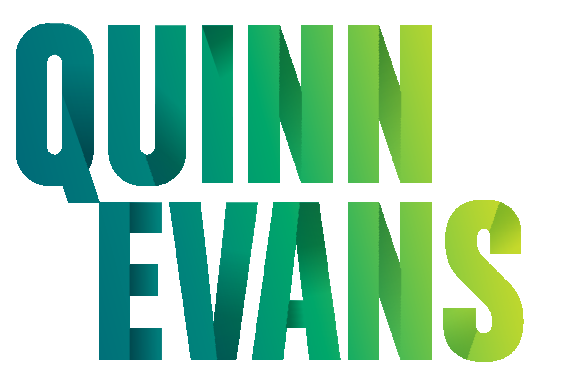
4219 WOODWARD AVE
 SUITE 301
 DETROIT, MI 48201
 v 313.462.2550
 QUINNEVANS.COM

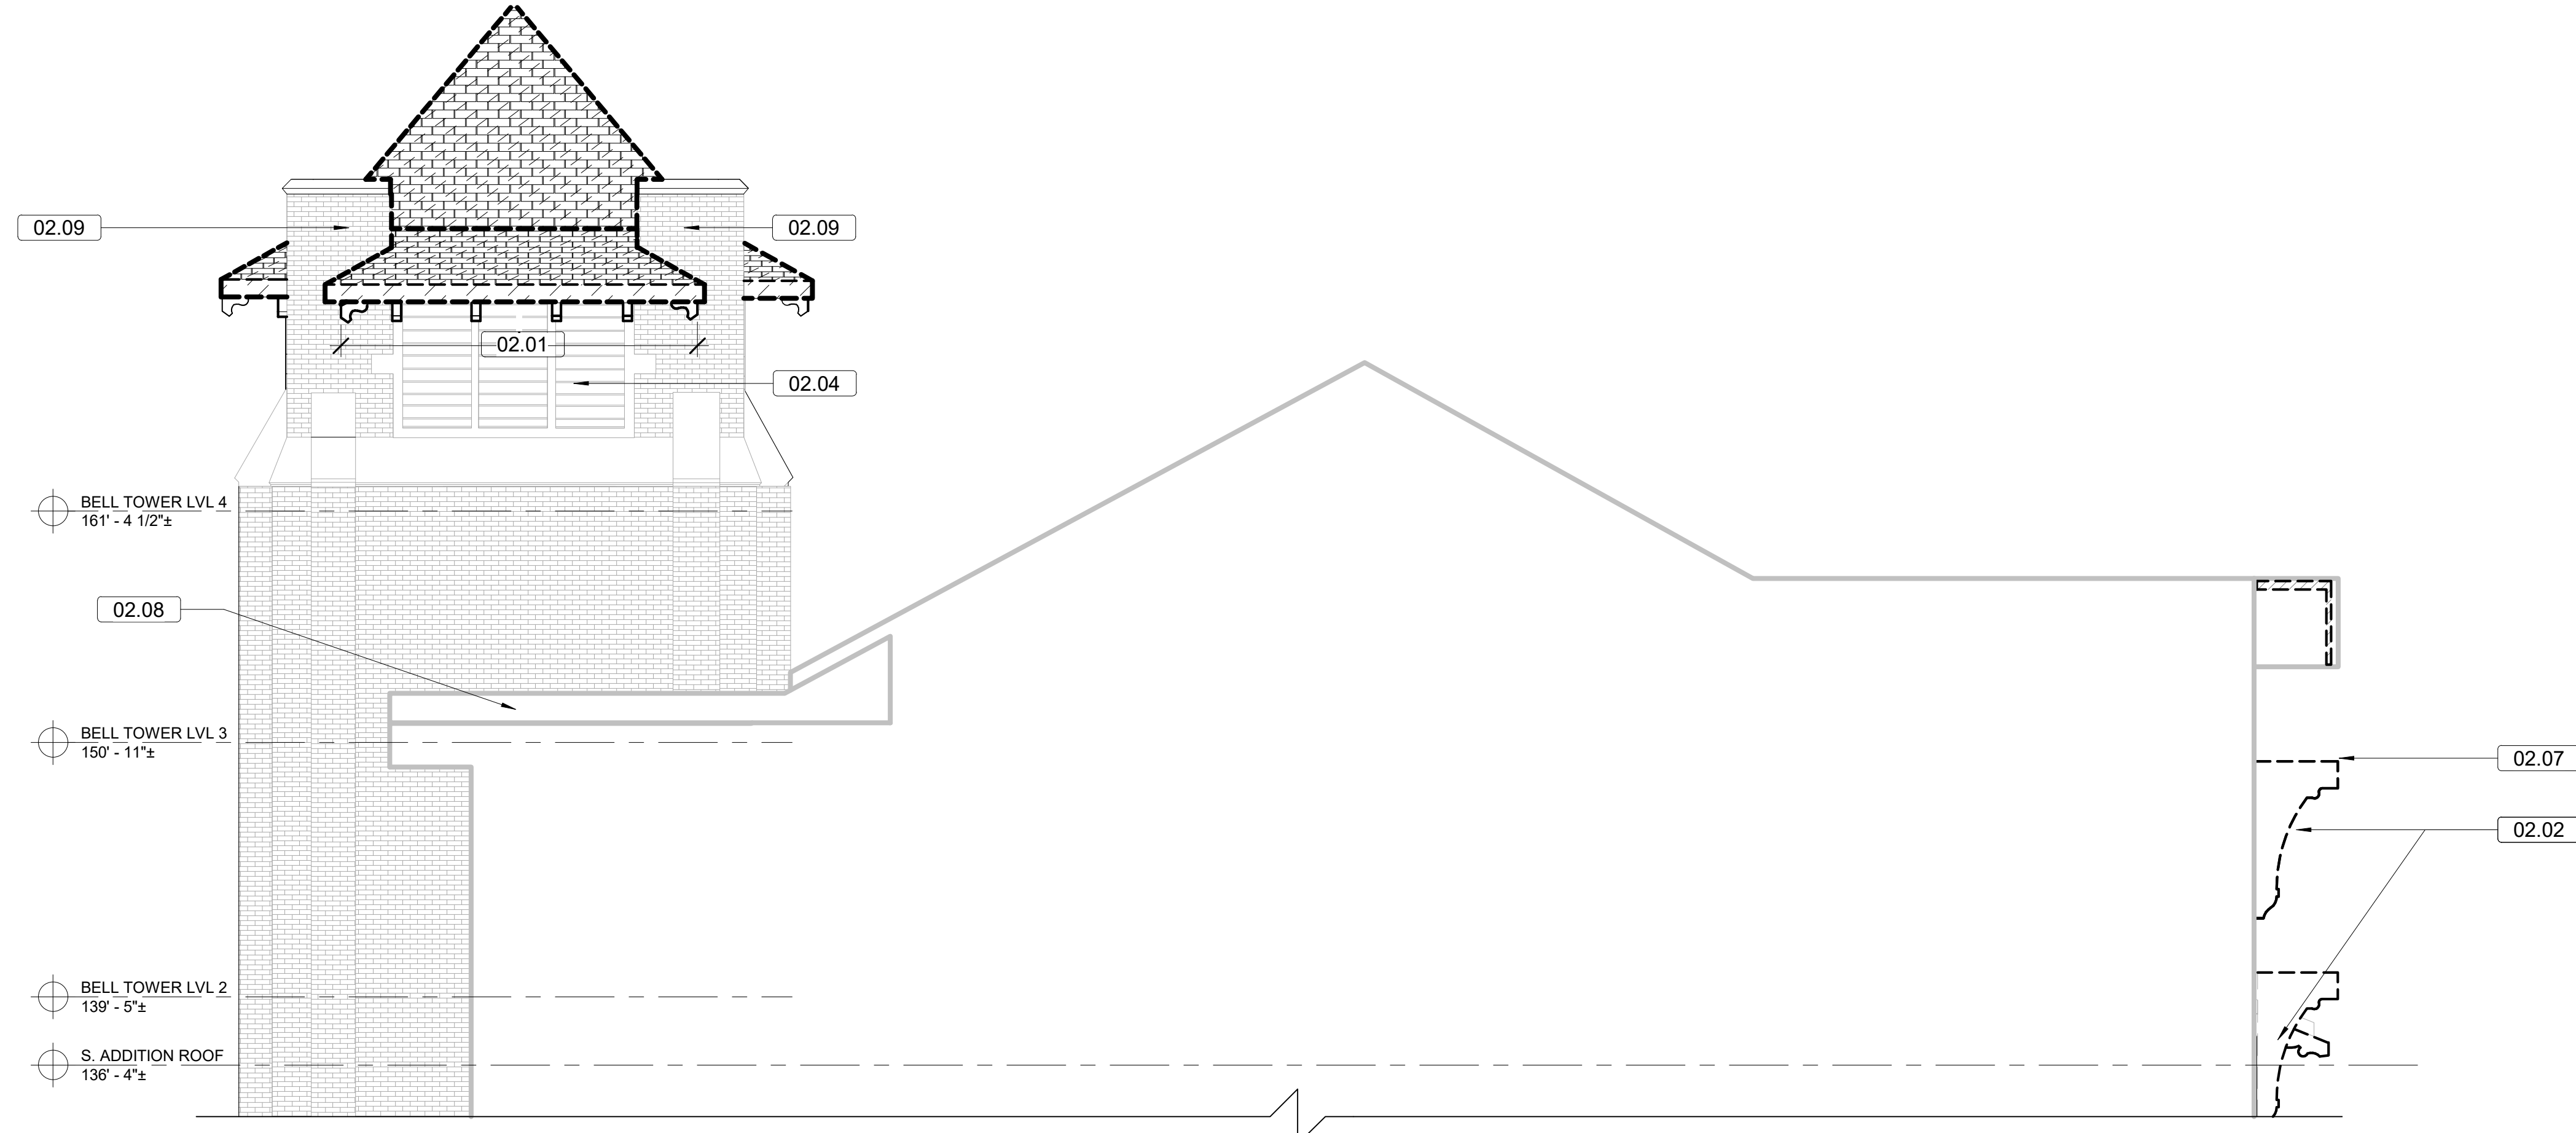
F1
AD202
3/16" = 1'-0" REFERRED FROM: A500
NORTH DEMOLITION ELEVATION

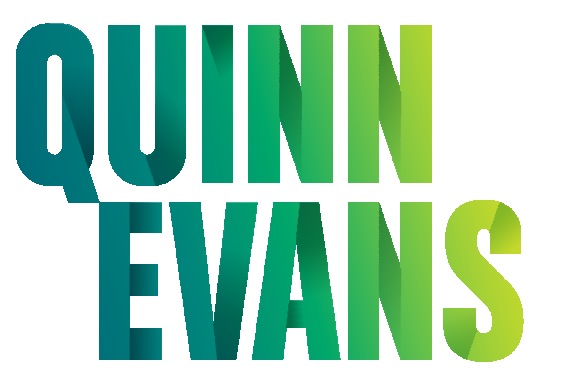
4219 WOODWARD AVE
SUITE 301
DETROIT, MI 48201
v 313.462.2550
QUINNEVANS.COM

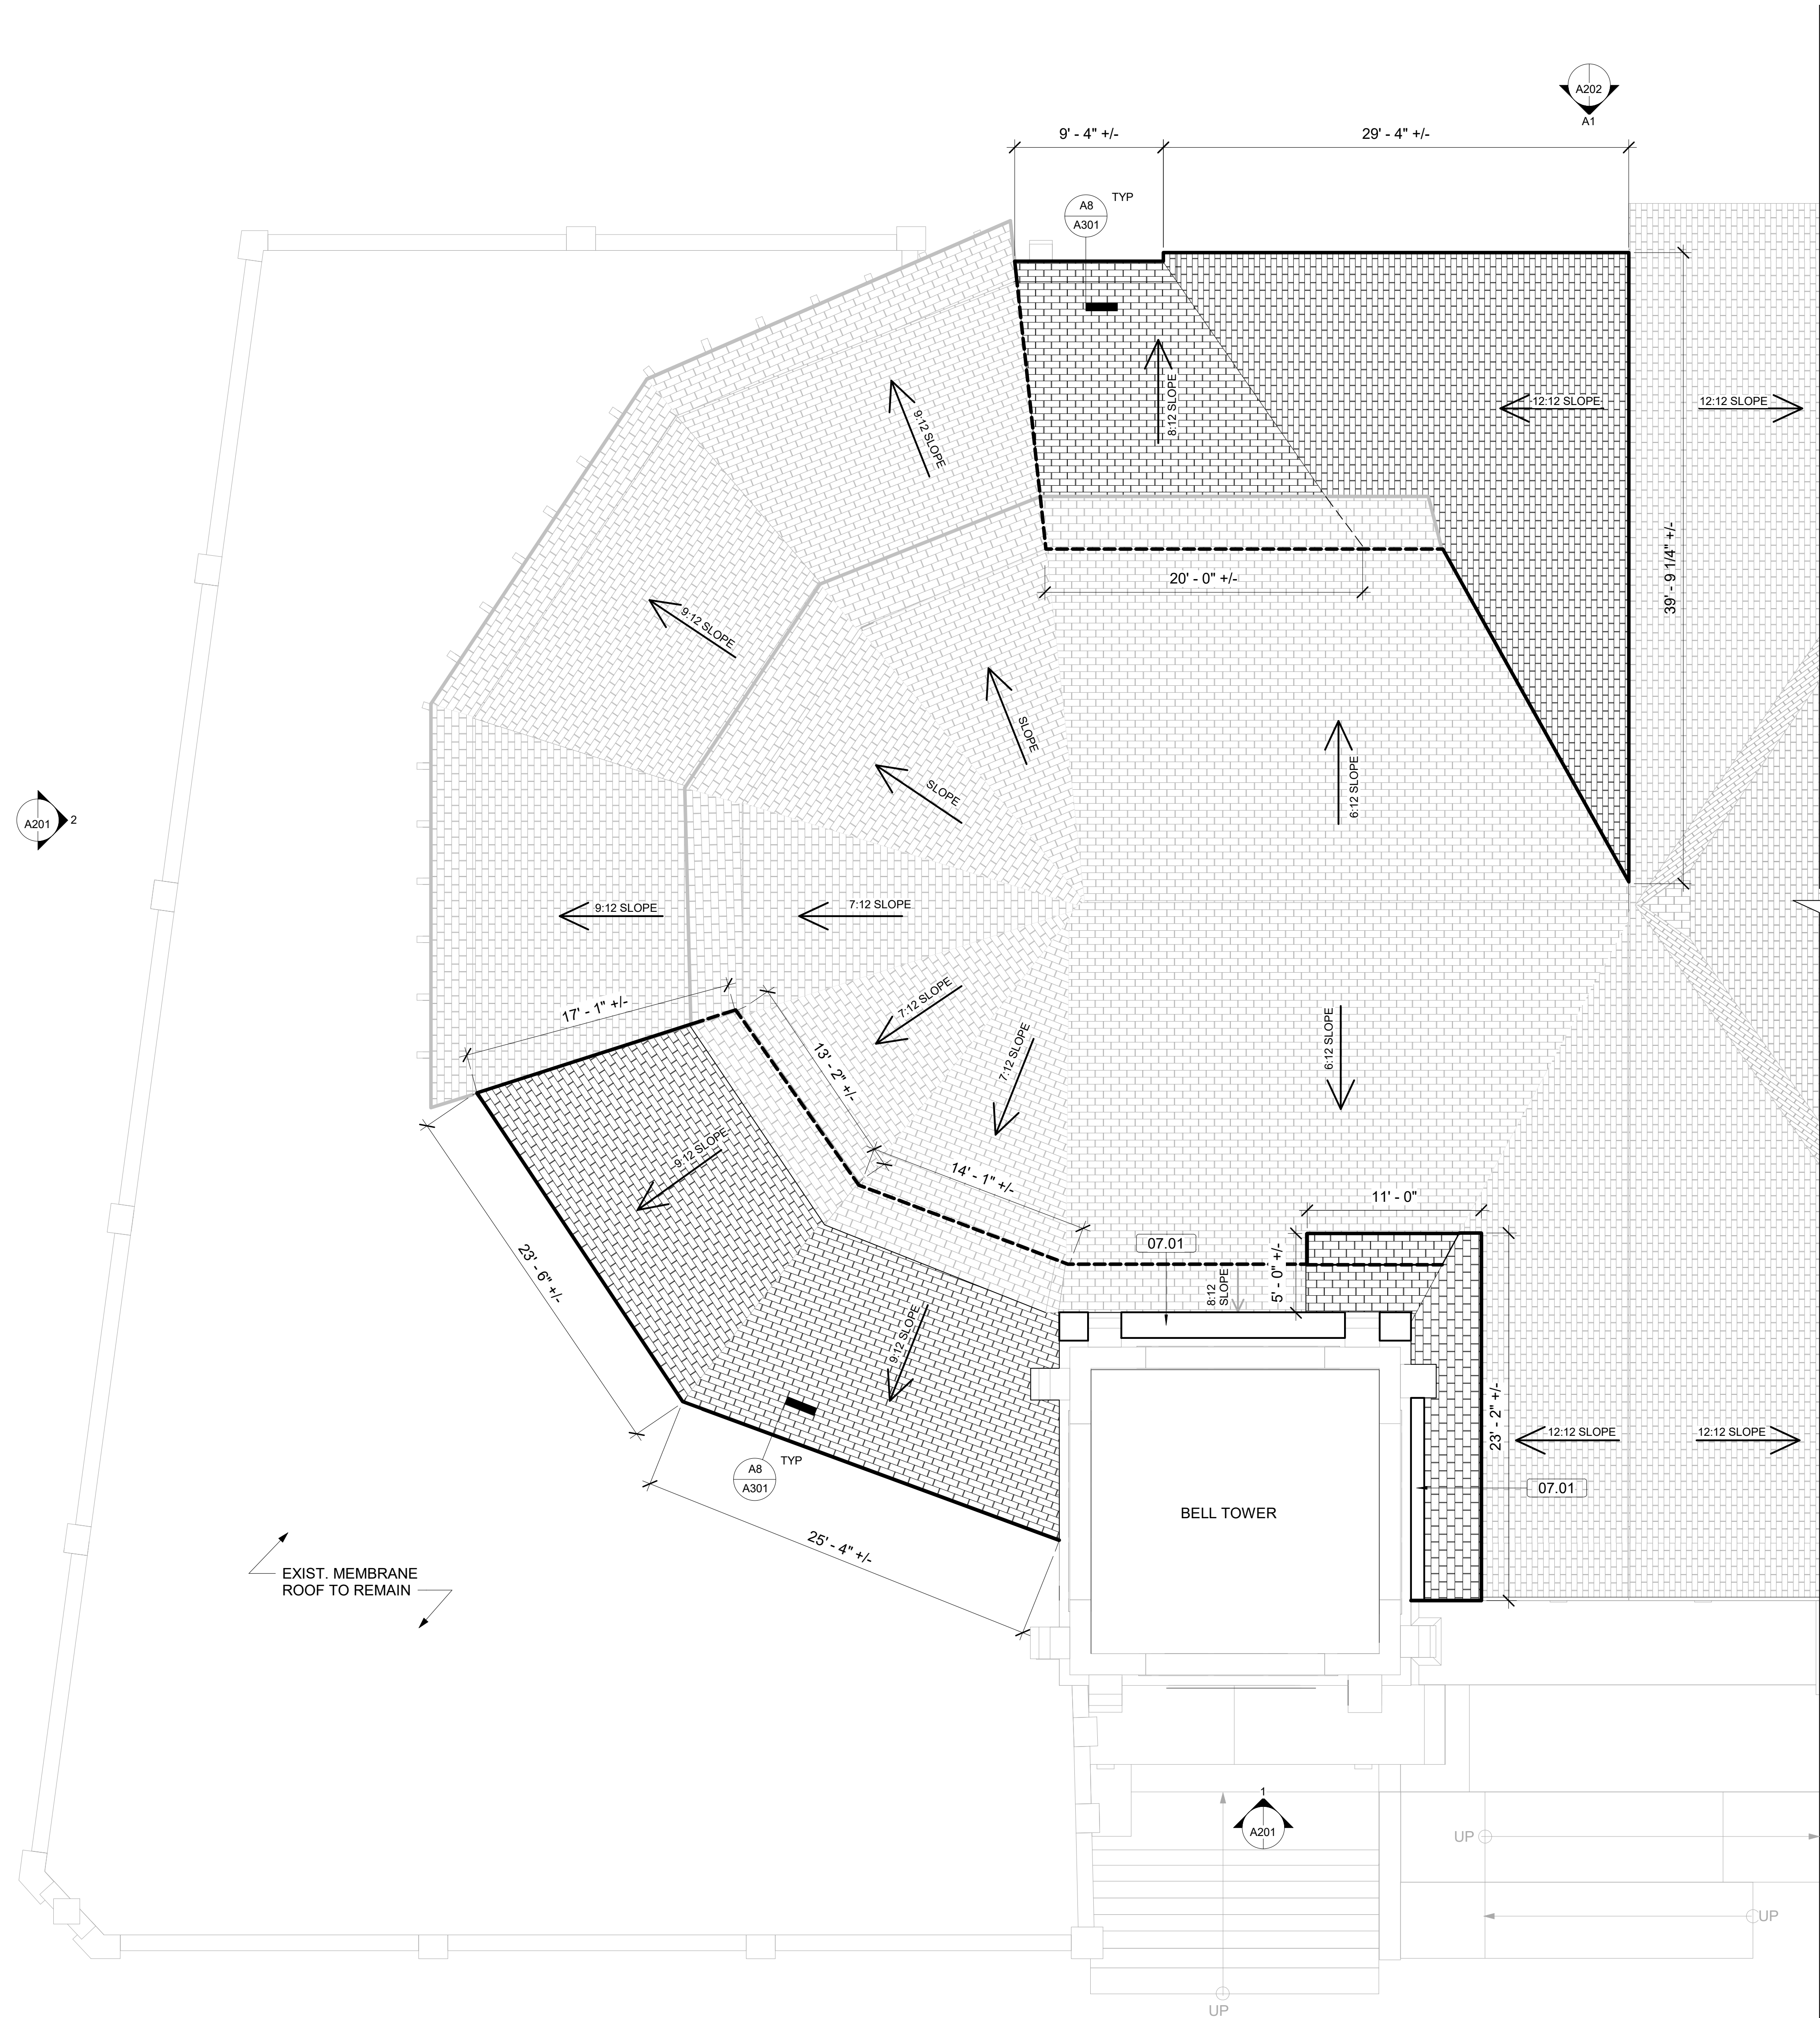
A1 HEPTAGON AND CENTRAL GABLE ROOF PLAN
 A110 3/16" = 1'-0" REFERRED FROM:
