STAFF REPORT 03-16-2022 SPECIAL MEETING

PREPARED BY: A. PHILLIPS

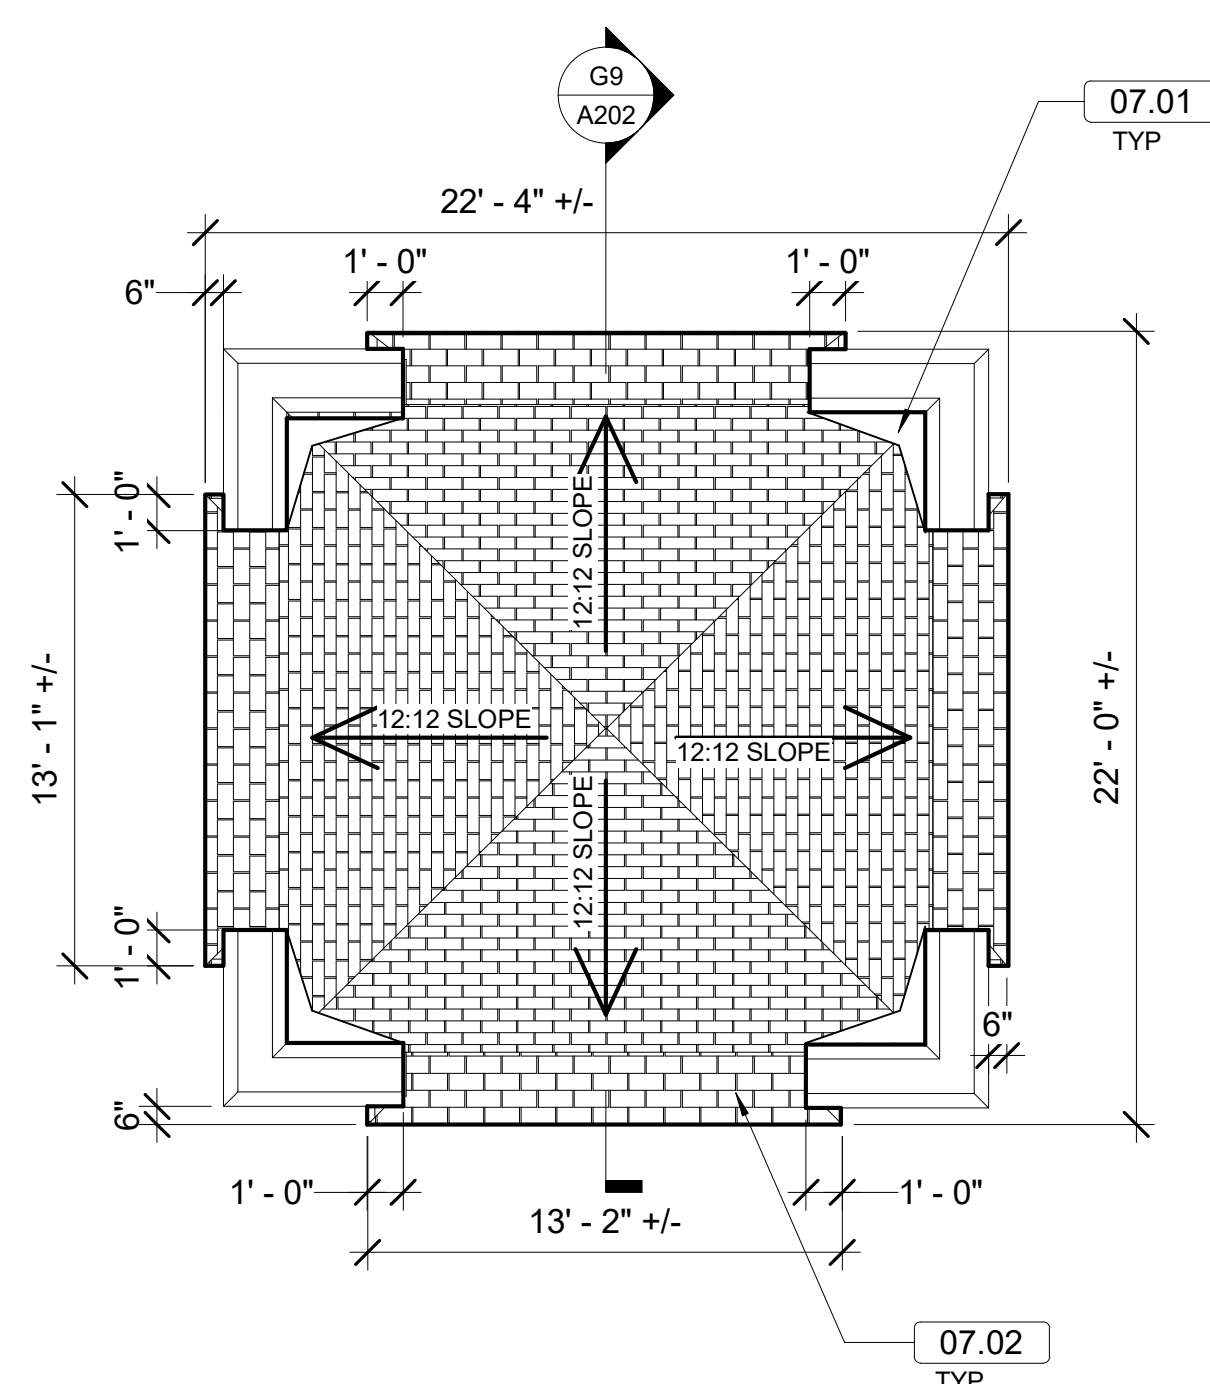
A10 BELL TOWER ROOF PLAN
 A110 3/16" = 1'-0"

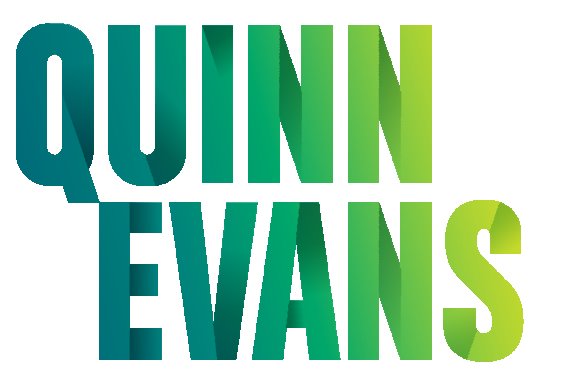
4219 WOODWARD AVE
 SUITE 301
 DETROIT, MI 48201
 v 313.462.2550
 QUINNEVANS.COM

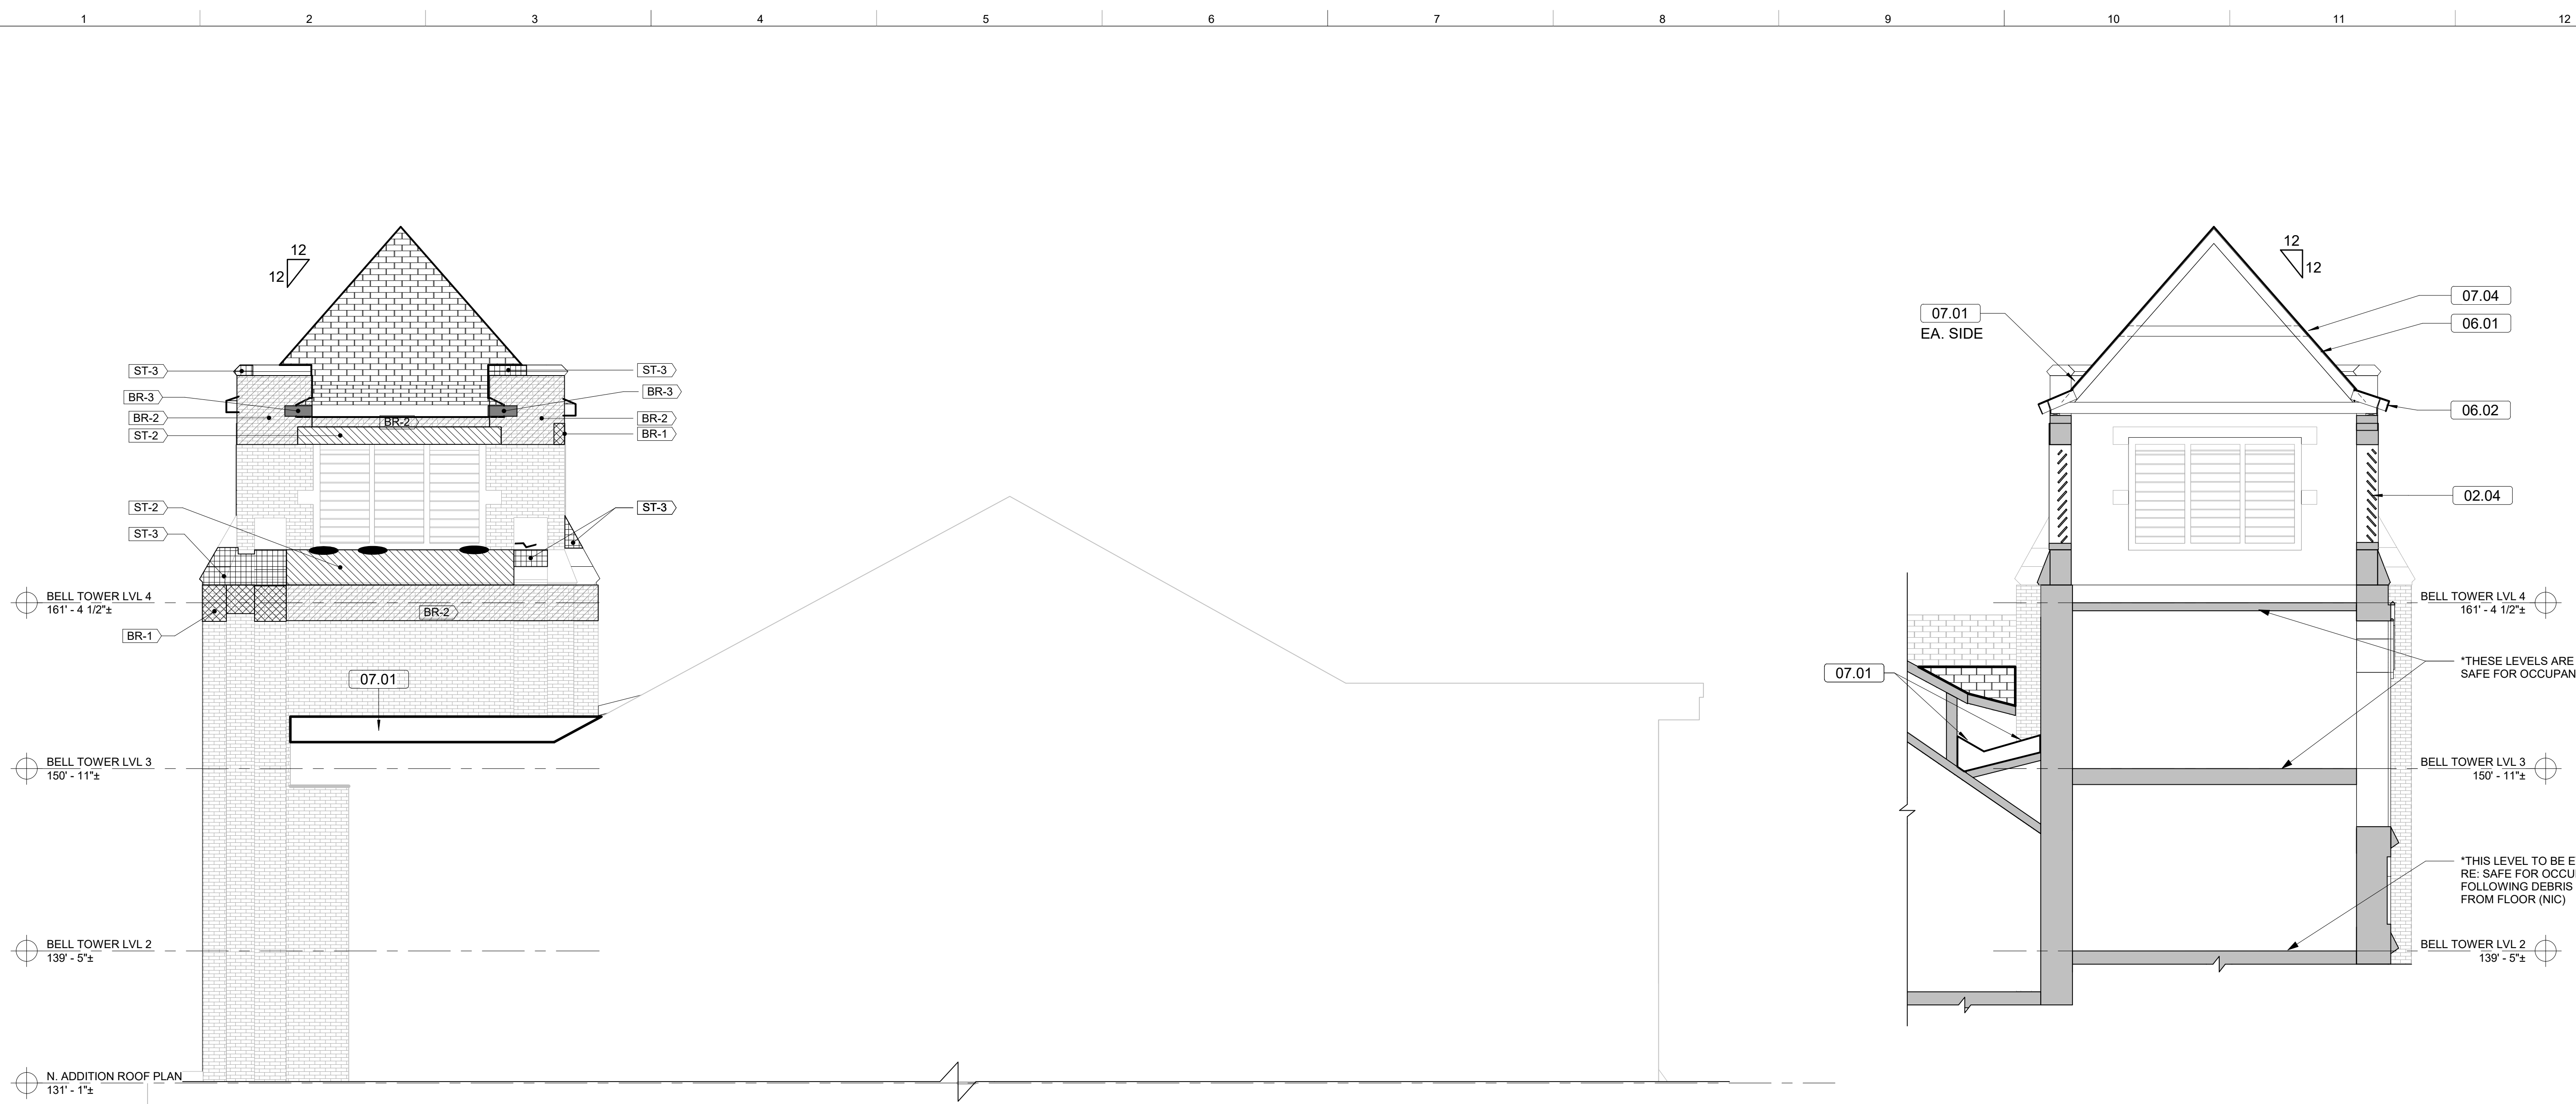
G1 NORTH ELEVATION
 A202 3/16" = 1'-0" REFERRED FROM A110

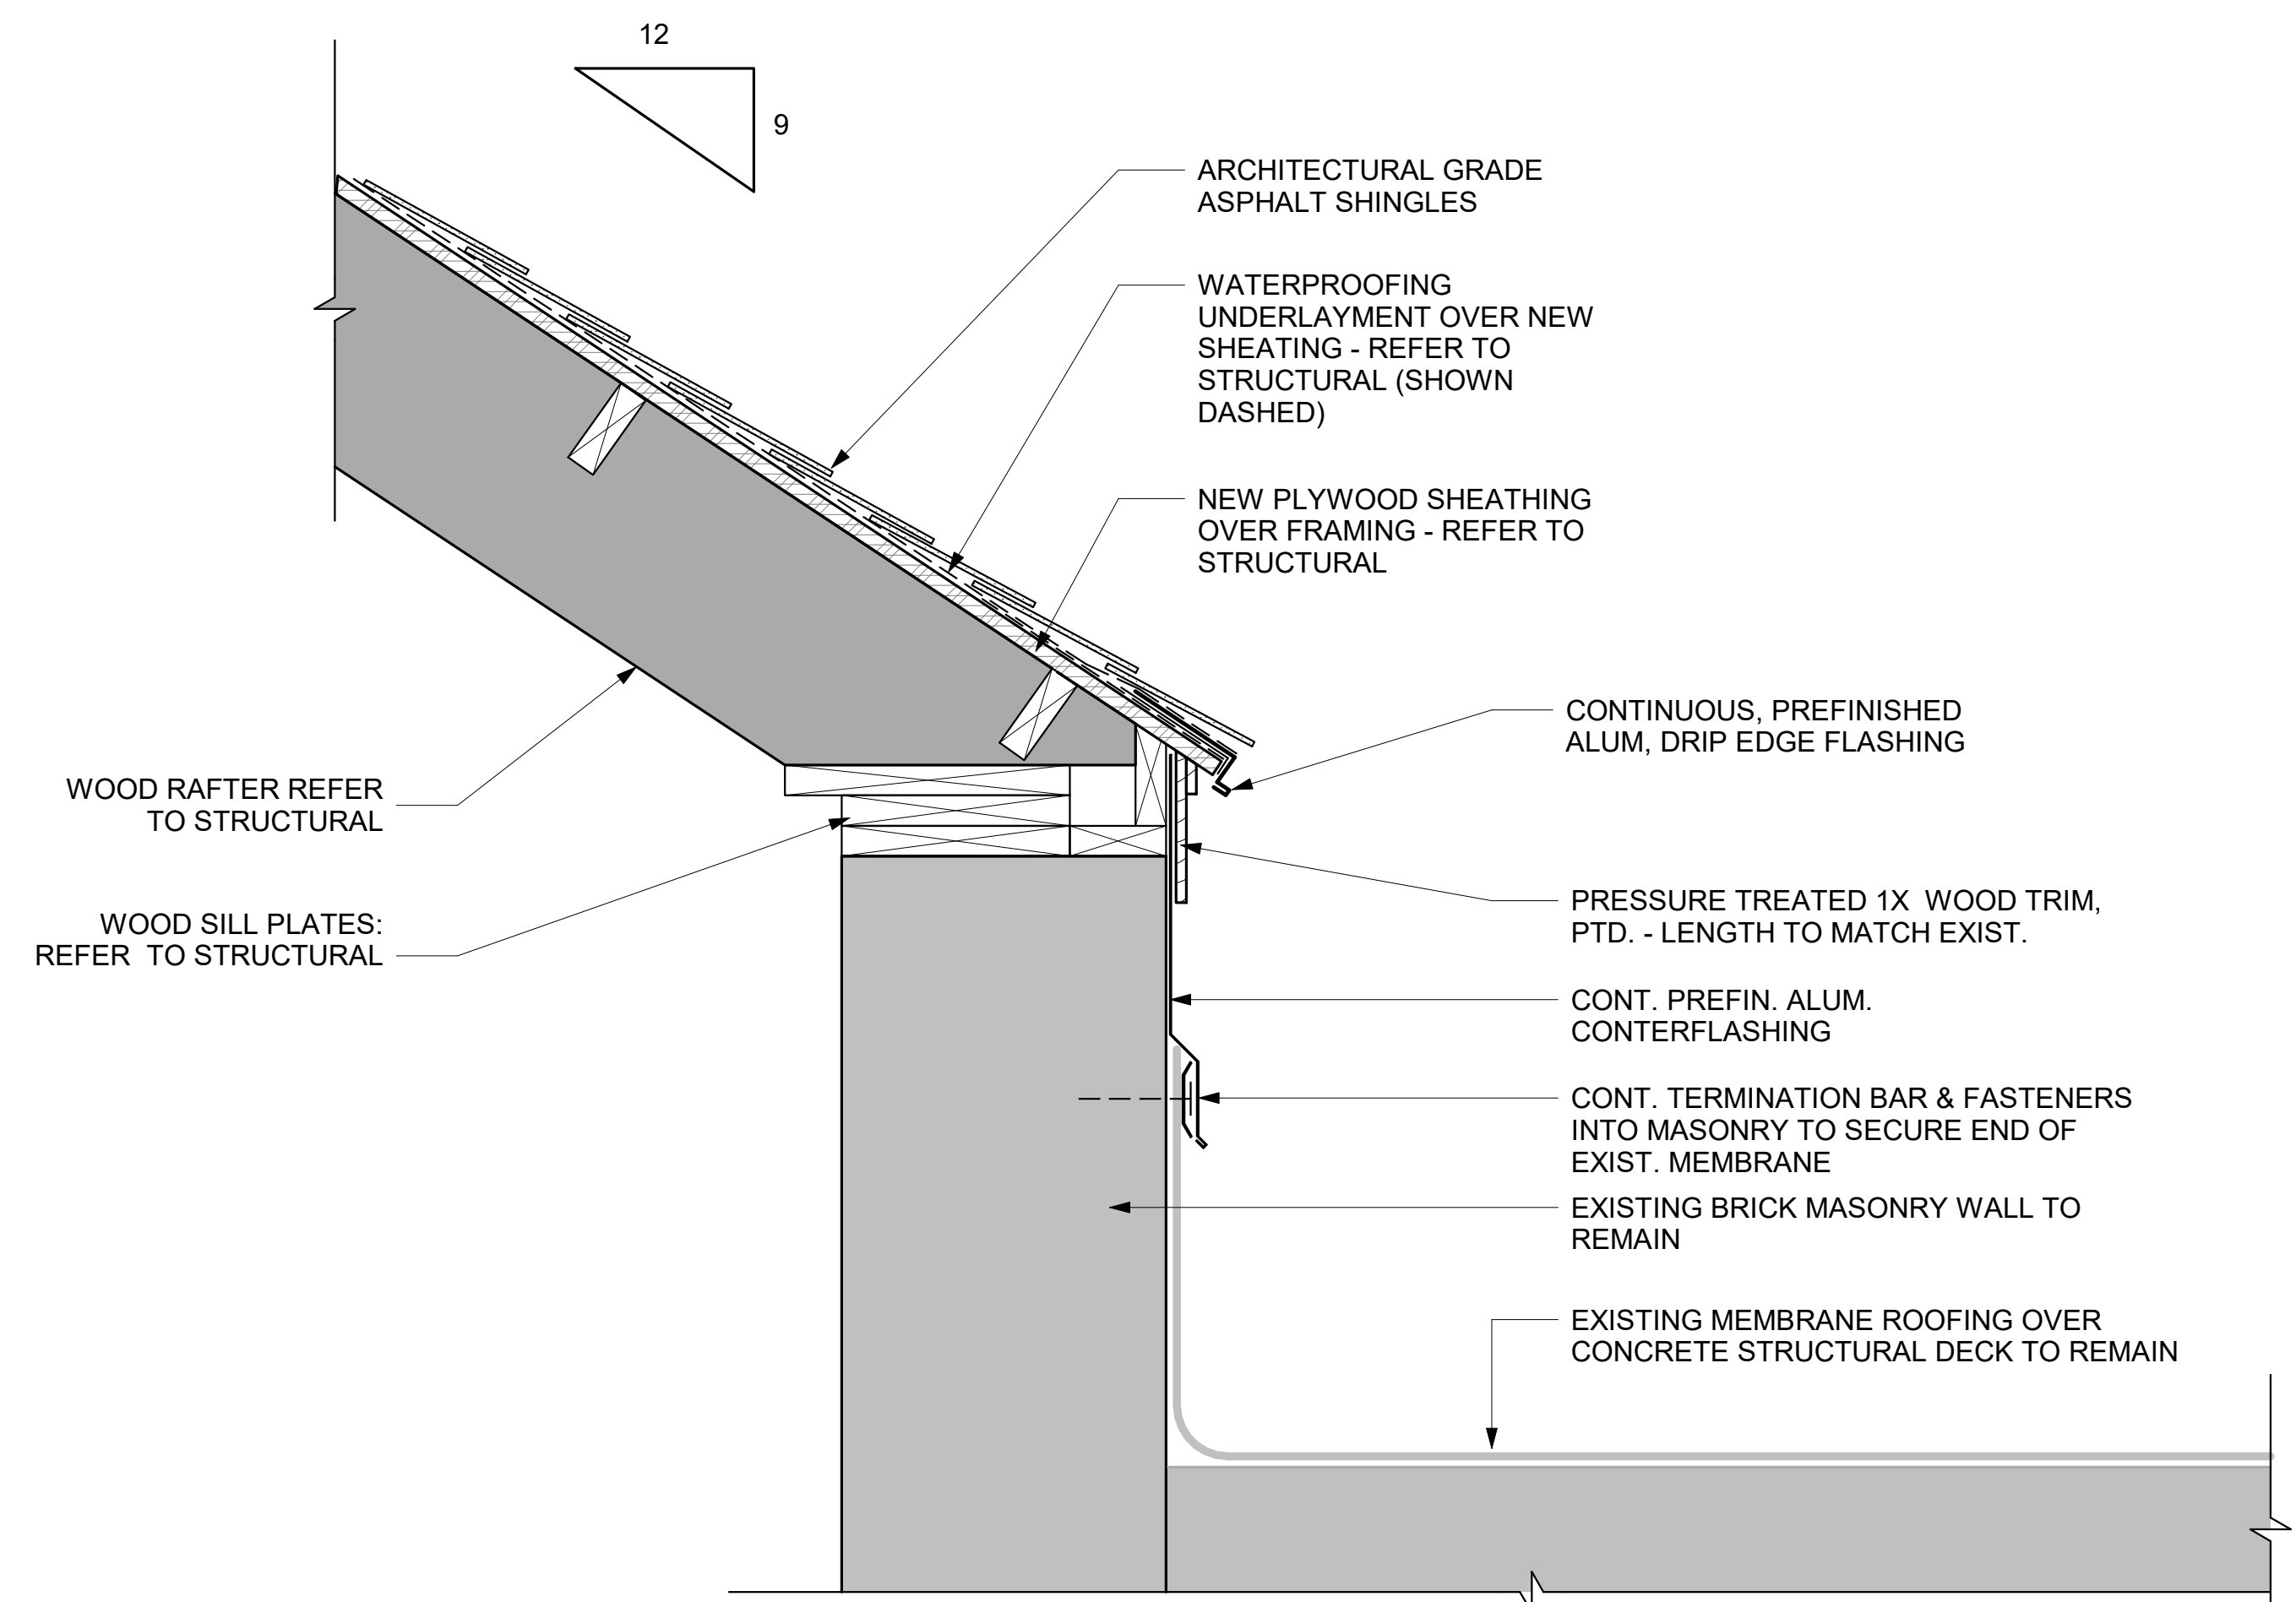
BIM 360://King Solomon Baptist Church Roof Replacement/42134130_King Solomon Church (pdf) (cloud).ht
 PLOTTING DATE & TIME: 1/24/2022 3:11:18 PM
