**STAFF REPORT: JULY 13, 2022 MEETING**

**APPLICATION NUMBER: 22-7906**

**ADDRESS: 1659 LONGFELLOW**

**HISTORIC DISTRICT: BOSTON EDISON**

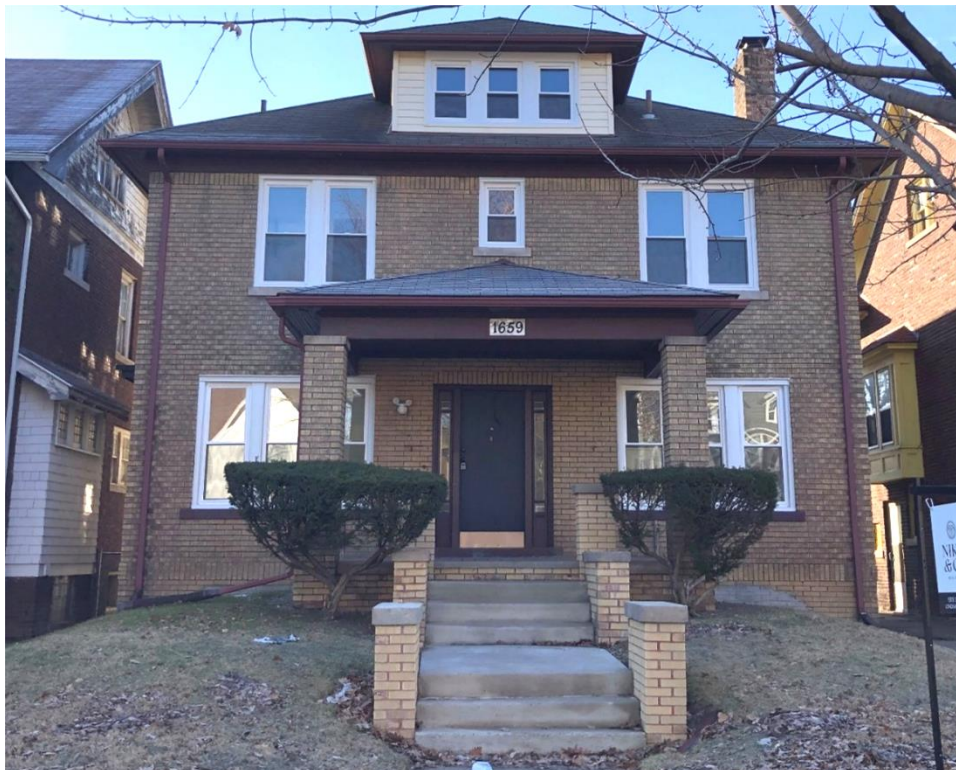
Constructed circa 1916, the house at 1659 Longfellow sits mid-block on the south side of the street. A stepped front walk, flanked by short brick piers at each set of steps, bisects the front yard and leads to a covered front porch, which is supported by full-height brick piers. The centrally placed front door is balanced by a large window opening at each side, while smaller mulled window openings and a small, centrally placed single window create a similar three-part pattern at the second floor. The raised porch, stepped-in second floor windows and the porch's hip roof, lead the eye upward to the centrally placed dormer and three-part window opening. The ribbons of windows, wide fascia, overhanging boxed eaves and unadorned yellowish-brown brick, create a vernacular Prairie style expression to the house. Due to narrow lots, there are only a few feet between the house and its eastern neighbor, but a shared driveway offers a few extra feet between the house and its neighbor to the west. The property features a hipped main roof with four, hipped-roof dormers. Cream-colored vinyl siding and white vinyl windows have been added to each of the four dormers.

*HDC staff photo, June 29, 2022*

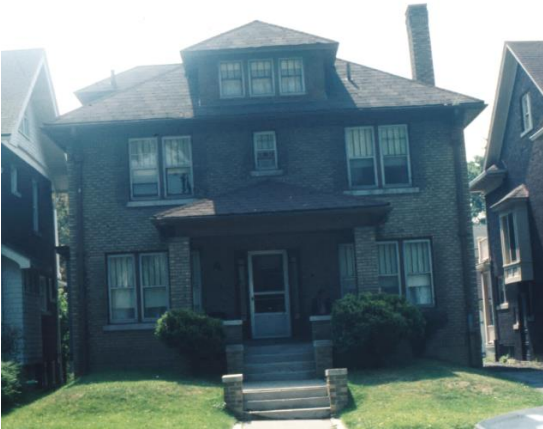
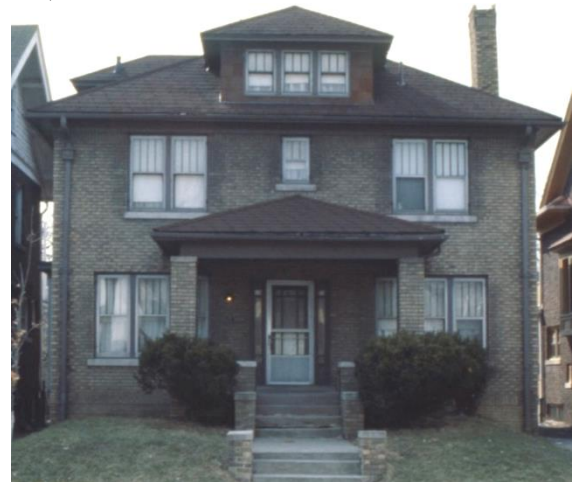
- The photos below confirm the original windows were wood, double-hung units with vertical-only muntin bars in the upper sash. The existing vinyl windows were installed between February 24, 2021 and May 21, 2021 (date of HDC violation letter).

*Above: 1974 district designation photo*

*Above right: 1980 photo*

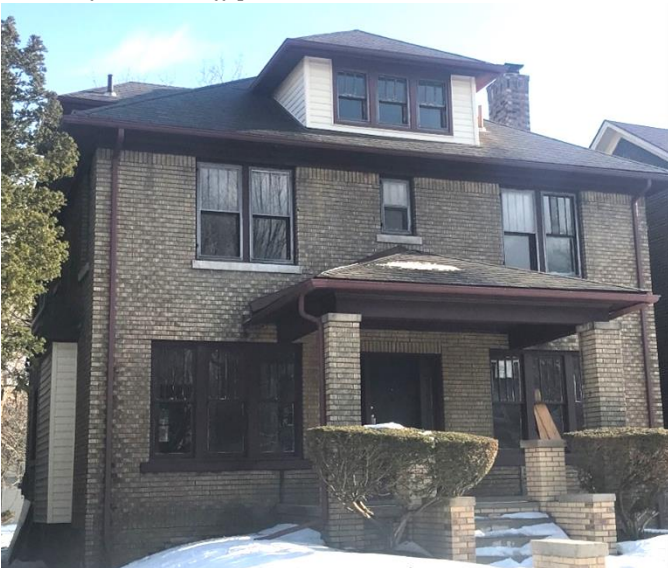
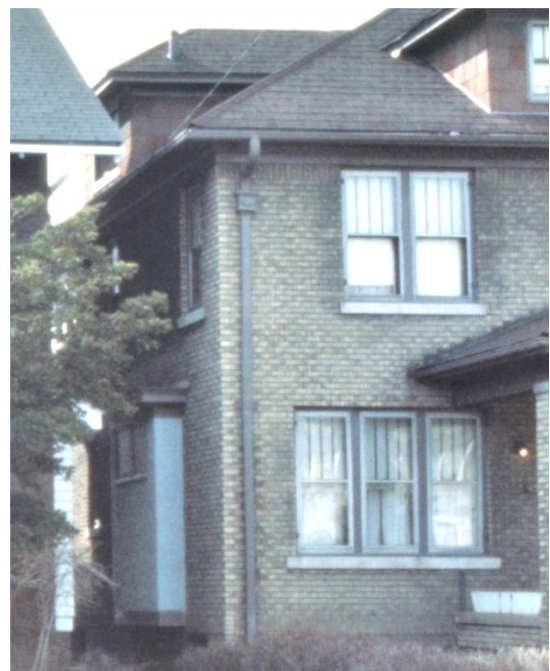
*Below right: 1980 photo of neighboring property shows the original stucco exterior and window openings on 1659's east elevation bump-out, as well as the reddish tile cladding the dormer walls.*

*Below left: HDC staff photo, Feb.24, 2021*

- The wood windows which were removed without approval in 2021 were distinctive, character-defining features of the house; the top sash-only vertical muntin pattern is a common feature of Prairie style houses.

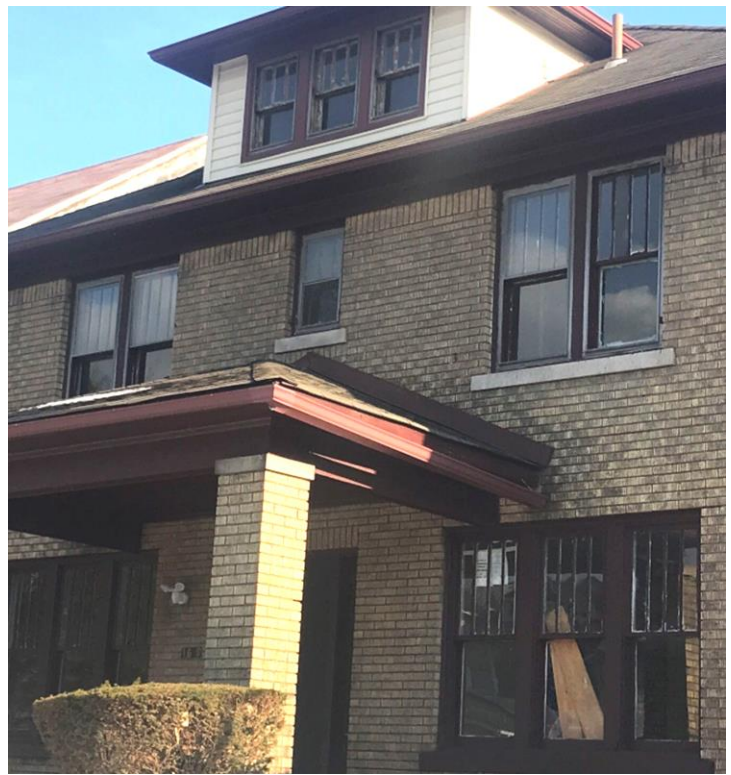
*Above: HDC staff photo, February 2021 Below : HDC staff photo, March 2022*

- As seen in the photo at right, each window on the front elevation was intact. The applicant’s original narrative stated that the windows could not be repaired. Due to the many parts of a historic wood window, repair is always an option (unlike replacement windows which are fabricated as one unit). While the wood windows showed evidence of deterioration, the deterioration didn’t look severe.

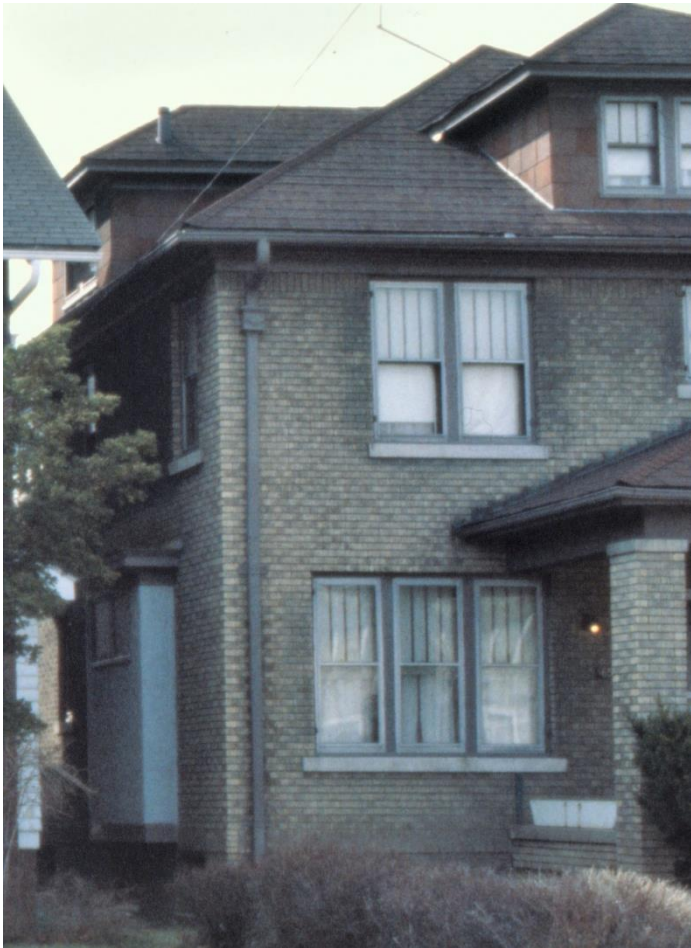
- The close-up of the below 1980 photo shows the original exterior wall cladding of brick, stucco, and tile created a cohesive design to the structure through material, pattern and color. The stucco on the side projecting bay creates a textural relief against the pattern of the brick and tiled dormer walls. Projecting bays on side walls near the front elevation are a common design feature in the Boston-Edison district. It is staff’s opinion this element is a distinctive character-defining feature of the house and district at-large. Commonly covered with stucco with two-to three small (usually decorative) windows, the installation of vinyl siding has significantly altered this feature of the

*1980 appearance of side bumpout*

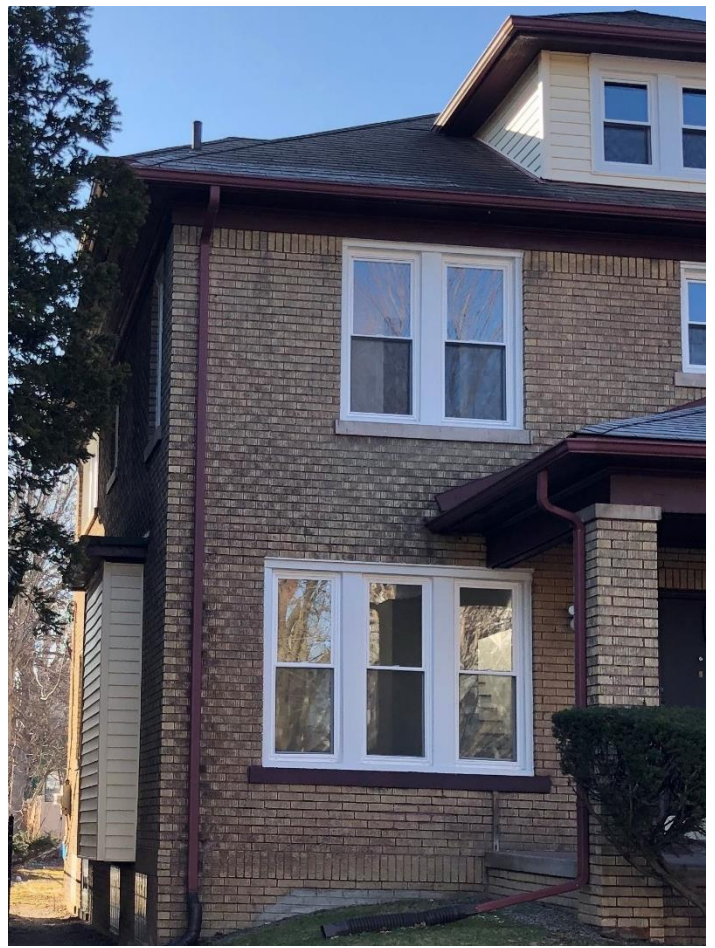
house. The removal of the windows at this location does not meet the SOI's Standards because it will result in an appearance that more closely resembles a stucco box rather than an integrated design feature/a true bay. Therefore, the windows should be restored. However, staff does support the removal of the siding at this location and the restoration of the stucco which remains beneath.

*Current appearance of side bumpout*

- New wood windows at the east elevation bump out bay shall be installed to replicate the windows that were removed without approval

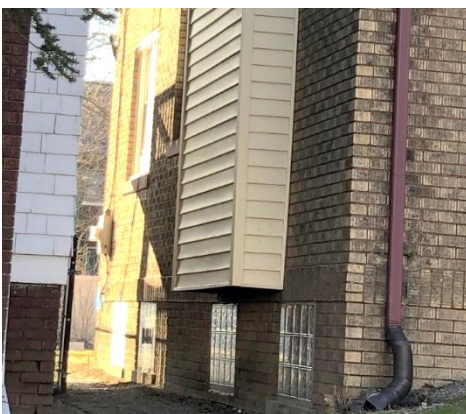
*Current appearance of side bumpout*

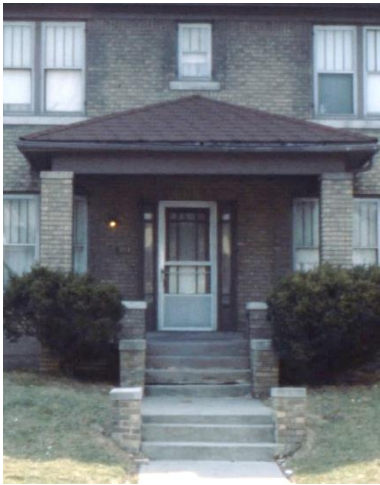
*Front porch steps/piers, 1980*

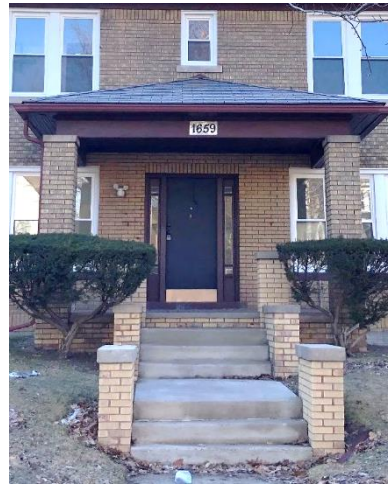
- The brick piers at the front yard (leading to the porch) were rebuilt sometime before August 2013 (based on Google street view, see below photos). The location of the piers, stepped relationship between the sets of piers. And the use of a buff brick were duplicated, however the height of the first set of piers was raised for an unknown reason. However, it is staff's opinion that the new, higher piers present an appearance which is generally in keeping with the home's/porch's historic appearance.

*Front porch steps/piers, current appearance*

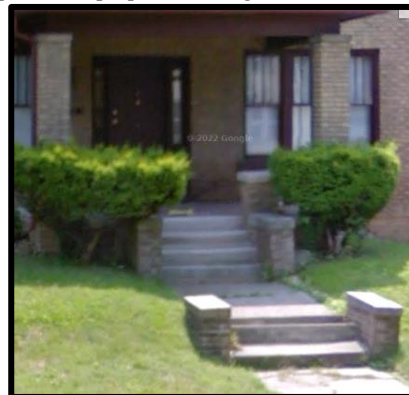
*Front porch steps/piers, Google Streetview, 2013*
