STAFF REPORT 07-13-22 MEETING

APPLICATION NUMBER: 22-7909

ADDRESS: 1901 CHICAGO

SCOPE: REPLACE WINDOWS

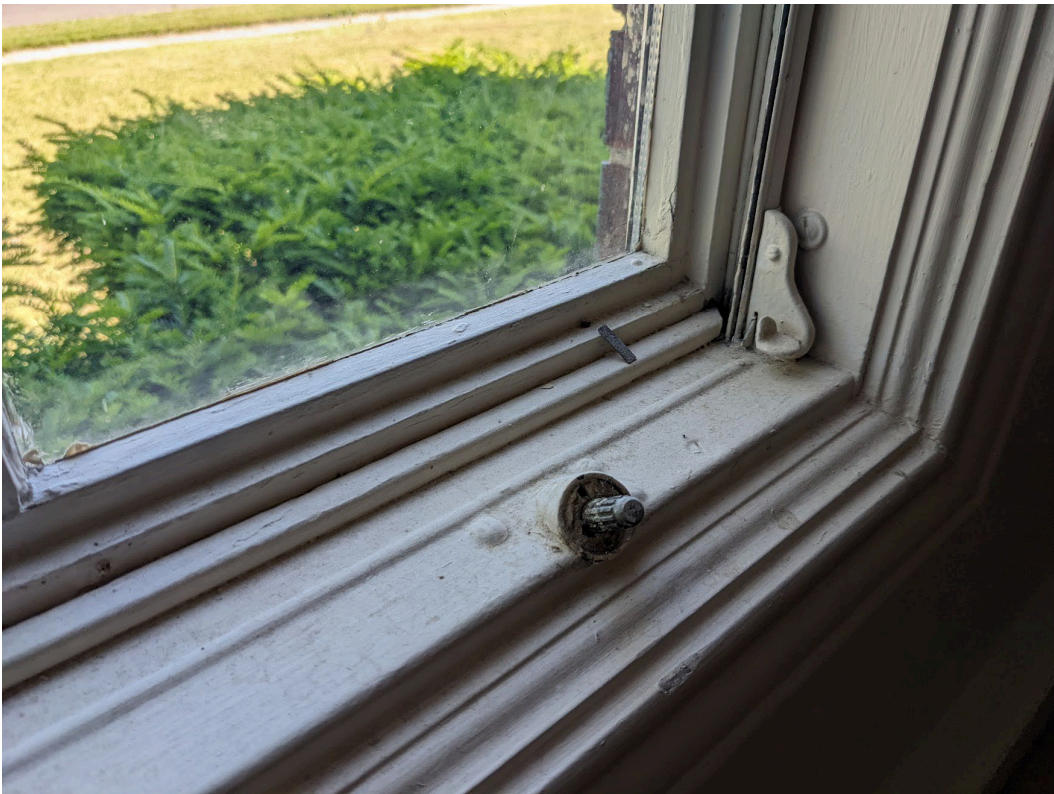
Interior detail view of typical sill conditions. Note missing operator, worn spline, and insulated glazing. Staff photo, July 12, 2022

- The Boston-Edison Historic District was established in 1973
- The house features Pella wood casement windows with what appears to be bronze or other non-ferrous metal hardware. The windows are glazed with thin double-glazed panes. A majority of the windows are missing the operators (turn cranks). At least one windows is missing the entire operator unit at the sill. Most sash locks are intact. At the exterior, ornamental hinges, typically three (3) to a side, are present. One original casement at the south (rear yard) dining room bay window is missing (1 of 6 at that location). In its place is an amateurish reproduction created out of plexiglass and low quality wood that has fallen to pieces. At another, second, location, a vinyl unit has been installed to accommodate a window A/C unit.

- The windows are of historic age (now more than 70 years old), in generally fair to good condition (with missing hardware) and apparently original to the property. Staff observed only limited and repairable deterioration of wood elements. In staff’s opinion the windows are distinctive character-defining features on an uncommon mid-century historic property, and at a highly visible corner location. As a mid-century home, the building is somewhat less ornamented than pre-war colonial precedents. For this reason the original windows have a strong role to play in establishing and perpetuating the property’s historic character.

- Because Standard 6 of the Secretary of the Interior’s Standards for Rehabilitation requires the repair of distinctive character-defining features, when technically feasible, it is staff’s opinion that the windows should not be replaced. Staff assesses that repair is possible, though not necessarily as simple as mere replacement. Staff stipulates that typical window contractors, and current Pella factory representatives, may not be familiar with and do not undertake or supply parts for such repairs; however, vintage operators and mechanisms for Pella casement windows appear to be available from several sources online and it is not unreasonable to expect that a competent craftsman or mechanic could make the installations. While exact matching bronze handles may not be found, the splines and mechanisms will accept alternate models that will allow these historic windows to survive additional decades into the future.

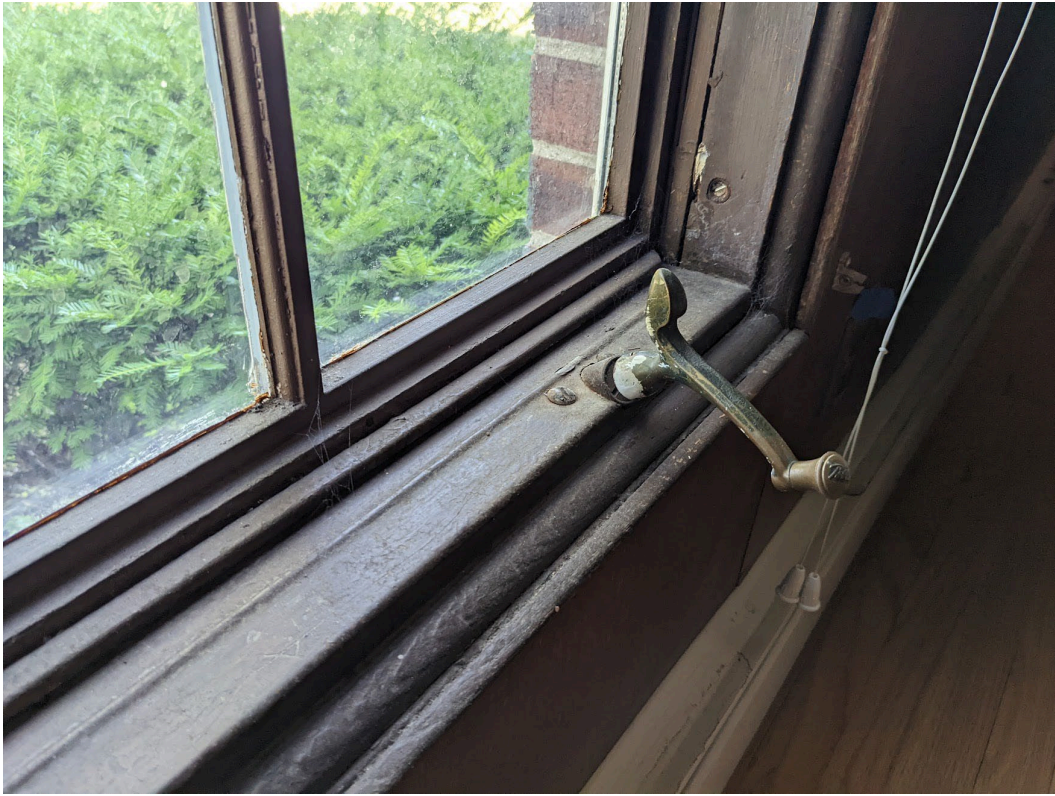
View of window with operator crank intact. Staff photo, July 12, 2022

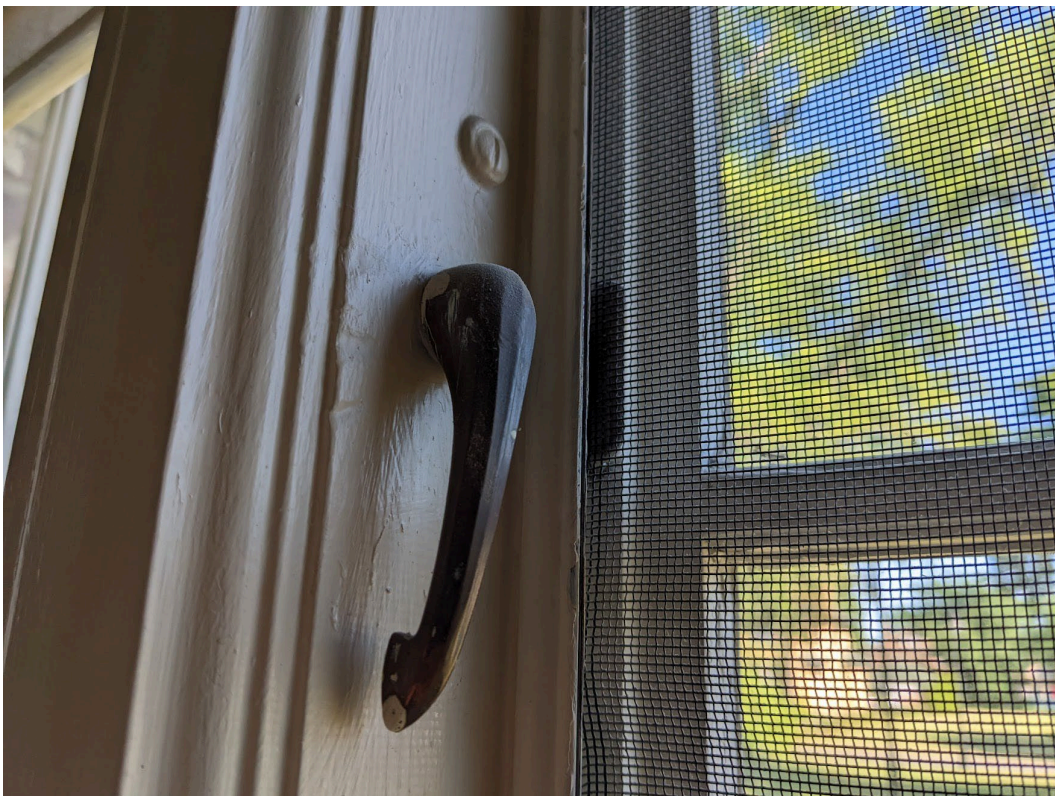
Typical view of ornamental closer at mullion, one of two per sash. Staff photo, July 12, 2022
