**STAFF REPORT:** 9/14/2022 MEETING

**APPLICATION NUMBER:** #22-8009

**ADDRESS:** 269 WATSON

**SCOPE:** REPLACE EXTERIOR WALL AND DOORS (WORK STARTED WITHOUT APPROVAL),  
INSTALL REAR DECKS, ENCLOSED BASEMENT STAIRWELL AND BALCONY

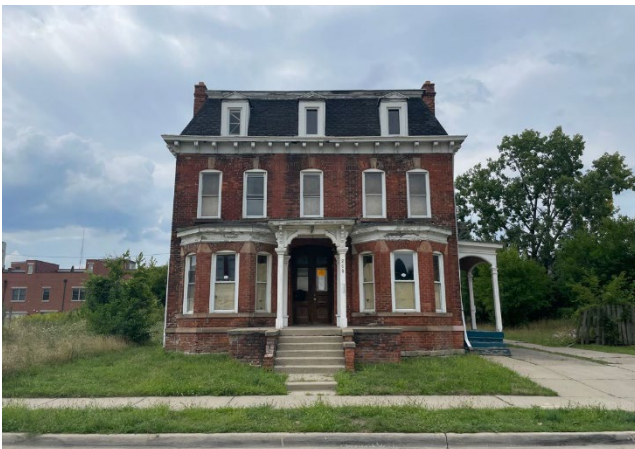
Site Photo 1, by Staff August 25, 2022: (Southeast) front elevation.

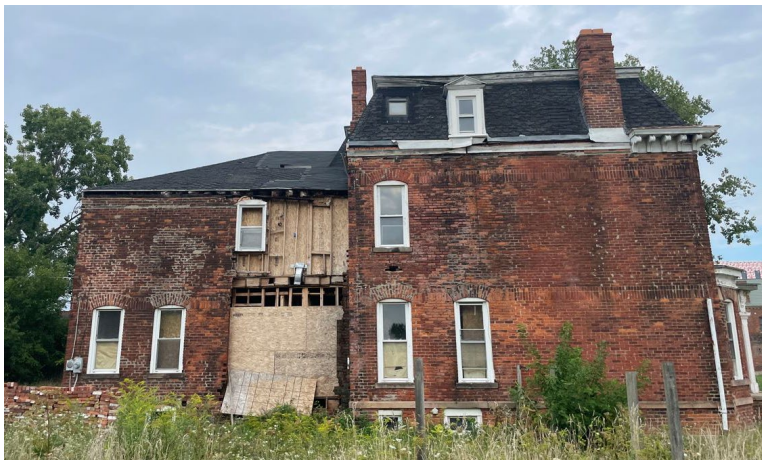
Site photo 2, by staff, August 25, 2022: (Northwest) side elevation showing brick wall, window and door removal locations.

- Staff observes that the arching and soldier/header brick patterns, the blind arched window openings and the stone sills for the windows of the original west wall are distinctive character-defining features of the building. Staff has not yet received details on how the west wall will be reconstructed to address these features where at least one window and a door have been removed.

- The rear and east elevation doors were replaced, and the west wall removal work was done without HDC approval.
- Staff has not yet received details on how the west wall repair will be reconstructed.

- The applicant provides a sketch and detail on the reconstruction of the west wall that demonstrates how it will replicate the existing brick pattern of the wall and provide a sample/photo of proposed matching brick to blend in with the existing brick, should the original bricks not be enough.
- The applicant changes the vinyl siding to wood lap siding or cementitious board siding with a dimension, color and smooth surface to match the design of the house.
- The doors be painted a color that matches Color System C color scheme of the HDC color guide.
- Deck and balcony stain or paint provided for review and approval.
- Staff receives a final plan showing product and detail description of the above work.
- The applicant provides HDC staff a review of the above items before installation.

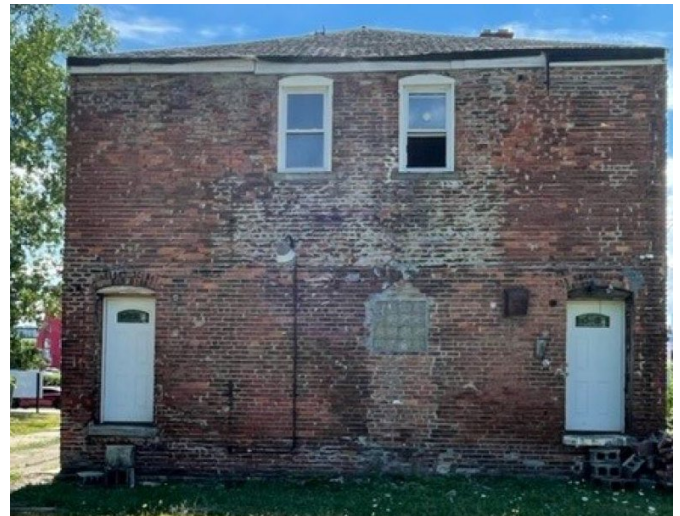
Site photo 3, by Applicant, (Northeast) rear elevation, showing location for proposed balconies, doors and decks.

- Staff observed from the Sanborn map that the rear elevation once supported a rear deck and/or balcony that has since been removed. Staff reviewed Google Street and saw images from Brush street that confirms this rear elevation has had no rear structures since at least 2008.

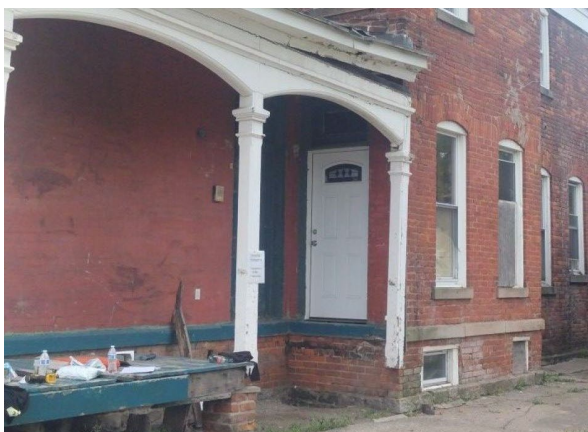
Site photo 4, by applicant: (East) side elevation showing new replaced door and portion of wood porch removed (work done without approval).

- The Brush Park Historic District was established in 1980.
- Staff noticed that the east porch has been partially removed. This work is not part of this application and the applicant has not yet responded with a status update on this work.

- Staff observed the replaced doors on the east and rear elevations is work that was completed without approval.
- Staff observed that the rear elevation has had what may be a former doorway removed and sealed with glass block and brick. Staff has not received an explanation of this work. Staff observed that the proposed work in this application will largely obscure the visibility this area.

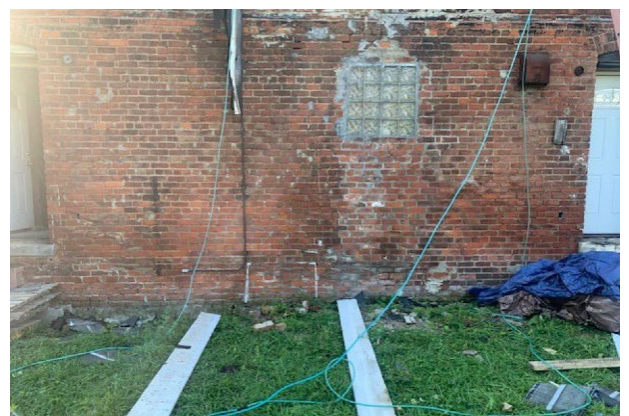
Site photo 5, by Applicant, (Northeast) rear elevation, showing proposed location for stairwell (two boards) and basement door (white outline).

- Staff offers the opinion that because the rear elevation is not a primary or secondary elevation, and the removal of some brick material to access the basement is very minimal (approximately 2'x3' area) off the ground plane, the introduction of a new basement door for egress is appropriate.

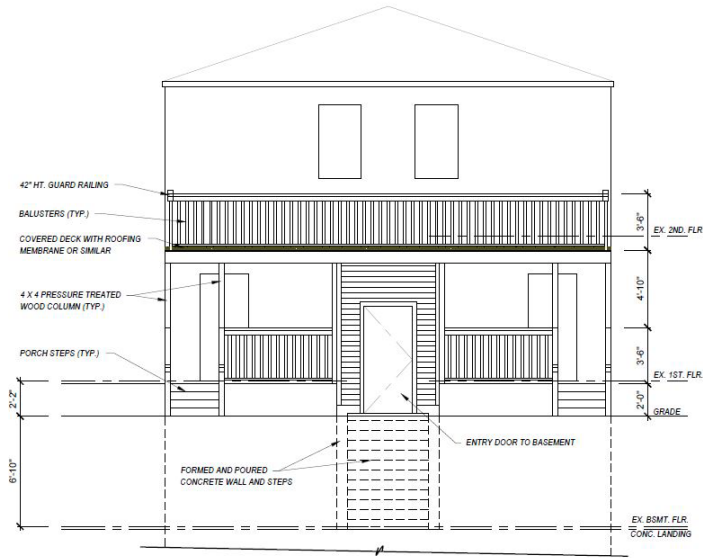
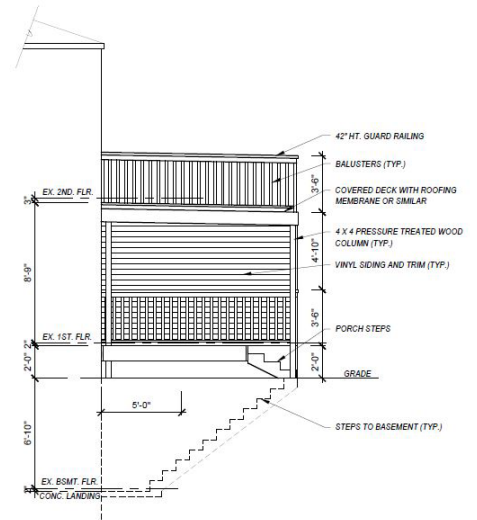
*Elevations 1&2, by applicant: (North) rear of building showing proposed stairwell, decks, and balcony*

- Staff observed that the siding for the enclosed stairwell is vinyl and has asked the applicant if they would consider an alternative material. It is staff's opinion that the proposed vinyl siding is not an appropriate material consistent with the design and material of the house, as shown in the drawings. Staff requested confirmation on the use of this (or alternative material) with a product description sheets and a proposed color. At the time of this report, staff has not received a response.

- Other than the vinyl siding and lack of stain or paint for the decks/balcony, staff offers the opinion that the design, scale and materiality of the decks, basement stair enclosure and the balcony are appropriate.

- Staff recommends that the proposed rear basement access, rear decks and balcony are an appropriate design that does not conflict with the design of the house and is appropriate for the district. However, staff does recommend that the siding be of wood or cementitious board in a color and dimension that closely matches the house, with a smooth surface, and a color paint be selected per the HDC color guidelines.
