STAFF REPORT: JULY 14, 2021 MEETING

APPLICATION NUMBER: 21-7360

ADDRESS: 1321 LABROSSE

SCOPE: WINDOWS REPLACED WITHOUT APPROVAL

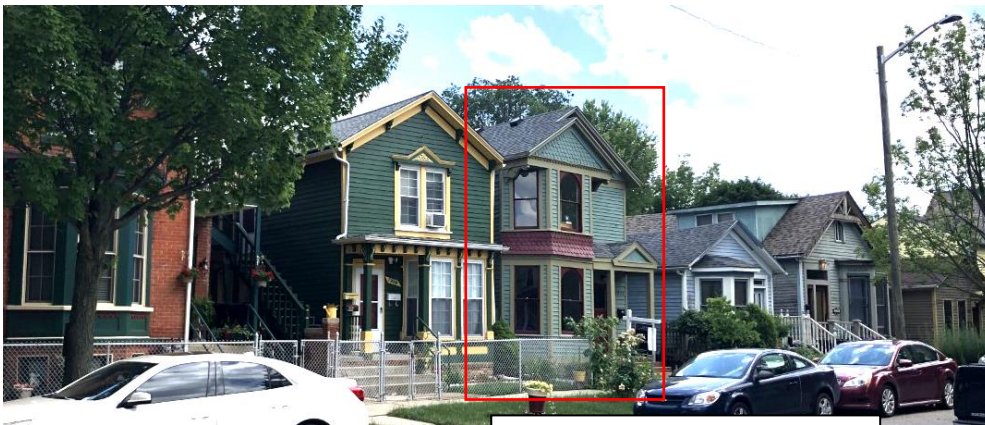
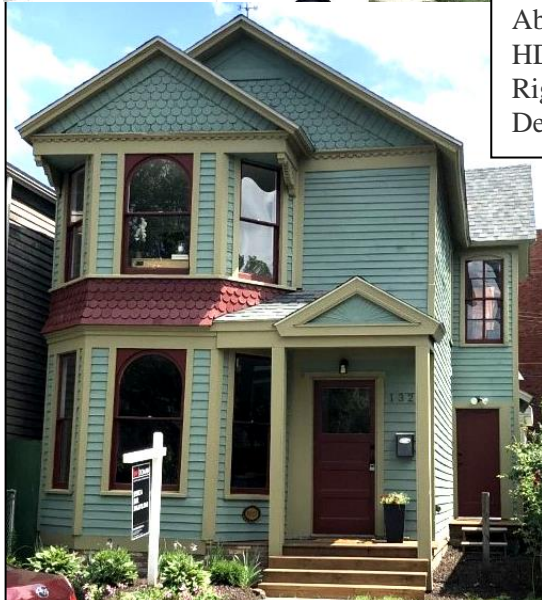
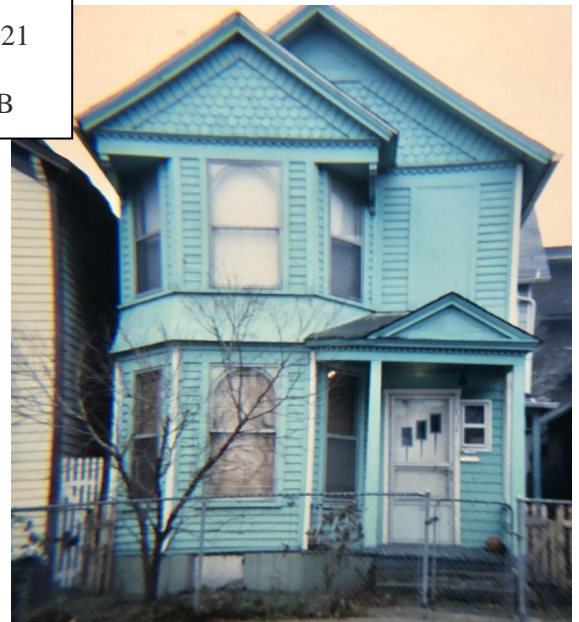
The two-story house at 1321 Labrosse sits mid-block on the south side of the street amongst an intact streetscape filled with a mixture of two-story and single-story historic residential structures. Constructed in 1900, the house fills the width of the lot and is within feet of the neighboring houses. Victorian in styling, the steeply pitched front-gabled roof is reinforced by a small projected front-gable roof that covers a two-story bay. Clapboard siding is the dominant cladding material. The triangular portions of the gable walls are covered with fishscale siding; this siding is also used on the flared wall separating the two bay windows. The windows on the house are mostly wood, double-hung, one-over-one sash. The central bay windows have arched tops that echo the fishscale siding pattern.

Above and left:
HDC Photos, June 28, 2021
Right:
Designation photo, HDAB

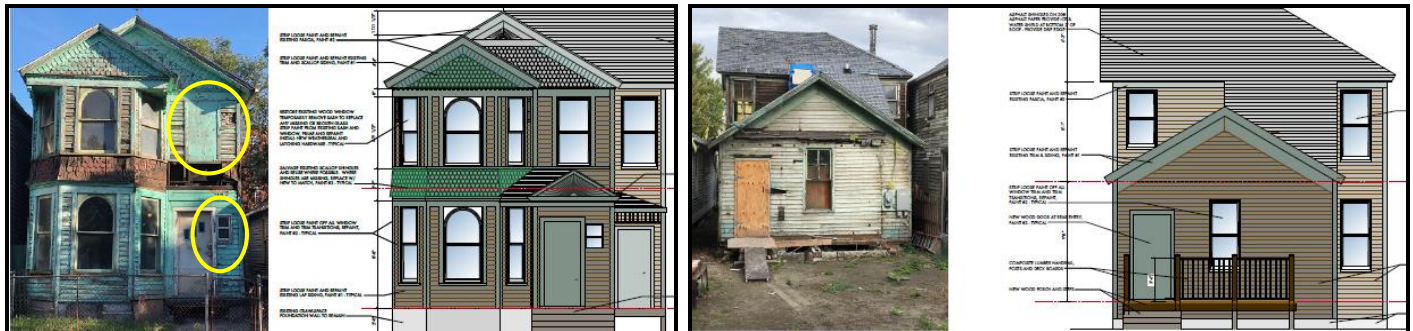
- The Corktown Historic District was established in 1984.
- In 2019, HDC staff issued a Certificate of Appropriateness for the rehabilitation of the house, which included the repair of the existing wood windows as well as exterior painting. (#19-6555)
 - As shown on the applicant’s renderings below, the boarded up window opening on the front elevation was to be re-opened and the small window opening adjacent the front door was to be retained. On the rear elevation, double-hung windows were to be retained in the window openings.

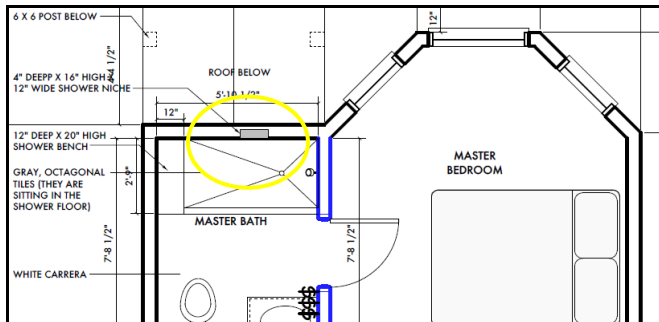
Applicant’s 2021 Floor Plan – “Scheme G”

- The second story floor plan (“Scheme G” – included with the applicant’s submission materials) shows the front elevation second story window gone, in contrast with the floor plan submitted as part of the 2019 rehabilitation application.

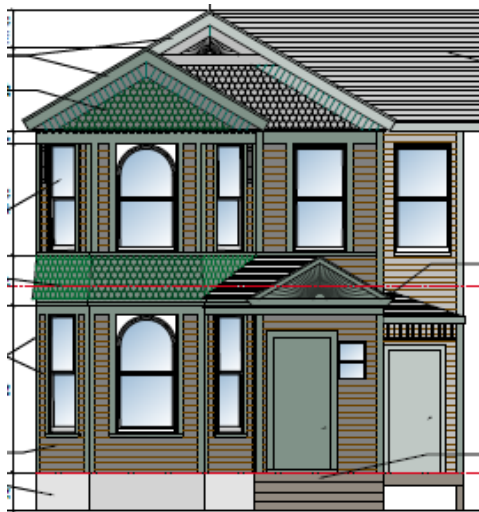
Applicant Rendering

- The façade of this house offers a multitude of patterns and angles, in line with the Queen Anne architectural style. The window opening above the front porch (as shown in the below-left rendering) completed the horizontal line (or rhythm) of windows at the second story, as well as creating a vertical balance with the first story openings. The removal of this window opening created a flat void within this highly detailed façade.

It is staff's opinion the removal of the four wood windows and installation of vinyl windows and glass block, as well as the removal of the two front elevation window openings, has altered the features and spaces that characterize the property. Staff therefore recommends the Commission deny a Certificate of Appropriateness for the work as proposed because it does not meet the Secretary of the Interior Standards for Rehabilitation and the Elements of Design for the district, especially Standards:

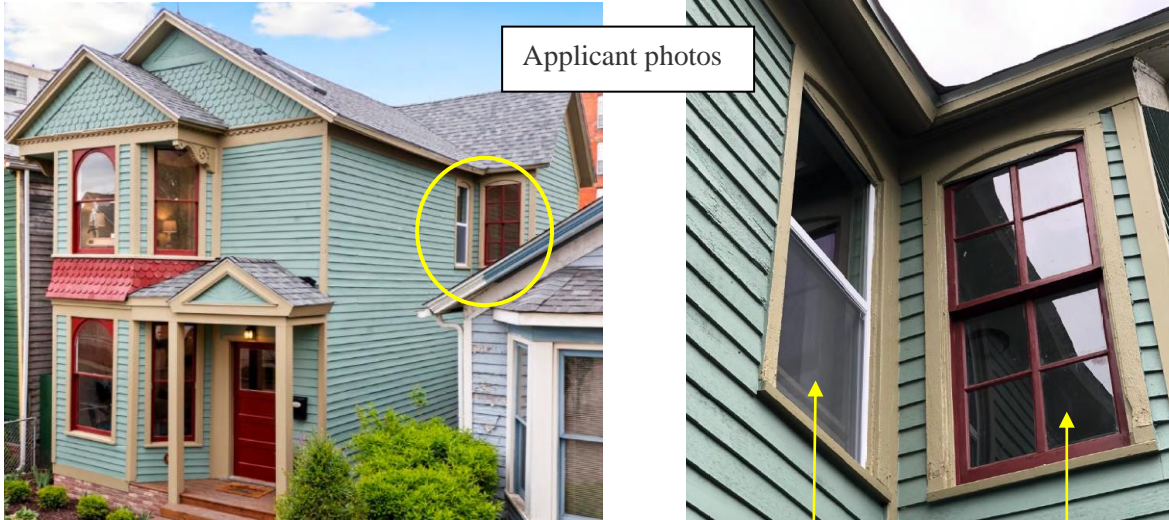
Front and west side elevation

- The applicant states the existing sash within the second story openings (side and rear elevations) were missing components and therefore used to repair other windows/sash on the house. While staff agrees this can be a common practice in window repair, which then requires entirely new sash to be installed in those openings, it is not clear why wood sash replacement windows were not selected.

Side Elevation - The white vinyl window immediately adjacent a historic window creates a jarring visual juxtaposition for the two window openings.

Replacement Window Historic window

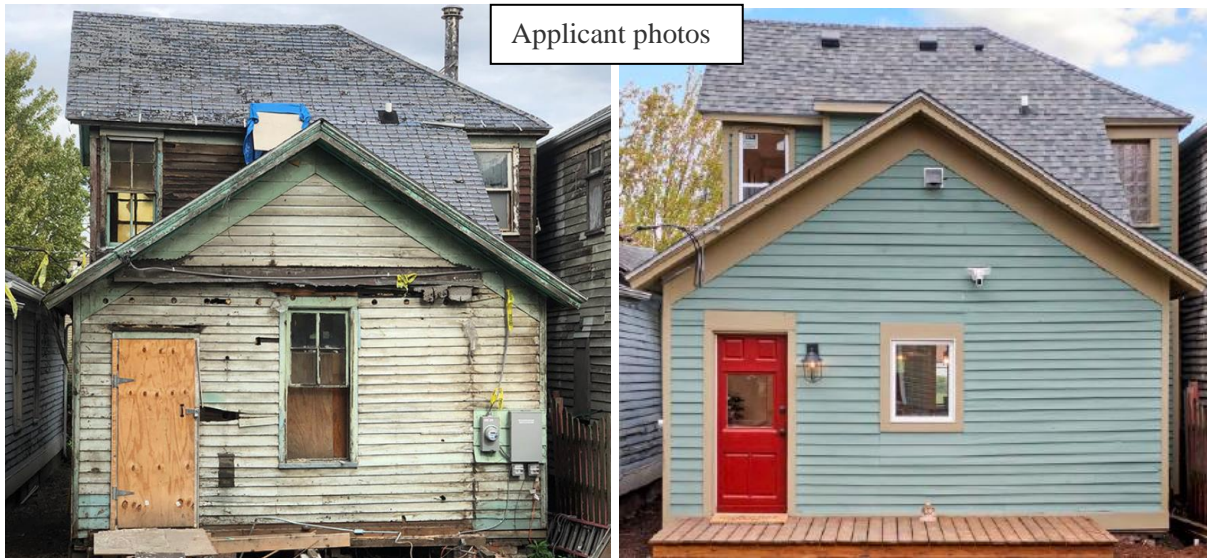
Rear Elevation - The historic windows, due to their wood sash and double-hung operation (with the two taller windows also having a matching muntin pattern), offered a level of uniformity to the asymmetrical rear elevation. As the windows are now different operations, sizes and materials, a discordant appearance to the rear elevation has been created.

Before 2019 rehab

Current conditions
