**STAFF REPORT: 10/12/2022 REGULAR MEETING**

**APPLICATION NUMBER: #22-8056**

**ADDRESS: 4290 LESLIE**

**SCOPE: REHABILITATE DWELLING, INSTALL FENCE (WORK COMPLETE WITHOUT APPROVAL)**

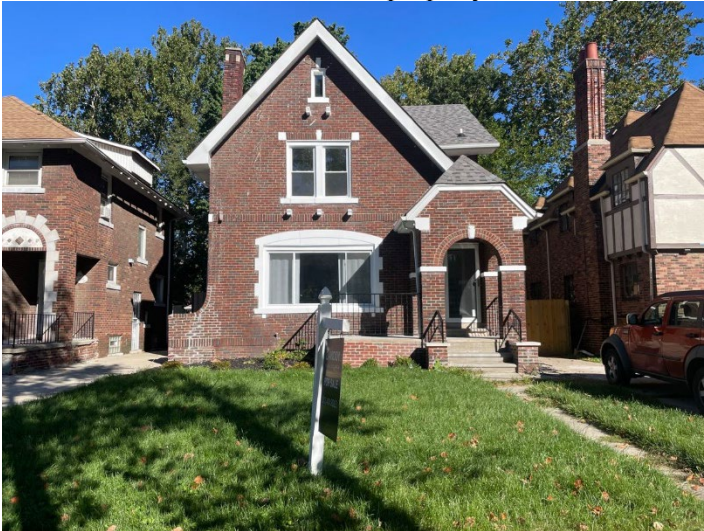
*Site Photo 1, by Staff Sept.23, 2022: (South) front elevation.*

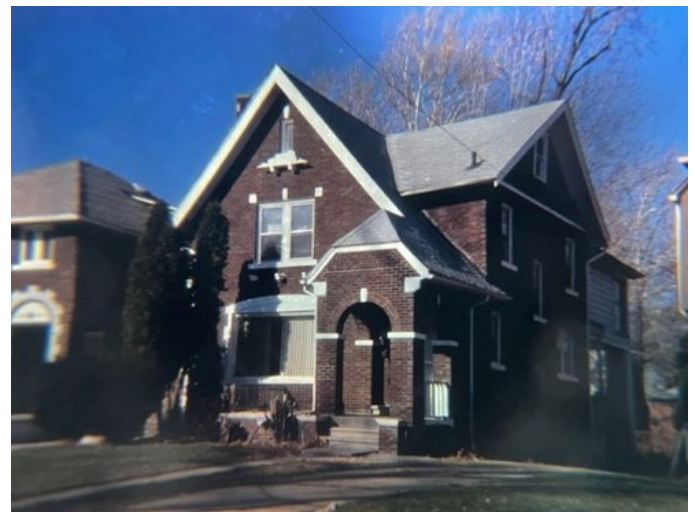
*Designation Slide, 1999: (Southeast) front/side elevation original windows, porch, and painted cast stone.*

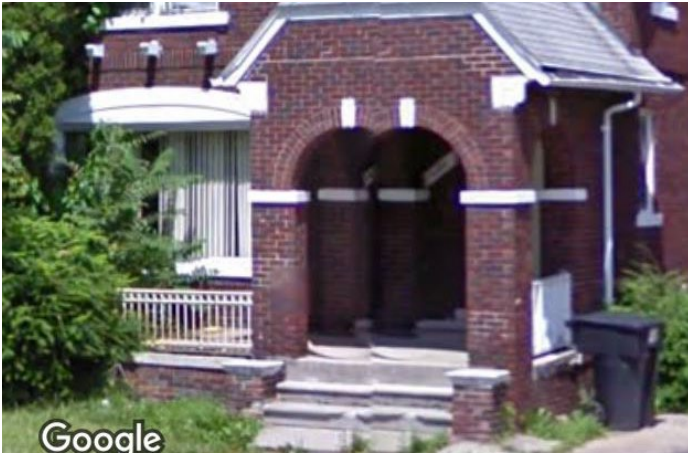
Site Photo3, Google Streetview August 2013: (South) front/side elevation showing original front porch railing, which was black, here painted white. Image quality is poor with double image line at center of porch archway.

- The preceding images (*see site photos 2 & 3*) of the front porch captures the design and height of the front porch railing, which did not exceed the height of the first-floor windowsill. Staff offers the opinion that the scale and design of this porch, its matching brick to the house, and the railing and their collective relationship to the house's architecture are distinct, character-defining features that have been altered or destroyed. It is staff's opinion that the mismatched brick, the raising of the porch height, the porch railing scale and addition of railings to the wing-walls of the current steps are inappropriate.

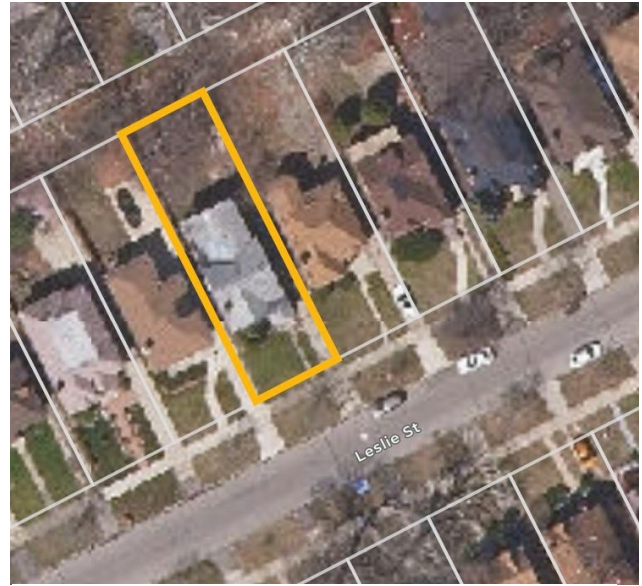
Aerial of Parcel #14004966, showing garage is missing.

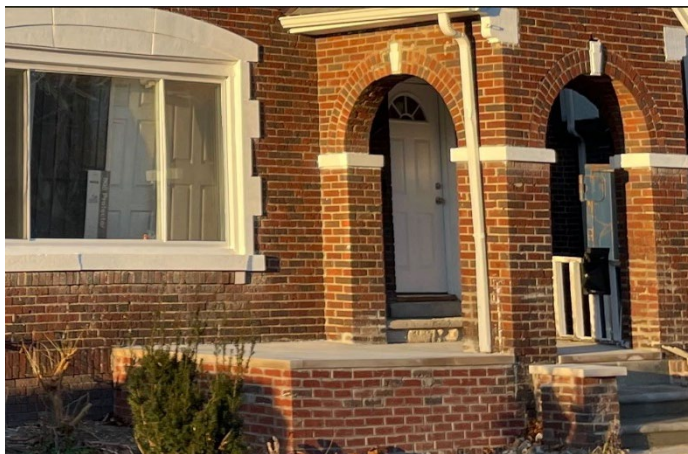
Site Photo 4, by Staff Dec. 12, 2021: (South) front elevation, showing front door with arching radial windows.

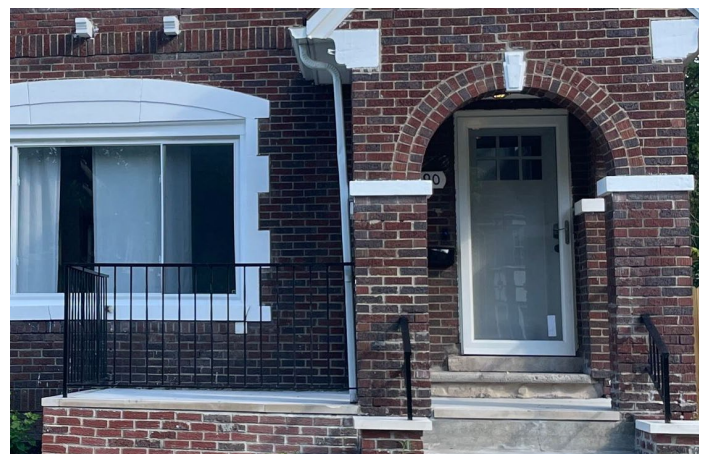
Site Photo 5, by Staff July 26, 2022: (South) front elevation showing new door with square windows.

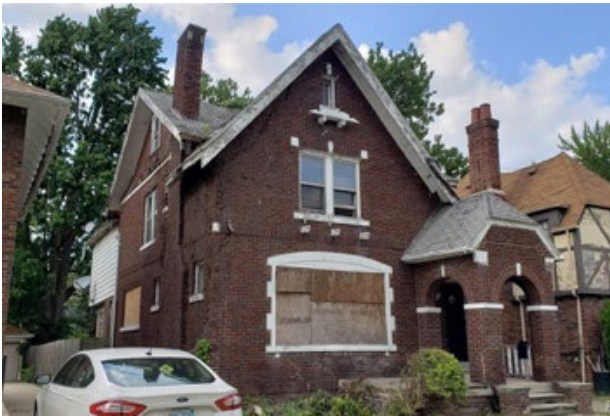
*Site Photo 6, by Applicant, exact date unknown 2020: (South) front and side elevation showing condition of house after purchase.*

- The applicant was not able to provide a clear count of aluminum windows removed nor their specific locations. Staff observed that the front windows of the third and second floor has been changed to vinyl windows between 2020 and December 2021. (See photos 6 & 8).

- Staff observed in the 2020 photo provided by the applicant the original darker brick facing of the front porch was present, but some of the rebricked area is not clearly visible in this photograph. (*See photo 6*)

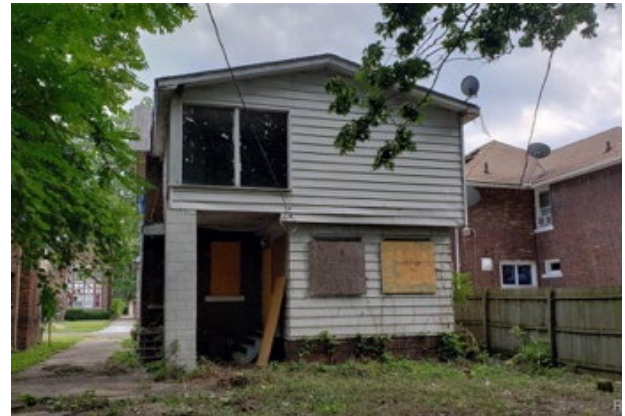
*Site Photo 7, by Applicant exact date unknown 2020: (North) rear elevation showing condition of house after purchase.*

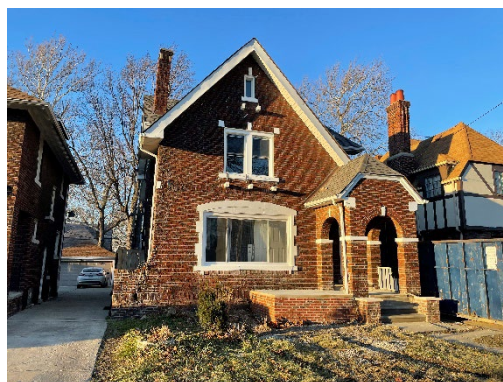
Site Photo 8, by Staff December 13, 2021 : (South) front elevation showing new vinyl windows on front 2nd and 3rd floors.
