STAFF REPORT: OCTOBER 12, 2022 MEETING

APPLICATION NUMBER: 22-8048

ADDRESS: 1515 CHICAGO

SCOPE: REPLACE FRONT PORCH COLUMNS AND REPAIR PORCH FLOOR AND STEPS, ERECT REAR DECK

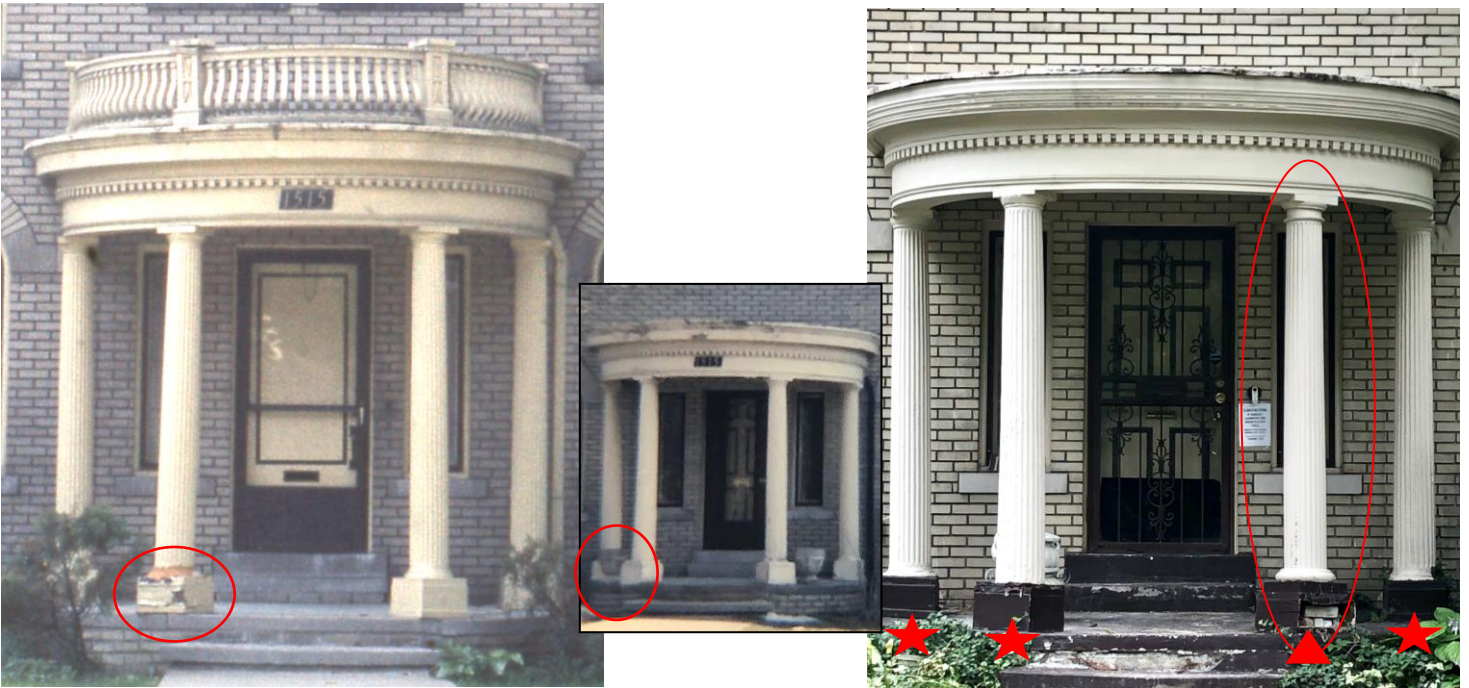
- The Boston-Edison Historic District was established in 1974.
- The 1974 designation photo (below left) shows the four matching columns in place, along with a decorative railing at the roof. It also shows deterioration present at the front left pedestal, which may explain why this column no longer has the slightly flared base. The 1988 photo (center, found in property file) shows the upper railing removed and deterioration/work being completed on the back left column base and pedestal. The front right column was replaced between 1988 and 2007 (per Google street view) without Commission review. The 2022 staff photo (below right) shows existing conditions. Symbols reference column designs shown on page 5.

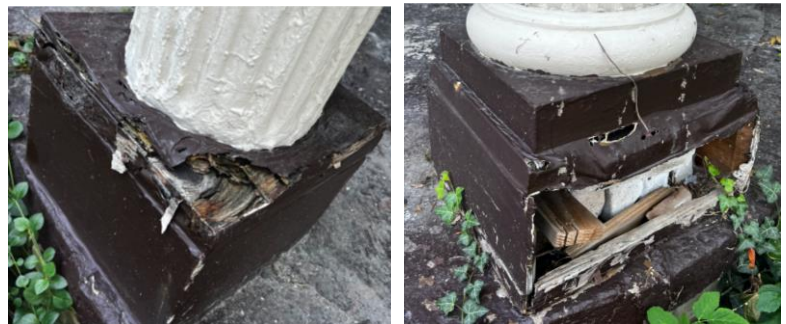
Applicant photos

- The 1974 and 1988 photos give visual evidence of deterioration and repair of the pedestals supporting the left two columns. The photos at right are closeups of the two outward pedestals (front left and front right, adjacent the porch steps). The pedestal in the photo on the right was modified when a replacement column of slightly different design and height was installed between 1988 and 2007.

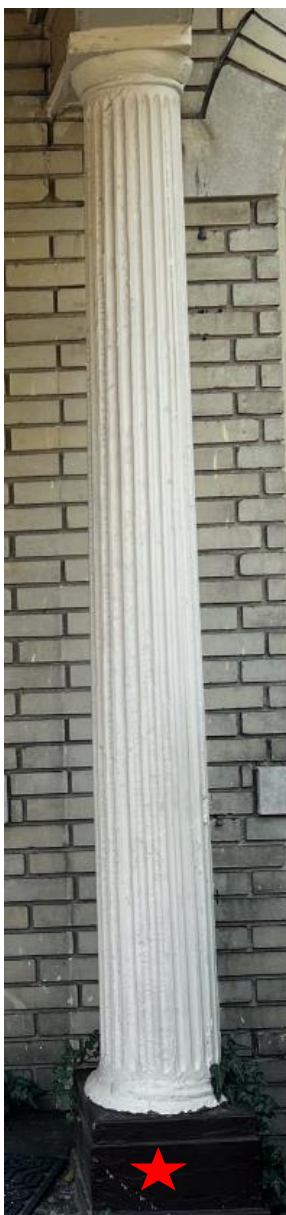
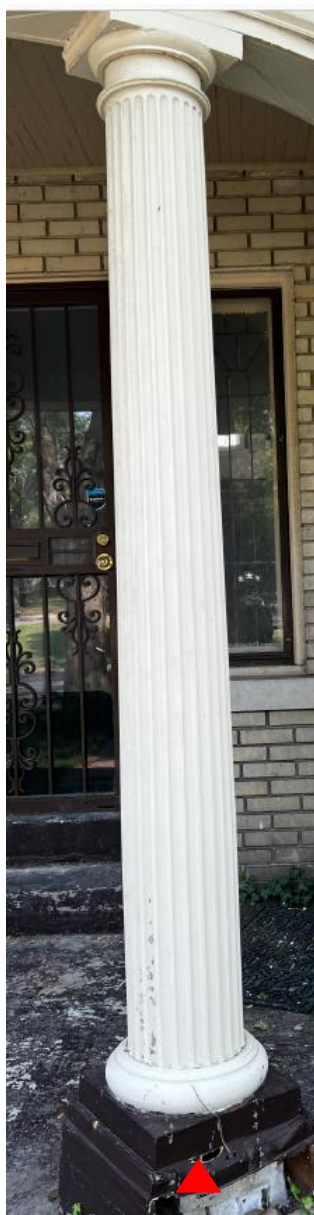
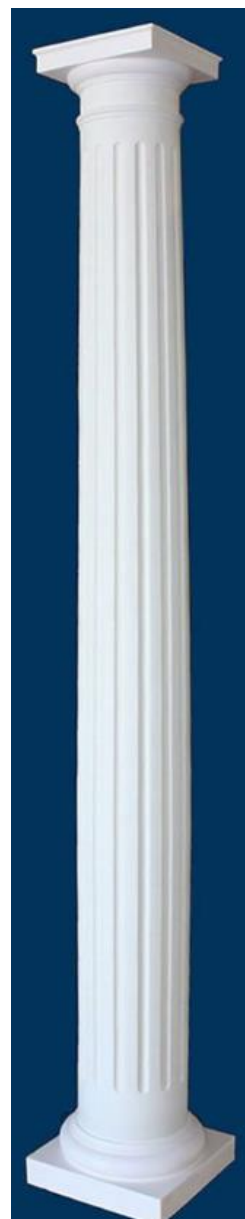
- Doric columns typically have 20 flutes. Staff counted 10 visible flutes on the original columns, so the columns likely have 20 flutes along the column’s circumference.

- The previously installed replacement column is slightly shorter than the original columns, has a rounded base, and a more intricate capital. The fluting also has a slightly more pronounced edge than the original columns, but otherwise is similar in diameter and number of flutes (20).

- It is staff’s opinion, when viewed from the sidewalk the appearance of the replacement column does not stand out strongly in contrast to the original columns due to the similar fluting pattern (circumference and height).

Left - Original column (3)
 Middle: Replacement column (1)
 Right: Proposed column

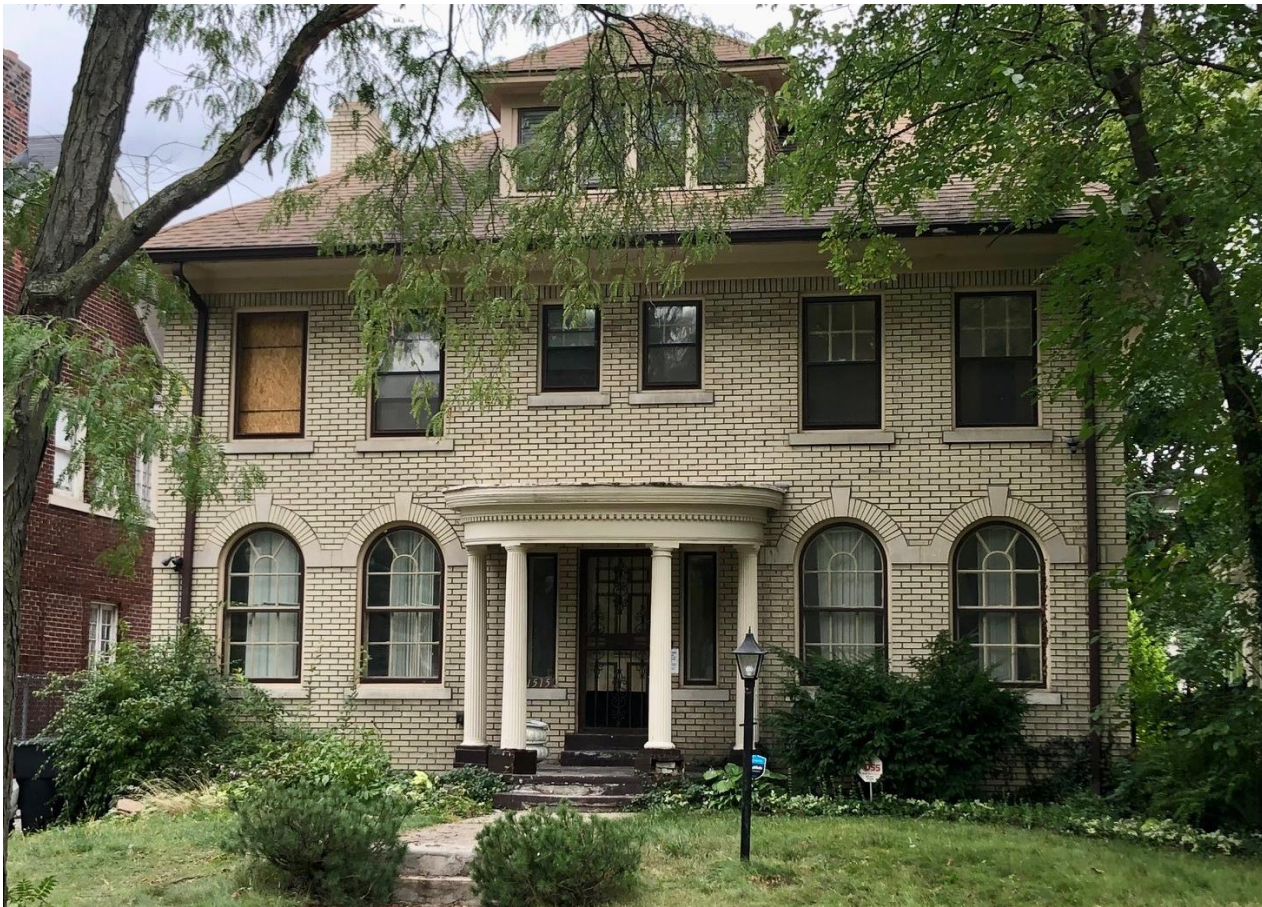
Staff photo

- The portico is a distinctive character-defining feature. Details on the level of deterioration of the existing columns was not submitted. Standard Six states “*Deteriorated historic features shall be repaired rather than replaced. Where the severity of deterioration requires replacement of a distinctive feature, the new feature shall match the old in design, color, texture, and other visual qualities and, where possible, materials.*”

- The design of the proposed new replacement column offers significantly less fluting around the circumference, as well being significantly shorter in length. These reductions create a flatter, more contemporary appearance which is counter to the highly detailed and patterned front elevation. Also, the proposed columns extend to grade, eliminating the need for a pedestal, furthering a more streamlined appearance to the portico.

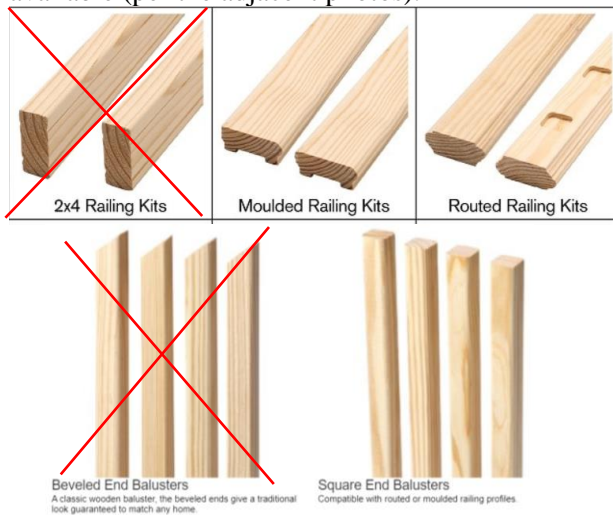
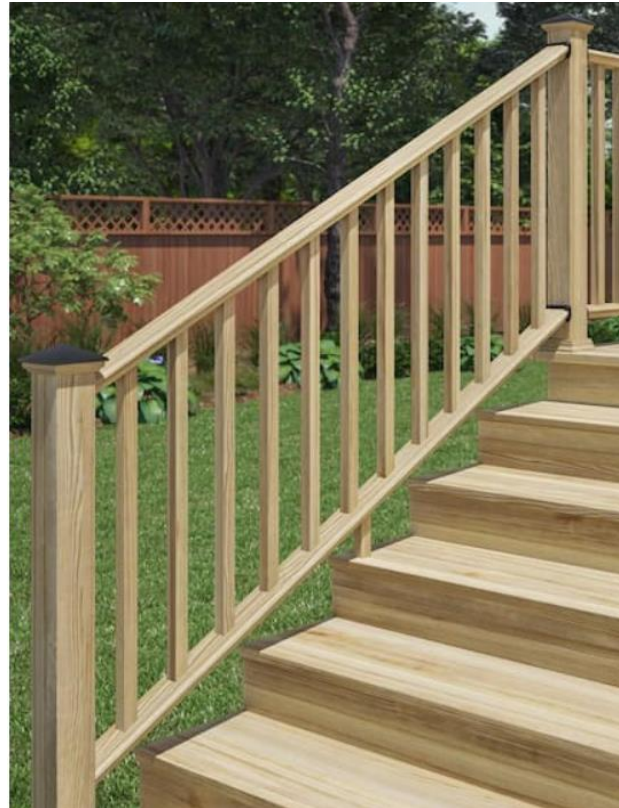
- The selected angled balusters applied to the outer side of the top and bottom rails is a contemporary deck design and is in sharp contrast to the historic dwelling. Installing square end balusters to the underside of the top and bottom rails is similar to the design of a historic railing. Staff researched the manufacturer's railing designs and a more sympathetic baluster and top/bottom rail is available (per the adjacent photos).

- The deck and stair railings will be constructed with the molded or routed railings and square balusters. The final selection will be listed on the deck material list and drawings.
- The deck will be inset from the west wall of the house by 3". The deck plan will be revised, or a note stating this design change will be added to the existing drawings.
- A site plan will be submitted confirming the porch step repair will retain the existing footprint and radius, along with the dimensions for the new concrete front walkway steps.
- Repaint painted porch elements in off-white colors to match historic conditions. Paint samples will be submitted to staff for field verification for approval prior to application.

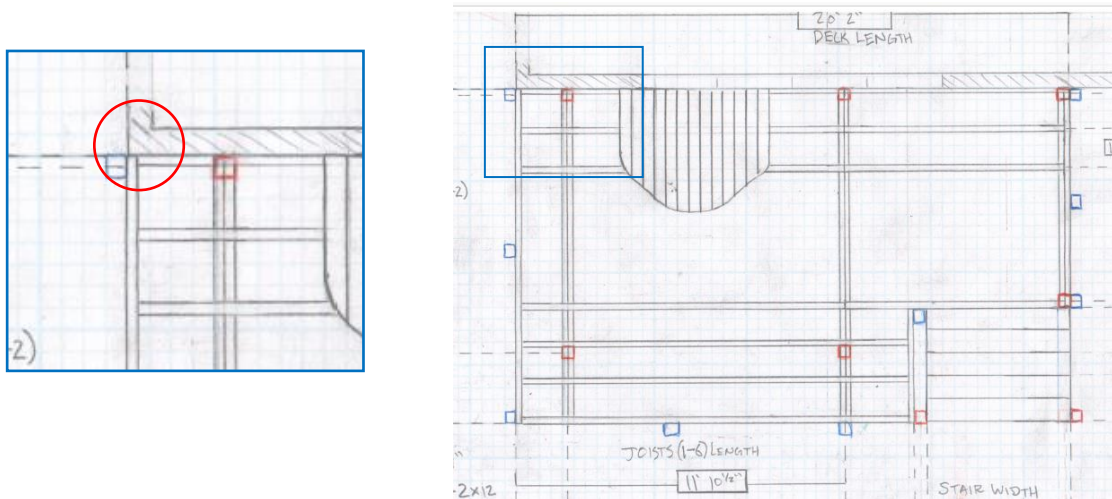
- The blue squares denote the supporting deck posts and are placed adjacent the deck edge only for illustration so the location of the porch balusters can be clearly identified. The posts will be installed below the deck floor.
- Staff believes the deck should be inset 3" from the side of the house. This will create a slightly deferential condition for the deck to the house and will eliminate any challenge of lining up the deck wall to the house wall.
