ADDRESS: 4370 GLENDALE

APPLICATION NO: #22-8170

HISTORIC DISTRICT: RUSSELL WOODS-SULLIVAN

SCOPE: REHABILITATE HOUSE (WORK COMPLETED WITHOUT APPROVAL)

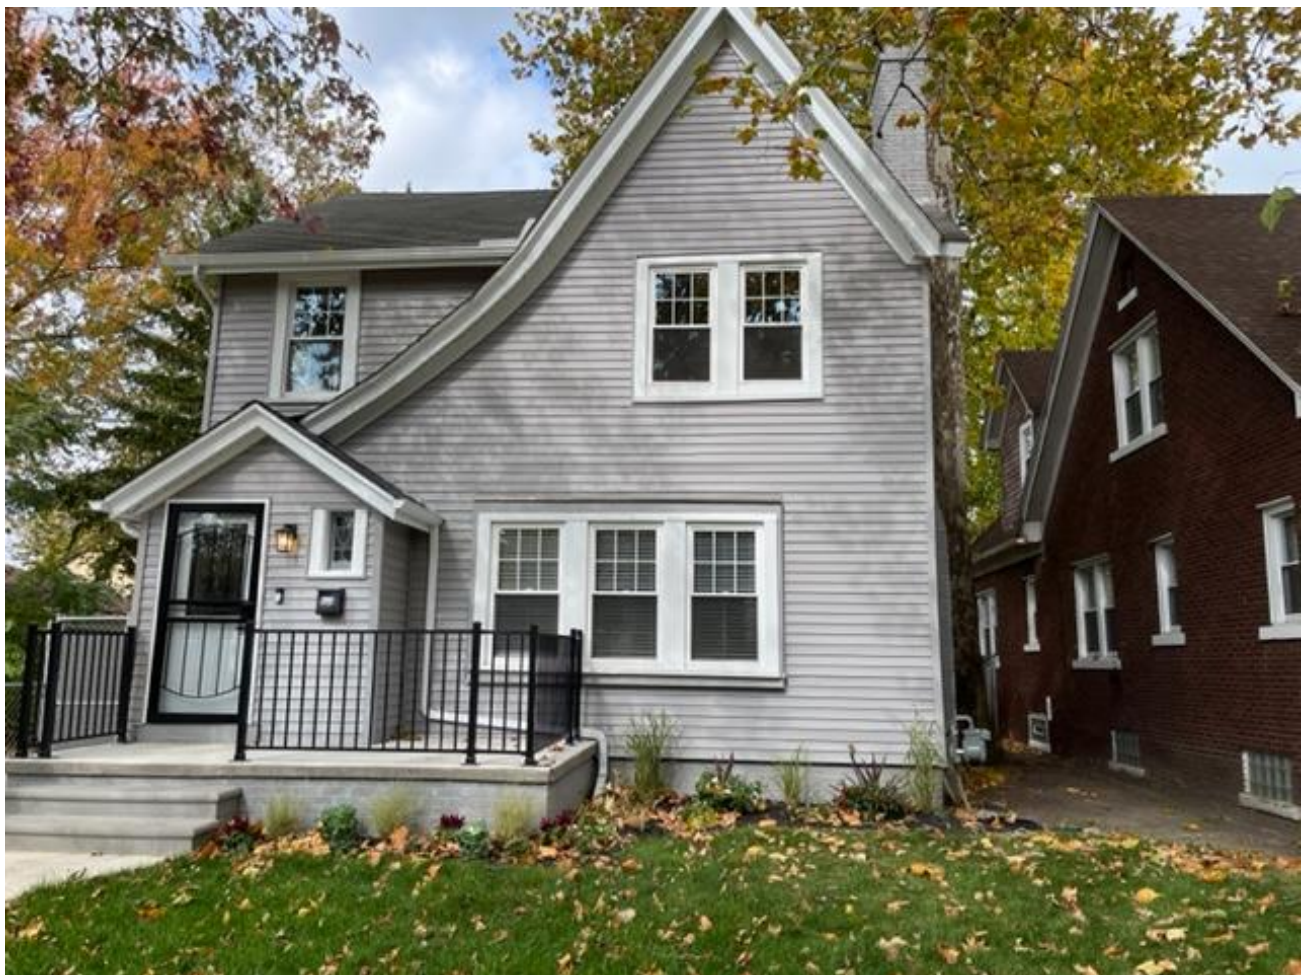
4370 Glendale, current appearance (staff photo taken 12/2/2022)

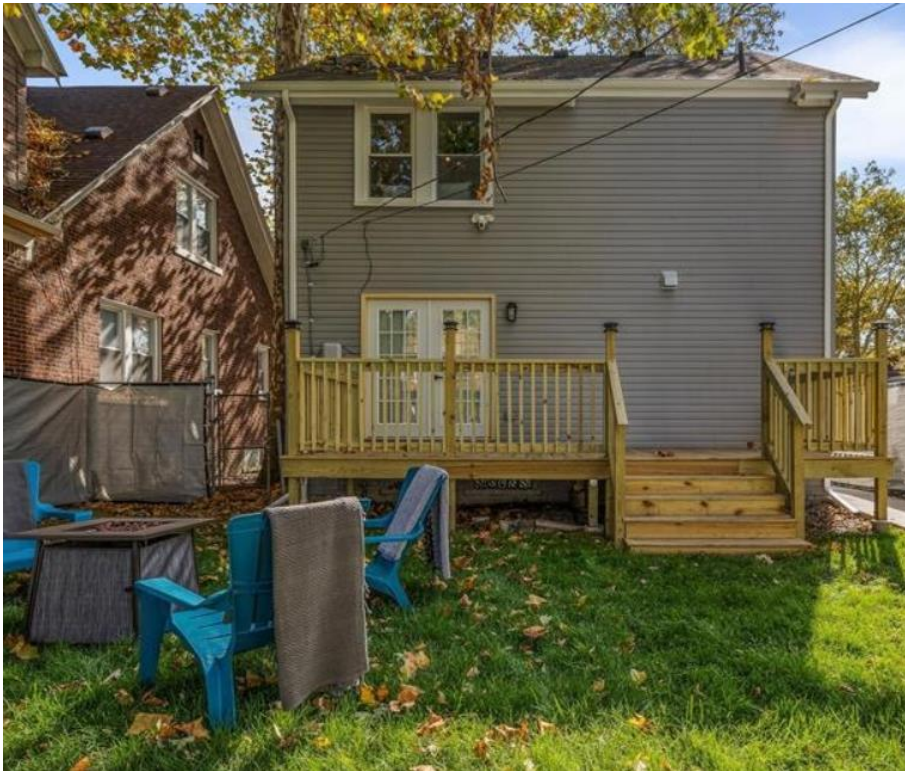
4370 Glendale, current appearance of rear elevation (source - realty.com [4370 GLENDALE, Detroit, MI 48238, MLS# 60155412 - mimc \(realty.com\)](#))

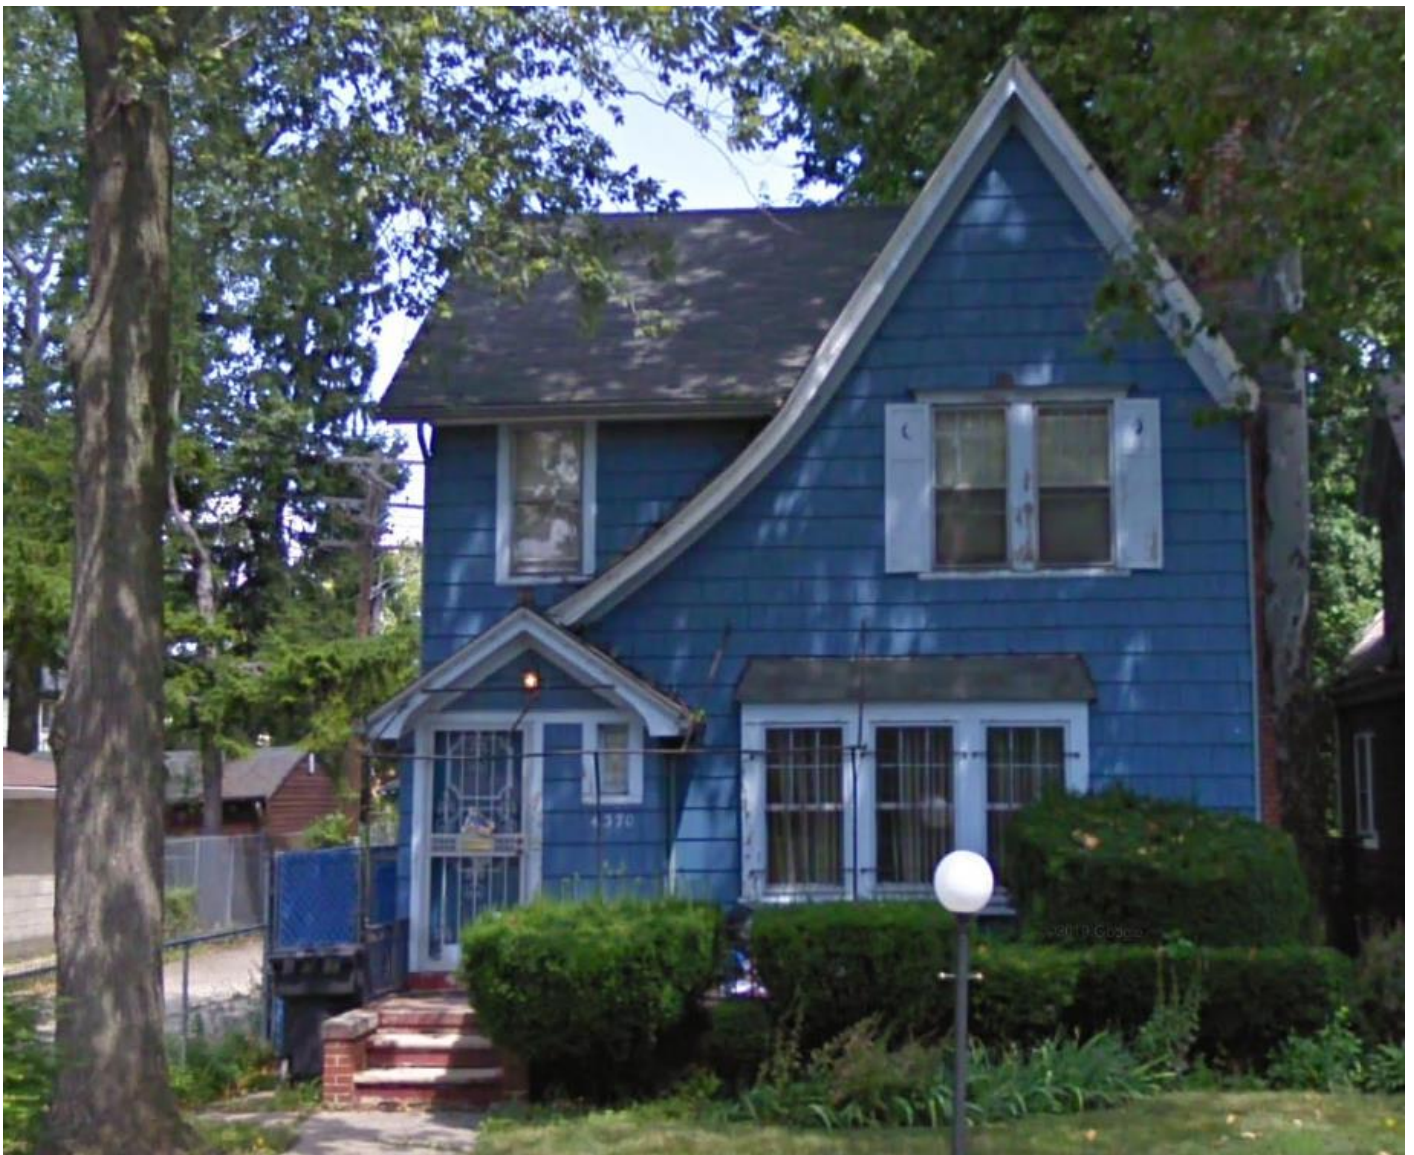
4370 Glendale, Google Streetview image dating from 2009, prior to the unapproved installation of vinyl siding and the current unapproved work

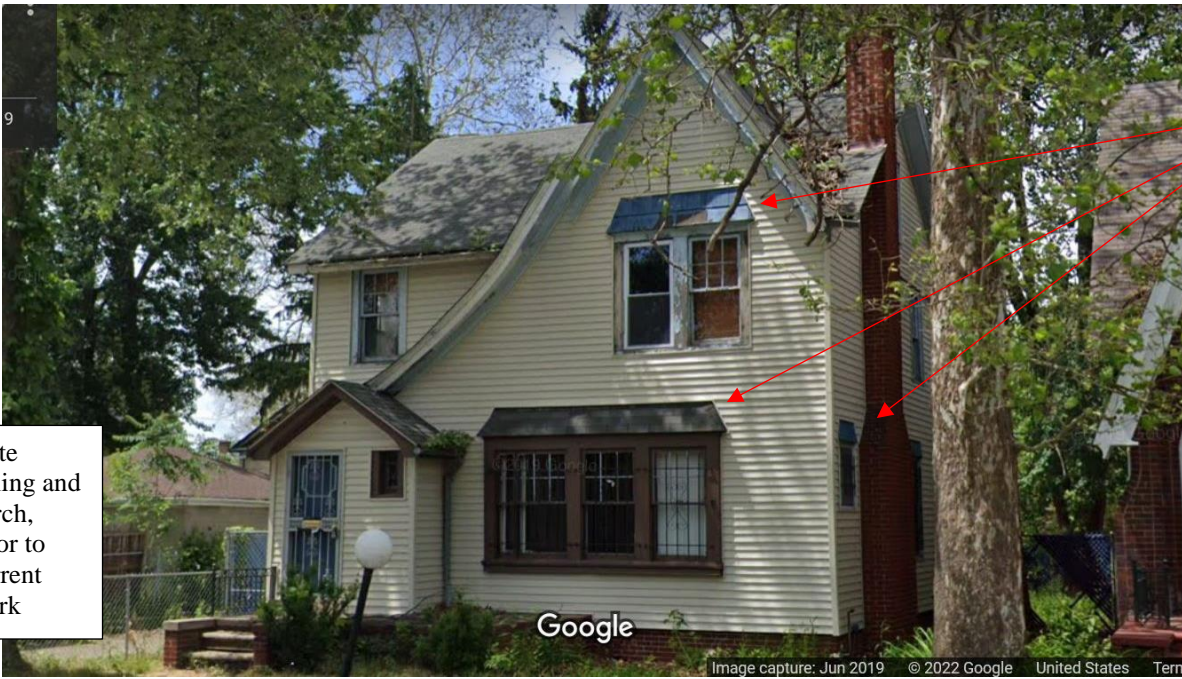
Note railing and porch, prior to current work

Note window overhangs, prior to current work

4370 Glendale, Google Streetview image dating from 2019, prior to the current unapproved work.

- Please see the above Google Streetview Image from 2019 and note that the original front porch included concrete steps with brick wingwalls and a 36”-high metal handrail. It is staff’s opinion that this porch was a distinctive character defining feature of the home. The current porch does not provide an adequate replication of the original due to the new higher handrails, the lack of brick wingwalls, and the application of the grey paint to the brick. It also appears that the footprint of the new porch may be larger than the original. For these reasons, staff does not recommend that the Commission approve the current front porch.

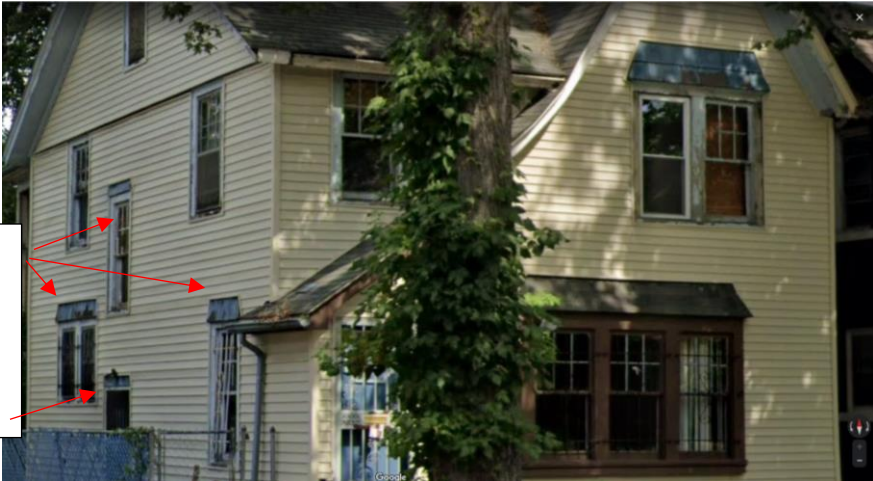
Note window overhangs, prior to current work

4370 Glendale, Google Streetview image dating from 2019, prior to the current unapproved work.

- It is staff's opinion that the windows which were replaced were distinctive character defining features of the home. Also, the former window overhangs at the front and side elevations were a significant design element. Finally, the current vinyl windows and the aluminum coilstock trim detract from the building's historic character. For these reasons, staff does not recommend that the Commission approve these work items.

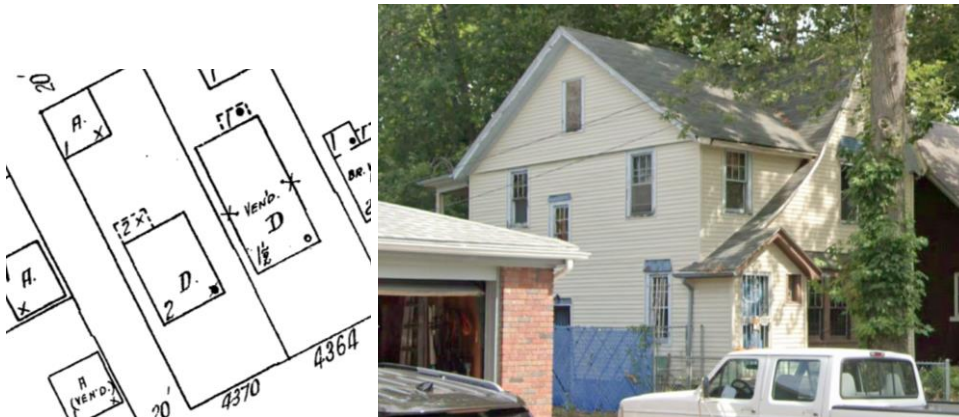
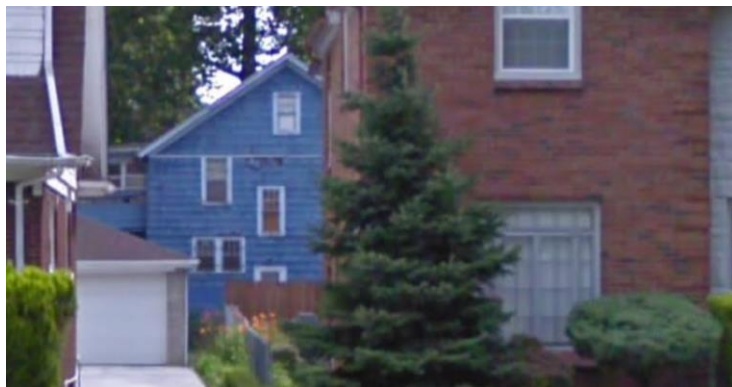
- Per the below Sanborn map, Google Streetview image, and the applicant's narrative, a two-story open porch at the rear elevation was removed as a result of the current project. The applicant states that it was removed because it was in poor condition. The two doors which lead to the porch (one at the first story and one at the second story) were enclosed and covered with vinyl. A third rear door opening at the first story was also enclosed and covered with vinyl siding. A new door opening with a set of French doors was added to the rear elevation at the first story. Finally, a gap at the fascia/soffit remains at the location of the former two-story porch roof. Note that the applicant has not provided staff with a photo of the rear elevation prior to

this work so staff was unable to ascertain the condition of the rear porch prior to its removal. As this porch was historic age, it is staff's opinion that the work as completed at the rear of the home is inappropriate.

Sanborn Map and Google Streetview images from 2019 and 2009 which show the rear two-story porch
