**STAFF REPORT: 3/8/2023 REGULAR MEETING**

**APPLICATION NUMBER: #23-8201**

**ADDRESS: 761 WHITMORE**

**SCOPE: INSTALL VINYL WINDOWS, (WORK COMPLETED WITHOUT APPROVAL)**

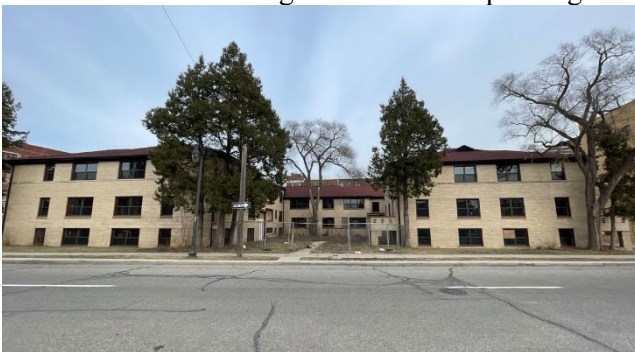
*Site Photo 1, by Staff February 20, 2023: (West) Front elevation and courtyard on 3<sup>rd</sup> Street, showing vinyl window installation.*

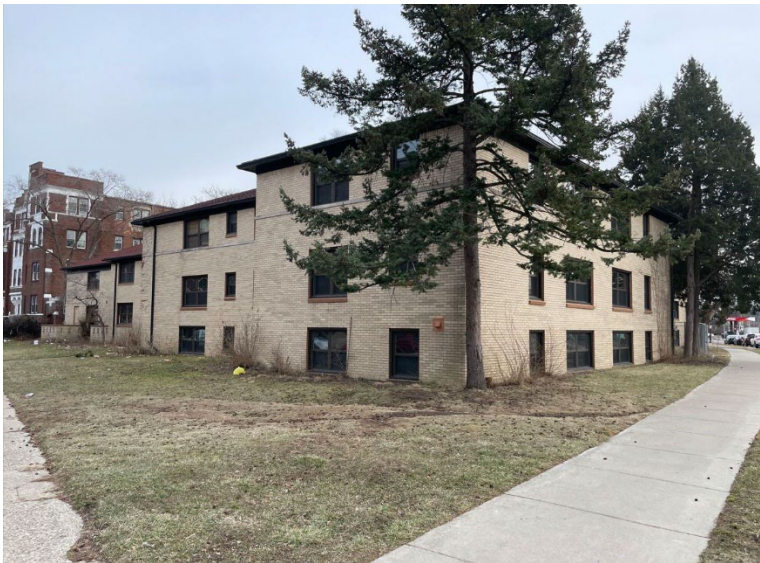
Site Photo 3, by Staff February 20, 2023: (North) side elevation on Whitmore, showing vinyl window installation.

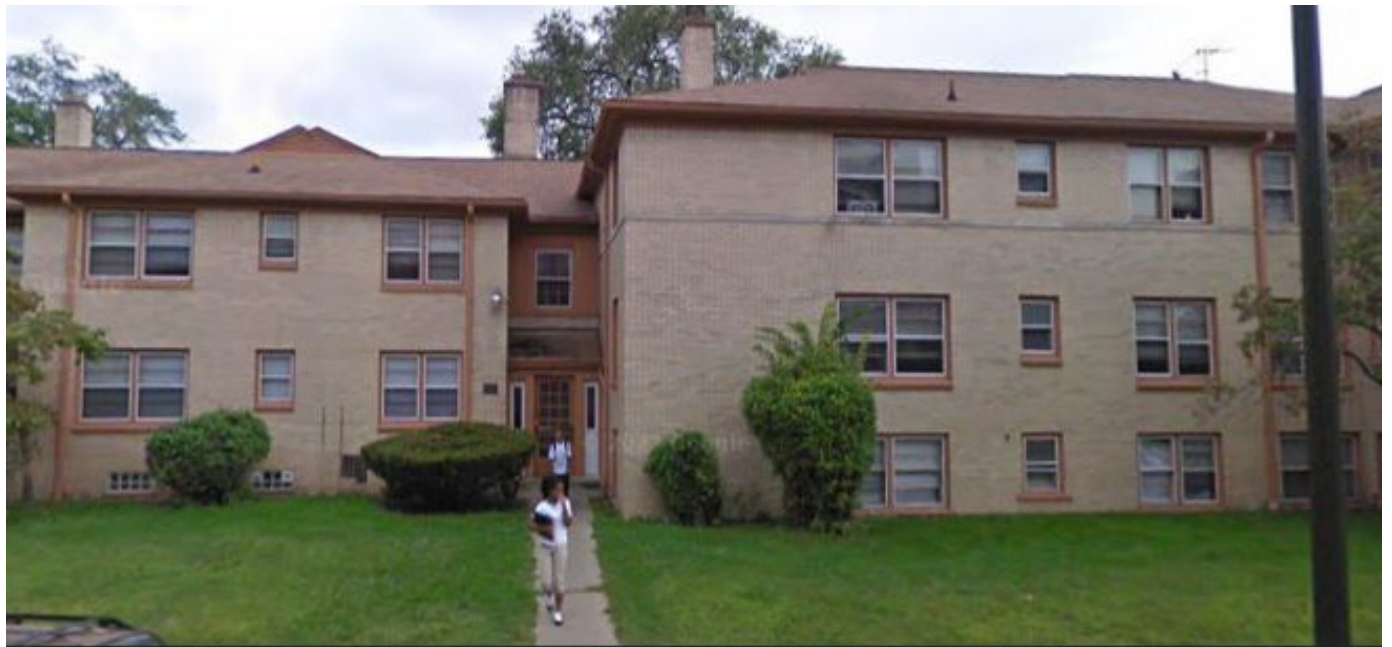
Site photo 4, by Google Street, September 2009: Whitmore (North) elevation, showing 2/2 horizontal muntin, double hung wood windows.

- Staff observed from Google Street View, that in September 2009, a vast majority of the original windows appeared to be in place. The building was vacated since at least July 2011 with the windows and doors boarded up. (See site photos 4) The Buildings, Safety Engineering and Environmental Department (BSEED) shows a Vacant Property Registration issued in March 2012.

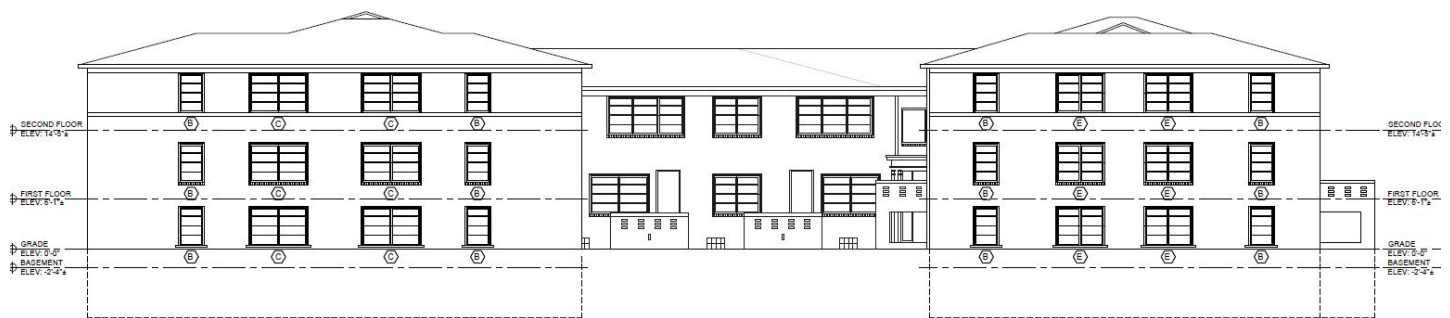
1/A200 west elevation

Figure 1, by applicant, showing proposed window designs, with applied muntins. See also drawing A200

replicate the impression of the historic divided light of the original windows. It is staff's opinion that the application of adhesive muntins is not an appropriate treatment, based on concerns around durability and appearance.

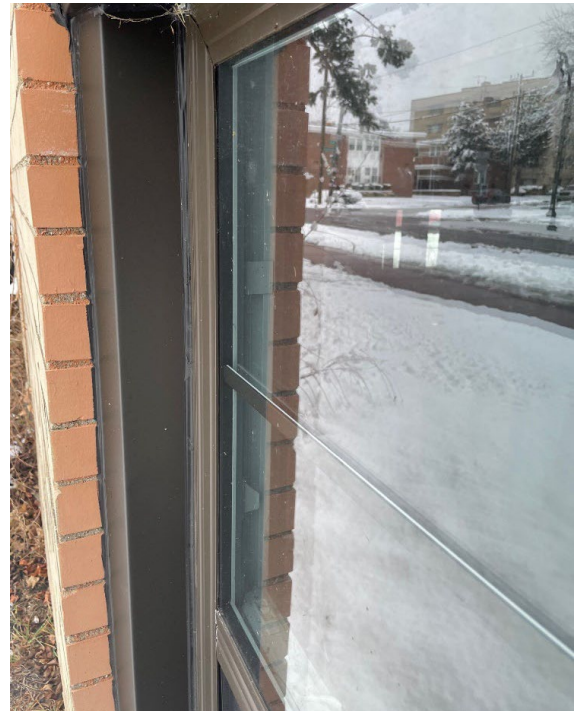
- The Palmer Park Apartment Buildings Historic District was established in 2012.
- Staff requested the applicant to provide documentation of the original condition of the windows. The applicant stated that both were removed before he was involved with this project. He stated that the contractor believed the entries were beyond repair with rotted wood. The applicant confirmed that no documentation of the original condition of the windows exists. The applicant also confirmed that some original brick moulds were covered with aluminum brick moulds, other brick moulds were lost after fire damage to the building and the entire window openings (19) were rebuilt without wood brick moulds. (See detail photos 1- 2)

Detail photo 1, by applicant: Third street (west) front elevation, showing where original brick mould was replaced with aluminum brick mould and horizontal muntin between the glass

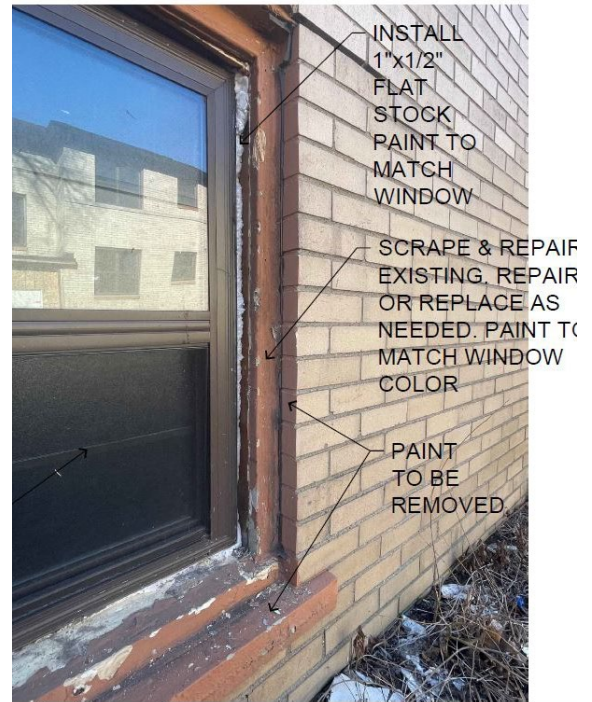
Detail photo 2, by applicant: Showing exposed brick mould after brake metal was removed. Application proposes to repair wood, scrape and repaint wood, and caulk where needed.

Each brake metal will be removed around each brick mould that has it. Scrape existing paint, repair and repaint wood. Each window will be inspected and if required readjusted within the opening. Any pieces that need to be replaced, replacement pieces will be milled. A flat stock filler of 1"x1/2" wood will need to be installed between the backside of the brick mould and the window frame. This will be painted to match as well. The windows will be recaulked with a matching color.

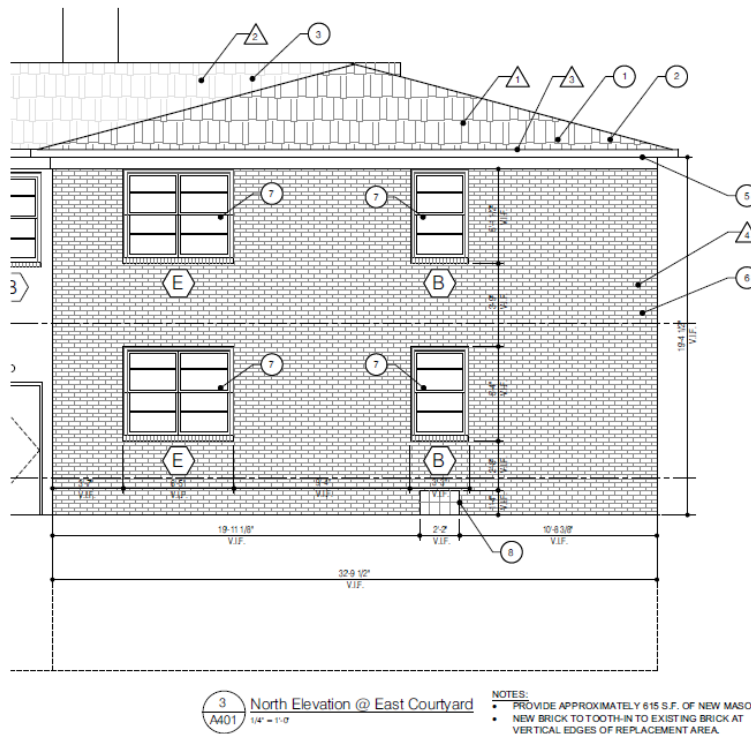
- Staff issued a COA in 2019, which states that the brick wall at the North Elevation at the East Courtyard to match existing and the associated signed BSEED permit BLD2019-06541 which states that: “Exterior Openings: Areas in which window and door openings are to be framed shall match the size and location of the original openings that they are replacing...” and associated approved drawings A401, A402, A403 show notes that state “New masonry wall brick to match existing, window penetrations to have rowlock sill to match existing. New wall to have soldier course, match existing. Tooth in brick where new masonry meets existing masonry.” Despite the drawings, and COA issued, staff observed that the construction of these 19 window openings that were damaged by fire, they were not constructed to their approved original size. Therefore, staff observes, the windows may match in dimensions to the other windows, but the window openings, do not and lack the space to accommodate the brick moulds. This work adds to the violation status of the property. (See figures 2-3).

Figure 2, by BSEED e-Plans BLD2019-06541: East Courtyard (East) north elevation, showing where brick wall was rebuilt and some of the window openings, along with the elevation key notes that state brick to match existing penetrations.

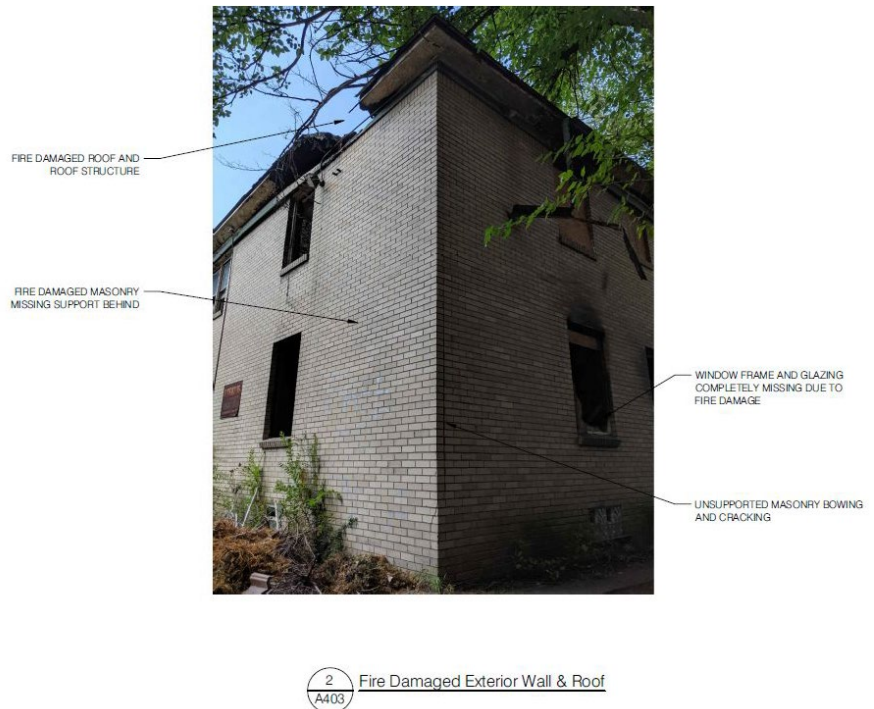
Figure 3, by BSEED e-Plans BLD2019-06541: East Courtyard (East) north elevation, showing fire damaged window openings prior to work on brick wall, window openings, and roof.
