STAFF REPORT: 3/8/2023 REGULAR MEETING
APPLICATION NUMBER: #23-8235
VIOLATION NUMBERS: #693, 694, 695
ADDRESS: 269 WATSON
HISTORIC DISTRICT: BRUSH PARK
APPLICANTS: MEIR ISRAEL, ROSE VALENCIA
PROPERTY OWNER: ARBEN GJEKAJ
DATE OF PROVISIONALLY COMPLETE APPLICATION: 2/13/2023
DATES OF STAFF SITE VISITS: 3/29/21, 4/27/22, 8/25/22, 2/20/23

SCOPE: DEMOLISH GARAGE, RECONSTRUCT SIDE PORCH, INSTALL FENCE (WORK COMPLETED WITHOUT APPROVAL)

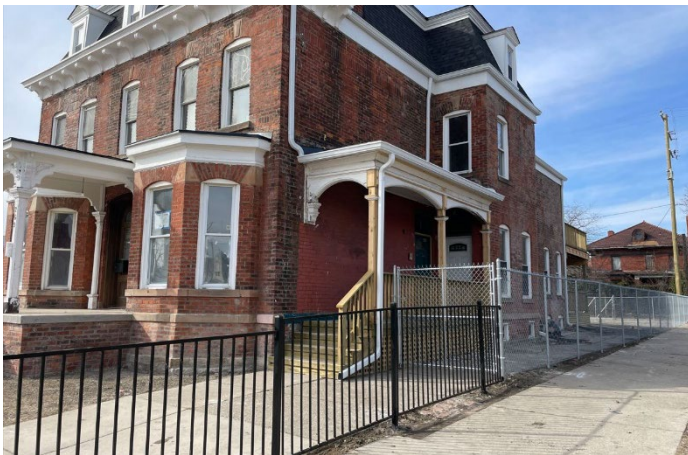
Site Photo 2, by Staff February 20, 2023: (East) side elevation, showing front and rear fence installations, east porch installation (work completed without approval).

- Staff observed that the front yard fence is over the 3’ allowable height for front yards according to the HDC Fence and Hedge Guidelines. However, staff observed that Brush Park has fences in the front yard that are 4’ high similar to this fence. While the color and the metal material of this fence are appropriate, the execution of its installation has some of the top and bottom rails disjointed. *(See Site photos 2-3)*

- When the applicant last appeared before the Commission in September 2022, staff noted that the east porch was in the process of demolition. At that time, the applicant was invited to include this work in their application but did not respond.
- The square Tuscan capitals of the wood posts, the wood railing and the brick pier supports of the wood posts of the original east elevation porch are distinctive character-defining features of the building.
- The original porch had brick piers under the wood deck that supported the wood posts. These brick piers have been removed and replaced by wood posts by the current construction of the new porch.

- The original porch posts had square Tuscan capitals that have been replaced by simple ledges. Staff observed that wood plate detail has been applied to the archways that were not previously present. These modifications in design are not appropriate and do not follow the Secretary of Interior Standards.

- Staff observed that the railing design is different from the original design in the following ways:
 - It introduces a handrail along the steps
 - The railing design has a 2x4 sub-rail and lower rail running face-forward along the top and bottom of the railing, creating a thicker, less elegant design that is not appropriate to the detailing of this property's historic architecture. The original railing had a simple upper and lower rail that was less obtrusive and could be replicated by rotating these rails so that they are less visible.

- Staff has observed that the rear porch and this side elevation porch have introduced new skirting that are not historic to the house. (The rear skirting was not approved in the 2022 COA, and the rear deck and balcony has not yet been stained or painted as stipulated as a condition in this COA.)

- While the railing height approximates the original scale, the design of the railing has created an excess of bulk and thickness that has exceeded the historic finesse and elegance of the original design of the porch railing. It is staff's opinion that the new railing does not meet Standards 2, 5 and 6.

- The installation of skirting should be installed behind framing, per National Park Service Brief 45 "Preserving Historic Porches". Larger vertical boards should divide the skirting a the location of columns/piers to continue the porch's vertical support line from roof-to-grade. This house formerly had brick columns that were destroyed at these locations, which could have served as this vertical support line that is lost. It is staff's opinion that both the restoration of the brick piers, with upper and lower framing and then placing the skirting behind these elements, the skirting would then meet the guidelines as described in Brief 45.

Recommendation 1: East porch (work completed without approval)

Staff finds that the reconstruction of the east porch posts, replacement of brick piers with wood, redesign of the railing and introduction of skirting does not meet the Secretary of Interior Standards for the following reasons:

- The east porch railing, the applied detailing to the arches and the altered post design destroys and alters the original features that characterizes the original railing and original square Tuscan capitals of the posts, which are historic character defining features of the building.
- The replacement of the brick piers from the east porch with wood posts that are obscured with skirting that is neither framed nor follows historic standards.

Staff therefore recommends that the Commission issue a Denial for the above work items, as it do not meet the Secretary of the Interior's Standards for Rehabilitation, specifically Standards:

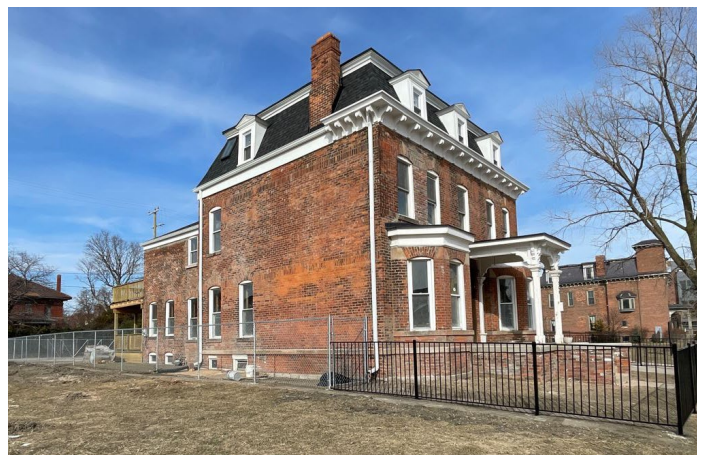
Site Photo 3, by Staff February 20, 2023: (West) side elevation, showing front and rear fence installations, and former site of rear garage (work completed without approval).

- The chain link fence at the side and rear of the property is appropriate and does meet the HDC Fence and Hedge Guidelines. However, staff offers the opinion that a more appropriate location for the chain link fence gate would be at the corner of the brick east porch entrance, rather than at the corner of the wood post of the east porch, so that the height of the fence does not obstruct the detailing of the building’s architecture. *(See Site photo 2)* Also, staff offers the opinion that the fence be painted black to create some continuity with the front yard fence.

- The applicant relocates the east gate of the chain link fence to the brick corner of the house, behind the east porch, painted black.
- The deck be painted a color that matches Color System C color scheme of the HDC color guide.
- The applicant provides HDC staff a review of the above items before installation.

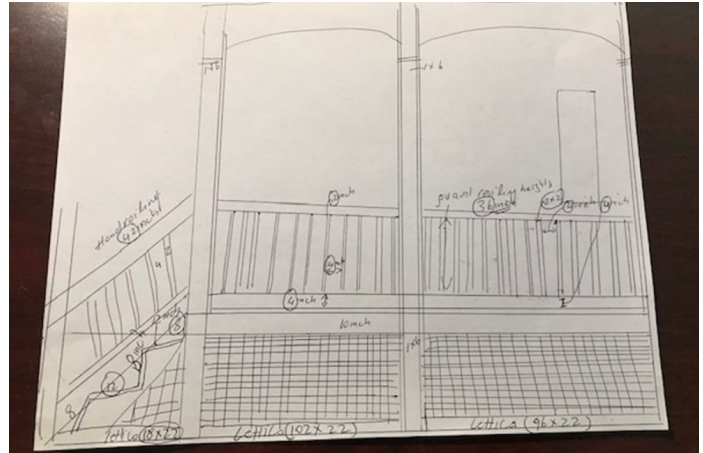
The applicant proposes to replace all wood decking, posts, railing and stairs on the east elevation porch, but retaining the roof, ceiling, arches and pediment support at the porch entrance. (See attached sketch and description.) Some wood fascia is replaced with wood. And some of the post headers have additional header application details that were added at the top of each post that were not original to the porch. The porch dimensions stay within their historic floorplan. However, the railing has been raised to 42" height. All wood is pressure treated wood. Staff requested information on paint or stain treatment of the porch and the skirting but has not received any information to date of this report. (See also Site photo 2)

Figure 1, by Applicant: (East) side elevation, showing proposed porch.

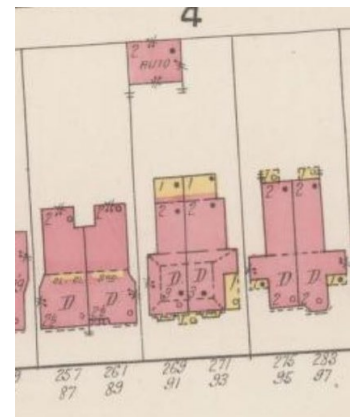
- Because staff has not received information from the applicant regarding the condition of the garage prior to its demolition, staff has utilized images from Sanborn maps and Google Street view to yield the following observations:
 - The 1921 Sanborn map shows the presence of a two-story brick garage that predates the concrete block garage at the northwest property corner.

Sanborn V3, P117, 1921, showing the original garage location and materiality.

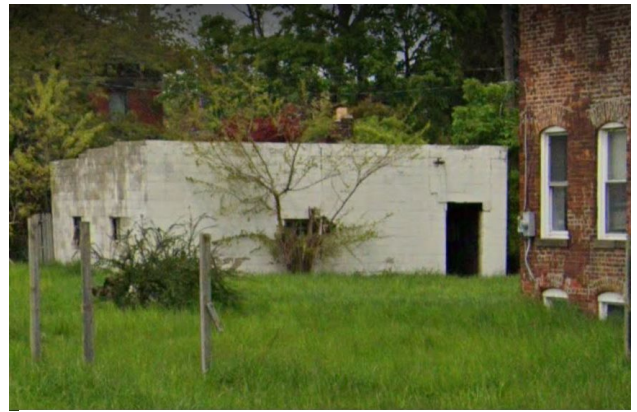
- The 1971 Sanborn map shows the presence of a concrete block garage prior to the historic designation of Brush Park in 1980. *(see Sanborn above)*
- Staff observes from Google Street images that the building appears to be concrete block construction and not likely to be original to the time of the construction of the house.
- Staff estimates the demolition occurred sometime between April and August of 2022.
- It is staff’s opinion that the concrete block garage that was demolished by the applicant was not the original historic garage as depicted in the 1921 Sanborn, and based on the limited information available, the garage was non-contributing.

Site Photo 4, by Google Street May,2019: (Northwest) Rear elevation, showing rear garage prior to demolition.

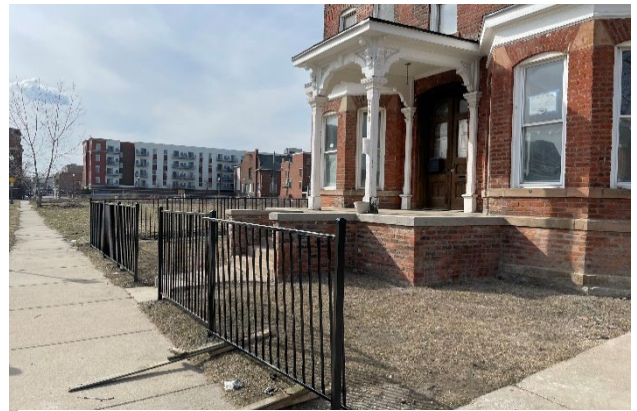
Site Photo5, by Staff February 20, 2023: (South) front elevation, showing front fence installation.

It is staff's opinion the installation of the front and rear fence and east porch deck and stair are appropriate. Staff therefore recommends the Commission issue a Certificate of Appropriateness for the work as proposed because it meets the Secretary of the Interior Standards for Rehabilitation and the Brush Park Historic District Elements of Design.

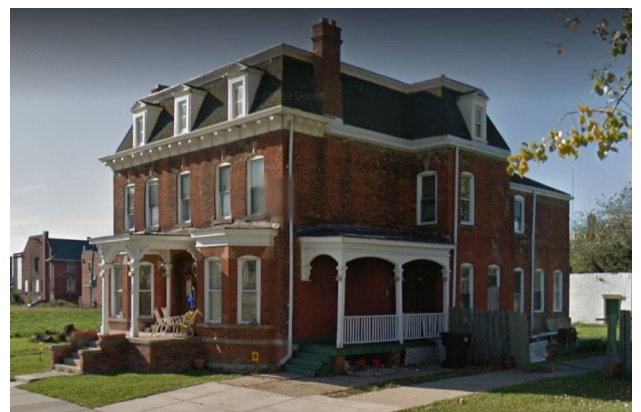
Site Photo6, by Google Street Oct 2011: (East) side elevation, showing east original porch with brick pier supports and original railing and post design. Also note the garage in the rear.
