**STAFF REPORT: NOVEMBER 16, 2022 MEETING**  
**APPLICATION NUMBER: 23-8244**  
**ADDRESS: 2475 CHICAGO**

**HISTORIC DISTRICT: BOSTON-EDISON**  
**APPLICANT: MARTIN LEGER, CENTRAL DWELLINGS, CORP.**  
**PROPERTY OWNER: MARTIN LEGER**  
**DATE OF PROVISIONALLY COMPLETE APPLICATION: FEBRUARY 13, 2023**  
**DATE OF STAFF SITE VISIT: OCTOBER 25, 2022**

**SCOPE: REPLACE WOOD WINDOWS WITH ALUMINUM-CLAD WOOD WINDOWS,**

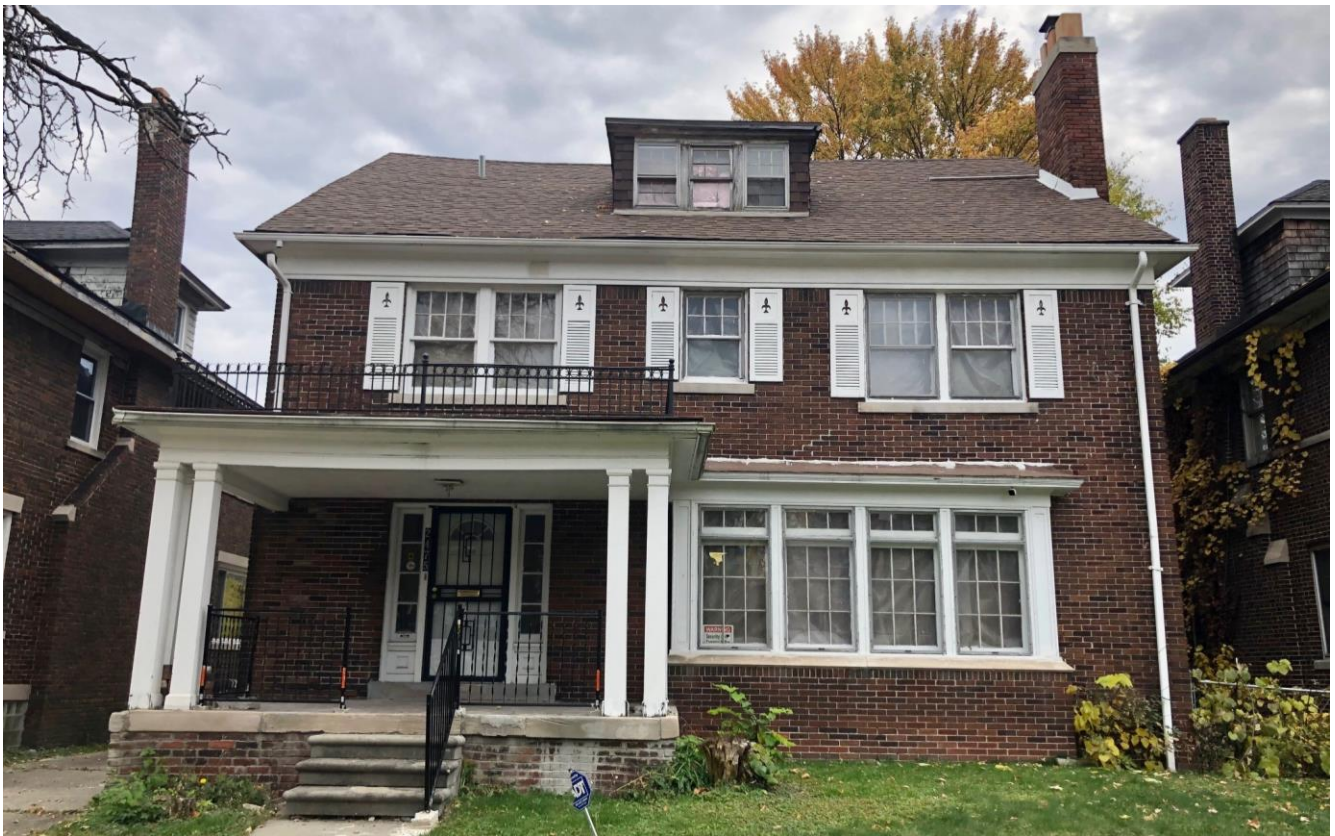
*Staff photo, October 25, 2022*

The dwelling at 2475 Chicago was erected in 1923. The house is clad with variegated brown brick; the reverse gable roof is covered with asphalt shingles and is punctuated by a small, shed dormer with three mullied double-hung windows. The window and door openings on the first floor closely align with the window openings at the second floor, however the window groupings and operations, coupled with the dominant front porch, obscure this alignment. A box bay at the first floor slightly protrudes from the main elevation; the casement windows with single light transoms further accentuate this distinctive character-defining feature. The dominant double-hung wood sash with 6-over-1 and 8-over-1 patterns, decorative wood shutters (front elevation), and unpainted light-colored stone sills remain intact on the majority of the four elevations and are also character-defining features of the dwelling.

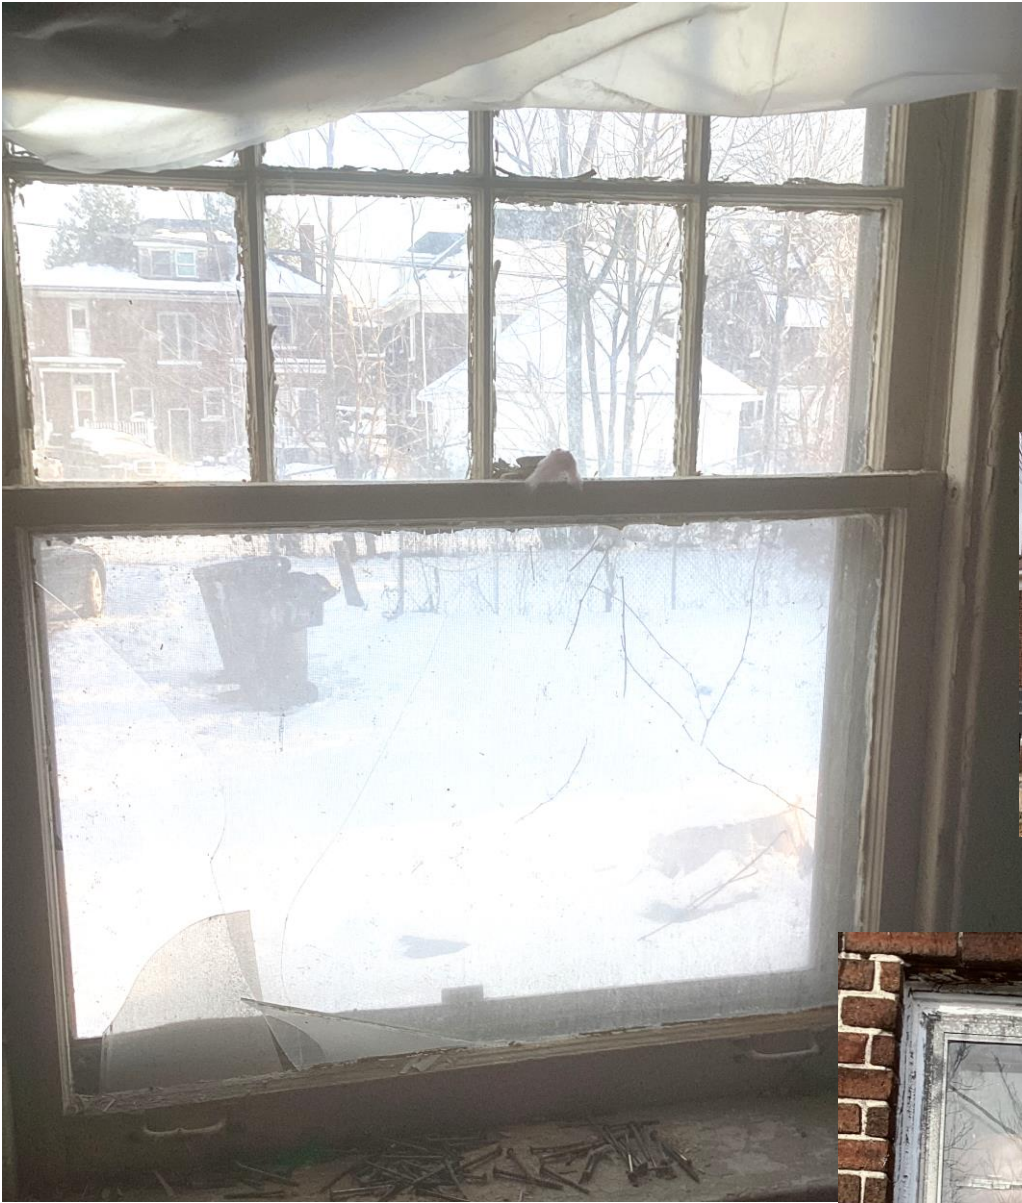
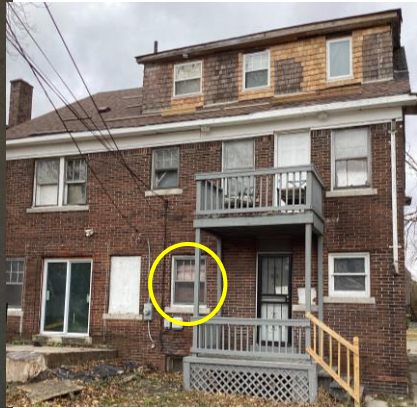
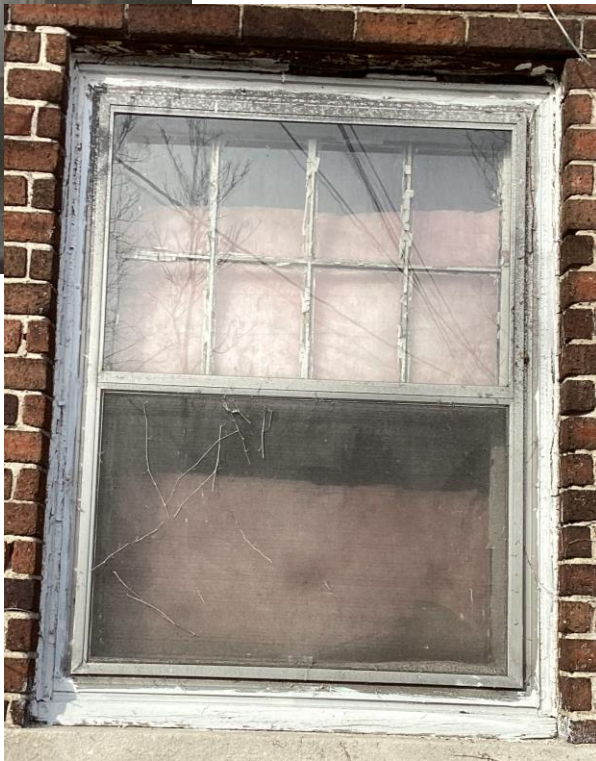
*Applicant photos. Rear elevation, first floor.*

- It is staff’s opinion the photographs submitted by the applicant do not demonstrate that the windows are beyond repair. The frames need to be scraped and painted, and some wood filler/putty may be needed. Most of the openings have storm windows in place, sash are intact (understanding an occasional glass panel was broken), and appear dry.

It is staff's opinion the existing wood windows are not deteriorated beyond repair. The wood sash retains a level of materiality and dimensionality that offers significant architectural detail to the structure; installing the proposed replacement windows would alter features that characterize the property. Therefore, staff recommends the Commission deny a Certificate of Appropriateness for the work as proposed because it does not meet the Secretary of the Interior Standards for Rehabilitation and the Elements of Design for the district, specifically Standards:

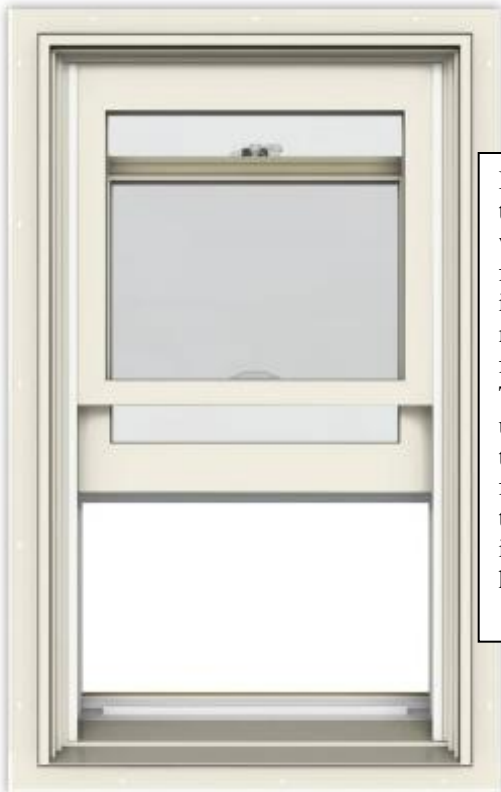
It appears as though this window line is fabricated with an integrated brick mould, which is flat in profile. This integrated unit doesn't offer the opportunity for an alternate trim color, which is common on historic structures.
