STAFF REPORT: 4/12/2023 REGULAR MEETING

APPLICATION NUMBER: #22-8280

ADDRESS: 729 SEWARD

SCOPE: REPLACE WOOD WINDOWS WITH ALUMINUM-CLAD WINDOWS (WORK COMPLETED WITHOUT APPROVAL)

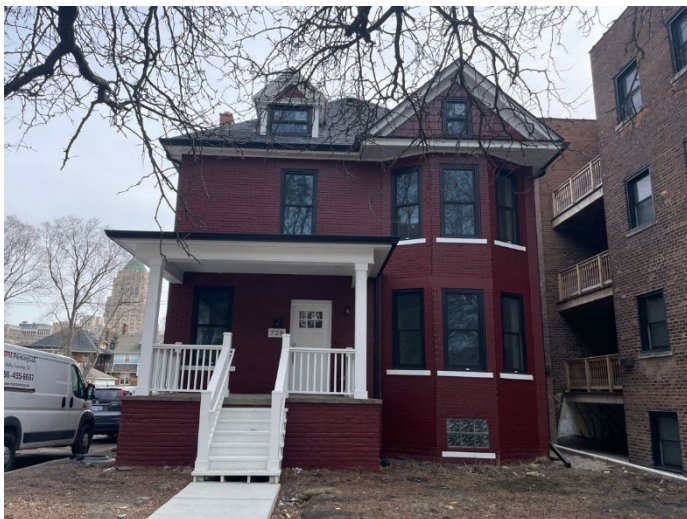
Site Photo 1, by Staff March 24, 2023: (North) front elevation.

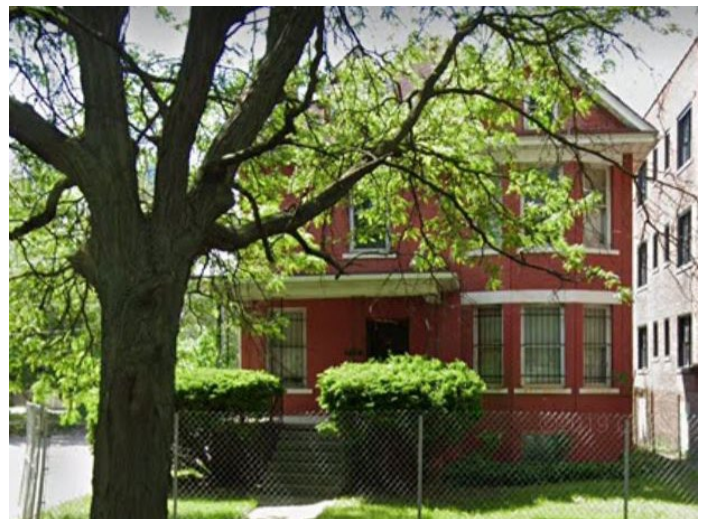
Site Photo 2 by Google Street, June 2019: (North) front elevation showing original windows.

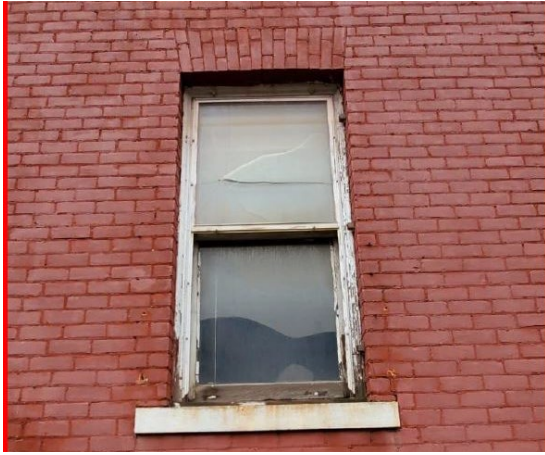
Site Photo 3, by Applicant 2019: (East) side elevation, showing original wood, double-hung window and depth of inset of the sash into the window opening.

- Staff observed that the execution of the installation of the windows alters the historic appearance of the building by erasing the distinctive character-defining feature of the recessed, wood, double-hung windows, creating a flat wall-like feature that erased the dimensions of these historic character defining features. (*See Site photos 3 & 4*)

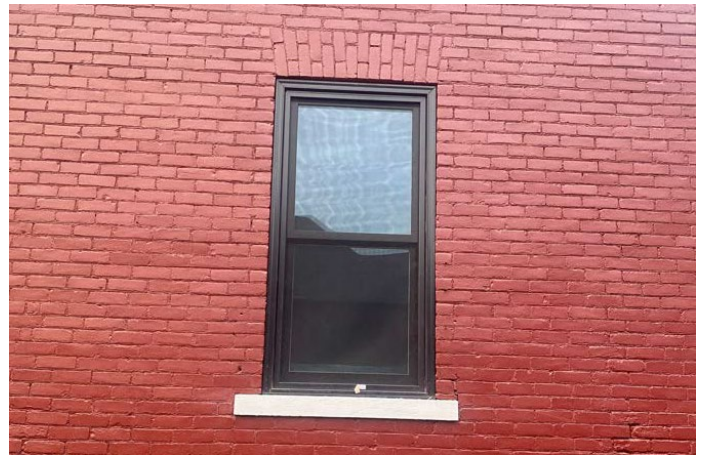
Site Photo 4, by Applicant 2023: (East) side elevation showing new installed window flush with wall opening.

Staff therefore recommends that the Commission issue a Denial for the proposed window replacement, as it does not the district's Elements of Design nor meet the Secretary of the Interior's Standards for Rehabilitation, specifically Standards:
