PREPARED BY: D. RIEDEN

SCOPE: INSTALL WOOD WINDOWS, INSTALL STEEL SIDE DOOR

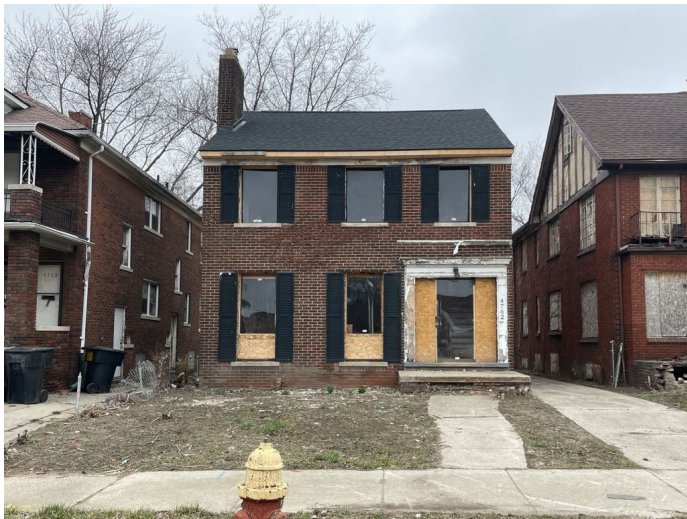
Site Photo 1, by Staff March 22, 2023: (South) front elevation.

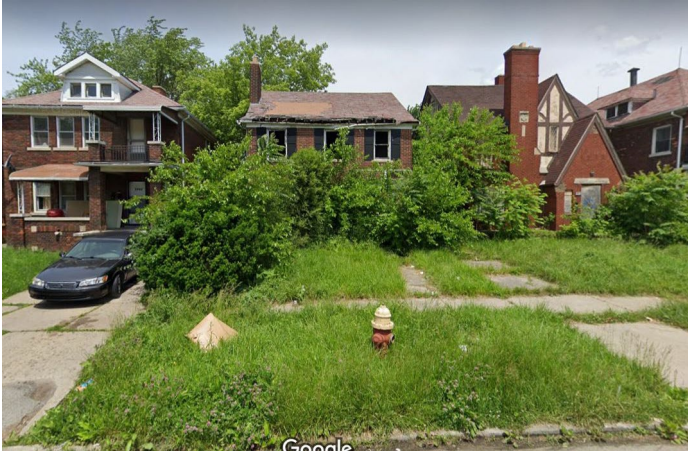
Site Photo 2, Google Streetview June 2019: (South) front/side elevation showing conditions before work and current owner purchase.

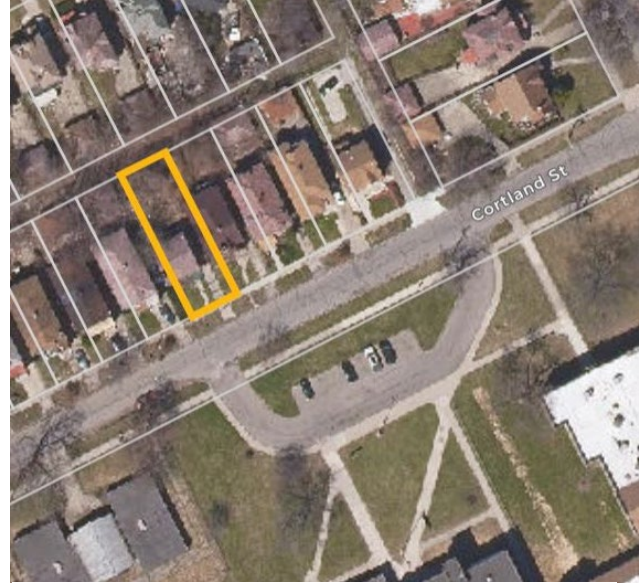
Aerial of Parcel # 14004592.

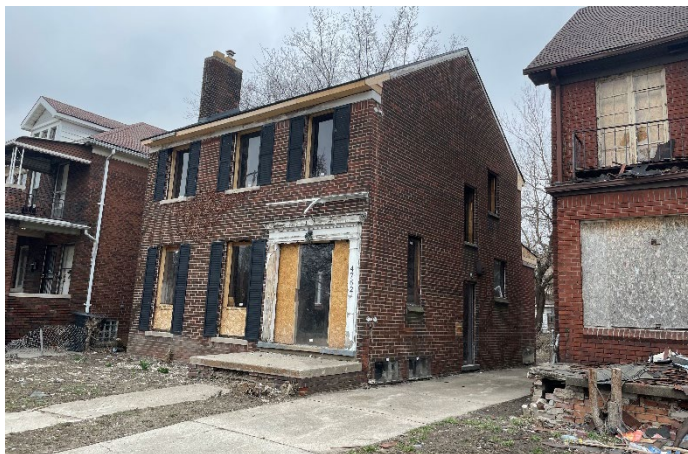
Site Photo 3, by Staff March 22, 2023: (South) front elevation, showing secure view and boarding on windows and side door missing on east elevation.

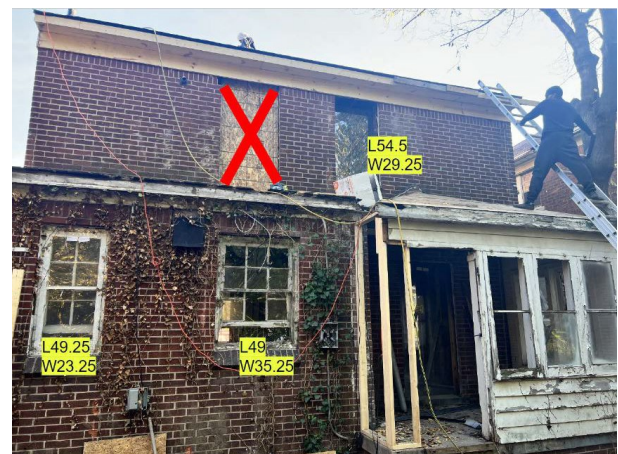
Site Photo 4, by Applicant 2022: (North) rear elevation showing proposed locations for new, single-hung windows, replacing the existing wood, double-hung windows on the first floor.
