STAFF REPORT: 5/10/2023 REGULAR MEETING-**REVISED 5/4/2023** **PREPARED BY:** D. RIEDEN
APPLICATION NUMBER: #23-8326
VIOLATION NUMBER: 571
ADDRESS: 7840 VAN DYKE PLACE
HISTORIC DISTRICT: WEST VILLAGE
APPLICANTS/PROPERTY OWNERS: AMY HAIMERL, KARL ROYDEN KAEBNICK
DATE OF PROVISIONALLY COMPLETE APPLICATION: 4/17/2023
DATES OF STAFF SITE VISITS: 1/25/22, 4/27/23

SCOPE: DEMOLISH GARAGE, REPLACE DORMER SIDING (WORK COMPLETED WITHOUT APPROVAL)

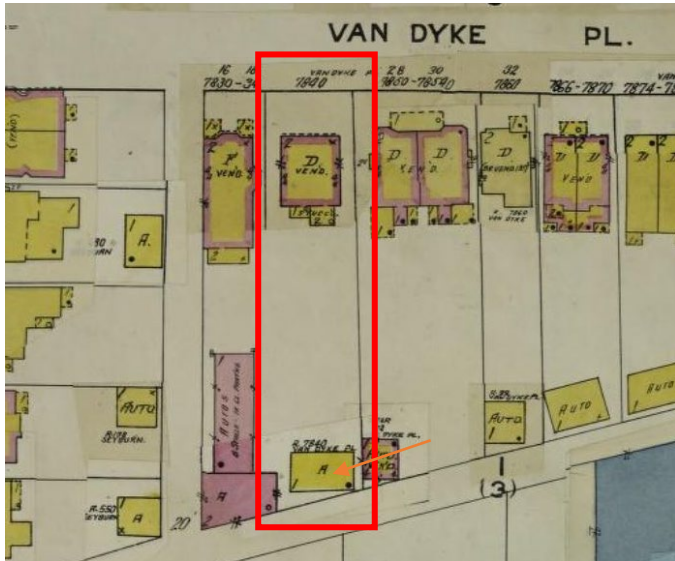
Sanborn V8, P94, 1951, showing the demolished garage location and materiality (arrow).

- The 1951 Sanborn map shows the presence of a one-story wood frame garage at the southeast property corner.
 - The Local Historic District map shows that the garage is at the very edge of West Village Historic District, across the alley from Jennings Senior Living's parking lot.

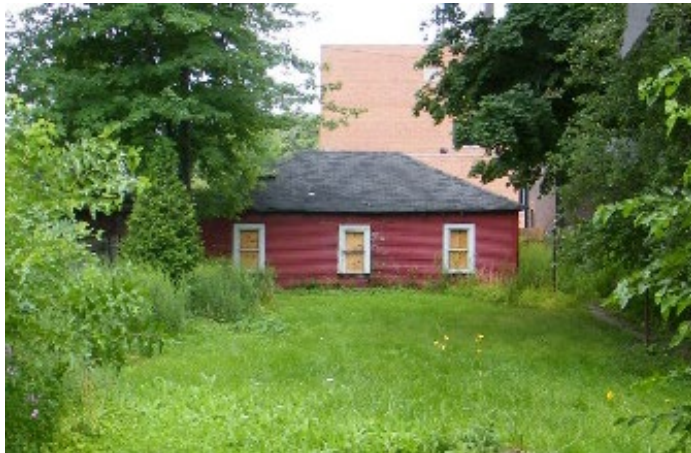
Site Photo 2, by applicant June 2013: (facing south) north elevation of garage, showing previous condition.

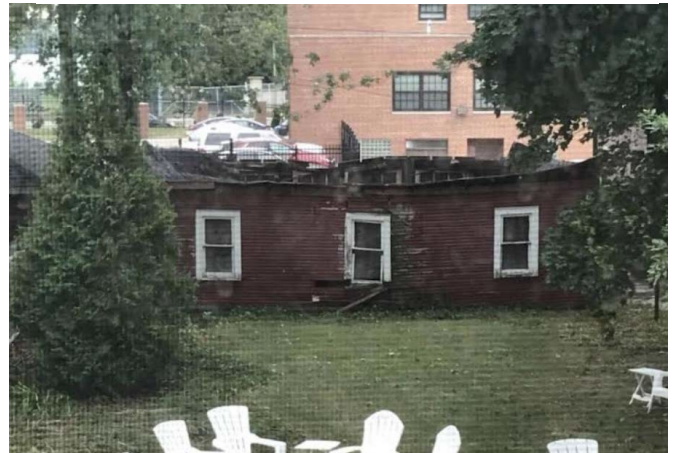
Site Photo 3, by applicant September 2018: (facing south) north elevation of garage, showing roof collapse and wood framing failure.

- Staff observes that the condition of the roof, frame and condition of the garage in the 2018 images, shows that the garage is severely compromised and questions the economic viability for repair of the structure. As shown by the applicant's photos, the roof collapsed in September 2018 and demolition occurred soon afterwards. The roof appears to have a severe lean to the west with significant need of repair, subsidence failure in the center (see site photos 2 and 7), and the exterior walls in a state of collapse.

- While the garage was a contributing structure to the property and the historic district through at least 2013, at some point thereafter, and certainly by 2018, it appeared to lose the integrity necessary to convey its historic significance, because of its ruinous condition.

- Demolition of a contributing structure that has lost its historic integrity due to catastrophic failure would meet the Standards.
- Staff observed that a privacy fence has been erected in the location of the former garage without approval. **Staff invited the applicant to add this unapproved work to the application and revised this report to accommodate their response to include this work in their application.** (See Site Photo 8)

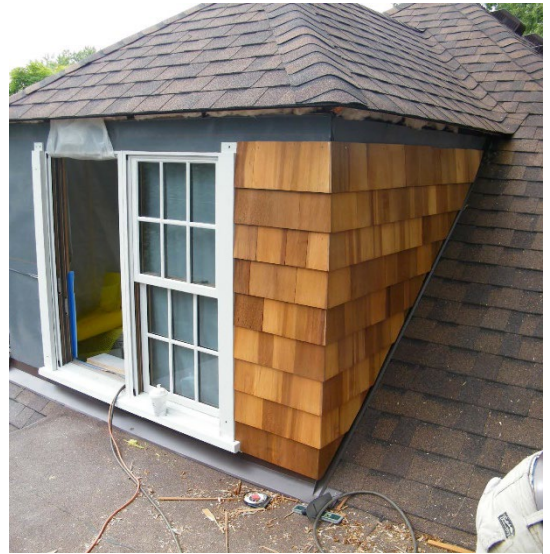
Site photo 4, by Applicant, 2013: roof and dormer, showing asphalt roof and cedar shake siding

- While the color of the asphalt shingle roof was changed from dark grey to a blend of brown and dark grey, it is the staff’s opinion that this replacement of materials is appropriate. (See Site photos 4)

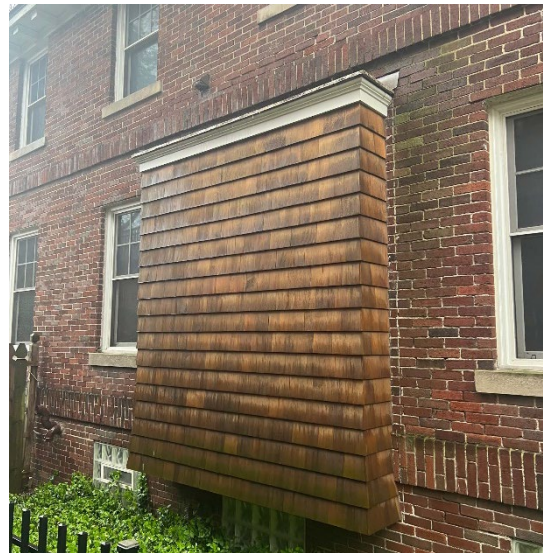
Site photo 5, by Applicant: (East) side elevation, showing cedar shake siding installation at bump-out.

- It is the staff's opinion that the cedar shake shingle installation at the dormers and east elevation bump-out is of an appropriate material, design and scale and meets the historic district's Elements of Design.

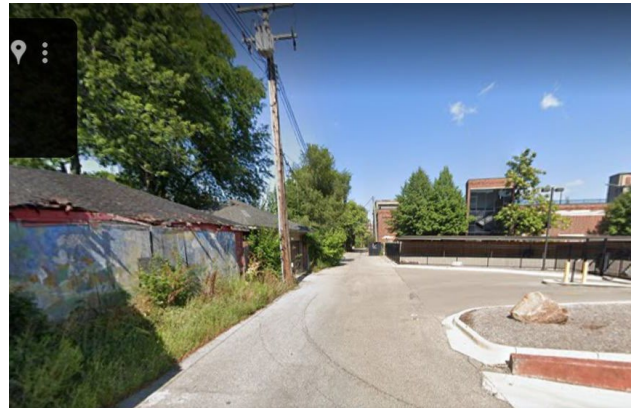
- Staff observes from Google Streetview images that the building appears to be wood frame with wood cladding construction, and while a utilitarian product of its time, does not share character-defining architectural features with the primary structure (ie., the house).

Site Photo6, by Google Streetview August 2018: (Facing east) rear alley, showing garage to the left and parking lots to hospital to the right.

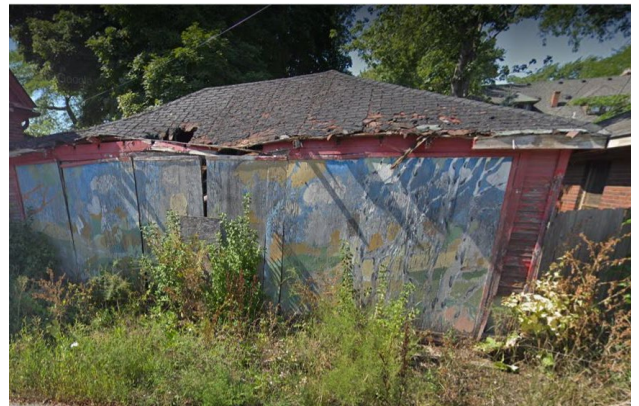
Site Photo7, by Google Streetview August 2018: (Facing north) former garage from rear alley, showing conditions one month prior to roof collapse.

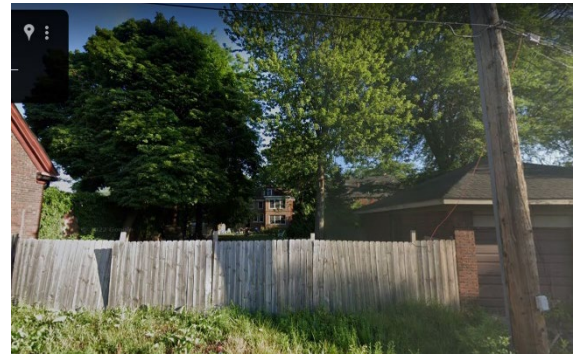
Site Photo8, by Google Streetview July 2022: (Facing north) former garage site from rear alley, showing privacy fence.
