STAFF REPORT: 5/10/2023 REGULAR MEETING

APPLICATION NUMBER: #23-8333

ADDRESS: 4325 FULLERTON

SCOPE: INSTALL VINYL WINDOWS, PAINT TRIM, REPAIR REAR DECK (WORK COMPLETED WITHOUT APPROVAL)

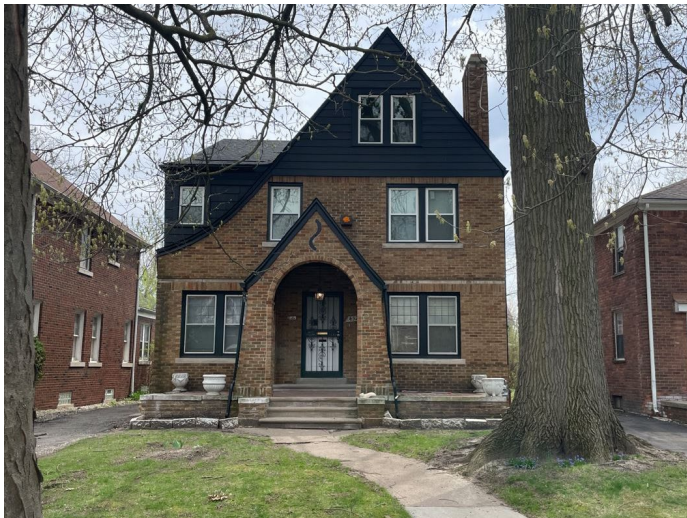
Site Photo 1, by Staff April 20, 2023: (North) front elevation showing replaced windows on 2nd & 3rd floors, black painted siding/trim, and removed light post.

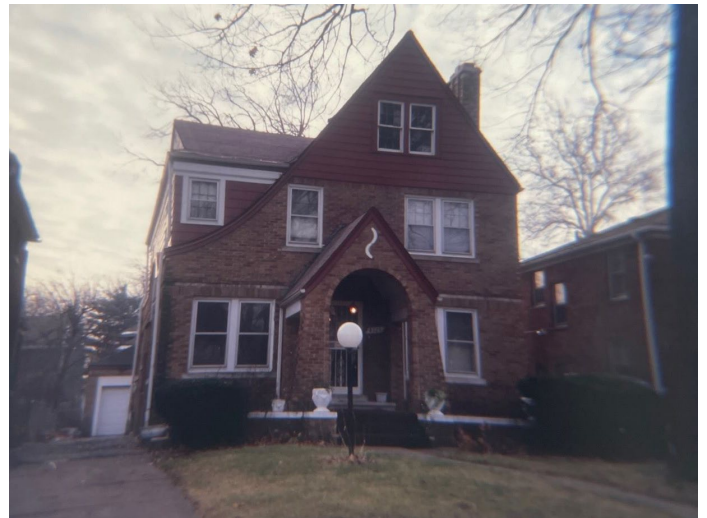
Designation Slide, 1999: (North) front/side elevation showing original windows and light post.

- From the designation slide, it is staff's observation that the original windows were wood, double-hung with a 6/1 configuration on the upper floors. It is staff's opinion that these original wood windows, their double-hung operation, and 6/1 divided lite configuration are distinctive character-defining features that have been removed/destroyed.
- Vinyl is not an appropriate material for replacement windows in the Russell-Sullivan Historic District, given its inability to faithfully replicate historic profiles, its detracting color/sheen, and its poor detailing.

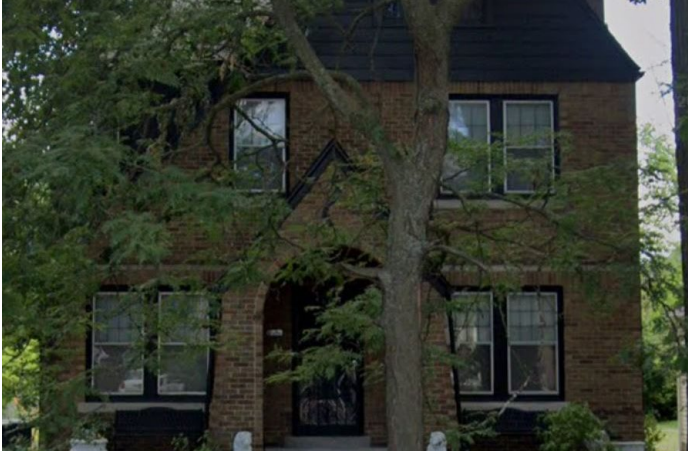
Site Photo 2, Google Streetview June 2022: (North) front/side elevation showing windows before work.

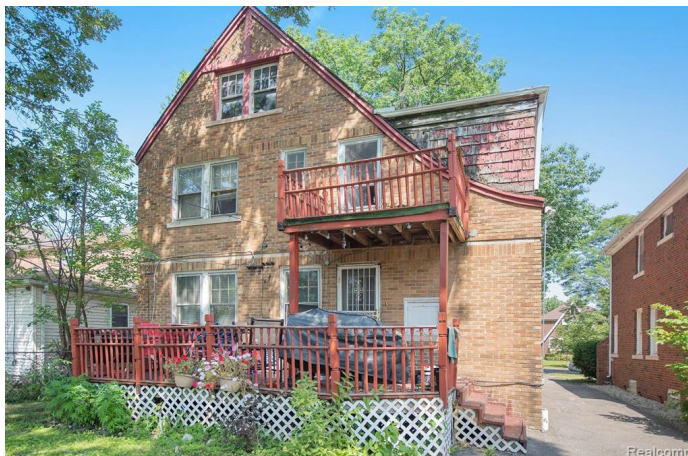
Site Photo 3, by Applicant (unknown date) March 22, 2023: (South) rear elevation, showing original windows, deck and balcony railing, siding, and trim colors.

- From the applicant photos, staff observed that the original railing exhibited spun spindles with a double railing top and no bottom rail, which has been replaced by square-spindled wood railing with a single top and no bottom rail. Typically, historic railings would consist of a top and bottom rail, similar to the railing added to the stairs as shown in site photo 4. Staff has the opinion that the current railing design would be more historically appropriate if the bottom rail was returned as part of a porch design rather than a deck. However, given that the bi-level deck likely predated the designation of the district, reconstruction in the manner executed would be acceptable. This is not a porch but a deck.

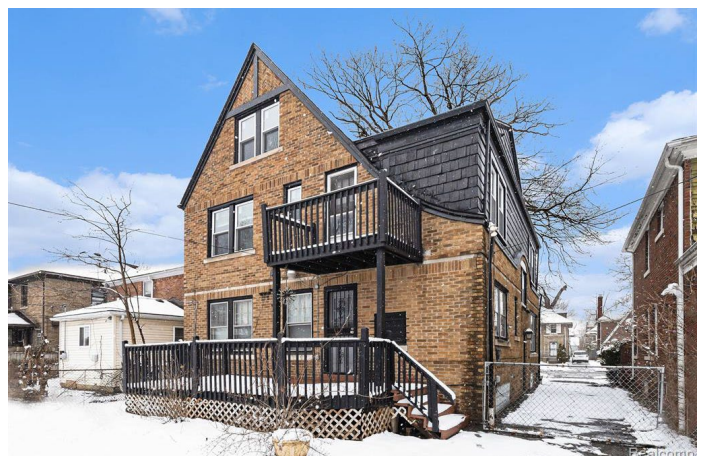
Site Photo 4, by Applicant 2022: (South) rear elevation showing replaced windows, repaired siding, new railings, and trim/siding paint work. Notice windows on 2nd and 3rd floor have been replaced, while the original first-floor windows remain.

- While painting the deck to match the siding and trim of the house is appropriate, the color black is not appropriate, in staff's opinion, and is addressed in the next section.

- Staff has no issue with the proposed repair of the wood siding.
- According to the Commissions guidelines, Color System D for Tudor Revival homes and the color black is not listed as an appropriate color for the shingle siding and deck. Dark grayish olive would be the closest appropriate color. Other colors include Moderate Brown (B6), Grayish Brown (B8), and Moderate Olive Brown (B13).

- The shingle siding, deck and trim be repainted a color selected from Color System D of the HDC color chart guidelines.

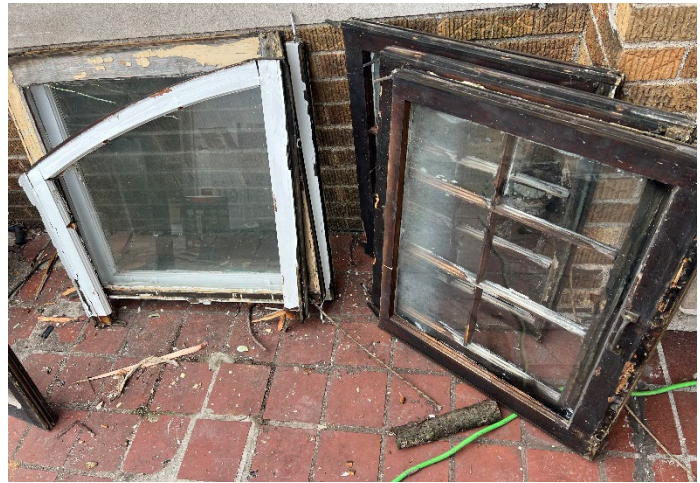
- Staff requested original window photos and condition details and received a photo (*see Site Photo 5*) and the following description: “*When I purchased the home, it was completely derelict and had been occupied by squatters. After removing them from the property, we discovered that the second floor windows had at some point been replaced, and were non-functioning/rotted through. At first, we attempted to repair the windows, but after continual breakage, degradation, and a repair specialist telling me they weren’t able to be fixed, we were forced to use Mulligan Windows in Farmington to replace them*”.

- Staff has confirmed with the applicant that the original windows have been removed and destroyed by the window contractor.
- The applicant states that three other vendors were contacted, Majic Windows, Wallside Windows and Iovan Door and Glass, and all including the installer, Mulligan Windows, confirmed that the windows were beyond repair. It is staff’s opinion that these window suppliers may not have window repair services to adequately assess the conditions and reparability of historic windows.

Site Photo 5, by Applicant, showing conditions of original windows removed.
