**STAFF REPORT: JUNE 14, 2023 MEETING**  
**APPLICATION NUMBER: 23-8388**  
**ADDRESS: 1186 EDISON**  
**HISTORIC DISTRICT: BOSTON EDISON**  
**APPLICANT: LEON HUNTER, III**  
**PROPERTY OWNER: HB1 ALTERNATIVE HOLDINGS, LLC**  
**DATE OF PROVISIONALLY COMPLETE APPLICATION: MAY 22, 2023**  
**DATE OF STAFF SITE VISIT: MAY 30, 2023**

**SCOPE: DEMOLISH GARAGE, ERECT GARAGE, REPLACE WOOD WINDOWS**

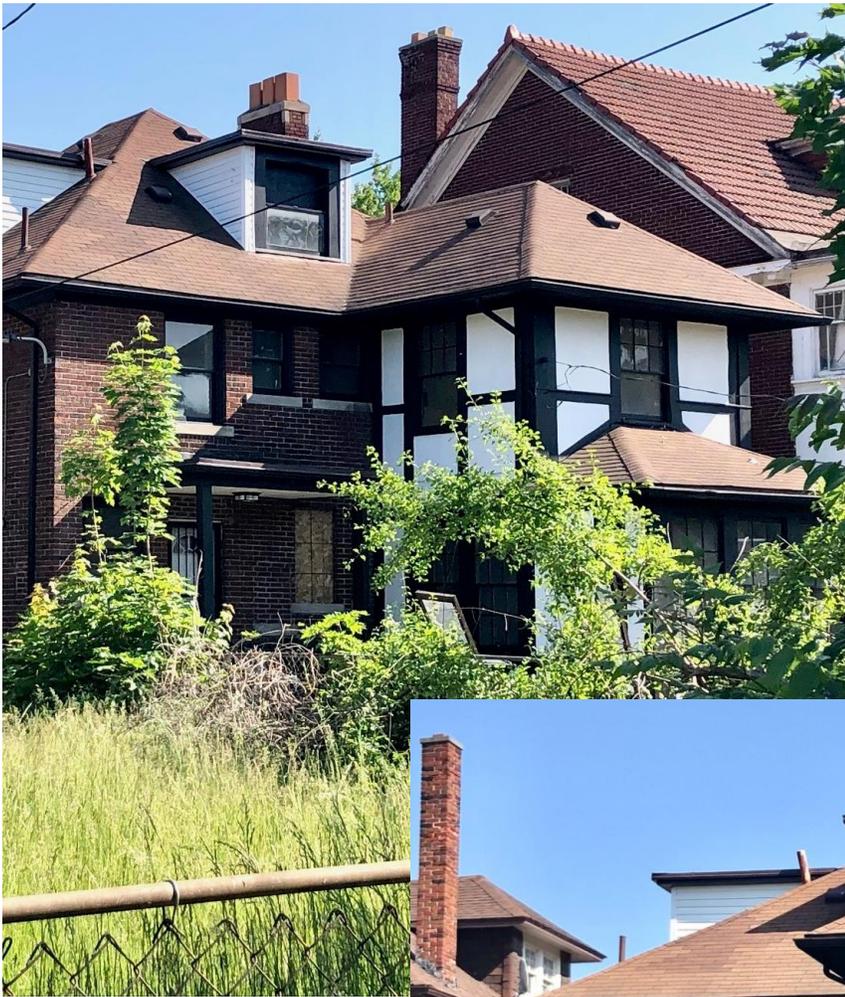
The rear elevation is remarkably intact. The historic window and door openings, and exterior wall surfaces (except for the vinyl siding at the shed dormers), appear to be unaltered and in very good surface condition. Only a few window openings have what might be replacement units (with one window opening boarded up). The design and color of the non-historic rear door is not appropriate for the age and design of the house.

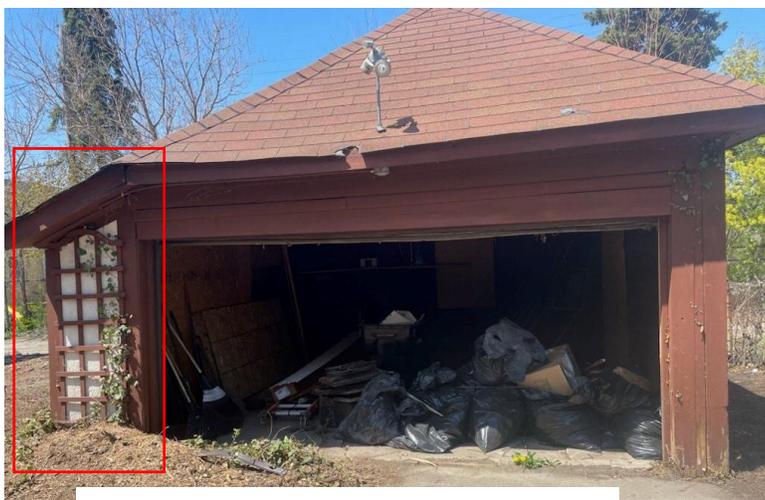
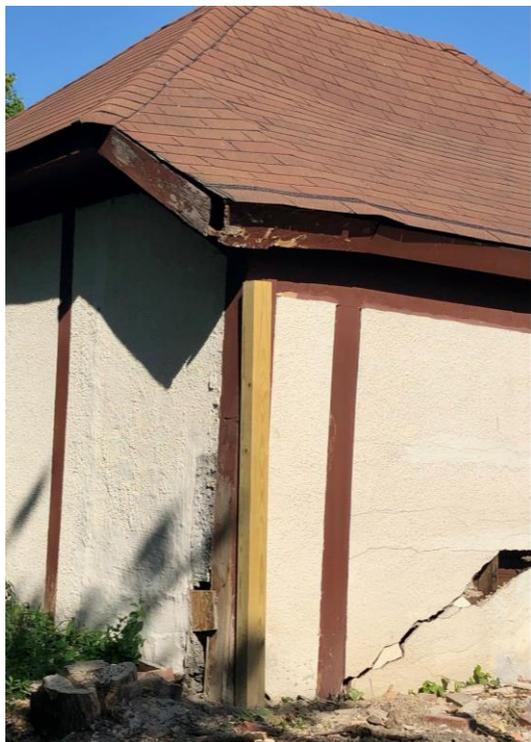
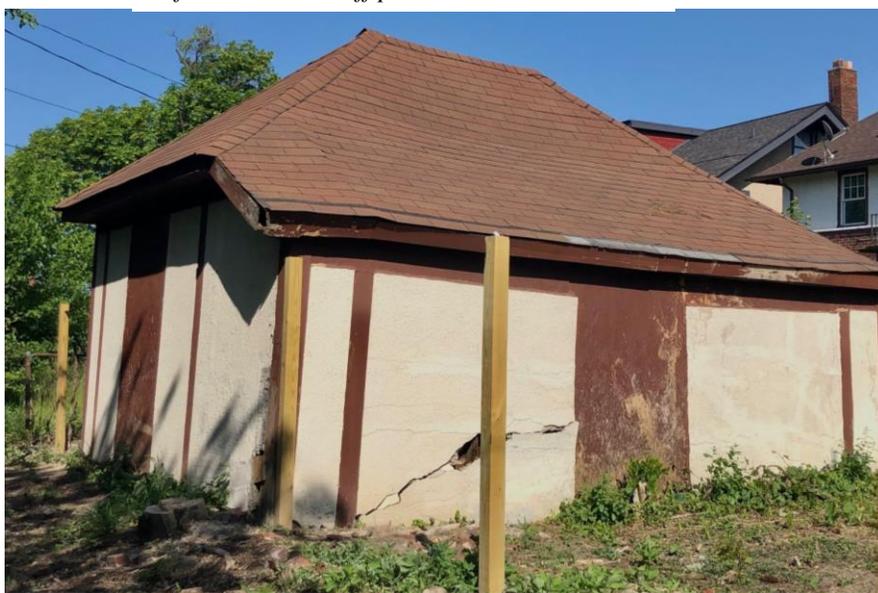
- At some point in time, an extension to the garage was erected at the west wall, and the shed roof of the extension was tied into the garage's hip roof.
- During staff's May 2023 visit, the buckling of the roof where it sits over the extended area was evident; the main roof appeared intact. The leaning wall and severely cracking stucco were evident at the "newer" walls.

- Staff requested a detailed assessment of the garage and supportive photographs demonstrating that it is beyond repair. This information was not submitted. Based on the short description and submitted (mostly exterior) photographs, staff doesn't believe the garage is deteriorated beyond repair. Its demolition would alter the features and spaces that characterize the property.
- The applicant submitted a generic rendering and material list for the proposed garage. In response, staff requested a site plan and drawings so all details and elevations related to the new construction could be reviewed. This information was not submitted.
- It is staff's opinion that the proposed garage is not appropriate for the property as the overall form and materiality do not relate to the house and site.

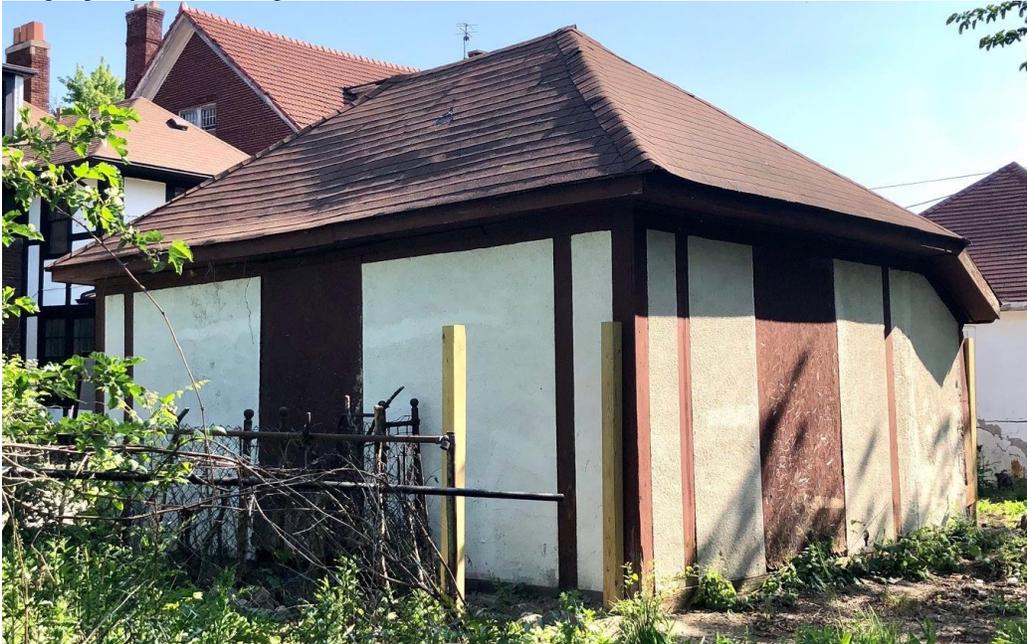
- The photos below of the garage walls show a repeating pattern of stucco and timber, which echo the vertical patterns on the house. Oriented strand board fill the center openings on these walls. Staff isn't sure what this is covering (window openings?) or if it replaced some other decorative material.
- It is staff's opinion the overall design of the garage is directly linked to the main house, evident through the matching pitched hip roof and the stucco/timber walls, and is therefore, a distinctive character-defining feature of the property (with exception of the extension at the west wall).

*Staff photo - east and north elevations*

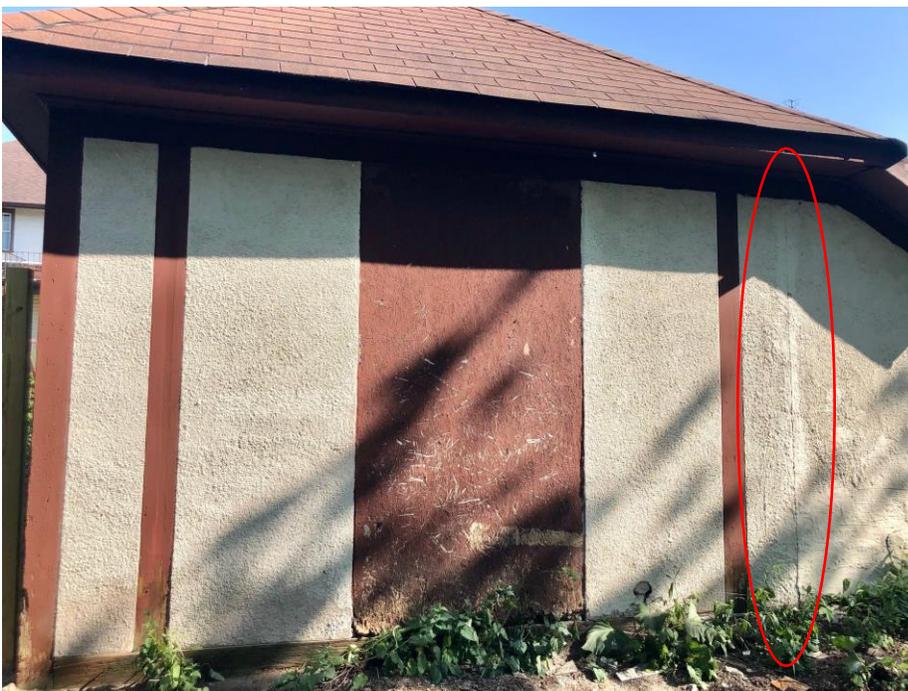
*Staff photo, north elevation facing alley – joint where wall was extended is visible.*

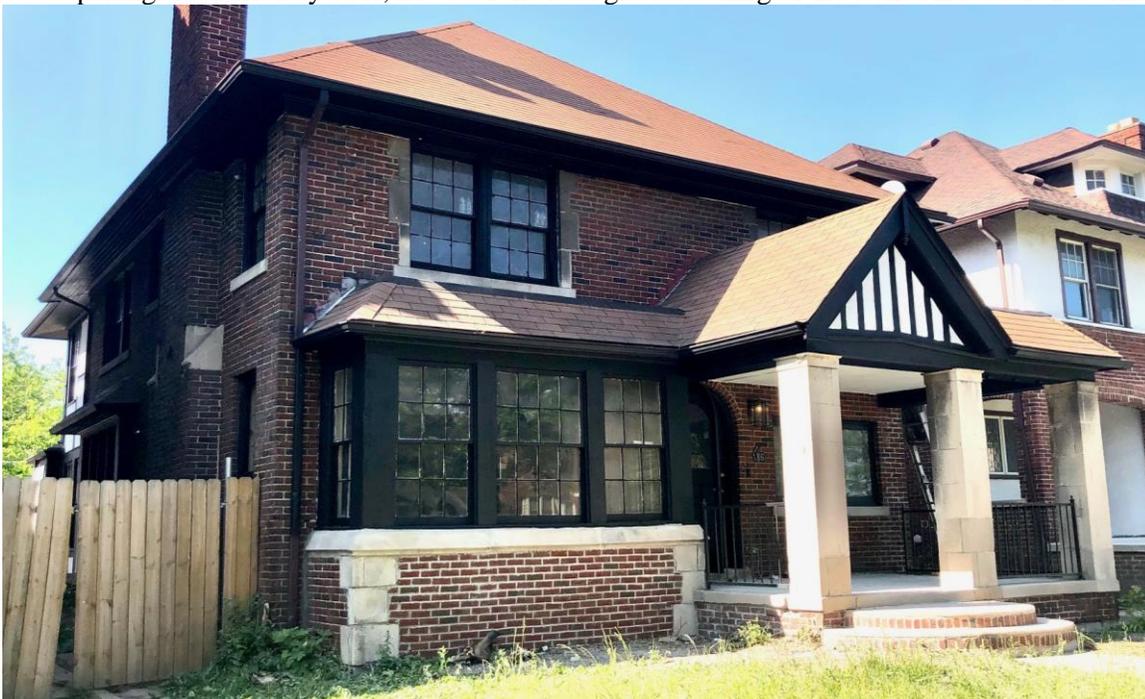
*Staff photo*

- Based on the photos taken during the site visit, the historic wood windows are intact and, from the exterior, don't offer evidence of severe deterioration.
- The applicant, in responding to staff's request for comprehensive documentation on all the windows, submitted only a few interior photos of single window openings that are dark, far away, or partially covered. No full exterior elevation photos were submitted so staff doesn't know what each window looks like. Leaded glass windows are visible from the sidewalk, and it is possible there are more leaded glass windows on the home that are not visible for the public right-of-way. Photos on the following page offer visual aid as the locations of openings identified by staff, however the lead glass detailing of the stair windows is not visible.

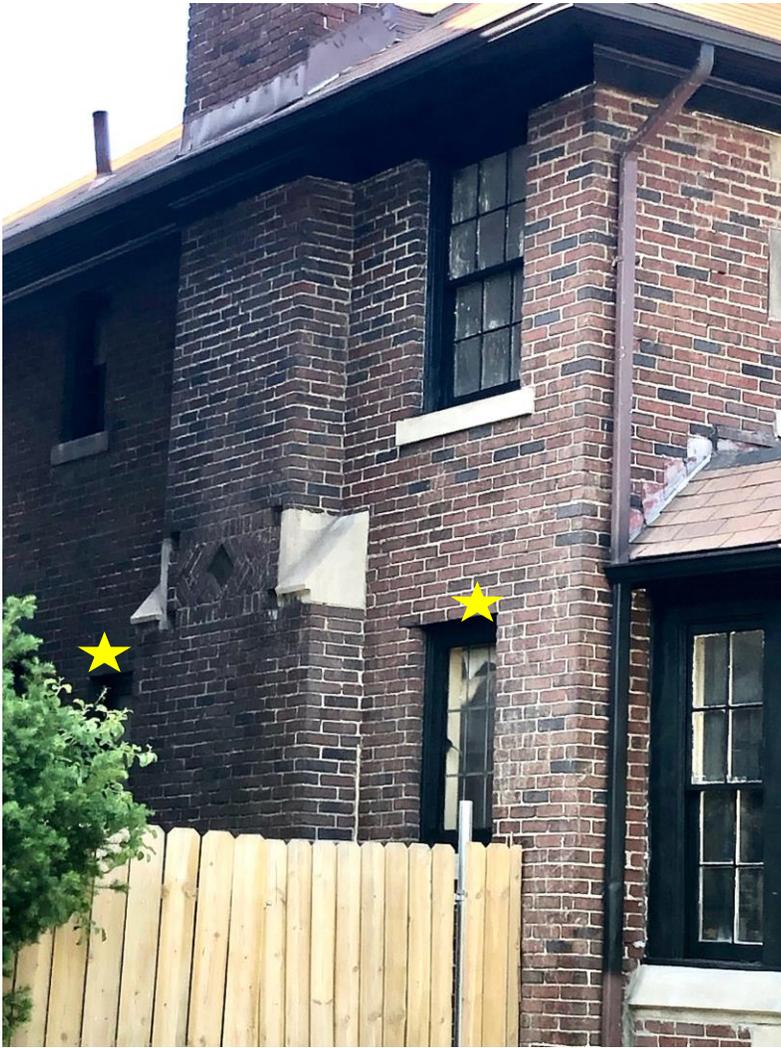
*Staff photos. Leaded glass casement windows are adjacent the chimney, fill the opening at the stairwell, and open onto the front porch.*

- The applicant has not proven the existing windows are beyond repair.
  - Dimensions of the historic window sash were not submitted to determine how closely (or not) the Pella product will match the wood double-hung windows.

- The Pella window order specifies that wood, aluminum-clad windows will be installed in each window opening. This means that leaded glass windows would be replaced with windows that do not match the dimension, texture, and visual qualities of the existing windows.
