**STAFF REPORT: JUNE 14, 2023 MEETING**

**APPLICATION NUMBER: 23-8404**

**ADDRESS: 8022 KERCHEVAL**

**SCOPE: REHABILITATE HOUSE, ALTER LANDSCAPE**

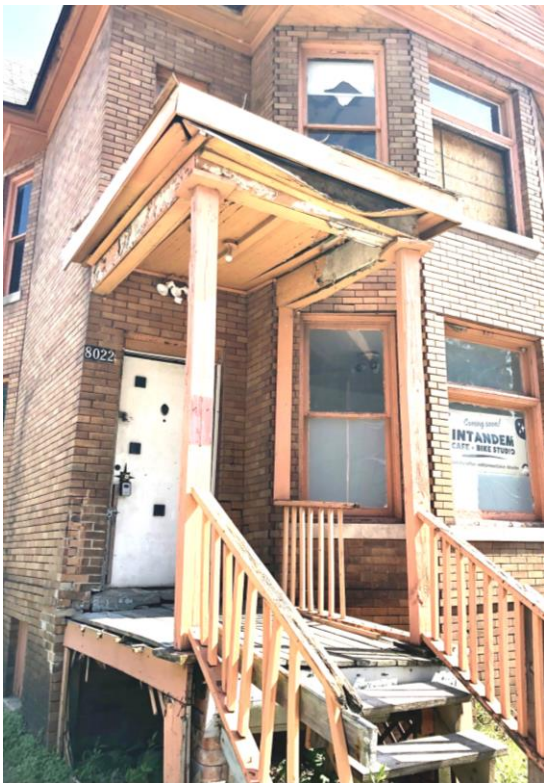
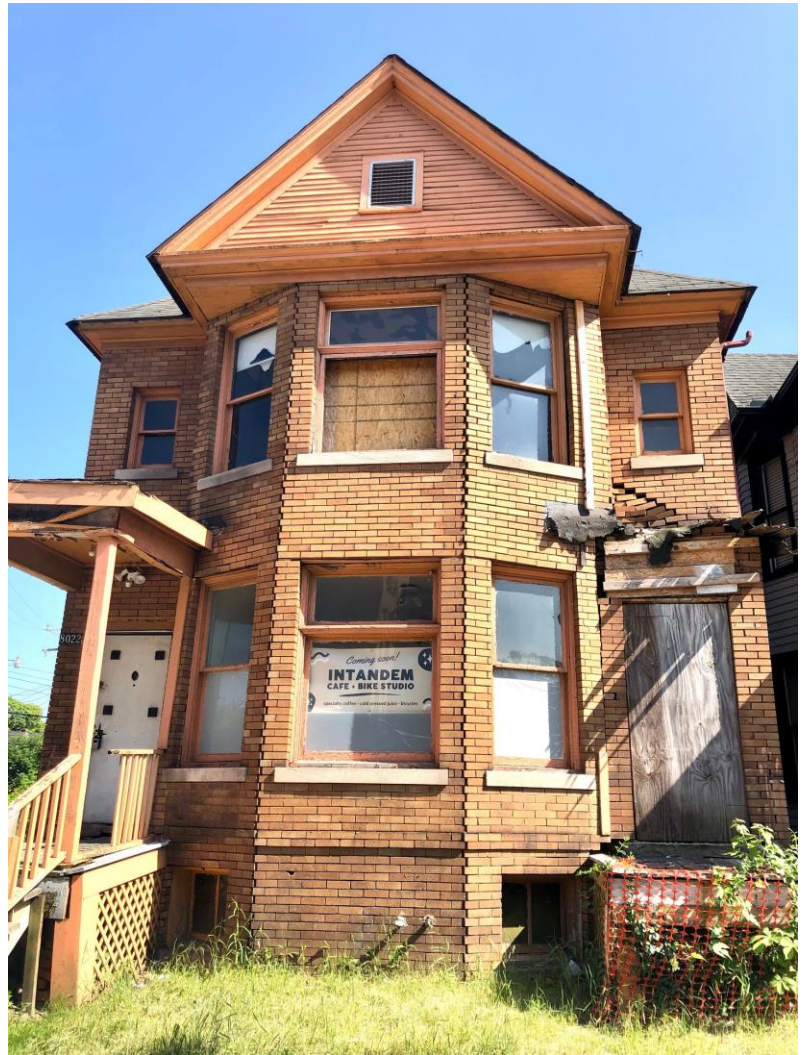
*Staff photos, May 30, 2023.*

The west front entrance porch is partially intact; mismatching grout joints at the wall shows where a porch rail once met the house. The east porch is missing and while the brick adjacent the front door appears intact, damage to the brick above the missing porch is visible.

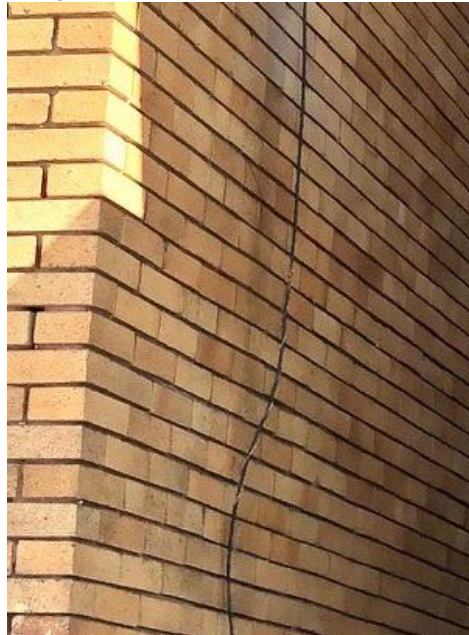
*Staff photos, May 30, 2023*

Upon close inspection of the site visit photographs, staff noticed that the vertical mortar joints are flush with the brick, while the horizontal mortar joint have a raked/recessed joint. This creates the effect of a traditional brick pattern when looking at a façade straight on and offering strong horizontal lines when looking at a wall from an angle.

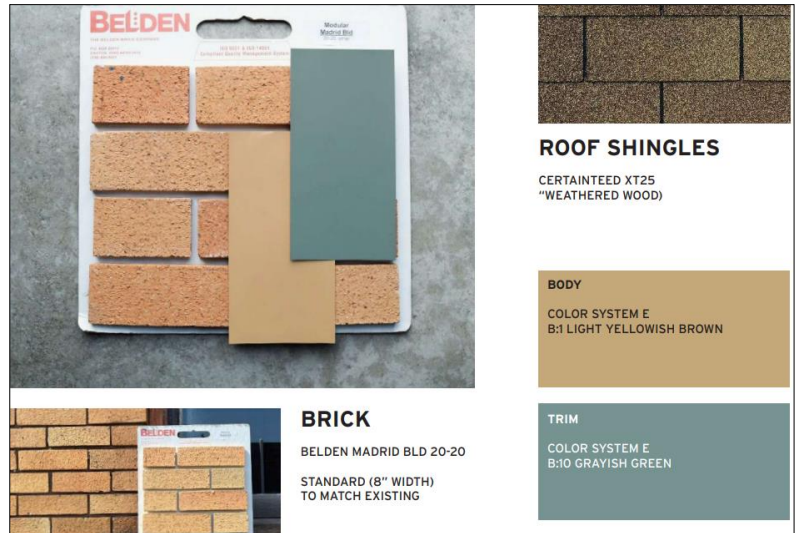
- The restaurant will need to have an exhaust fan and it is proposed for the existing historic round opening at the basement level on the east elevation. The specifications for the venting haven’t been determined, so the impact on the existing opening and elevation isn’t known at this time.

- The concrete block enclosing the wheelchair lift will be painted to match the color selected for the lap siding.
- A cut sheet of the proposed skylights, which lists all details, dimensions and finish, will be submitted for staff review.
- A cut sheet of the selected exhaust vent shall be submitted for staff review that offers a picture of its exterior appearance, in addition to the details, dimensions and finish of the product. Revised elevation drawings will be submitted for staff review should the selected vent require modifications to the existing opening.

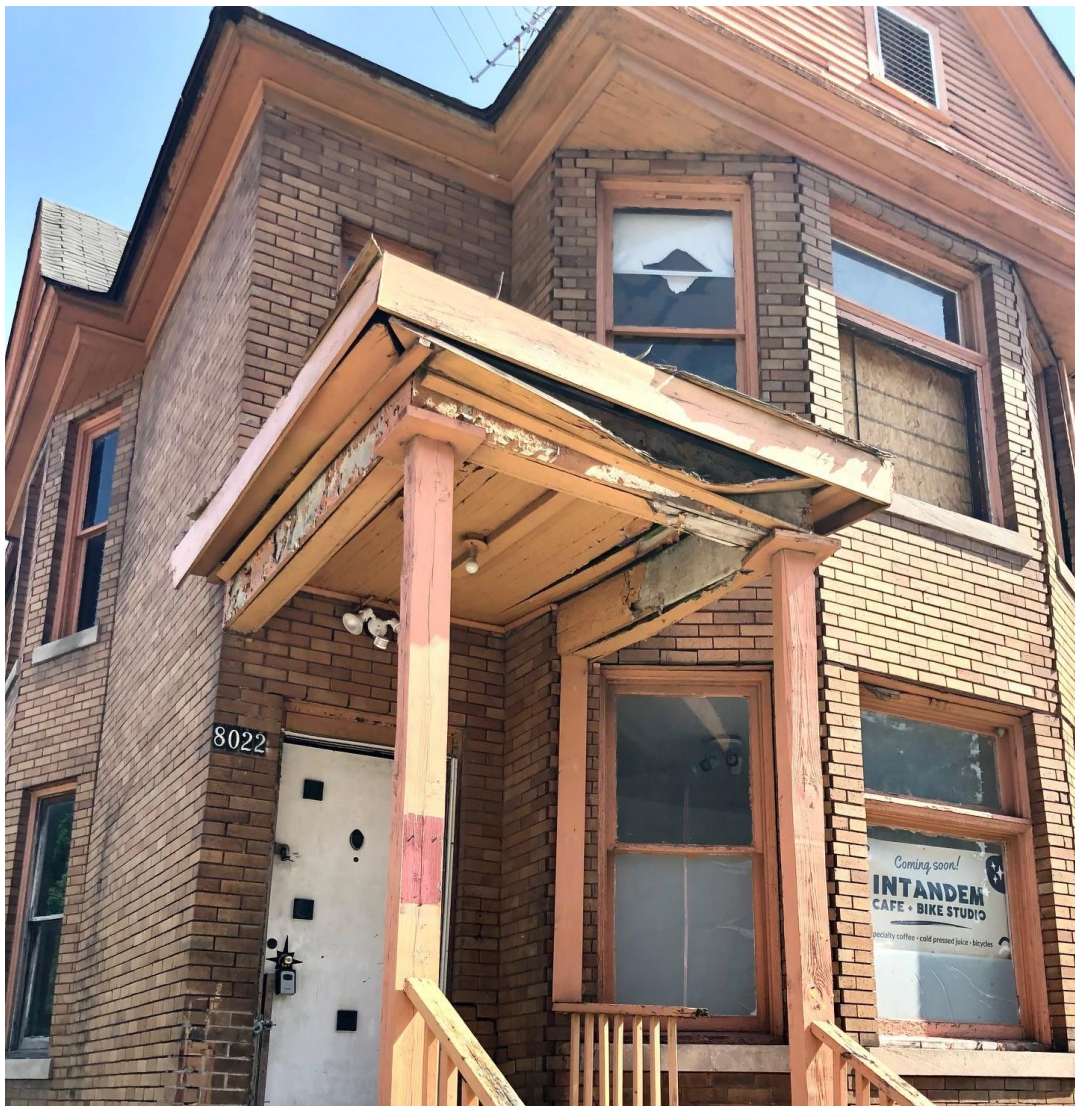
*Staff photo, May 30, 2023*

- Staff questioned the need to remove the historic brick veneer from the front elevation and the laying of new brick due to deteriorated masonry anchors. Staff inquired as to whether replacement masonry ties or anchors can be installed to reattach most of the existing bricks to the structure. Staff's reasons for retaining the existing brick facade are:

- This structure doesn't have articulated corners (such as quoins or wood/stone pilasters), so the bricks wrap the corners of the building. Laying new brick on the front elevation to seamlessly fit into the existing condition would be challenging. The new brick would need to be identical in all details to the historic brick – a comparison of dimensions (including depth of each brick) hasn't been submitted.

- The historic brick has a patina due to its age and exposure to weather and other elements; the new, brighter brick would create a distracting contrast against the historic structure.

- The bay's angled corners have a unique break to them which may also be difficult to duplicate.
  - The brick and its method of installation, including the different mortar joint applications and broken corners at the bays are distinctive character-defining features of the structure.

- Replacing the historic brick on the front elevation with new brick will drastically alter the appearance and features of the structure, due to the loss of patina and the subsequent contrast between old and new brick. Additionally, it is not known if the new brick offers an identical dimensional product to seamlessly fit within the existing brick pattern and mortar joints.

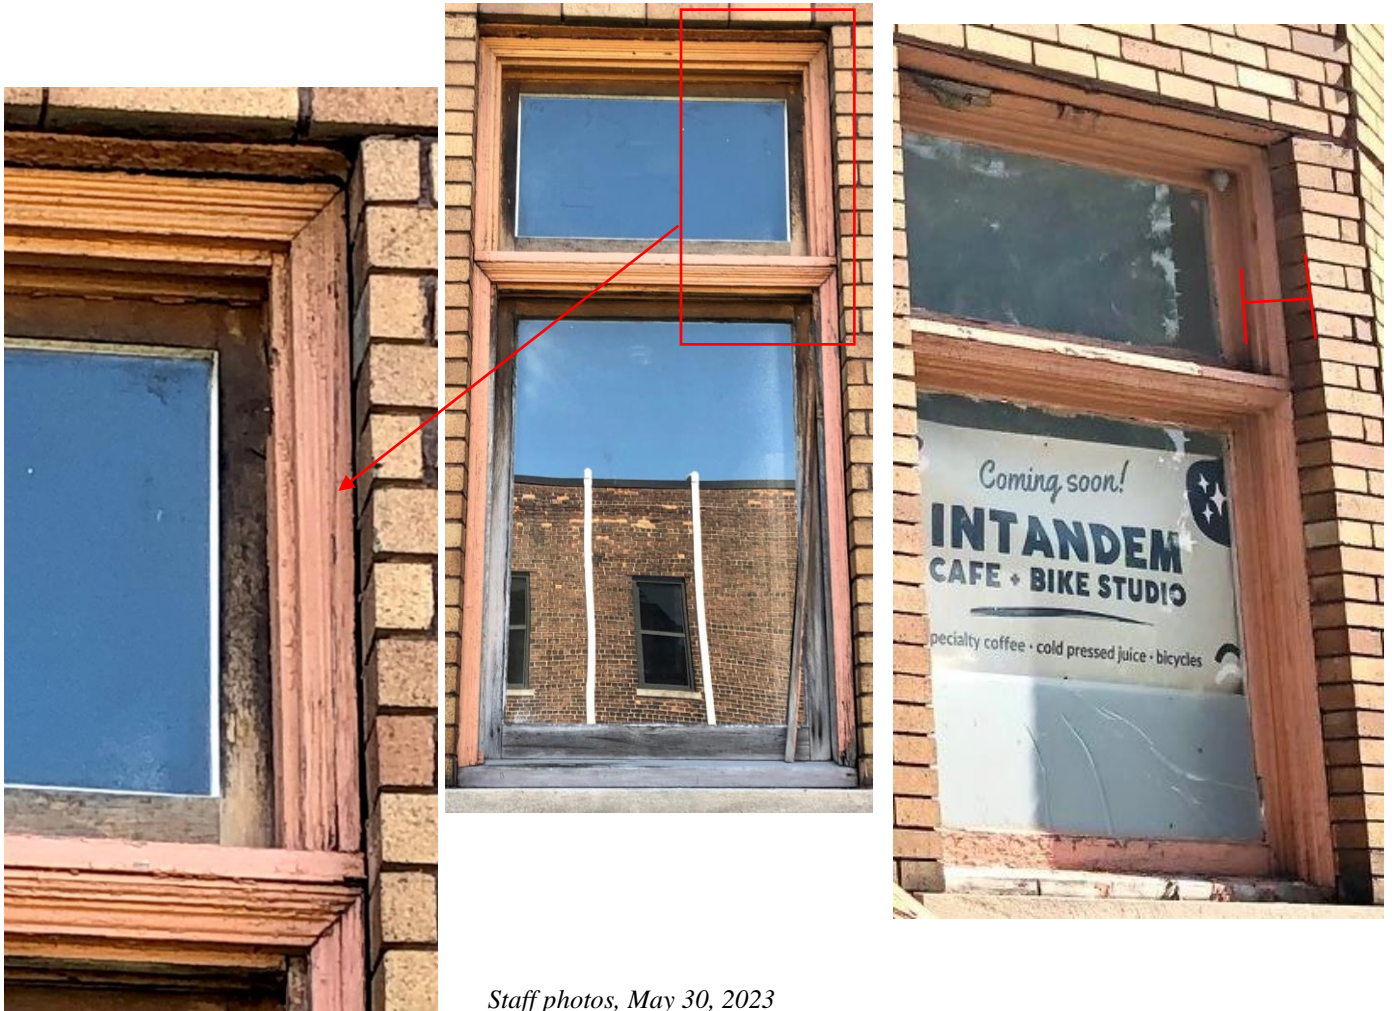
Staff photos, May 30, 2023

- Like the staff concerns listed with the replacement of the front elevation brick veneer, the replacement of the windows and brickmold with aluminum-clad wood windows and metal brickmold will alter the historic architectural features of this structure. It is staff's opinion, the wood windows, due their deep setting within the openings, and exceptionally detailed brickmold, are distinctive character-defining features of this property.

- It is staff's opinion that the only window that can match the existing windows would be wood windows set in the same recessed location with a custom wood brickmold. As the existing windows are likely the original pre-1910 windows, the wood sash and brickmold are fabricated from dense, old growth wood, which is much more stable and durable than contemporary fabricated wood windows. Many studies have been conducted to show that repair, and ultimately restoration, of old growth wood windows coupled with new storm windows can meet the energy efficiency of new insulated windows.

- Staff requested a repair estimate so the Commission can understand the level of deterioration of the existing window sash. Most window openings retain upper and lower sash, a small number of sash require new glass.

- The existing wood windows are set deeply within the openings, and the wide brickmold has an exceptionally detailed profile. Replacement windows and aluminum brickmold will not offer the same dimensionality and placement.

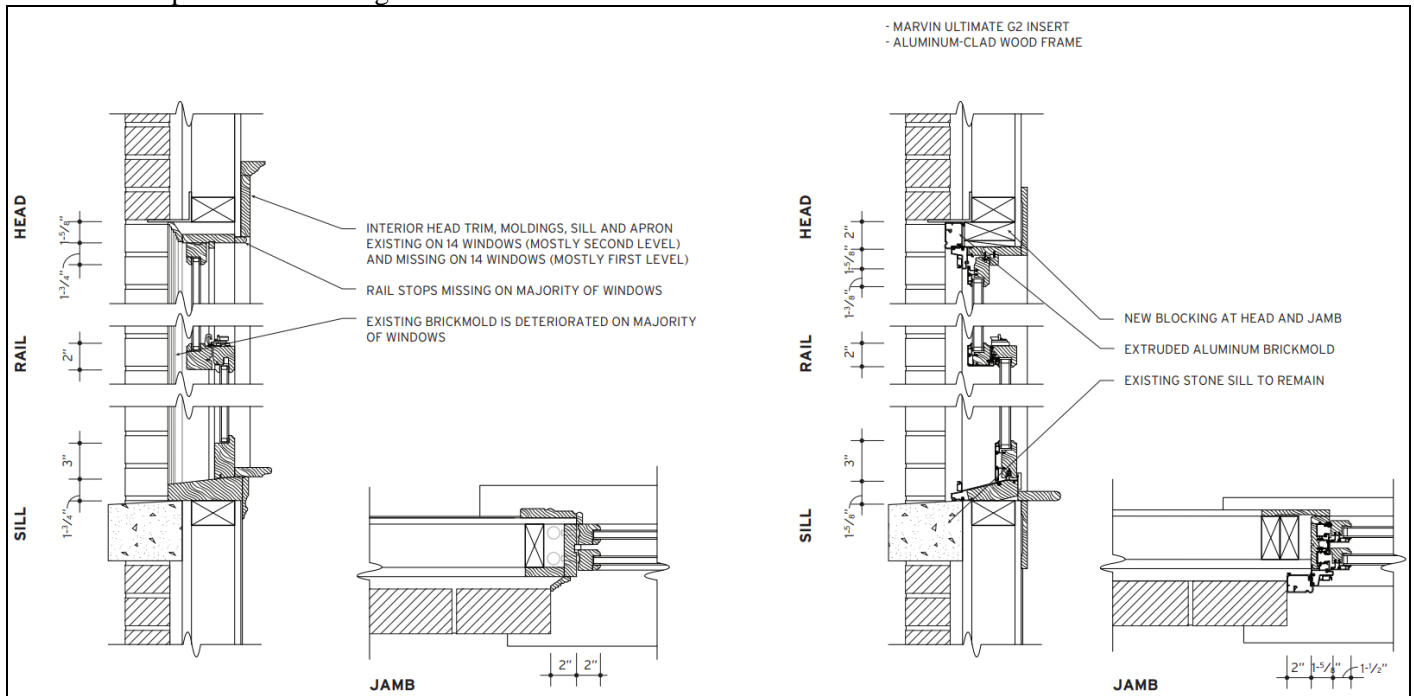
Drawings provided by applicant

Component-Horizontal	Existing	New	Change of new window	Comments
Brickmold	1-5/8"	2"	3/8" increase	
Top Rail	1-3/4"	3"	1-1/4" increase	New window breaks down the top rail with two dimensions due to multiple components (1 3/8 + 1 5/8)
Meeting Rail	2"	2"	0	
Bottom Rail	3"	3"	0	
Window Sill (stone sill to remain)	1-3/4"	1-5/8"		Existing sill has a thicker front portion, and less angle back to window (looks thicker and flatter)
Component-Vertical	Existing	New	Change	Comments
Stile	2"	2-1/8"	1/8" increase	
Brickmold	2"	2"	0

- The most drastic increases in dimensions for the new window are with the brickmold (3/8" taller) and top rail (1-1/4" taller).
- The manufacturer's section shows a standard brickmold with only one small bend, so it has a mostly flat appearance, which is drastically different from the highly detailed existing brickmold. Although the applicant is working with the manufacturer to design a more detailed brickmold, staff is unsure if aluminum can be bent in such a way to match the existing profile and retain adequate strength.

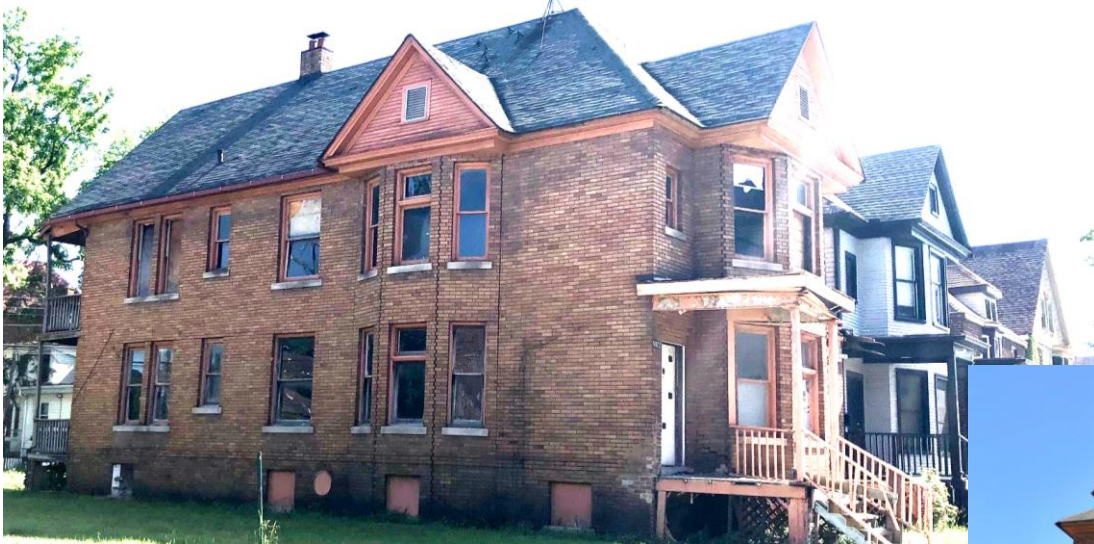
Staff photos, May 30, 2023

- The two family house was designed as a cohesive structure. Patterning is found in the symmetrical window openings, horizontal raked mortar joints, water table, and decorative brick, all of which is found on each side of the building.
- The two-story bay windows are distinctive character-defining features; the uniformity and relationship between the bay window openings on each floor and elevation is an important historic component of the structure and offers a visual clue as to its original multi-family residential use and era of construction.

- The two-story bay windows are distinctive character-defining features; the uniformity and relationship between the window openings on each floor and elevation is an important architectural component of the structure. The installation of storefront glass in the front elevation first floor bay windows would disrupt and alter the symmetry of these window openings.
