APPLICATION NUMBER: 23-8698

ADDRESS: 2274 CHICAGO

HISTORIC DISTRICT: BOSTON-EDISON

SCOPE: REPLACE WOOD WINDOWS WITH VINYL WINDOWS, ~~INSTALL DOOR~~ (WORK COMPLETED WITHOUT APPROVAL)

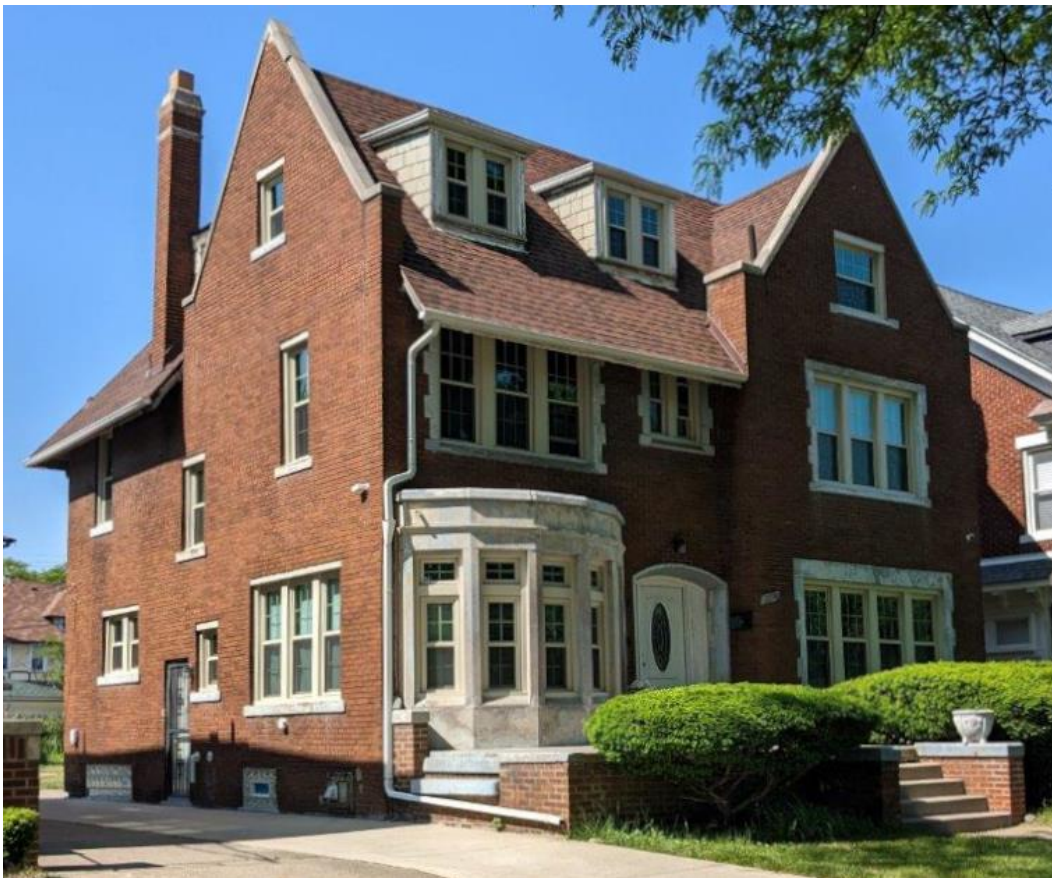
May 2023 photo by staff.

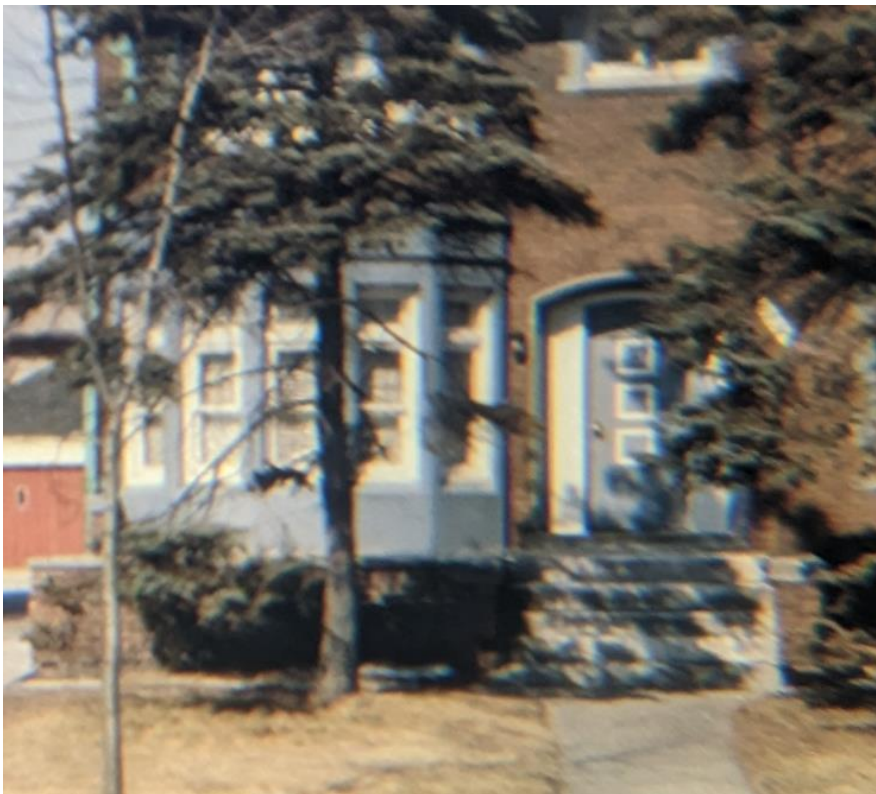
1980 Historic Designation Advisory Board photo. (Note that a grey paint visible in this photo has largely peeled off to reveal the underlying

stone door and window surrounds.)

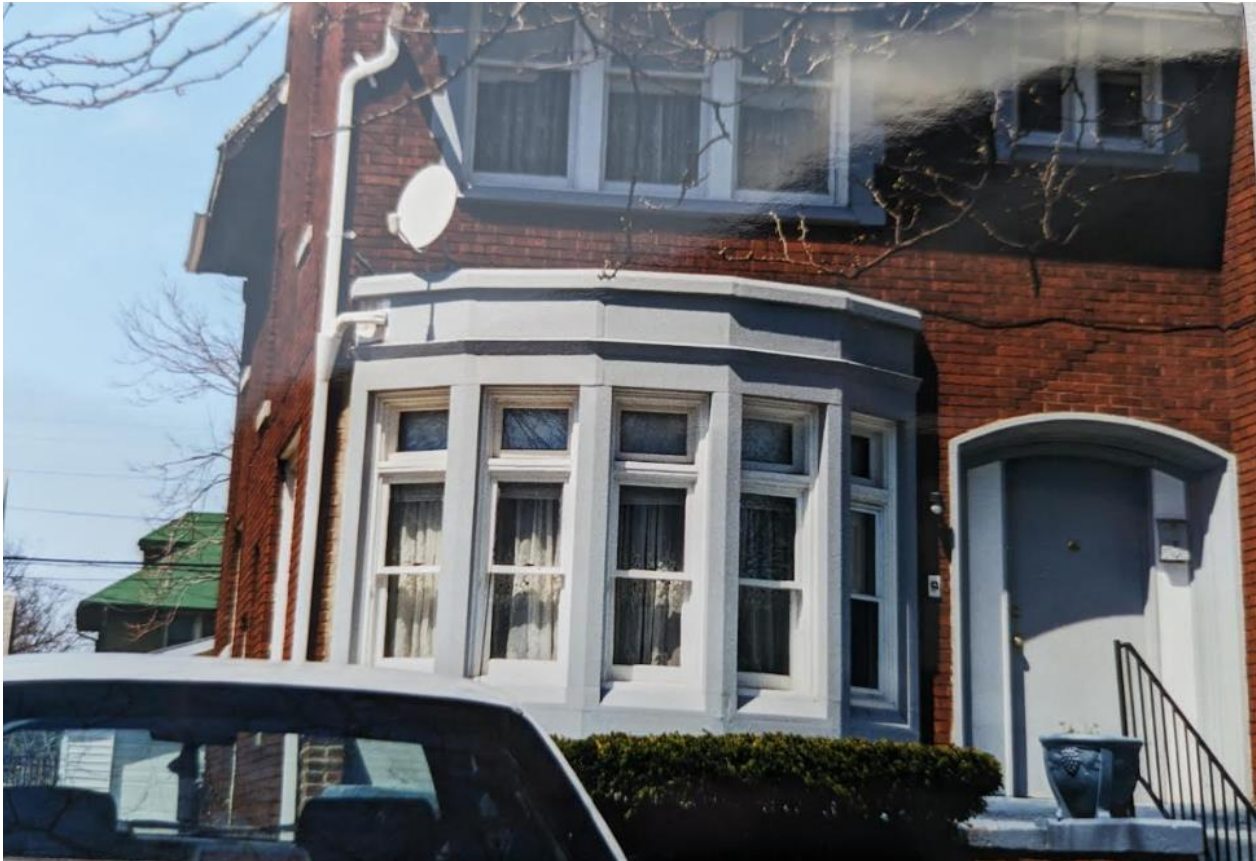
May 2000 staff photo. Note thickness and depth of window sashes differs from current windows. Note also the non-historic door.

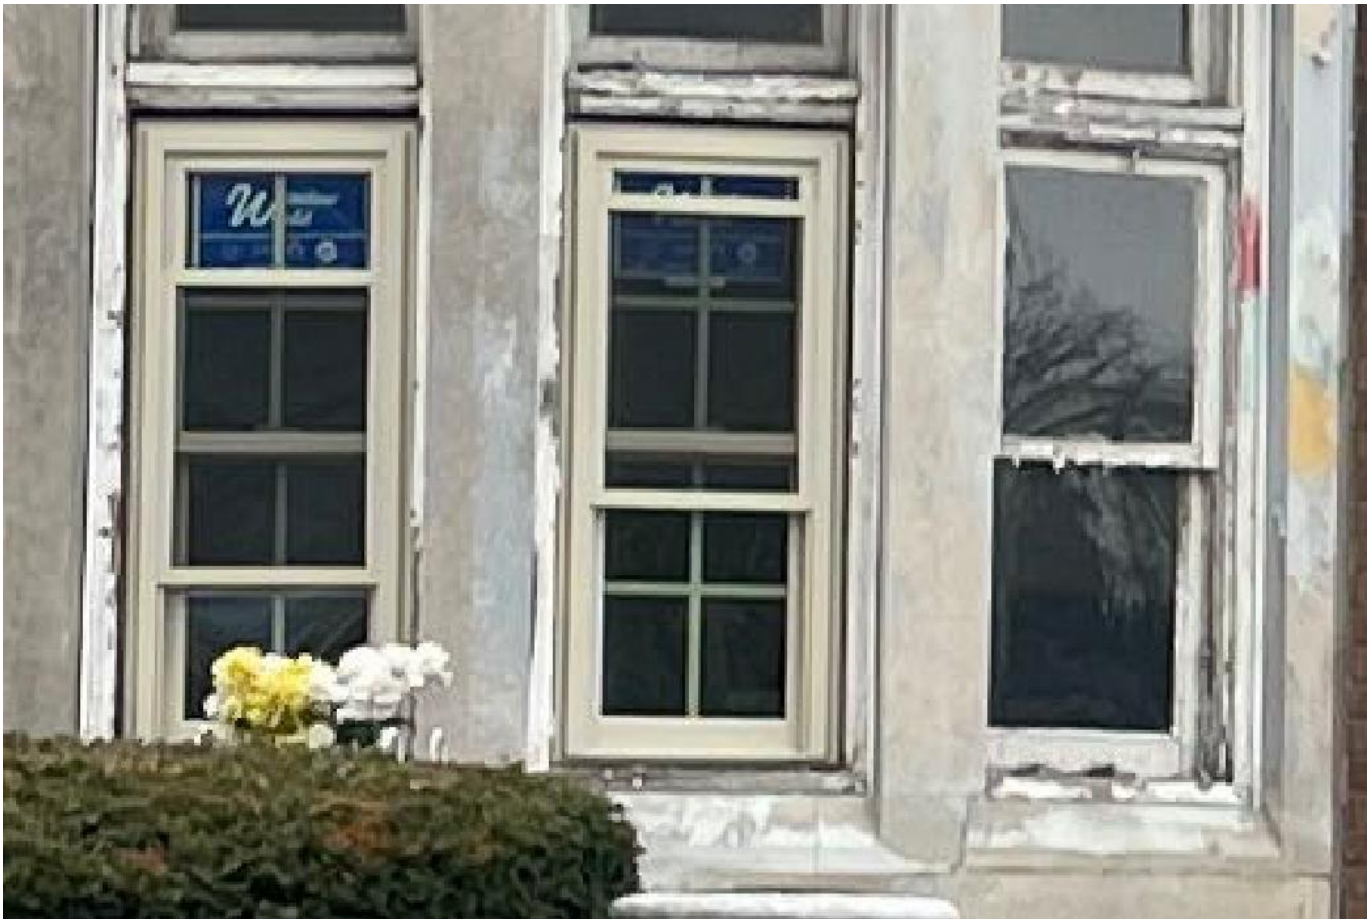
- The replacement windows do not match the three-dimensional qualities of the historic windows (Standard #6).
- The replacement windows do not match the materials of the historic windows (Standard #6).

- The replacement windows, through the use of between-the-glass grilles, add additional subdivisions beyond what is shown in photographic evidence or what would ordinarily be found on a house from its time period and architectural style, contrary to Standard #3 (quoted below).

- The addition of aluminum coil stock constitutes an “alteration of features and spaces that characterize the property” (Standard #2).
- ~~The proposed door appears to contain an oval window with a decorative came pattern; neither the oval shape nor the nature of the pattern reflect features found elsewhere on the building or within the Tudor Revival style as a whole. In addition, the door appears to be unpainted (primed) steel, which is likewise not appropriate for the particular building or the Tudor Revival style in general. Staff notes that the aforementioned National Park Service guidelines state that “substitute materials” are appropriate; potentially, a painted steel door with a rectangular window or no window could be minimally appropriate, depending on the design.~~

December 2022 staff photo comparing historic and new windows.

Therefore, staff recommends that the Commission issue a Denial as the proposed work fails to meet the Secretary of the Interior's Standards for Rehabilitation, in particular:
