STAFF REPORT: 7/12/2023 REGULAR MEETING

APPLICATION NUMBER: #23-8441

ADDRESS: 729 SEWARD

SCOPE: REPLACE WOOD WINDOWS WITH ALUMINUM-CLAD WINDOWS, PAINT PORCH (WORK COMPLETED WITHOUT APPROVAL)

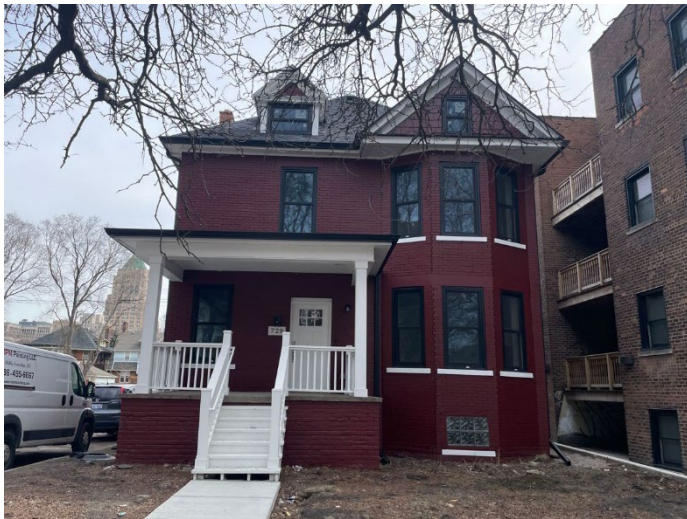
Site Photo 1, by Staff March 24, 2023: (North) front elevation.

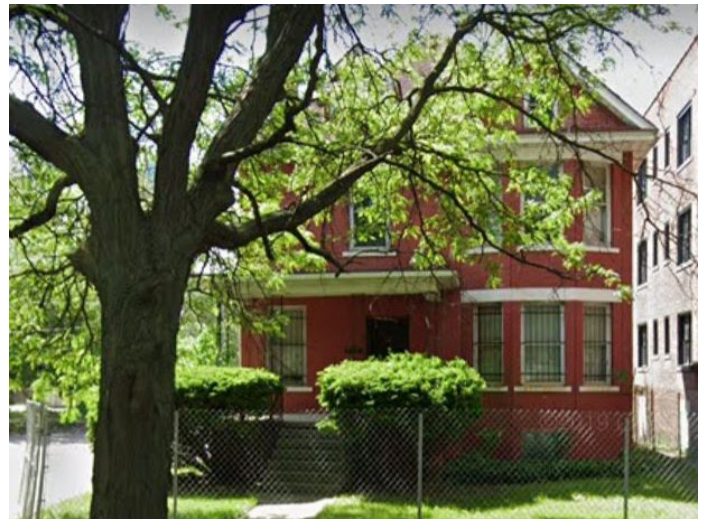
Site Photo 2 by Google Street, June 2019: (North) front elevation showing original windows.

- From the Google Street images and previous images, it is staff’s observation that the original windows were wood, double-hung with a 1/1 configuration. And the windows are recessed in the opening, which creates a dimensionality that is a historic character-defining feature of the building. (Staff has not received a report on the condition of the original windows.) It is staff’s opinion that the original wood windows, their double-hung operation, and their recessed placement in the window opening are distinctive character-defining features that have been removed.

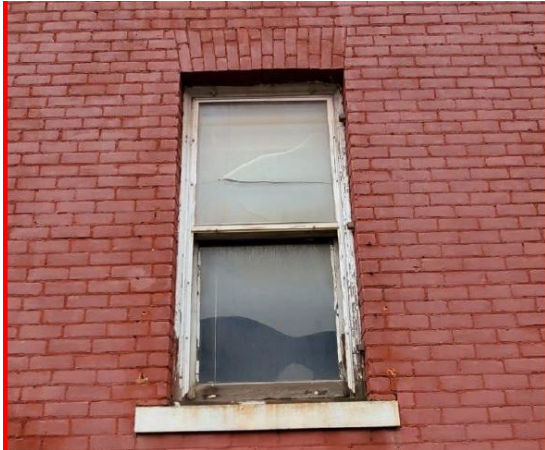
Site Photo 3, by Applicant 2019: (East) side elevation, showing original wood, double-hung window and depth of inset of the sash into the window opening.

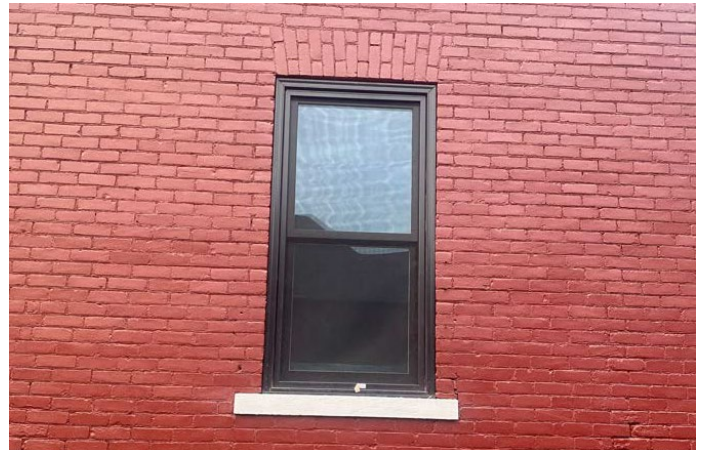
Site Photo 4, by Applicant 2023: (East) side elevation showing new installed window flush with wall opening.

- Some double-hung windows were replaced with single-hung windows.
- The installation of the windows has created a flatness across the exterior of the house, destroying the distinctive, character-defining features of shadow lines and recessed window openings.

- While this application addresses the previously stated issue regarding the flat, wall-like feature that the current installation has created by recessing the unapproved windows deeper into the window openings, it is staff's opinion that the removal of the original wood windows alters the original *design and materiality* and introduces new windows that are incompatible and inappropriate for this historic property, and therefore does not meet the Secretary of the Interior's Standards for Rehabilitation. Some double-hung windows were replaced with single-hung windows, altering the original window's operation.

The current proposal consists of the following work: replace all double-hung, wood windows with Quaker Brighton Series double-hung, aluminum-clad wood windows, color black, per the attached drawings and details, which is the same as the previously submitted application with one difference: all windows will be reinstalled in their respective window openings in a recessed position per the attached window details prepared by the architect of record.

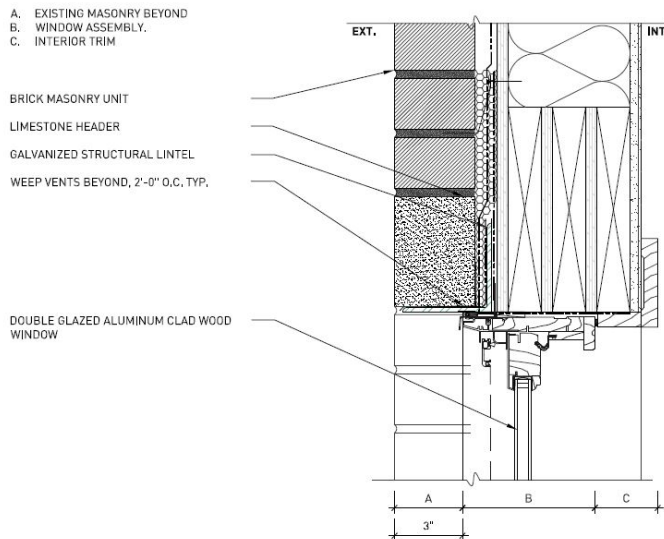
Figure 1, by Applicant 2023: Window head detail, showing 3” recessed inset from exterior wall.

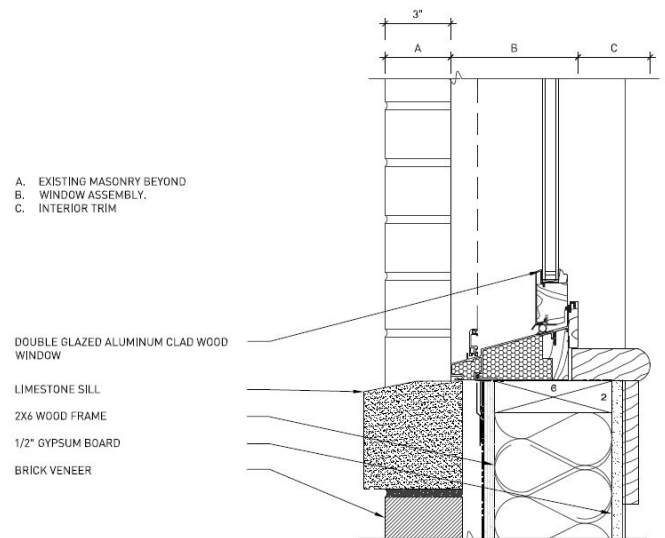
Figure 2, by Applicant 2023: Window sill detail, showing 3” recessed inset from exterior wall.
