**STAFF REPORT: JULY 12, 2023 REGULAR MEETING**

**APPLICATION NUMBER: 23-8435**

**ADDRESS: 19540 SHREWSBURY**

**SCOPE: REPLACE STEEL WINDOWS WITH VINYL WINDOWS**

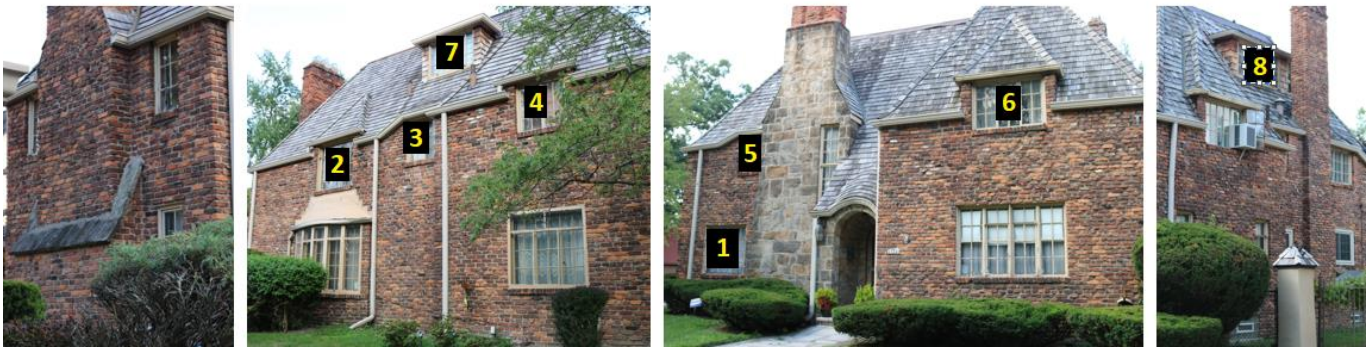
*Windows proposed for replacement. From left to right; Back (northeast): zero windows; side (northwest): 4 windows; front (southwest): 3 windows; side (southeast): 1 window. Illustration by staff.*

The proposed new windows are WeatherGard 700 series vinyl slider windows, tan colored, with flat grids matching the existing divided light pattern. In one instance (window #8 shown above), the installation would require removal of a steel mullion. It is not clear if the metal frames would remain in place.

- Although the remaining windows are described as being difficult to open, this condition can be improved by regular maintenance, such as the removal of layers of paint. They are not beyond repair; Standards #2 and #6 direct that they retained.

- The existing windows proposed for removal are historic and distinctive materials and features that contribute to the character of the property that have not been shown to be deteriorated beyond repair.
- The proposed new windows are not appropriate as they do not match the existing windows in design (they are slider windows rather than casement), visual qualities (the proposed flat grids do not provide the same textural depth as the existing windows), or materials (they are vinyl rather than metal).

### Recommendation One: Denial, replacement of window #1 and #3 through 8

Staff concludes that the proposed replacement of window #1 and windows #3 through 8 (as numbered in the application materials) does not meet the Secretary of the Interior’s Standards for the following reasons:

Therefore, staff recommends that the Commission issue a Denial as the proposed work fails to meet the Secretary of the Interior’s Standards for Rehabilitation, in particular:

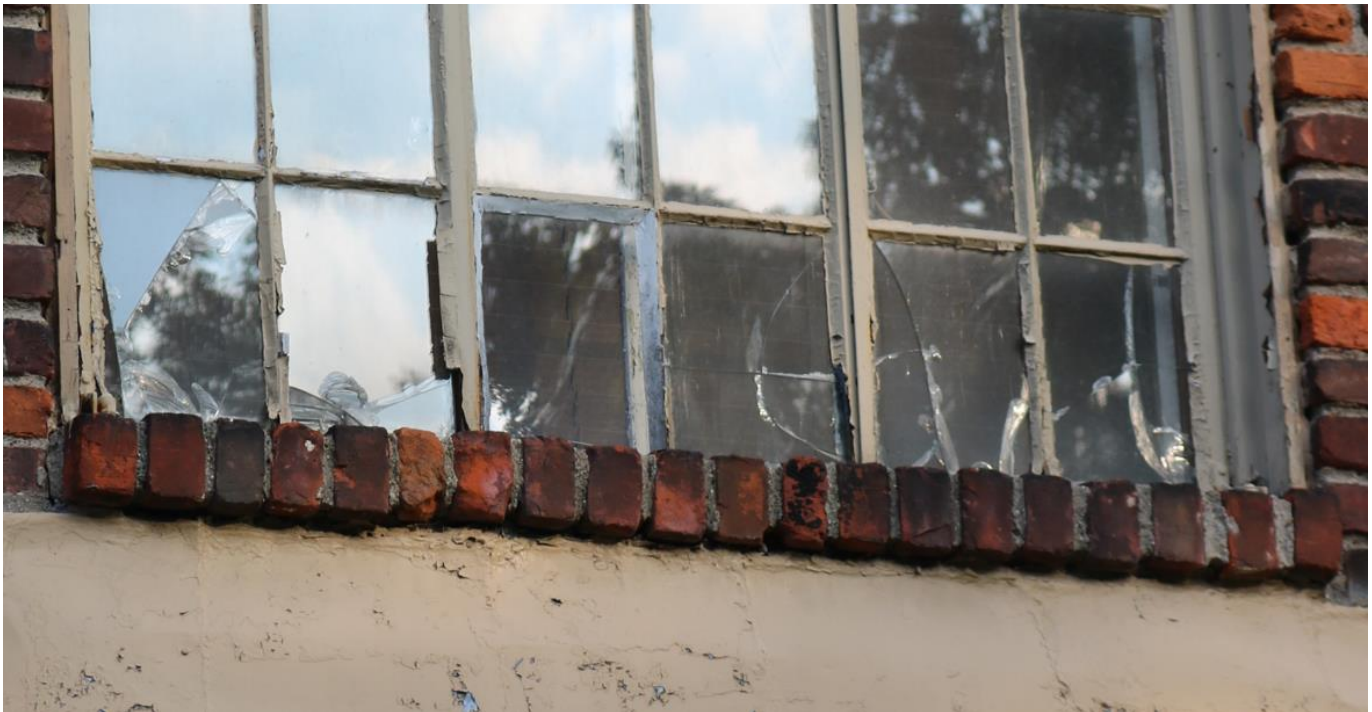
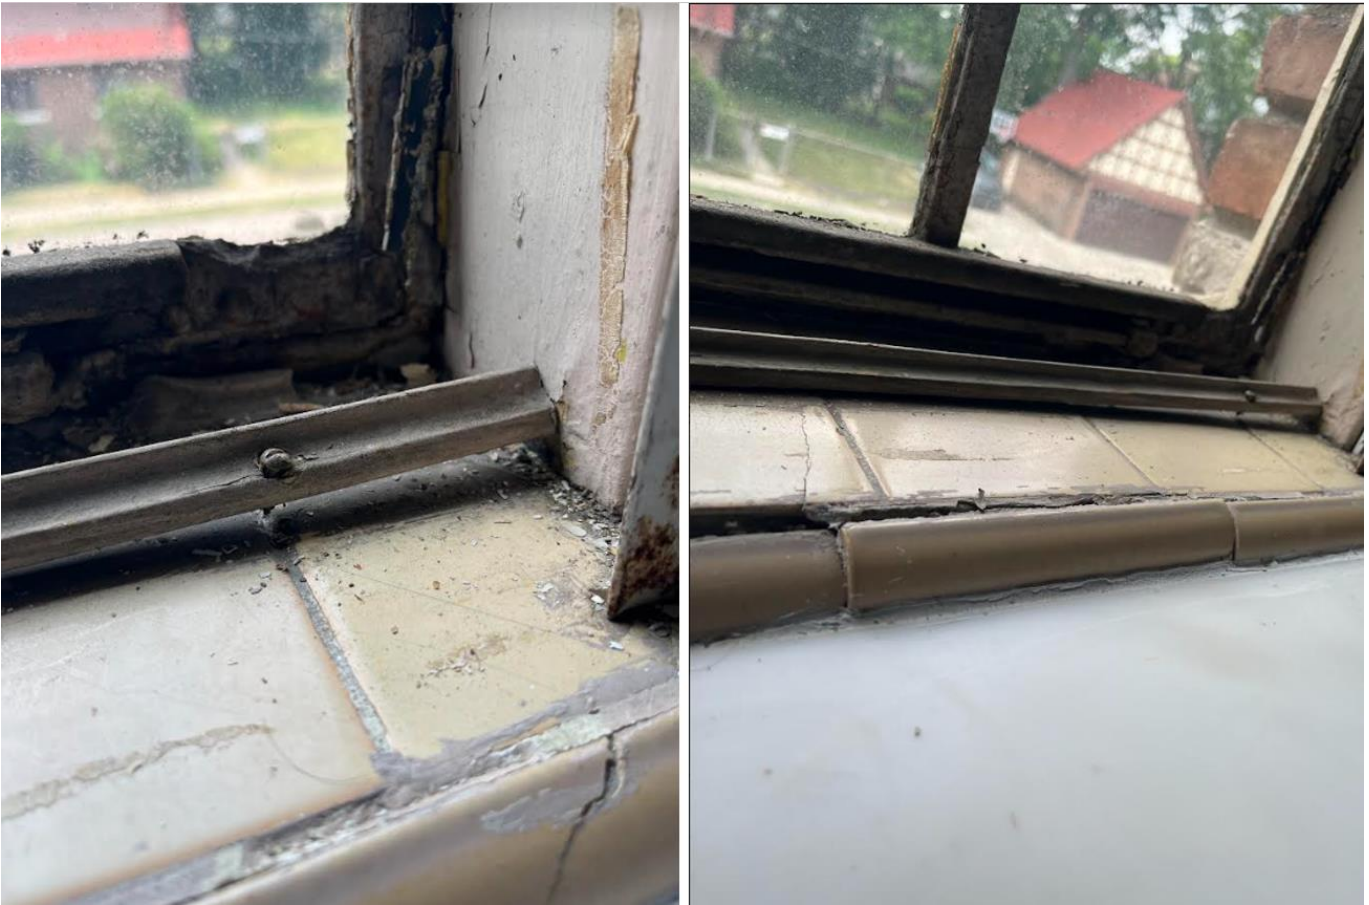
- Staff observes that one of the windows (#2 in the above image) appears to be deteriorated beyond feasible repair. The window shows signs of corrosive expansion, which has deformed the bottom portion of the unit. Broken glass and evidence of prior repairs are visible. A full repair would require removal of the window, disassembly, and the welding in of new rolled steel sections. Even so, the repaired window would be subject to the same deterioration, likely caused by rainwater collecting against the brick sill. Continued expansion of the window would eventually cause additional damage to the building’s exterior and interior.

*Window #2. Photo by staff.*

Window #2. Photo by homeowner.

- Standard #6 allows for the replacement of historic features if they are deteriorated beyond repair, as is the case with window #2. However, the replacement features must “match the old in design, color, texture, and other visual qualities, and where possible, materials.” The proposed windows do not match because they are slider windows, rather than casement, because the grids would not mimic the texture and depth of true divided lights, and because they are vinyl rather than metal.

### Recommendation Two: Certificate of Appropriateness, replacement of window #2

Staff recommends that the Commission issue a Certificate of Appropriateness for the remaining work item (the replacement of window #2, as numbered in the application materials) as it meets the Secretary of the Interior’s Standards for Rehabilitation and the Elements of Design for the Sherwood Forest Historic District with the following condition:

- The new window will be a metal casement window matching the visual qualities of the old window, subject to approval by staff.

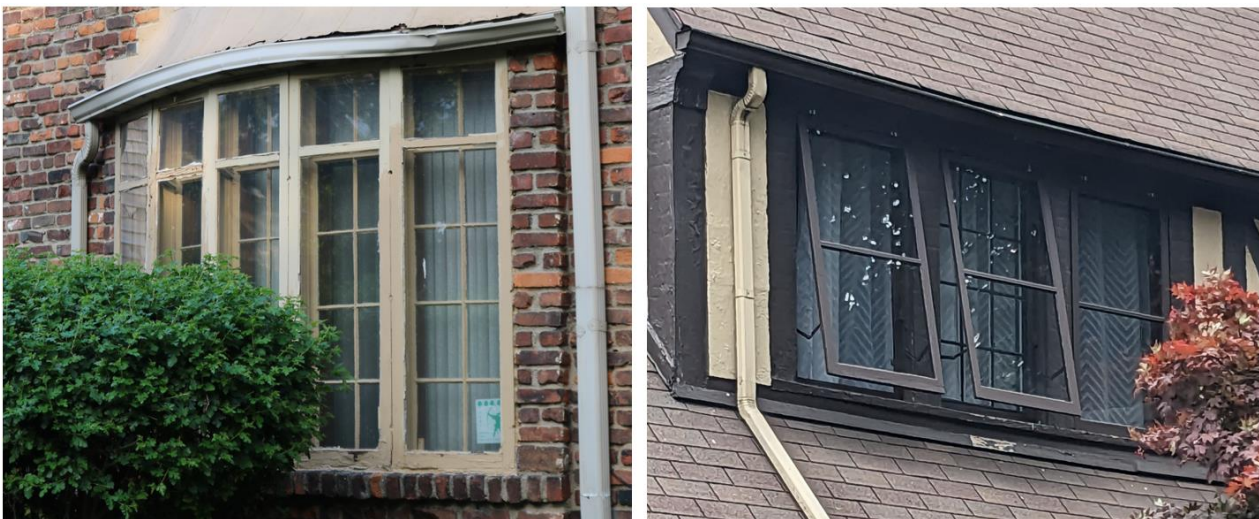
- Staff observes wood storm windows on the northeast-facing, first-floor bay window. Although this window and its storms are not subject of this application, it provides an example of how storm windows can be employed to increase energy efficiency and security. Other, nearby houses show additional examples of functional, well maintained storm windows.

Left: storm windows on subject property. Right: storm windows on adjacent property. Photos by staff.
